**Historic Resources Survey
City of McMinnville
Yamhill County, Oregon**

801 SW Baker Street

Dodson House

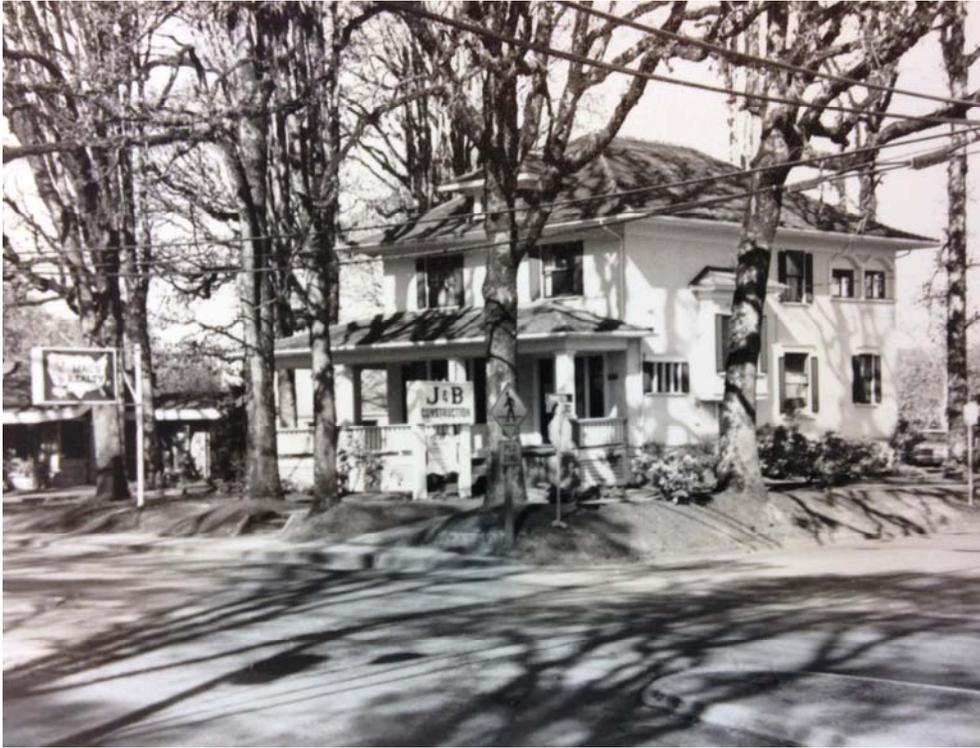
Original 1983 Survey Photo

Slight damage to porch steps (sagging floors of porches).
