CHAPTER 5

STRUCTURAL CONDITION DATA EVALUATION

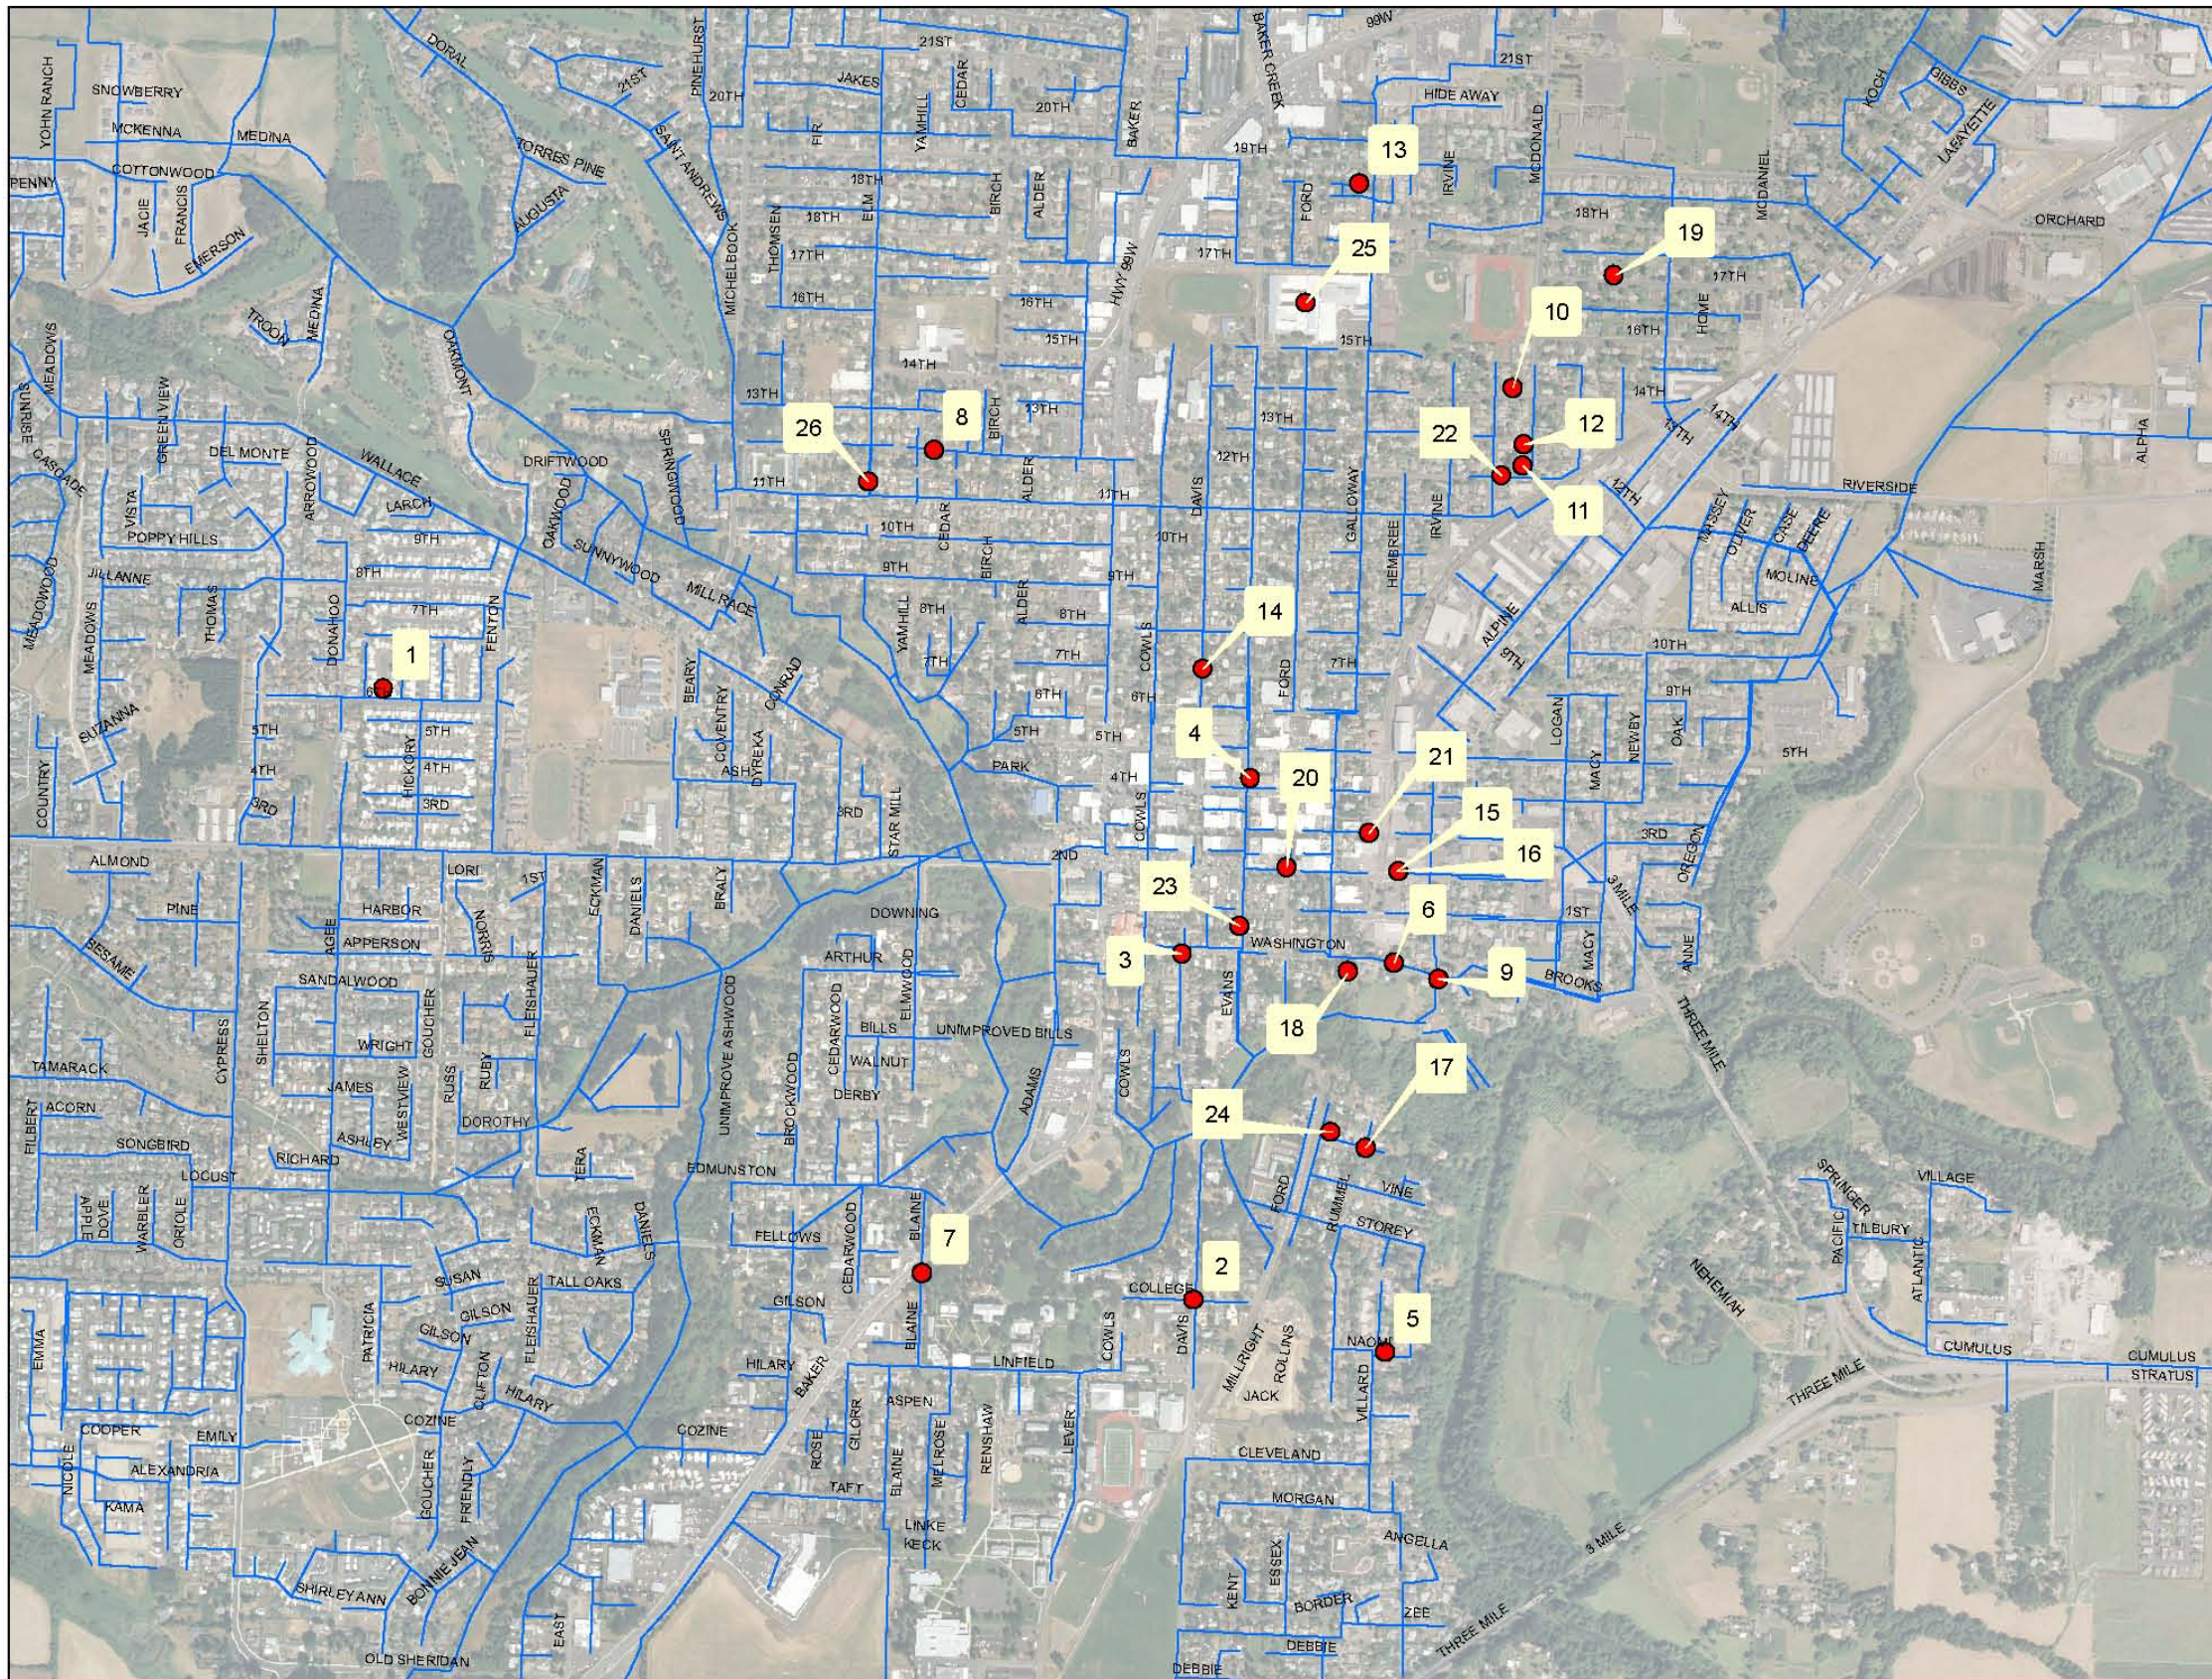
Figure 5-2
City Of McMinnville
Potential & Planned
Projects

Staff identified both planned maintenance projects (as indicated by an assigned budget) and potential maintenance projects, which do not yet have enough detail to assign costs. These have been summarized in Table 5-2, which describes project locations and descriptions. These areas are also generally shown on Figure 5-2. Only some of the listed potential project locations are shown in the figure, due to limited notes regarding project description and location.

It can be observed in Figure 5-2 that the correlation between the pipes identified by maintenance staff and those indicated by high structural ratings in the Hansen system is not great. One reason for this inconsistency is the defect types observed are not causing maintenance related problems. Cracks, ovaling, and leaking joint problems, for example, may not cause the blockages or service interruptions that result in maintenance projects.

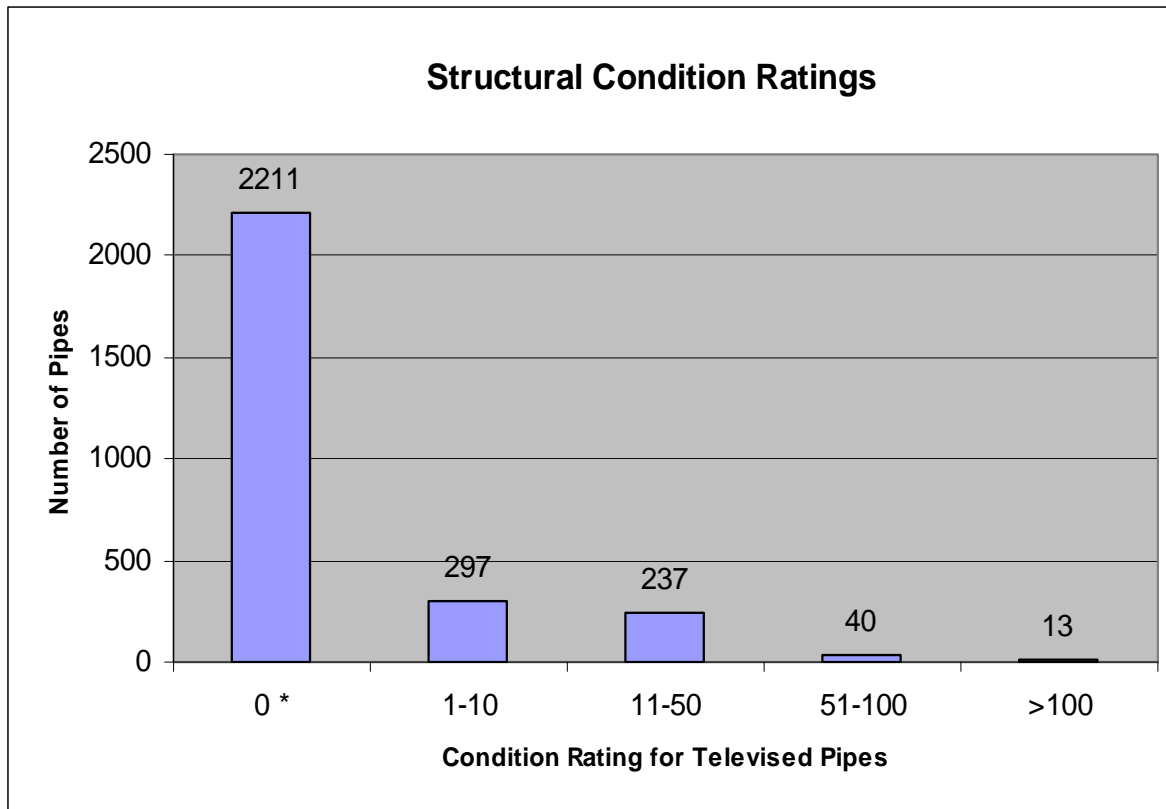
Figure 5-3. Hansen Database Structural Rating Scores for McMinnville Collection System

Staff also provided information from the Hansen system, including identifying labels (GIS Compkey) that match the City’s geographic information system (GIS). In some cases, minor discrepancies between Hansen and GIS occur, such as pipeline length values. The Hansen data contained a structural rating score that is calculated using a formula derived from reported defects. Each defect is assigned a score based on its relative severity. Multiple defects in a single pipe are additive. The Hansen CMMS reports structural rating scores from 0 to a maximum allowed score of 1,000, where higher scores represent pipes that approach failure, although the highest allowed score does not necessarily represent a specific pipe condition. The City’s rated pipes ranged from a score of 0 to 702. Figure 5-3 indicates the rated condition of pipes.

All pipes showing in Figure 5-3 have been inspected. Pipes with a rating score of 0 may be a new pipe, have low spots, dips, misalignments, or other minor defects that are not reported as part of the Hansen structural rating system.

*Pipes with zero rating may possess minor defects that are not registered in the rating system

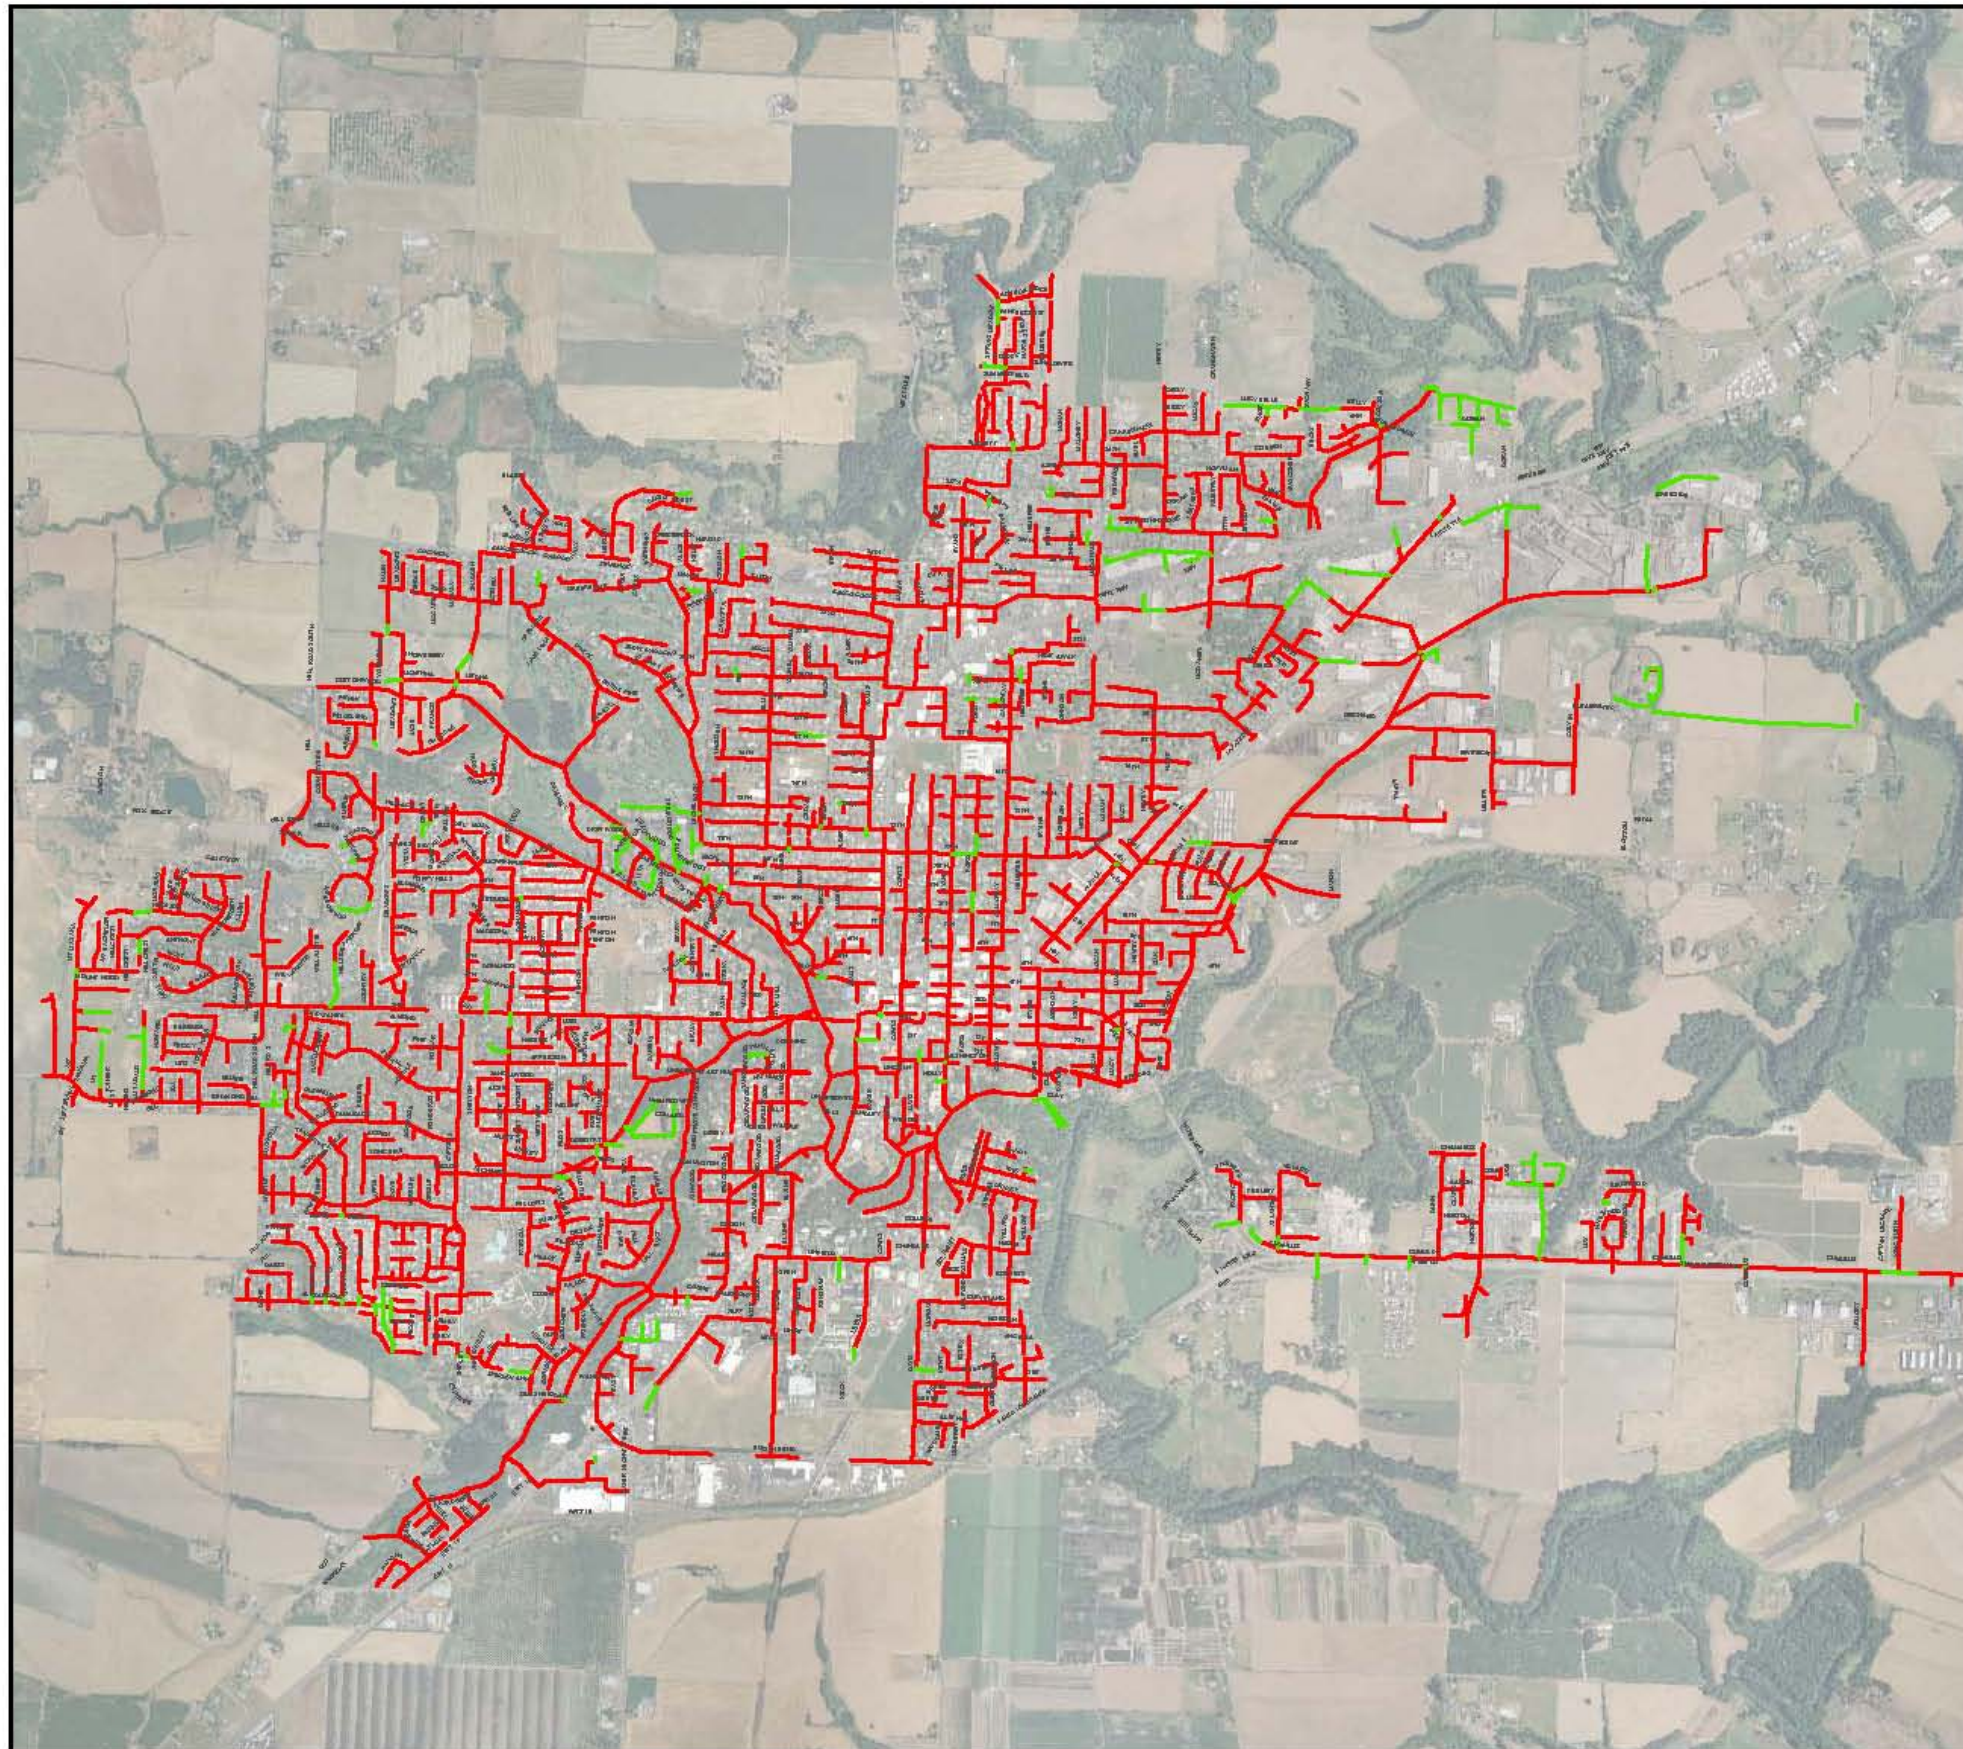
Figure 5-4
City Of McMinnville
TV Inspected
Sanitary Pipelines

Over 90% of the collection system has been inspected as shown on Figure 5-4. There are less than 300 pipes (less than 10%) that have not been TV inspected. In some cases, a blank database entry may indicate an open work order. In those cases, the pipe has been rated previously and is currently in a repair process. As part of work order development, narrative is recorded describing the known defects and associated repair requested.
