FACILITY CONDITION ASSESSMENT

City of McMinnville
231 Northeast Fifth Street
McMinnville, Oregon 97128
Mike Bisset

FACILITY CONDITION ASSESSMENT
OF
AQUATIC CENTER
138 NORTHWEST PARK DRIVE
MCMINNVILLE, OREGON 97128

February 11, 2019

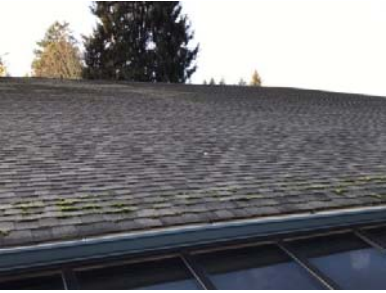
<p>Roof Assembly in Failed condition.</p> <p>Asphalt Shingle, Rigid Insulation, Sleepers Aquatic Center Roof</p> <p>Uniformat Code: B3011 Recommendation: Replace in 2018</p>	<p>Priority Score: 90.0</p> <p>Plan Type: Performance/Integrity</p> <p>Cost Estimate: \$240,800</p> <p>\$\$\$\$</p>
<p>Roof assembly has failed requiring entire system replacements - AssetCALC ID: 1082581</p>

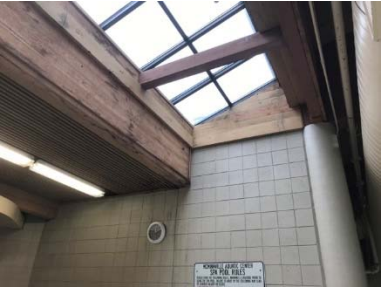
<p>Structural Flooring/Decking in Failed condition.</p> <p>Wood Aquatic Center Roof</p> <p>Uniformat Code: B1012 Recommendation: Repair in 2018</p>	<p>Priority Score: 90.0</p> <p>Plan Type: Performance/Integrity</p> <p>Cost Estimate: \$191,500</p> <p>\$\$\$\$</p>
<p>Roof structure/decking replacement allowance - AssetCALC ID: 1091536</p>

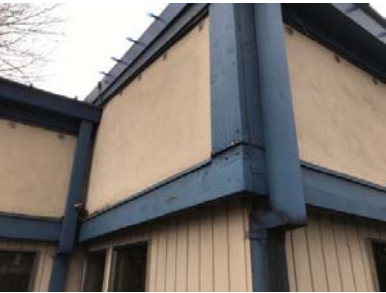
<p>Wood Trim in Poor condition.</p> <p>Exterior Wood Aquatic Center Building Exterior, Original Portion of Structure</p> <p>Uniformat Code: B2011 Recommendation: Replace in 2019</p>	<p>Priority Score: 90.0</p> <p>Plan Type: Performance/Integrity</p> <p>Cost Estimate: \$2,700</p> <p>\$\$\$\$</p>

<p>Wood trim on original portion of structure noted to have widespread evidence of rot and related damage. Replacement required in order to maintain integrity o building envelope - AssetCALC ID: 1082540</p>

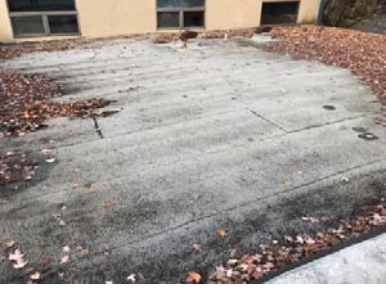
<p>Roof in Poor condition.</p> <p>Modified Bituminous Aquatic Center Roof</p> <p>Uniformat Code: B3011 Recommendation: Replace in 2019</p>	<p>Priority Score: 90.0</p> <p>Plan Type: Performance/Integrity</p> <p>Cost Estimate: \$11,700</p> <p>\$\$\$\$</p>
<p>Roofing at end of its useful life - AssetCALC ID: 1082583</p>

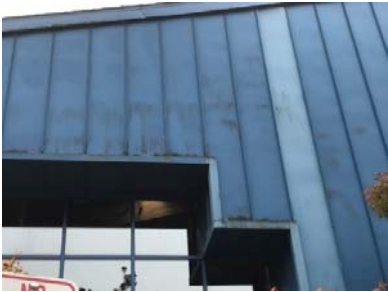
<p>Exterior Wall in Poor condition.</p> <p>Aluminum Siding Aquatic Center Building Exterior</p> <p>Uniformat Code: B2011 Recommendation: Replace in 2020</p>	<p>Priority Score: 90.0</p> <p>Plan Type: Performance/Integrity</p> <p>Cost Estimate: \$84,500</p> <p>\$\$\$\$</p>
<p>Discolored, damaged and unattached wall panels noted throughout - AssetCALC ID: 1082547</p>

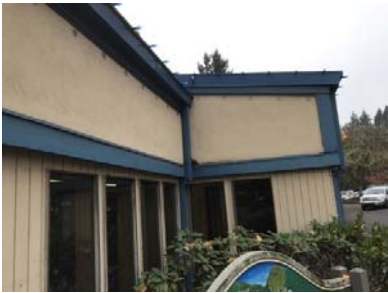
<p>Exterior Walls in Poor condition.</p> <p>Painted Surface Aquatic Center Building Exterior</p> <p>Uniformat Code: B2011 Recommendation: Prep & Paint in 2020</p>	<p>Priority Score: 89.9</p> <p>Plan Type: Performance/Integrity</p> <p>Cost Estimate: \$13,800</p> <p>\$\$\$\$</p>
<p>Stained and discolored painted noted throughout - AssetCALC ID: 1082518</p>

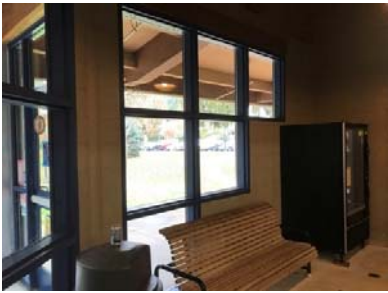
<p>Window in Poor condition.</p> <p>Hollow Metal Aquatic Center Building Exterior, Lobby Area</p> <p>Uniformat Code: B2021 Recommendation: Replace in 2019</p>	<p>Priority Score: 88.0</p> <p>Plan Type: Performance/Integrity</p> <p>Cost Estimate: \$26,700</p> <p>\$\$\$\$</p>

<p>Severe corroding observed - AssetCALC ID: 1082524</p>

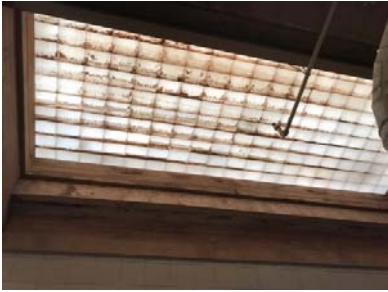
<p>Roof Skylight in Poor condition.</p> <p>Glass Single Unit Aquatic Center Roofs Above Lockers</p> <p>Uniformat Code: B3021 Recommendation: Replace in 2020</p>	<p>Priority Score: 88.0</p> <p>Plan Type: Performance/Integrity</p> <p>Cost Estimate: \$15,800</p> <p>\$\$\$\$</p>
<p>Skylights are not leaking but the insulated air gap between translucent skins appears to have failed - AssetCALC ID: 1082574</p>

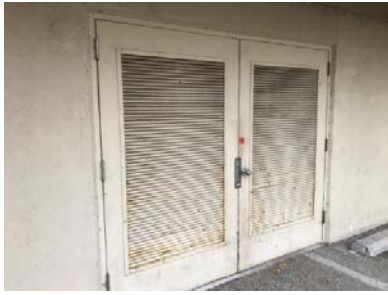
Exterior Door in Poor condition.

Steel
Aquatic Center Building Exterior

Significant corrosion noted - AssetCALC ID: 1082536

Uniformat Code: B2032
Recommendation: **Replace in 2020**

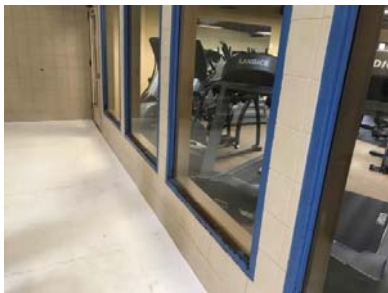
Window in Poor condition.

Steel Fixed
Aquatic Center Natatorium and Lobby

Severe corrosion noted on frames. - AssetCALC ID: 1082532

Uniformat Code: B2021
Recommendation: **Replace in 2020**

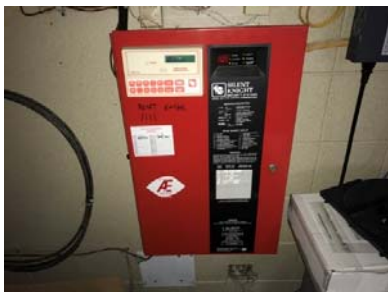
Fire Alarm Control Panel in Poor condition.

Multiplex
Aquatic Center Second Floor Office

Passed useful life - AssetCALC ID: 1082566

Uniformat Code: D5037
Recommendation: **Replace in 2019**

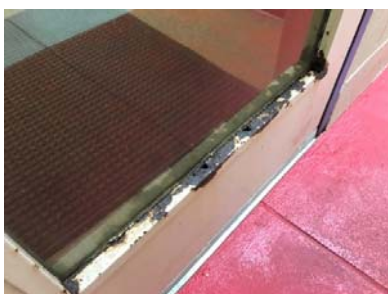
Interior Door in Poor condition.

Steel
Aquatic Center Natatorium, Office & Lobby

Severe corrosion noted due to nightly hosing washing caustic chemicals against steel - AssetCALC ID: 1082586

Uniformat Code: C1021
Recommendation: **Replace in 2020**

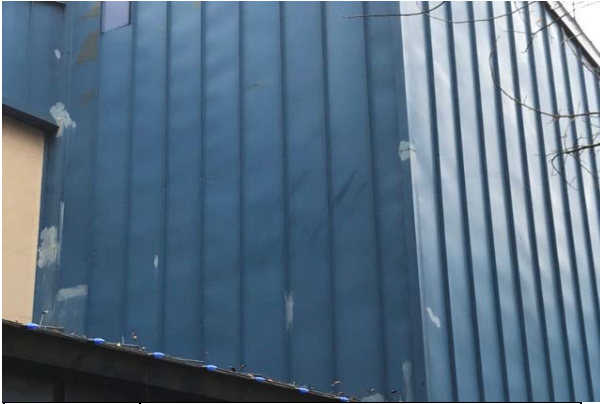
#13	DAMAGED METAL WALL PANELS
-----	---------------------------

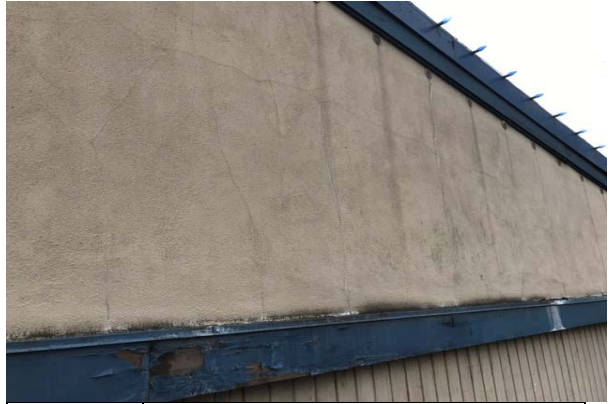
#14	DAMAGED STUCCO WALL ASSEMBLY AND TRIM
-----	---------------------------------------

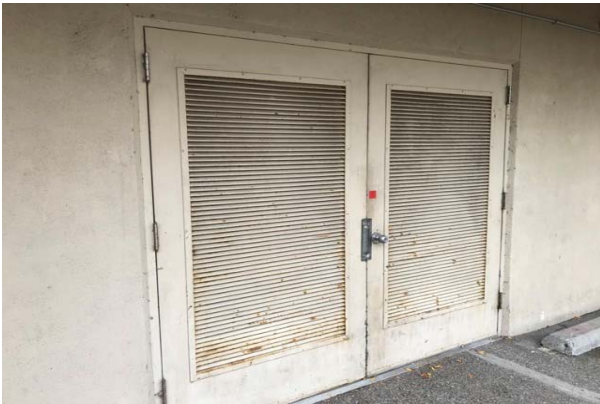
#15	EXTERIOR DOOR, STEEL, REPLACE
-----	-------------------------------

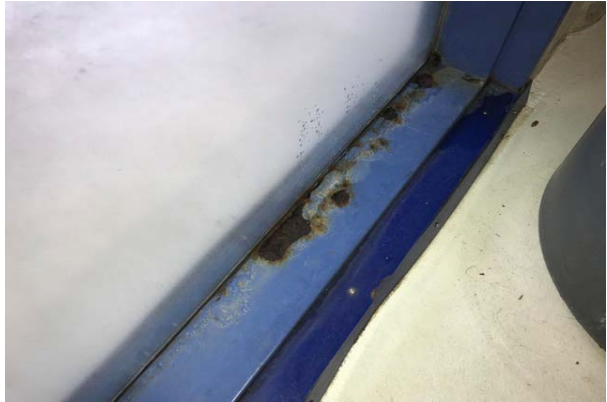
#20	DAMAGED WINDOW FRAME
-----	----------------------

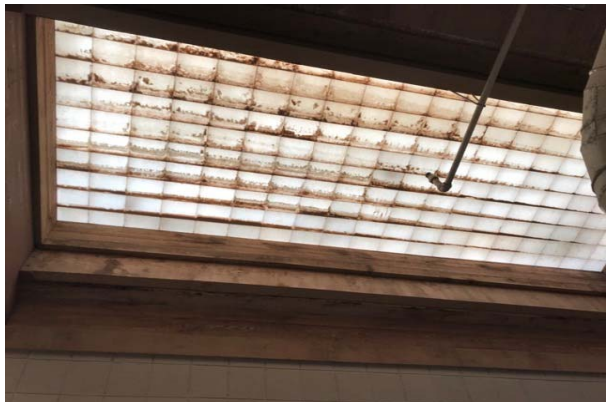
#24	FAILED SKYLIGHTS
-----	------------------

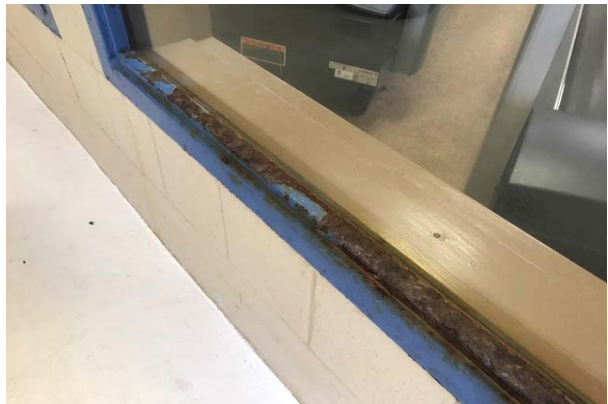
#36	DAMAGED INTERIOR WINDOWS
-----	--------------------------

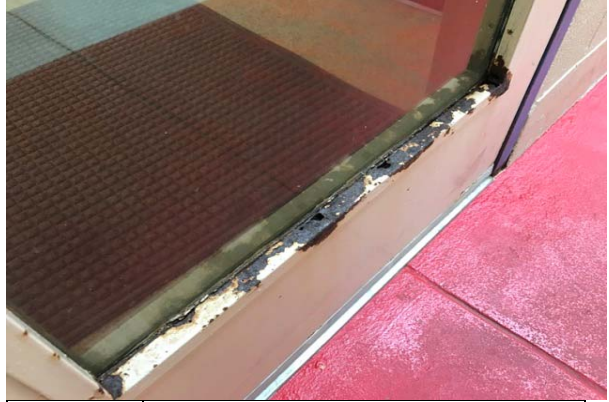
#38	INTERIOR DOOR, CORRODED
-----	-------------------------
