FACILITY CONDITION ASSESSMENT

FACILITY CONDITION ASSESSMENT
OF
COMMUNITY CENTER
600 NORTHEAST EVANS STREET
MCMINNVILLE, OREGON 97128

February 8, 2019

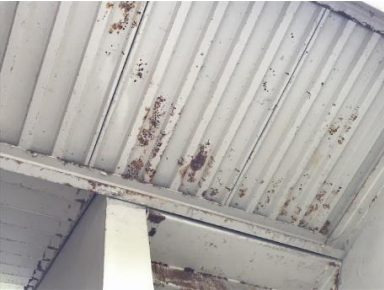
<p>Structural Flooring/Decking in Failed condition.</p> <p>Concrete Community Center Southwest Exit Stair</p> <p>Uniformat Code: B1012 Recommendation: Replace in 2018</p>	<p>Priority Score: 99.0</p> <p>Plan Type: Safety</p> <p>Cost Estimate: \$9,500</p> <p>\$\$\$\$</p>
<p>Metal pans on stair landings have corroded and failed and require immediate replacement - AssetCALC ID: 1018477</p>

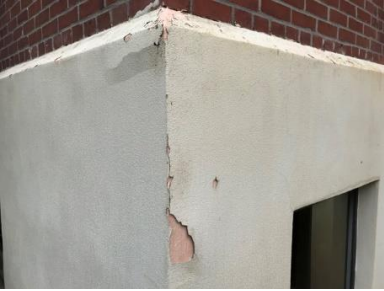
<p>Exterior Wall in Poor condition.</p> <p>Stucco, 1-2 Stories Community Center Building Exterior, Lower Floor</p> <p>Uniformat Code: B2011 Recommendation: Replace in 2018</p>	<p>Priority Score: 90.0</p> <p>Plan Type: Performance/Integrity</p> <p>Cost Estimate: \$5,100</p> <p>\$\$\$\$</p>
<p>Stucco textured surface failing at several locations - AssetCALC ID: 1018459</p>

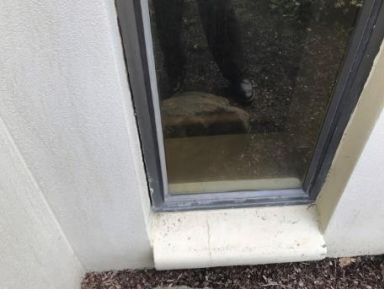
<p>Exterior Windows in Poor condition.</p> <p>Joint Caulking 0" to 1/2", 1-2 Stories Community Center Building Exterior</p> <p>Uniformat Code: B2011 Recommendation: Replace in 2018</p>	<p>Priority Score: 90.0</p> <p>Plan Type: Performance/Integrity</p> <p>Cost Estimate: \$5,000</p> <p>\$\$\$\$</p>

<p>Caulking notice to be missing and certain locations and some leaking reported - AssetCALC ID: 1018458</p>

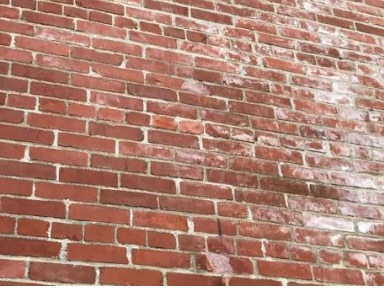
<p>Exterior Wall in Poor condition.</p> <p>Brick or Brick Veneer Community Center Exterior Walls, Concentrated on North elevation</p> <p>Uniformat Code: B2011 Recommendation: Repoint in 2018</p>	<p>Priority Score: 90.0</p> <p>Plan Type: Performance/Integrity</p> <p>Cost Estimate: \$292,300</p> <p>\$\$\$\$</p>
<p>Mortar on north face was not repointed when other sides were repaired. Fern observed growing in mortar cracks on top floor. - AssetCALC ID: 1018546</p>

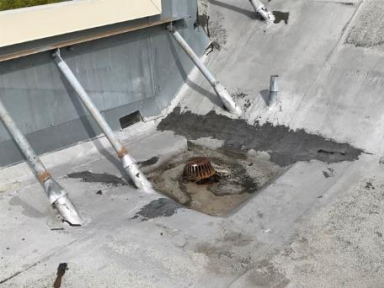
Roof in Poor condition. Priority Score: **90.0**

Built-Up
Community Center Joint of Barrel Vault and Flat Roof

Uniformat Code: B3011
Recommendation: **Repair in 2018**

Apply overall covering to replace temporary patches, possibly metal flashing at joint of vault and flat roof. - AssetCALC ID: 1032245

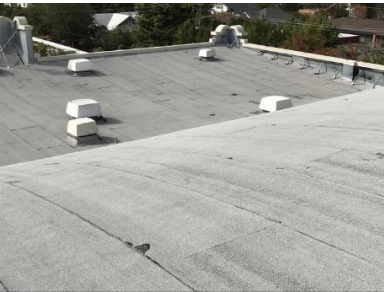
Roof in Poor condition. Priority Score: **90.0**

Modified Bituminous
Community Center Roof

POC reported that there were a number of previous leaks and repairs - AssetCALC ID: 1018552

Uniformat Code: B3011
Recommendation: **Replace in 2020**

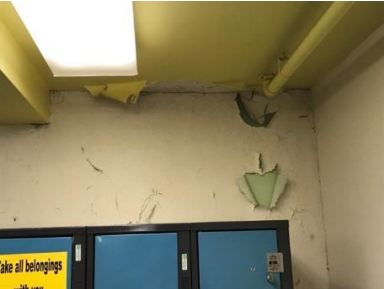
Basement Wall in Failed condition. Priority Score: **89.9**

Concrete
Community Center Men's Locker Room 112

Peeling paint indicate the presence of moisture or moisture vapor. Condition located nearby other areas of previous water intrusion - AssetCALC ID: 1018485

Uniformat Code: A2021
Recommendation: **Prep and amp; Paint in 2018**

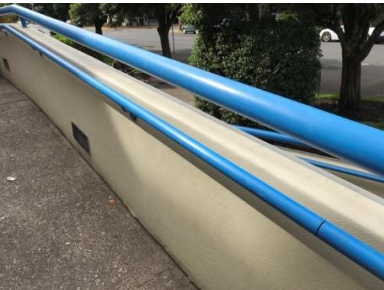
Exterior Wall in Poor condition. Priority Score: **89.9**

Painted Surface, 1-2 Stories
Community Center Building Exterior

paint coating are stained and peeling - AssetCALC ID: 1018492

Uniformat Code: B2011
Recommendation: **Prep and amp; Paint in 2020**

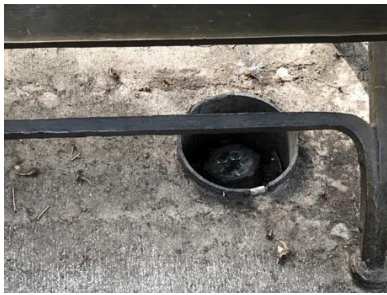
LED Lighting Fixtures in Failed condition.

Exterior, Ground Mounted
Community Center Front Entrance Plaza

Fixture below and around the bench appears to be damaged - AssetCALC ID: 1018502

Uniformat Code: D5022
Recommendation: **Replace in 2018**

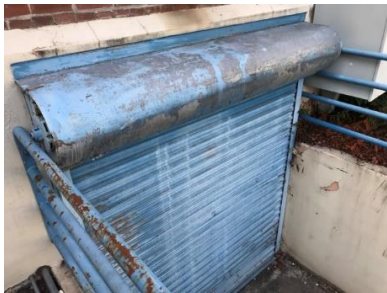
Overhead Door in Poor condition.

Steel Roll-Up 144 SF
Community Center Building Exterior, Southeast Corner

Severe corrosion and daylight visible - AssetCALC ID: 1018531

Uniformat Code: B2034
Recommendation: **Replace in 2020**

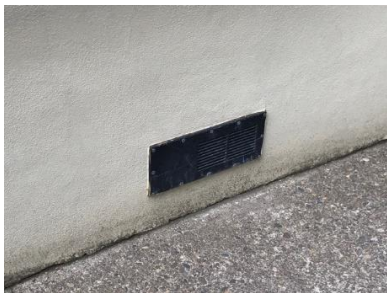
Flood Light in Poor condition.

Exterior, HID
Community Center Exterior Walls

Lighting appears to be near the end of its useful life - AssetCALC ID: 1018534

Uniformat Code: D5022
Recommendation: **Replace in 2020**

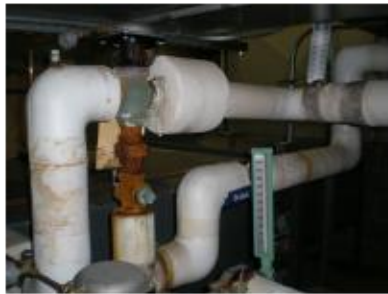
HVAC System Piping Repairs in Poor condition.

Copper (Uniformat Code: D3049)
 Community Center Boiler room
 Recommendation: **Replace** in 2018.

Piping and valves are currently leaking and have significant rusted pipe locations.
 AssetCALC ID: 1032247

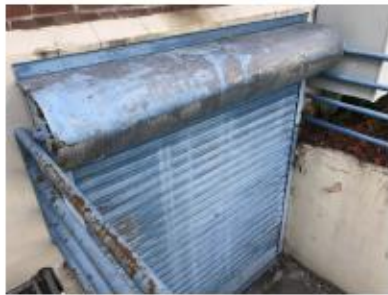
Overhead Door in Poor condition.

Steel Roll-Up 144 SF (Uniformat Code: B2034)
 Community Center Building Exterior, Southeast Corner
 Recommendation: **Replace** in 2020.
 Severe corrosion and daylight visible
 AssetCALC ID: 1018531

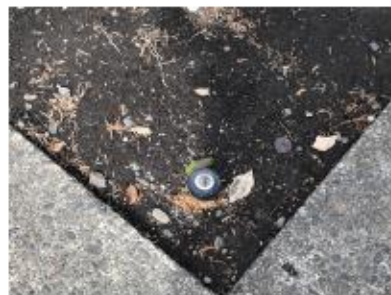
Irrigation System in Failed condition.

Underground (Uniformat Code: G2057)
 Community Center Site
 Recommendation: **Replace** in 2018.

POC reported that the landscape irrigation system is not operating
 AssetCALC ID: 1018537

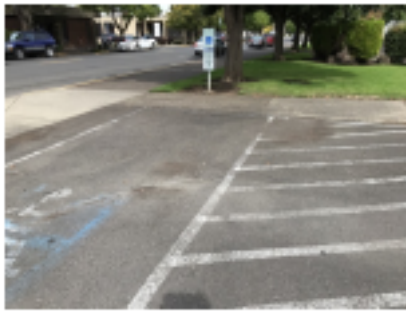
Parking Lots in Poor condition.

Asphalt Pavement (Uniformat Code: G2022)

Recommendation: **Seal & Stripe** in 2020.

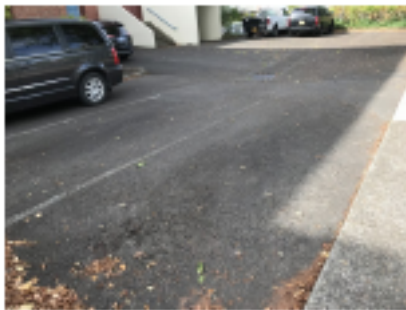
Parking Lots in Poor condition.

Asphalt Pavement (Uniformat Code: G2022)

Portions of the parking areas exhibit damage requiring mill and overlay
AssetCALC ID: 1018495

Recommendation: **Mill & Overlay** in 2020.

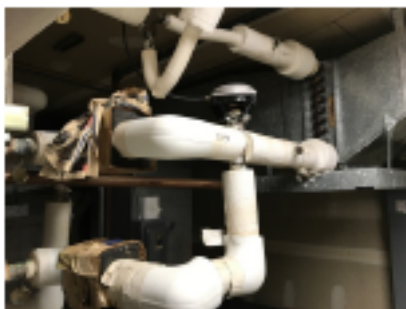
HVAC System Hydronic Piping in Poor condition.

2-Pipe (Uniformat Code: D3049)

POC reported a history of leaking indicating that piping reach the ends of its useful life
AssetCALC ID: 1018547

Recommendation: **Replace** in 2020.

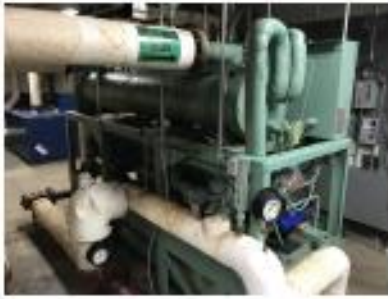
Chiller in Poor condition.

Carrier 30 HR080 CG00 (Uniformat Code: D3031)

POC reported that one of the 3 compressors was not working but that chiller still satisfies actual demand

Recommendation: **Replace** in 2020.

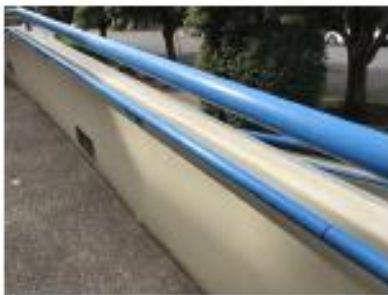
Exterior Wall in Poor condition.

Painted Surface, 1-2 Stories (Uniformat Code: B2011)

paint coating are stained and peeling

Recommendation: **Prep & Paint** in 2020.

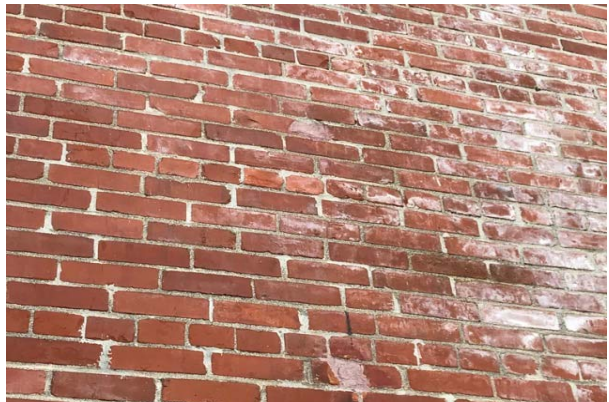
#12	DEGRADED MASONRY
-----	------------------

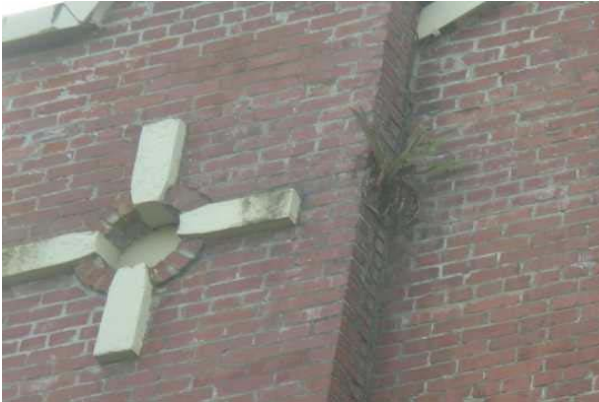
There is damaged masonry grout on the North side of the building and repointing is recommended. The fern growing on the upper floor wall should be removed.

#13	DAMAGED MASONRY GROUT
-----	-----------------------

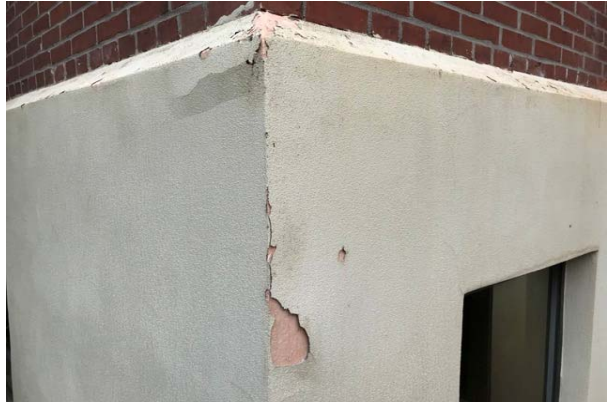
#14	DAMAGED STUCCO TEXTURE
-----	------------------------

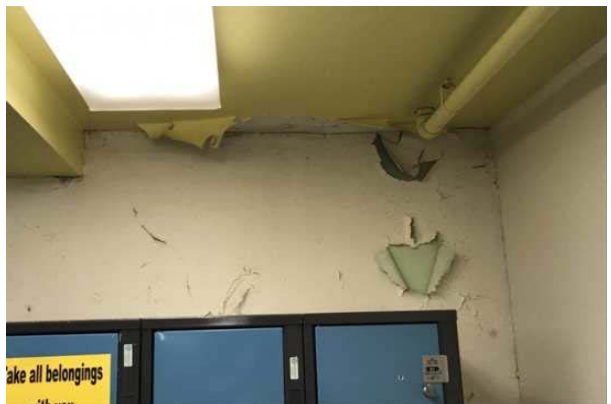
#18	WATER LEAK IN MEN'S LOCKER ROOM
-----	---------------------------------

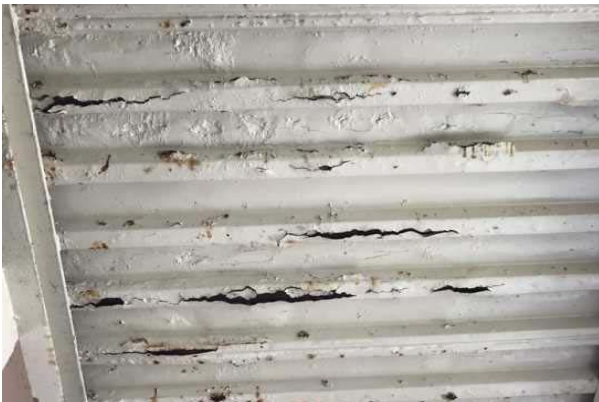
There is significant damage to the exterior exit stair landings.

#23	FAILED STAIR LANDING
-----	----------------------

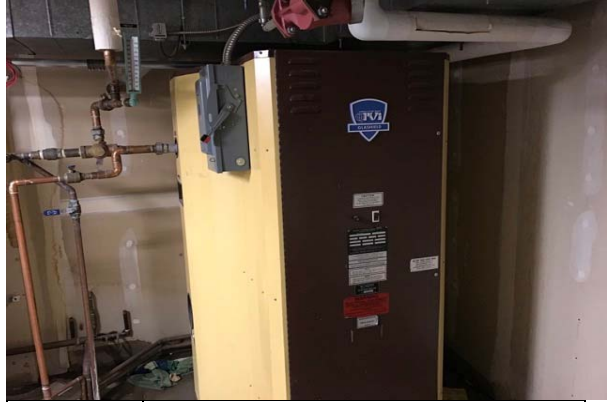
The older domestic water boiler leaked and reportedly in failed condition.

#38	FAILED DOMESTIC WATER HEATER
-----	------------------------------
