# TIER 1 SEISMIC ASSESSMENT

TIER 1 SEISMIC ASSESSMENT  
OF  
COMMUNITY CENTER  
600 NORTHEAST EVANS STREET  
MCMINNVILLE, OREGON 97128

132218.18R000-001.002

October 16, 2018

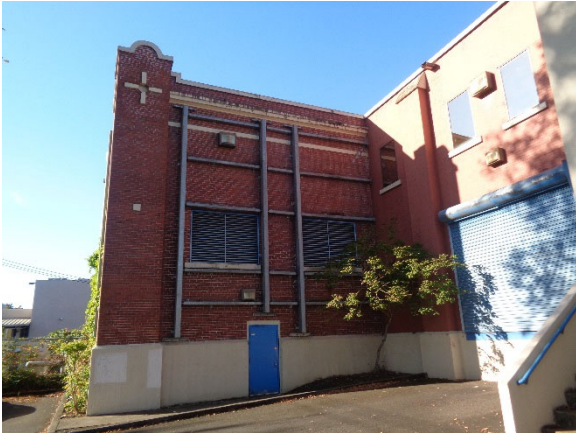
#7	ELEMENTS OF PRIOR RETROFIT
----	----------------------------

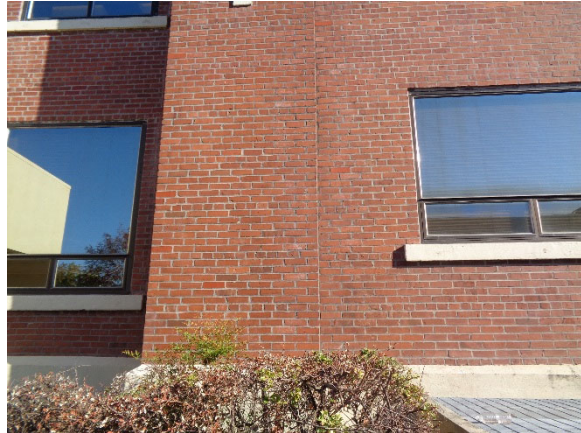
The mortar joints of the masonry walls are in very good condition as they were repointed in approximately 2000.

#8	MASONRY
----	---------

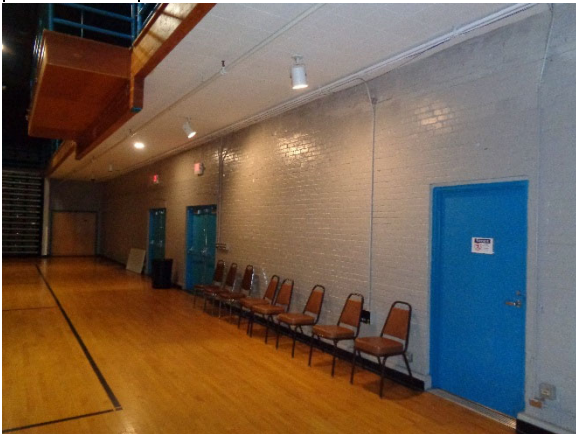
2. Shear Stress Check – The masonry shear walls do not have sufficient shear strength to meet the IO performance goal. Additionally, they also do not meet the lower performance option of Life Safety. This indicates the walls may experience earthquake damage that would reduce the strength of the building such that it cannot be occupied until repairs are made. The Tier 1 criteria is based on a low allowable stress. A more detailed engineering analysis such as a Tier 2 evaluation may find that the walls have sufficient strength for the actual demands. The 1994 seismic upgrade did not strengthen the shear walls for in-plane forces. The available drawings do not state if the in-plane strength was evaluated at that time or to what criteria.

#9	INTERIOR MASONRY SHEAR WALL
----	-----------------------------

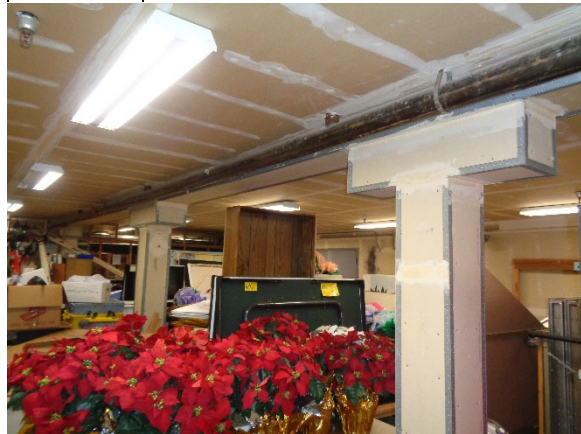
#10	BASEMENT COLUMNS
-----	------------------

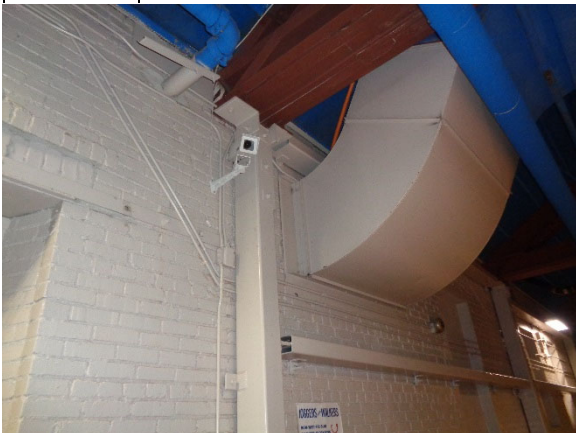
#11	INTERIOR RETROFIT ELEMENTS
-----	----------------------------

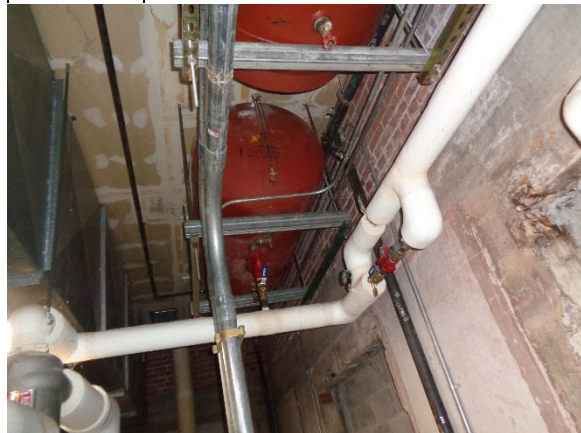
7. Suspended Equipment – mechanical, electrical, or plumbing equipment that is suspended should either be restrained against swinging or free to swing without damaging itself or adjacent components. In the mechanical room in the basement, two tanks were observed on supports hung from the floor above. No bracing was observed.

#12	SUSPENDED TANKS, UNBRACED
-----	---------------------------

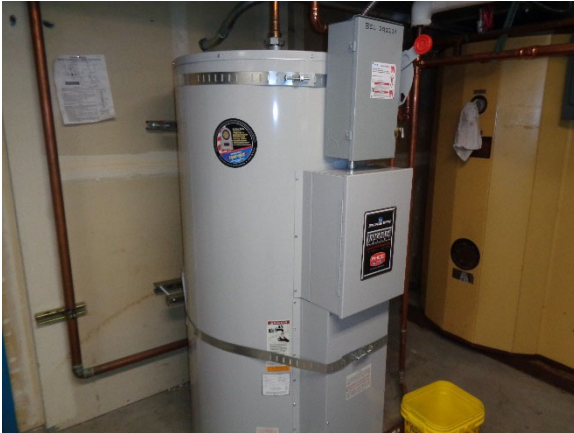
#13	RESTRAINED WATER HEATER
-----	-------------------------

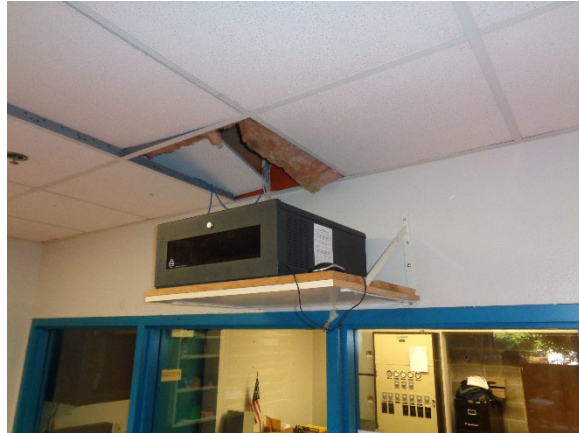
6. Fall-Prone Contents – Equipment or stored items that weigh over 20 pounds located 4 feet or more above the floor should be restrained from falling off shelves. Items were not weighed for this evaluation but there were a few items observed that may exceed 20 lb. and be recommended to have some kind of restraint. A computer up on a shelf in the storage room, for example, could have a strap added or an edge to the shelf to prevent the computer from sliding off the shelf.

#14	UNRESTRAINED COMPUTER ON HIGH SHELF
-----	-------------------------------------

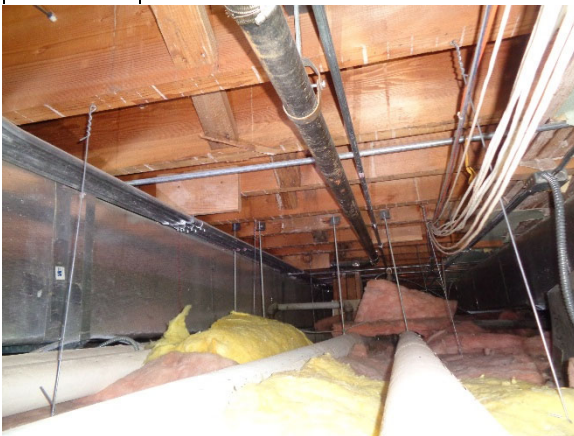
8. Fluid Piping – piping should be braced to the structure to limit displacement and potential for leaks or failures. The primary piping type observe in the building is domestic water. Piping was observed just above the suspended ceiling with no bracing. Water leaks due to earthquake shaking are common. To mitigate the risk, pipes should be supported by the structure in a manner that limits differential movement. Typically, hangers less than 1-foot in length or with periodic diagonal bracing is the method used to meet these criteria.

#15	ABOVE CEILING SPACE WITH UNBRACED PIPING AT BOTTOM
-----	--

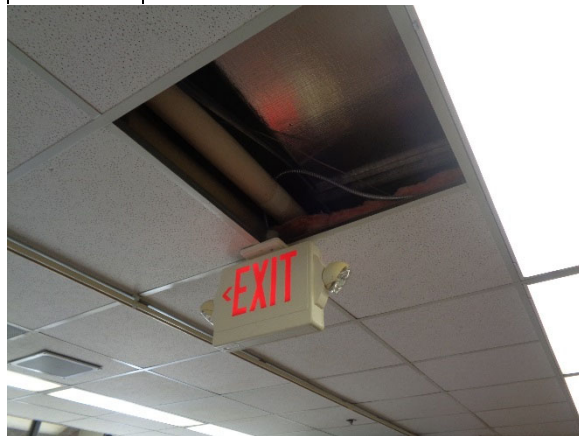
#16	EMERGENCY EXIT LIGHTING SUPPORTED BY SUSPENDED CEILING
-----	--

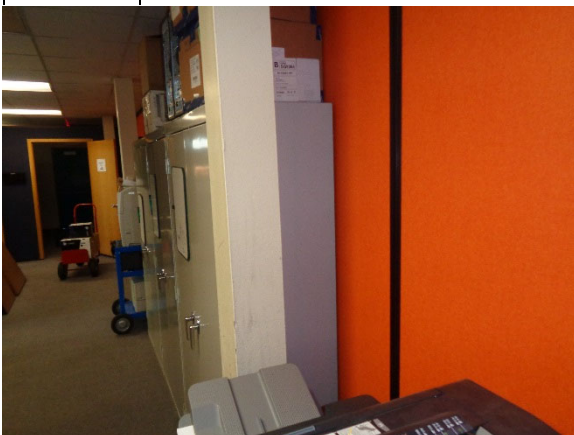
5. Tall Narrow Contents – There were only a few pieces of furniture or storage shelves taller than 6-ft. however, those observed were not restrained from tipping over.

#17	TALL NARROW CONTENTS, UNBRACED
-----	--------------------------------

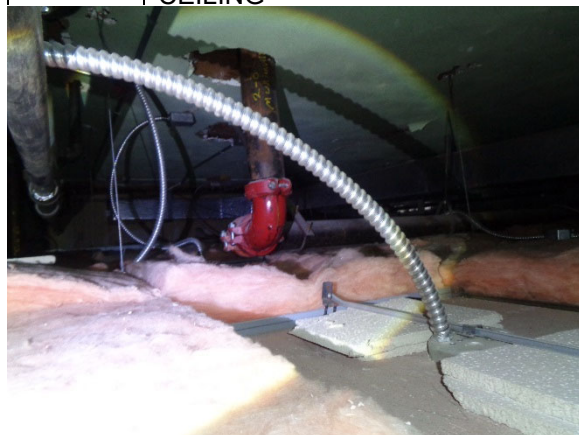
#18	BRACED FIRE SUPPRESSION PIPING
-----	--------------------------------
