FACILITY CONDITION ASSESSMENT

SENIOR CENTER
2250 NORTHEAST MCDANIEL
MCMINNVILLE, OREGON 97128

February 11, 2019

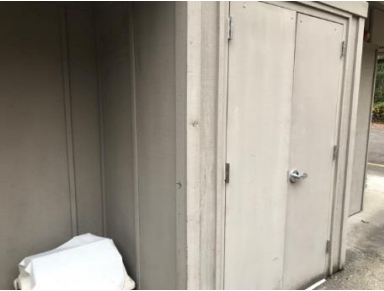
<p>Exterior Door in Poor condition.</p>	<p>Priority Score: 88.0</p>
	<p>Wood Solid-Core Senior Center Building Exterior</p>	<p>Plan Type: Performance/Integrity</p>
	<p>Uniformat Code: B2032 Recommendation: Replace in 2019</p>	<p>Cost Estimate: \$3,200</p>
		<p>\$\$\$\$</p>
<p>The exterior doors to the main panel board closets are at the end of their expected useful life, and are currently stuck closed due to broken strike plate. - AssetCALC ID: 1085847</p>

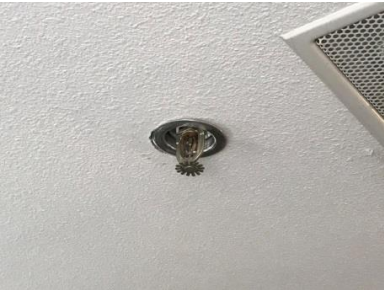
<p>Sprinkler Heads (per SF) in Poor condition.</p>	<p>Priority Score: 88.0</p>
	<p>Commercial Senior Center Throughout Building</p>	<p>Plan Type: Performance/Integrity</p>
	<p>Uniformat Code: D4019 Recommendation: Replace in 2019</p>	<p>Cost Estimate: \$15,100</p>
		<p>\$\$\$\$</p>
<p>According to Pre Survey Questionnaire, Unresolved building, fire or zoning issues, the sprinkler heads throughout the building require replacement. - AssetCALC ID: 1085814</p>

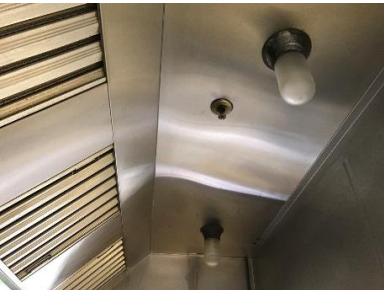
<p>Kitchen Fire Suppression System</p>	<p>Priority Score: 61.0</p>
	<p>Commercial Senior Center Kitchen Exhaust Hood</p>	<p>Plan Type: Modernization/Adaptation</p>
	<p>Uniformat Code: D4091 Recommendation: Replace in 2018</p>	<p>Cost Estimate: \$5,000</p>
		<p>\$\$\$\$</p>
<p>According to Pre-Survey Questionnaire, the kitchen fire suppression is been identified as a fire code violation. Currently a sprinkler head is installed in place of approved agent. - AssetCALC ID: 1088264</p>

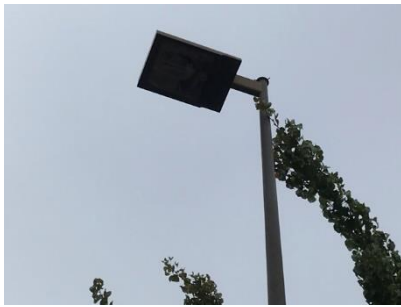
Pole Light

According to Pre-Survey Questionnaire, inadequate lighting in parking lot. This is an allowance for the installation of two more pole lights. - AssetCALC ID: 1088265

Uniformat Code: G4021
Recommendation: **Replace/Install in 2018**

Cost Estimate: \$10,500
