Architectural
Resources Group

609, 611, and 619 NE 3rd Street
McMinnville, Oregon

Historic Resource Assessment
November 2022

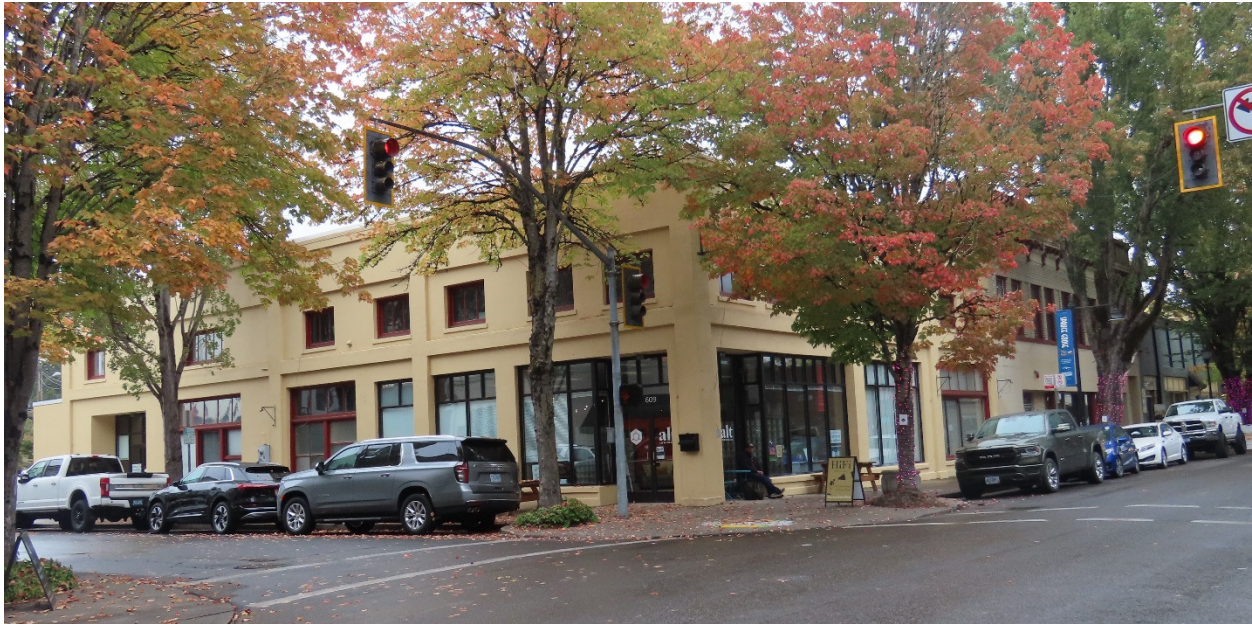
The bays at the corner of the ground floor have been infilled with the current street-facing storefront; three original storefront bays remain (ARG, October 2022).

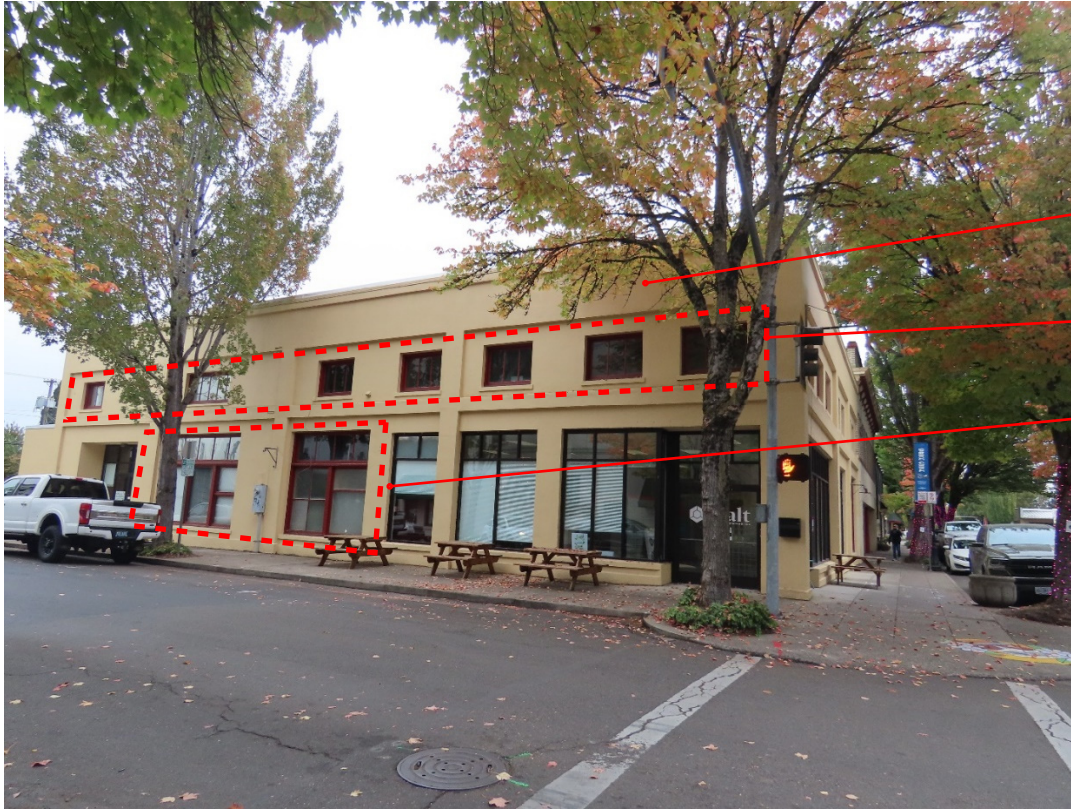
Stucco added over historic brick

Original wood windows, frames and sash

Original wood frames and sash

West Elevation facing NE Ford Street, illustrating original features (ARG, October 2022).

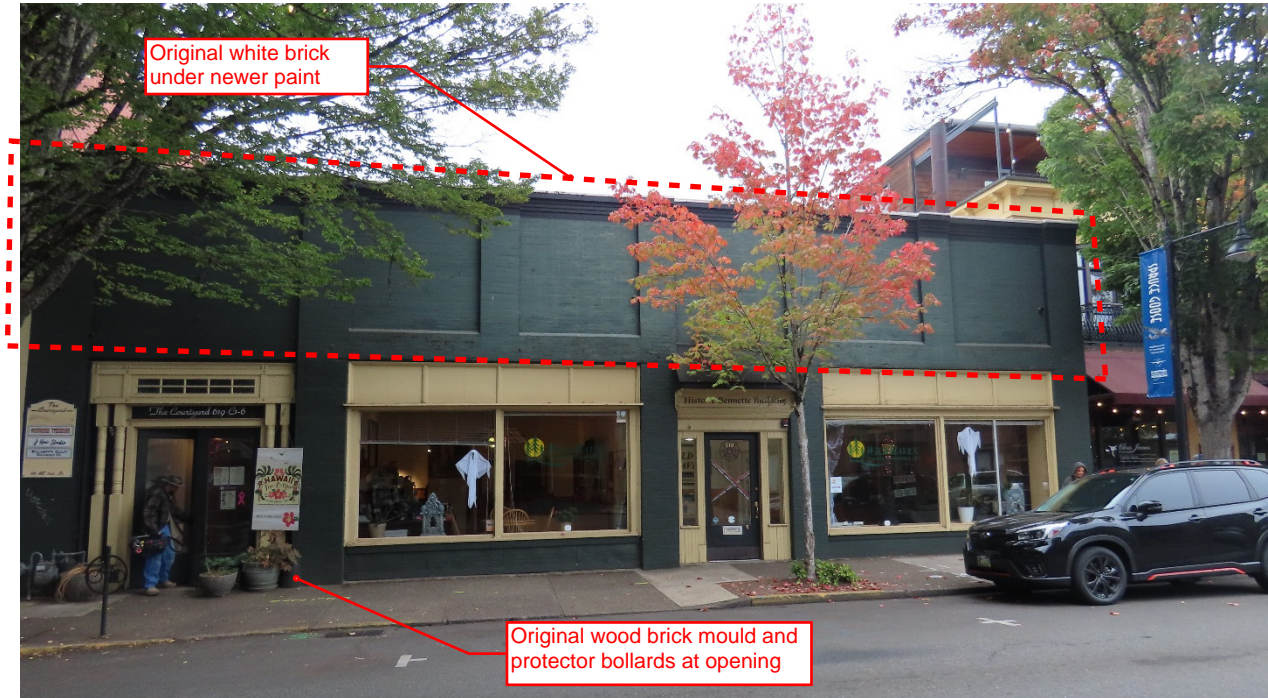
Current view of 619 NE 3rd Street (ARG, October 2022). Paired doors with wood trim elements have been inserted into the westernmost bay, while the formerly double-wide opening has been replaced with a storefront window matching the window in the easternmost bays.

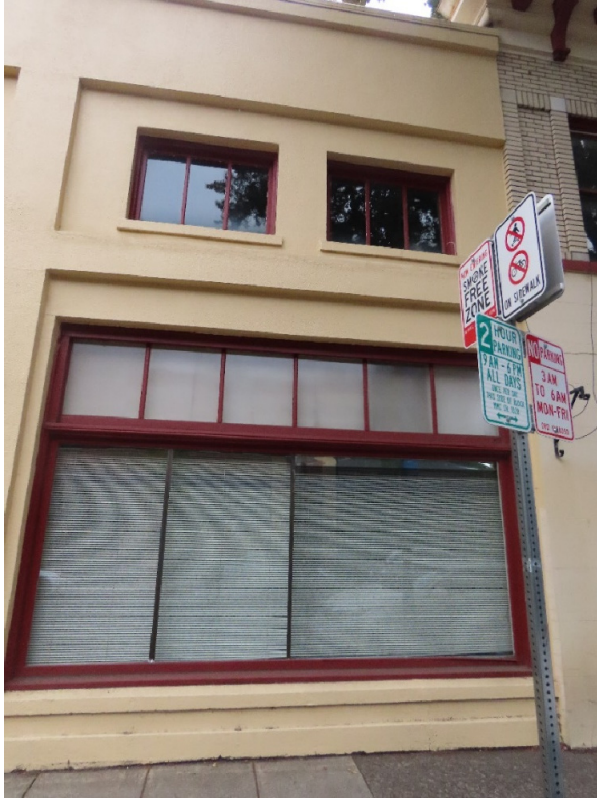
Photo 1. NE 3rd Street elevation: Original wood storefront window and transom, and second-floor windows; storefront has been modified with addition of metal mullions (ARG, October 2022).

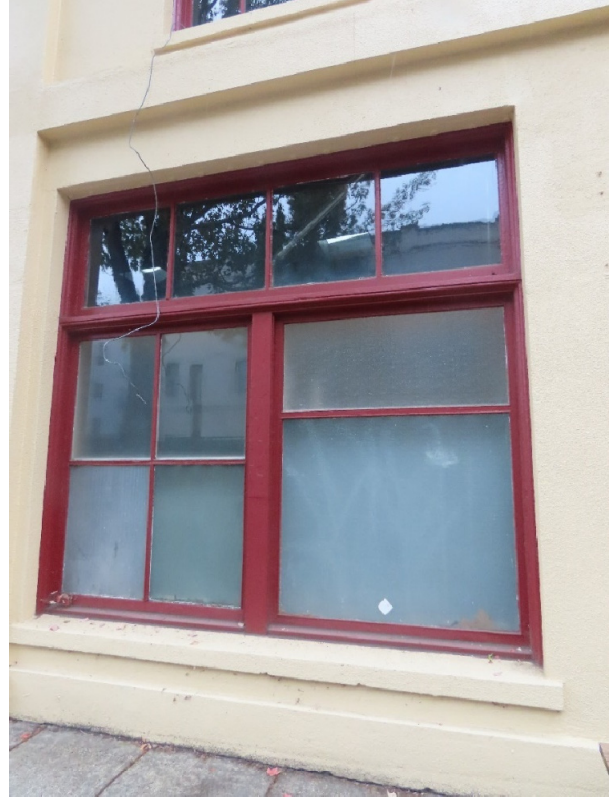
Photo 2. NE Ford Street elevation: Original wood storefront window and transom; mis-matching translucent glass types. Storefront muntins may have been reconfigured (ARG, October 2022).

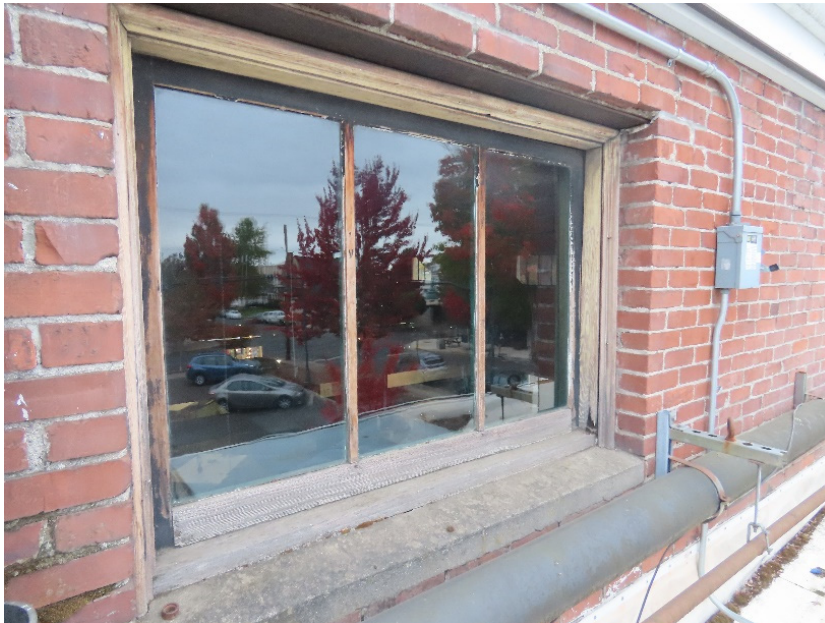
- The three original wood storefront windows and transoms, and south, west, and north elevation second-floor windows, are in fair to good condition. Paint failure and putty bead deterioration and loss are typical, and windows need to be repaired. Translucent glass types are mismatched at the original west elevation storefront windows. The second-floor windows at the north elevation were observed from the north roof setback, and are in relatively good condition, considering almost complete loss of paint and putty due to deferred maintenance. Wood rot was observed at the exterior jamb at one of these locations, which would require wood infill (dutchman) repair.

Photo 4. Second floor window, north (rear) elevation, with nearly complete loss of paint, and putty bead loss. Note wood deterioration at right lower jamb (ARG, October 2022).

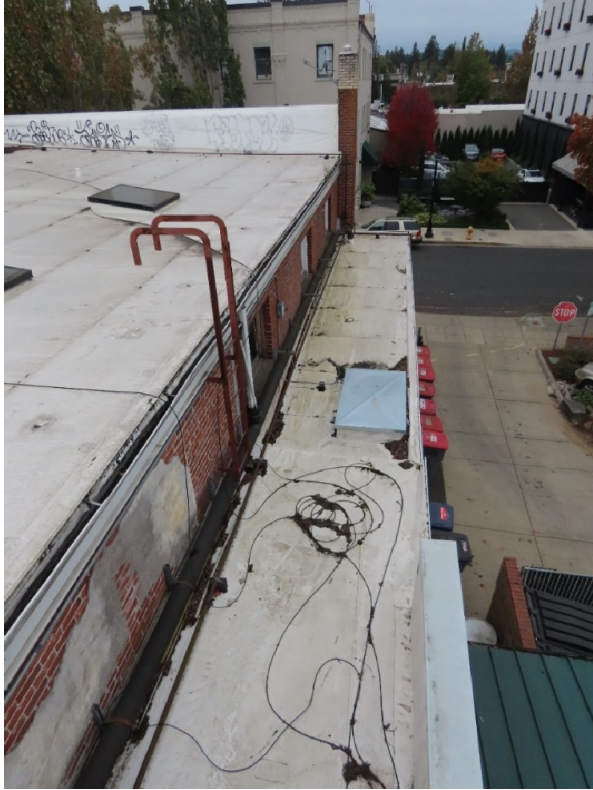
- The original roof configuration remains. The current roofing system appears to have been installed relatively recently. A sign at the roof of 611 NE 3rd Street indicates the roofing is a Duro-Last Roof. Roofing replacement at all three buildings appears to have been done at roughly the same time, with the same roofing system. Roofing appears to be in good condition generally, and keeping water out of the building, although details that wrap surfaces such as parapets and copings are atypical and do not allow assessment of the substrate. Damaged plaster and areas of water infiltration are visible at the south end second-floor interior, but it is unknown if water infiltration is active or if it pre-dates the roofing replacement. The roof surface drains to a gutter at the rear of the building, with an external leader emptying to a surface mounted drainage line below.

Photo 5. Replacement roofing; main roof at left, one-story north bay at right (ARG, October 2022).

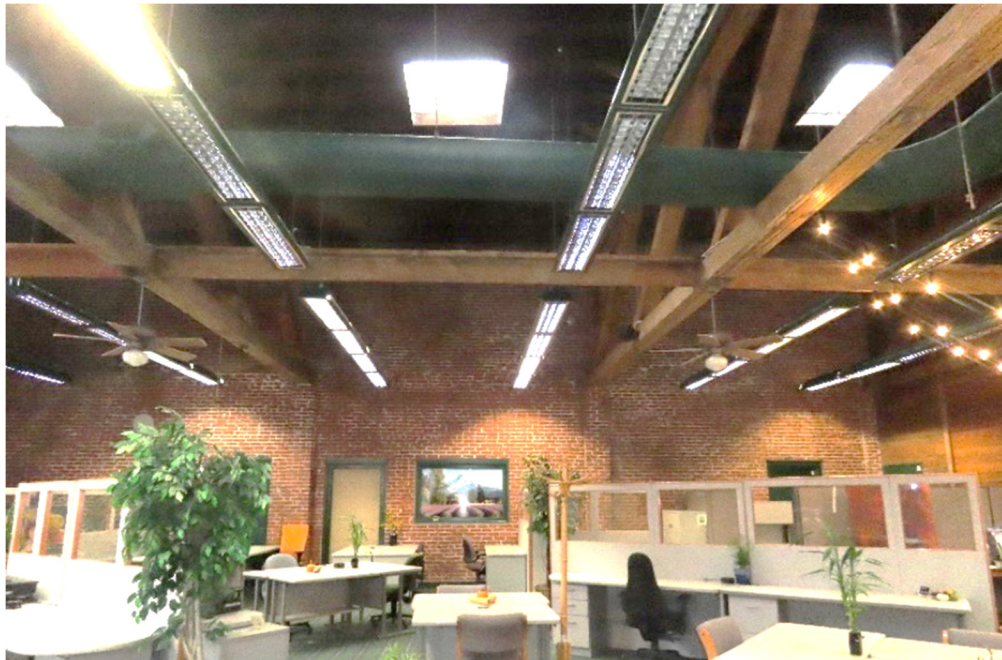
- Original wood trusses at the interior appear to be in good condition, and convey the original use of the building, the large spans permitting a large open floor plan at the ground floor.

Photo 7. Wood trusses at interior (ARG, October 2022).

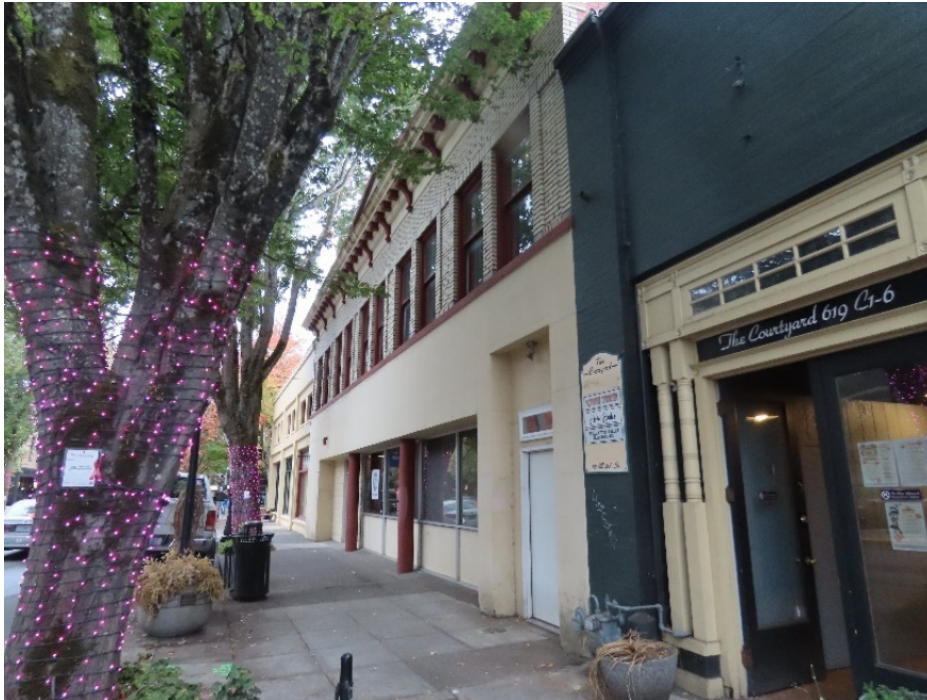
Photo 9. Overall view of south elevation, showing modified ground floor and original second floor (ARG, October 2022).

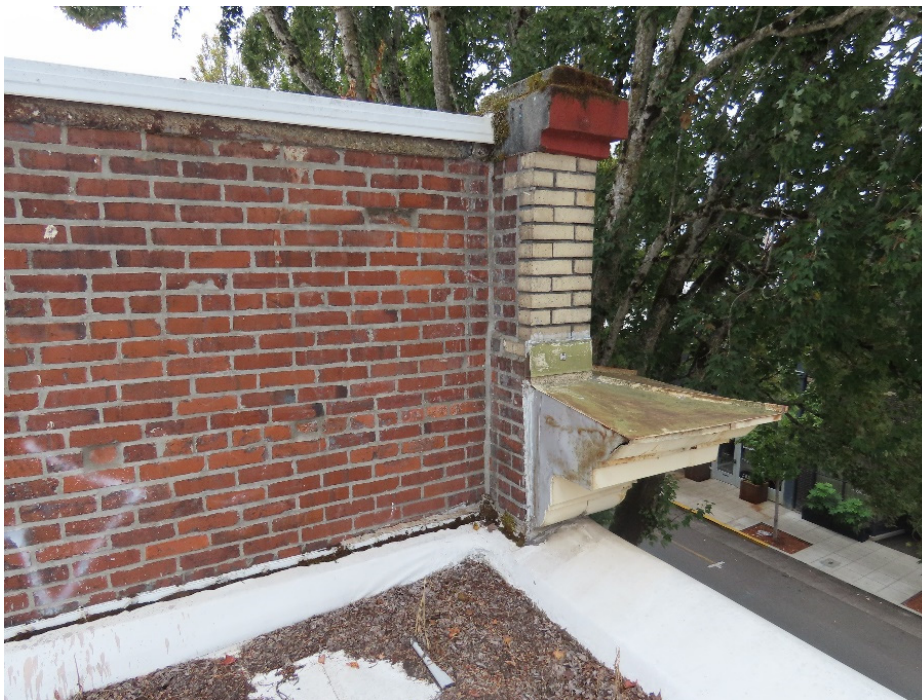
Photo 10. Parapet and top of metal entablature exhibiting minor corrosion (ARG, October 2022).

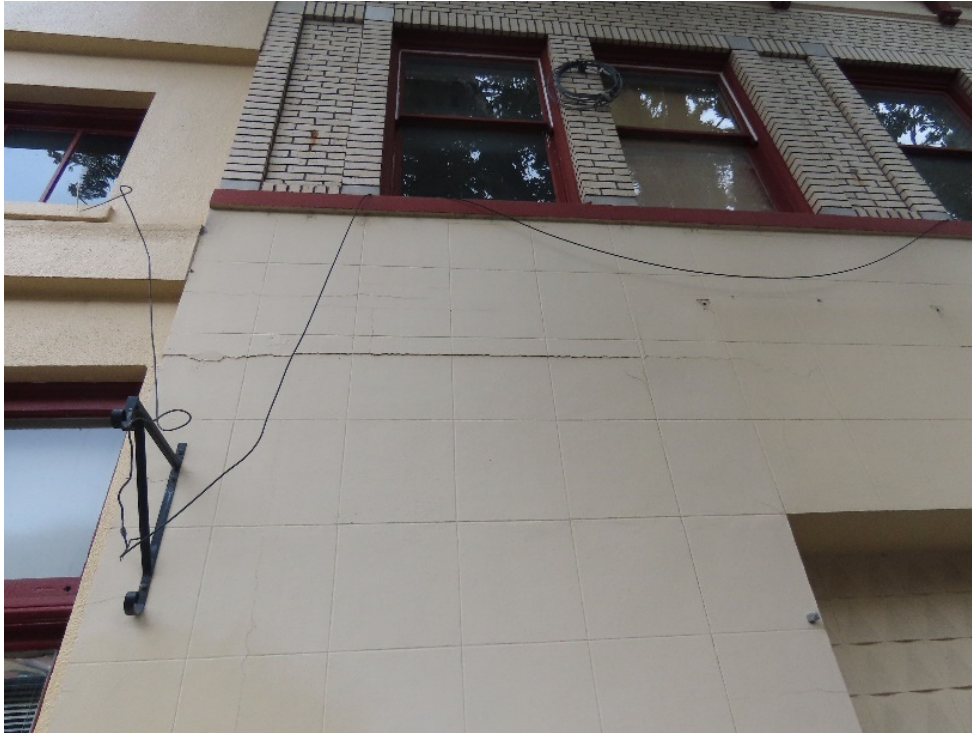
- The ground floor at the south elevation has been surfaced with stucco scored to resemble tile cladding. Hairline cracks were observed throughout the stucco; a significant horizontal crack and minor displacement is located at the west portion of the ground floor at the end bay. No original portions of the original ground floor storefront were visible at the interior side of the storefront. The inside side of the south wall above the dropped ceiling was not observed.

Photo 11. South elevation, crack at non-original stucco, original windows and masonry at second floor (ARG, October 2022).

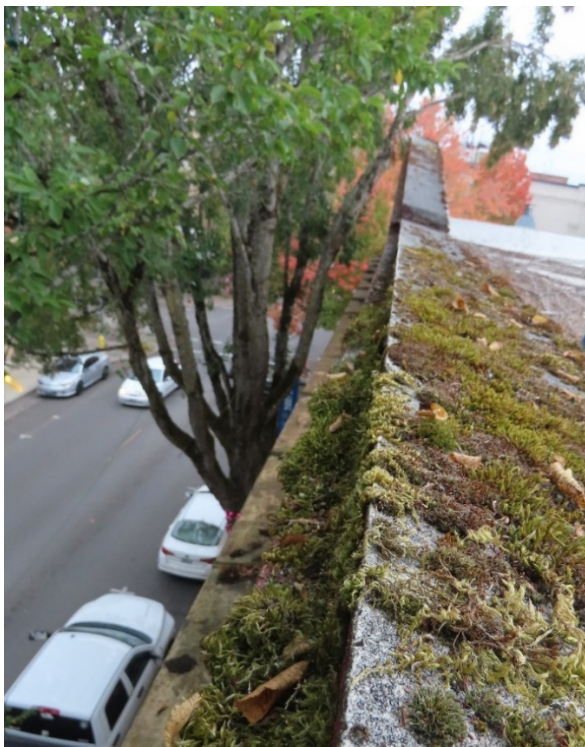
- All original elements of the south elevation remain intact at the second floor, and are generally in good condition. Minor paint failure was noted at the wood windows, and repair, prep and repainting of windows is recommended. One window has been covered at the interior side with plywood. The sheet metal cornice has areas of minor corrosion and should be prepped and repainted. Brick is in good condition, although areas of minor mortar deterioration were observed, and selective repointing of deteriorated areas of mortar is therefore recommended. Significant biological growth was observed at the top surfaces of the cementitious coping, and obscures conditions, although the cementitious material appears to be in good condition. Biological growth should be removed.

Photo 14. Top of coping with significant biological growth (ARG, October 2022).

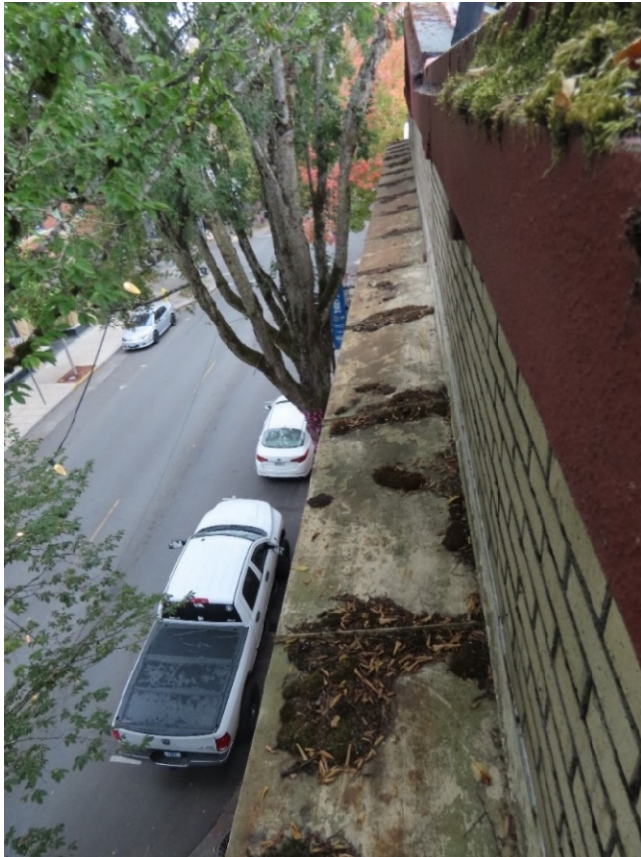
Photo 15. Top of cornice, with areas of biological growth (ARG, October 2022).

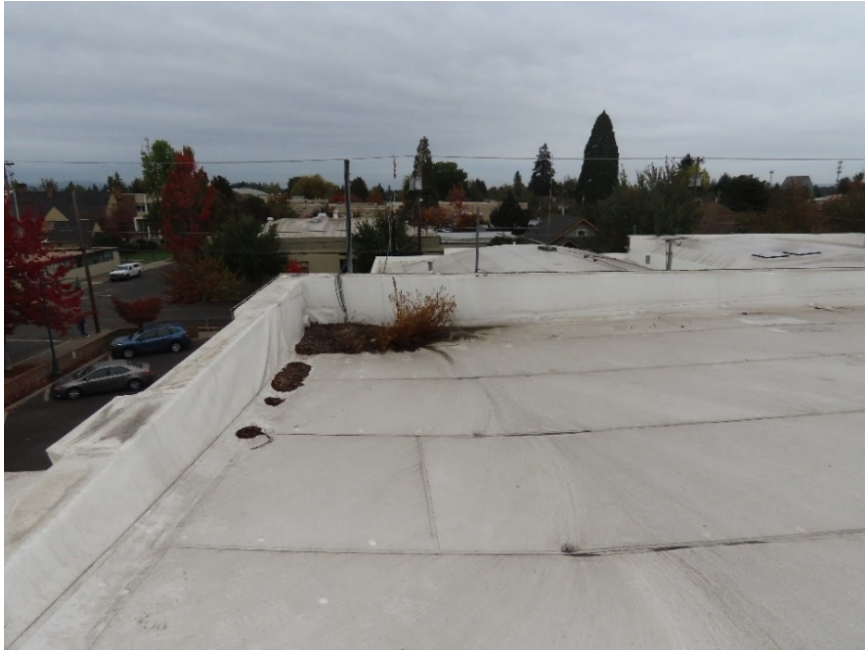
- The original roof configuration remains. As previously noted for 609 NE 3rd Street, a sign at the roof indicates that the roofing is a Duro-Last Roof. Roofing replacement at all three buildings appears to have been done at roughly the same time, with the same roofing system. Roofing appears to be in good condition generally, and keeping water out of the building, although details that wrap surfaces such as parapets and copings are atypical and do not allow assessment of the substrate. Significant areas of damaged ceiling finishes and areas of water infiltration are visible at the north end of the second floor, but it is unknown if water infiltration is active or if it pre-dates the roofing replacement. The roof surface drains to a drain at the rear, NW corner of the building, with an overflow scupper to an external leader emptying to the lower roof of 609 NE 3rd Street below. The roof drain is completely clogged, and it is therefore likely that during rain events water pools at this area of roofing, possibly infiltrating to the interior before reaching the overflow scupper. Leaf and branch debris at the south and north ends of the building is significant and should be removed as part of a regularly scheduled maintenance plan.

Photo 17. Roof looking north; note debris at location of roof drain (ARG, October 2022).

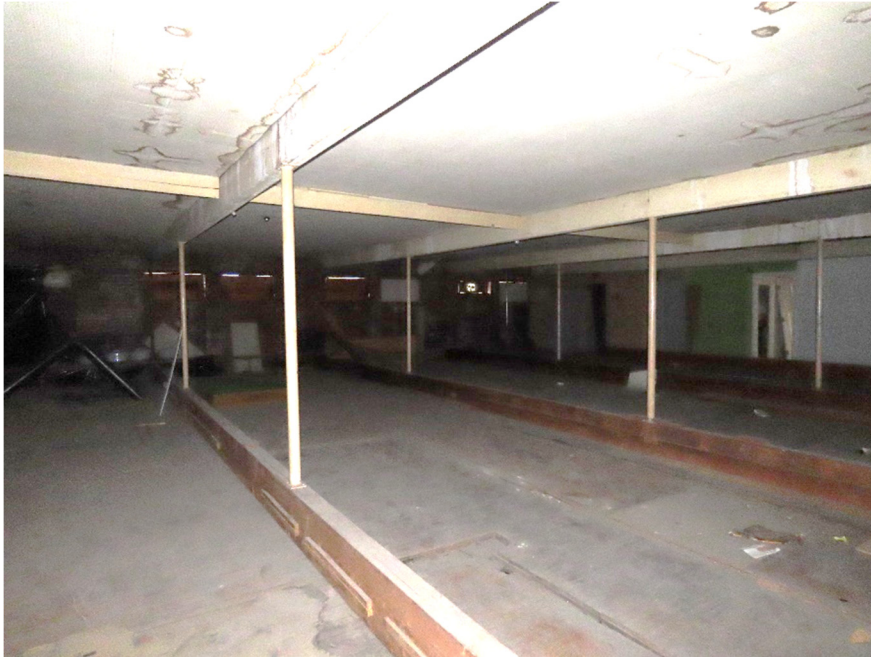
Photo 19. Round pipe columns at second floor with areas of removed partitions (ARG, October 2022).

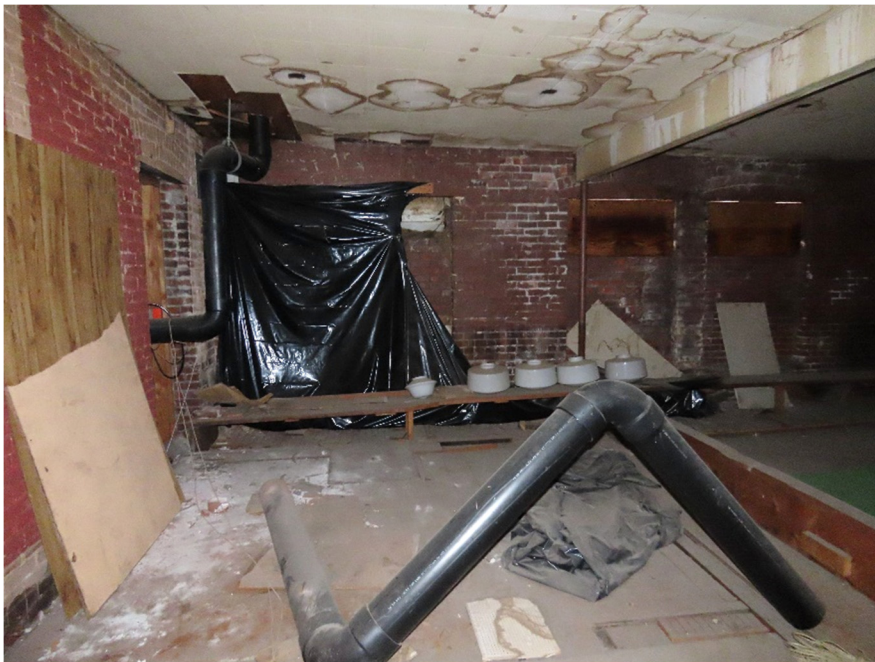
- The second-floor interior is vacant and has been unused for a significant period of time. Little of the original finishes remains. Finishes at the northern portion of the second floor are in poor condition. Outlines of removed partitions are visible in the remaining finish floor. Round pipe columns supported on added wood beams appear to have been added throughout to shore up the wood joists above and to distribute the load to joists below. The underside of the roof deck was not visible. Windows at the north elevation have been removed, and the openings enclosed with plywood with visible daylight at the perimeter, allowing air and water infiltration.

Photo 20. Second floor north wall with removed windows, damaged finishes below clogged drain (ARG, October 2022).

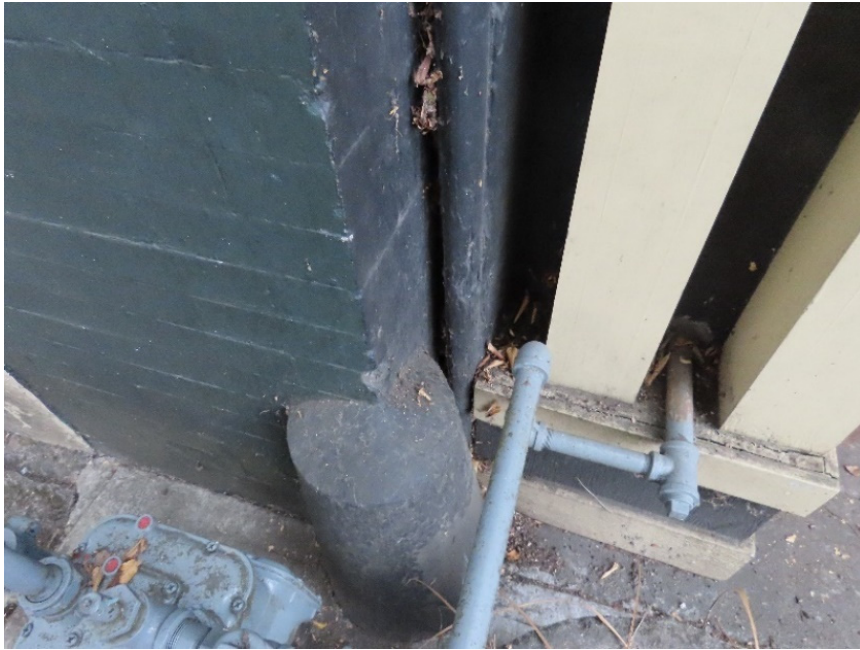
- Little remains of the original building materials at the ground floor. The original brick mould at the westernmost opening remains, although the opening has been infilled with a new door.

Photo 21. Original brick mould and bollard protector at westernmost opening (ARG, October 2022).

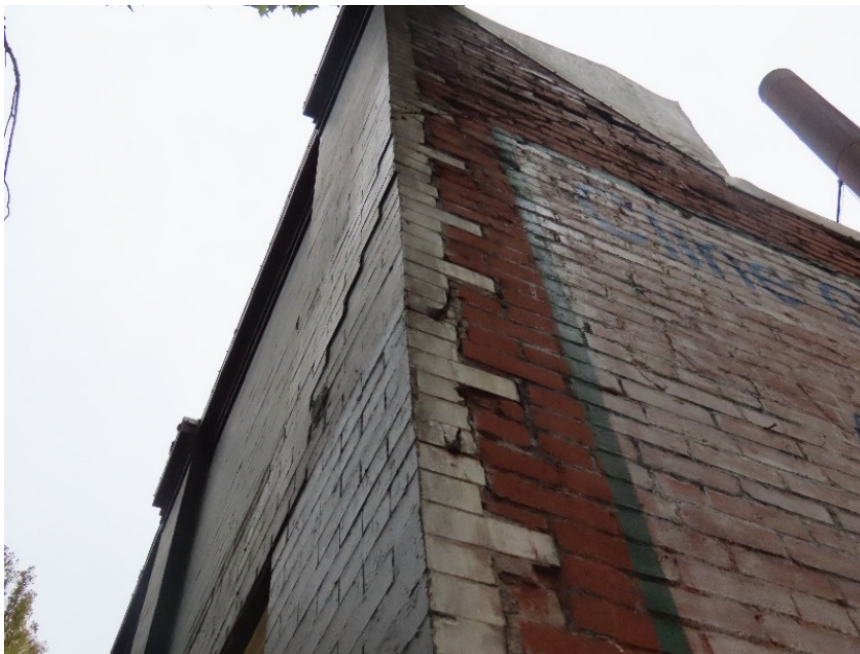
- The original white brick of the attic story/parapet remains, although it has been painted. Original unpainted white brick remains visible at the corner of the east elevation. Significant areas of brick cracking and displacement were observed in the attic story at the southeast corner of the building.

Photo 22. Southwest corner, note cracking and outward masonry displacement at attic story (ARG, October 2022).

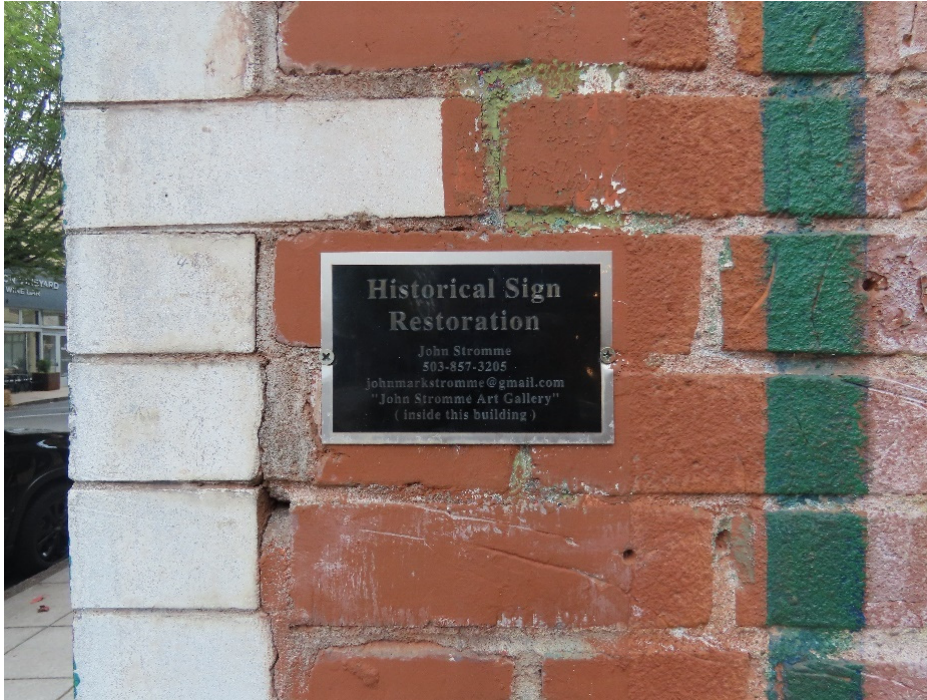
Photo 23. East elevation detail at southeast corner, unpainted white face brick at left (ARG, October 2022).
