Re: Documentation of Existing Building Structures

Project: Gwendolyn Hotel HHPR Structural Project OTA-07
609, 611 and 619 NE 3rd Street McMinnville Oregon

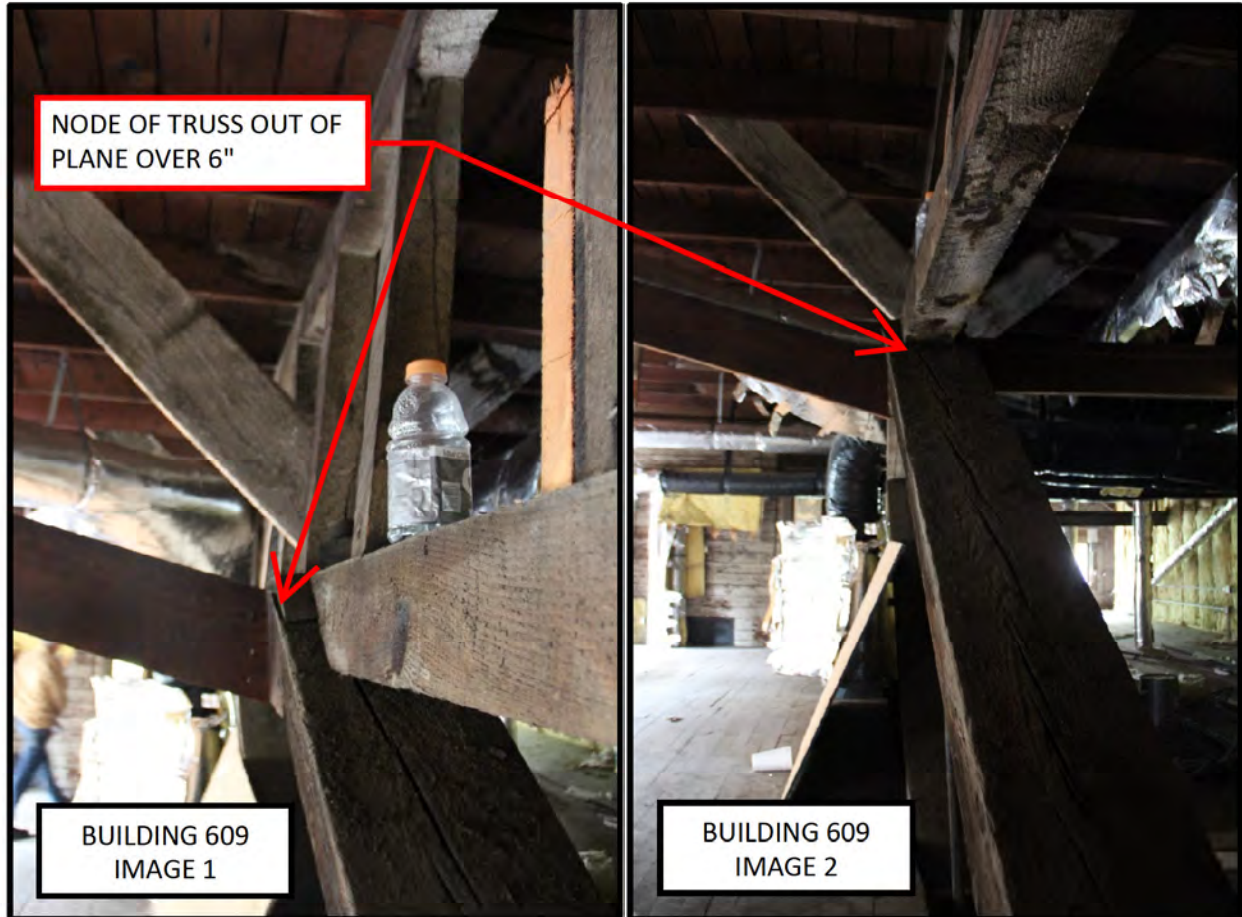
- The 1st truss from the south elevation is displaced over 6 inches horizontally at the top which represents a significant structural concern (see Image 1 and 2)

- The most southern roof truss in the 609 Building has a top chord node that is out of plane by over 6 inches. This represents a significant structural concern and should be evaluated further with possible remedial actions should the building remain. The remedial action includes installing a new girder and columns to support the truss thereby removing mezzanine and roof loading from the truss

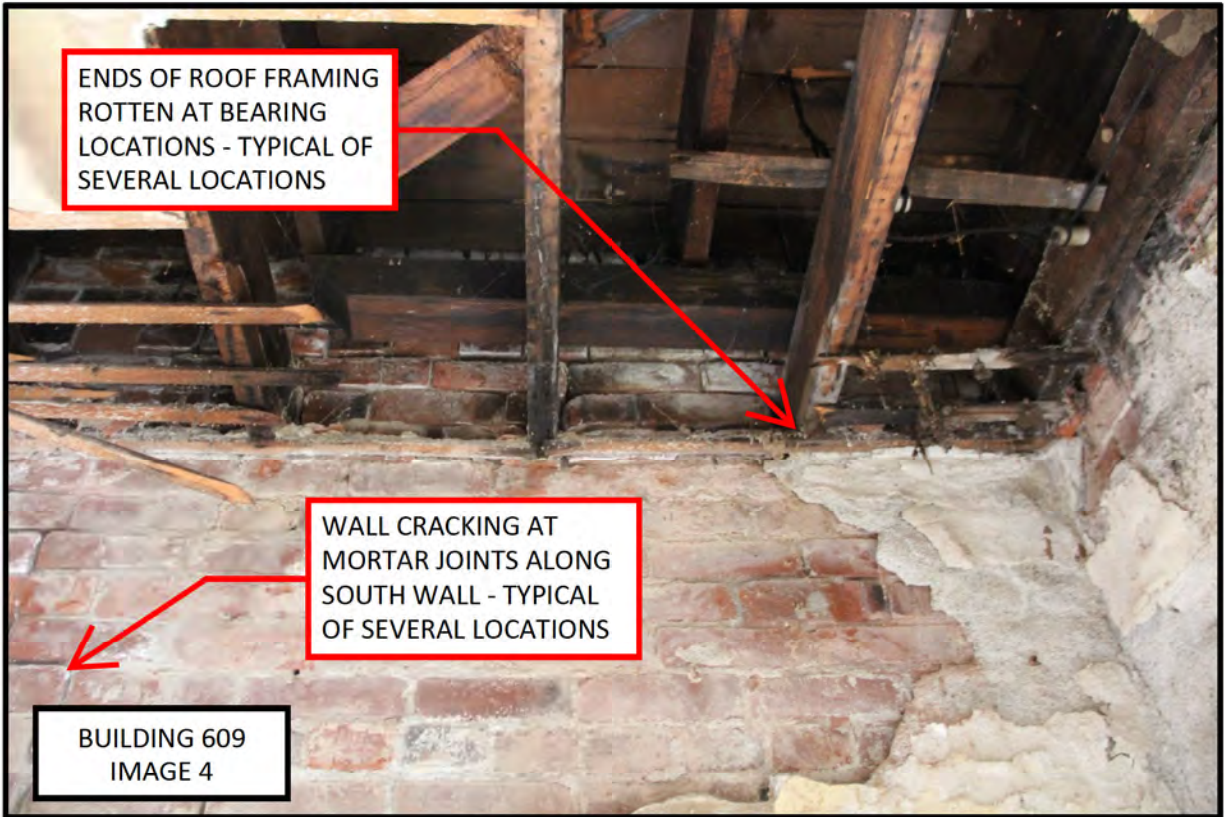
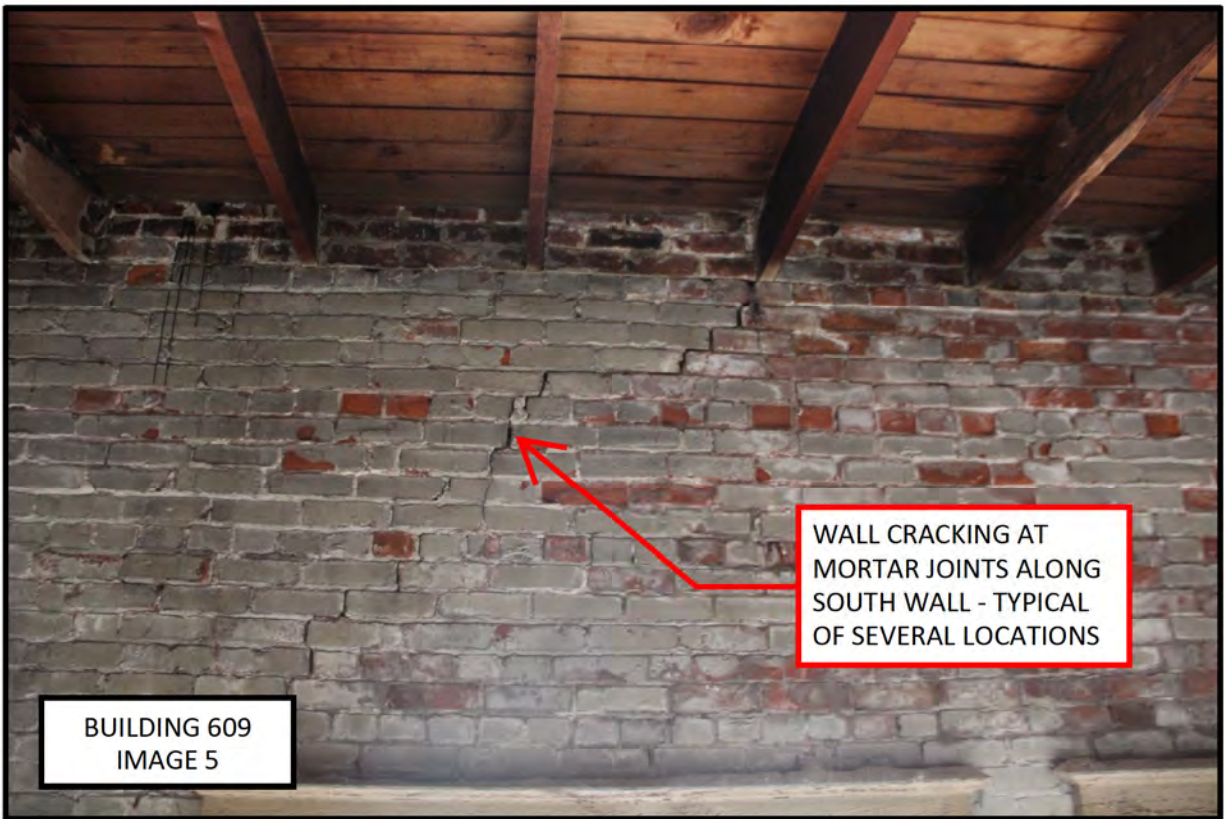
- Each pony wall decreases in height in the north south direction to allow for water drainage to the north
- The roof framing over the original 2nd level offices is significantly deteriorated in several locations (see Image 3 and 4)

- The south brick wall at the 2nd level offices is deteriorating and the mortar is no longer sound
- There are multiple diagonal cracks following the mortar lines at the 2nd level offices (see Image 5)

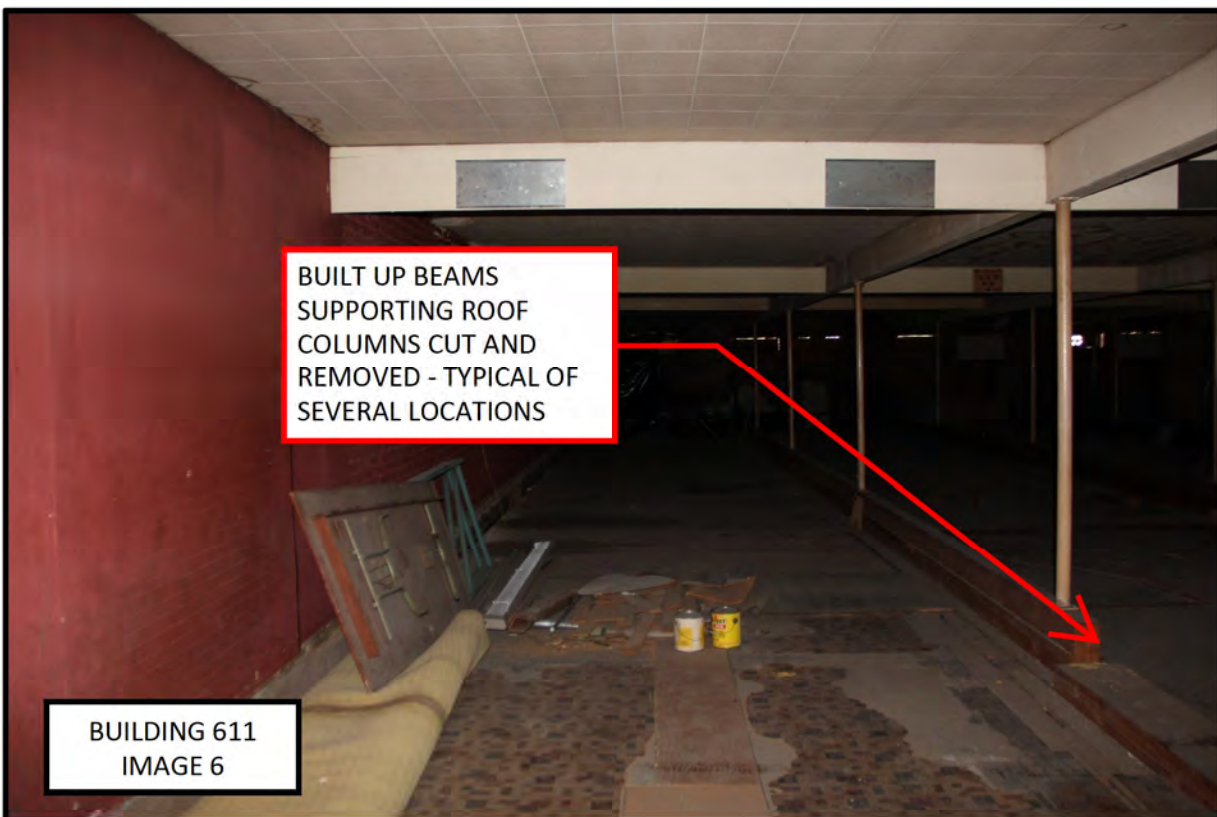
- At north and south walls the roof beams are supported by the perimeter brick walls
- In some cases, the built-up laminated beams across the floor have been cut and removed. This condition compromises the structure's ability to spread the concentrated roof load across the floor below (see Image 6)

- The removed floor beams distributing roof load in the 611 Building represent a significant structural concern and should be evaluated further with possible remedial actions should the building remain.

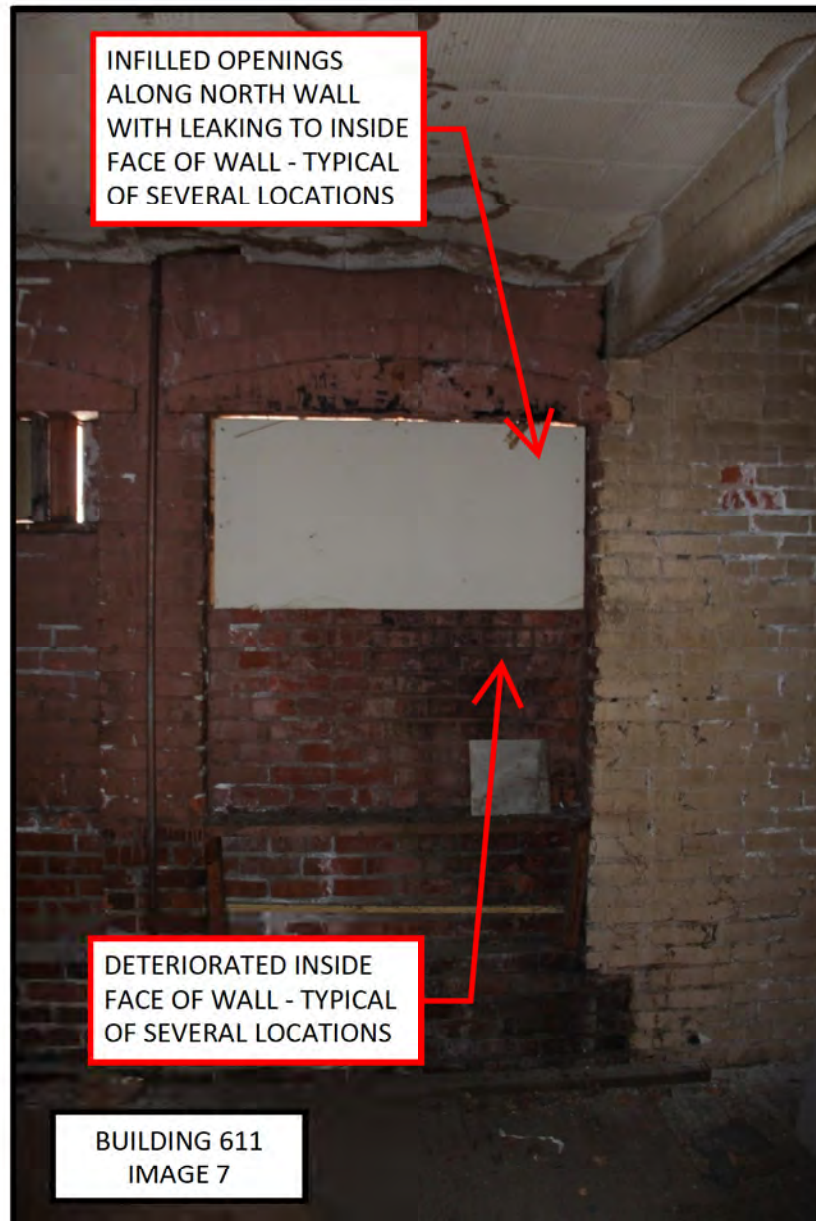
- The street level windows are newer and appears to have been remodeled in the 1970s
- The north elevation has a series of old window openings along the 2nd level that have been filled in, however the condition of the wall and infill is poor with a significant amount of water entering the building and debris from bird nests (see Image 7)

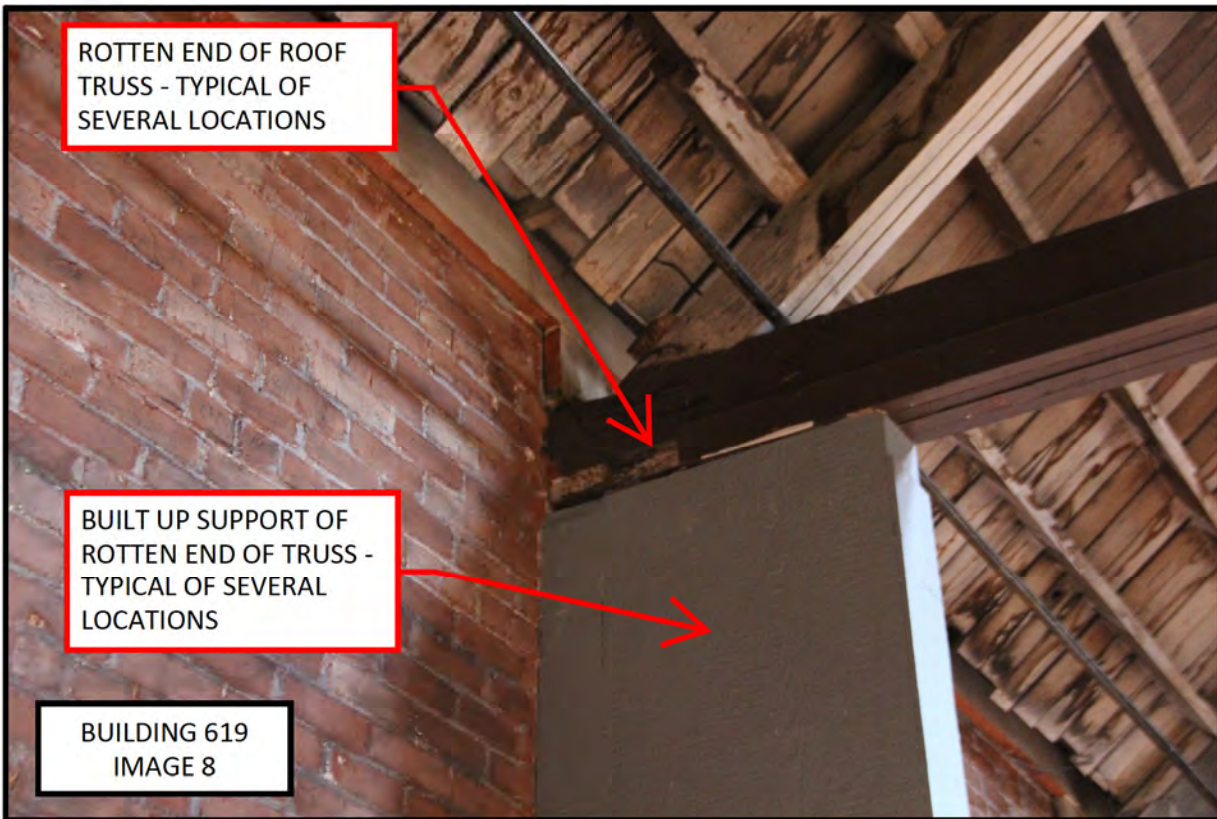
- Trusses constructed of 2x spanning east west, diagonal web members appear to be 4x or 6x dimensional members, vertical web members are steel rods
- Top chord is sloped steeply at then ends and then modestly sloped to the center of the truss at the ridge, the bottom chord of the truss is horizontal
- The bearing points of the trusses are deteriorated along the west wall and supplemental support has been framed under the trusses (see Image 8 and 9)
- This condition exists at the connection to the 611 Building and is the result of water penetration along the north south valley between the building

- The rotting bearing points of the roof trusses in the 619 Building represent a significant structural concern and should be evaluated further with possible remedial actions should the building remain.

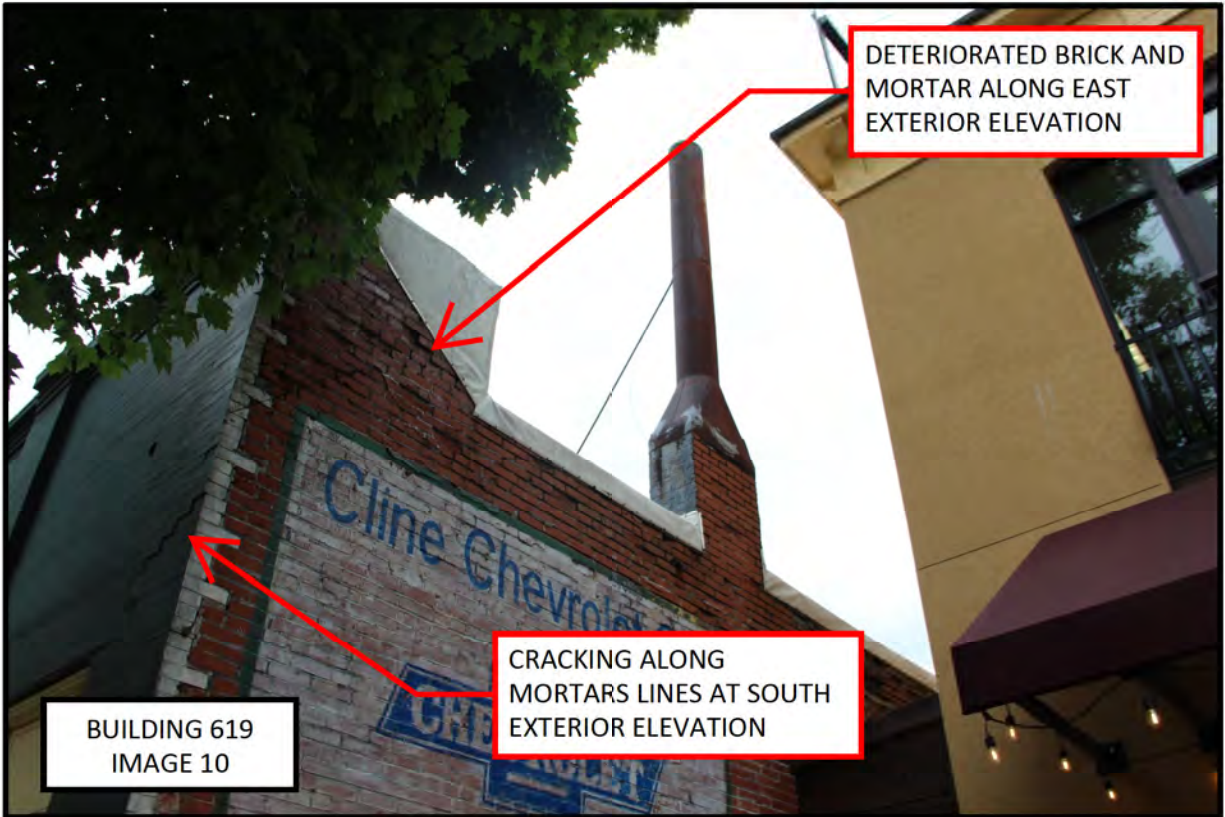
- The brick and mortar at south elevation show signs of deterioration and diagonal cracks along the mortar lines
- The east wall exterior has significant deterioration and is exposed due to the separation between the 619 Building and the recently constructed building to the east (see Image 10)
