## Certificate of Approval (Demolition, ~~Moving or New Construction~~)

Property Address 618 NE 3rd Street McMinnville OR

# Certificate of Approval Narrative, Demolition Structure at 618 NE Third Street, McMinnville

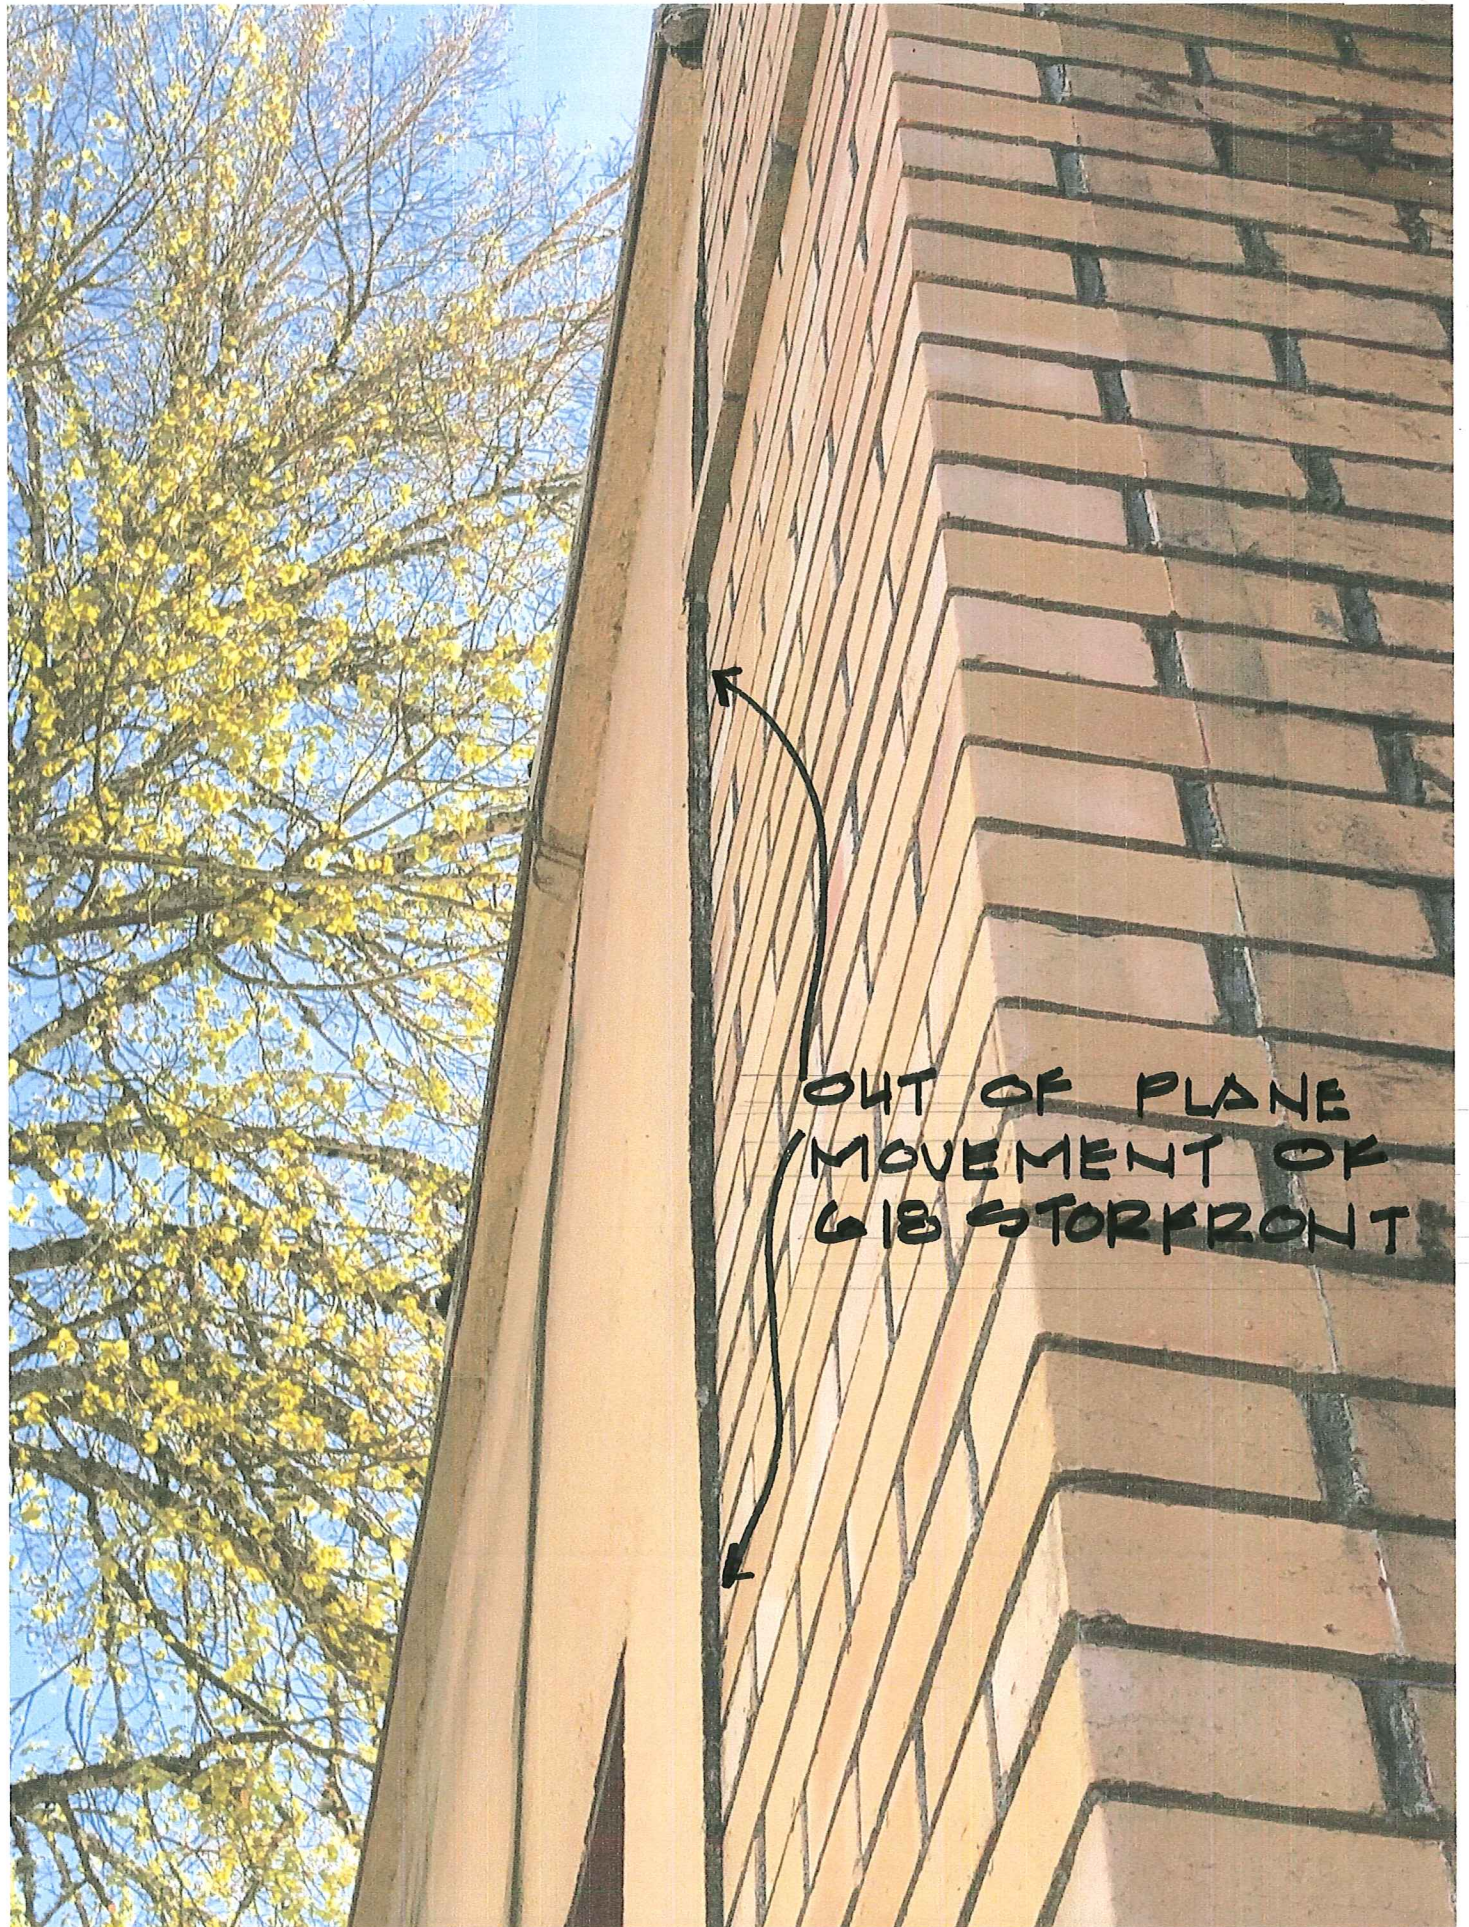
**The west support of the 3<sup>rd</sup> Street façade has shifted toward the street, indicating an out-of-plane structural failure. The reason for this movement, the competency of its restraint, could be discovered through destructive investigation. Its rate of movement has not been determined. If the building is undergoes a seismic retrofit, this building element would need to be rebuilt with a moment frame, and separated from the neighboring façades by 3"- 4" minimum gap.**

OUT OF PLANE  
MOVEMENT OF  
GIB STOREFRONT

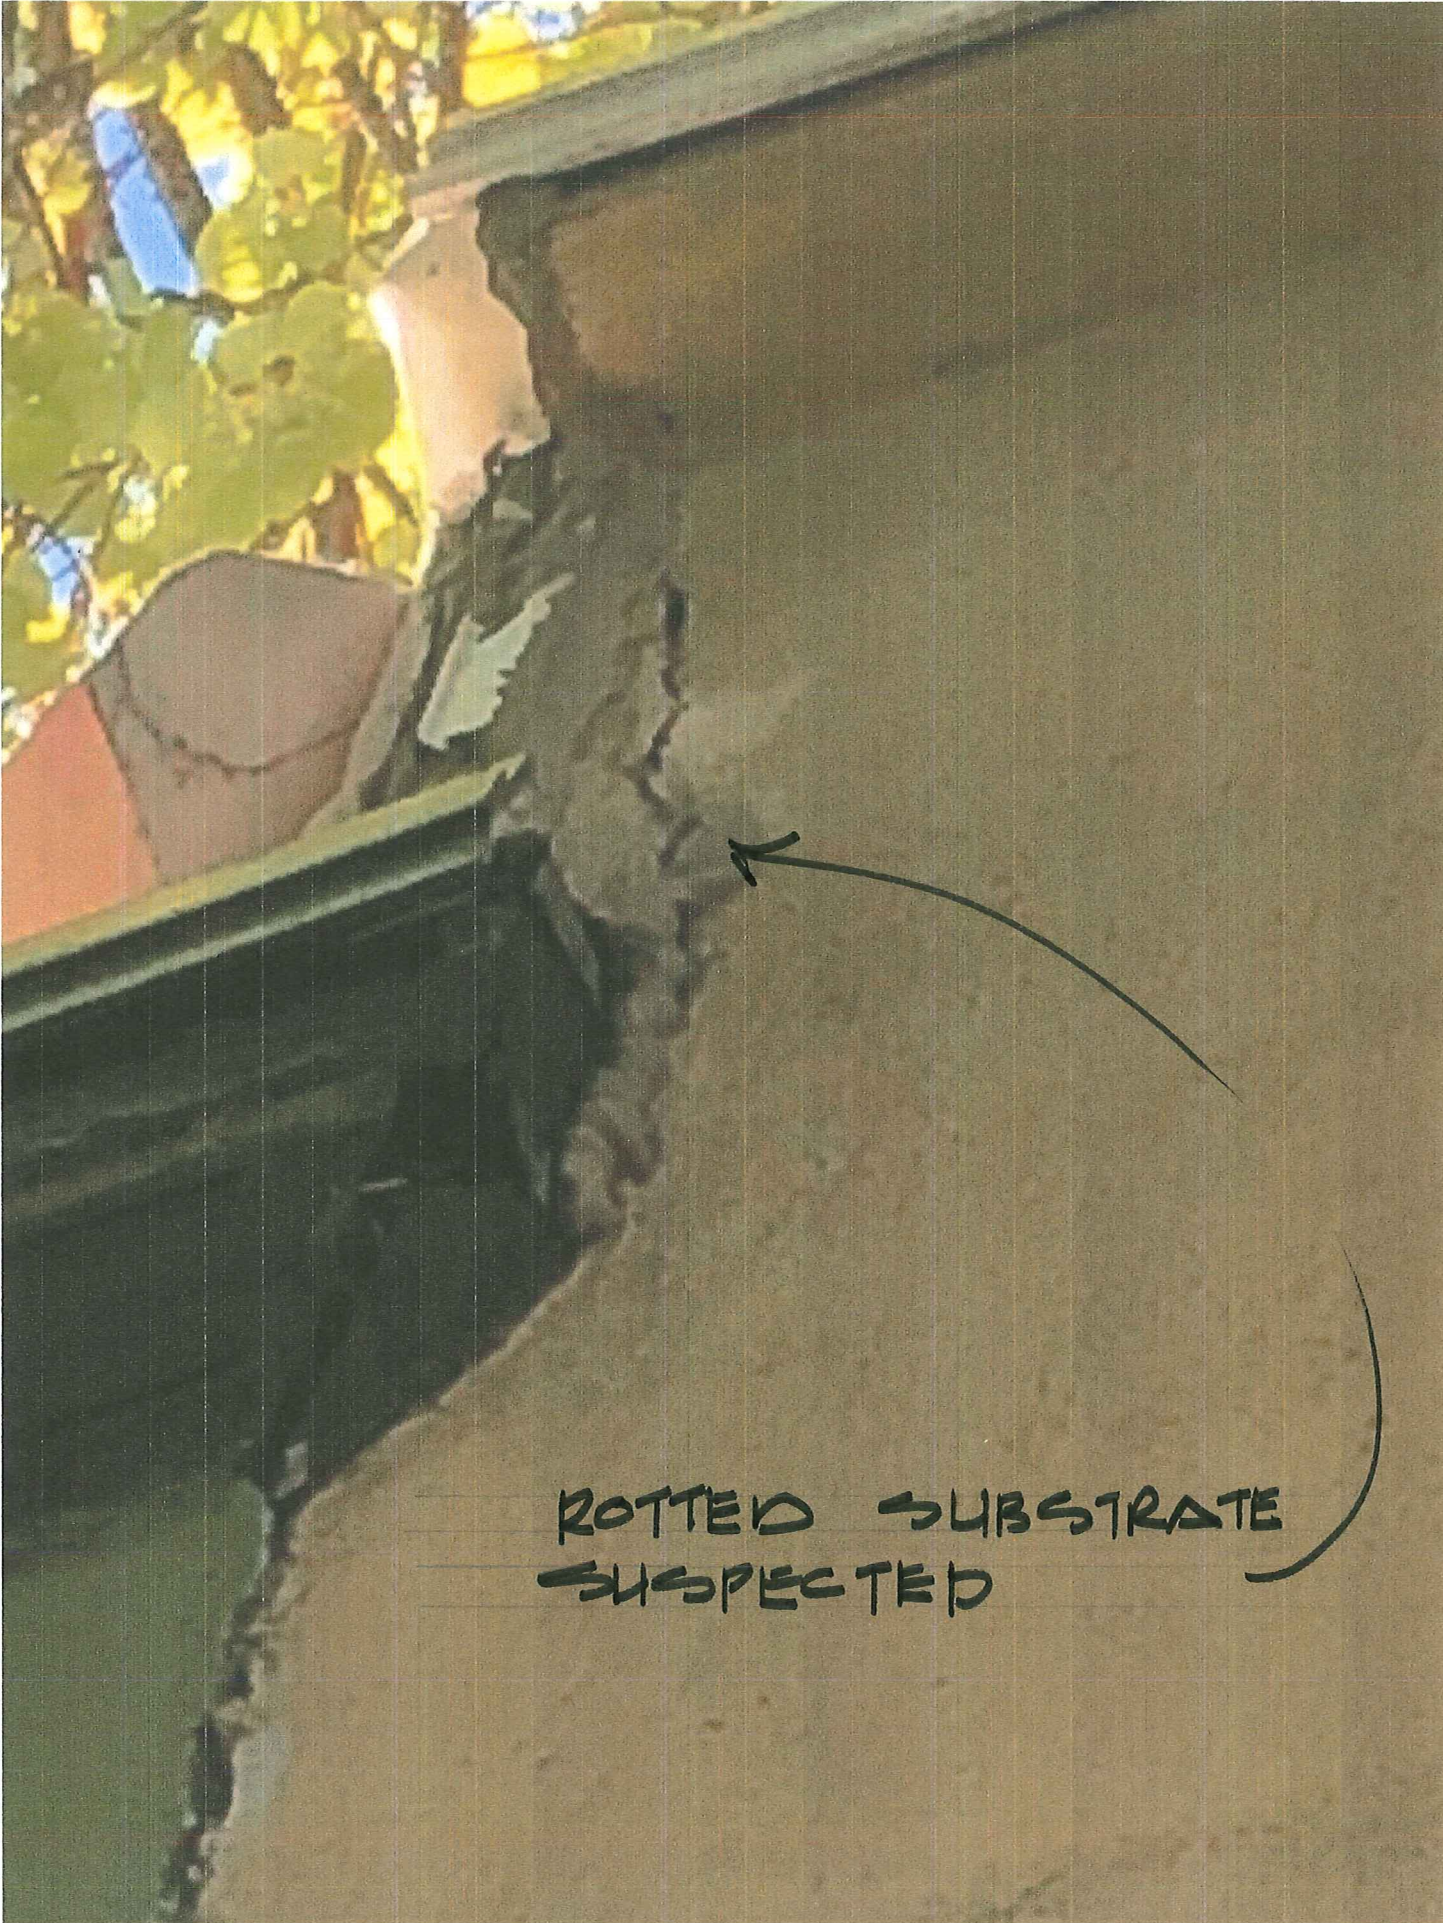
**The street façade of the existing building is showing signs of rot as the result of poor detailing. Rot of window and door framing and sheathing was detected in areas shown in the attached photos. The extent of damage to the main structural framing is unknown and cannot be determined without further destructive investigation.**

ROTTED SUBSTRATE  
SUSPECTED

ROTTED FRAME

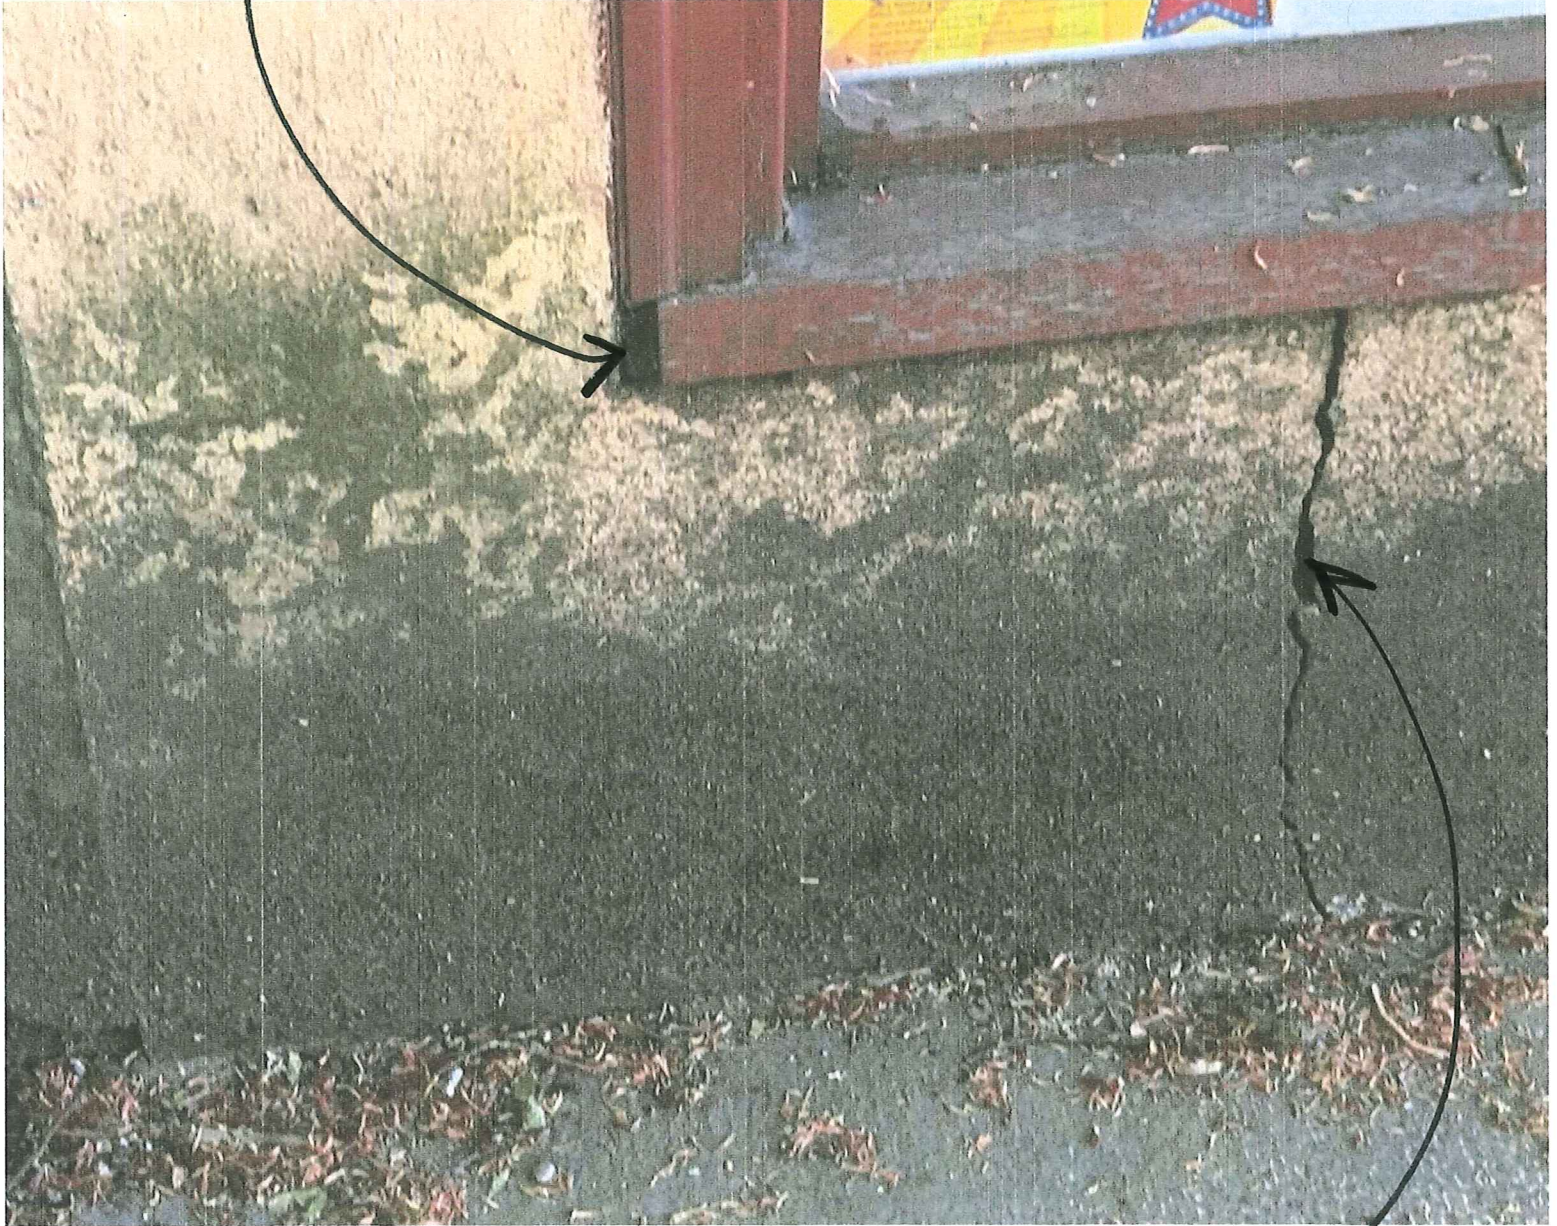
SUBSTRATE OK.

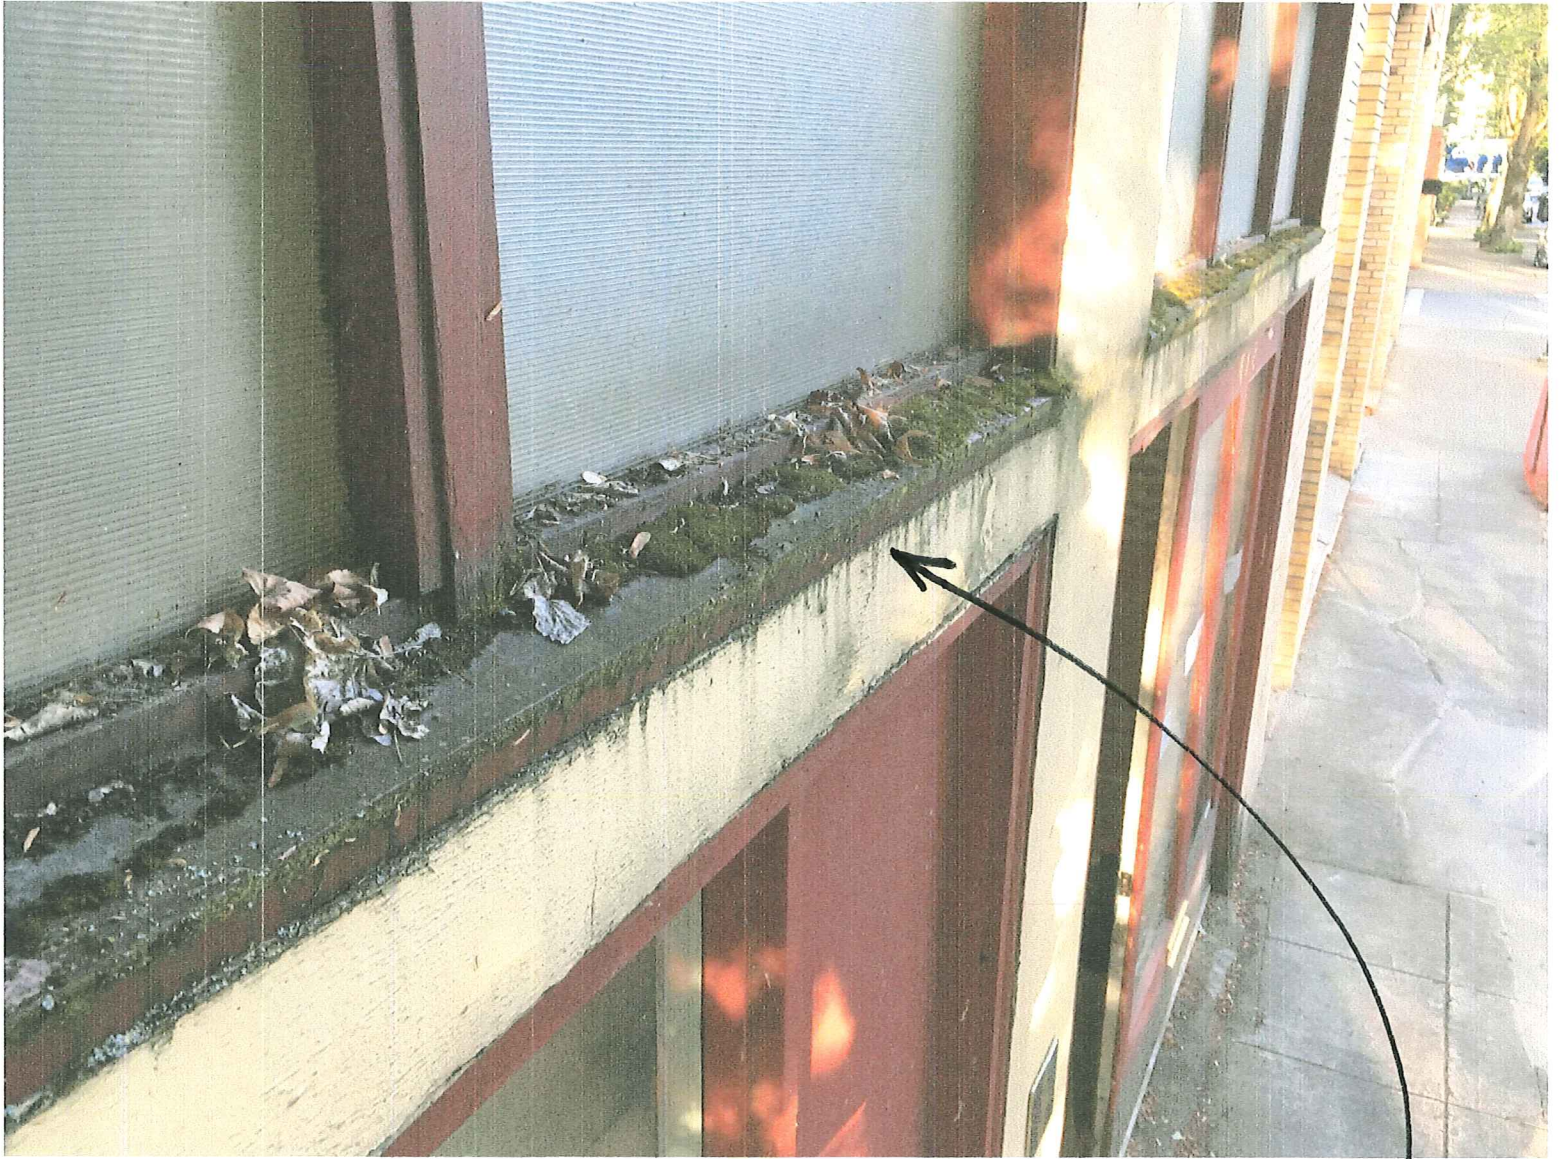
TRANSOM WINDOW SILL  
CONDITION
