# City of McMinnville Intensive Level Survey

McMinnville, Yamhill County, Oregon  
June 2018

Spencer Howard, Historic Preservationist, Northwest Vernacular, Inc.

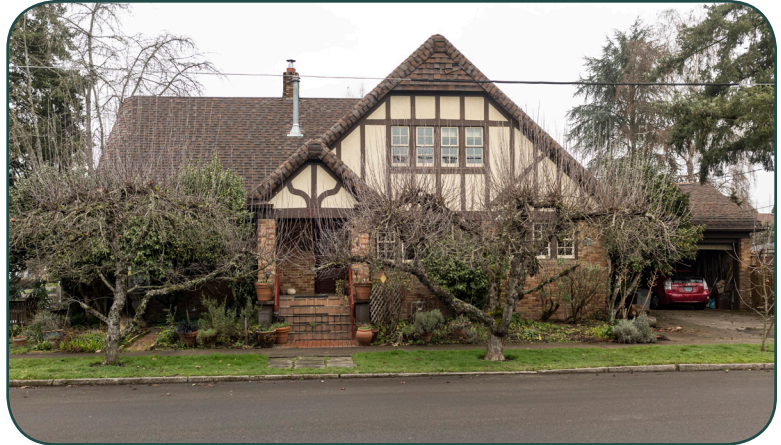
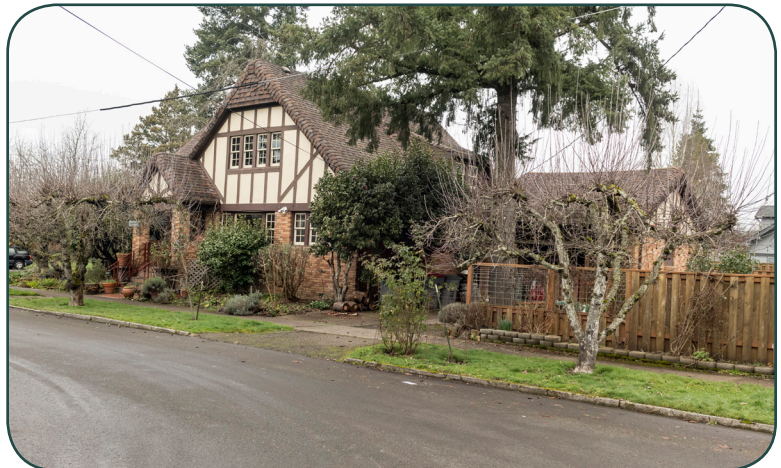
Front, south facade.

Front south and rear east facades.

- Blistered paint on the wood half timbering. It is critical to keep these members painted and in good condition to avoid openings in the stucco and water entry.
- Some mortar loss on the brick, mostly on the garage.

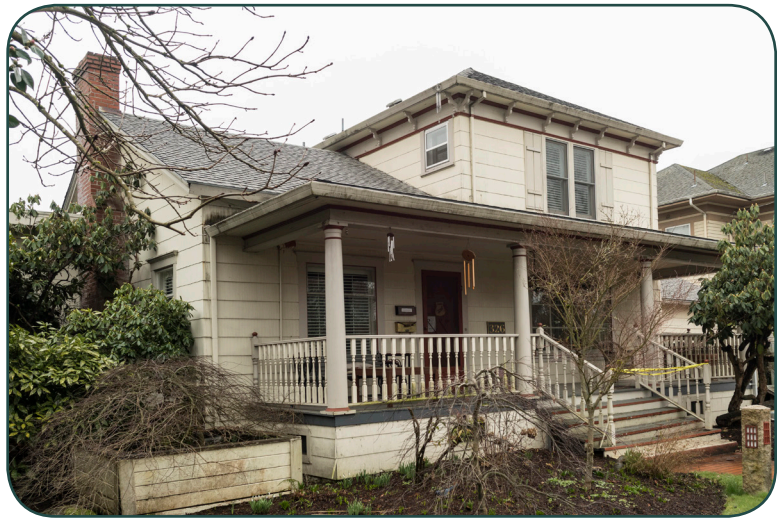
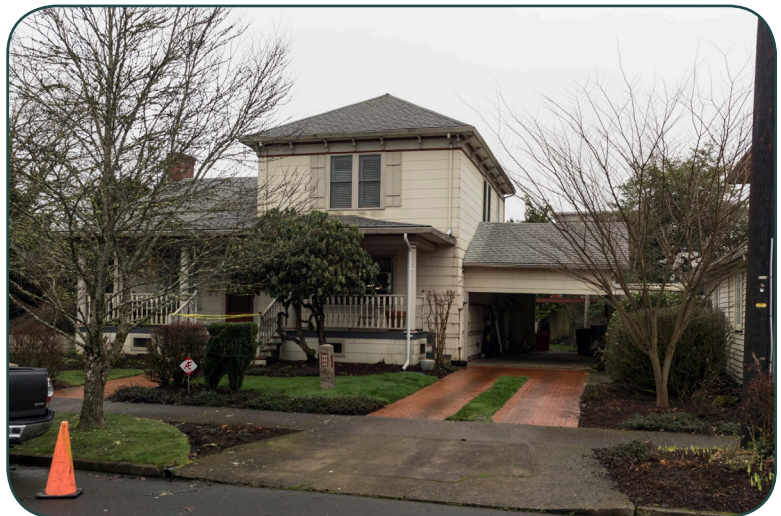
Side east and front north facades.

Front north and west side facades.

- Paint deterioration on the siding.

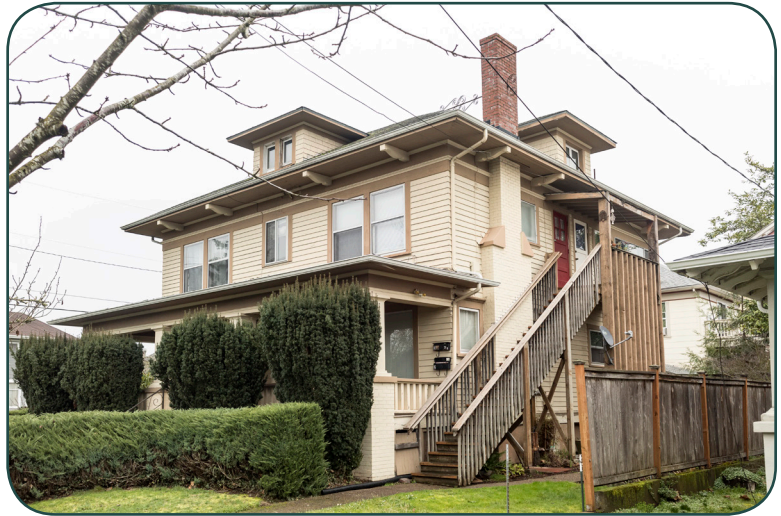
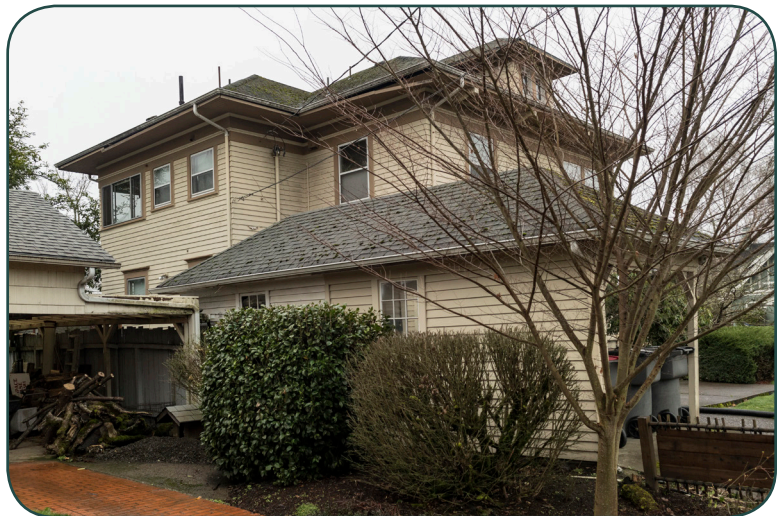
Front west and side south facades.

Rear east and side north facades.

- Loose fascia at the rear east facade.
- Deteriorated paint on the exterior siding.
- Deterioration in the soffit at the rear east facade near gutter downspout.

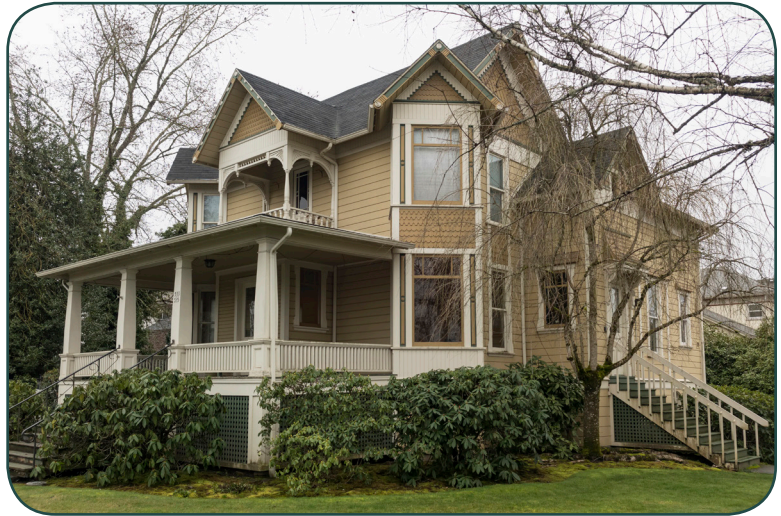
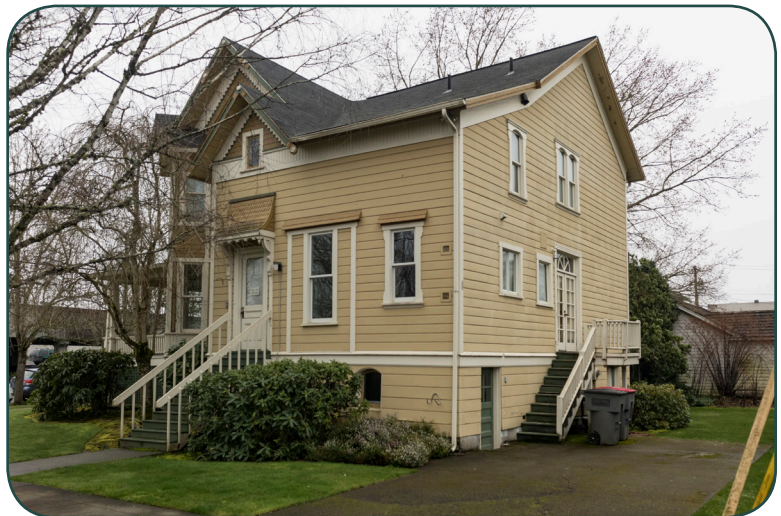
Front east and north side facades.

Rear west and side north facades.

- Paint deterioration on all facades.

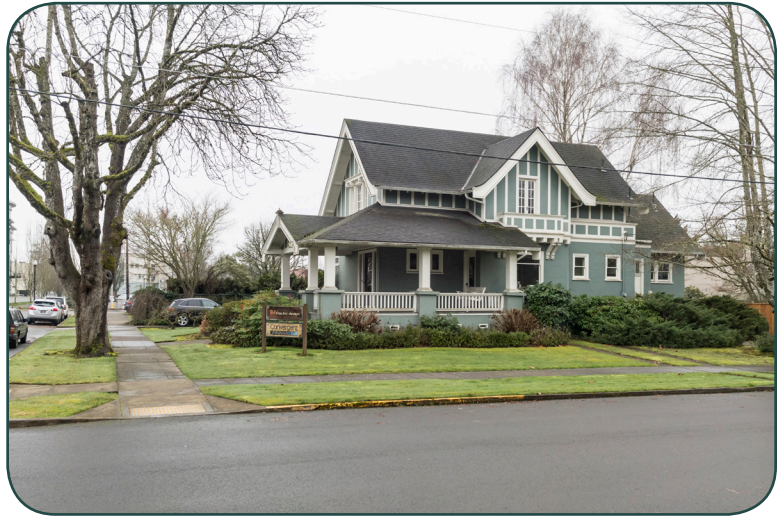
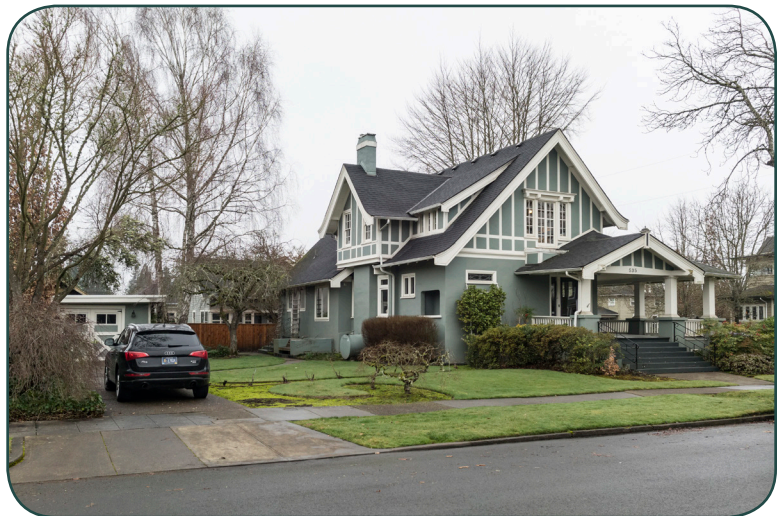
Front east and side north facades.

Rear south and front east facades.

- Paint loss along rafters and trim.
- Wood deterioration along the eaves, particularly at the northwest entry.

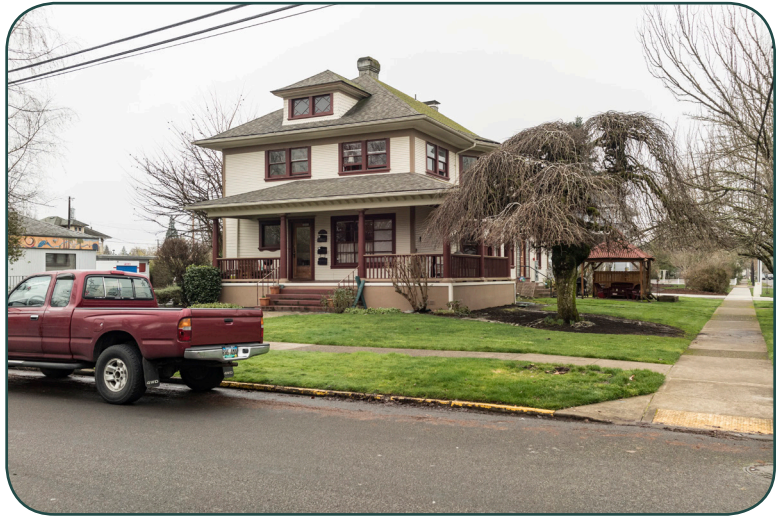
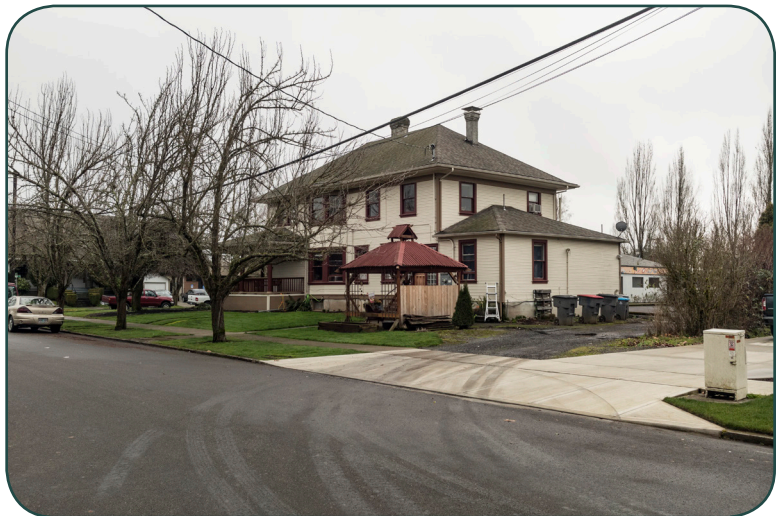
Front, east facade.

Side, north and rear west facades.

- Siding paint deterioration.
