## SECTION 8

# Operations and Maintenance Problem Areas and Claim History

City of McMinnville  
Stormwater Drainage Master Plan

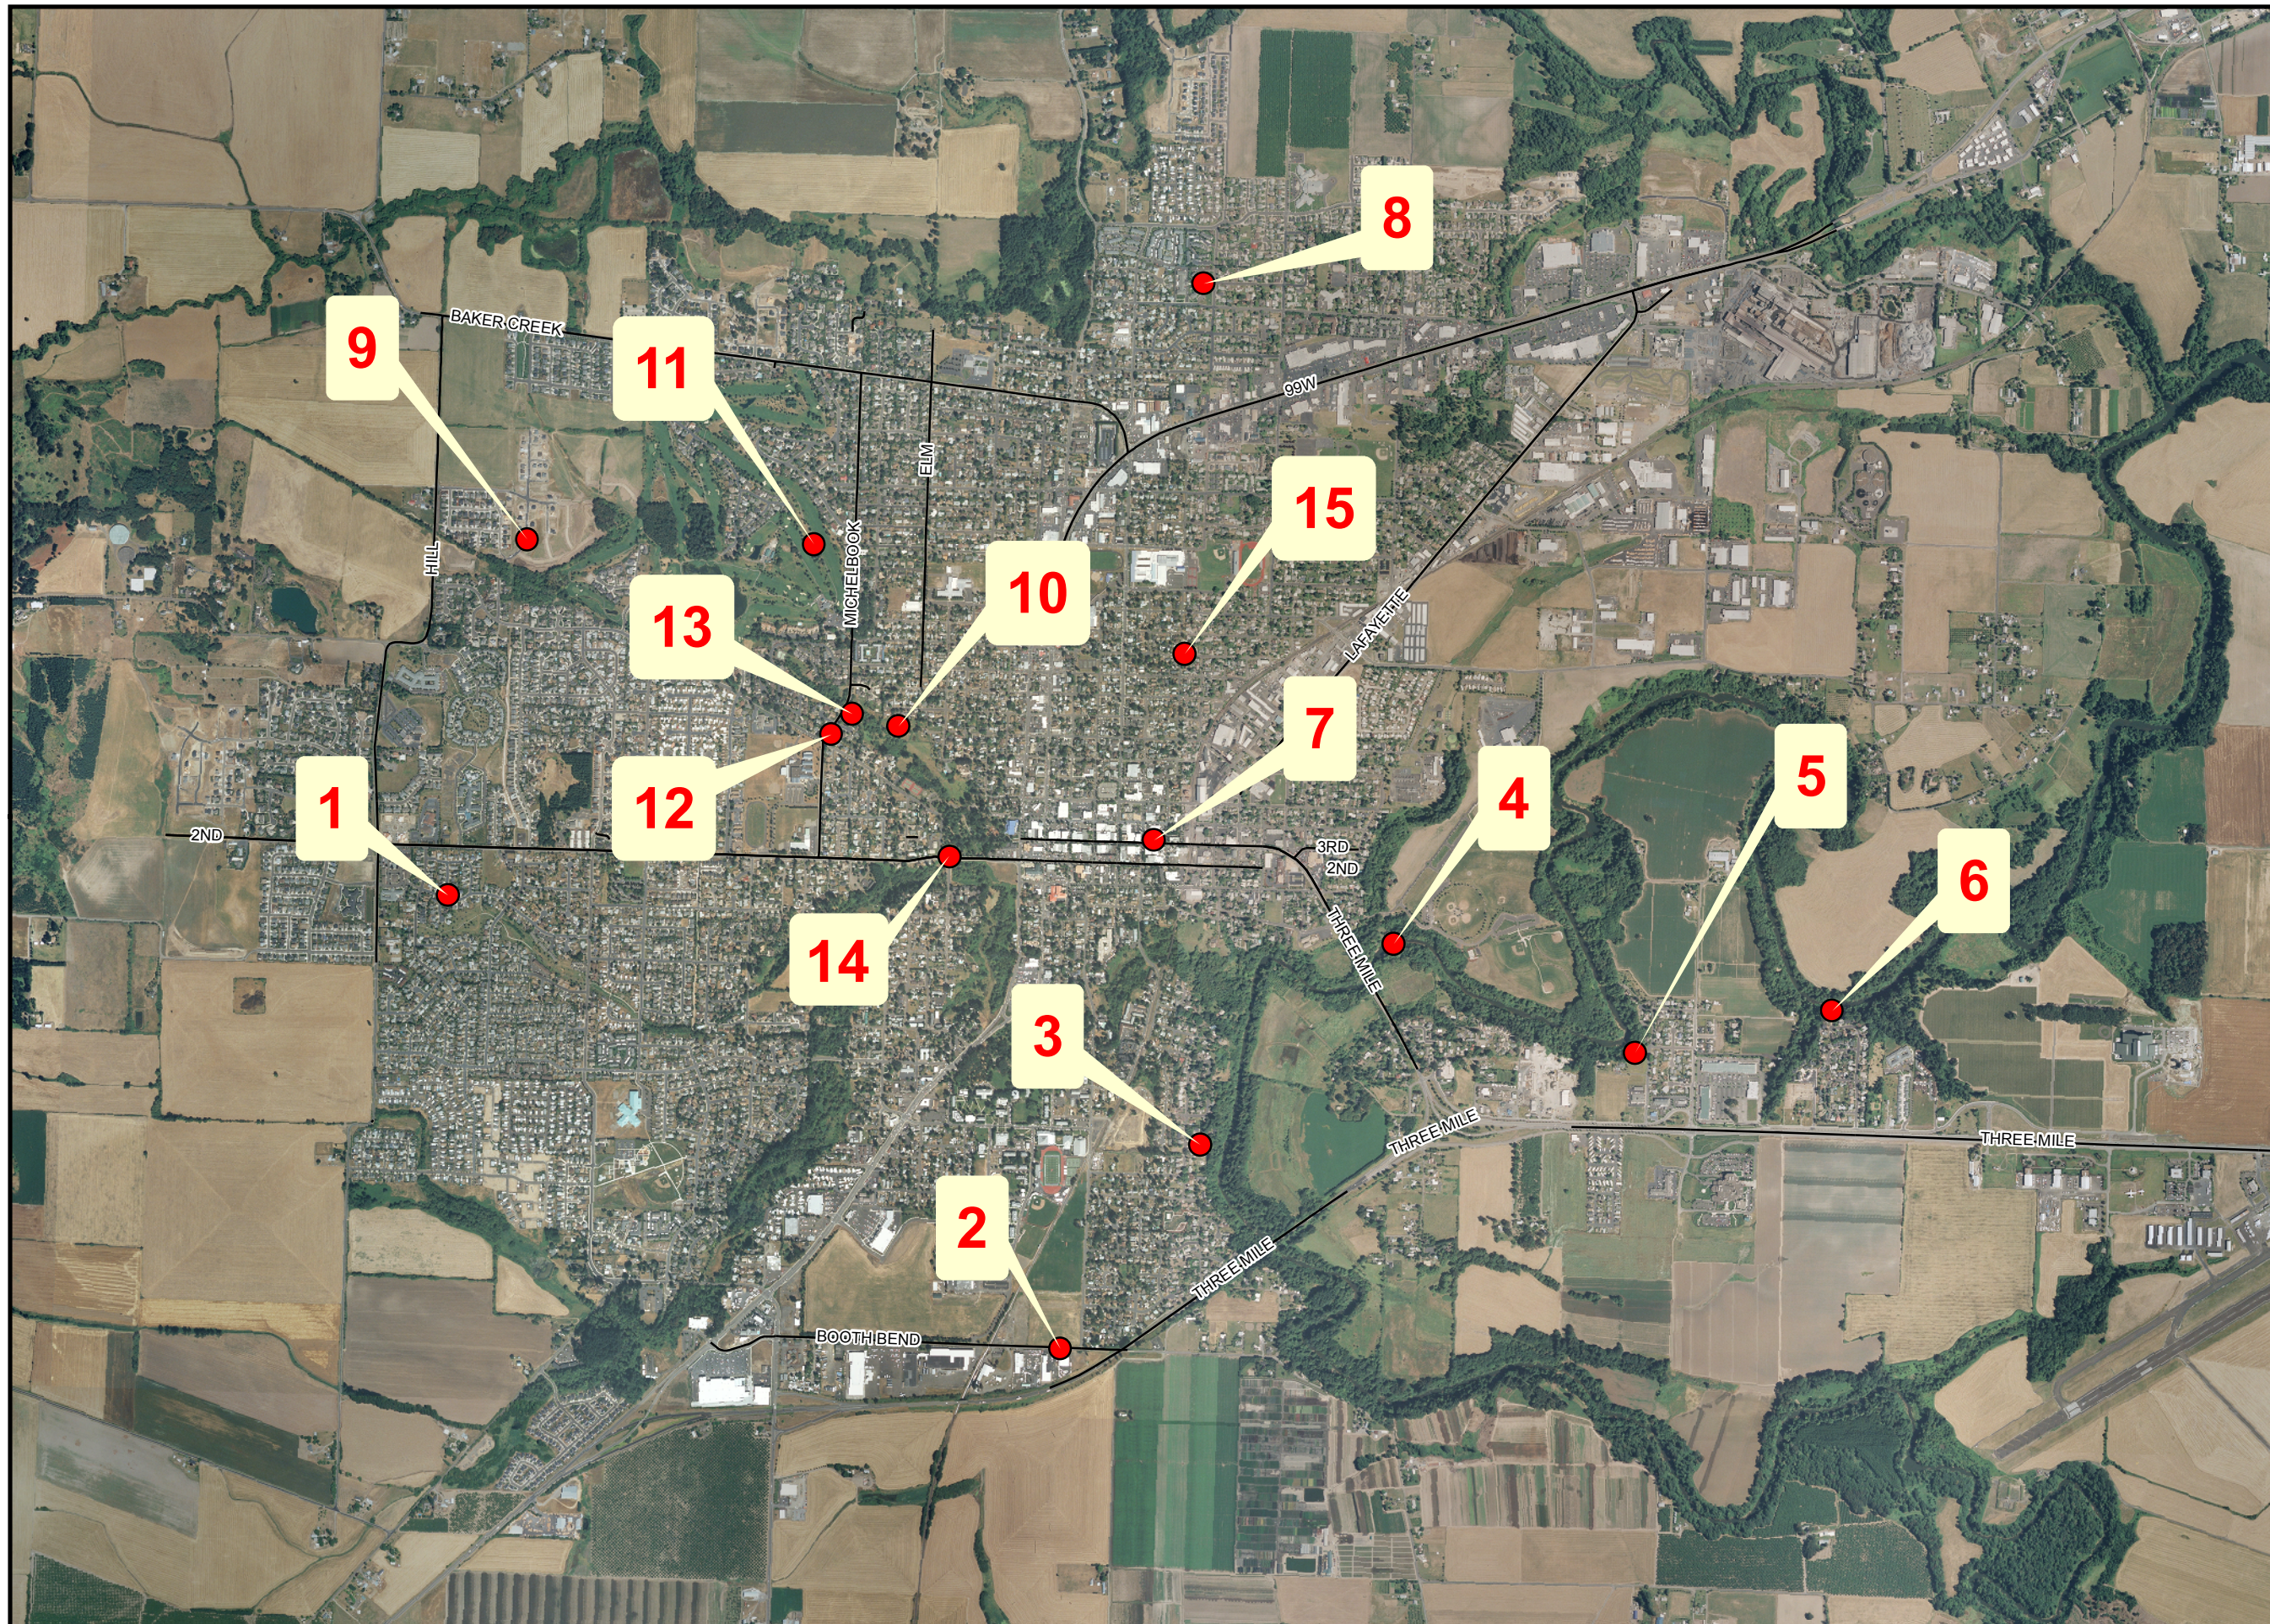
**FIGURE 8-1**

City staff identified operations and maintenance (O&M) problem areas as listed in Table 8-1. The locations of these problem areas are shown in Figure 8-1.

No.	Description
1.	Linear park detention ponds (between Westvale and Cypress and Cypress and Agee): During heavy rain events, the pond between Cypress and Agee has backed up, causing flooding across Cypress.

2.	Intersection of Booth Bend and Davis to the outfall southeast of that intersection. This backs up from the catch basin on the northeast corner.
3.	Bank erosion at the location of the outfall east of Cleveland Avenue. The bank is eroding away at this point, leaving the outfall undermined.

4.	Bank erosion at the location of the outfalls off Brooks Street. The bank is eroding away at this point, leaving the outfall undermined.
5.	Bank erosion at the location of the outfall off Dunn Place. The bank is eroding away at this point, leaving the outfall undermined.

6.	Bank erosion at the location of the outfall for Kingwood. The bank is eroding away at this point, leaving the outfall undermined.
7.	Combined systems (sewer, storm) on Irvine, Johnson, and Logan

8.	Pipe sizing west from 26th to N. Baker Street. This is surcharged and has backed up.
9.	Medinah detention pond function particularly emergency overflow protection.

10.	Catch basin sizing, location in the general area 12th – 15th, Adams to Elm. This area has surface problems, with many smaller, round catch basins that do not appear to be adequately sized or located.

11.	General capacity of the Michelbook system, from 21st south to the outfall south of 11th Street. Backups have occurred at the manhole on the golf course and from the catch basin along Michelbook pipe in this area is ungasketed; therefore, groundwater infiltration may be contributing to how the sidewalk is settling on the east side of Michelbook.

12.	Catch basin locations through the Michelbook dip, especially along the east side.
13.	Routing of pipe, catch basin sizing, and location south from 11th, between Elm and Michelbook, south to the outfall. Some of this pipe is inaccessible and/or runs under existing structures.

<b>No.</b>	<b>Description</b>
14.	Grade change along the line that runs west off 3rd Street through the city park. It has backed up during heavy rain events.
15.	Catch basin size and location in high school area.

**O&M PROBLEM AREAS**

Key O&M problem area projects were developed with a cost allowance and added to the list of recommended projects provided in Table 10-1.
