Property  
404 NE Irvine Street  
McMinnville, Oregon 97128

## Historic Resources Inventory Amendment

Photos of 404 NE Irvine Street

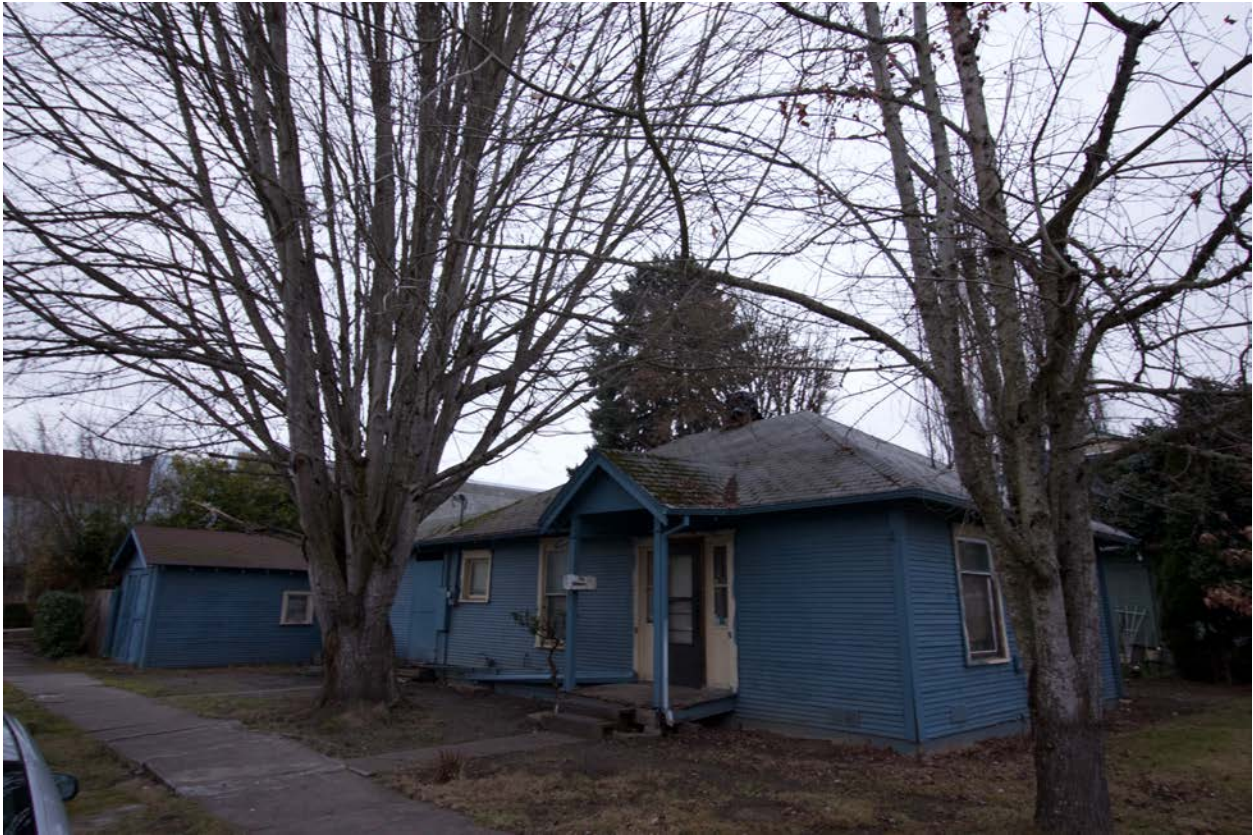
Exterior from 4th and Irvine

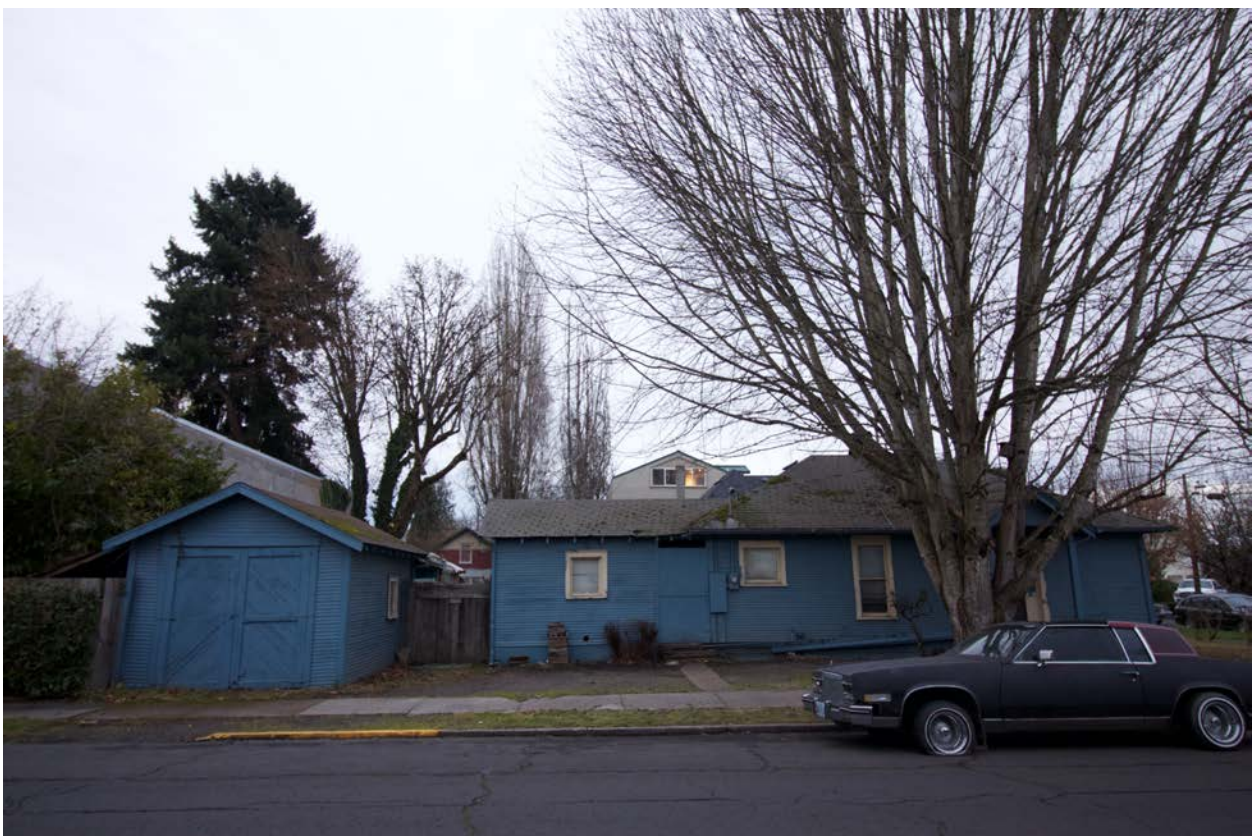
Exterior from Irvine

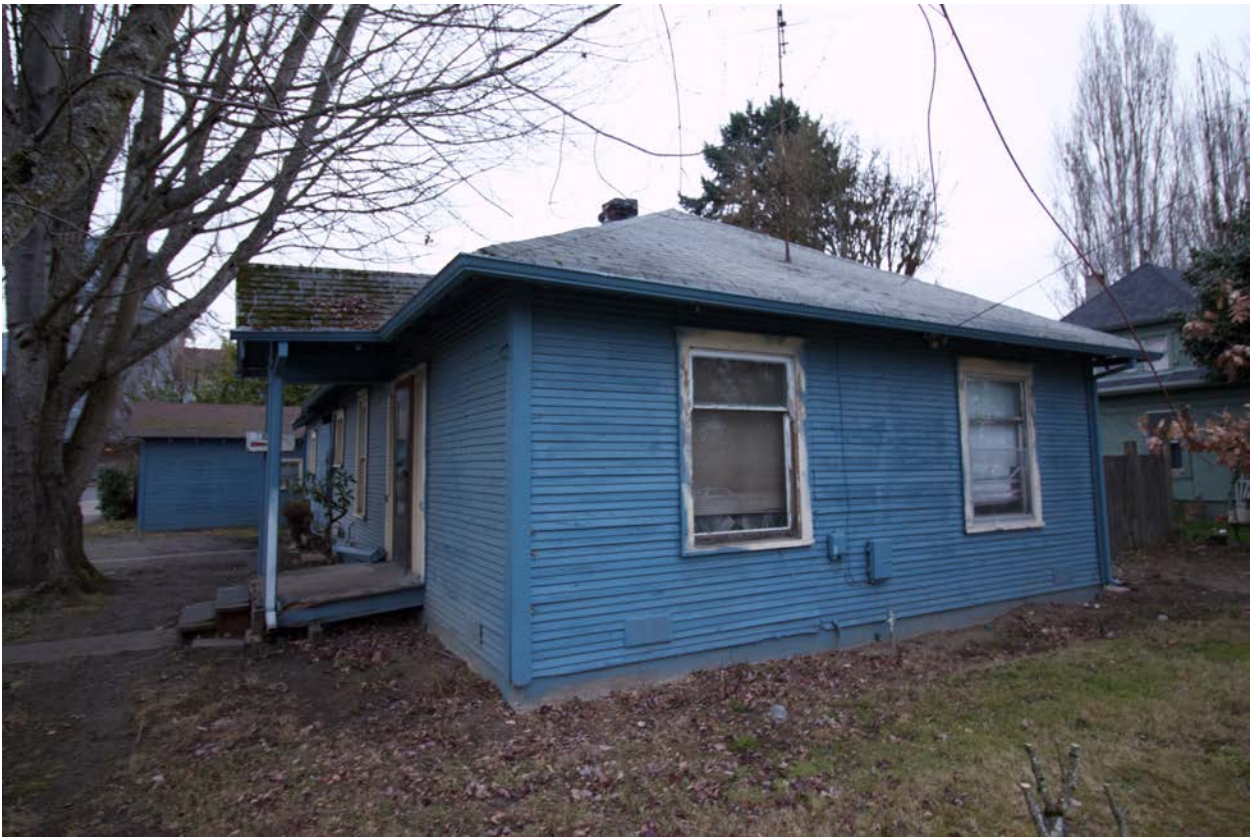
South side of house

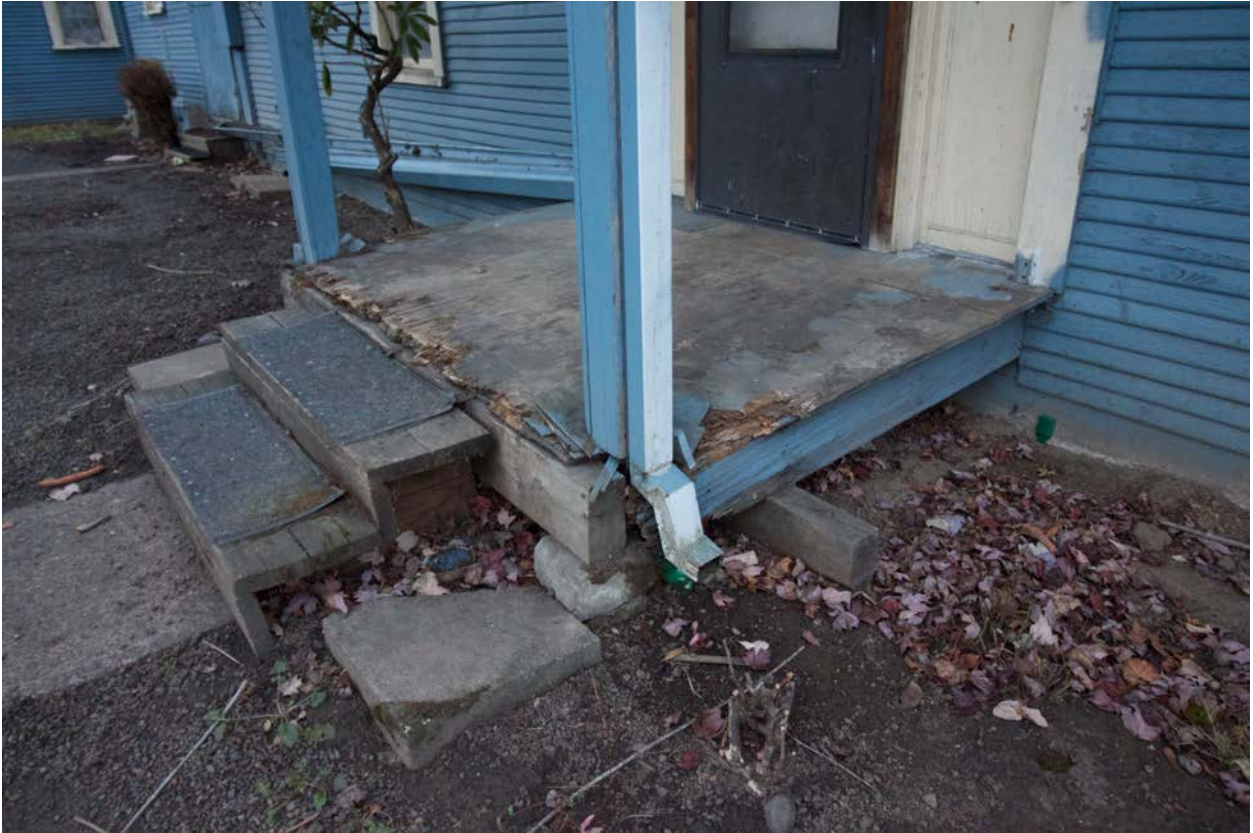
Current porch condition (West entry to Irvine)

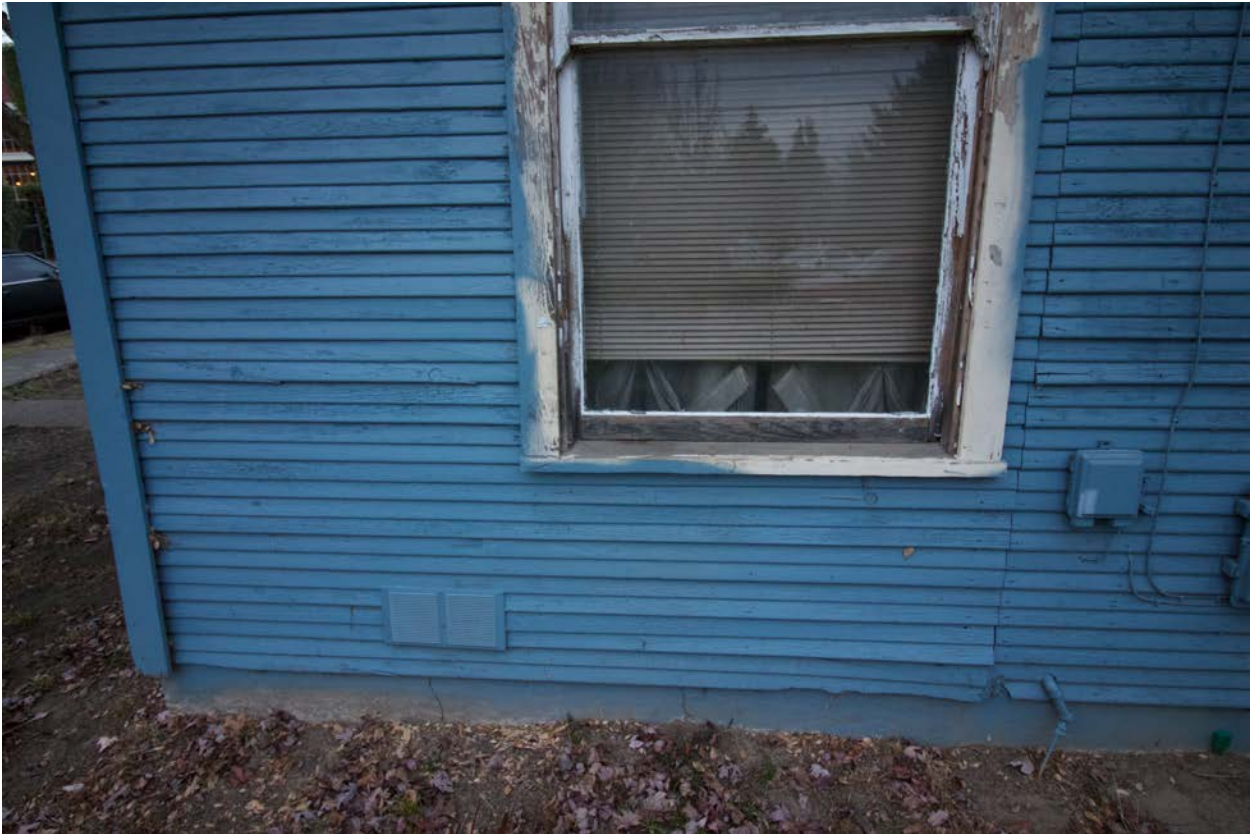
South side of house (window decay and siding butt-joint exposed)

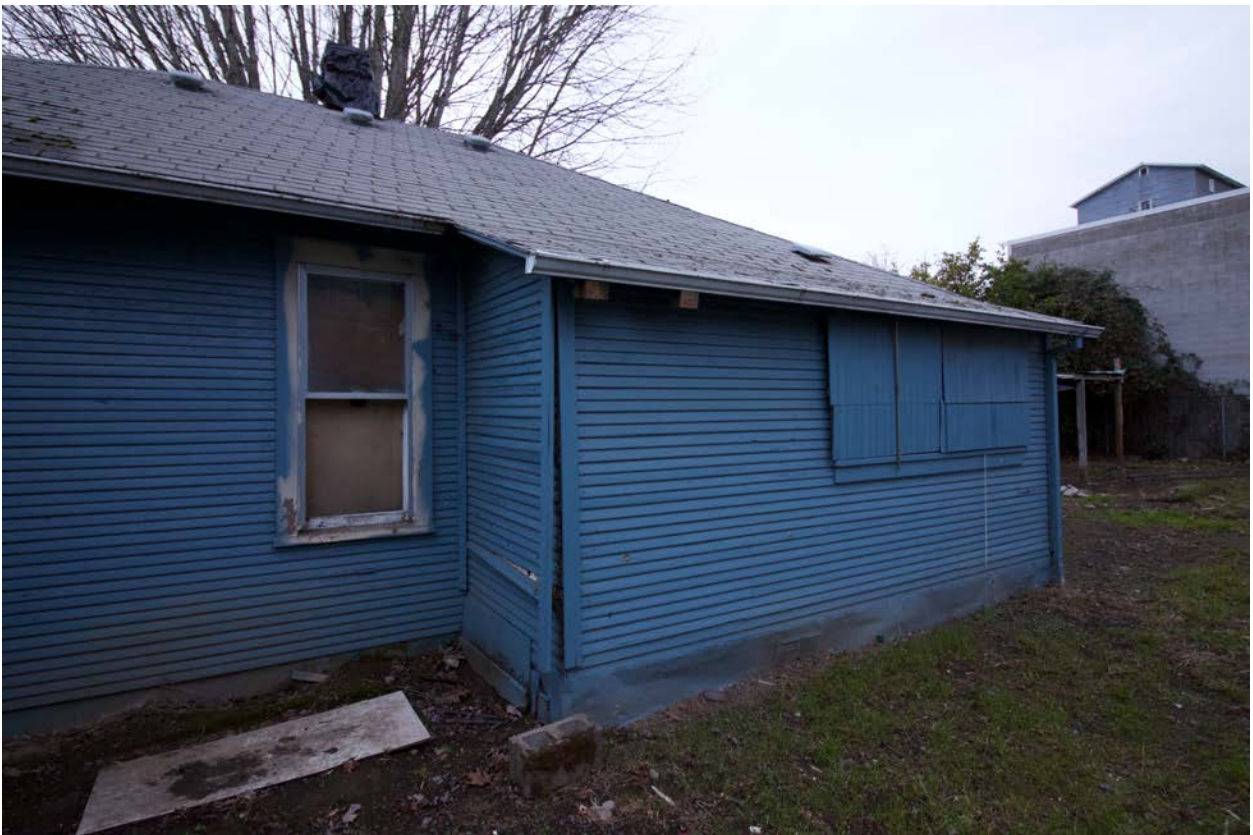
East side, no foundation, siding bowing out, boarded windows

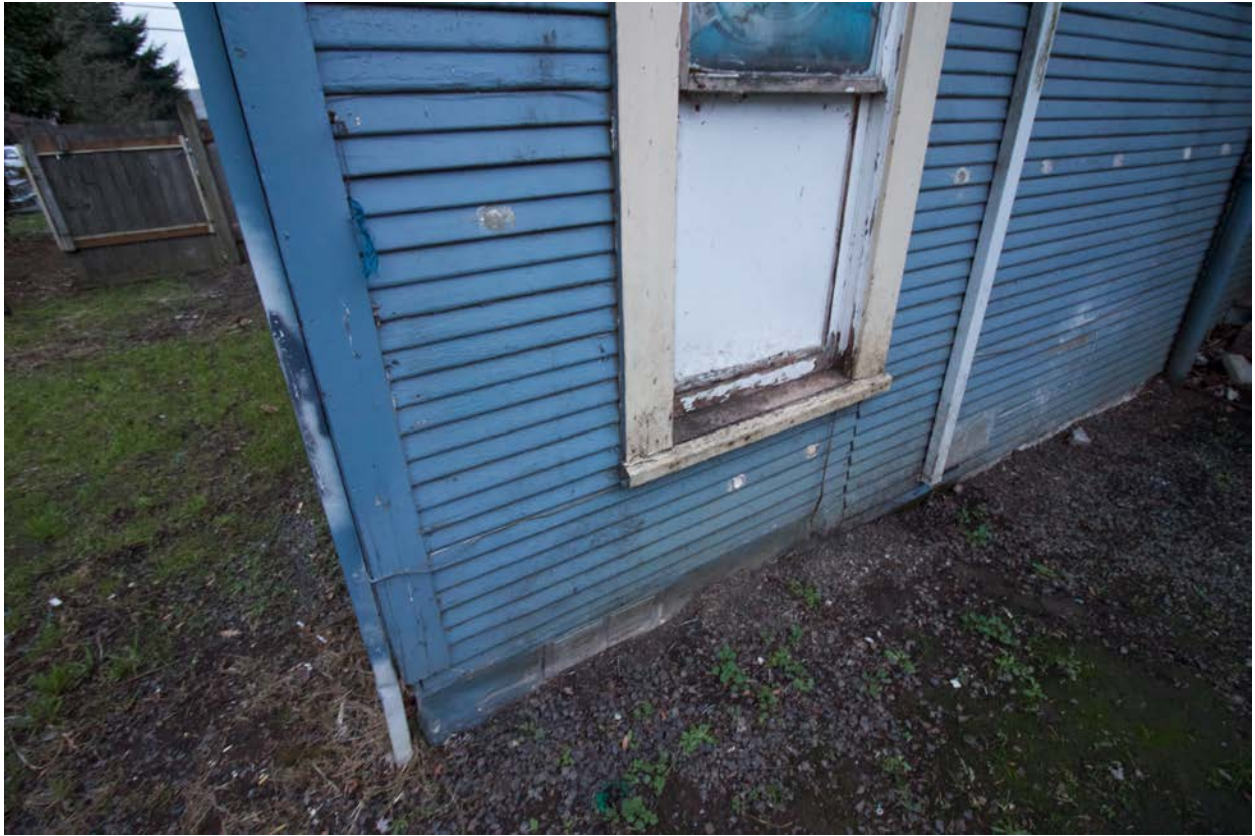
Window deterioration, missing glass, siding offset, untreated insulation holes

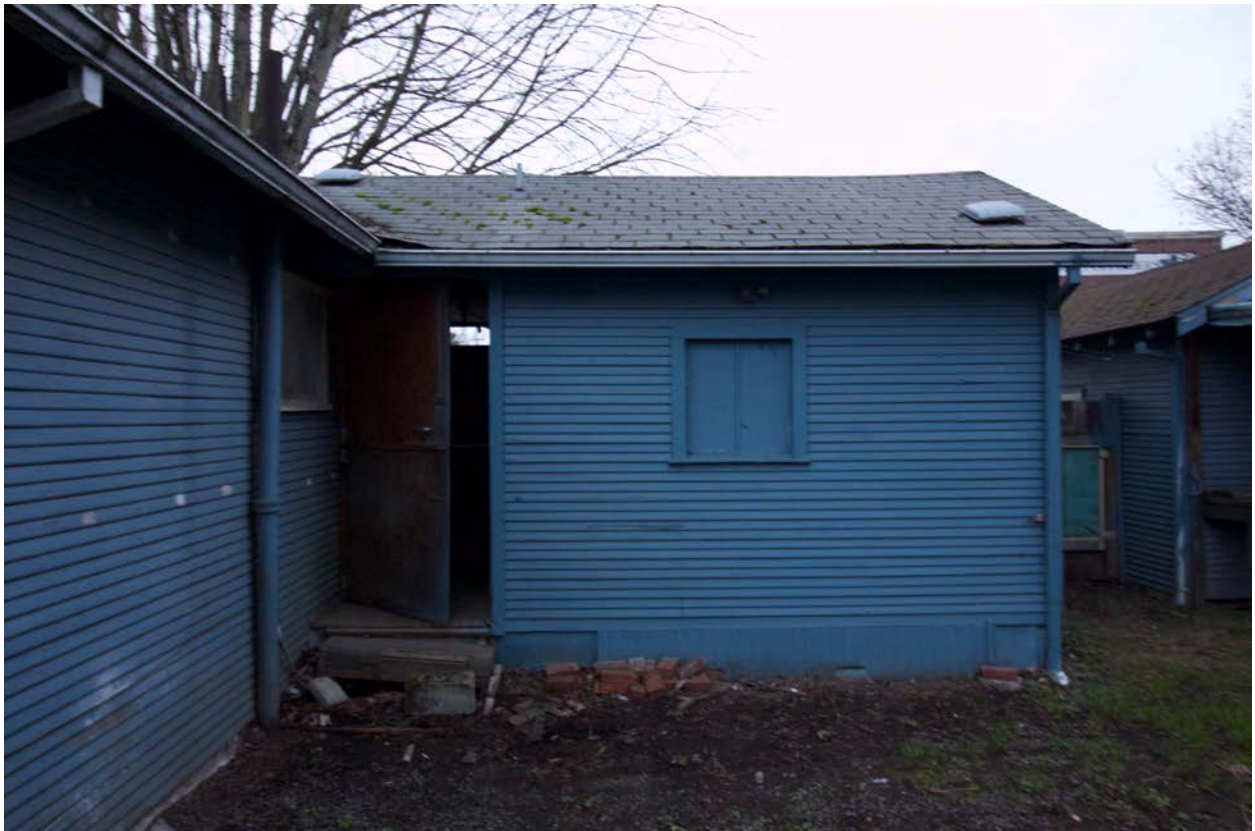
“Apartment” on North end of house

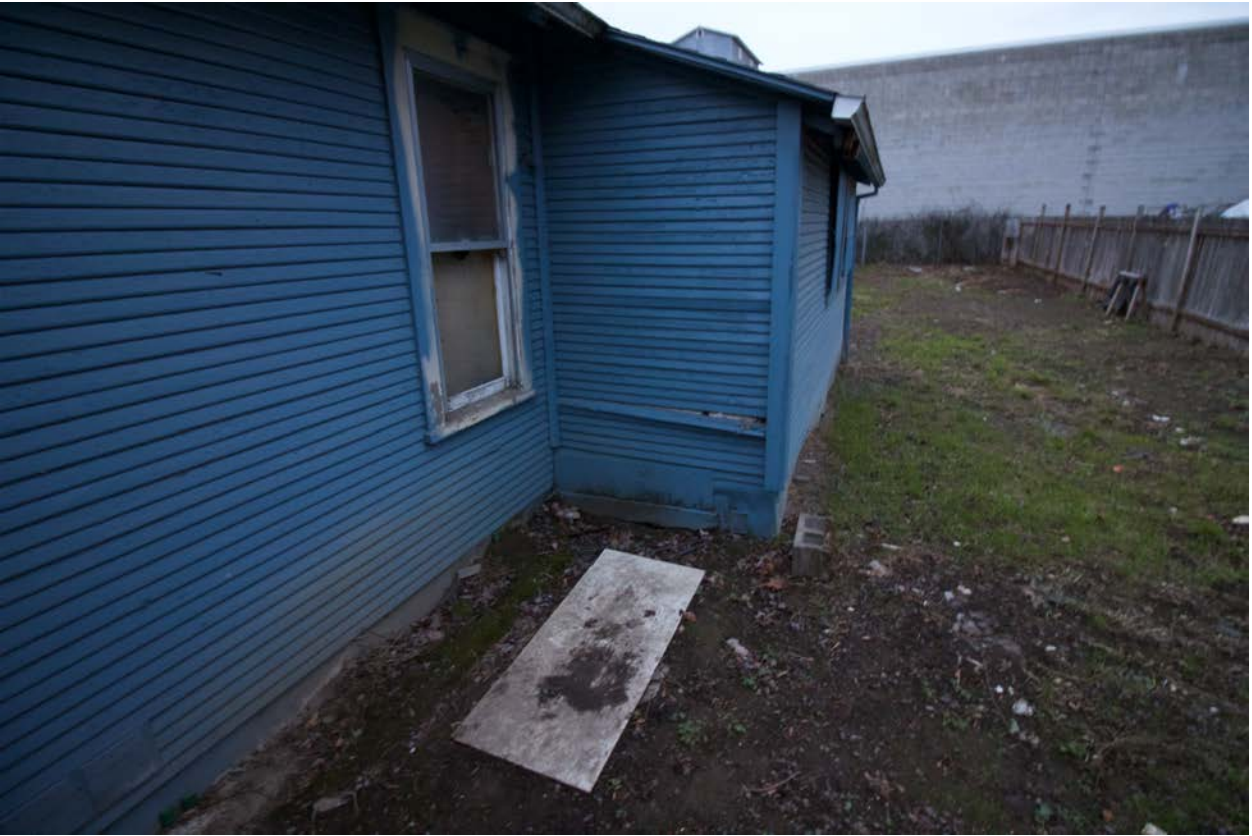
Siding falling off

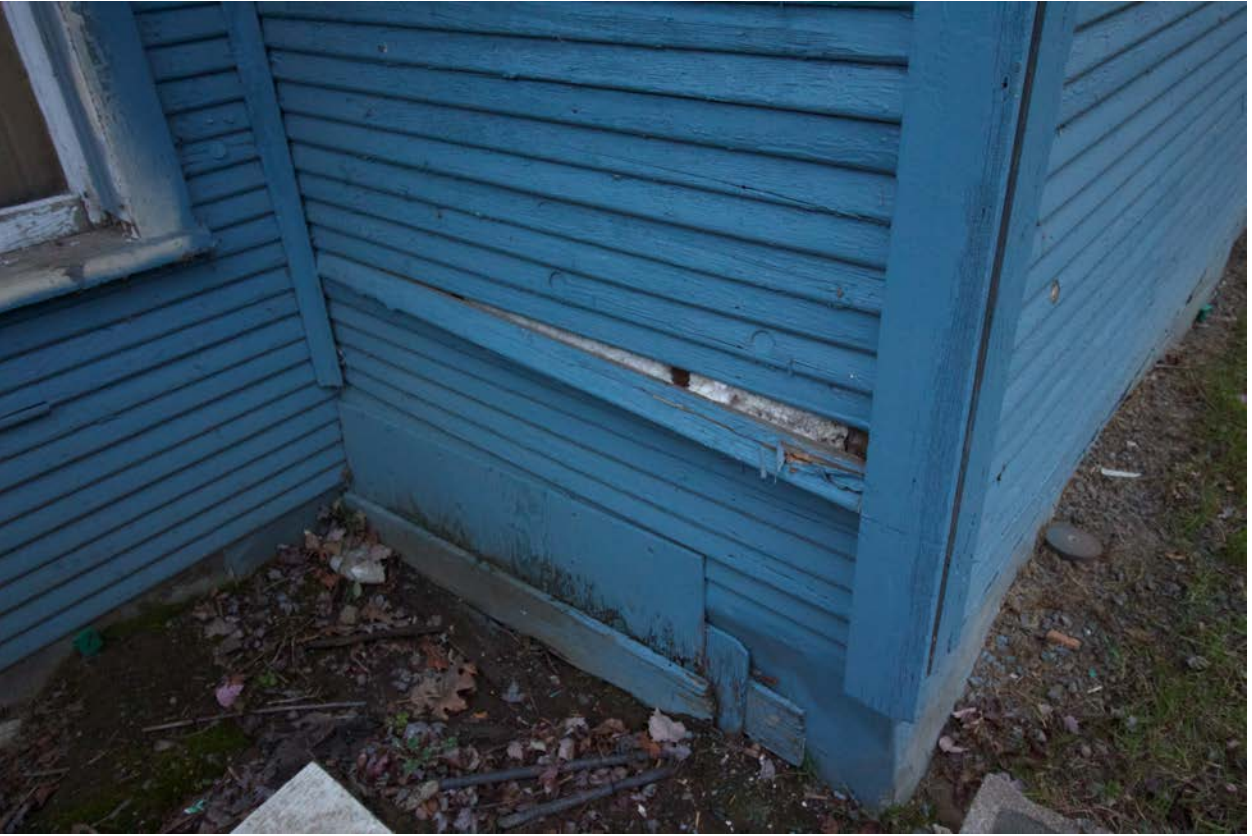
Siding falling off

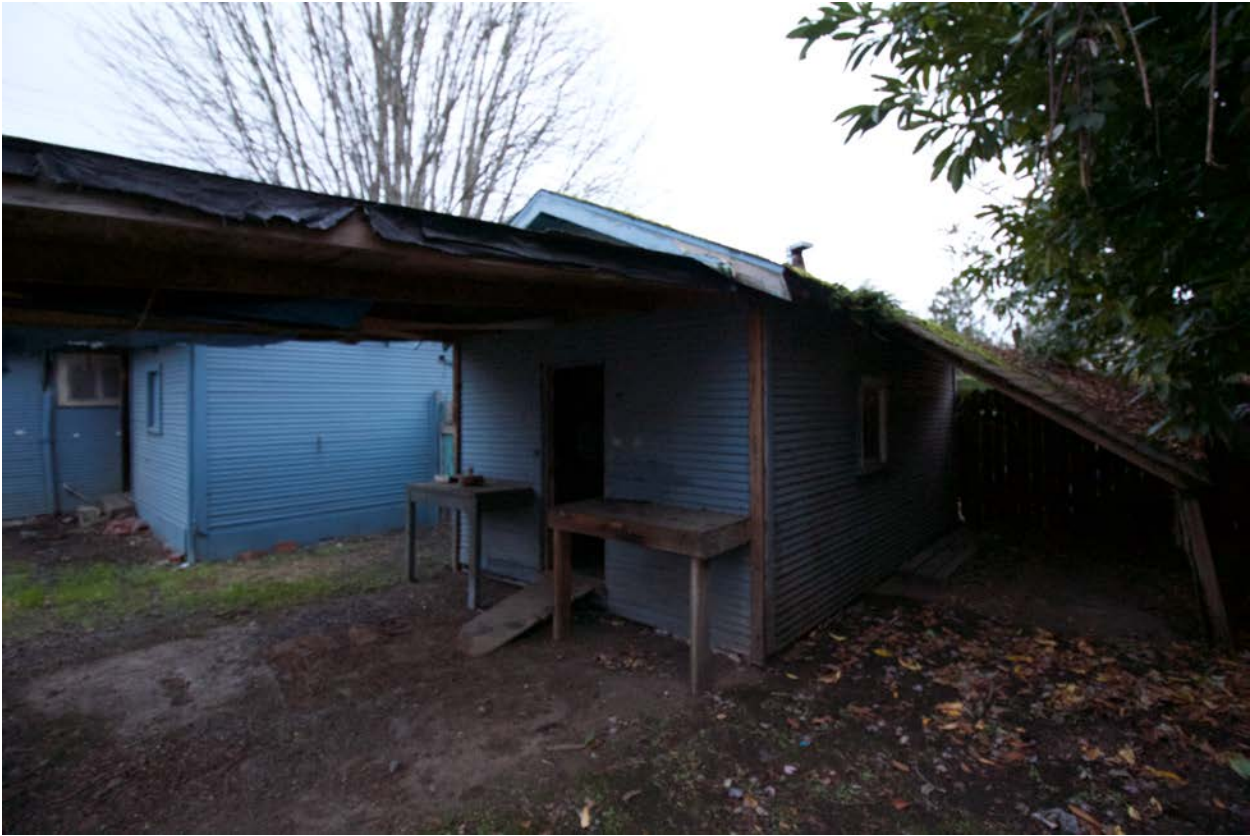
East side of garage

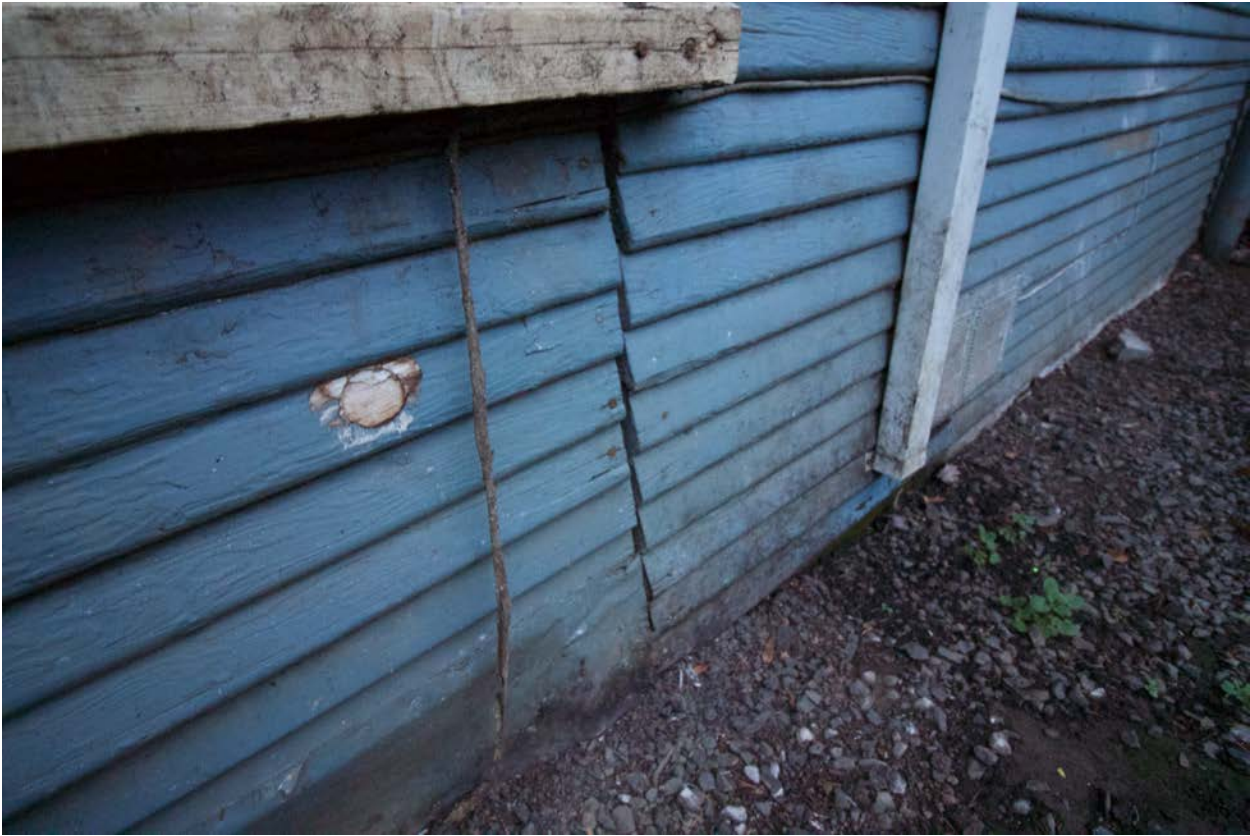
Close-up at exposed butt joint and misaligned siding

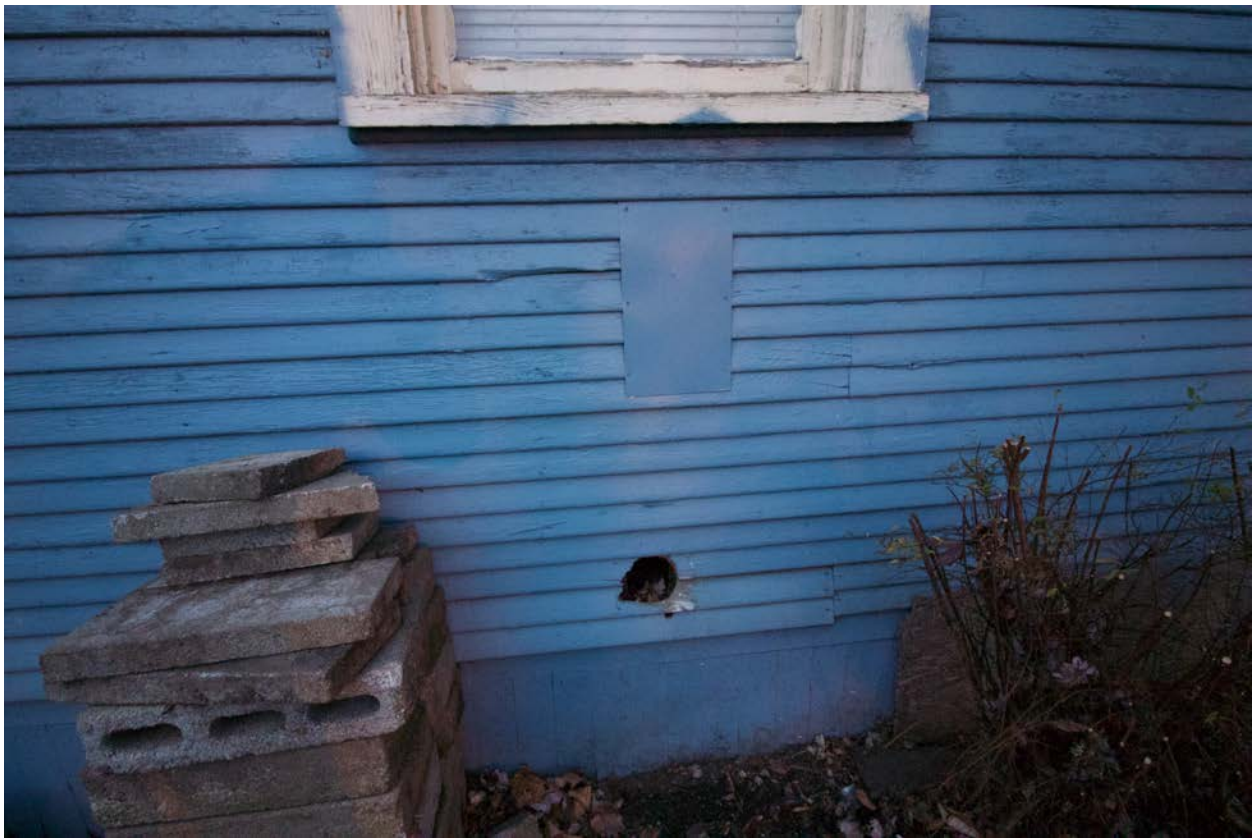
Large hole through house at East wall

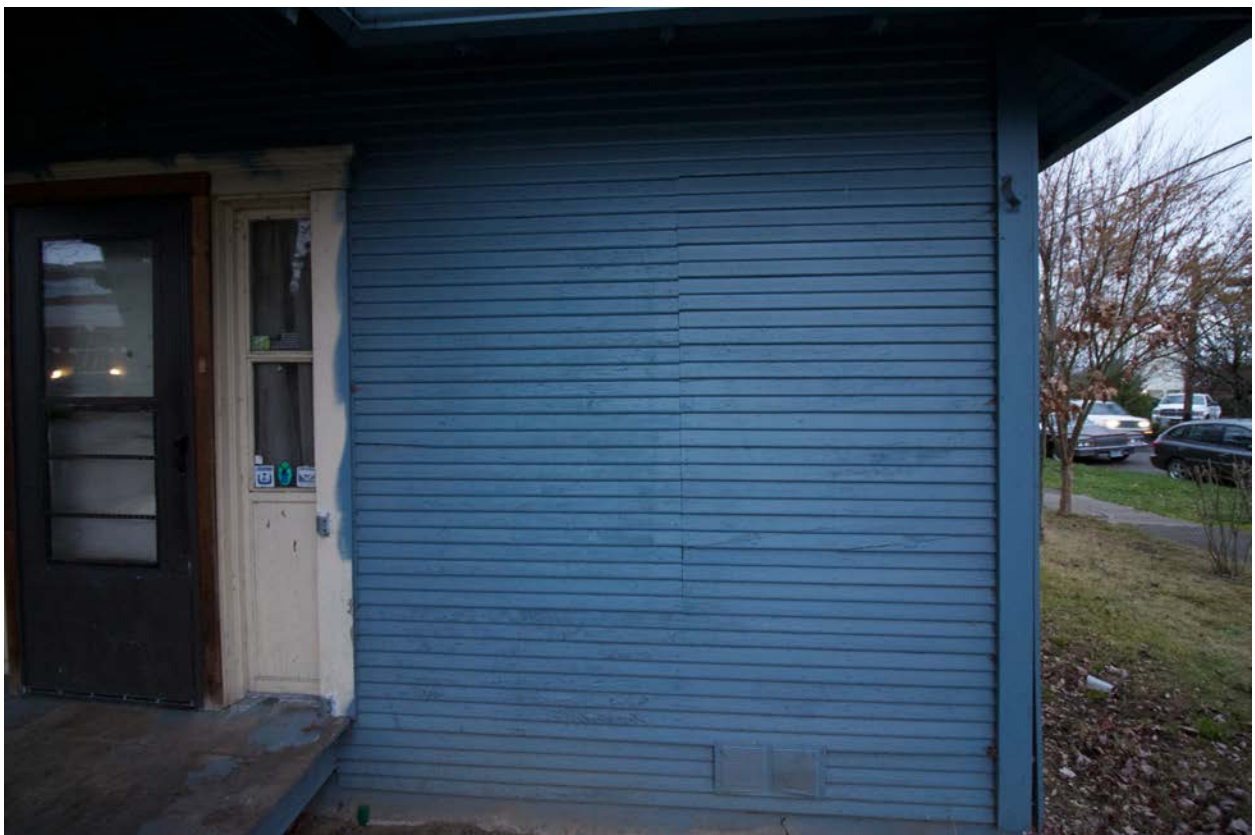
Butt joint and misaligned siding at East wall

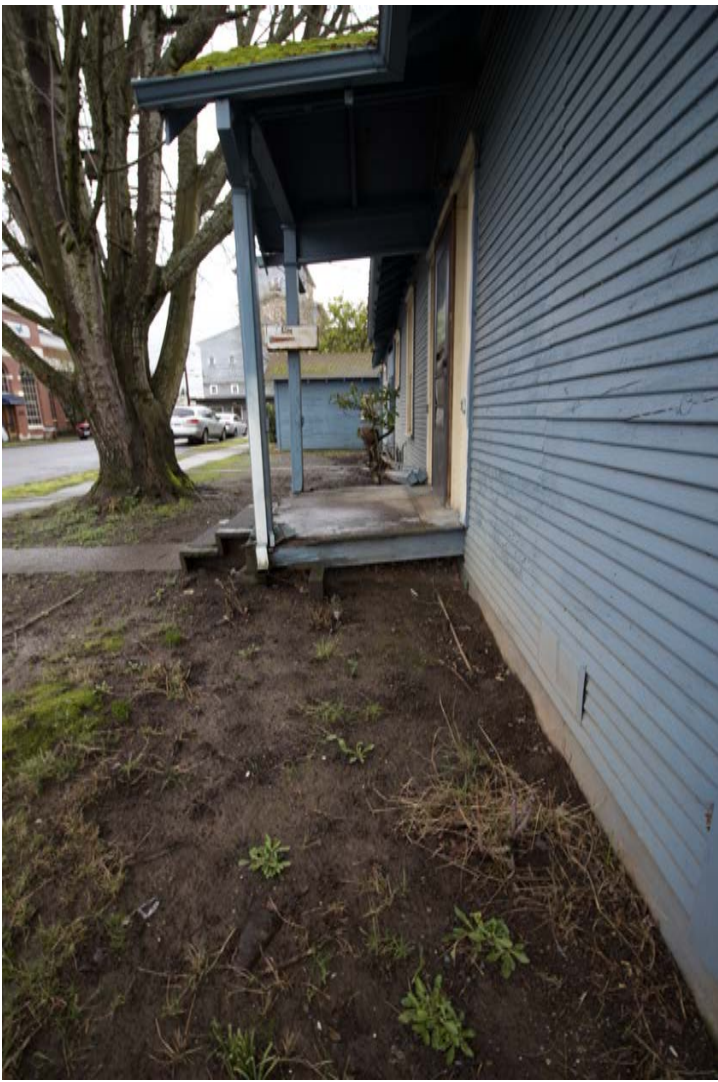
Sagging, unoriginal porch

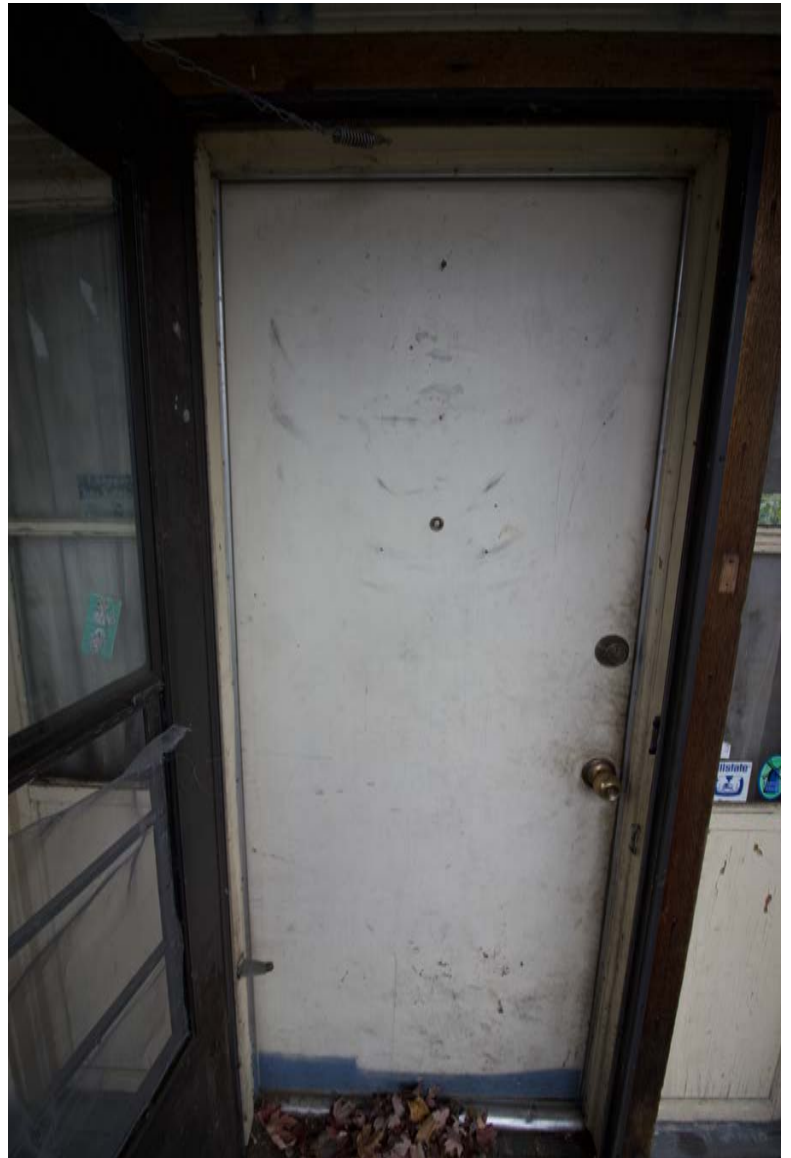
Replaced front door

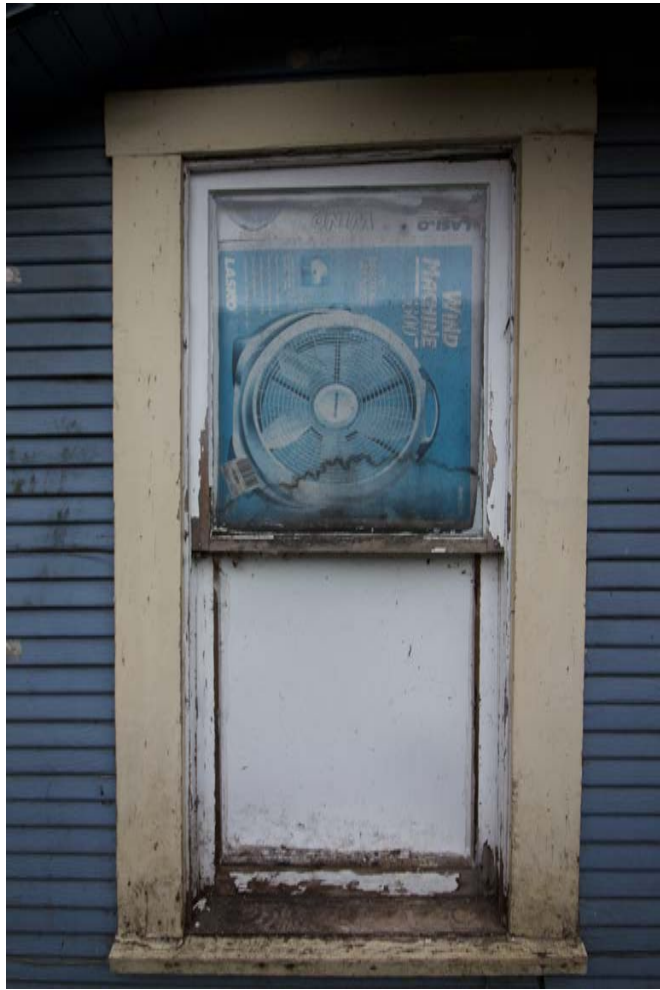
Boarded-up window

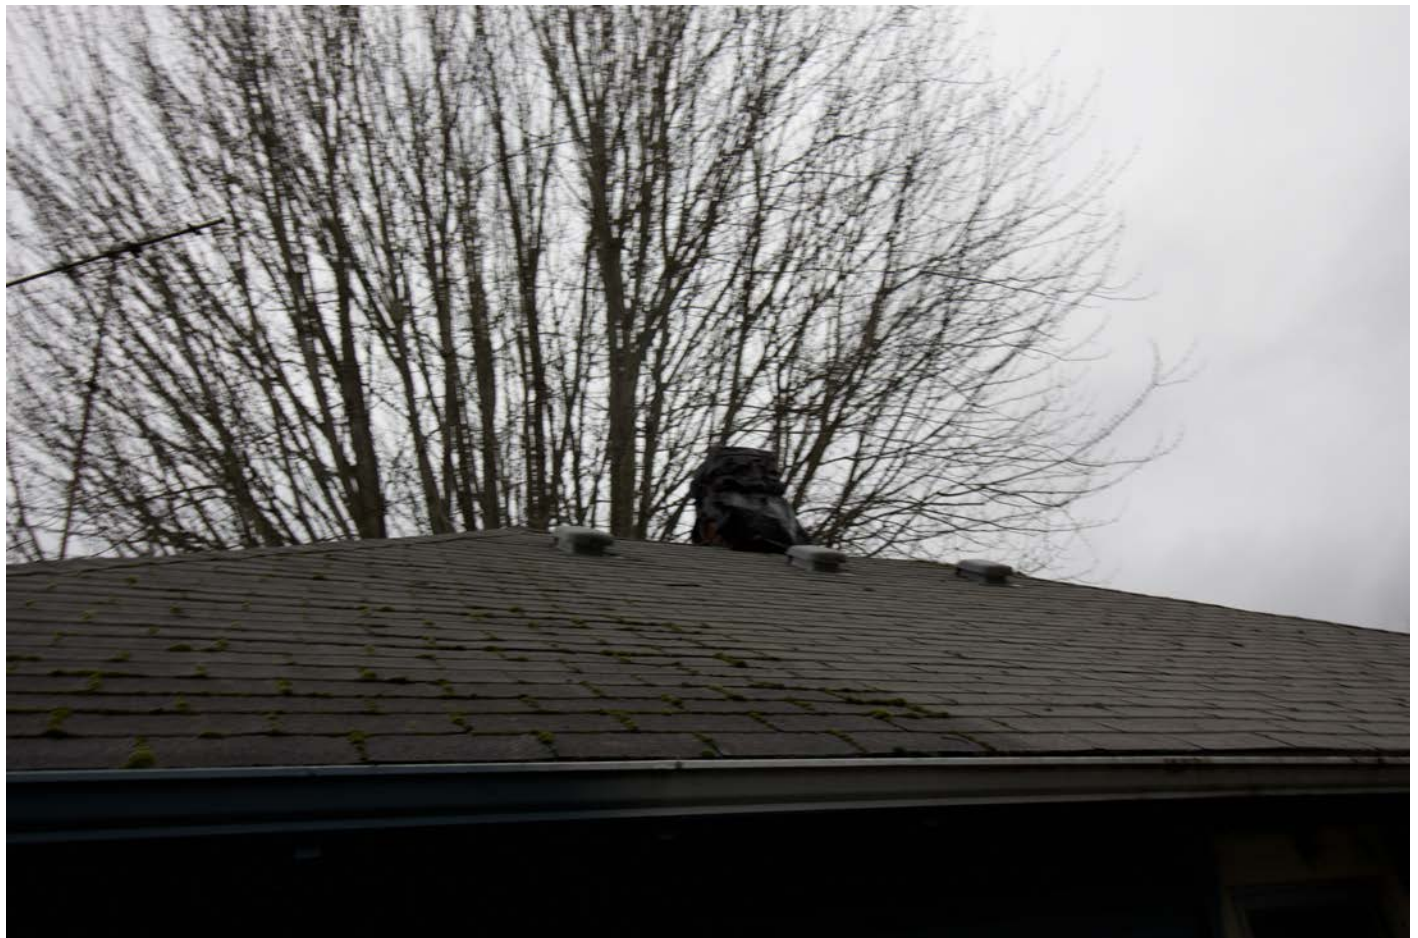
Covered chimney
