Historic Resources Survey City of McMinnville Yamhill County, Oregon

5.21 <u>J-10</u>	<u>A</u>	360	Primary Resource #109					
Historic Inforr	mation	1						
Date of Construction Early A	dditions/ Remod	dels Builde	r/Archit	ect				
ca. 1905		Unkno						
Historic Name Original Use		Commo	Common Name P			Present Use		
William Dielschneider House Residence			Residence					
Condition of Structure Com	nments (at time o	of Survey)						
Excellent								
Building Type	pe Outbuildings		Building Style		Stories			
Residential	None		Box		2			
Porch Basement Roof Styl ✓ □ □ Hip	le	Roof Type		Moved	Demolisi	hed	Year/Date	
Permit Number(s) Addition	ons/ Alterations							
10B0740, 99B0100 Interior	Remodel, New C	Garage						
Resource Info	rmation							
Recorded By	Date	;	Sources	6				
Jan M. Bennette	7-31-1980		Yamhill County Directory 1912, Flora Maloney Store, Letha Apperson

Historic Resource No. A360

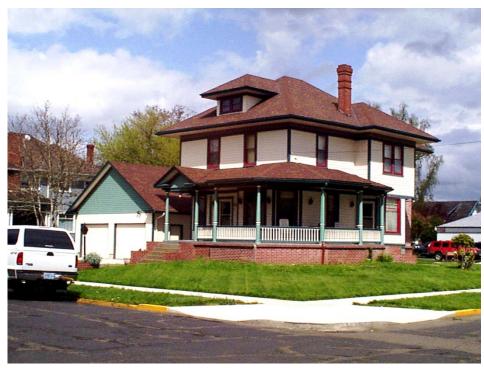
Photo April 2001

A basically two-story box home, probably built in 1905 with hip roof with small front facing hip roof dormer. The front façade is asymmetrical and features a wrap-around porch with a return gable sheltering front entry and then extending as a roof cover around and covering porch with classic column roof supports on exterior edge and one-half round columns against exterior wall as false roof supports. The exterior edge of porch also has low railing between columns with closely spaced vertical spindles. The second story level on south side features squared bay window.

This home was issued a porch remodel permit in 1977 and has had new concrete steps and much new brickwork on porch area. There is also a new brick façade on small area of south side from ground level to bottom of second story windows. If feel sure this is not original restoration or recreation work. The foundation of this building seems to include brick, stone, and wood.

Much restoration or remodeling seems to continue both on interior and exterior of home. A small gable roof garage with shed roof hood over front entry is in need of much foundation, roof, and paintwork.
