## Historic Resources Survey City of McMinnville Yamhill County, Oregon

## A402

## **Historic Resource No. A402**

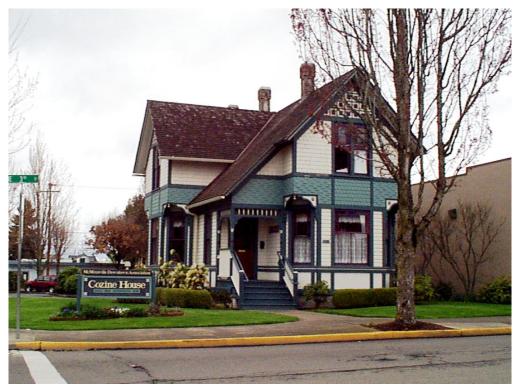
Photo March 2001

This wooden Queen Anne house is a cruciform plan with a cross-gabled roof. It sits on a busy city center corner facing south and has an attached garage on the north. The variety of texture in siding is particularly rich; a variety of decorative shingles and square panels decorate the gable ends and sections under the eaves. V-grooved lap siding sheathes the first story, and the area below the windowsills is covered with vertical or diagonal boards set within paneling. There are plain corner boards and a skirted water table at sill level all around. The foundation is brick, and windows indicate a daylight basement. The corners of the south and east facing sections are chamfered at the first story with pendants in the overhangs. A small porch is tucked into the angel of the cross gables at the southeast and is covered by a roof extension from the southern gable and supported by slender turned posts. Two corbelled brick chimneys are apparent from the street. Fenestration is irregular; all windows are double hung sash with the typical Queen Anne colored glass lights surrounding the upper pane. The lot has many old trees and shrubs which appear to be part of the original landscaping.
