**Historic Resources Survey
City of McMinnville
Yamhill County, Oregon**

Site Address		Owner at Time of Survey			
390 NE 2nd St.		United Presbyterian Church			
Map/Tax Lot	Current Zoning	Special Tax Assessment	Downtown Historic District		
R4421BC12900	C-3	No	No		
Subdivision Name		Block	Lot	Lot Size	Quadrant
McMinnville, Original Town of		14		23,000 sq.ft.	NE
Site Number	Aerial Number	Resource Classification	Resource Number	Historic Significance	
8.23a	J-11	A	467	Primary Resource #176

A467

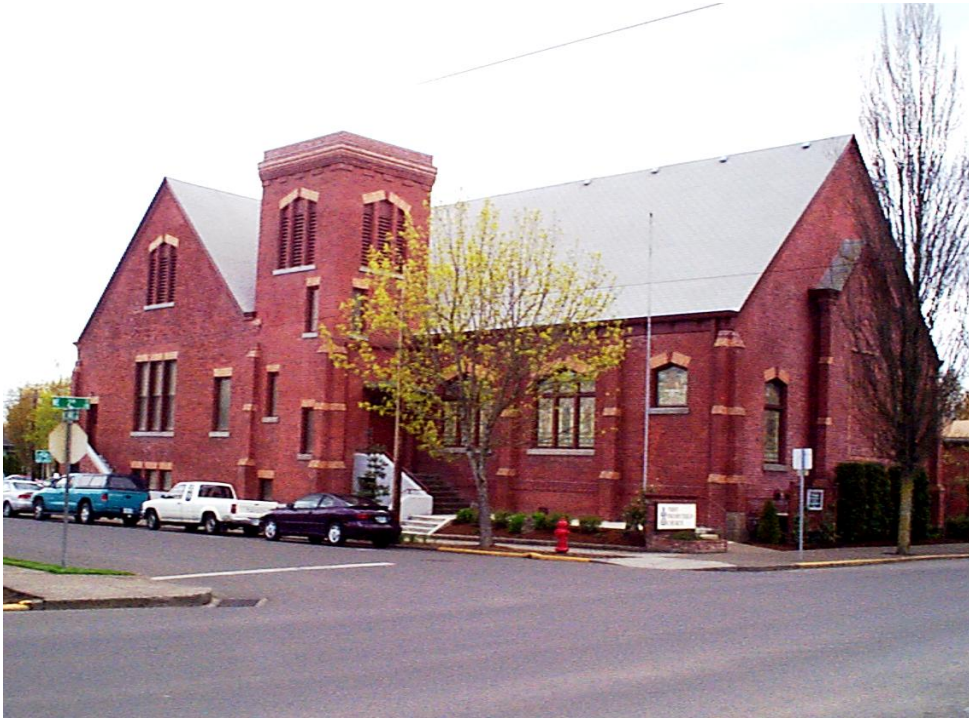
Photo April 2001

The Presbyterian Church was founded on the corner of Second and Davis in 1851. Two previous churches burned. Southeast part of wood building was erected in 1897. The building has been turned and the northeast corner (now the sanctuary) was added in 1909.

The original building had a brick foundation-now covered with cement. There is a complete cement basement under the northeast and southeast portions of the church. The roof is asbestos shingles. The roof is gabled except for one side which is hipped. There are corner brackets on the old building.

Window treatment is triangular shaped. Decorative stained glass, three-over-three, two-lighted pivotal, and single lights.

There is an off-center main entrance in the tower with corbelled cap. There is a cement stairway. Two exterior chimneys. Cement steps leading to two cellar entrances, one with arched entry.

New education and fellowship hall was built in 1968 with cement foundation and stucco and brick exterior. Asbestos shingles on a low gable roof. The new addition is separated by a courtyard attractively landscaped with metal sculptured waterfall. There are plans to add another office to this section. The old building is in need of repair from the basement up.
