**Historic Resources Survey
City of McMinnville
Yamhill County, Oregon**

836 NE Cowl's Street

Historic Resource Survey
City of McMinnville
Yamhill County, Oregon

Historic Resource No. B357

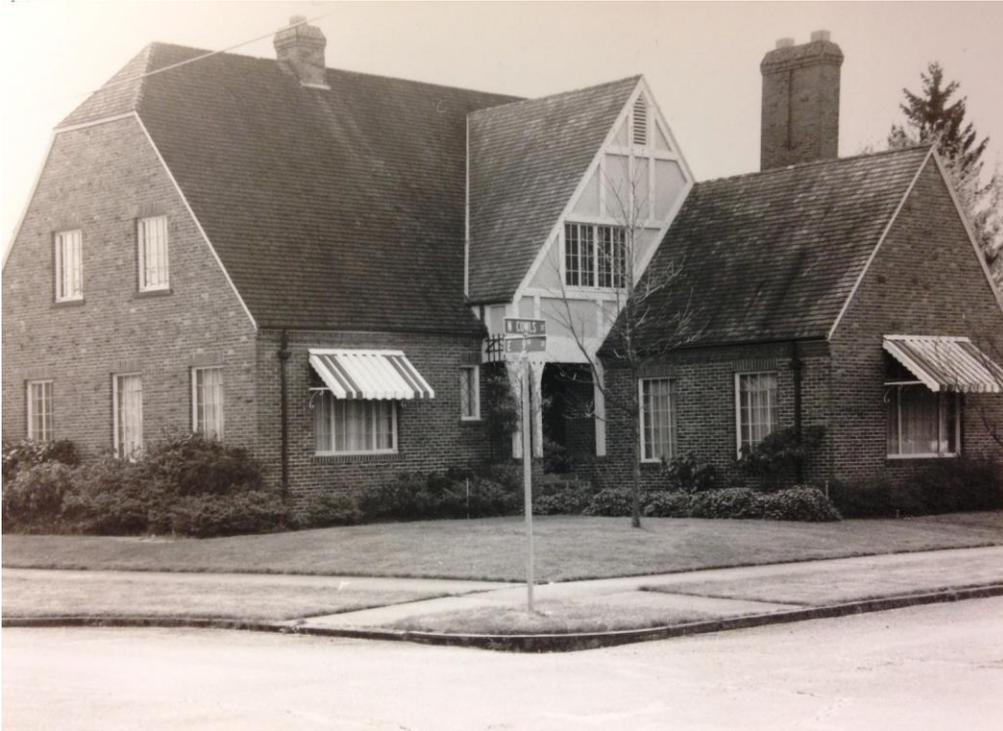
Original 1983 Survey Photo

A handsome Norman farmhouse of two and one-half stories, this house is a squat T in shape. The major structure sits along a north-south axis with a slightly lower ridge line extending to the west. Attached to this is a one and one-half story structure appearing as a high gable with east-west ridgeline about 10 feet below that of the former. The main structure has a high jerkinhead roof.

Construction throughout is brick with shingle roof. One central chimney emerges at the top of the main ridgeline. A rectangular large chimney rises ten feet above the high gable front structure.

The main entryway is at the northwest inner corner of the T structure.

Fenestrations: On the north side, three first floor; two second floor; west side, one double with awning on northwest corner; double four over four in high gable with one small window at gable peak. In front structure, two on north and south, one to west with awning.

A breezeway connects to a large north-south garage at the rear with double hipped shingle roof.

Cement foundation and probably a full basement. The entire structure appears in excellent condition. The grounds are beautifully landscaped.
