## Historic Resources Survey City of McMinnville Yamhill County, Oregon

Site Address				Owner at Time of Survey					
445 NE 3rd Street				W.G. Wright					
Map/Tax Lot		Current Zoning			Special Tax Assessment				
R4421BC06000 C-3			No	No		Yes			
Subdivision Name				Block	Lot	Lot Siz	ze Quad	drant	
Original Town				17	8		NE		
Site Number			Resource Classificatio		Resource H Number		Historic Significance

#### B490

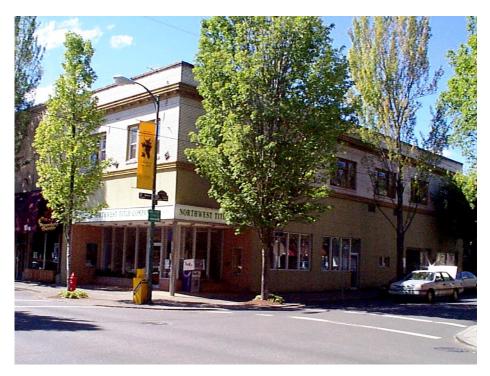
Photo August 2001

This is a rectangular, flat-roofed, two-story building sitting on the northwest corner of the intersection of Third and Evans facing south. The façade is two bays across; the east elevation, six. Upper story windows are the Chicago type: two fixed central panes with one-over-one, double-hung sashes flanking. The upper story is of buff-colored, commonbond brick. Labels of stretchers and sills of headers surround the wood-framed windows. A large cornice line with modillions stretches across the façade and the east elevation approximately two feet below the roofline which is articulated by a course of corbelled headers. A second, simpler cornice line articulates the division between the stories. The ground floor has been altered. It is covered with scored stucco and the façade has been cutaway. Aluminum windows have replaced the originals. The rear elevation which faces an alley is plain red brick with but two unornamented double-hung one-over-one sash windows in the upper story.
