**Historic Resources Survey
City of McMinnville
Yamhill County, Oregon**

448 NE 3rd Street

Fenton Building

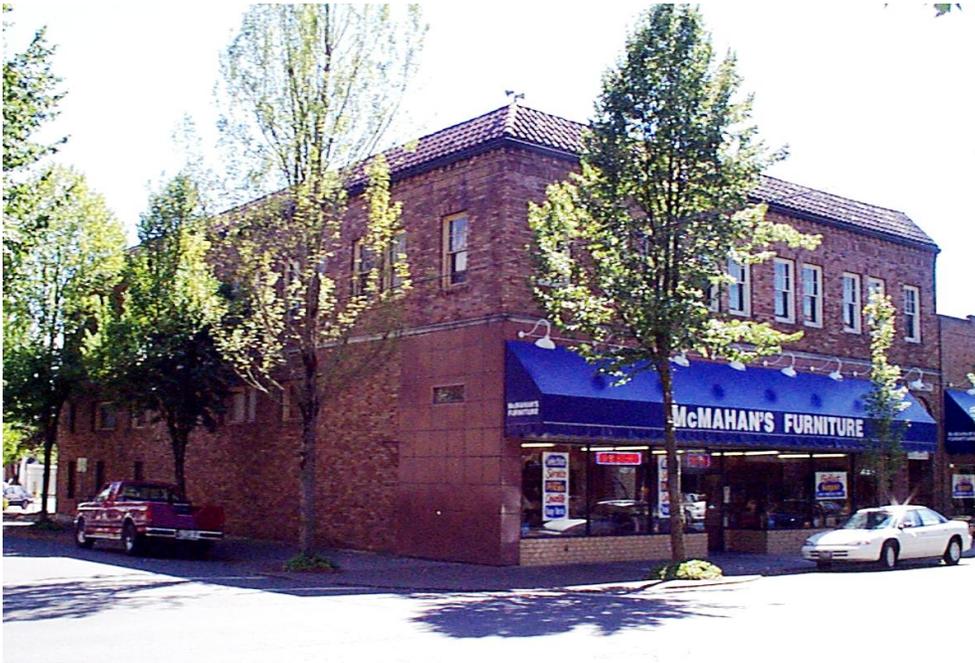
Photo August 2001

The Fenton Building is a large, square, brick structure facing north on the corner of Third and Evans Streets. Built in the '20's by Frank W. Fenton, prominent McMinnville attorney and property owner, it has always been occupied by a dry goods firm. The façade and east elevations are faced with variegated red brick and have a mansarded roofline covered with red Spanish tile. A cornice line of dentils runs immediately beneath this. A narrow stone belt course articulates story division. There is a basement and a second story (once offices, now storage). Fenestration at the second level is regular—there are symmetrically arranged one-over-one double-hung sash windows in pairs and singles along the façade and east elevation. They are set within moderately deep reveals and articulated by variation in bonding. Another irregular course of windows stretches across the east elevation at the mezzanine level. There is an arch over the stairwell at the west end of the façade. The remainder of the ground floor façade is faced with metal tile and the entrance has been cut away and fitted with aluminum windows. The rear elevation is plain stucco and has irregular fenestration with multi-lighted casement windows of varying sizes. The interior of the store has a pressed tin ceiling which has been painted over.
