**Historic Resources Survey  
City of McMinnville  
Yamhill County, Oregon**

425 SW Edmunston Street

**Historic Resource No. B503**

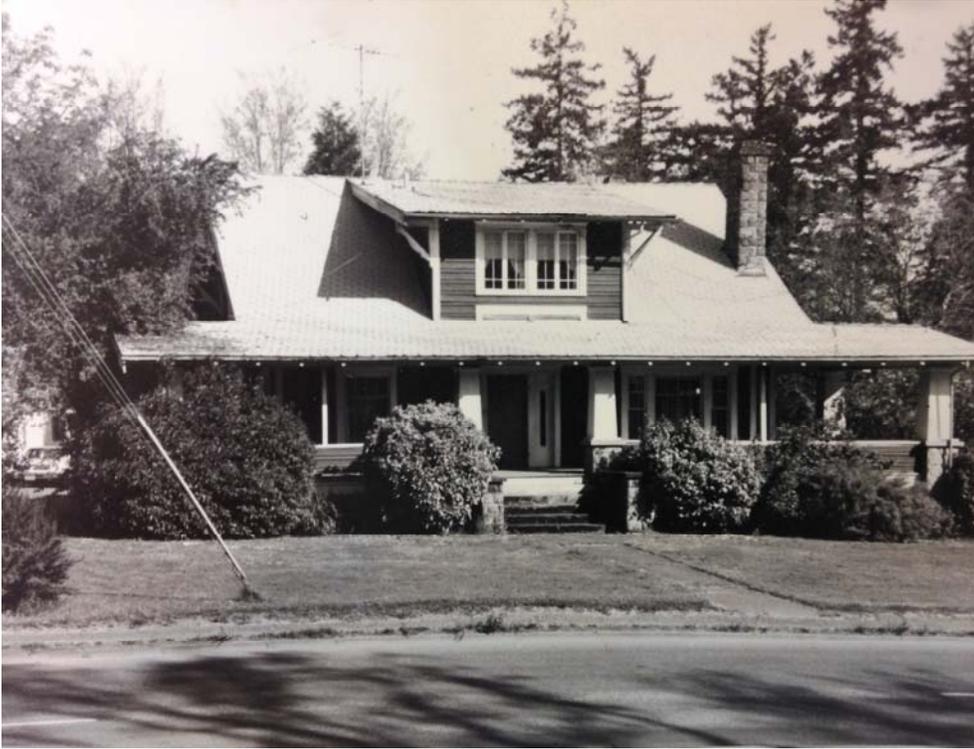
Slight damage to porch steps; Broken gutters or downspouts; In need of paint; Missing material in small areas.

This is a bungalow style house of wood frame construction. It faces east onto Highway 99W and is quite a large house. It is one and one-half stories with at least a partial basement and sprawling one story porch. The exterior walls and on porch railings are of bevel siding of alternate thick (6"?) and thin (3"?) widths. The roof is gabled with bracket at the ends and exposed rafters, carved at the ends. There are shed dormers in front and back of the house with casement windows. Other windows are double hung four-over-one, two-over-one, and three-over-one. Window placement is irregular on the south side. There are two extensions to the main house in the rear – both have shed roofs – one on the main floor level looks to be the same age as the house. The other, at ground level, is perhaps newer or has been re-done, as it has consistent (approx.) 4" bevel siding. It is a small entryway or stair landing. Rock-faced stone masonry makes up the bottom half of the porch posts and the front steps. The house has two chimneys and a concrete foundation.

Original 1983 Survey Photo
