# City of McMinnville

**Historic Landmarks Committee  
Hybrid In-Person & ZOOM Online Meeting  
Thursday, August 27 - 3:00 PM  
Kent Taylor Civic Hall, 200 NE 2nd Street**

This is a work session to develop a scope of work for the restoration and reconstruction of the brick wall/flume at Star Mill Way, which was damaged in two separate vehicular incidents over the past year. This scope of work will be used to procure a vendor to do the work.

# Historic Resources Survey City of McMinnville Wamhill County, Oregon

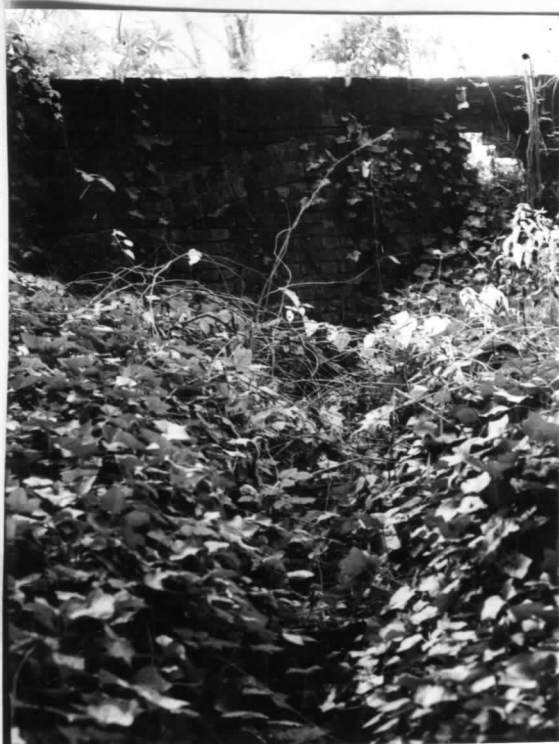
Site No. 3.2 Aerial Map J-10 10 of 59  
Block \_\_\_\_\_ Lot \_\_\_\_\_  
Addition City Park  
Tax Lot 44 20 AD  
Address Star Mill Way  
Common Name Flume Wall  
Historic Name Covered Mill Race  
Present Owner City of McMinnville  
Present Use Relic  
Original Use Transport water from Baker Creek to mill  
Builder or Architect William Newby  
Outbuildings Foundation ruins from Newby's mill  
Date of Construction 1853 — LATER SEE BELOW

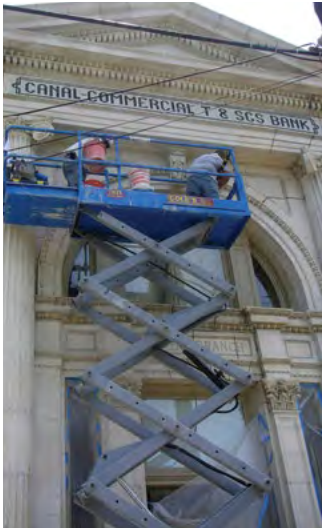
[1] An alkaline-based product is appropriate to use to clean historic marble because it will not damage the marble, which is acid sensitive.

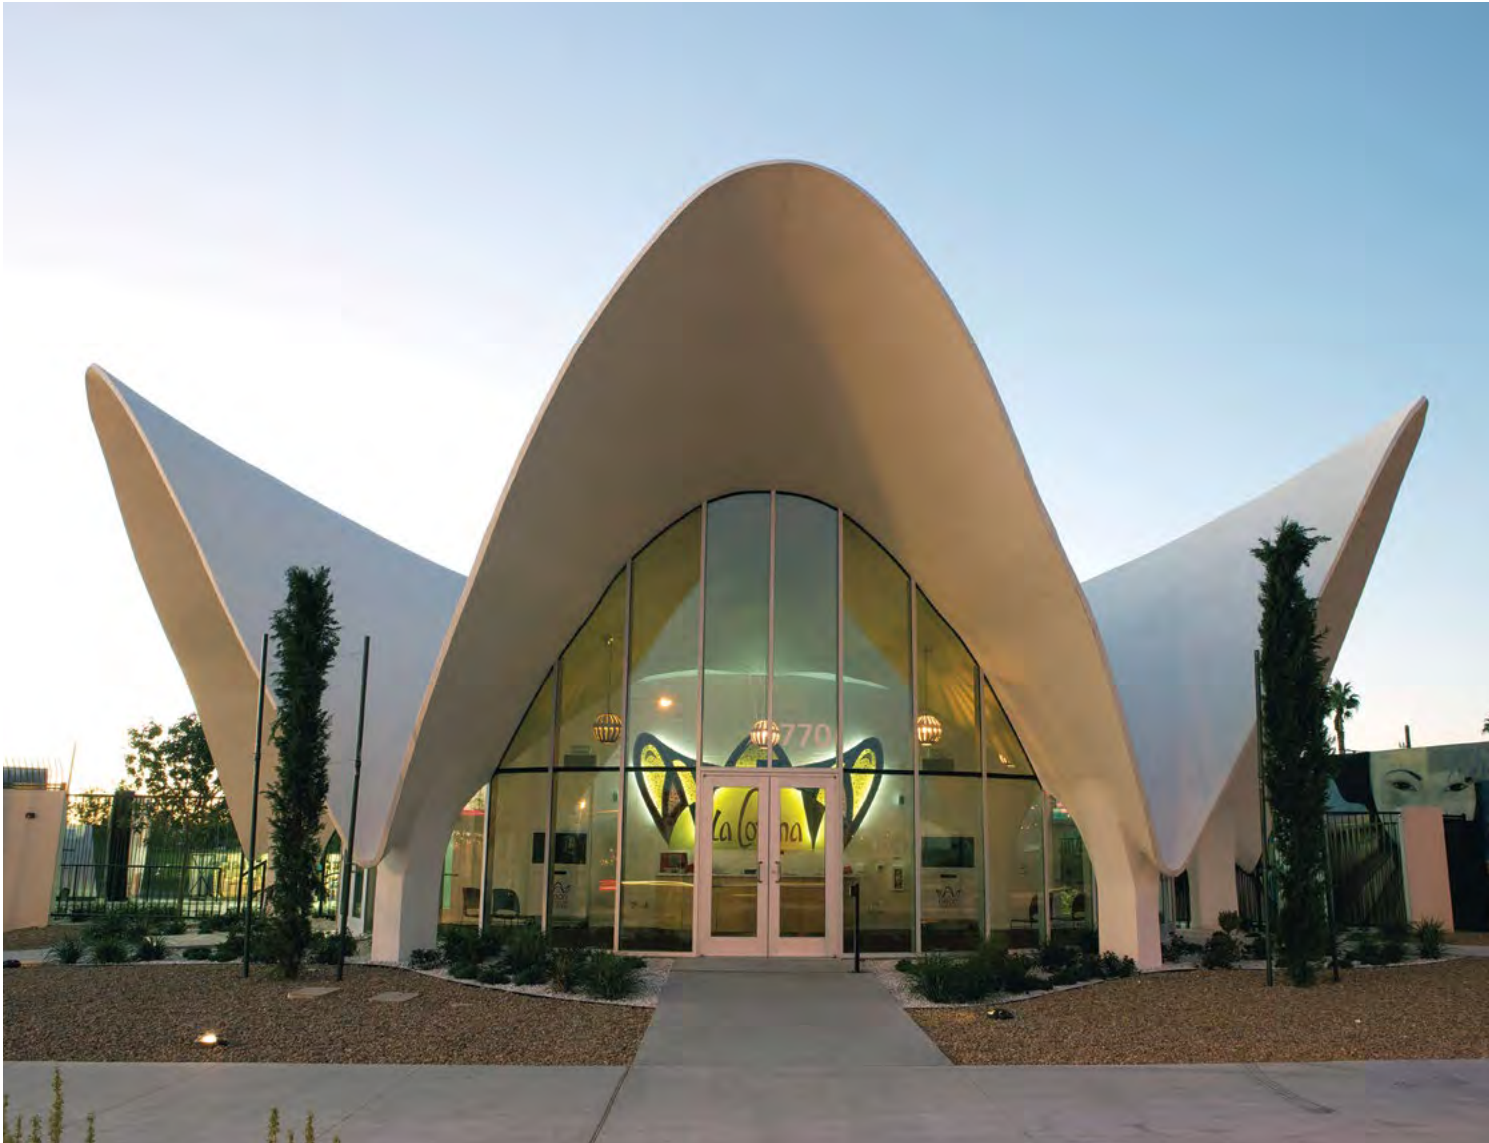
[2] Mid-century modern building technology made possible the form of this parabola-shaped structure and its thin concrete shell construction. Built in 1961 as the lobby of the La Concha Motel in Las Vegas, it was designed by Paul Revere Williams, one of the first prominent African-American architects. It was moved to a new location and rehabilitated to serve as the Neon Museum, and is often cited as an example of Google architecture. *Credit: Photographed with permission at The Neon Museum, Las Vegas, Nevada.*

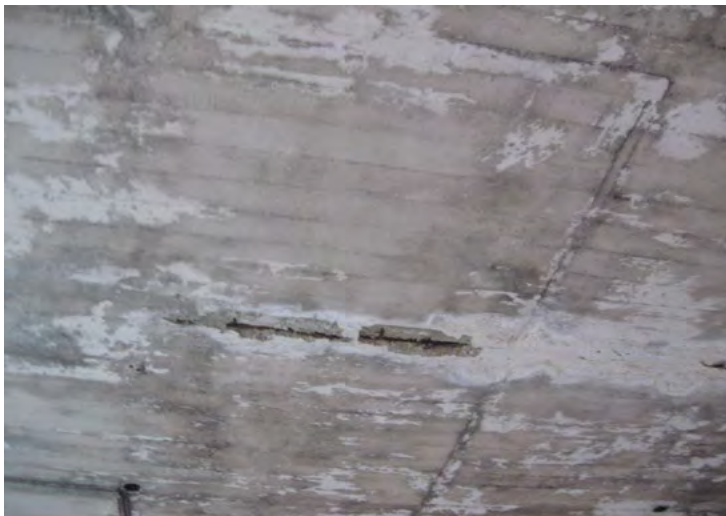
[5] Rebars in the reinforced concrete ceiling have rusted, causing the concrete to spall. The rebars must be cleaned of rust before the concrete can be patched.

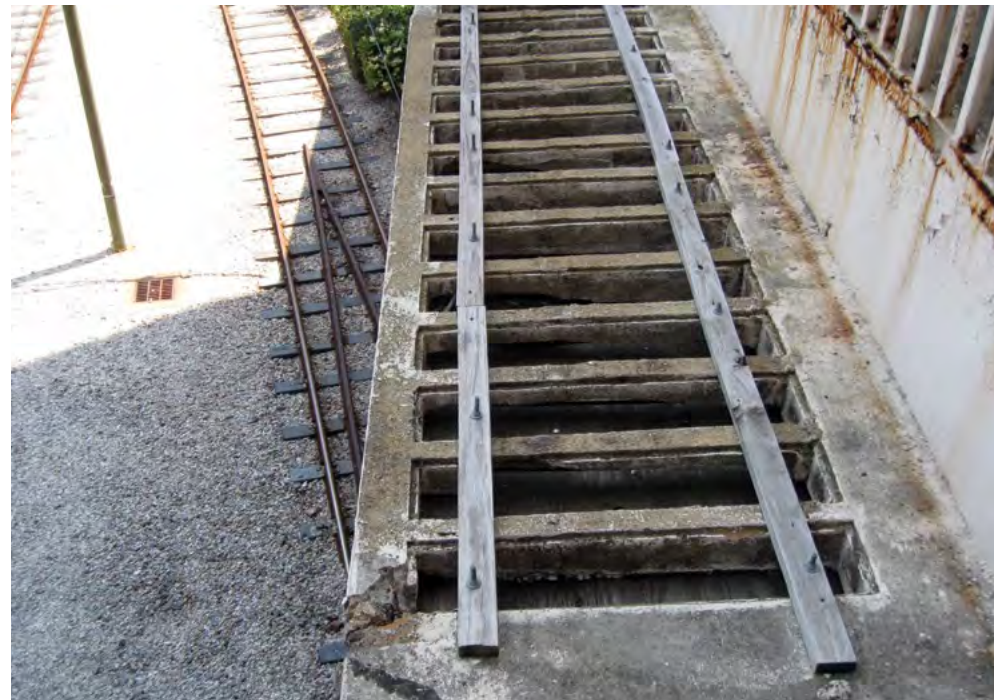
[6] Some areas of the concrete brise soleil screen on this building constructed in 1967 are badly deteriorated. If the screen cannot be repaired, it may be replaced in kind or with a composite substitute material with the same appearance as the concrete.

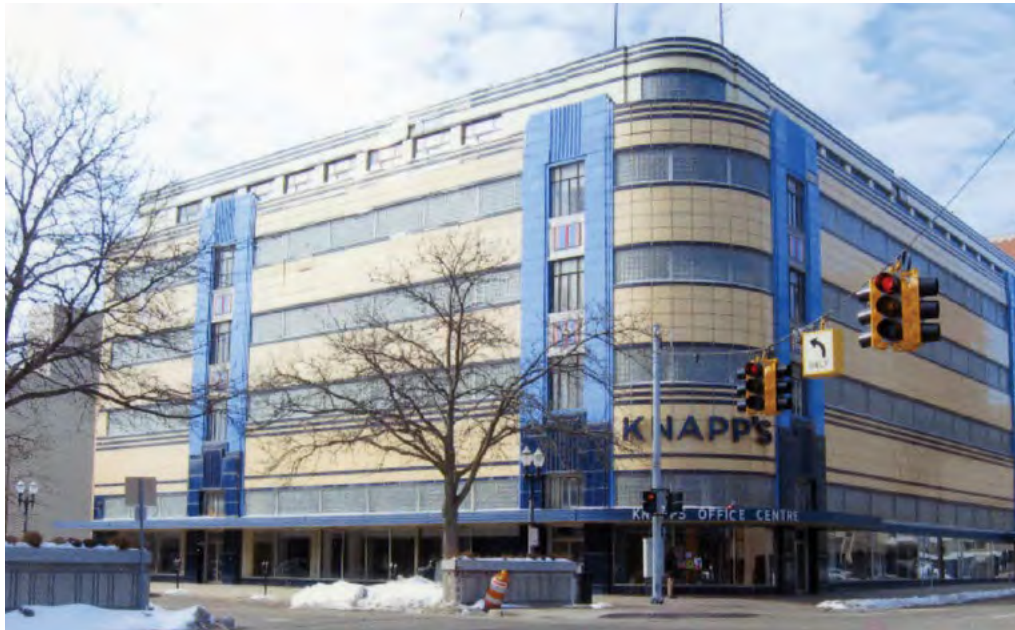
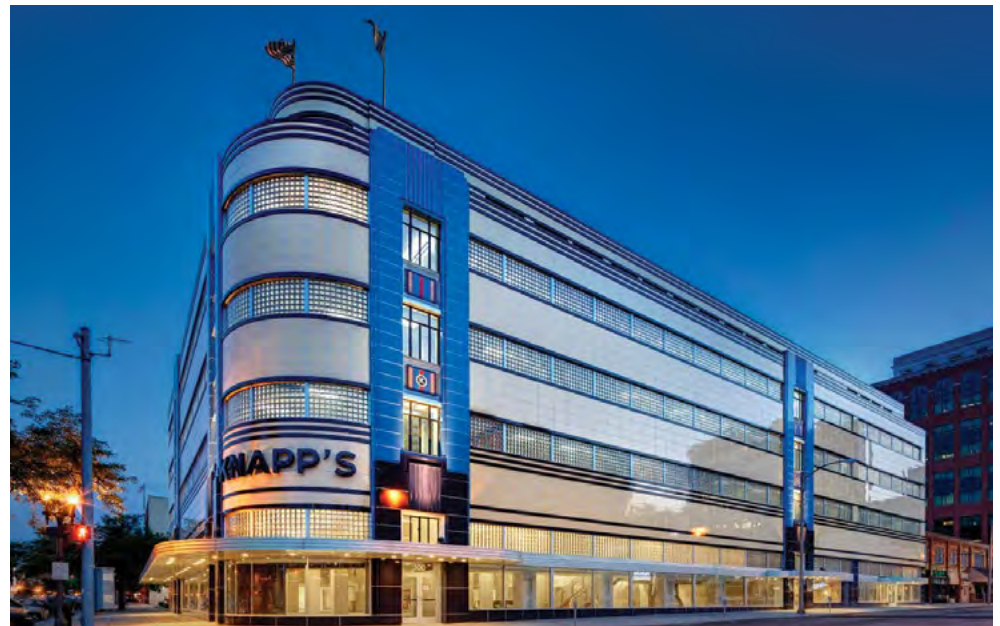
[7] (a) J.W. Knapp's Department Store, built 1937-38, in Lansing, MI, was constructed with a proprietary material named "Maul Macotta" made of enameled steel and cast-in-place concrete panels. Prior to its rehabilitation, a building inspection revealed that, due to a flaw in the original design and construction, the material was deteriorated beyond repair. The architects for the rehabilitation project devised a replacement system (b) consisting of enameled aluminum panels that matched the original colors (c). Photos and drawing (a-b): Quinn Evans Architects; Photo (c): James Haefner Photography.

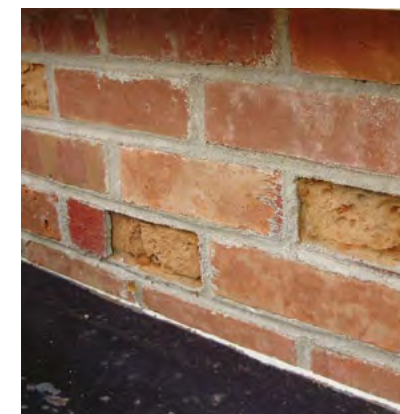
[2] **Not Recommended:** The use of inappropriate Portland cement mortar to repoint these soft 19th-century bricks has caused some of them to spall. *Photo: Courtesy Nebraska State Historic Preservation Office.*

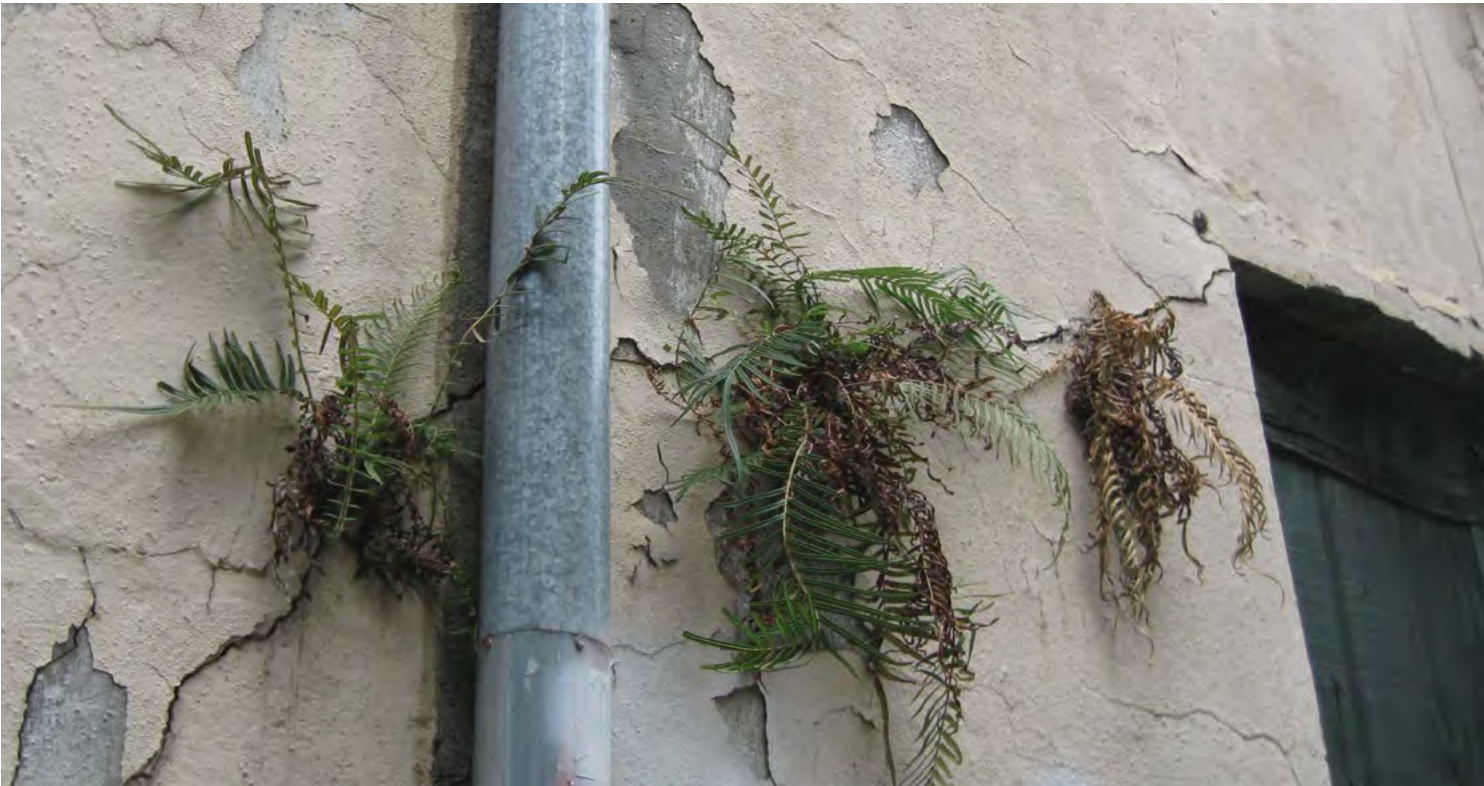
[3] **Not Recommended:** Cracks in the stucco have not been repaired, thereby allowing ferns to grow in the moist substrate which will cause further damage to the masonry.

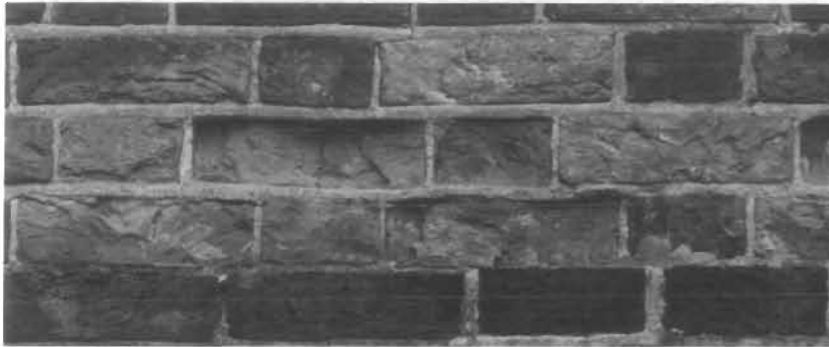
*Too hard and inflexible a mortar has caused this soft, 18th century brick to spall.*

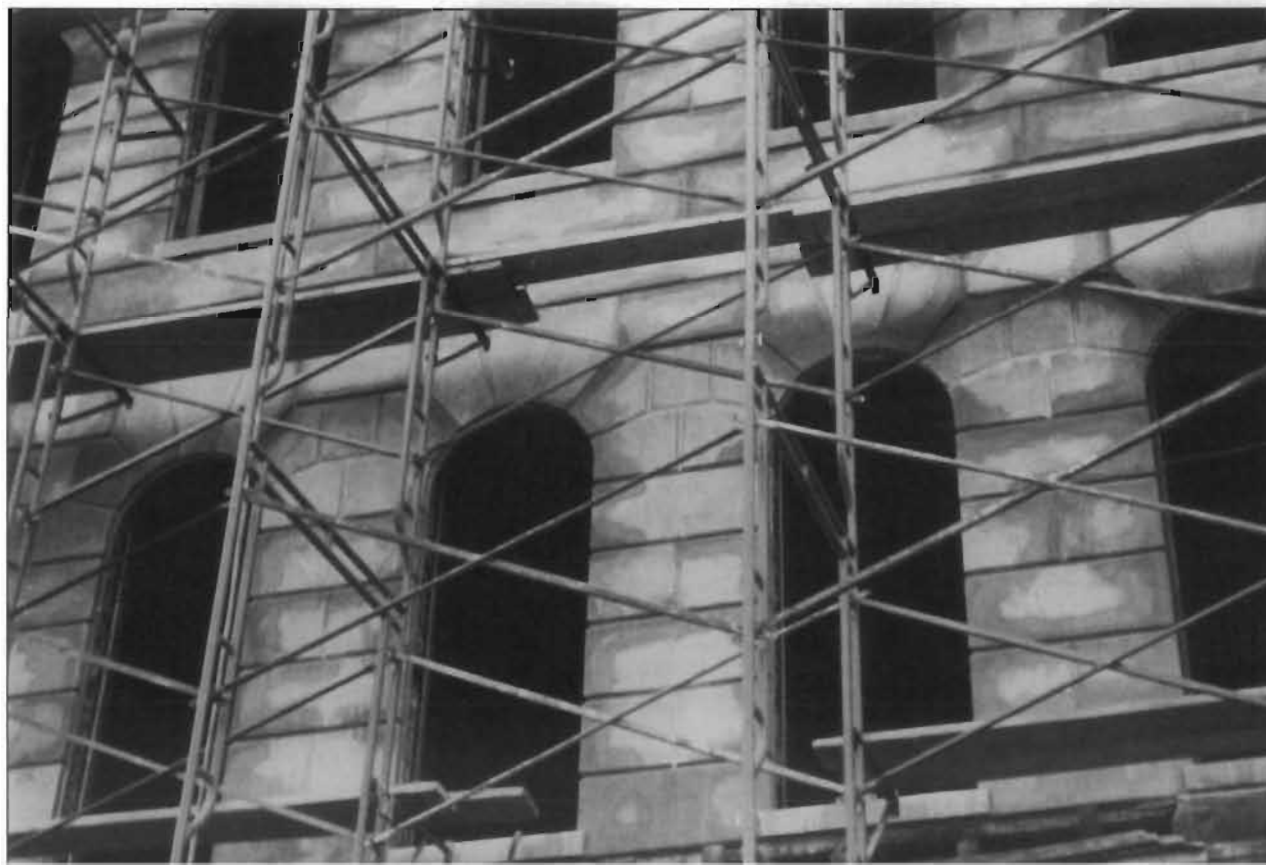
*Composite patching with a cementitious mixture is being used to repair eroded areas of this sandstone facade.*

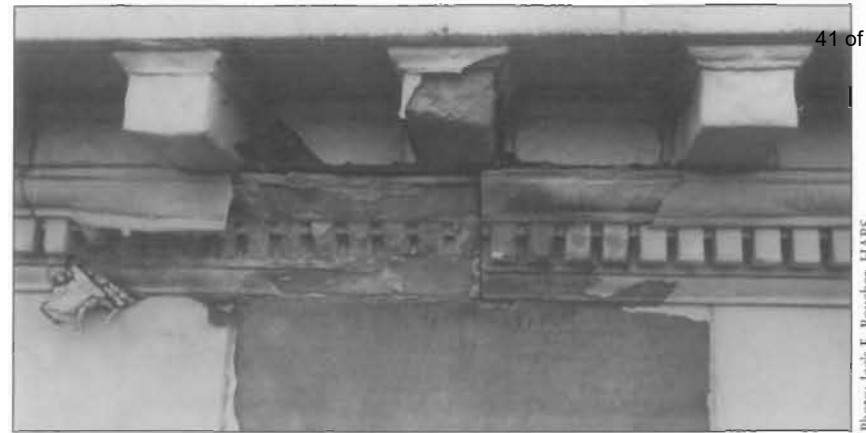
*Moisture from a faulty roof and drainage system has been trapped inside this limestone cornice by a waterproof coating, causing severe damage to the stone.*

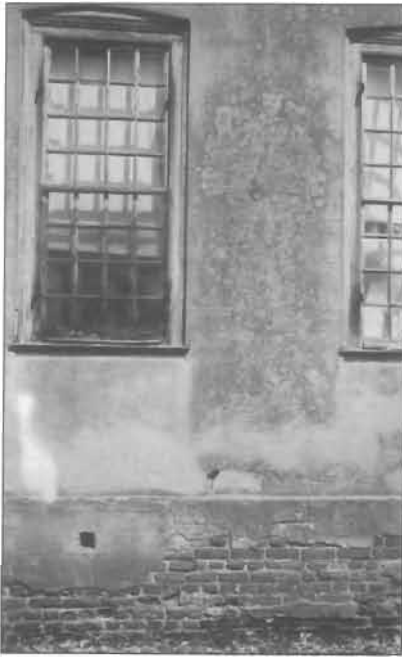
*Excessive moisture has damaged not only the stuccoed wall surface, but also the brick substrate.*

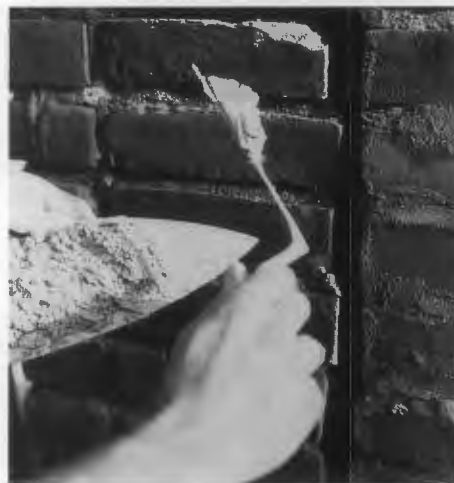
Figure 1. After removing deteriorated mortar, an experienced mason repoints a portion of this early-20th century limestone building. Photo: Robert C. Mack, FAIA.

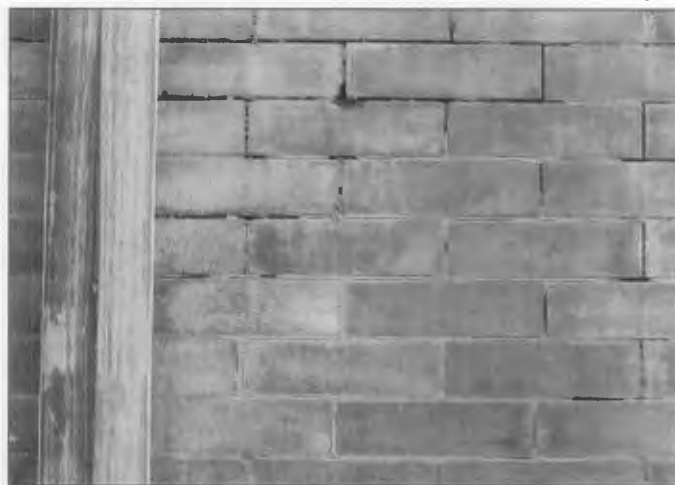
Figure 2. Much of the mortar on this building has been leached away by water from a leaking downspout. The downspout must be replaced and any other drainage problems repaired before repointing. Photo: Robert C. Mack, FAIA.

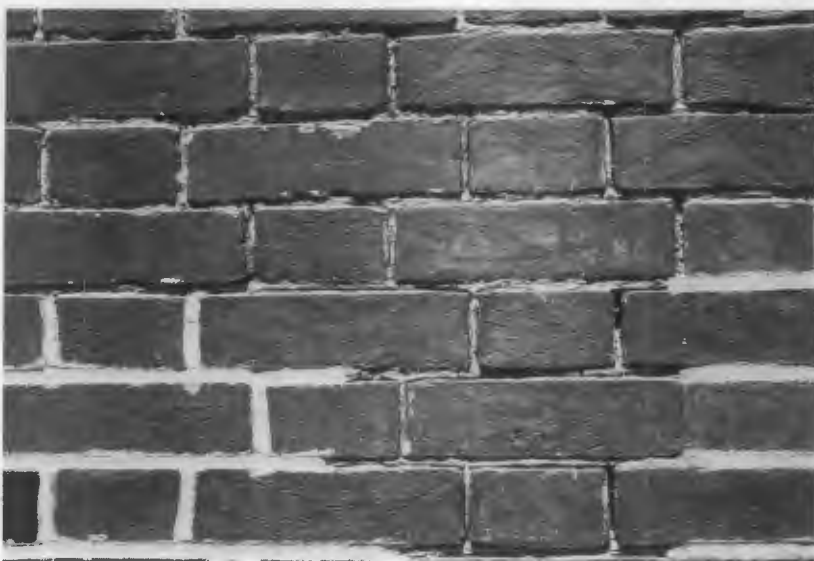
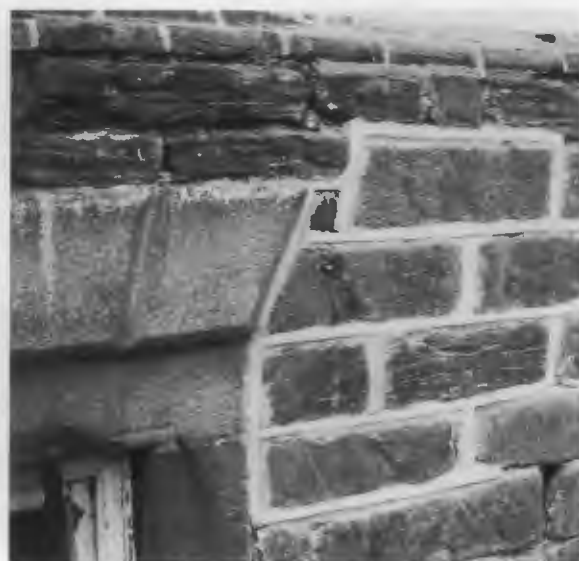
Figure 4. (left) The poor quality of this repointing—it appears to have been “tooled” with the mason’s finger—does not match the delicacy of the original beaded joint on this 19th-century brick wall. (right) It is obvious that the repointing on this “test patch” is not an appropriate replacement mortar joint for this early-19th century stone foundation. Photos: Lee H. Nelson, FAIA.

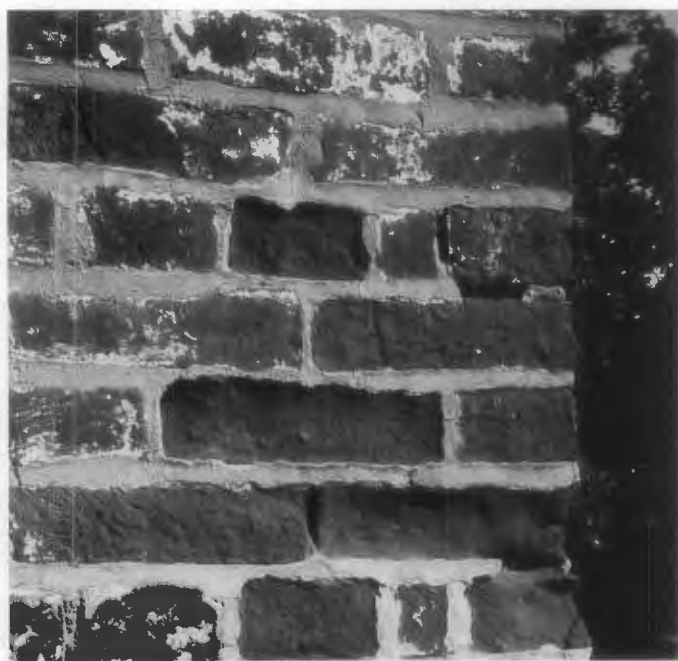
Figure 5. The use of hard, portland-cement mortar that is less permeable than the soft bricks has resulted in severe damage to this brick wall. Moisture trapped in the wall was unable to evaporate through the mortar which is intended to be sacrificial, and thus protect the bricks. As a result the moisture remained in the walls until water pressure eventually popped the surface off the bricks. Photo: National Park Service Files.

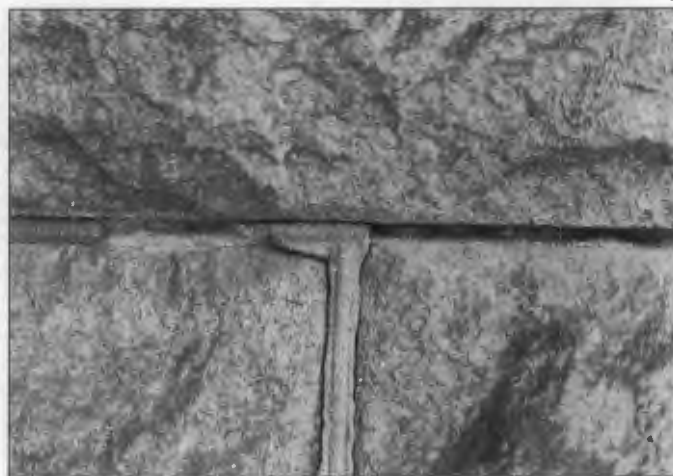
Figure 8. Due to inadequate joint preparation, the repointing mortar has not adhered properly and is falling out of the joint. Photo: Robert C. Mack, FAIA.

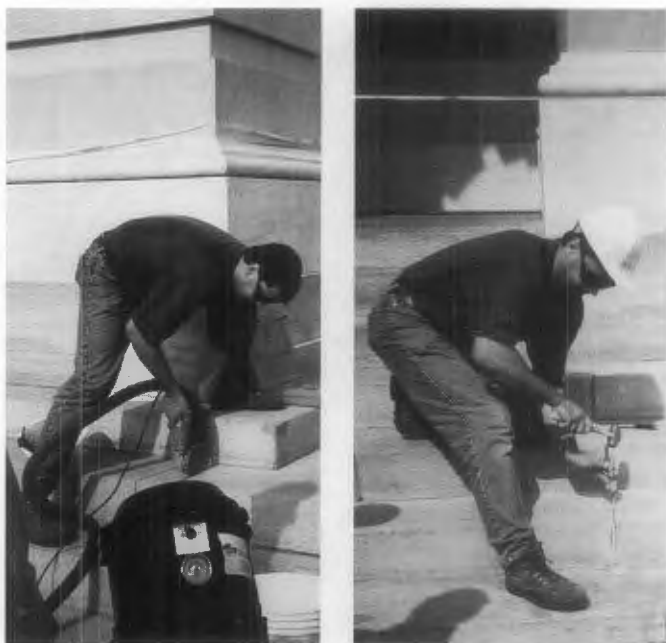
Figure 13. (left) In preparation for repointing, the mortar joints on these granite steps are first cut out mechanically (note the vacuum attached to the cutting tool in foreground to cut down on dust). (right) Final removal of the old mortar is done by hand to avoid damage to the edges of the joints. Mechanical preparation of horizontal joints by an experienced mason may sometimes be acceptable, especially where the joints are quite wide and the masonry is a very hard stone. Photos: Anne Grimmer.

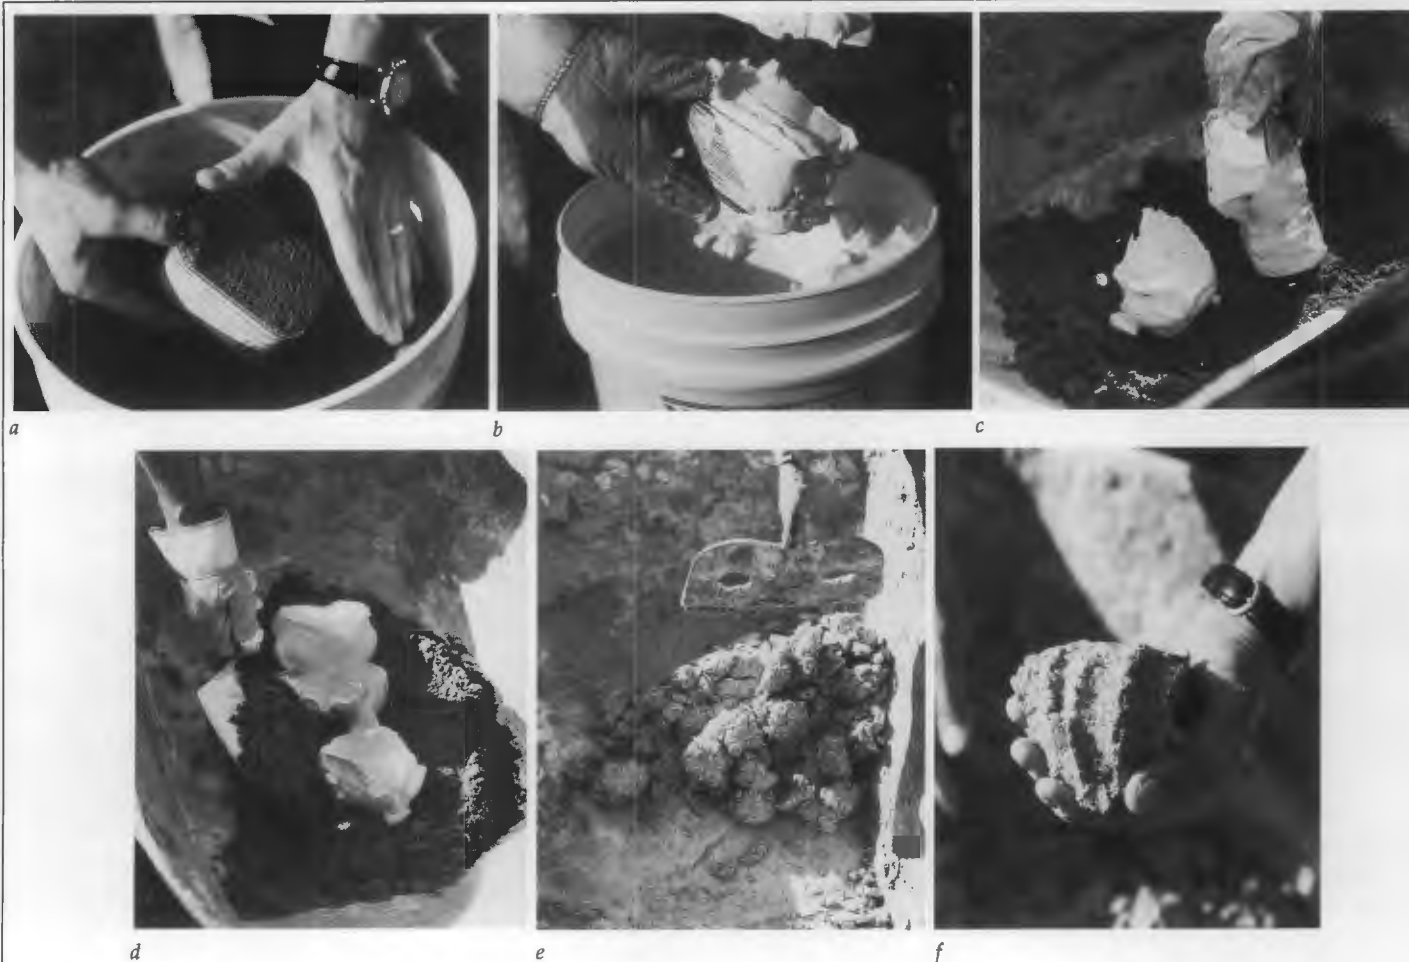
Figure 14. Mixing mortar using lime putty: (a) proportioning sand; (b) proportioning lime putty; (c) placing lime putty on top of sand; (d) mixing sand over lime putty; (e) hand mixing mortar; and, (f) sample of mortar after mixing. Photos: John P. Speweik.

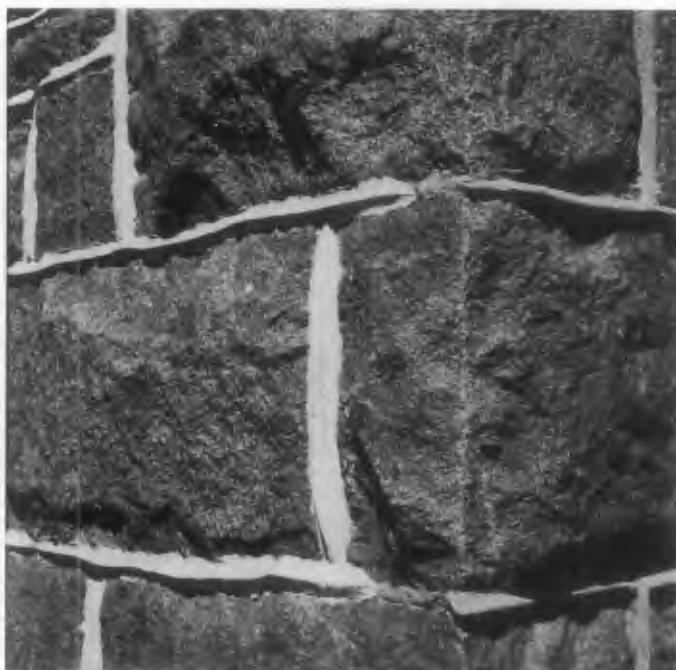
Figure 15. The profile of the repointed joints on the left replicate the historic joints around the corner to the right on the front of this stone building in Leesburg, VA. The contractor's pride in the repointing work is evident by the signature in the vertical joint. Photo: Anne Grimmer.

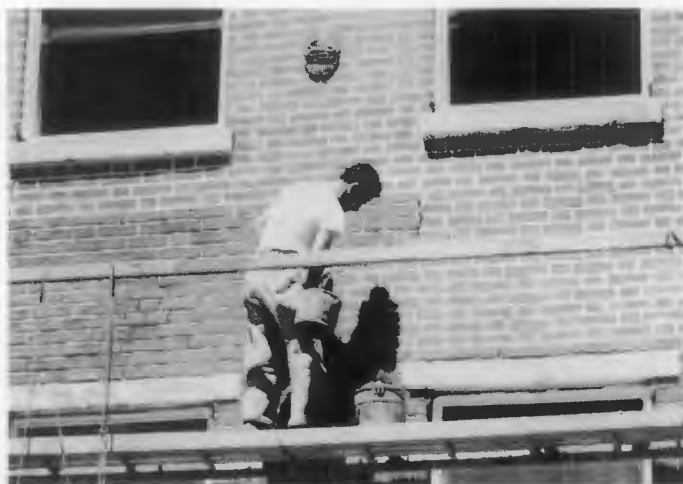
Figure 17. This photograph shows the significant visual change to the character of this historic brick building that has resulted from improper repointing procedures and a noticeably increased thickness of the mortar joints. Photo: Lee H. Nelson, FAIA.

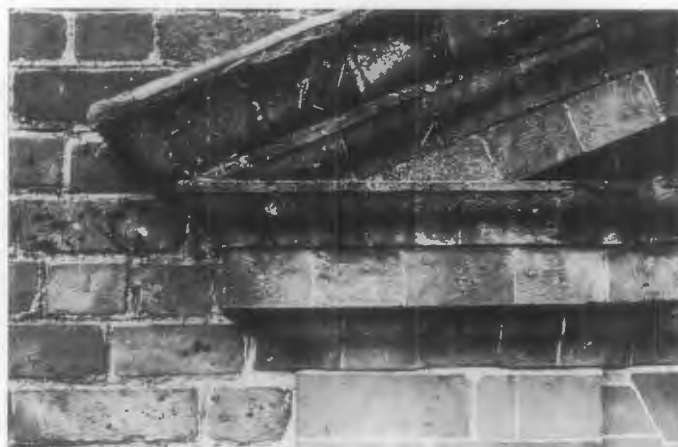
Figure 19. Mortar joints of 18th century brick buildings were often as much as 1/2 inch wide, cut flush and struck with a grapevine joint, but for window and door surrounds where a finer quality rubbed brick was used, mortar joints were very thin. Photo: National Park Service Files.

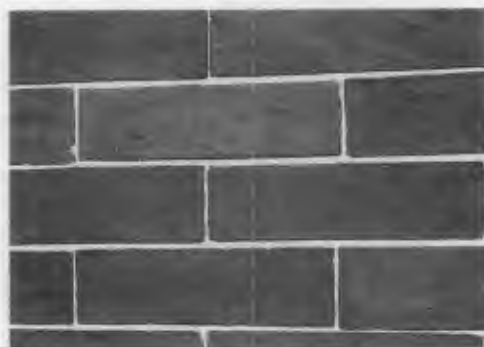
Figure 18. A cross-section of mortar joint types. (a) Grapevine joints on a mid-18th century brick building; (b) flush joints on a mid-to-late 19th century brick building; (c) beaded joints on a late-19th century brick building; (d) early-20th century beaded joints on rough-cut limestone where the vertical joints were struck prior to the horizontal joints; (e) raked joints on 1920s wire brick; (f) horizontal joints on a 1934 building designed by Frank Lloyd Wright where the vertical joints were raked back from the face of the bricks, and the horizontal joints were filled with a red-tinted mortar to emphasize the horizontality of the narrow bricks, and struck flush with the face of the bricks; (g) the joints on this 20th century glazed terracotta tile building are raked slightly, emphasizing the glazed block face. Photos: National Park Service Files (a,b,e); Robert C. Mack, FAIA (c,d,f,g).

**Pointing Style.** Close examination of the historic masonry wall and the techniques used in the original construction will assist in maintaining the visual qualities of the building (Fig. 18). Pointing styles and the methods of producing them should be examined. It is important to look at both the horizontal and the vertical joints to determine the order in which they were tooled and whether they were the same style. Some late-19th and early-20th century buildings, for example, have horizontal joints that were raked back while the vertical joints were finished flush and stained to match the bricks, thus creating the illusion of horizontal bands. Pointing styles may also differ from one facade to another; front walls often received greater attention to mortar detailing than side and rear walls (Fig. 19).
