# Historic Landmarks Committee Hybrid In-Person & ZOOM Online Meeting Thursday, June 27th - 3:00 PM Kent Taylor Civic Hall: 200 NE 2nd St.

### **MINUTES**

The subject property is located at 609 NE Cowls Street. The property is identified as Tax Lot R4421-BB-18900 **See Top View Map (Figure 1) below.**

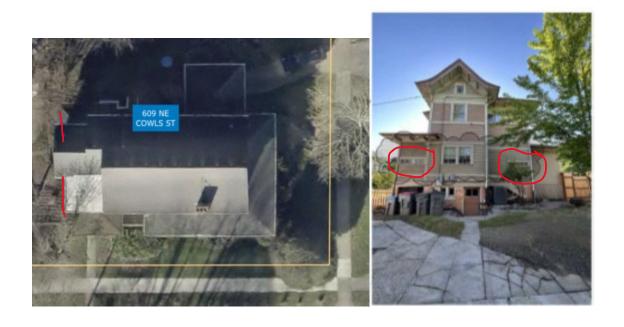
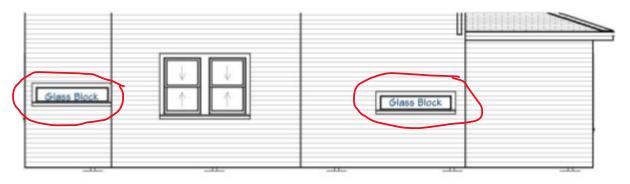
Glass block window replacement – rear of house, although it can be seen from the sidewalk from a few angles

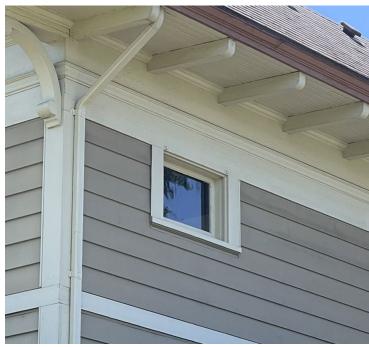
Applicant is requesting to remove the glass blocks on the north side (left) and replace them with siding. Applicant is requesting to remove the glass blocks on the south side (right) and replace them with two new, aluminum clad, windows matching the design of a window on the front corner of the home. Pictured below:

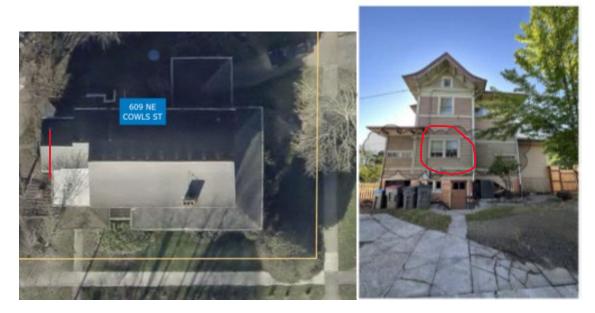
#### Exhibit 3 – rear facing wood windows

Existing wood window replacement – rear of house, although it can be seen from the sidewalk from a few angles

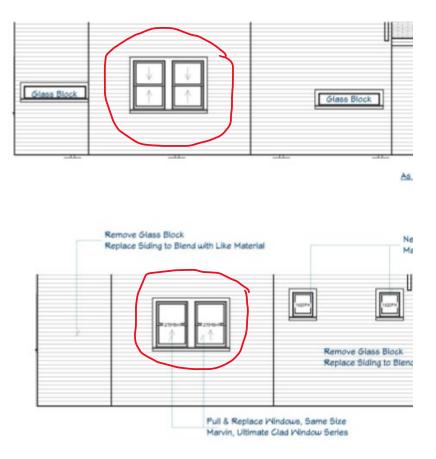
Applicant is requesting to replace the two central wood windows on the main floor with new aluminum clad double hung windows. The condition of the wood windows is not detailed. There is no note of considering repairs to these windows.

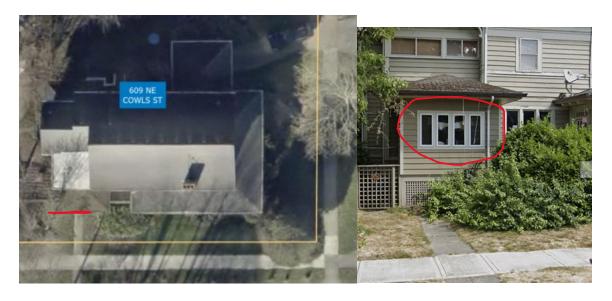
#### Exhibit 4 – nook window street facing

Nook Window Replacement: applicant is proposing replacing an existing vinyle window with an aluminum clad window.

Existing style – vinyl window

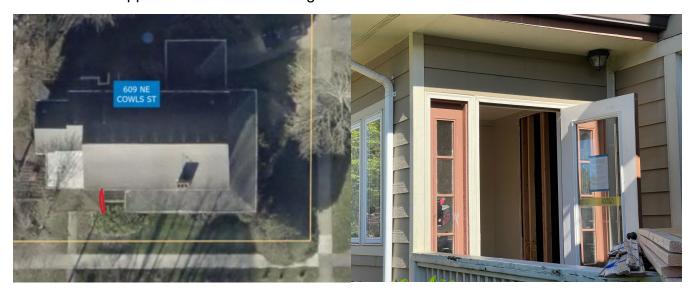
Nook Door Replacement: applicant is proposing replacing an existing vinyl (?) door with wood French doors. Applicant to confirm existing door material.

Existing door style – material unknown

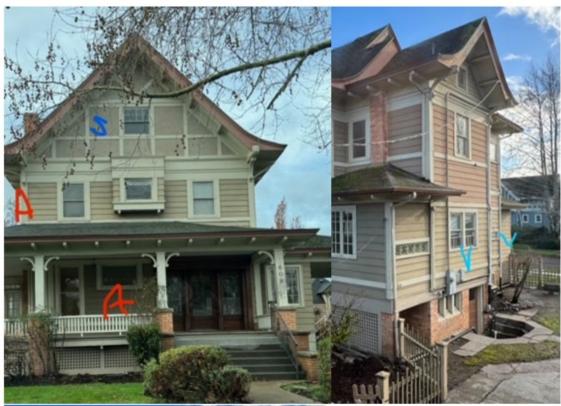
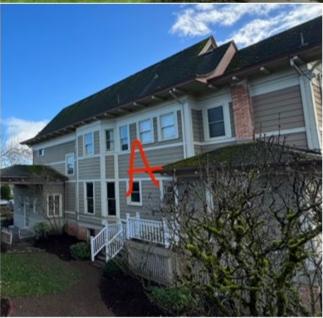
Applicant in requesting to use cementicious siding to replace cedar siding that cannot feasibly be repaired or replaced. Economics is the primary driver in this requested alteration.

1<sup>st</sup> photo is street facing, 2<sup>nd</sup> and 3<sup>rd</sup> photos are rear facing although much of both both can be seen from the sidewalks.

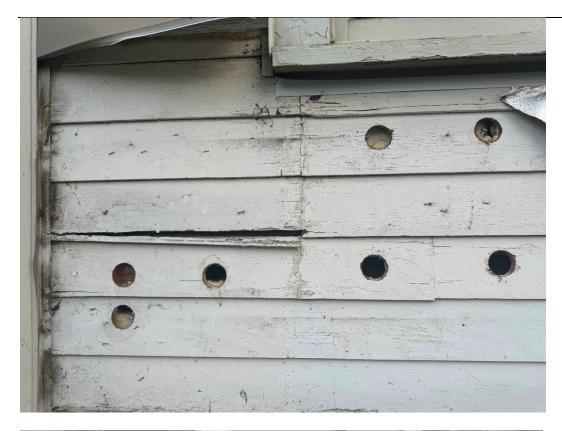
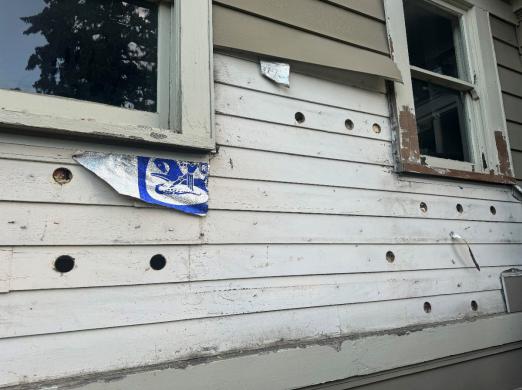
Existing Siding Under Aluminum. Only some original siding has been exposed so far.

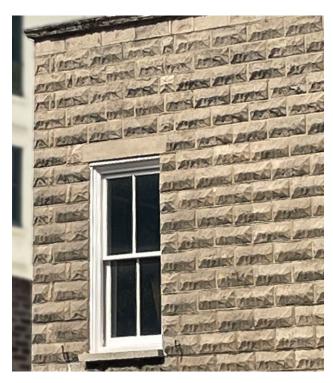
Figure 2a. Casting concrete blocks to mimic quarried stone was a popular late 19th-to mid 20th-century technique. Concrete masonry units could be completed by local craftsman, saving time and shipping costs. Photo: John Sandor, NPS.

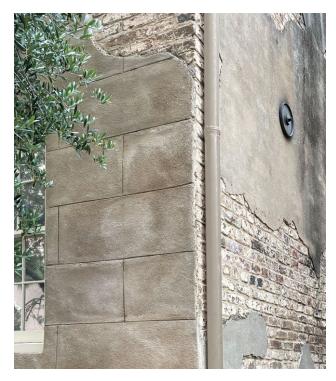
Figure 2c: Stucco has been used to imitate a number of building materials for many centuries. Seen here, stucco was applied to a brick structure and scored to represent a stone façade. Photo: John Sandor, NPS.

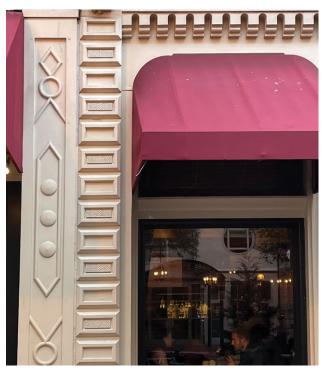
Figure 2b: The 19th century also produced a variety of metal products used to imitate other materials. Across the country, cast iron was used in storefronts to imitate stone. Photo: John Sandor, NPS.

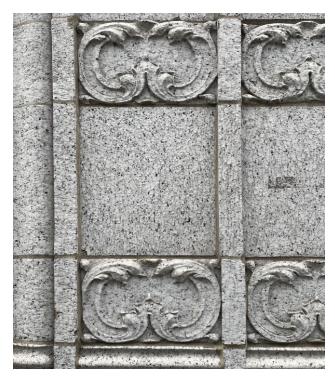
Figure 2d: Terra cotta gained popularity in the late 19th century as a cheap and lightweight alternative to stone. Glazing techniques allowed the blocks to imitate a variety of natural stone materials. Photo: John Sandor, NPS.

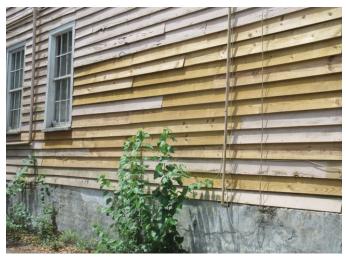
Figure 3: Incremental repair is best done using in-kind material to minimize differences in the performance characteristics that could negatively affect the overall assembly. Photo: NPS.

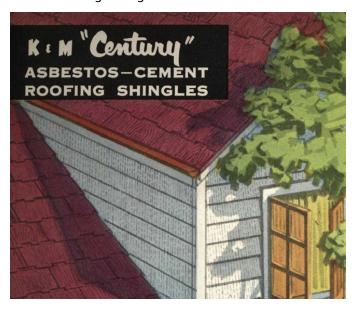
Figure 4. While occasionally used to imitate other materials such as wood or slate shingle, many asbestos shingles and siding materials had their own distinct shape and profile. No longer manufactured today, alternative materials must be found to replace these materials when they are distinctive features on a historic structure. Drawing: Association for Preservation Technology, Building Technology Heritage Library.

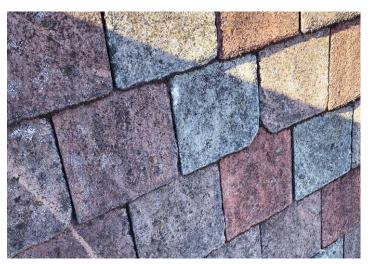
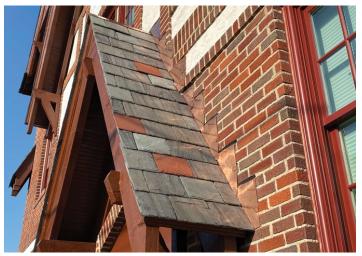
Figure 5. (Left) Asbestos shingles were often used as a substitute for traditional slate roof shingles. The historic asbestos roof on this rehabilitation project had reached the end of its lifespan and required complete replacement. (Right) Given the limited replacement materials available to match the historic asbestos shingles, utilizing natural slate was determined to be the best visual match for the original shingles and design intent in this instance. Photos: Crosskey Architects.

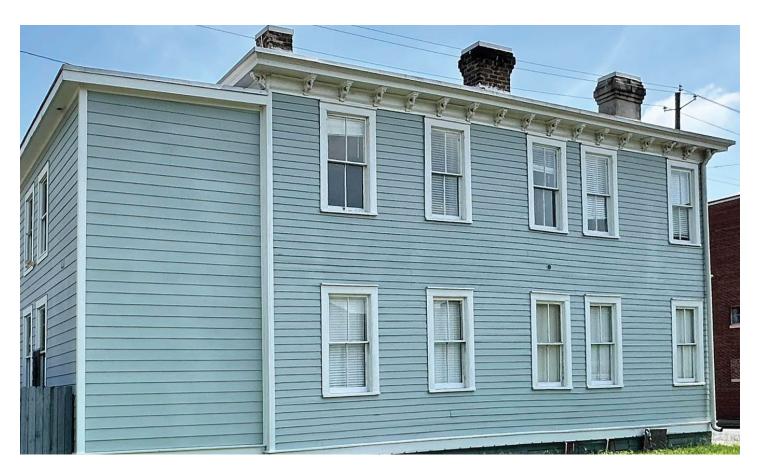
Figure 7. A new addition replaced non-historic construction on the rear elevation of this building. Fiber cement gives the addition a compatible appearance without replicating the exposure for thickness of the historic siding. Photo: Ward Architecture + Preservation.

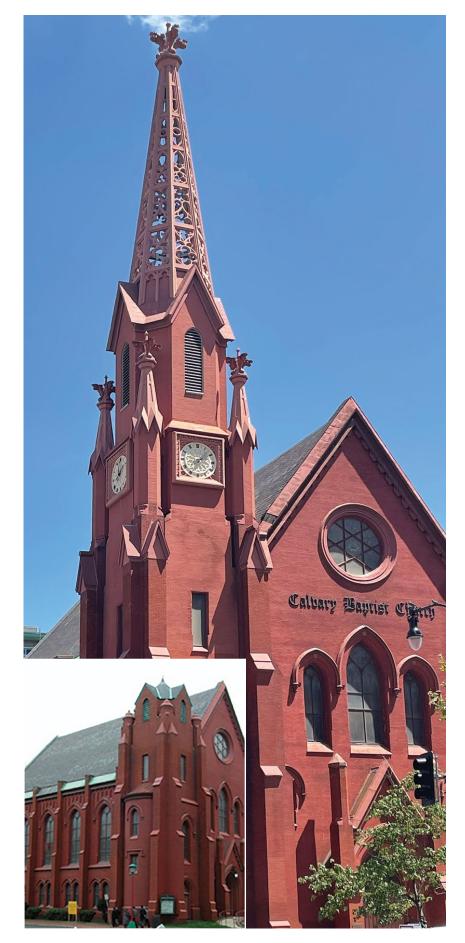
Figure 8. A long-missing cast-iron steeple was reconstructed in aluminum and fiber-reinforced polymer (FRP). Photo: John Sandor, NPS, Inset: Quinn Evans.

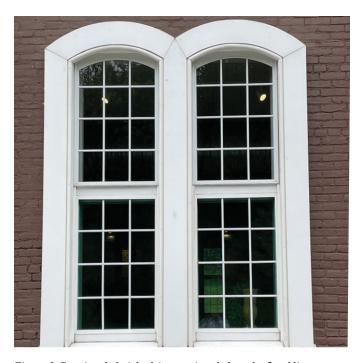
Figure 9. Previously bricked-in openings below the flood line were reopened and new aluminum windows installed with cellular PVC trim detailed to hold back moderate flood waters and survive exposure to water. Photo: John Sandor, NPS.

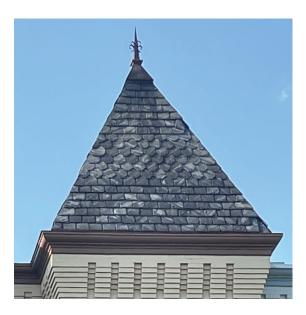
Figure 10. Polymer slates offer a choice of shapes but not sizes, limiting their ability to achieve a good visual match for some historic slate. With the size of the polymer slates (right) being nearly twice that of the historic slates (left), the scale of the entire feature is incompatibly altered. The molded edges of this material, which contribute to its ability to replicate slate, would be lost if each shingle was resized by cutting. Photo: John Sandor, NPS.

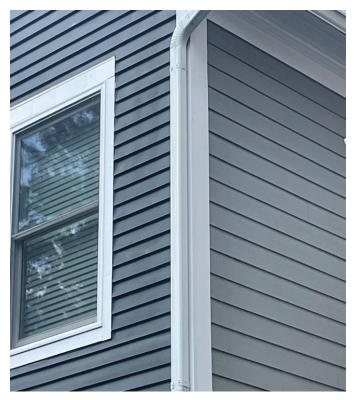
Figure 11. The thickness of the wood siding on the front (left) creates a deeper shadow line than is achieved with the fiber cement siding used on the side (right) elevation. While the exposure can be adjusted, fiber cement siding is not available in a matching thickness. Photo: John Sandor, NPS.

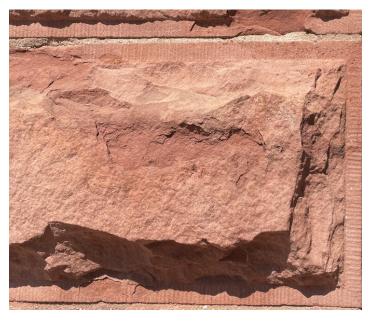
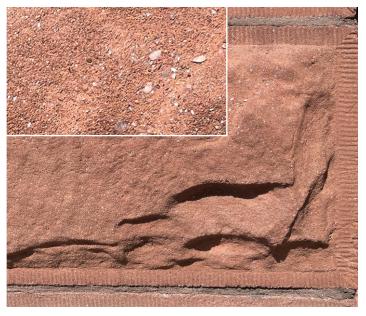
Figure 13. Cast stone was used to effectively replace individual blocks of sandstone. Both the original (left) and the substitute material (right) retain similar physical and visible properties. Having weathered for over 30 years, some erosion of the binder has revealed quartz grains of the aggregate (inset), but it is only noticeable upon close inspection. Photo: John Sandor, NPS.

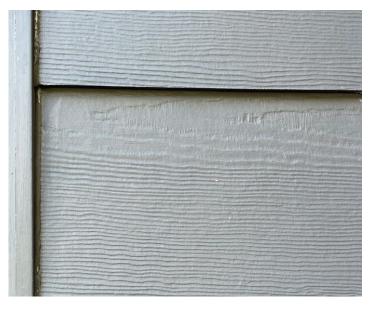
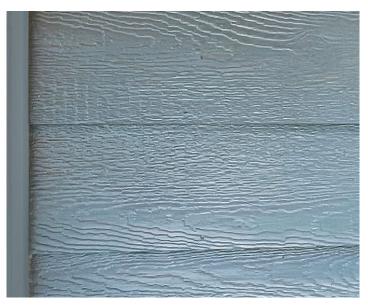
Figure 14. Surface texture is an important aspect in matching the appearance of a historic material, especially when a material is viewed at close range. As seen in these two images, many of the substitute materials produced for siding and trim have an embossed wood grain, making them incompatible for replacing historic wood that was typically planed to a smooth surface. Some substitute products are available with a smooth surface as well. Photos: John Sandor, NPS.

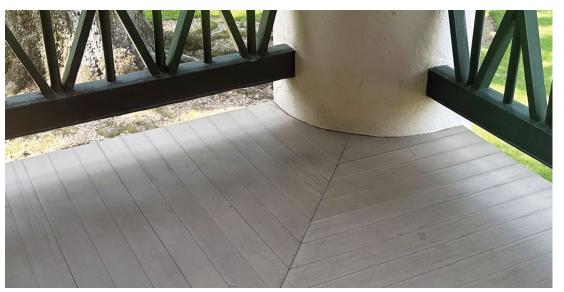
Figure 15. Tongue-and-groove porch flooring is manufactured in several different substitute materials. Each type has different properties, though most are more moisture-resistant than wood. The prefinished product shown can be painted when worn, but repainting is not recommended for some product choices. Photo: Oak Alley Foundation.

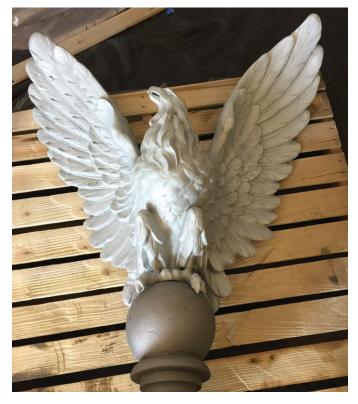
Figure 16. Aluminum is a highly corrosion-resistant metal that is commonly used as a substitute material for cast iron. Aluminum can be a more affordable and lightweight alternative to cast iron that retains a similar texture, shape, and maintenance cycle. Photo: NPS.

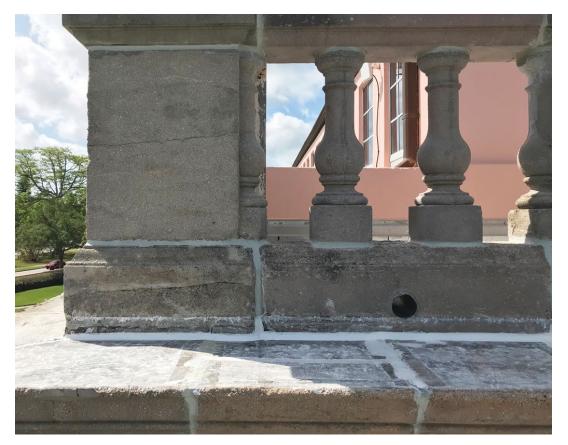
Figure 17. The balustrade consists of multiple prior campaigns of using cast stone to replace the natural stone. The effective match for the surface texture and color of the original stone allowed individual elements to be incrementally replaced only when they had failed, thus retaining the maximum amount of original material as long as possible. Photo: EverGreene Architectural Arts.

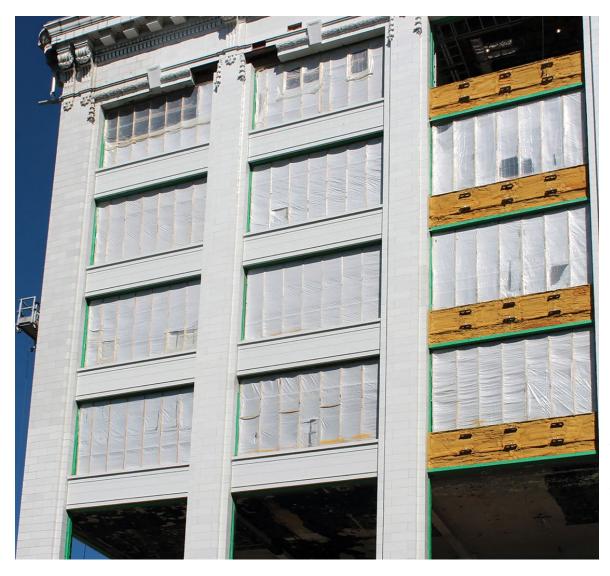
Figure 18. Missing historic terra cotta spandrel panels on all floor levels were recreated utilizing glass fiber reinforced concrete (GFRC) replacements. New spandrels were fabricated as individual components and attached with metal clips between historic terra cotta piers. Photo: Kris Frail, Dewberry.

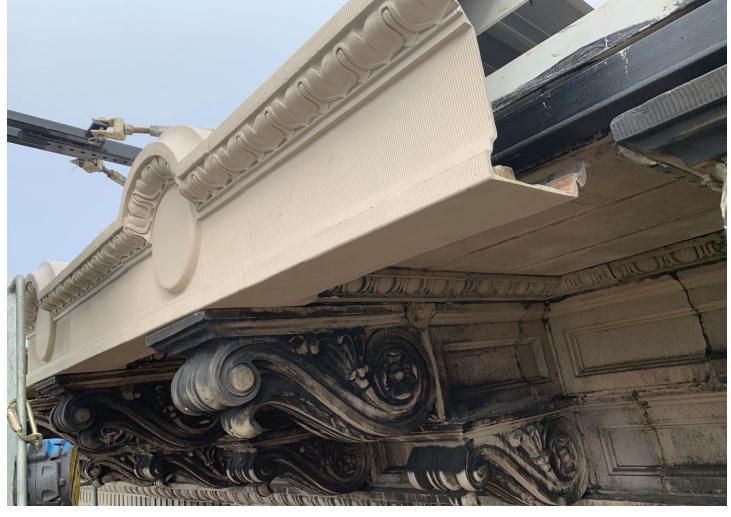
Figure 19. A new, lightweight fiber reinforced polymer is attached to a new metal armature to replicate damaged and missing elements of a terra cotta cornice. Photo: Quinn Evans.

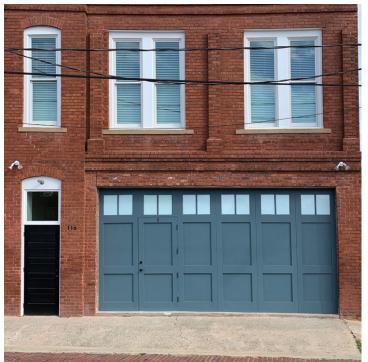
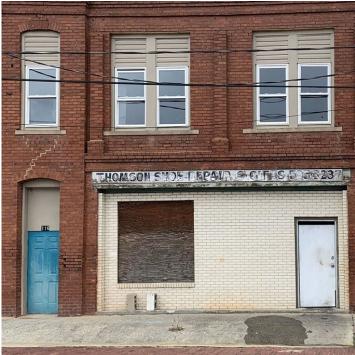
Figure 20. Cement board was used to replace a non-historic infill and mimics the configuration of a typical vehicular door of the period. Photos: Historic Augusta.

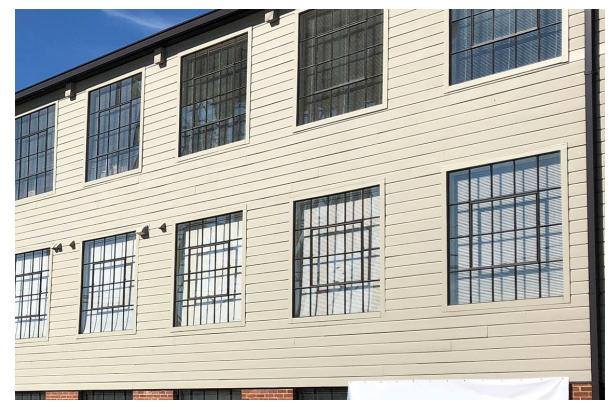
Figure 21. A mineral polymer composite siding was available in the profile very similar to the historic siding. The replacement siding was used where the original material was almost completely missing beneath a more modern covering. Areas where the original wood was largely intact were replaced with matching wood to sustain more of the material integrity of the building. Photo: Belk Architecture.

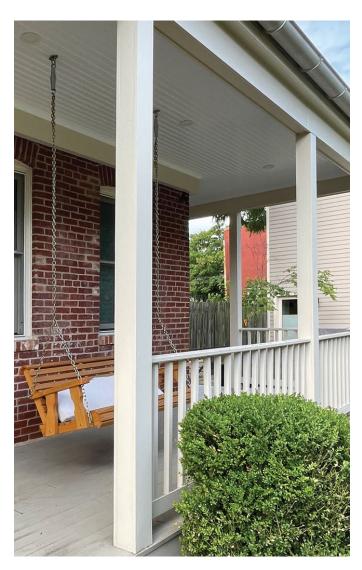
Figure 22. A porch was reconstructed using posts fabricated on site from a smooth-surface cellulose/polymer composite material. Though the face of the posts are painted, the lack of paint on the bottom at the cut ends is not consistent with manufacturers' recommendations. This treatment will allow moisture to be absorbed, shortening the life of the new replacement feature. Photo: John Sandor, NPS.

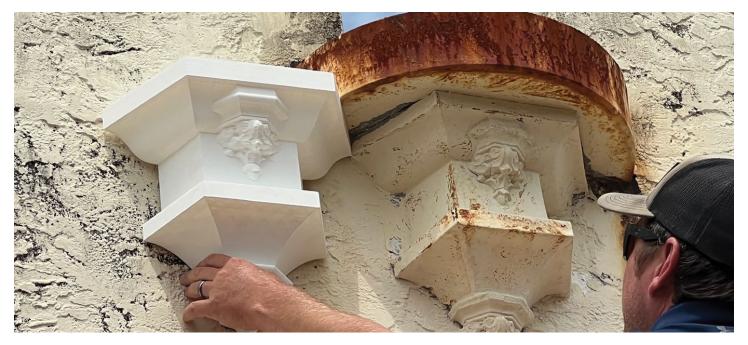
Figure 23. 3-D printing using various polymers is occasionally used to replicate missing metal or wood features. This new application is continually being refined, but the application can be successful when a painted, lightweight feature needs to be replicated. Photo: NPS.

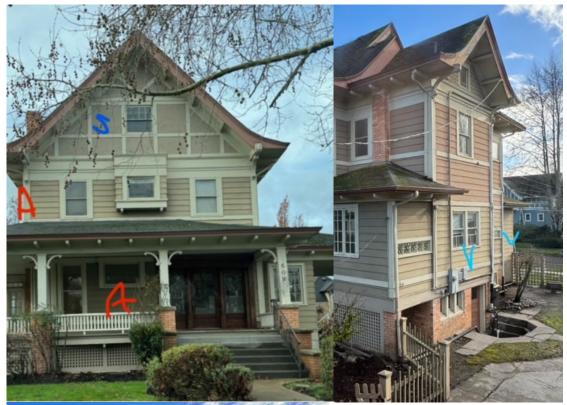
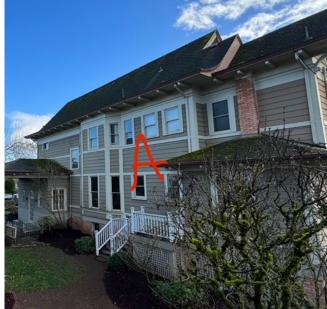
Pictures identifying location of aluminum (A) and vinyl (V) siding.

We talked to our siding company, and they said it is possible to replace the cedar boards with the holes. The question is if there are so many that we must decide if the new cedar would blend in or not. Our preference is to refurb the cedar siding, but it might be too expensive. We cannot afford to put new cedar on the entire home. In that case, we would do the cement lap boards. We will only do that if the cedar is in too bad of shape for refurbishing.

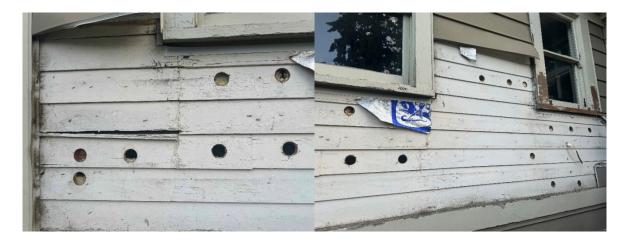
Pictures of original cedar siding with insulation holes under aluminum and vinyl siding.

**FINDING: SATISFIED WITH CONDITION OF APPROVAL #2.** The applicant's intention is to repair the original siding under the existing siding. Early investigation of the original cedar siding is that there may be more insulation holes drilled than expected and, in some cases, more than are feasible to repair. Residing the entire home with new cedar is financially unfeasible for the applicant and they are requesting permission to replace overly drilled sections of the existing cedar with cement board matching the reveals of the existing cedar. Total replacement area will be unknown until all the existing aluminum siding is removed. The applicant have provided multiple texture options, for the committee's review, to receive guidance on which texture would best meet the Secretary of Interior's Standards for Rehabilitation best. Seeking to match the old siding in design, color, texture and other visual qualities.

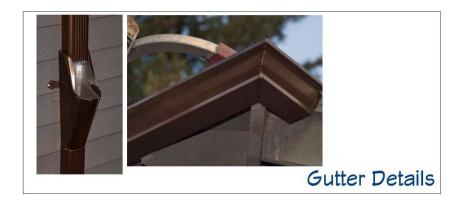
The applicant is proposing replacing all the existing gutters with rustic copper finish gutters.

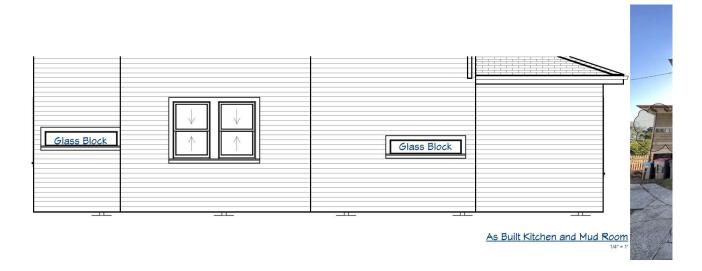
The applicant is proposing a removal of non-historic glass block windows on the rear of the home and replacing them with new aluminum clad windows.

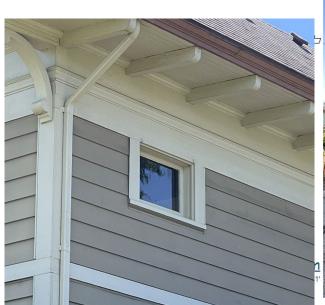
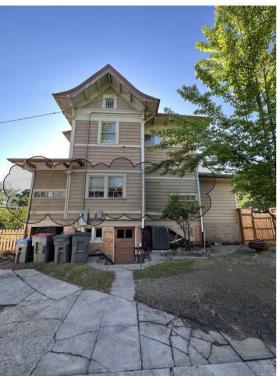
(Above are original square windows in the home matching the style of two of the proposed rear window additions replacing the glass block windows proposed for removal.)
