## EXHIBIT 1 - STAFF REPORT

**DATE:** March 20, 2024  
**TO:** Landscape Review Committee Members  
**FROM:** Taylor Graybehl, Senior Planner  
**SUBJECT:** Tree Removal Application (L 8-24)

**DOCKET:** L 8-24 (Street Tree Removal)

**REQUEST:** Approval of a tree removal application for the removal of two (2) Trees.

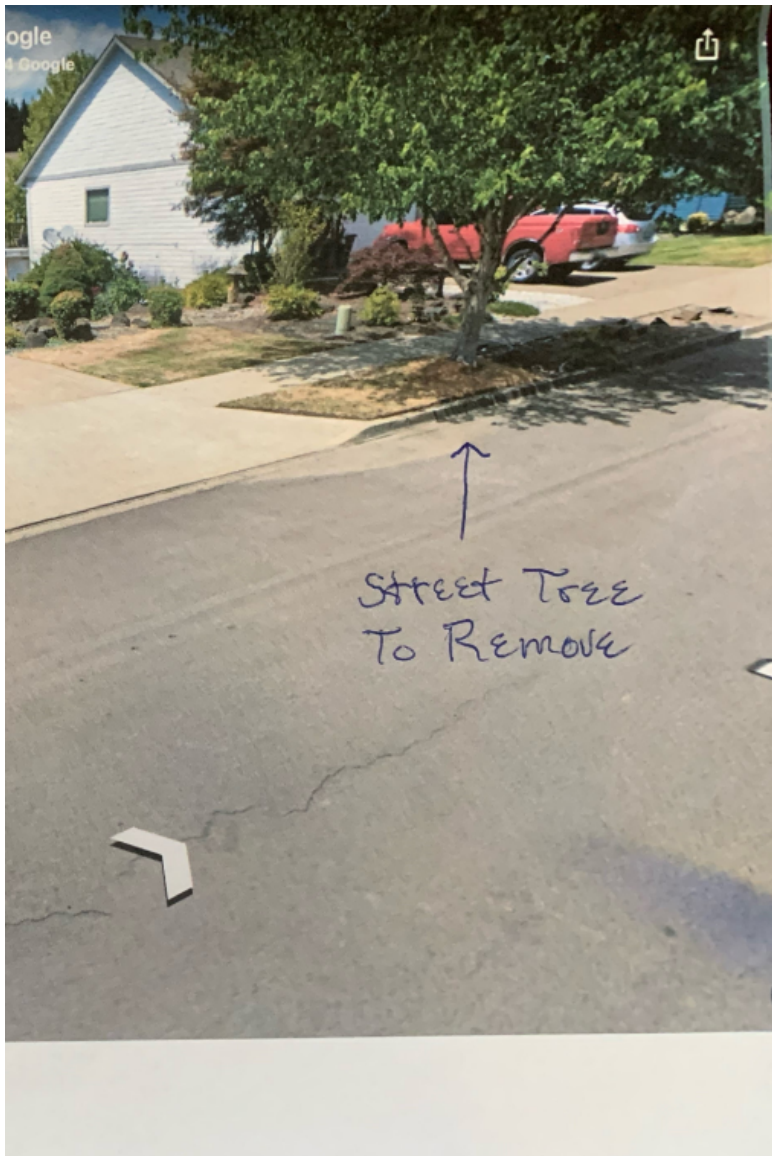
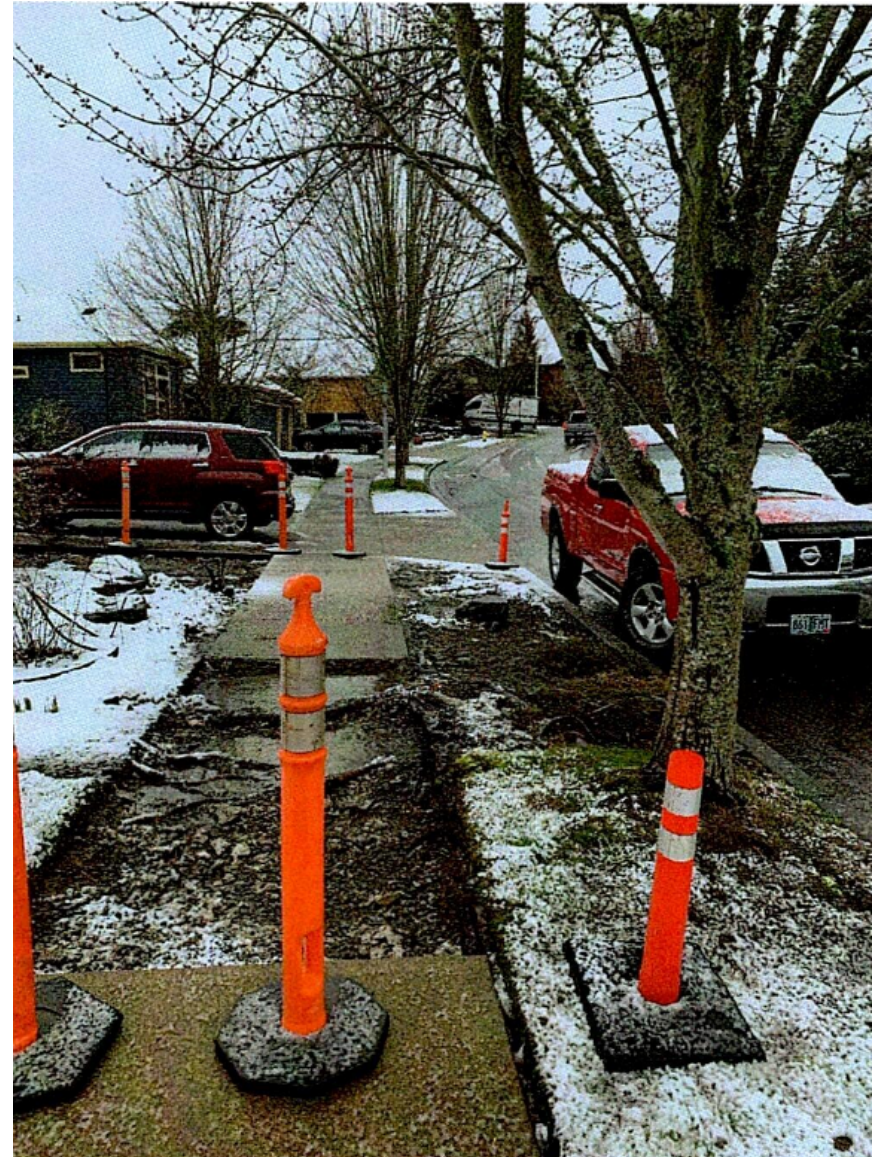
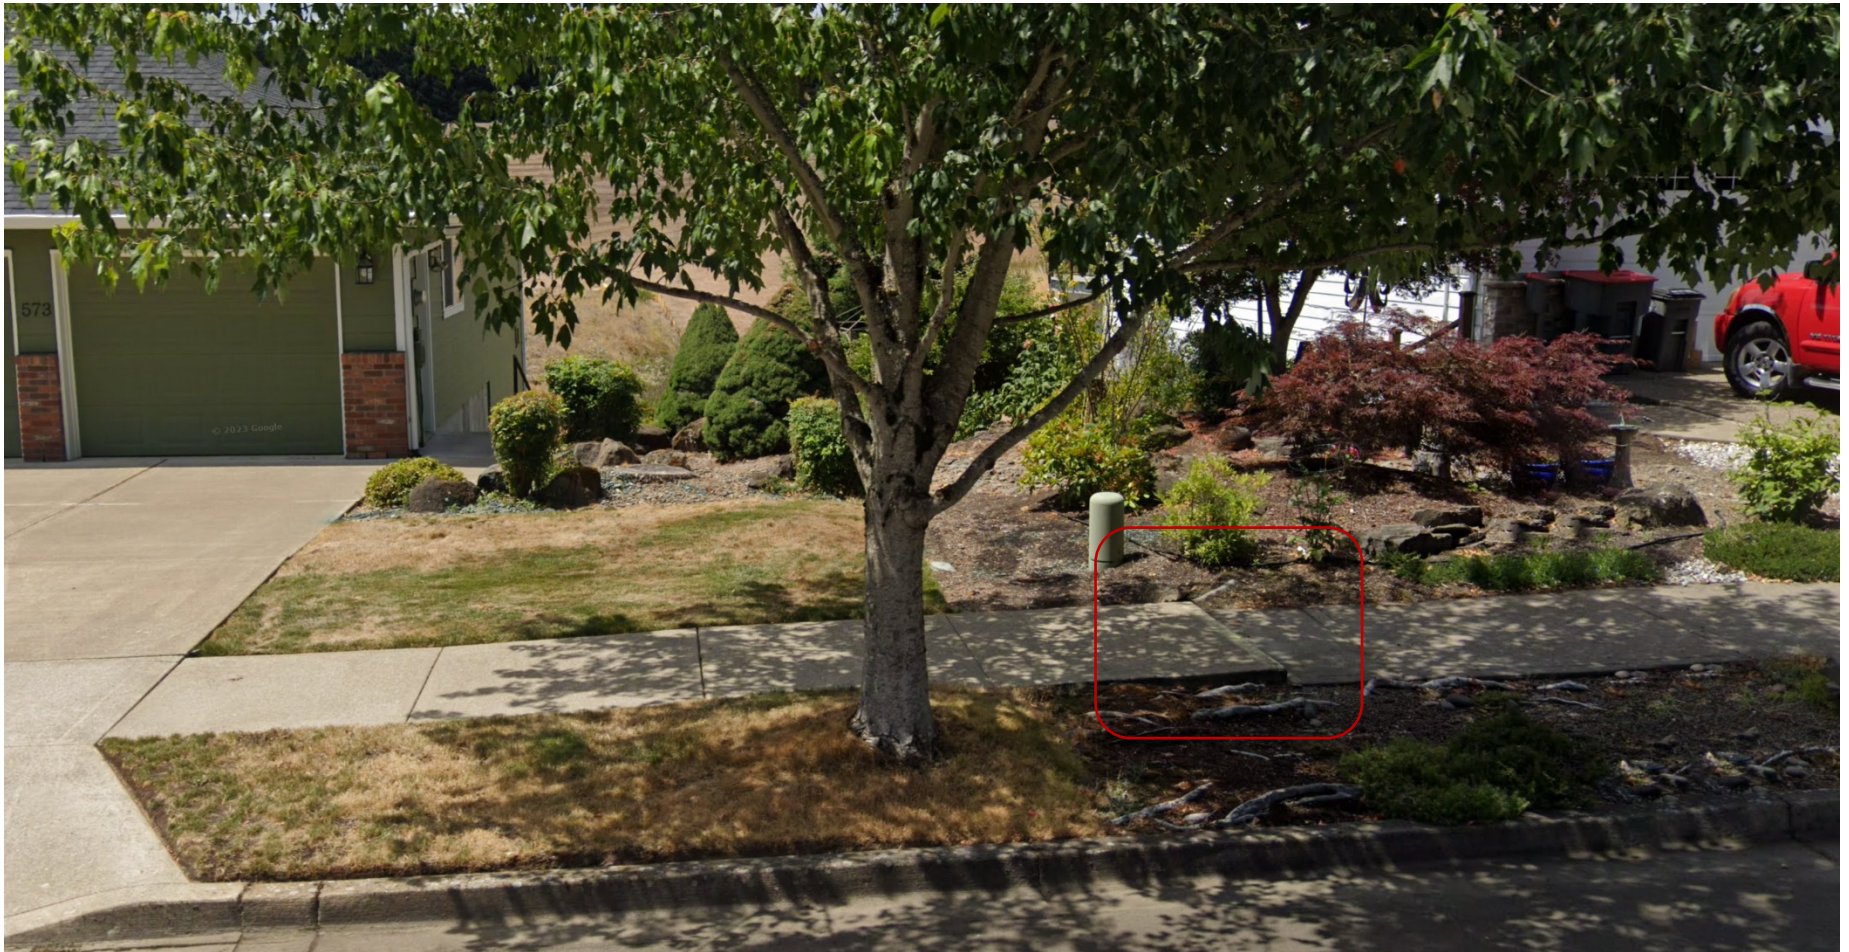
**Figure 2. Application Photos Tree #1.**

Tree #1 (northern tree). This tree was identified as the tree to be removed as part of the original application, but the tree species was not identified as part of the application. The applicant's imagery shows sidewalk panels removed with roots exposed (see **Figure 2**). It appears the roots have grown to the surface beneath the sidewalk and are now creating a trip hazard that needs to be addressed.

Both tree roots are causing trip hazards that need to be addressed and Engineering would be supportive of the tree(s) removal and replacement.

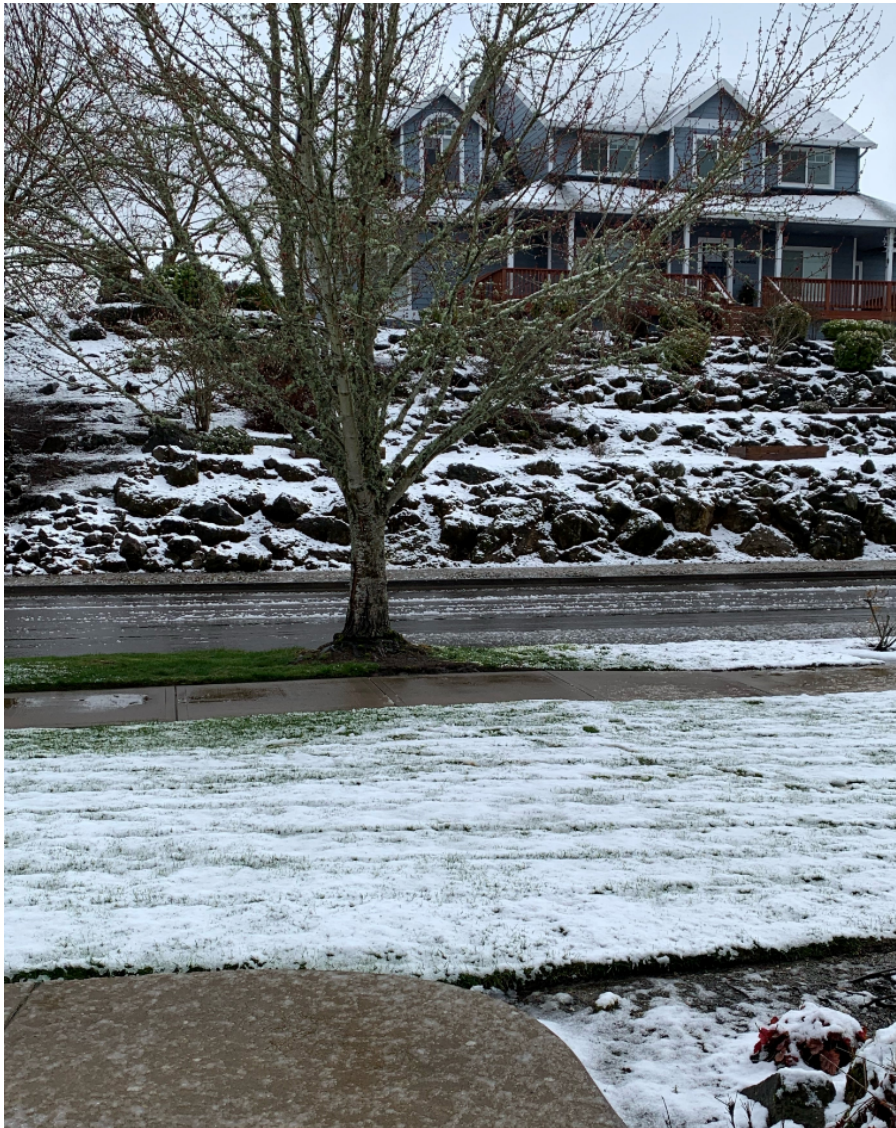
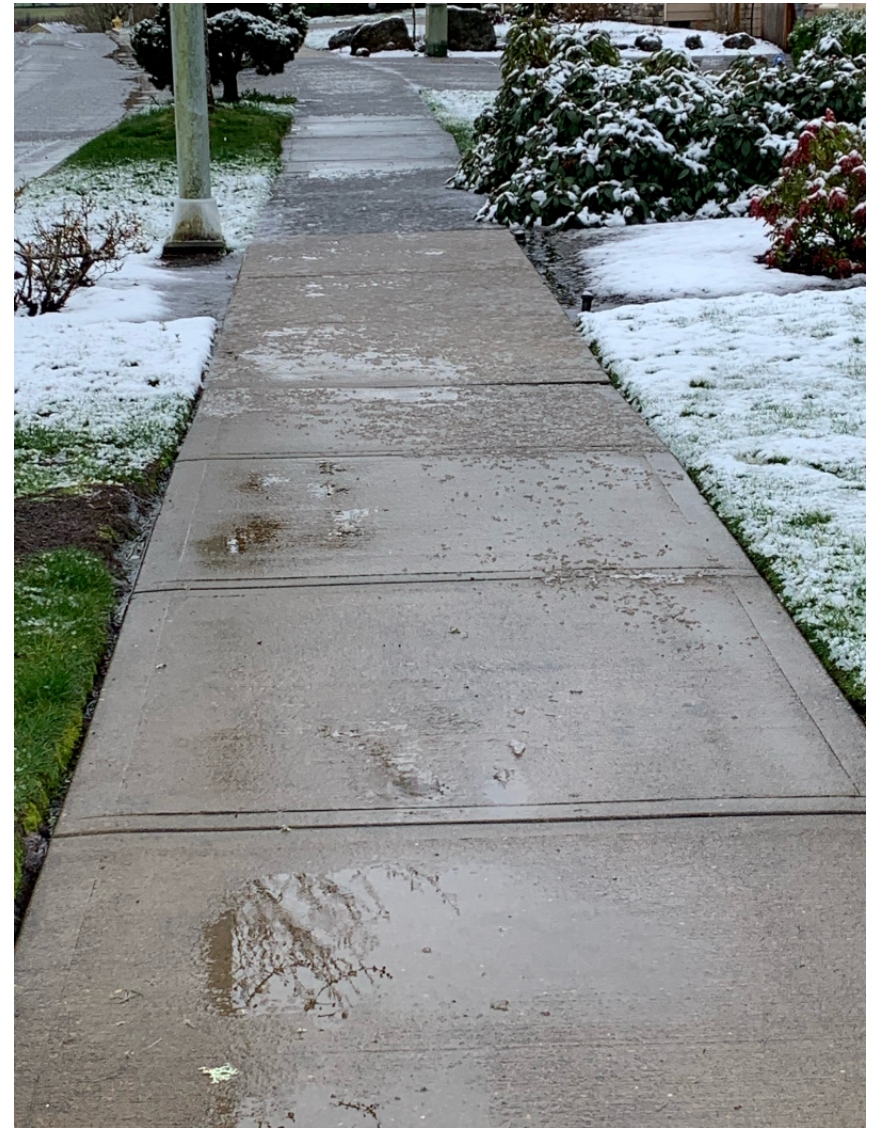
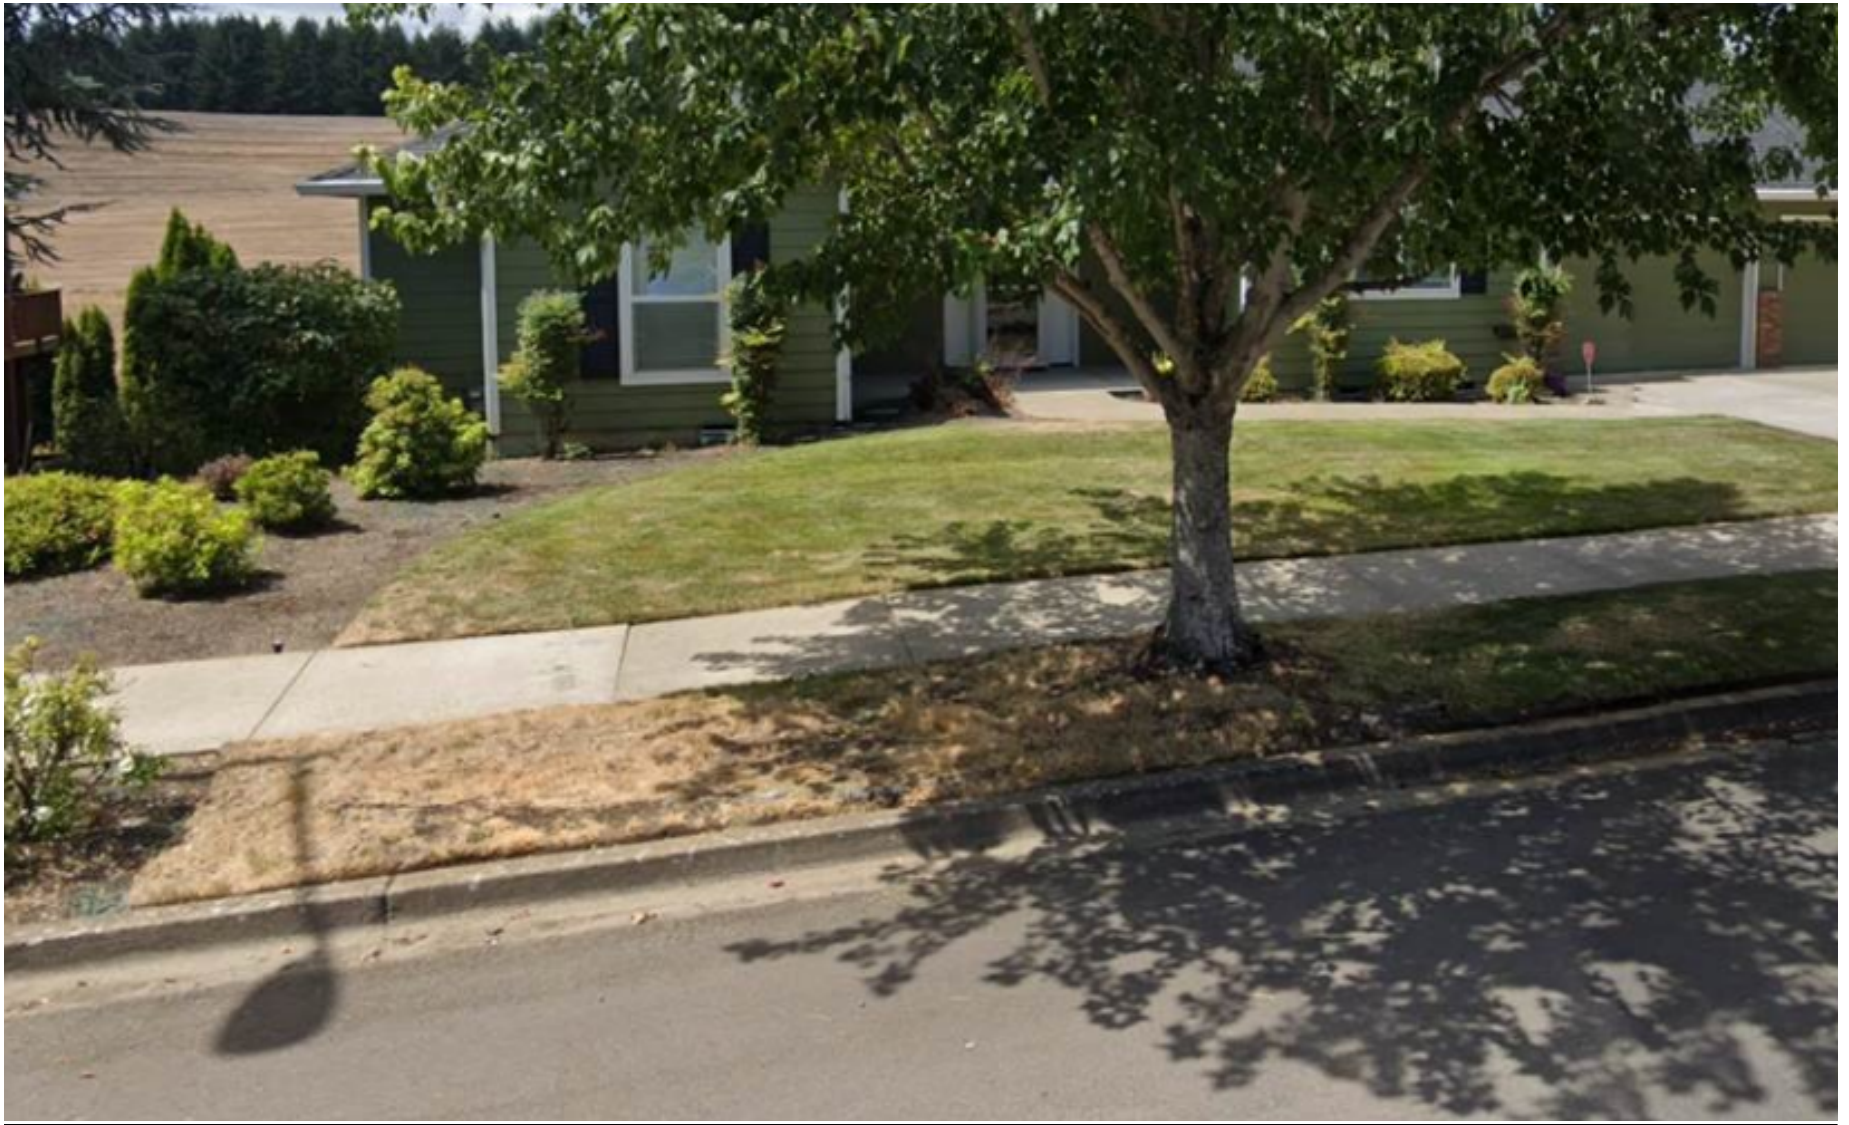
**Figure 3. Application Photos Tree #2.**

Tree #2 (southern tree). This tree was identified for removal as part of the supplemental application, but the tree species was not identified as part of the application. The applicant has indicated that the tree has impacted their irrigation system and raised the sidewalk (see **Figure 3**). After conducting a site visit, it was found that a trip hazard, which appears to be from the tree's roots, existed within the sidewalk.

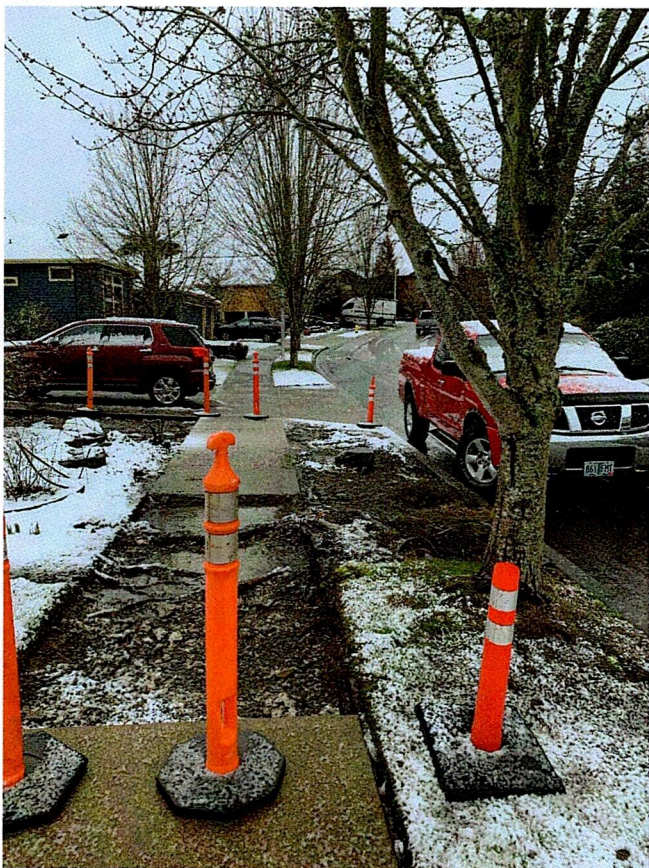
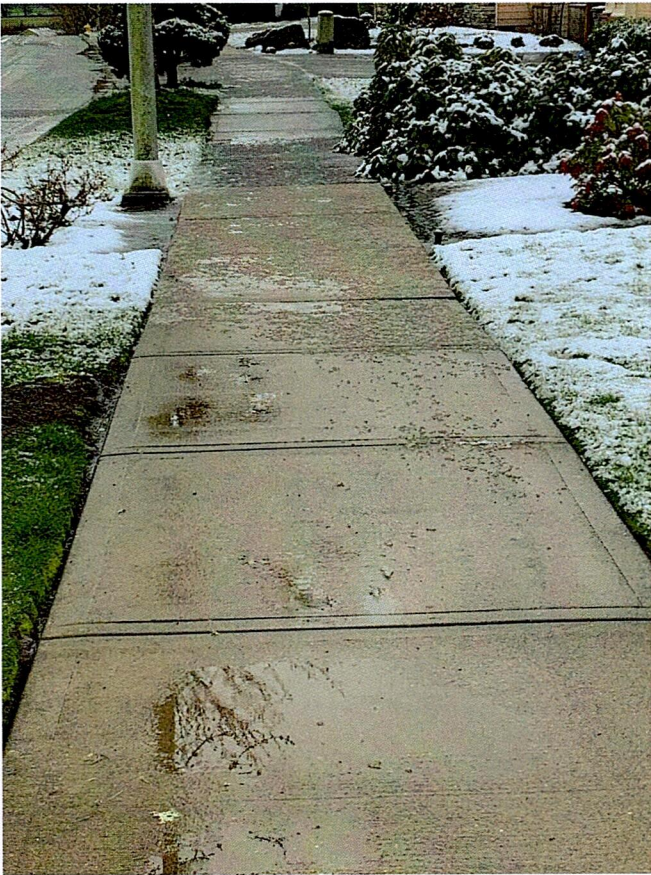
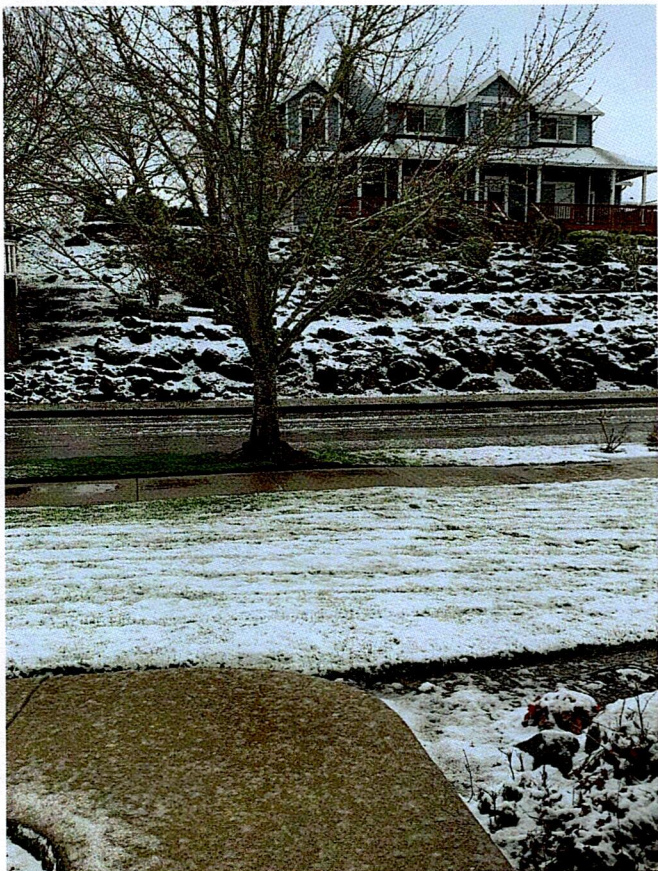
Hello Amanda, per our conversation this morning would you please revise our application to show the two trees needing removal. Attached, please find pictures of the two trees. The first one has the cement removed to expose roots. The second tree has already done damage to our sprinkler system and has buckled the sidewalk. Thank you, Greg and Vicki.

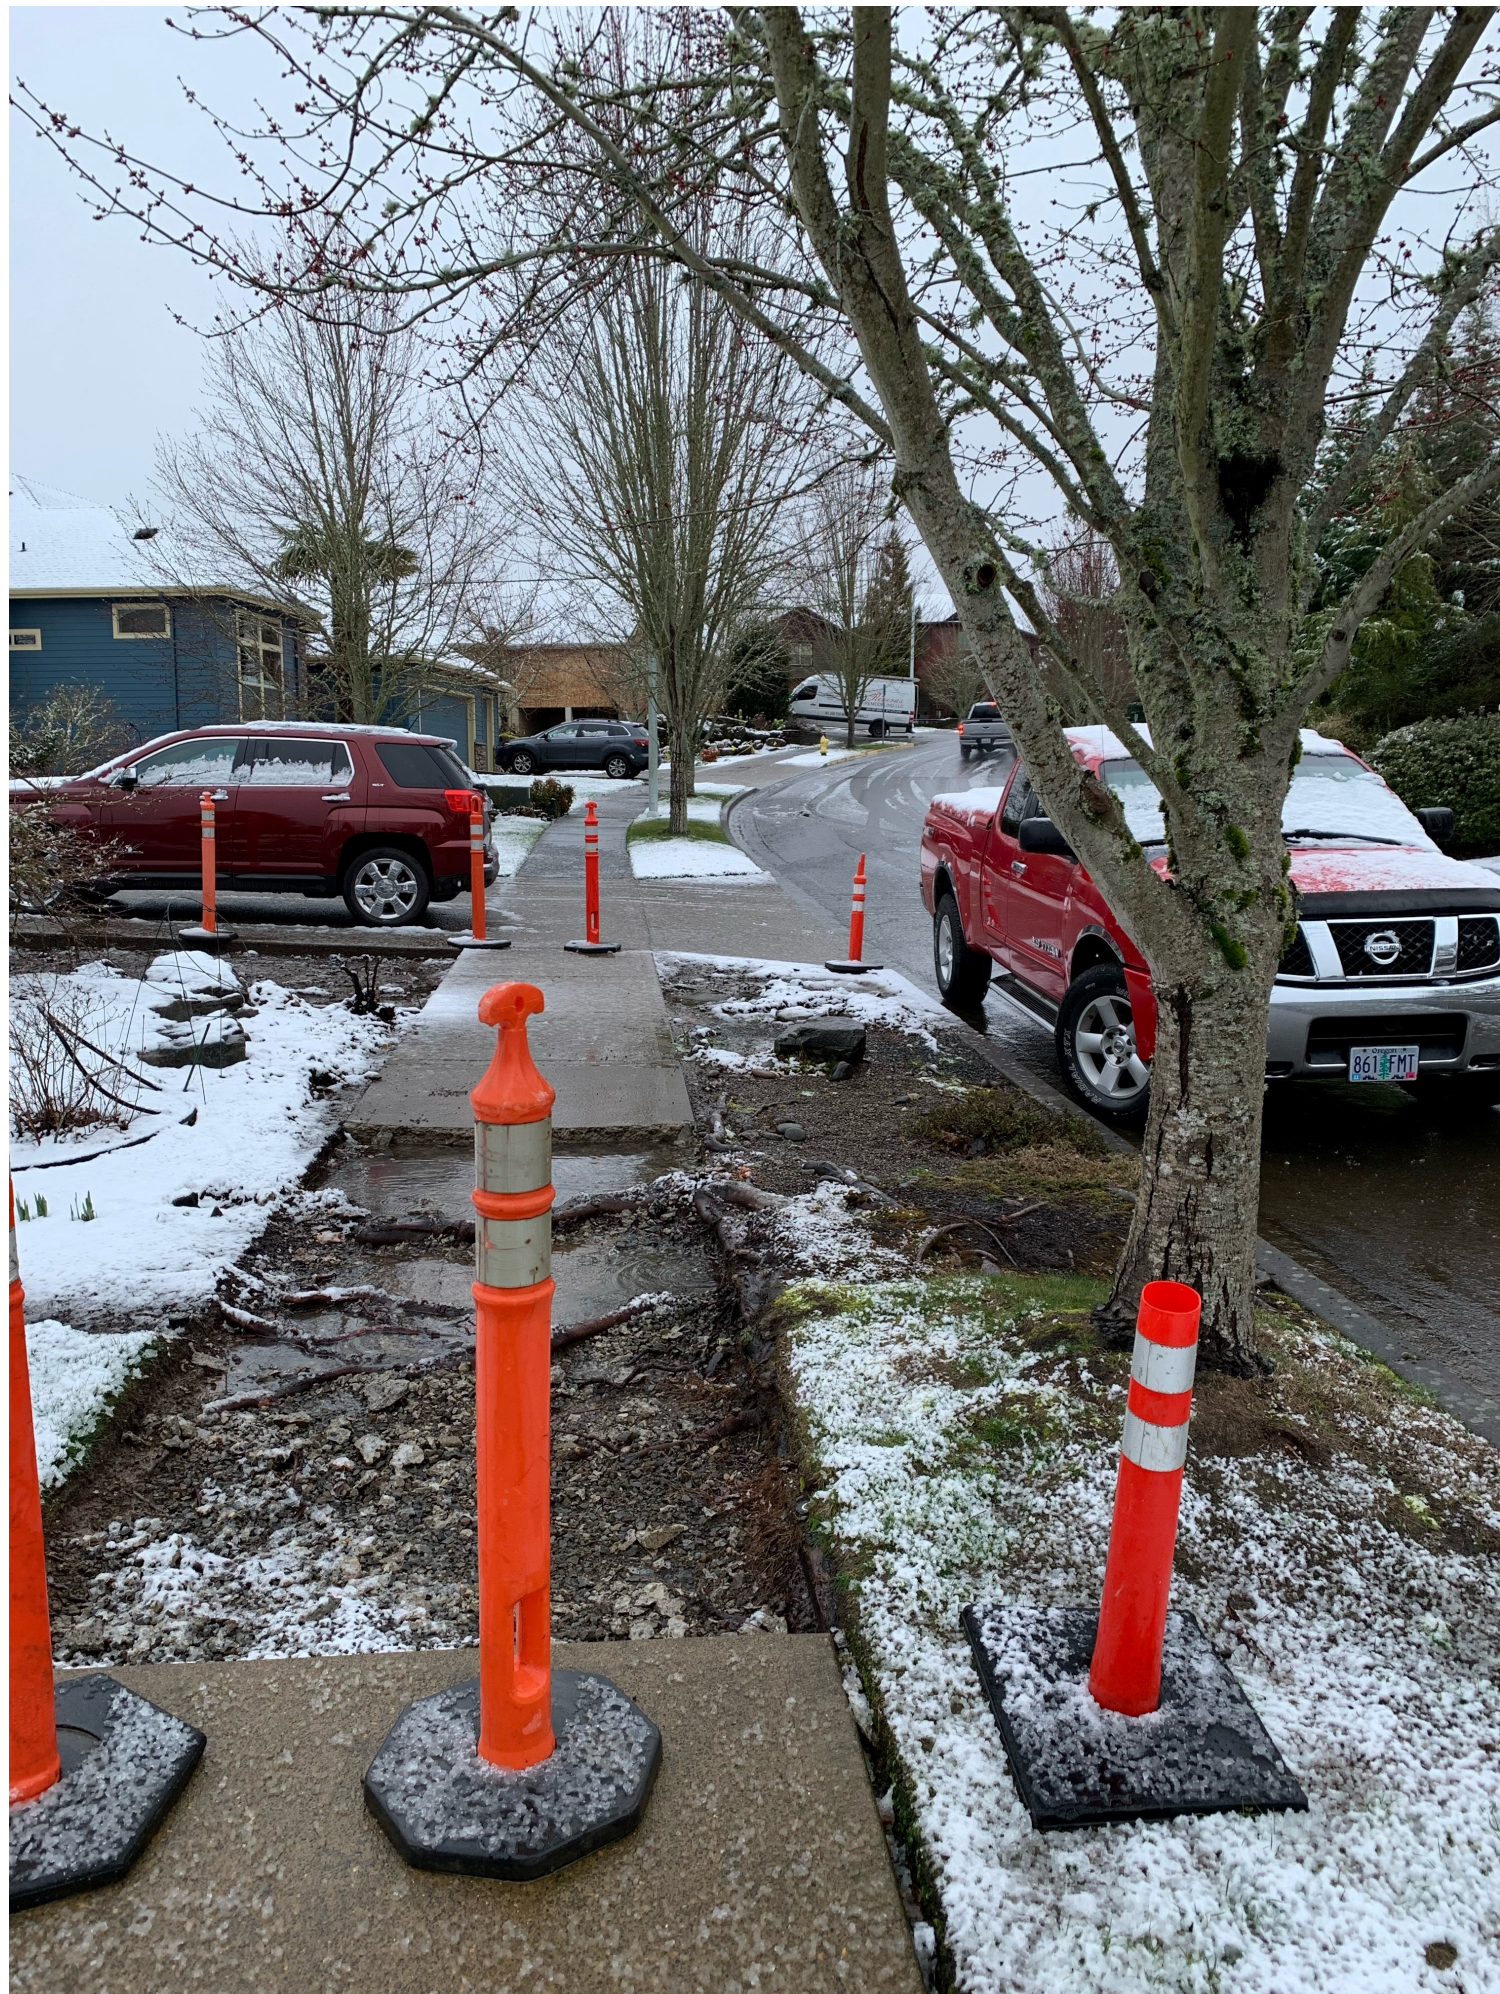
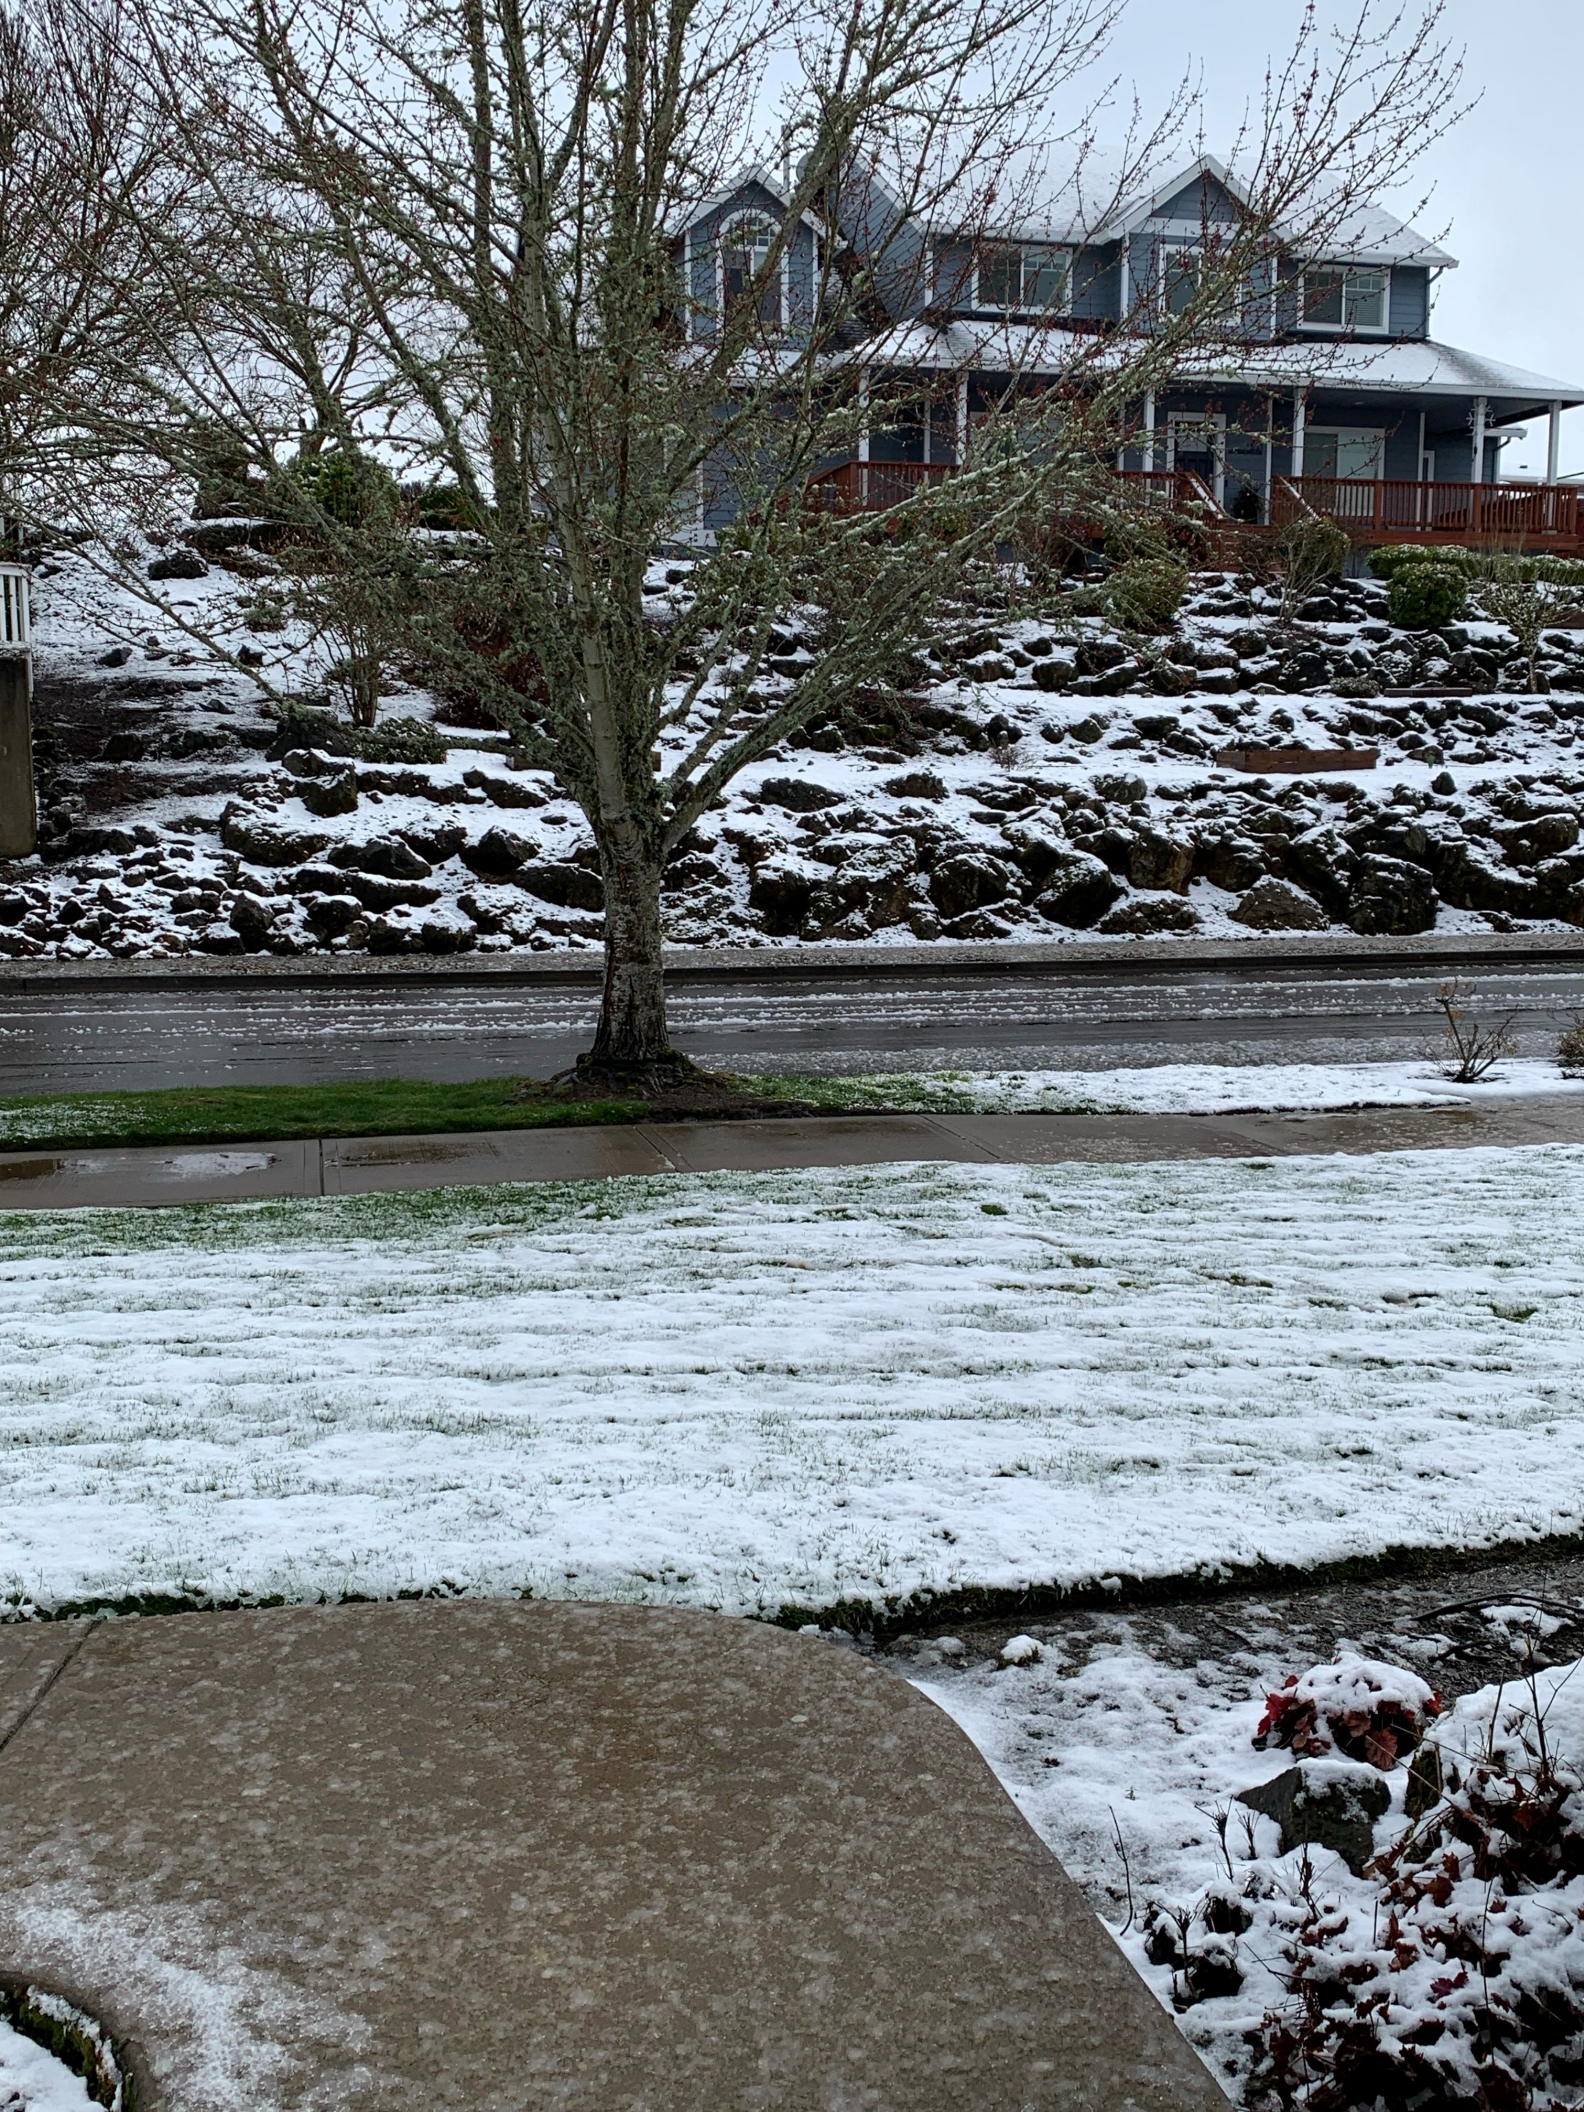
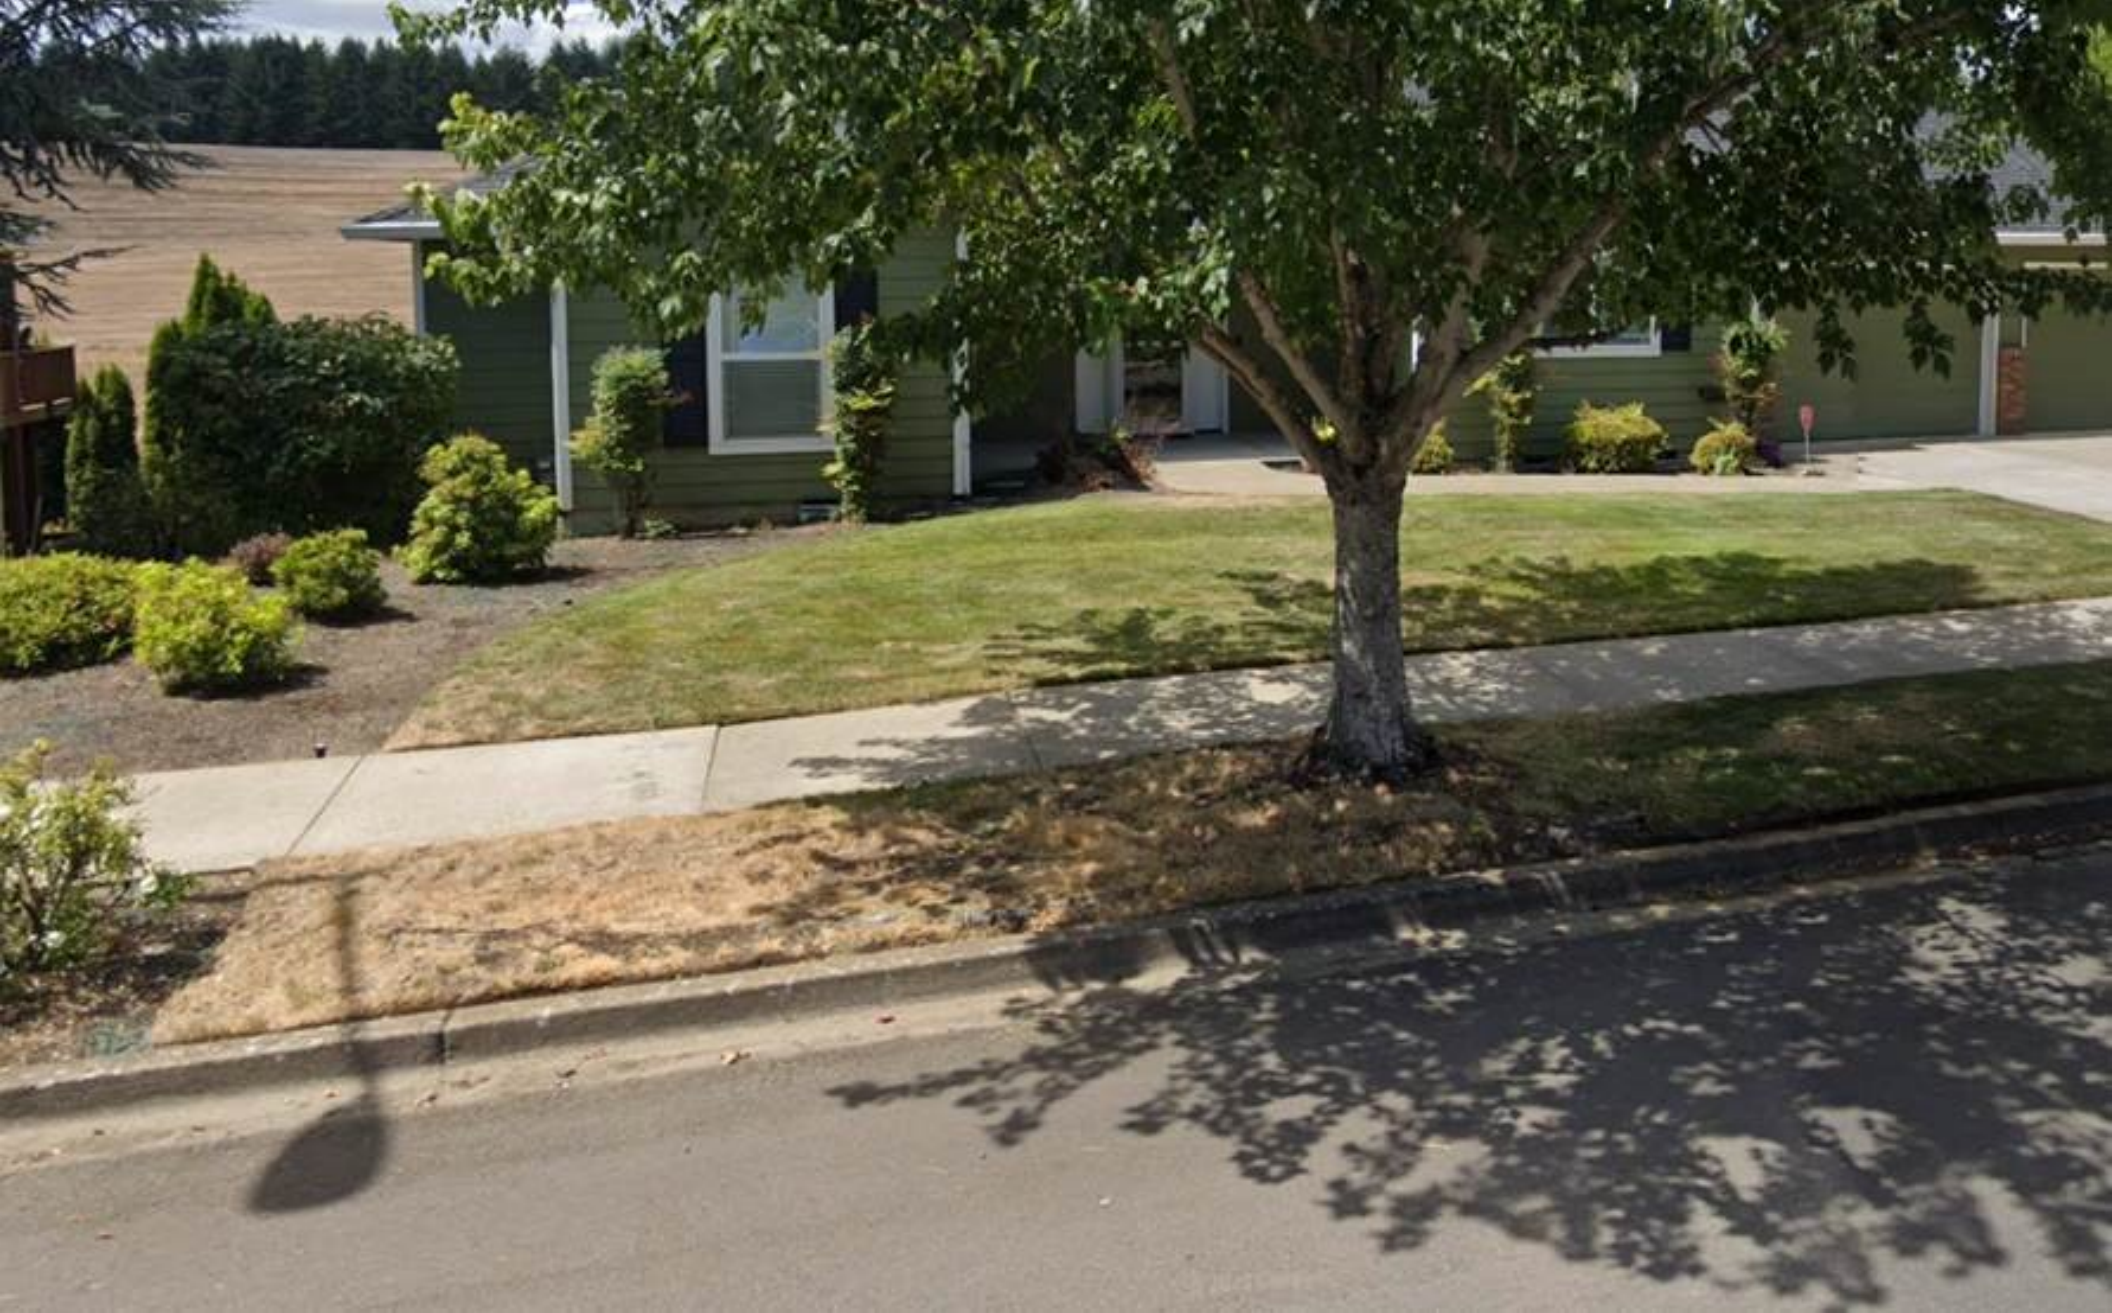
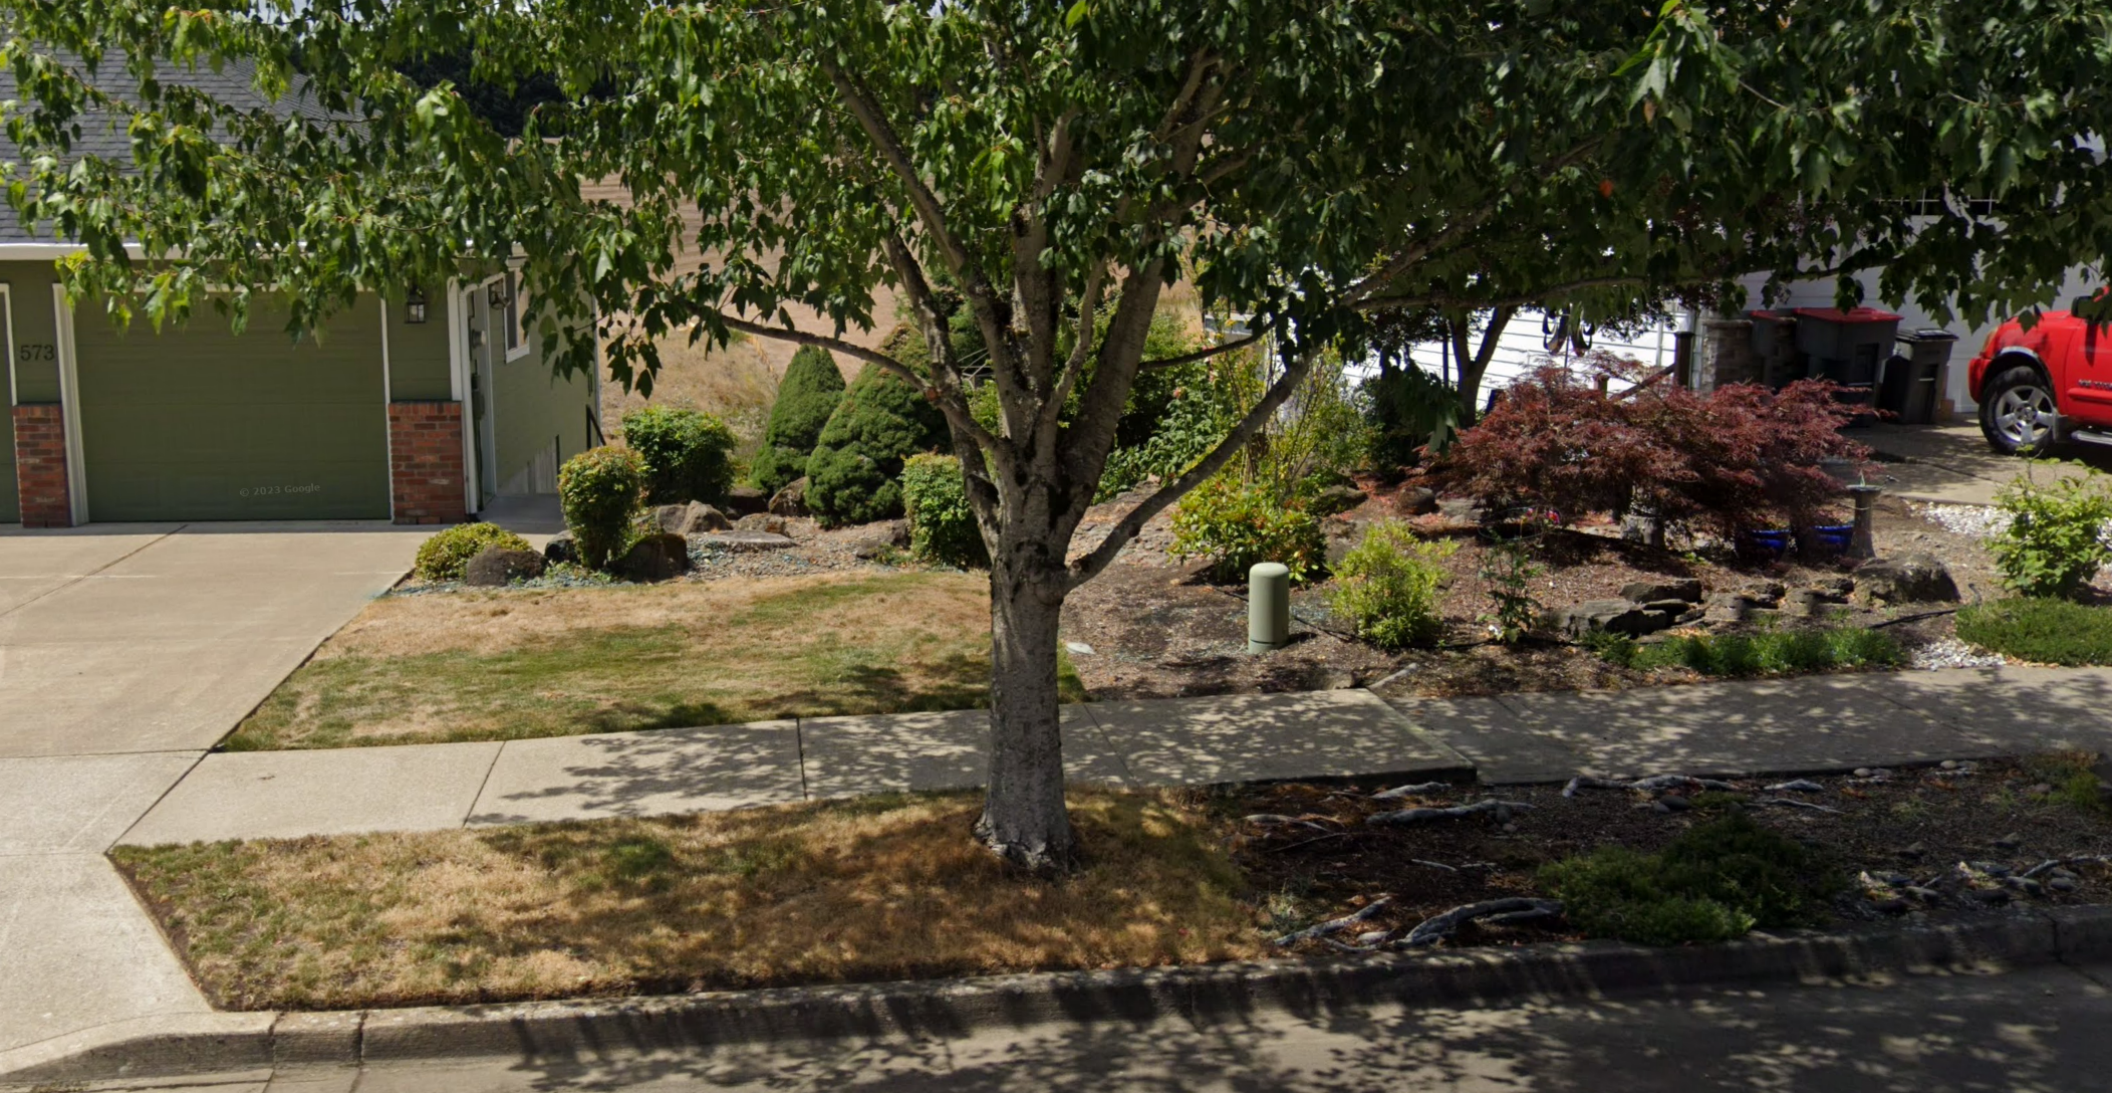
Hello Amanda, per our conversation this morning would you please revise our application to show the two trees needing removal. Attached, please find pictures of the two trees. The first one has the cement removed to expose roots. The second tree has already done damage to our sprinkler system and has buckled the sidewalk. Thank you, Greg and Vicki.

Street Trees (2) wrong species to plant in Calmed Area  
with Rocky/clay Base soil  
Remove! / Do not Replace in Right at any Area  
Replant in Lawn / Landscape Area.  
Shawn Shank  
PAW1585A
