## EXHIBIT 1 - STAFF REPORT

**DATE:** March 20, 2024  
**TO:** Landscape Review Committee Members  
**FROM:** Taylor Graybehl, Senior Planner  
**SUBJECT:** Tree Removal Application (L 8-24)

**DOCKET:** L 8-24 (Street Tree Removal)

**REQUEST:** Approval of a tree removal application for the removal of two (2) Trees.

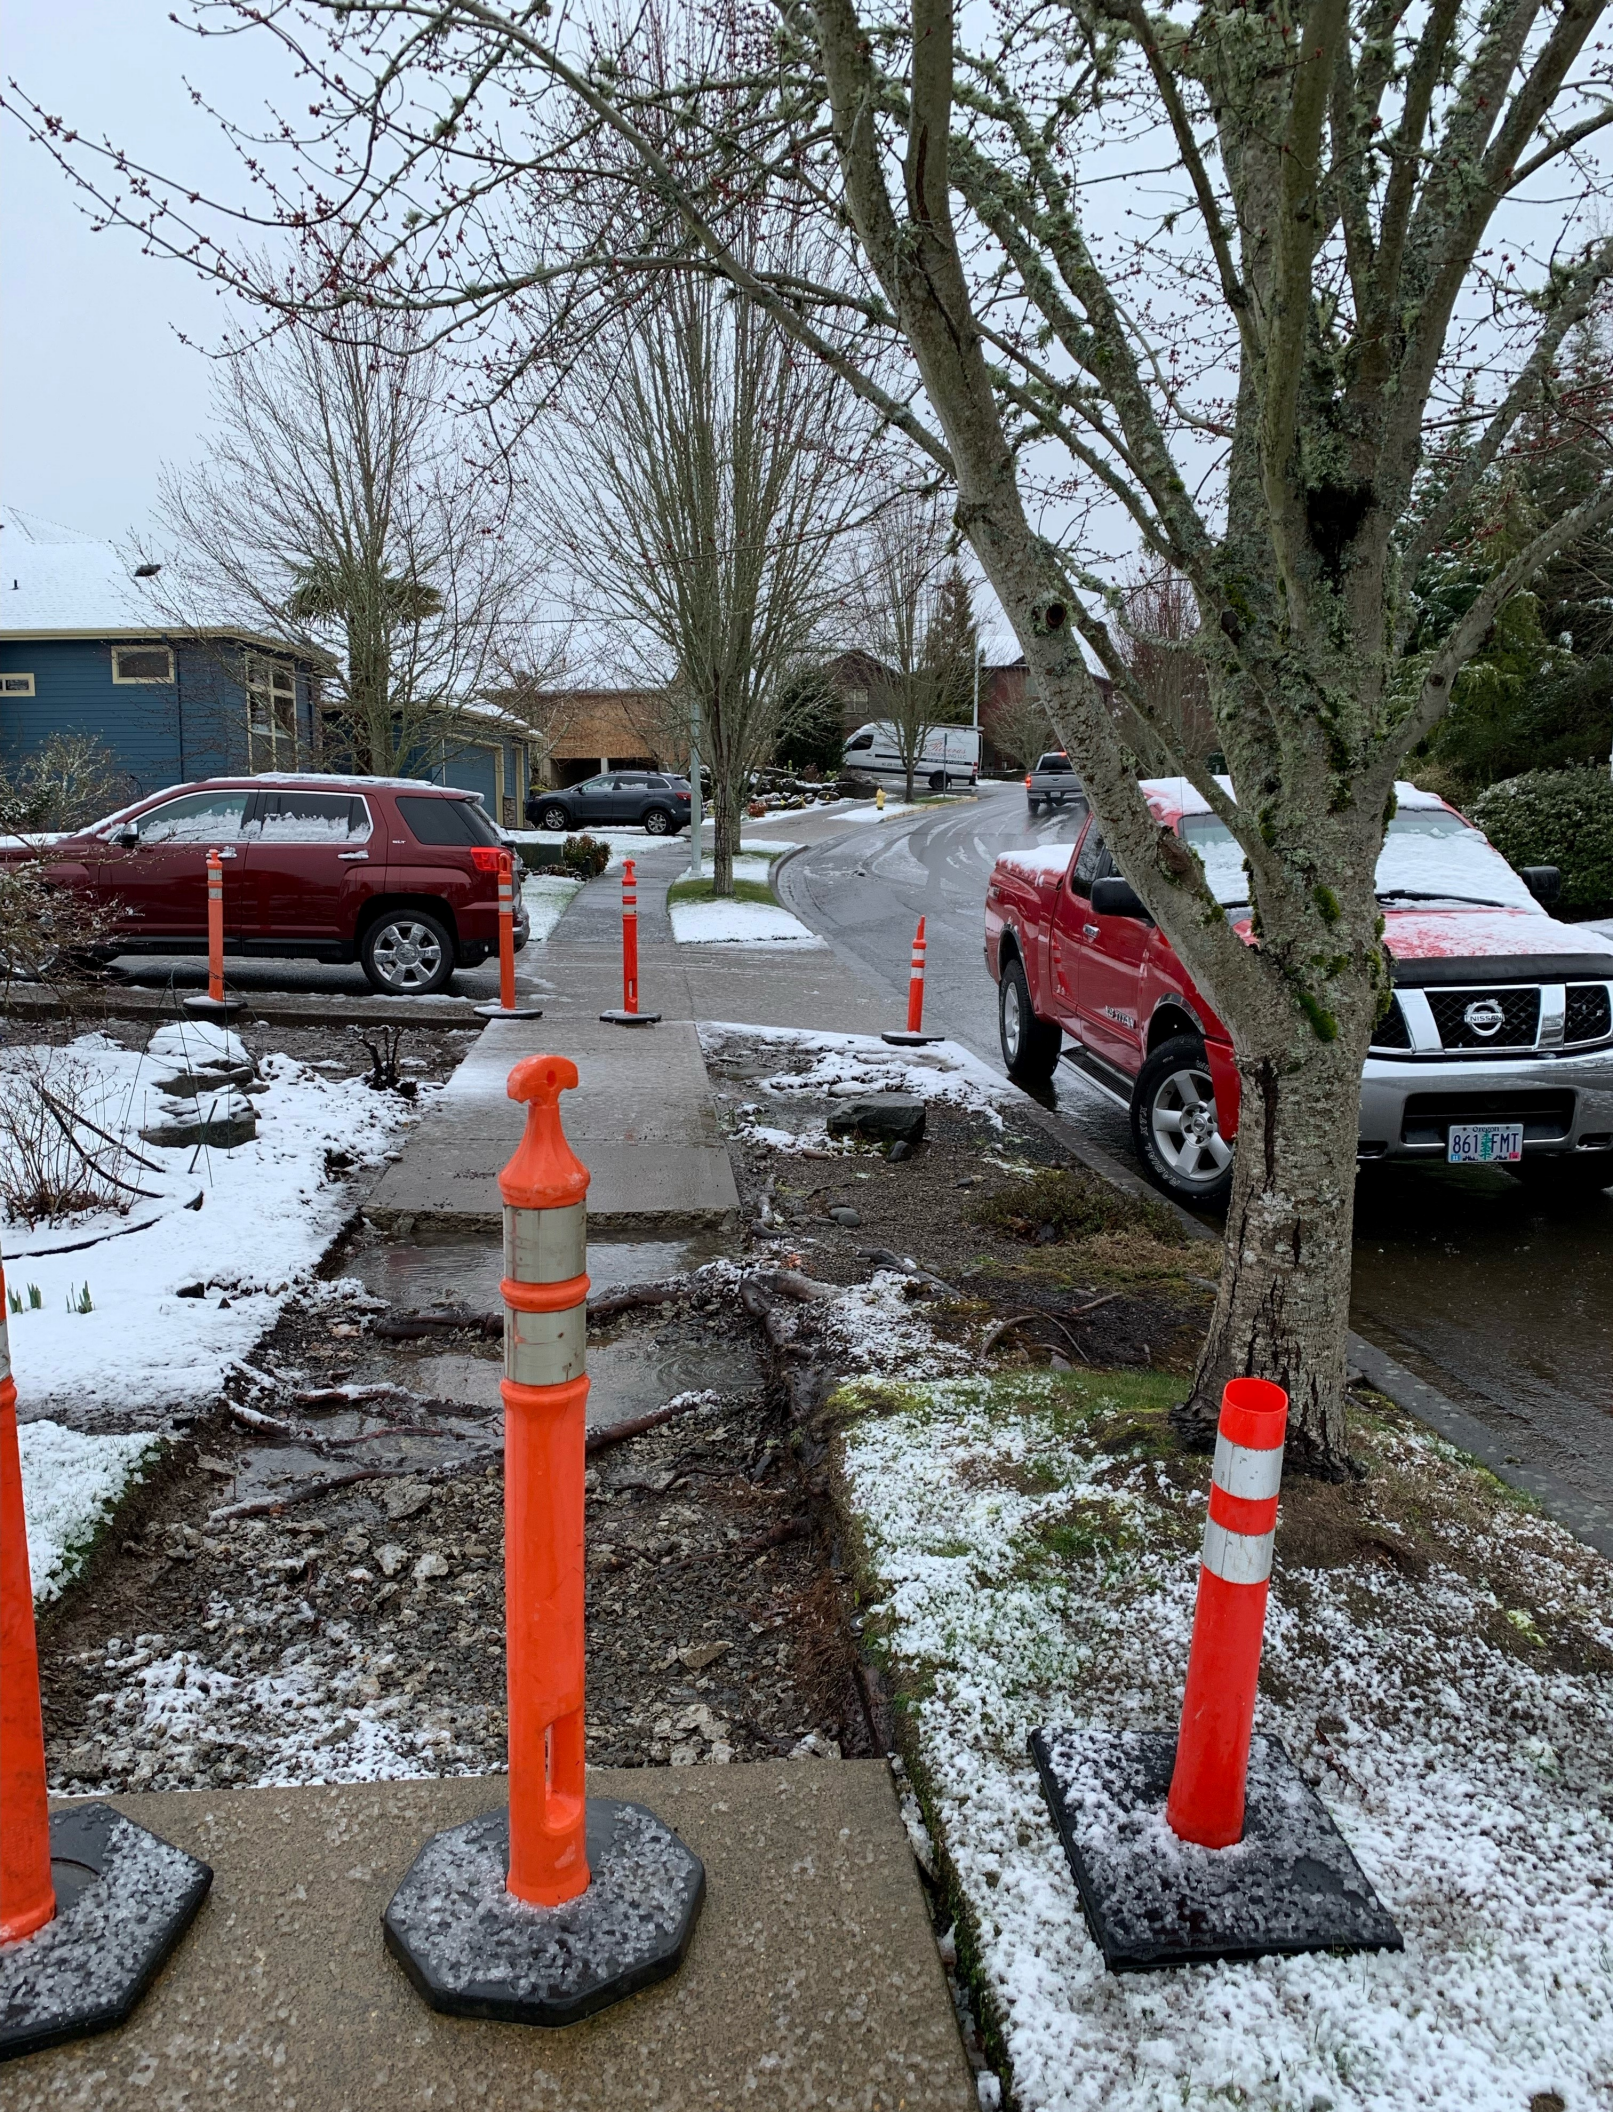
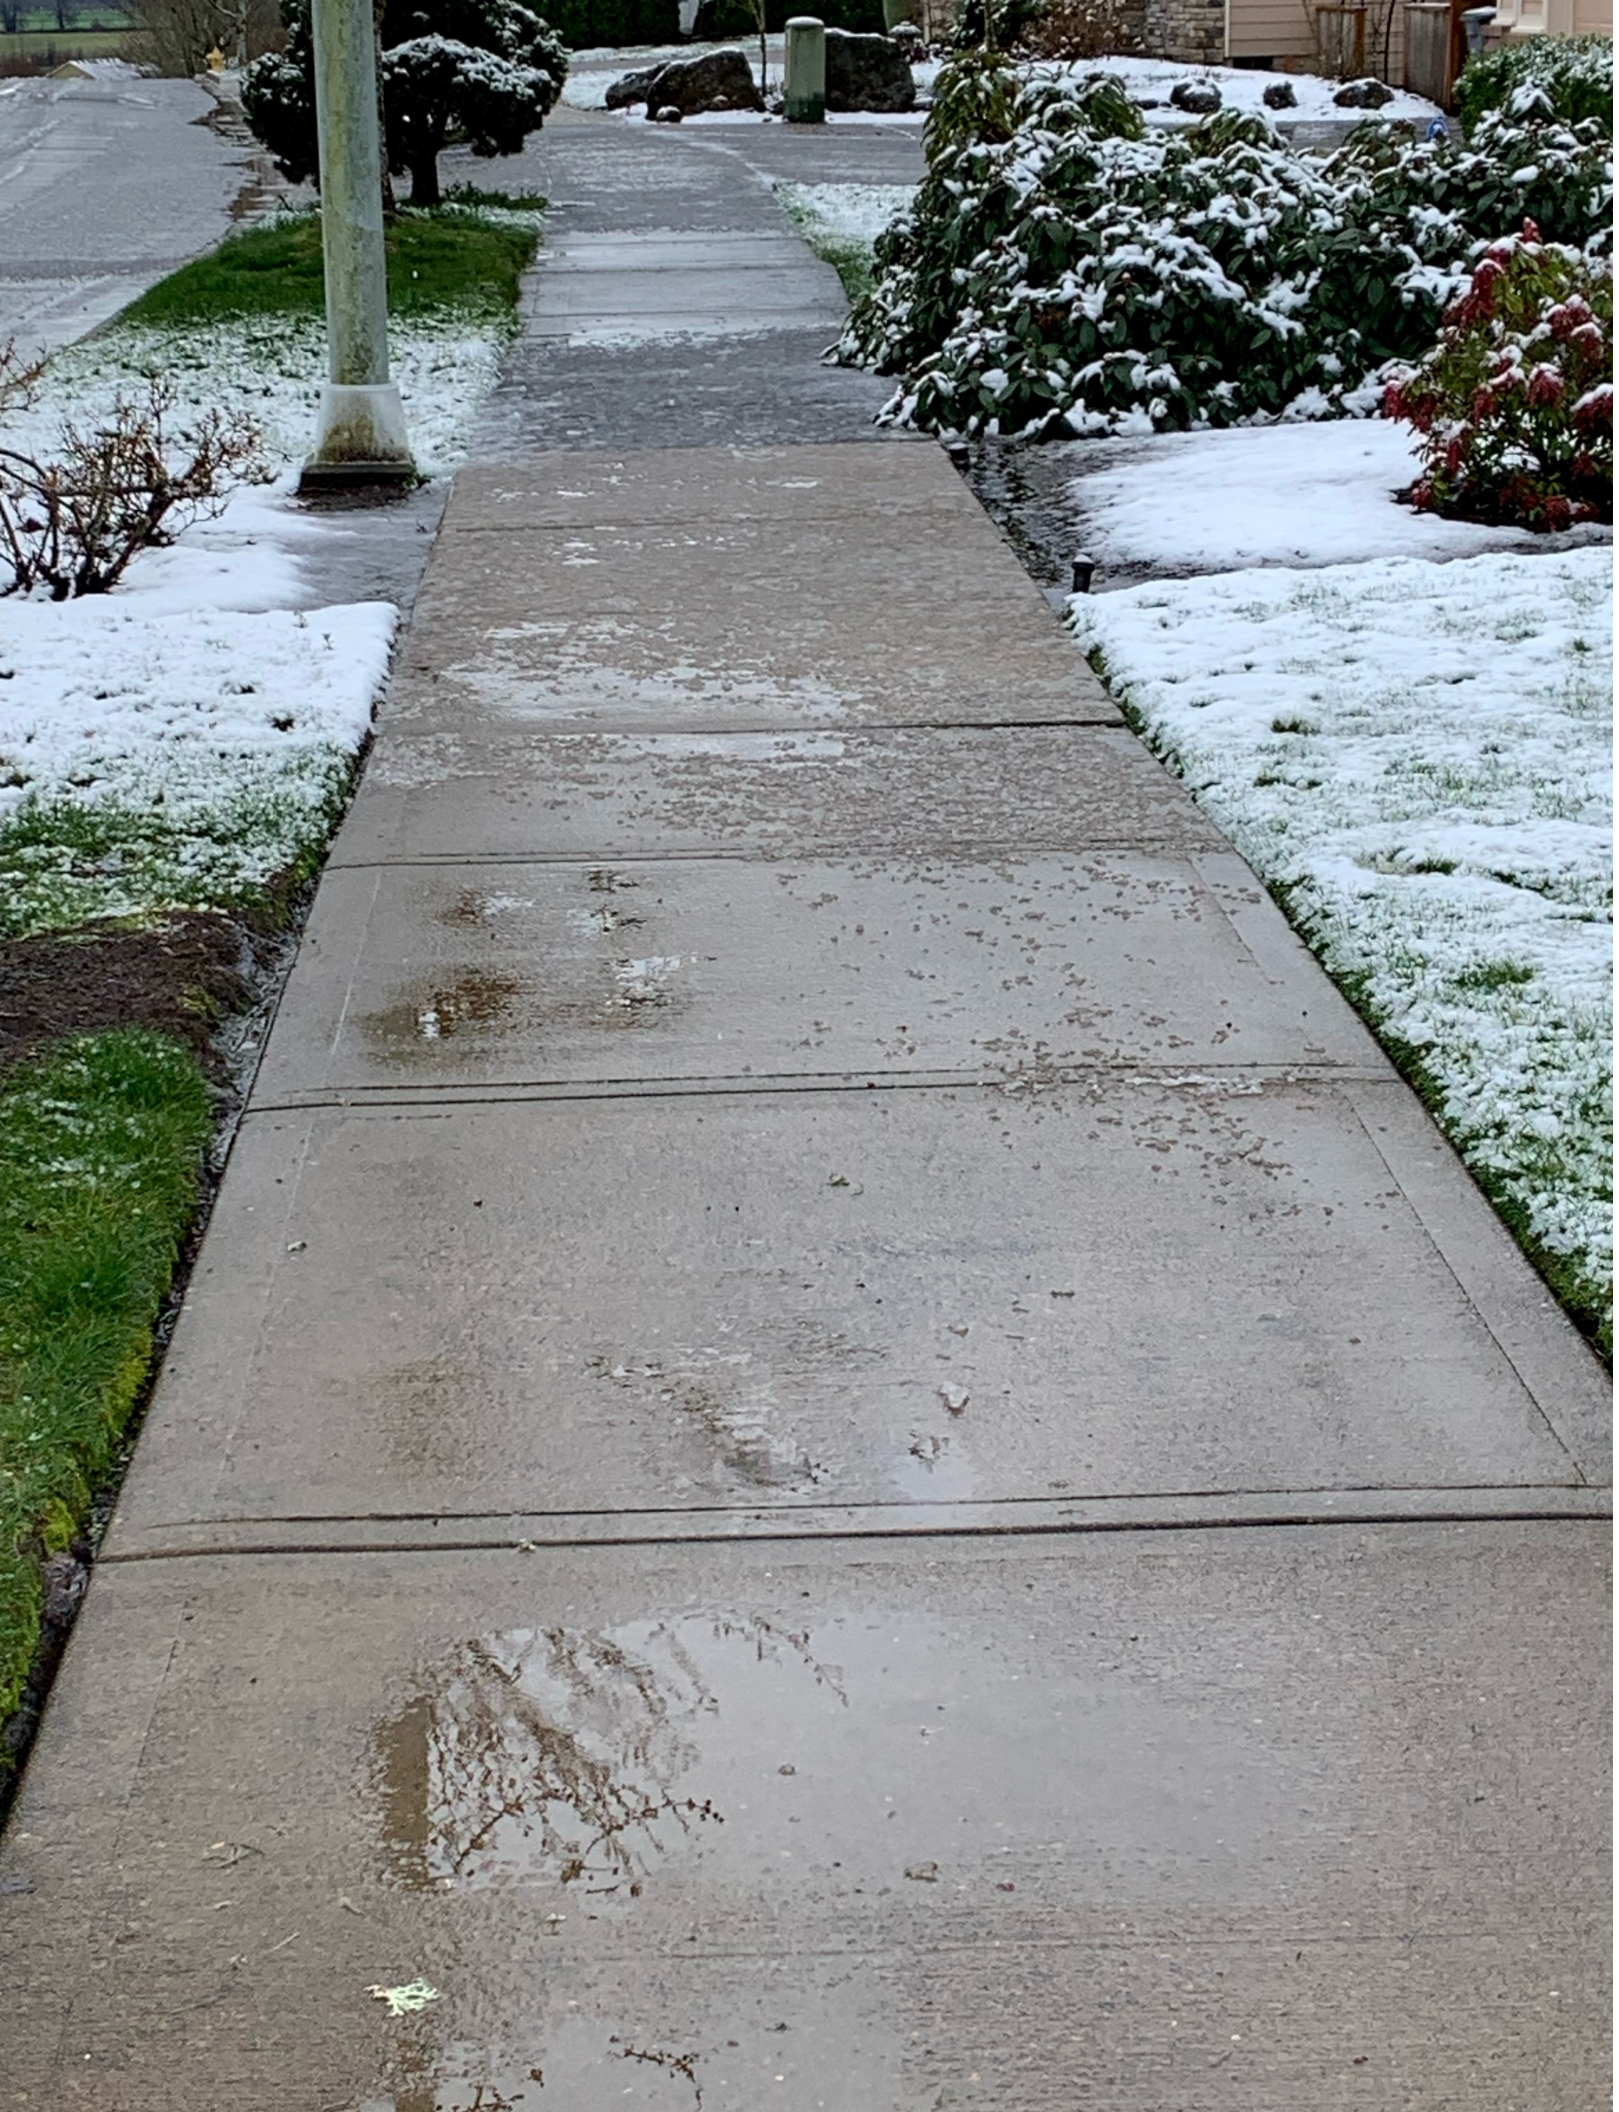
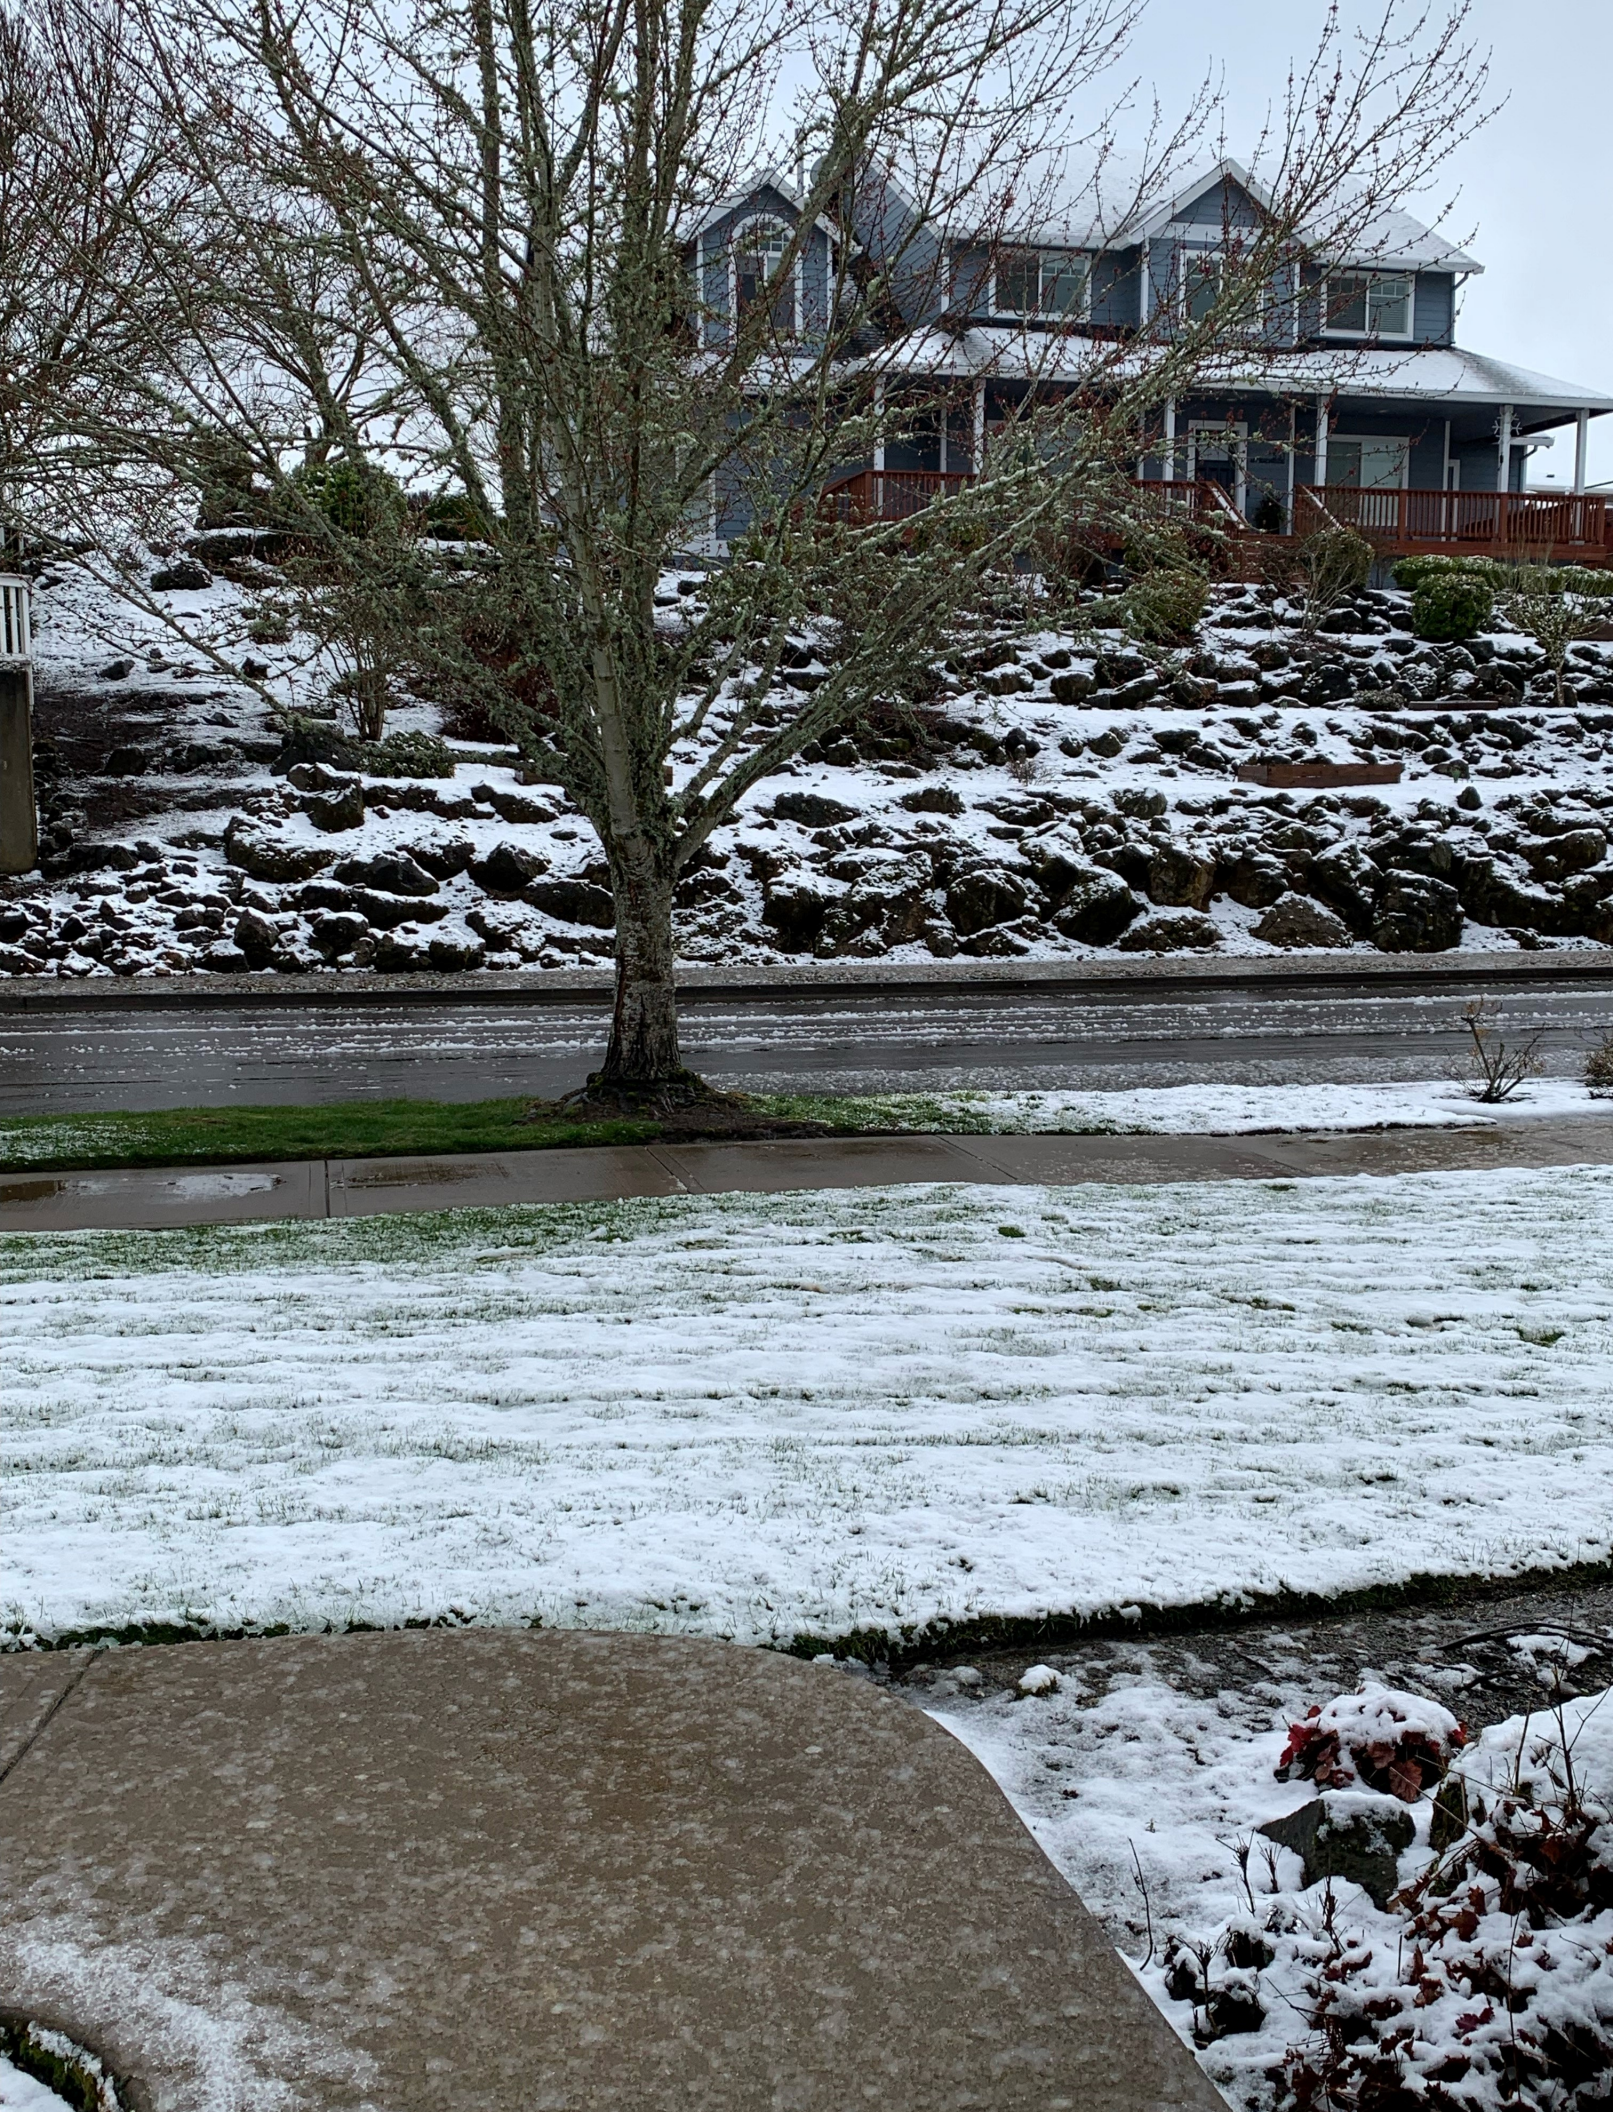
## Attachment 2 - Supplemental Application Materials

Hello Amanda, per our conversation this morning would you please revise our application to show the two trees needing removal. Attached, please find pictures of the two trees. The first one has the cement removed to expose roots. The second tree has already done damage to our sprinkler system and has buckled the sidewalk. Thank you, Greg and Vicki.

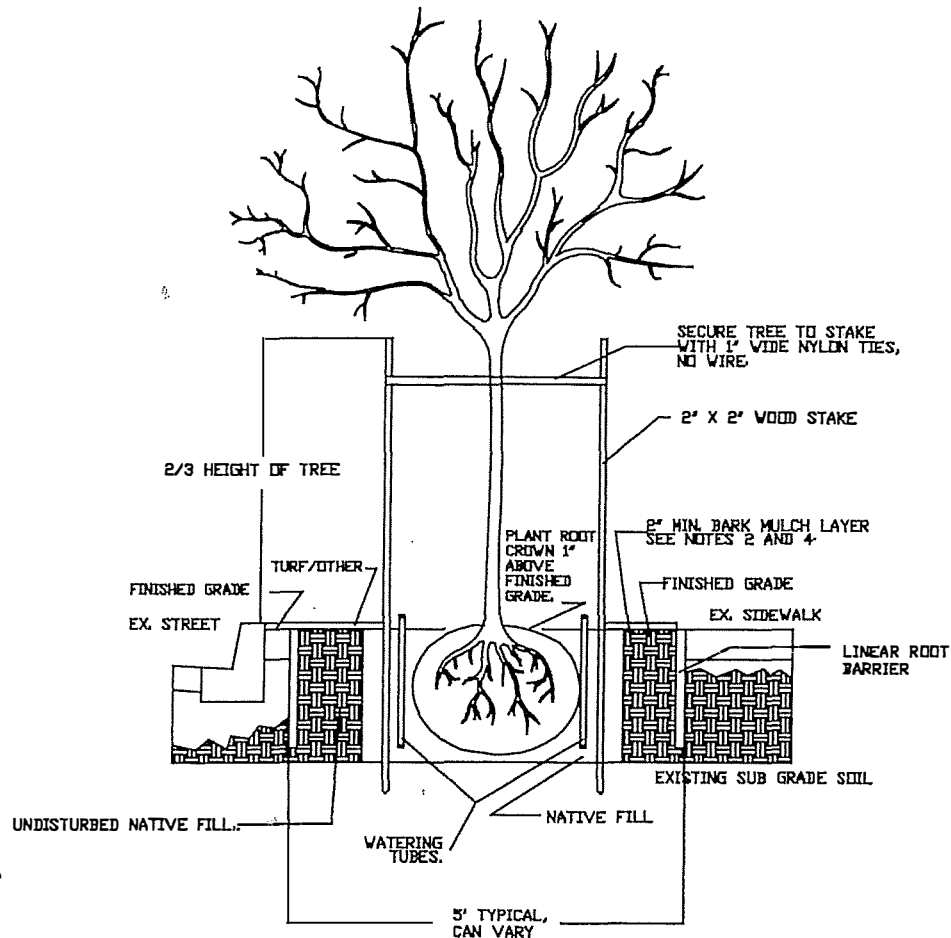
## TREE PLANTING IN PARKWAY DETAIL

1. PLANTING PIT 2X ROOTBALL WIDTH.
2. DIG PLANTING PIT NO DEEPER THAN ROOTBALL.
3. BACKFILL WITH NATIVE MATERIAL.
4. TO MINIMIZE SIDEWALK AND TREE ROOT CONFLICTS, INSTALL LINEAR ROOT BARRIER; COMMERCIALLY ENGINEERED, 10 FEET LONG CENTERED ON THE TREE, 18" DEEP, ON THE CURB SIDE AND SIDEWALK SIDE OF THE TREE.
5. ON BALLED AND BURLAP TREES, CUT & PEEL AWAY WIRE FRAME FROM ROOTBALL, LEAVE BURLAP AND FRAME IN PLANTING HOLE.
