Architectural
Resources Group

609, 611, and 619 NE 3rd Street
McMinnville, Oregon

Historic Resource Assessment
November 2022

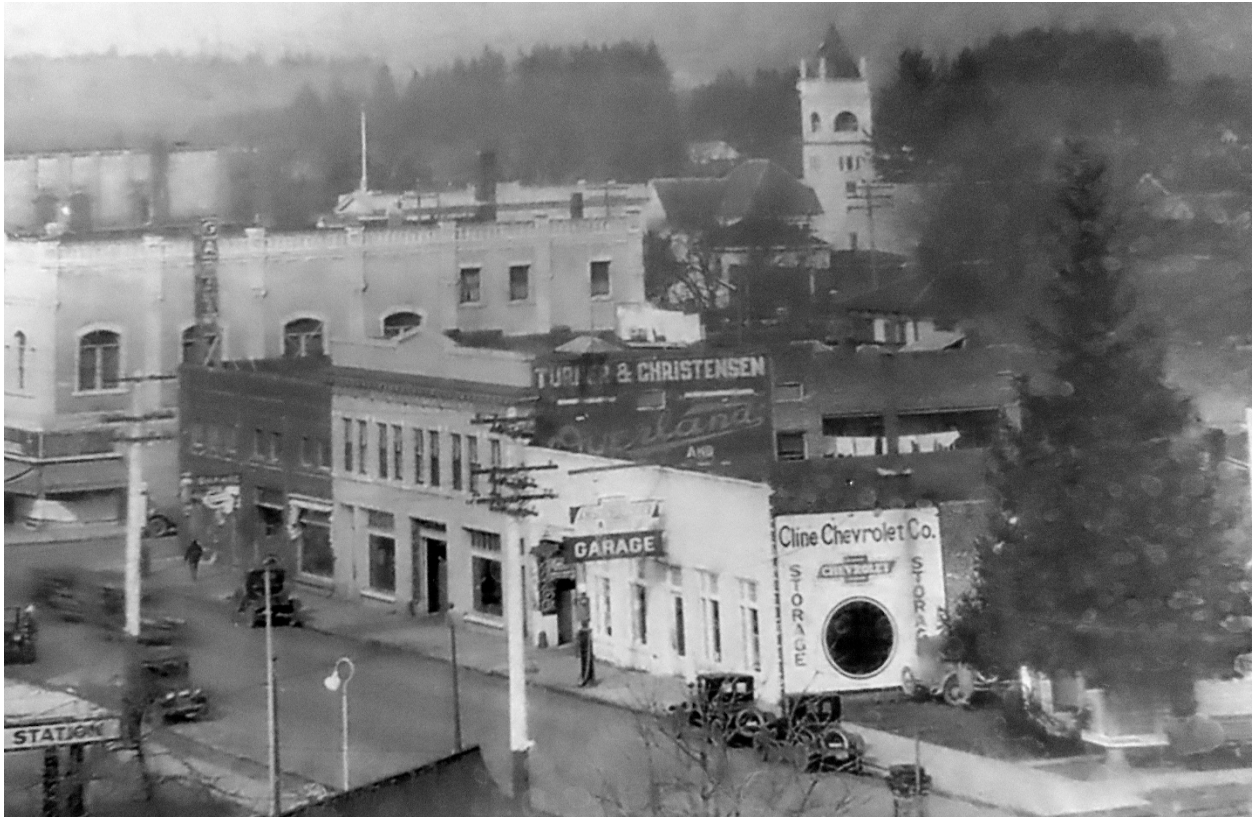
1927 photograph showing 609, 611, and 619 NE 3rd Street, looking northwest (News-Register Publishing Co).

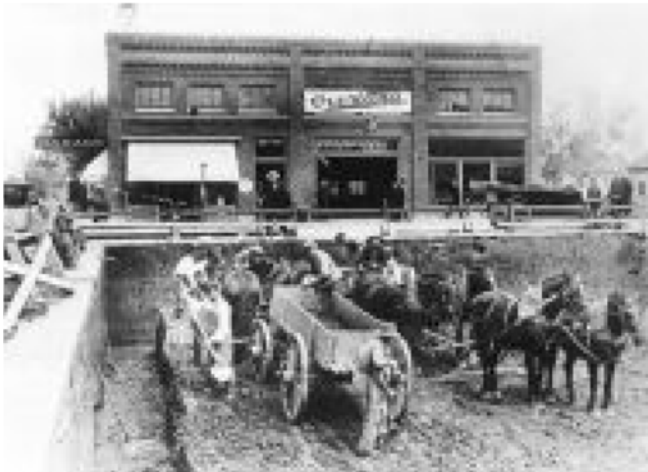
A c. 1904 photo from soon after 609 NE 3rd Street’s construction, showing the brick exterior and original ground floor configuration (Yamhill County Historical Society).

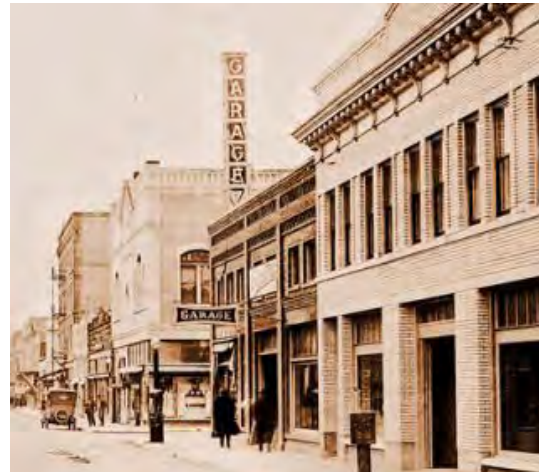
A 1919 photograph looking west along NE 3rd Street showing the original ground floor configuration of 609 NE 3rd Street (Yamhill County News-Register, collection of Michael Hafner).

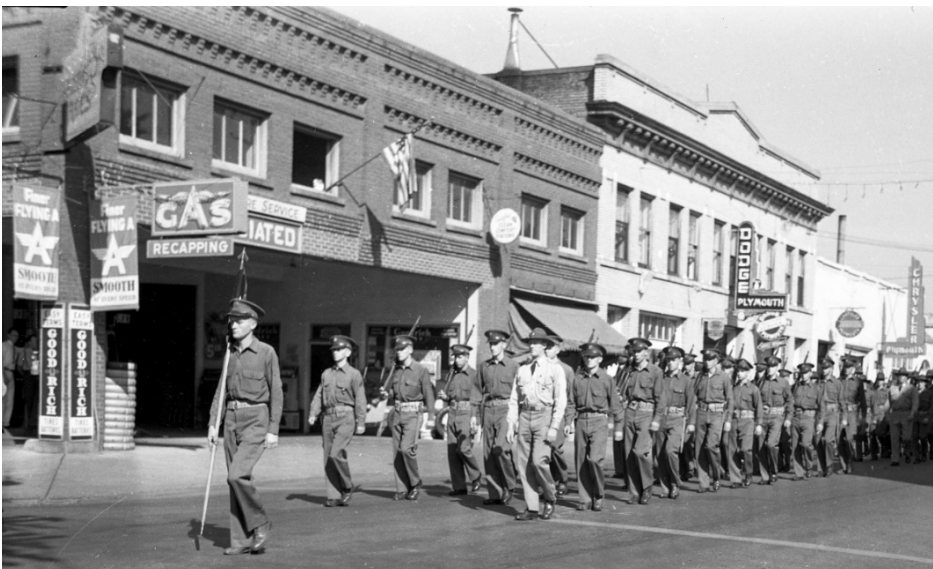
The ground floor was reconfigured to accommodate gasoline pumps prior to this 1940 photograph (Yamhill County News-Register).

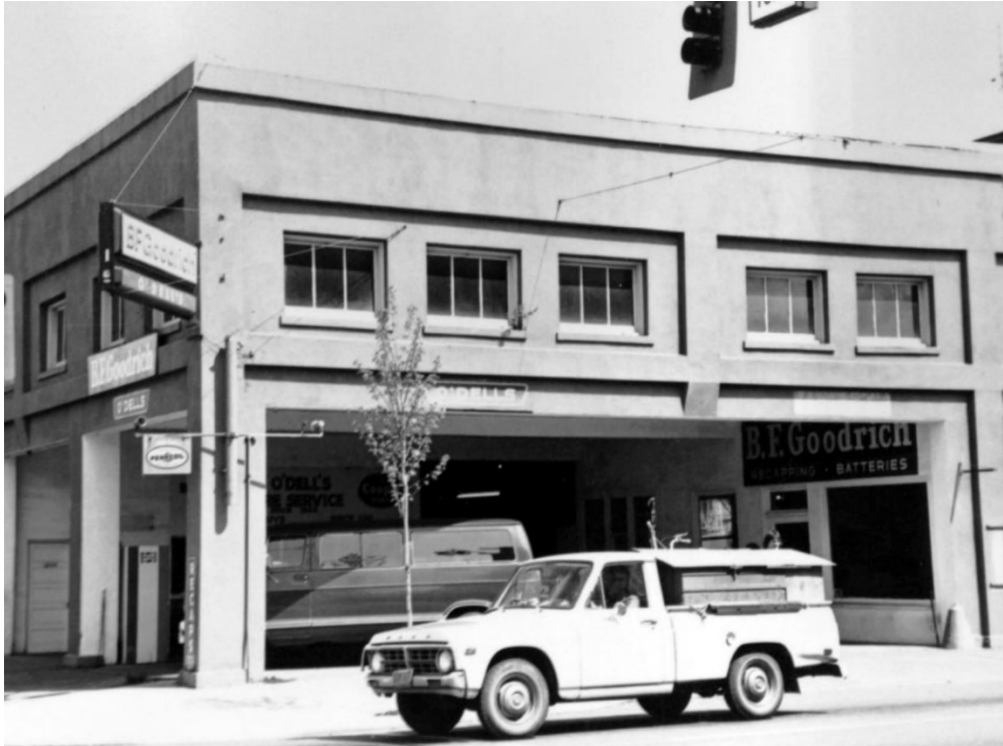
The building was covered in stucco sometime prior to this 1983 photograph (Historic Resources Survey, City of McMinnville, Yamhill County, Oregon).

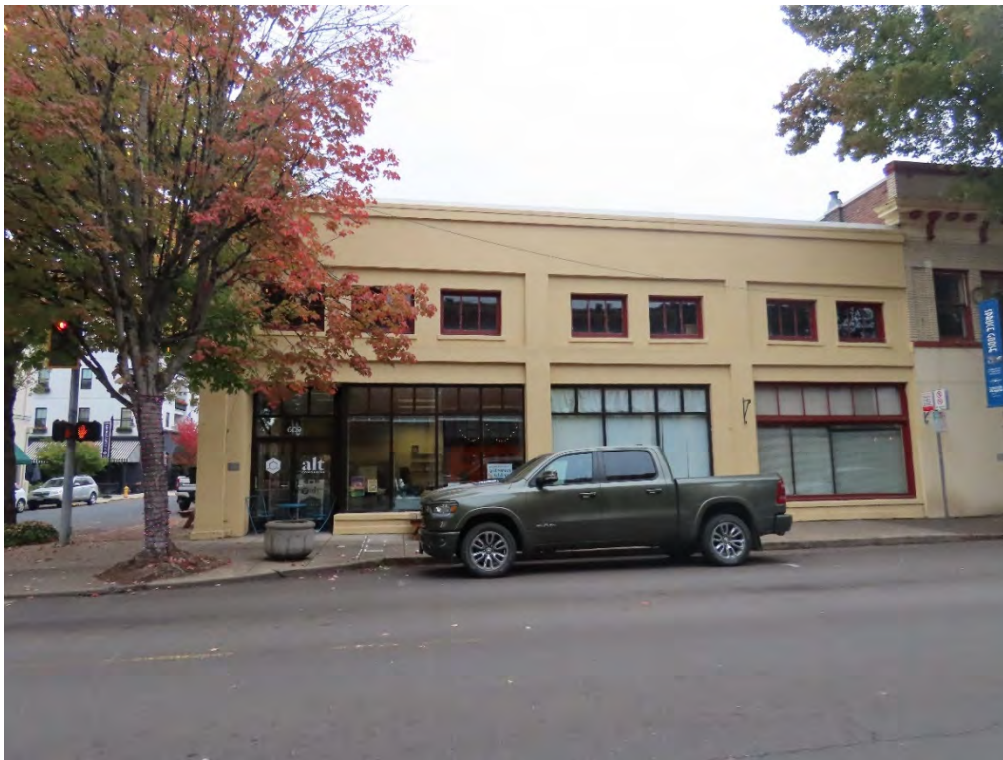
The left two bays of the ground floor have since been infilled with the current street-facing storefront (ARG, October 2022).

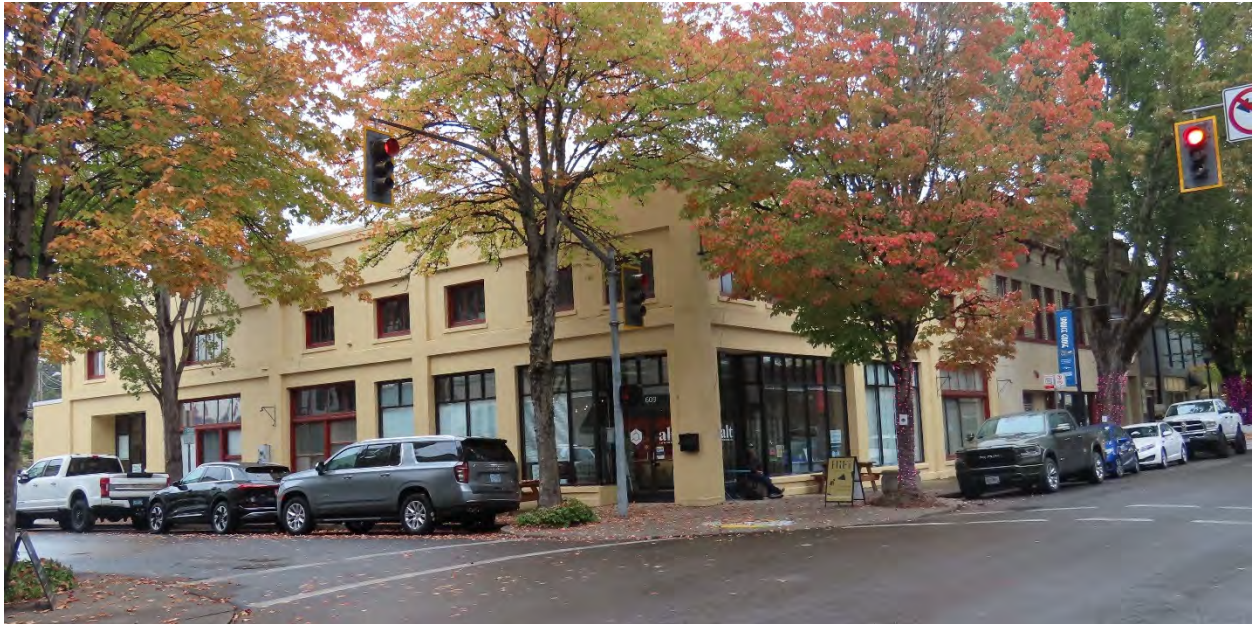
The bays at the corner of the ground floor have been infilled with the current street-facing storefront; three original storefront bays remain (ARG, October 2022).

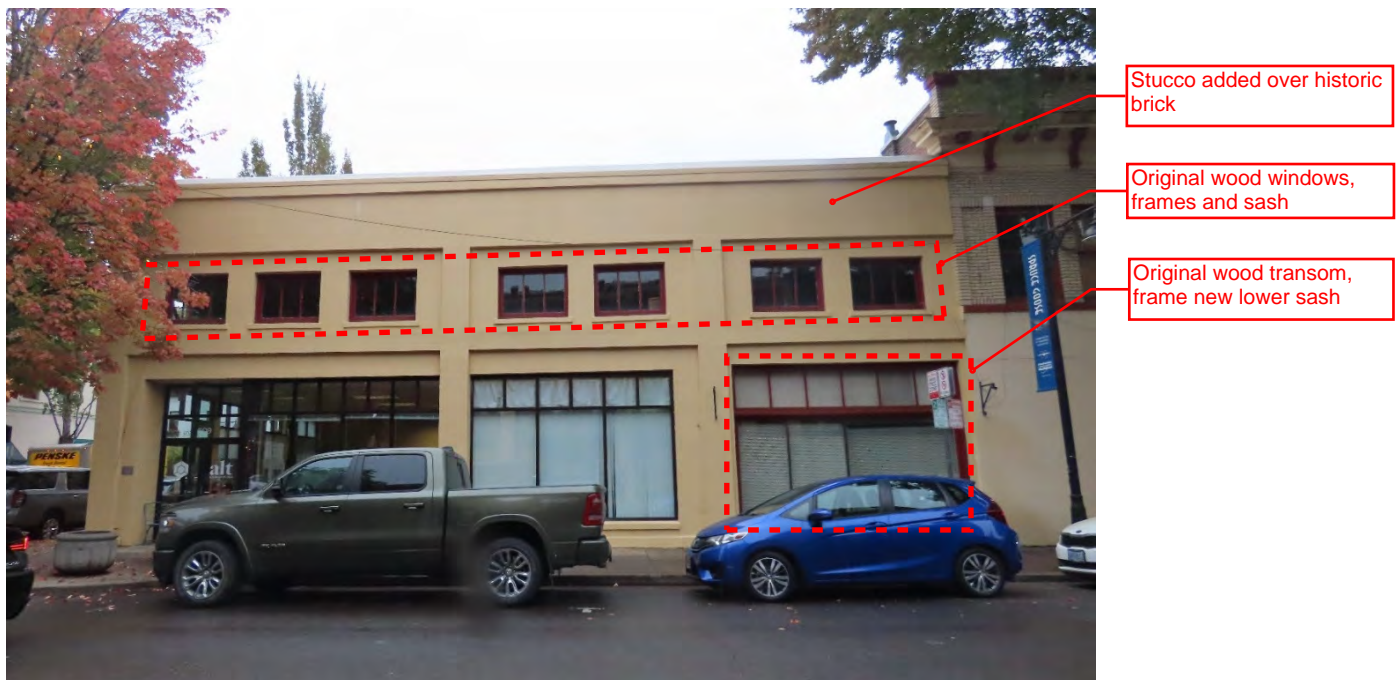
South Elevation facing NE Third Street, illustrating original features (ARG, October 2022).

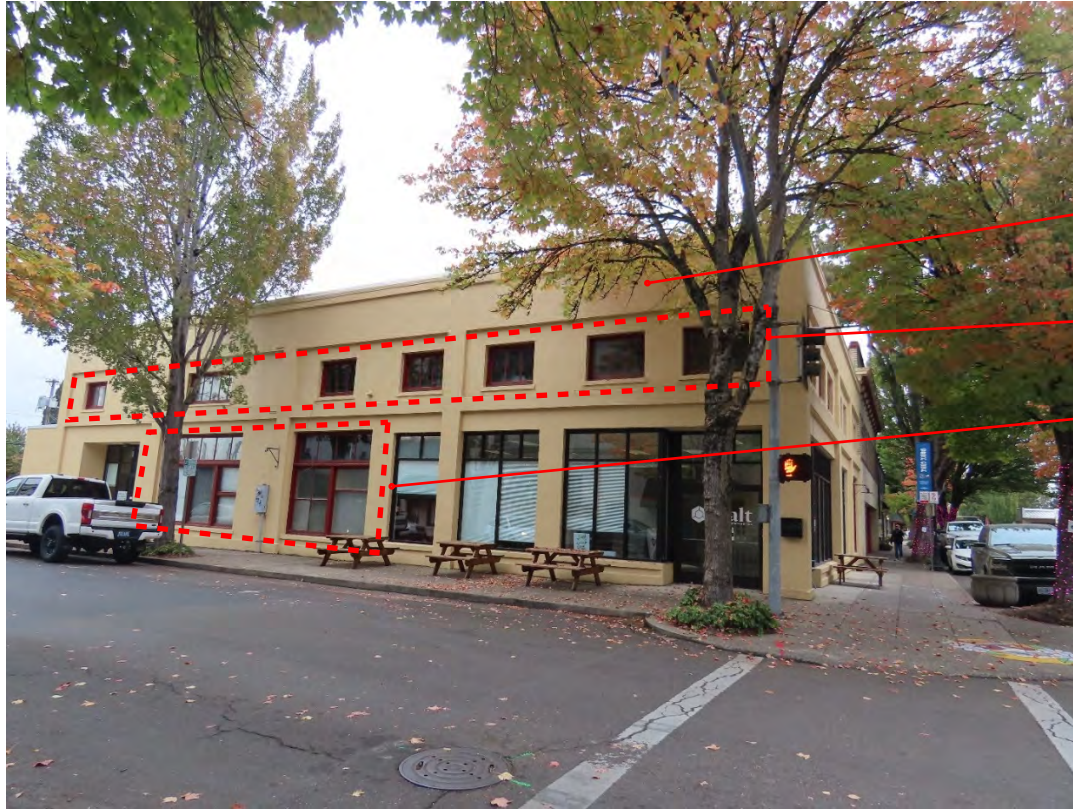
Stucco added over historic brick

Original wood windows, frames and sash

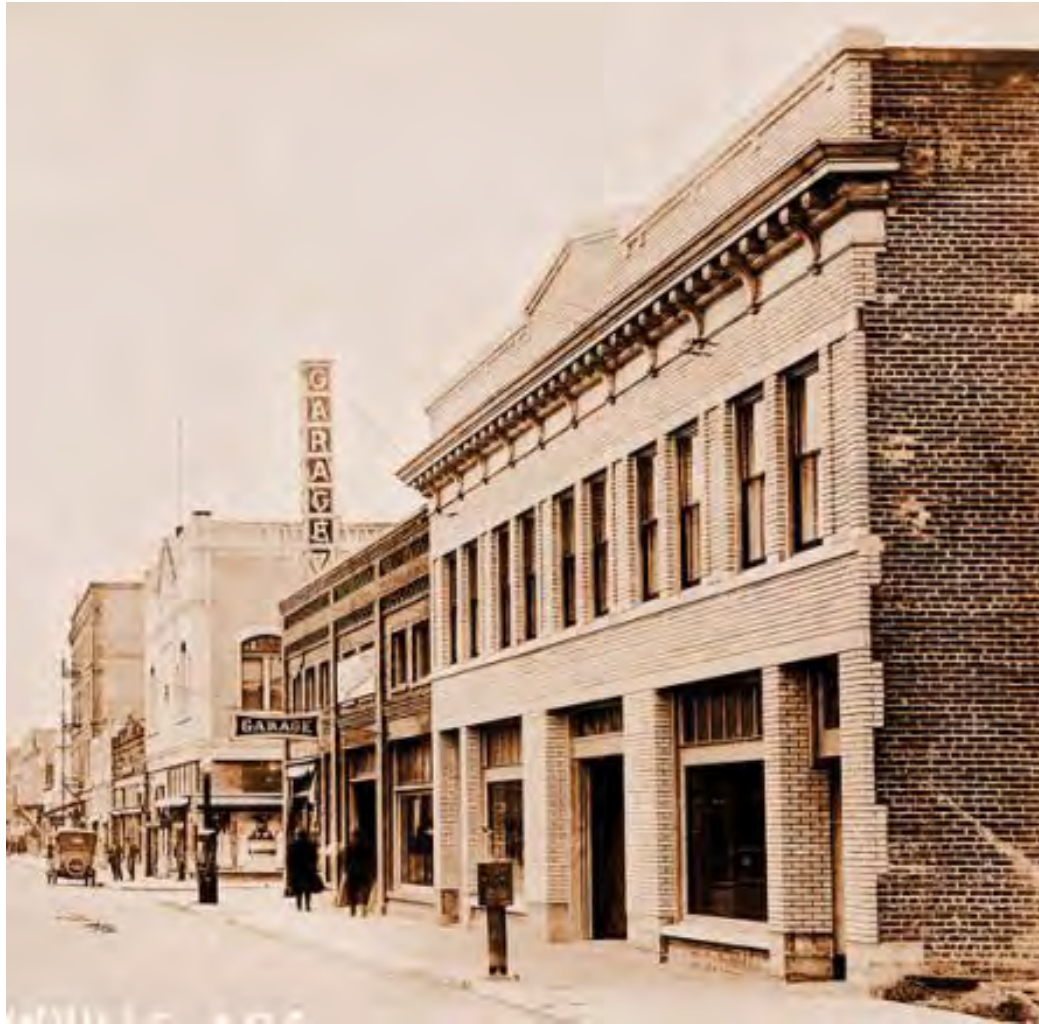
A 1919 photograph looking west along NE 3rd Street showing 611 NE 3rd Street soon after its construction (Yamhill County News-Register, collection of Michael Hafner).

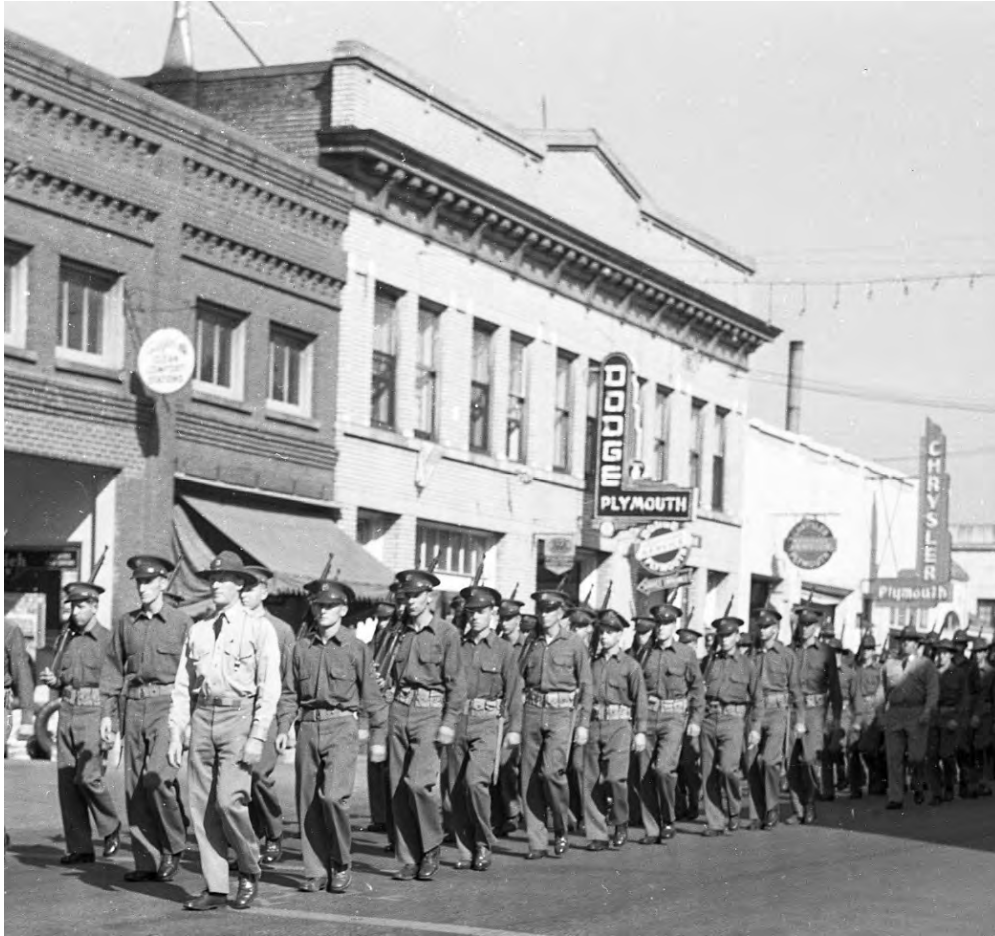
1940 view of 611 NE 3rd Street, looking east (Yamhill County News-Register).

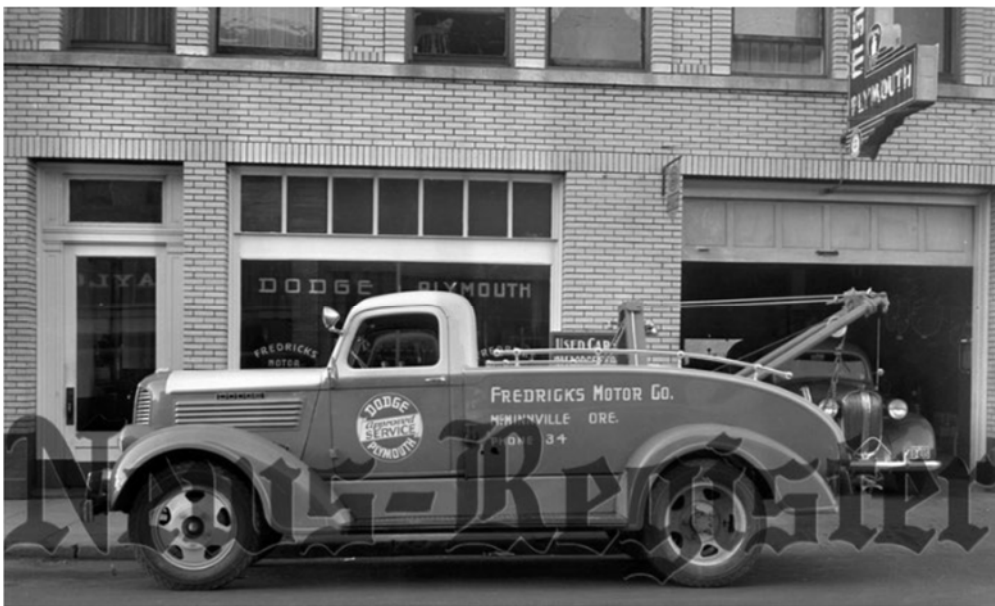
This 1948 photograph provides a more detailed view of the ground floor of 611 NE 3rd Street (Yamhill County News-Register).

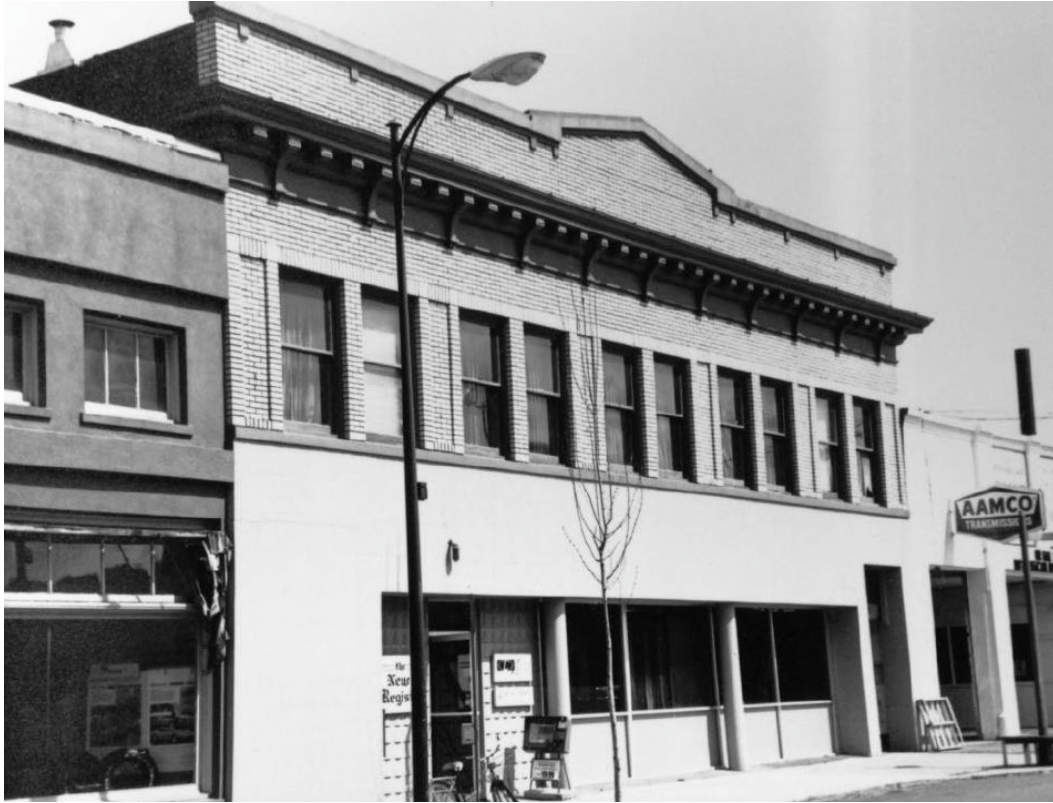
The ground floor of 611 NE 3rd Street was reconfigured prior to this 1983 historic survey photograph (Historic Resources Survey, City of McMinnville, Yamhill County, Oregon).

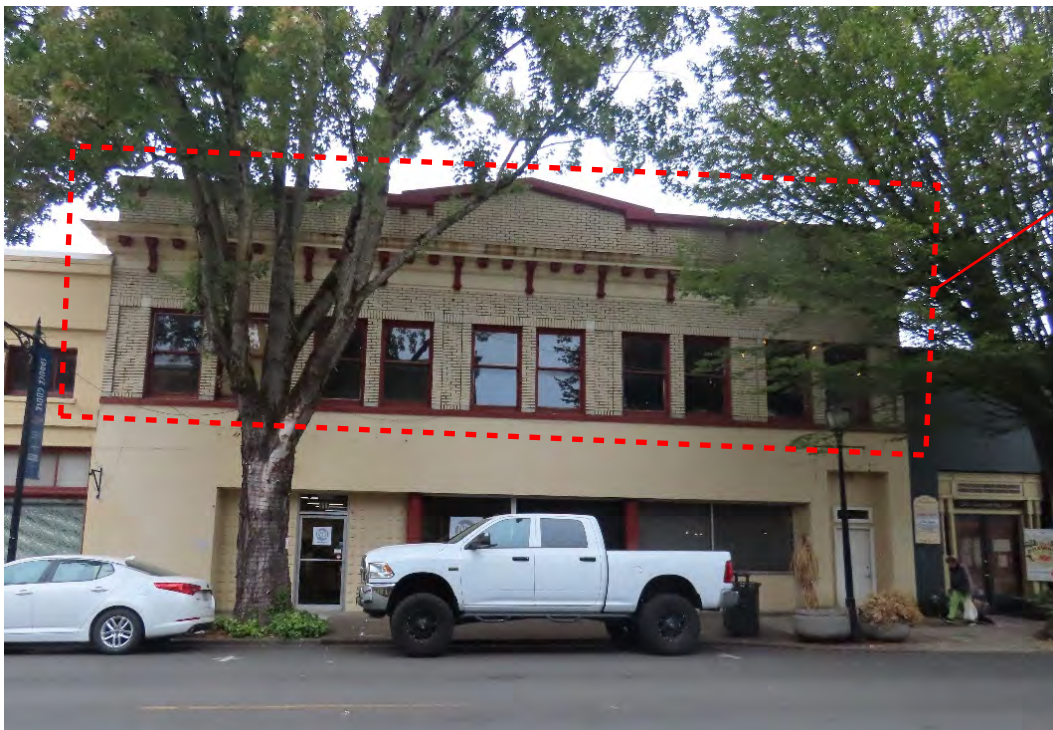
- Original wood windows, frames and sash
- Original brick and cast concrete elements
- Original pressed metal cornice

611 NE 3rd Street, current view (ARG, October 2022)

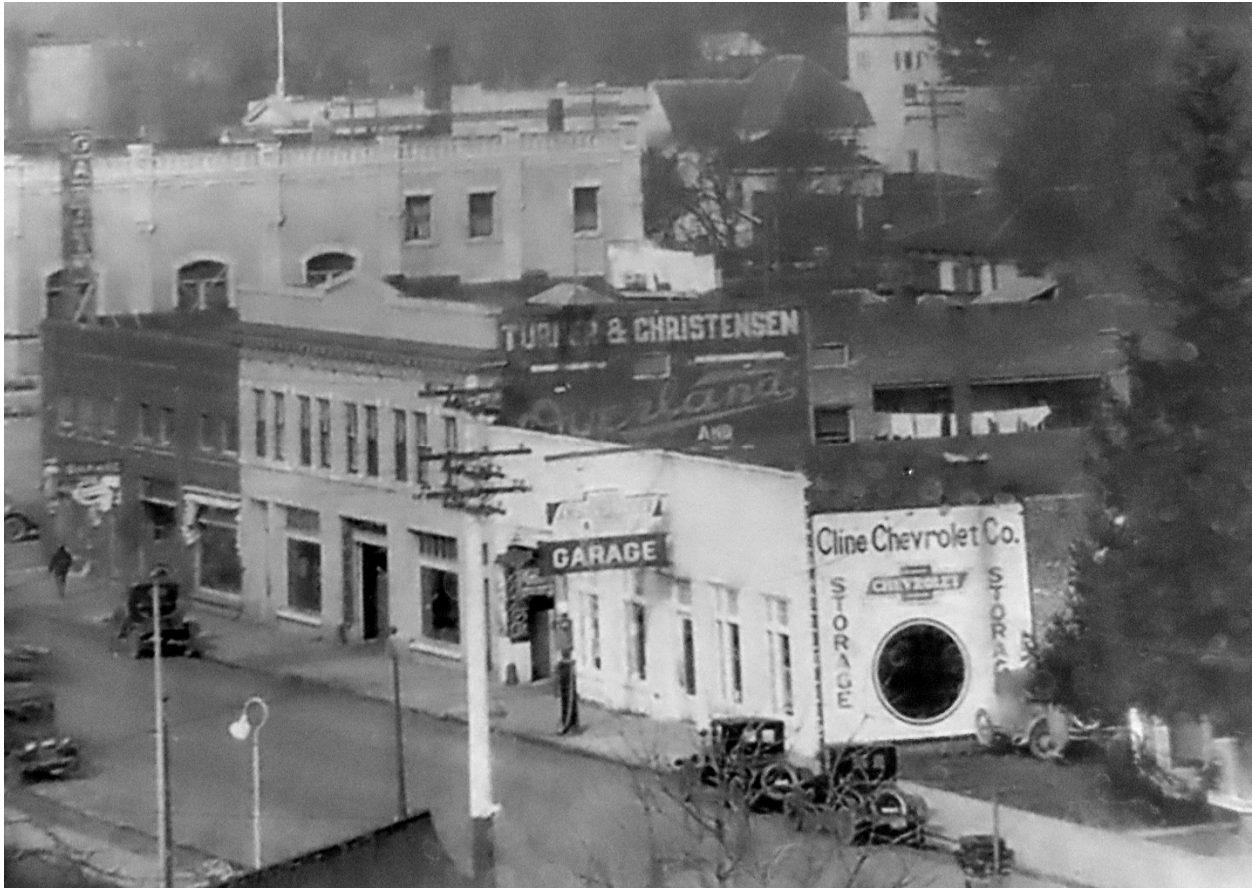
1927 photograph showing the original configuration of 619 NE 3rd Street (News-Register Publishing Co).

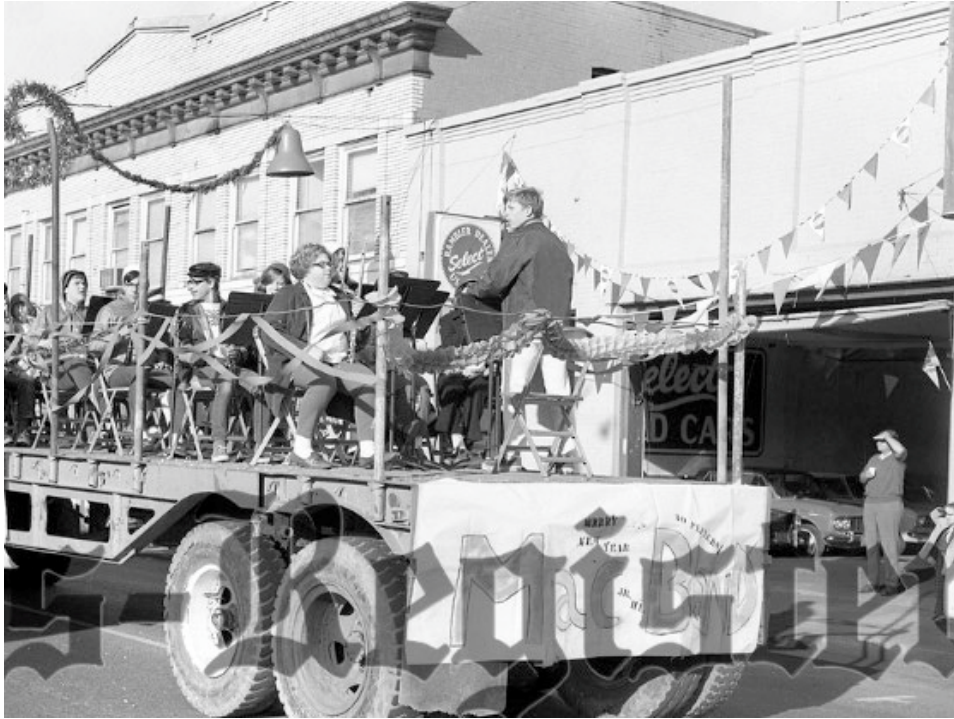
By the time of this 1969 photograph, the two windows immediately east of the original entry had been removed and converted to a double-wide wall opening (Yamhill County News-Register).

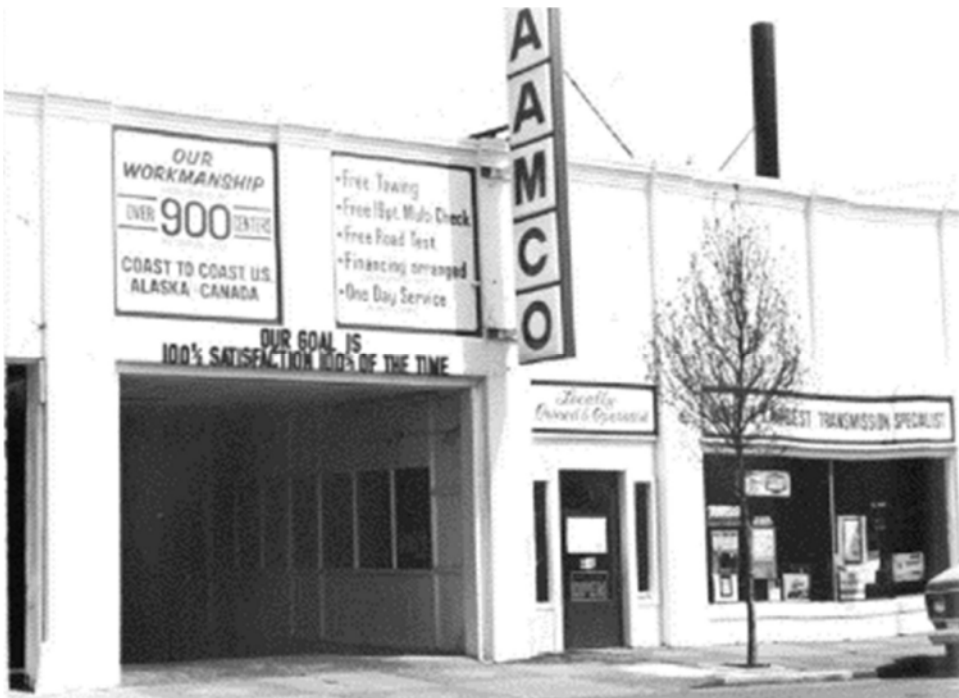
By the time of this 1983 historic survey photograph, the window to the east of the double-wide opening had been converted to an entry and the windows in the two easternmost bays had been replaced with a storefront window spanning both bays (Historic Resources Survey, City of McMinnville, Yamhill County, Oregon).

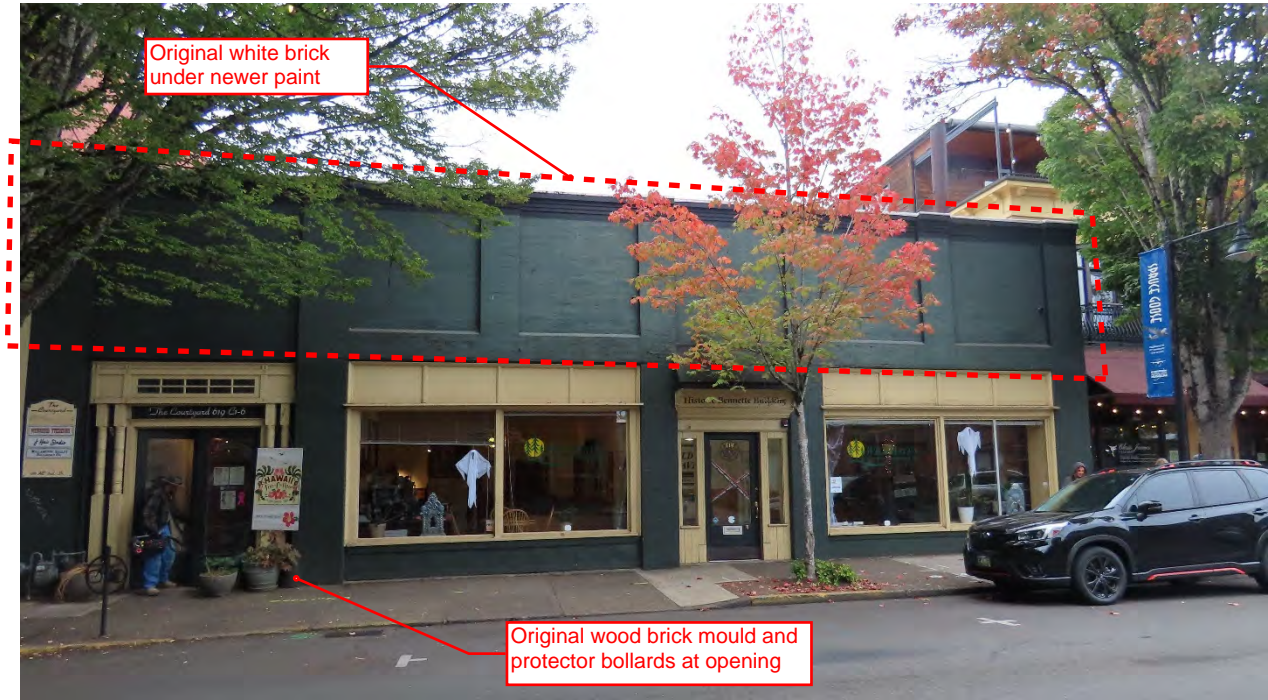
Current view of 619 NE 3rd Street (ARG, October 2022). Paired doors with wood trim elements have been inserted into the westernmost bay, while the formerly double-wide opening has been replaced with a storefront window matching the window in the easternmost bays.

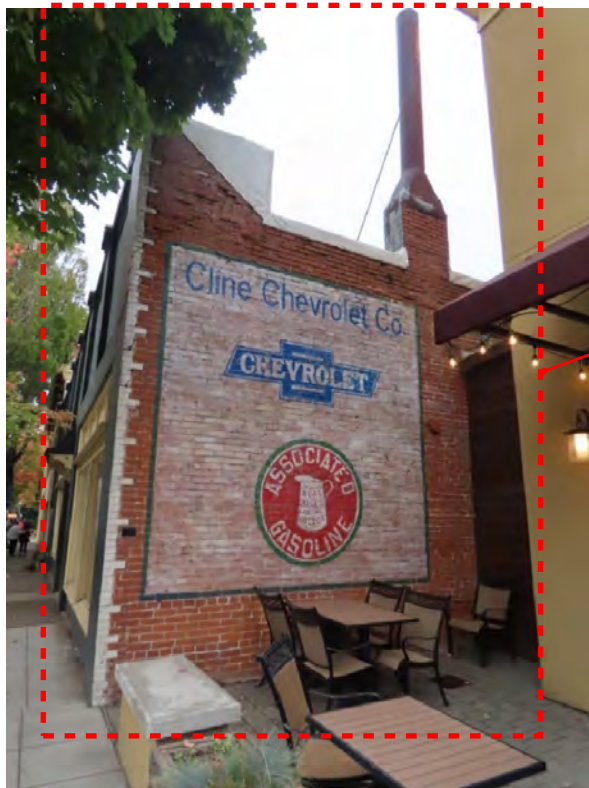
Original red brick east wall, white brick at south wall and metal flue. Original painted sign restored / recreated.

619 NE 3rd Street, Southwest corner, showing restored signage at east elevation (ARG, October 2022).

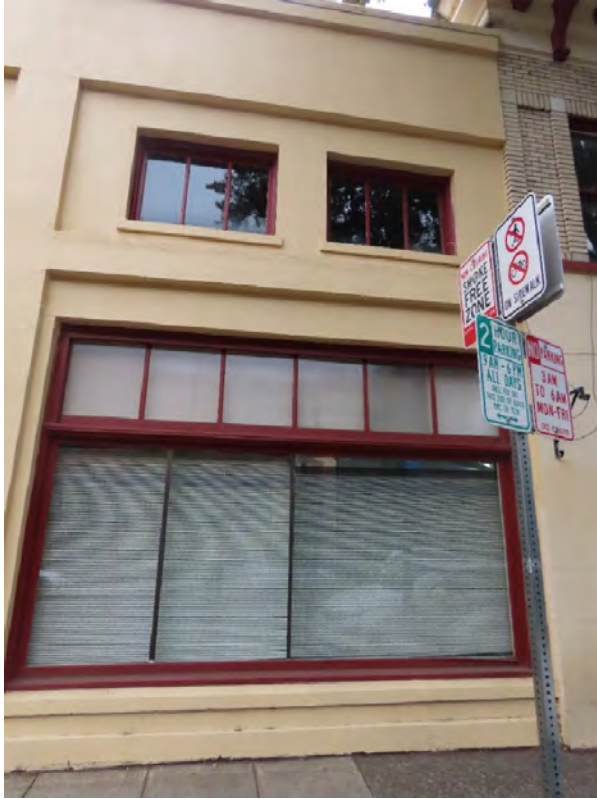
Photo 1. NE 3rd Street elevation: Original wood storefront window and transom, and second-floor windows; storefront has been modified with addition of metal mullions (ARG, October 2022).

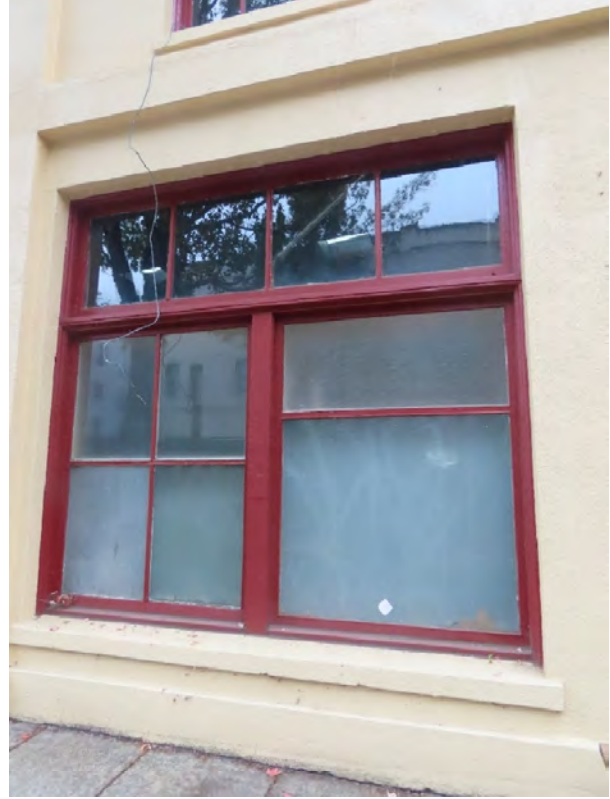
Photo 2. NE Ford Street elevation: Original wood storefront window and transom; mis-matching translucent glass types. Storefront muntins may have been reconfigured (ARG, October 2022).

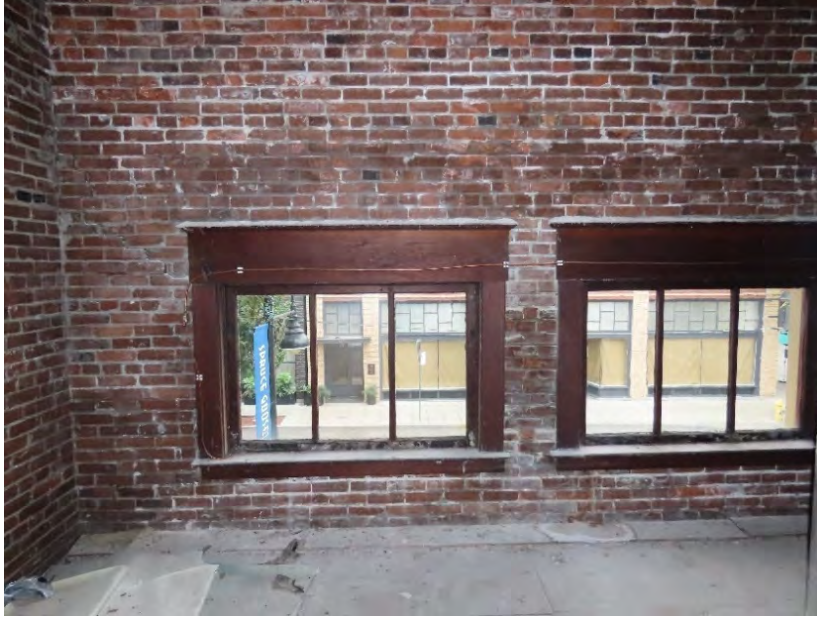
Photo 3. Second floor window, interior view, showing original millwork surrounds (ARG, October 2022).

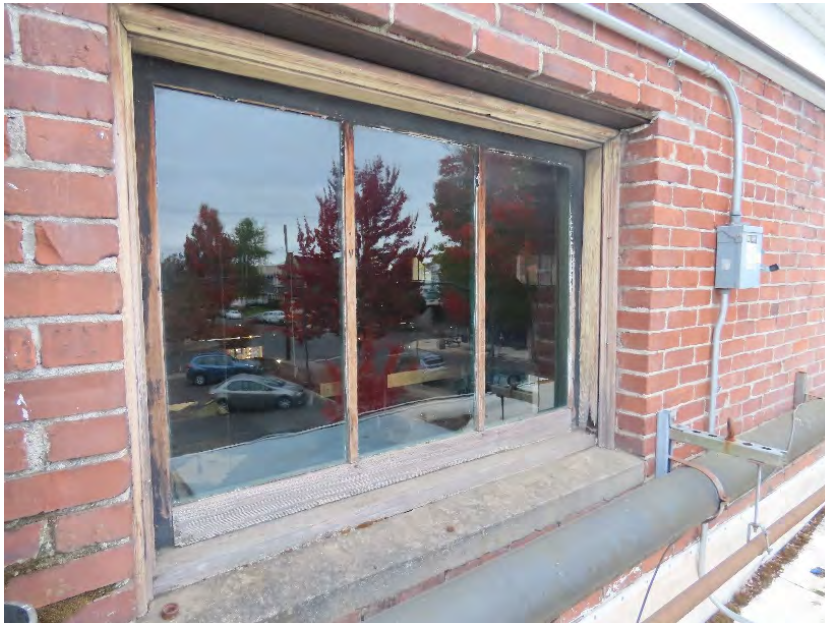
- The three original wood storefront windows and transoms, and south, west, and north elevation second-floor windows, are in fair to good condition. Paint failure and putty bead deterioration and loss are typical, and windows need to be repaired. Translucent glass types are mismatched at the original west elevation storefront windows. The second-floor windows at the north elevation were observed from the north roof setback, and are in relatively good condition, considering almost complete loss of paint and putty due to deferred maintenance. Wood rot was observed at the exterior jamb at one of these locations, which would require wood infill (dutchman) repair.

Photo 4. Second floor window, north (rear) elevation, with nearly complete loss of paint, and putty bead loss. Note wood deterioration at right lower jamb (ARG, October 2022).

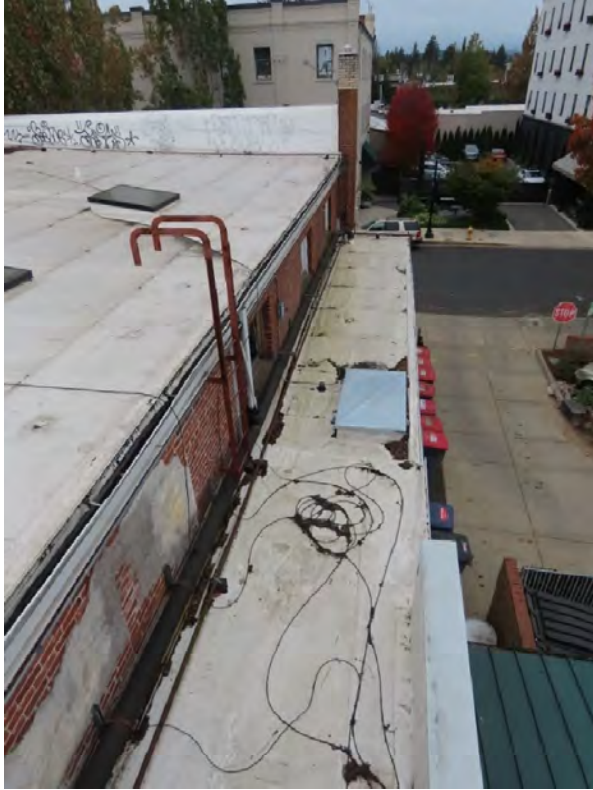
- The original roof configuration remains. The current roofing system appears to have been installed relatively recently. A sign at the roof of 611 NE 3rd Street indicates the roofing is a Duro-Last Roof. Roofing replacement at all three buildings appears to have been done at roughly the same time, with the same roofing system. Roofing appears to be in good condition generally, and keeping water out of the building, although details that wrap surfaces such as parapets and copings are atypical and do not allow assessment of the substrate. Damaged plaster and areas of water infiltration are visible at the south end second-floor interior, but it is unknown if water infiltration is active or if it pre-dates the roofing replacement. The roof surface drains to a gutter at the rear of the building, with an external leader emptying to a surface mounted drainage line below.

Photo 5. Replacement roofing; main roof at left, one-story north bay at right (ARG, October 2022).

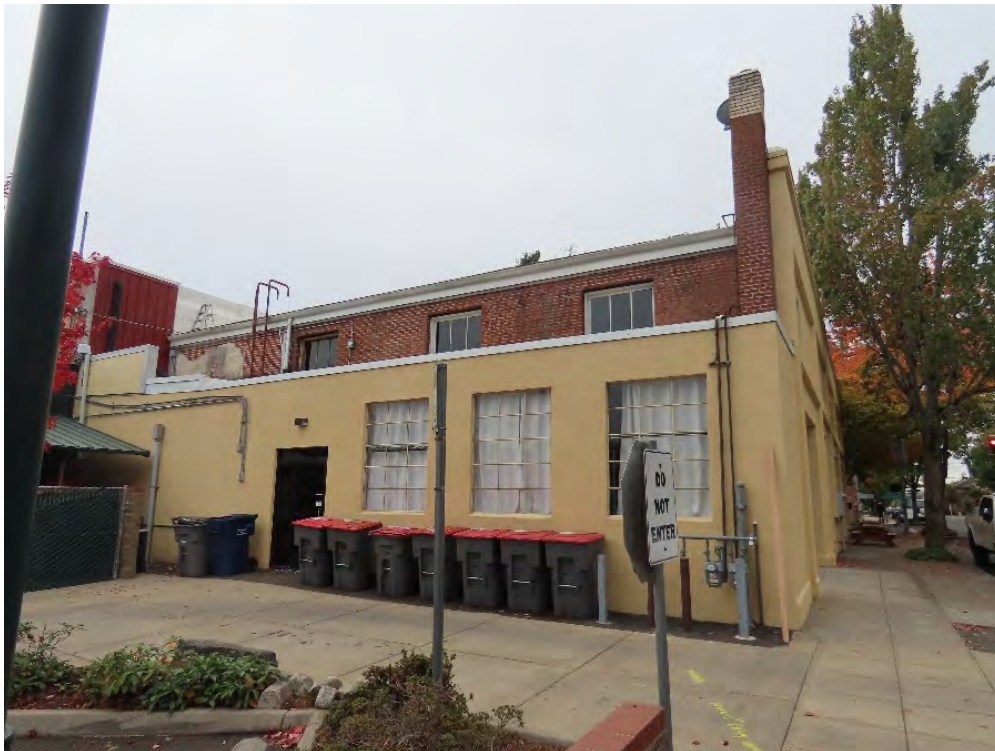
Photo 6. One-story north bay, rear elevation, showing original second floor windows, And steel windows at ground floor (ARG, October 2022).

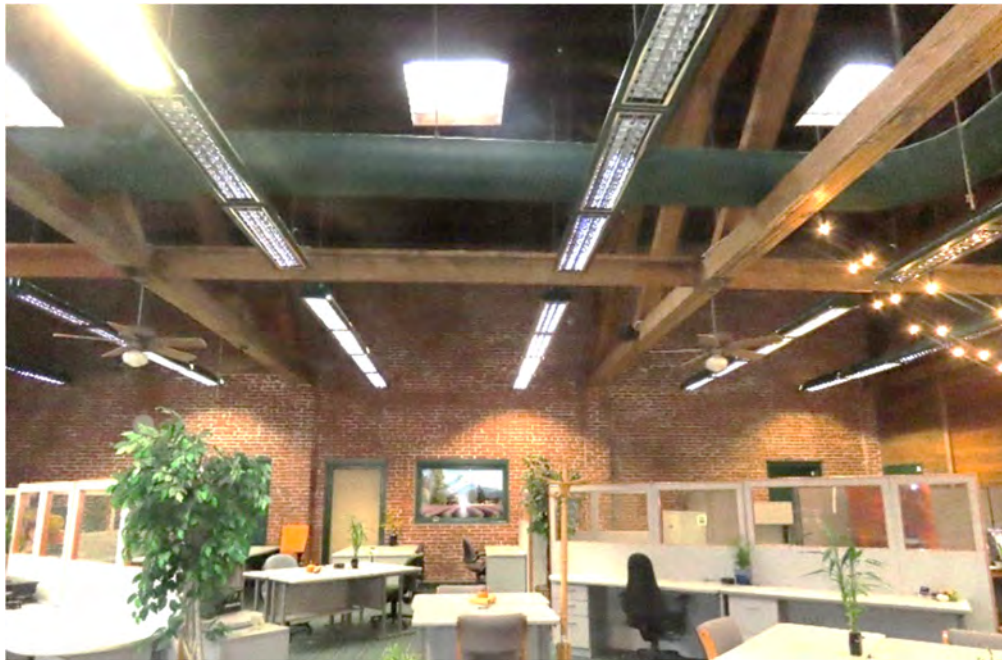
- Original wood trusses at the interior appear to be in good condition, and convey the original use of the building, the large spans permitting a large open floor plan at the ground floor.

Photo 7. Wood trusses at interior (ARG, October 2022).

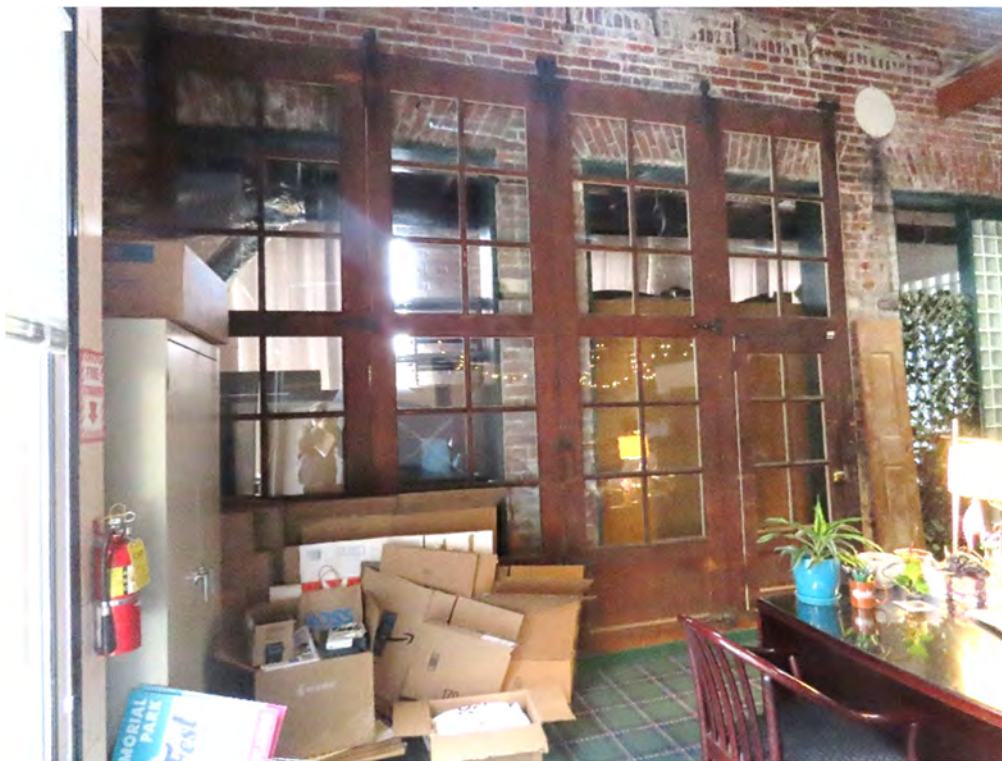
Photo 8. Wood door at NW corner interior, possibly relocated from an original storefront (ARG, October 2022).

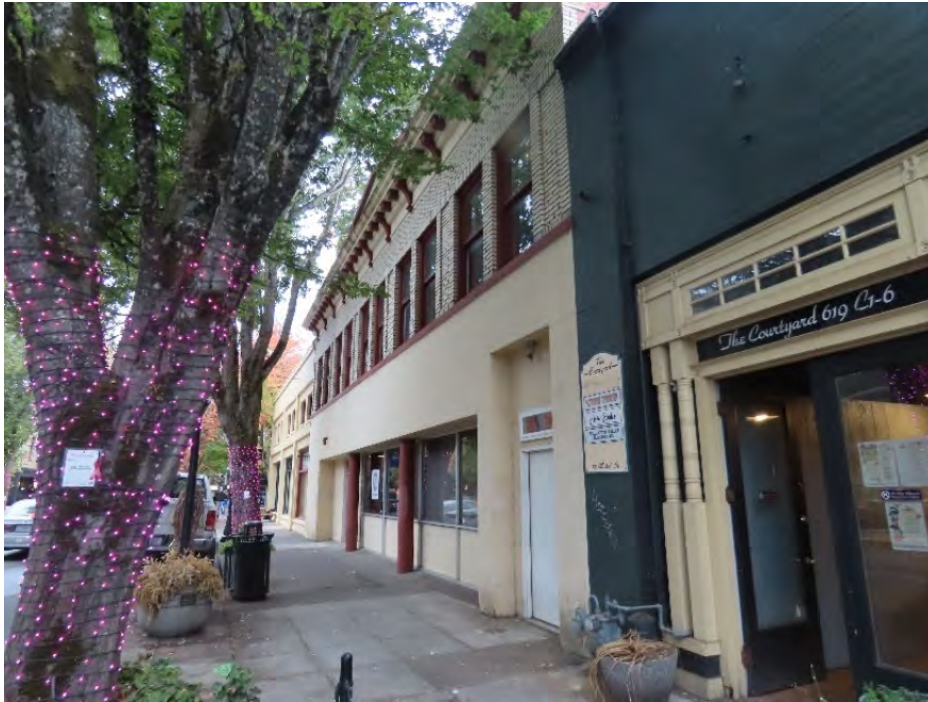
Photo 9. Overall view of south elevation, showing modified ground floor and original second floor (ARG, October 2022).

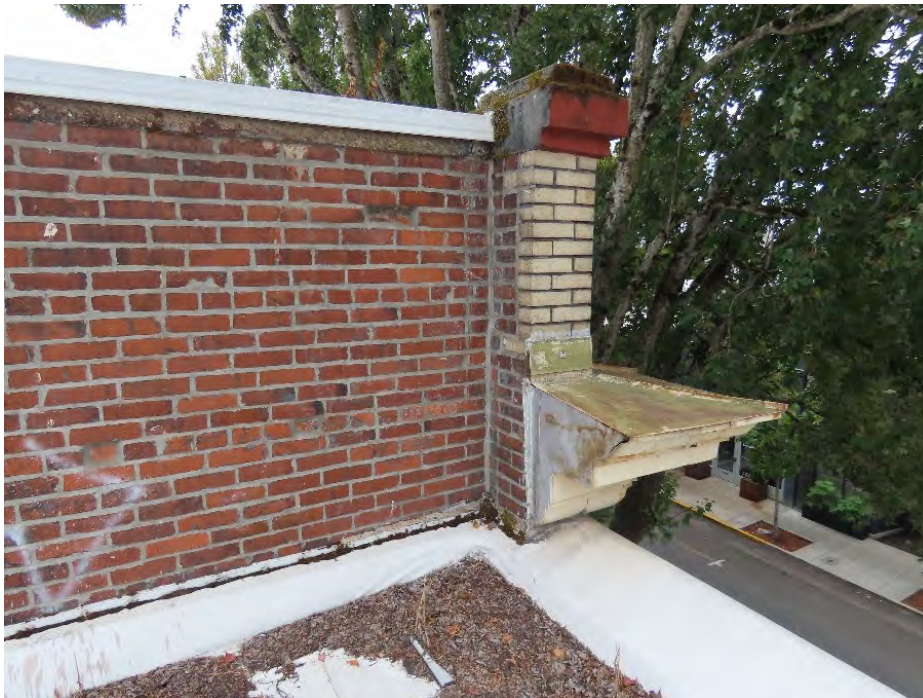
Photo 10. Parapet and top of metal entablature exhibiting minor corrosion (ARG, October 2022).

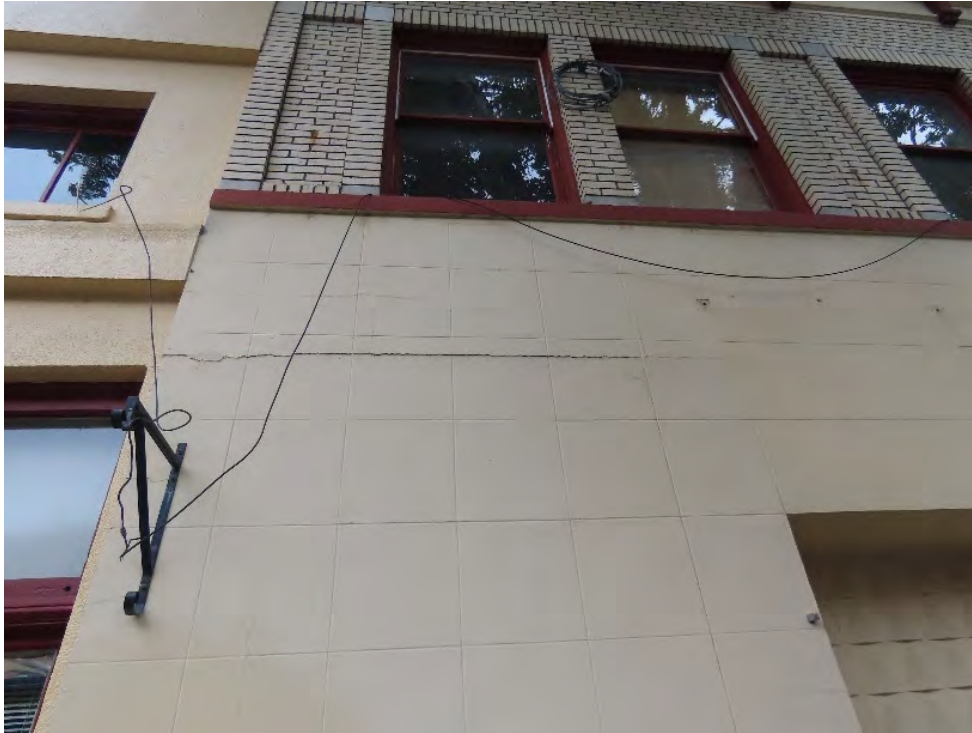
Photo 11. South elevation, crack at non-original stucco, original windows and masonry at second floor (ARG, October 2022).
