Architectural
Resources Group

609, 611, and 619 NE 3rd Street
McMinnville, Oregon

Historic Resource Assessment
November 2022

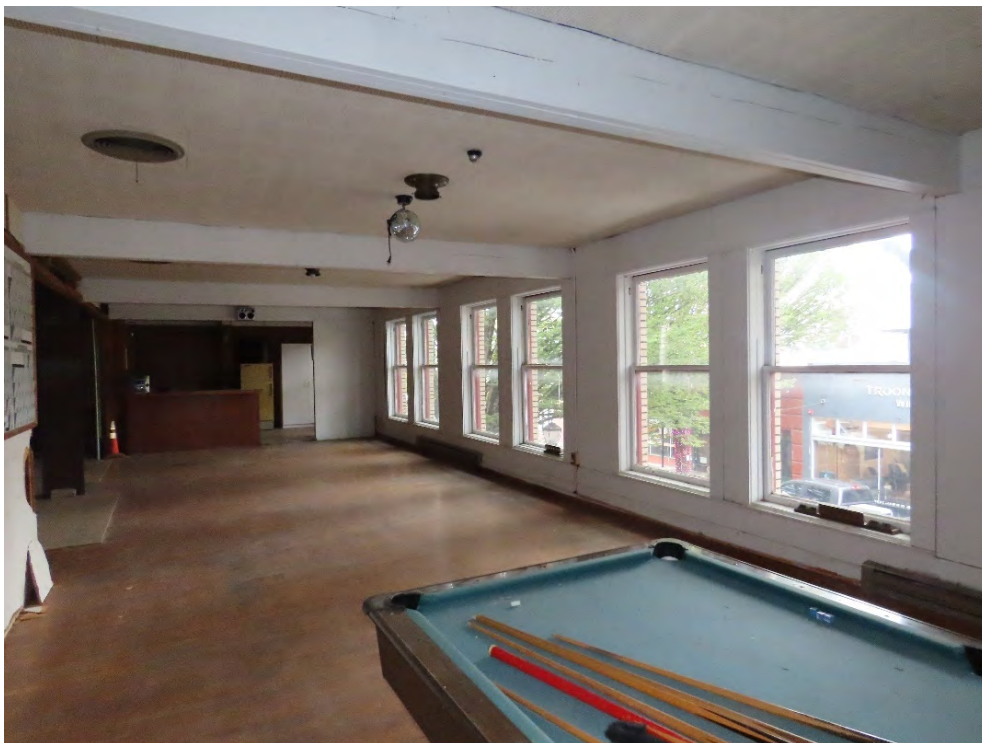
Photo 12. Second floor interior view of original wood windows (ARG, October 2022).

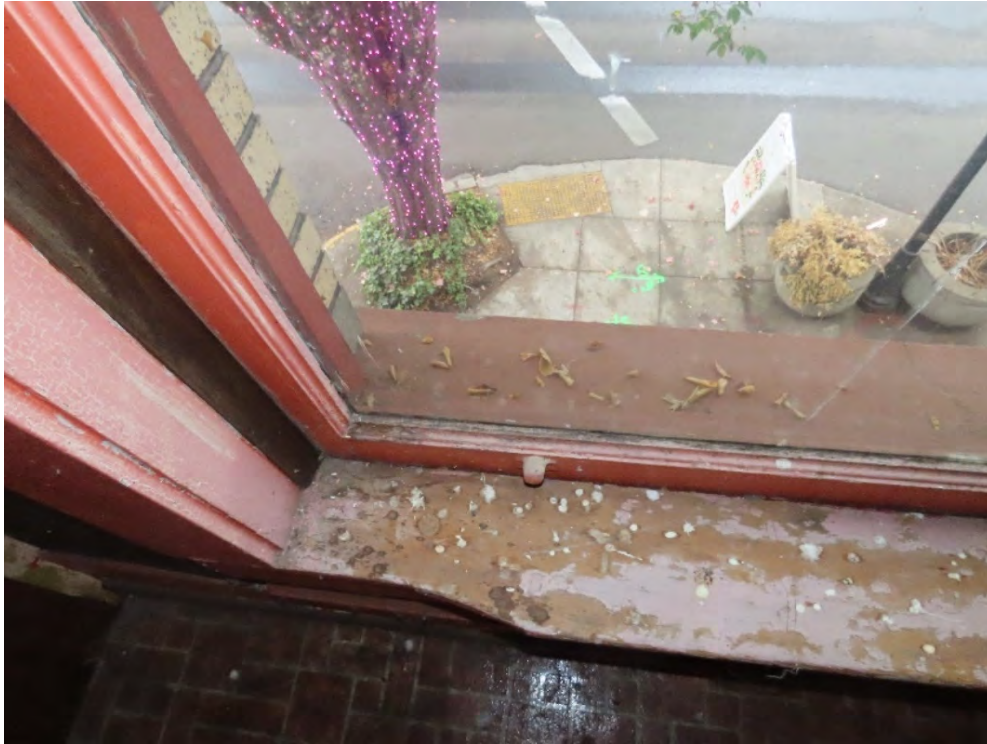
Photo 13. Detail, original second floor window (ARG, October 2022).

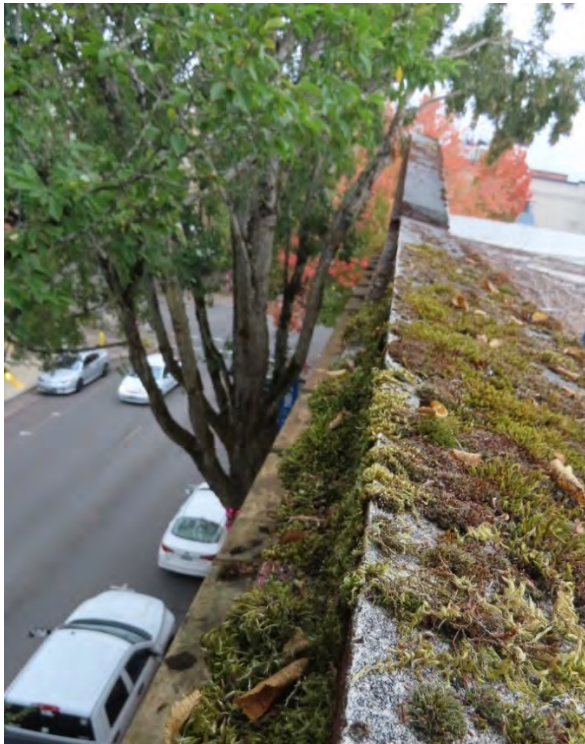
Photo 14. Top of coping with significant biological growth (ARG, October 2022).

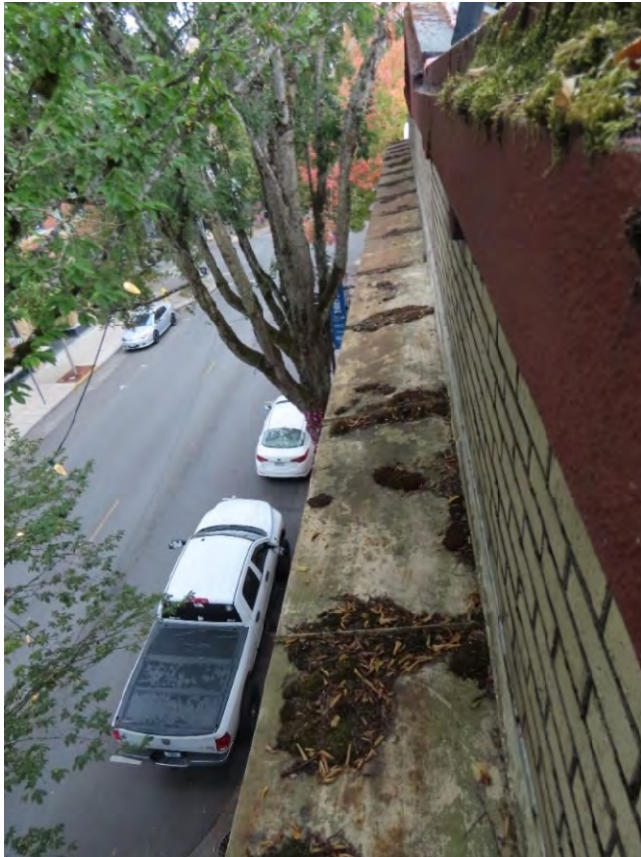
Photo 15. Top of cornice, with areas of biological growth (ARG, October 2022).

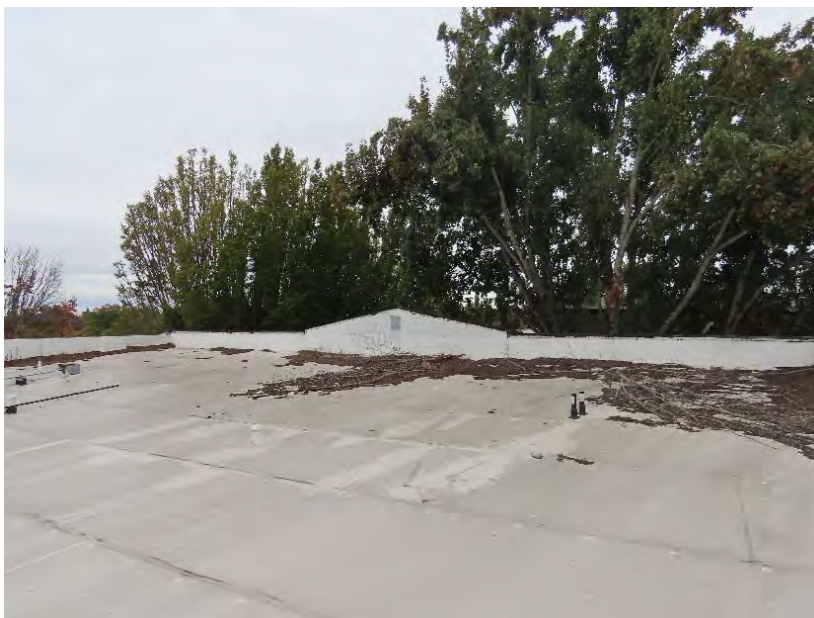
Photo 16. Roof looking south (ARG, October 2022).

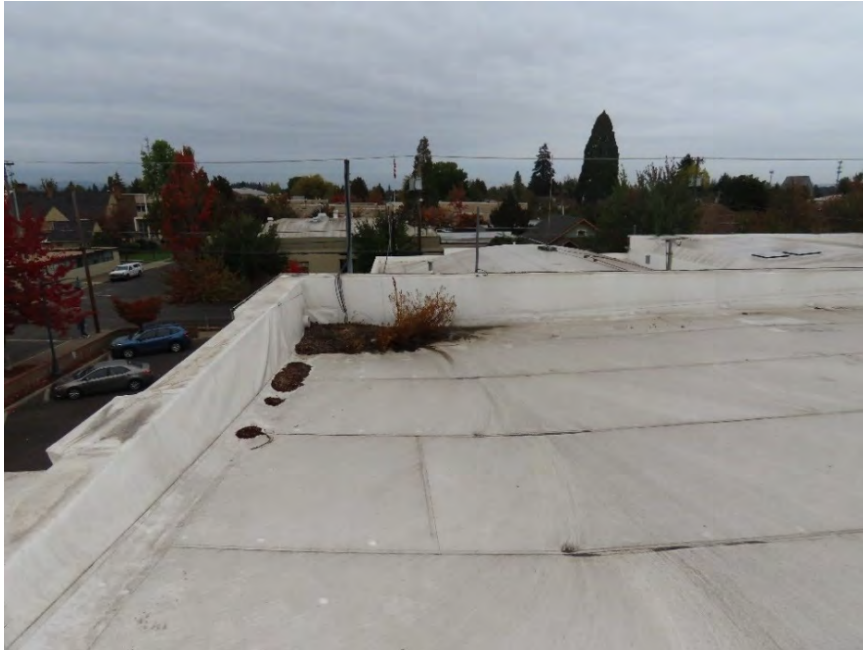
Photo 17. Roof looking north; note debris at location of roof drain (ARG, October 2022).

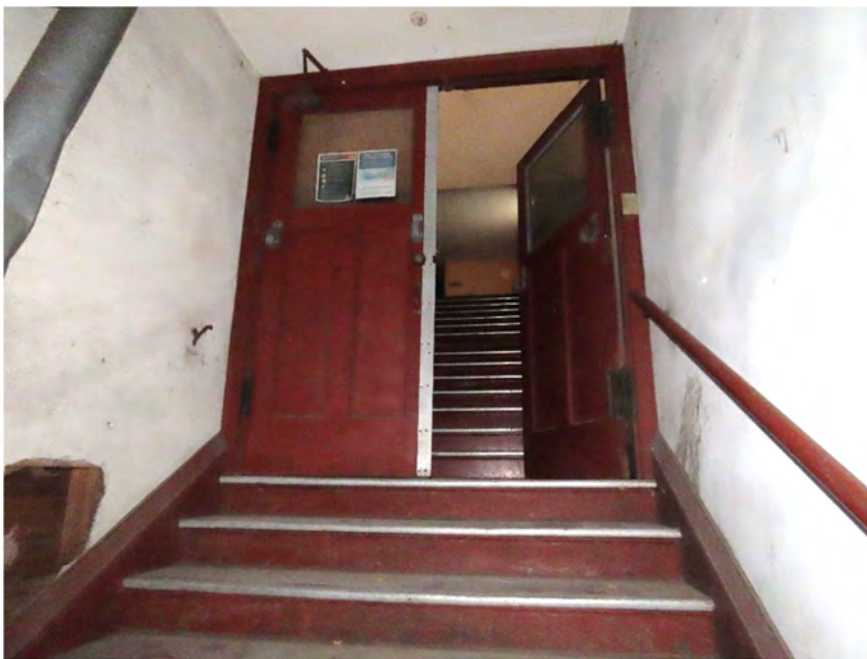
Photo 18. Original pair of doors at SE stair to second floor (ARG, October 2022).

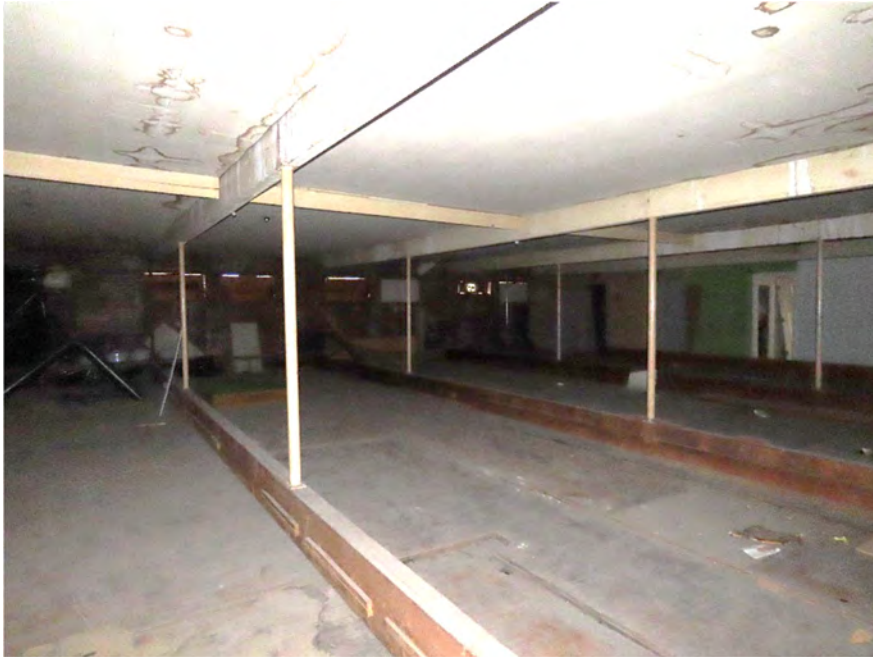
Photo 19. Round pipe columns at second floor with areas of removed partitions (ARG, October 2022).

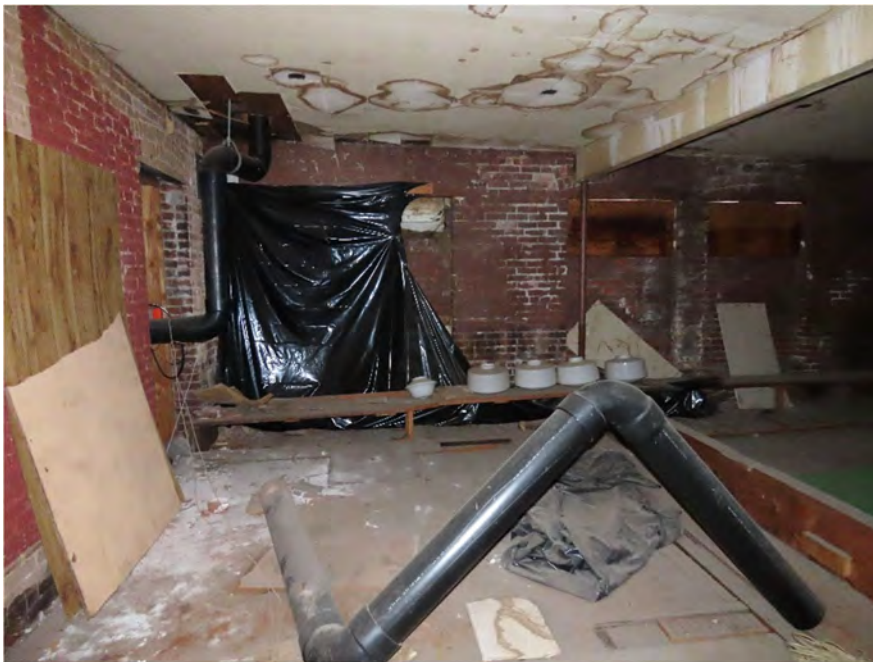
Photo 20. Second floor north wall with removed windows, damaged finishes below clogged drain (ARG, October 2022).

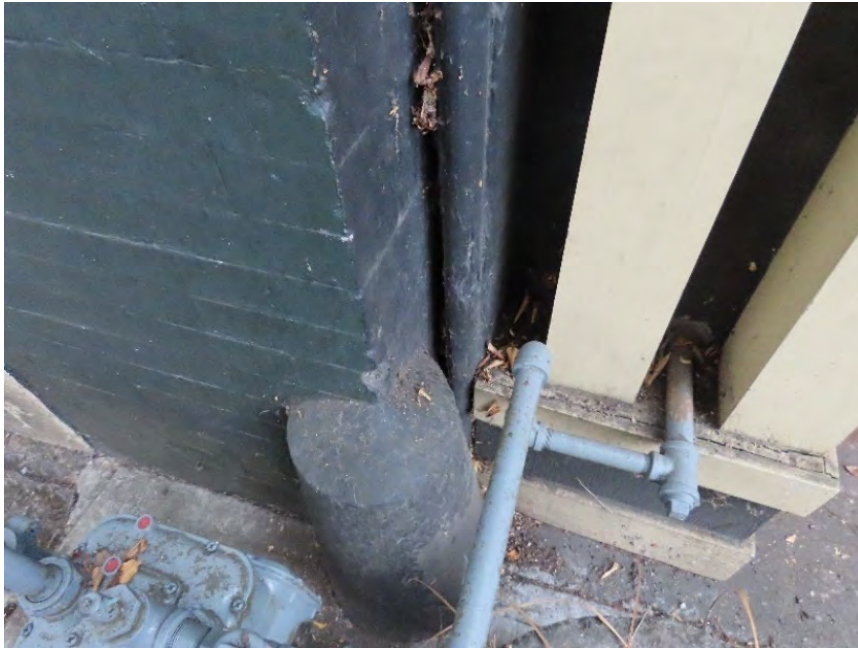
Photo 21. Original brick mould and bollard protector at westernmost opening (ARG, October 2022).

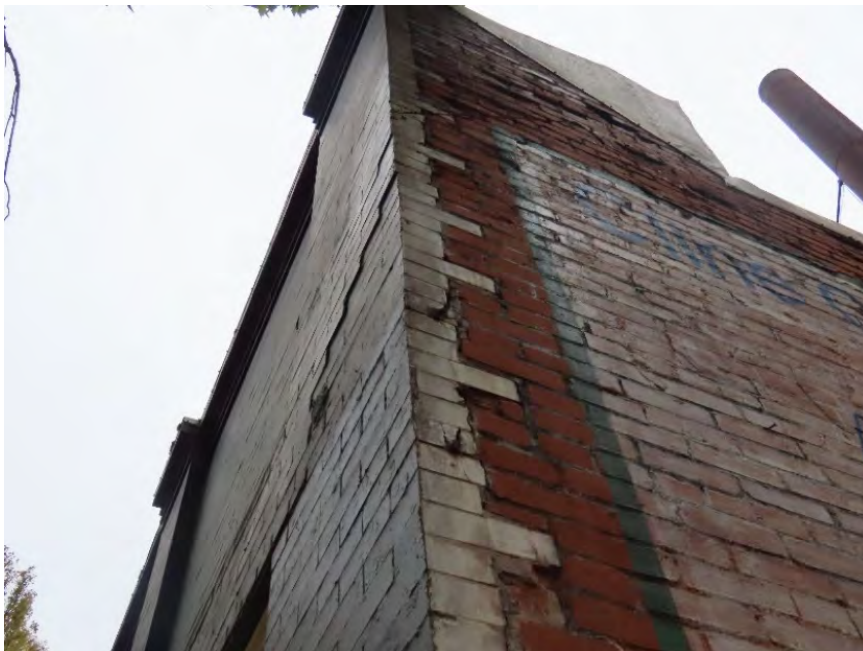
Photo 22. Southwest corner, note cracking and outward masonry displacement at attic story (ARG, October 2022).

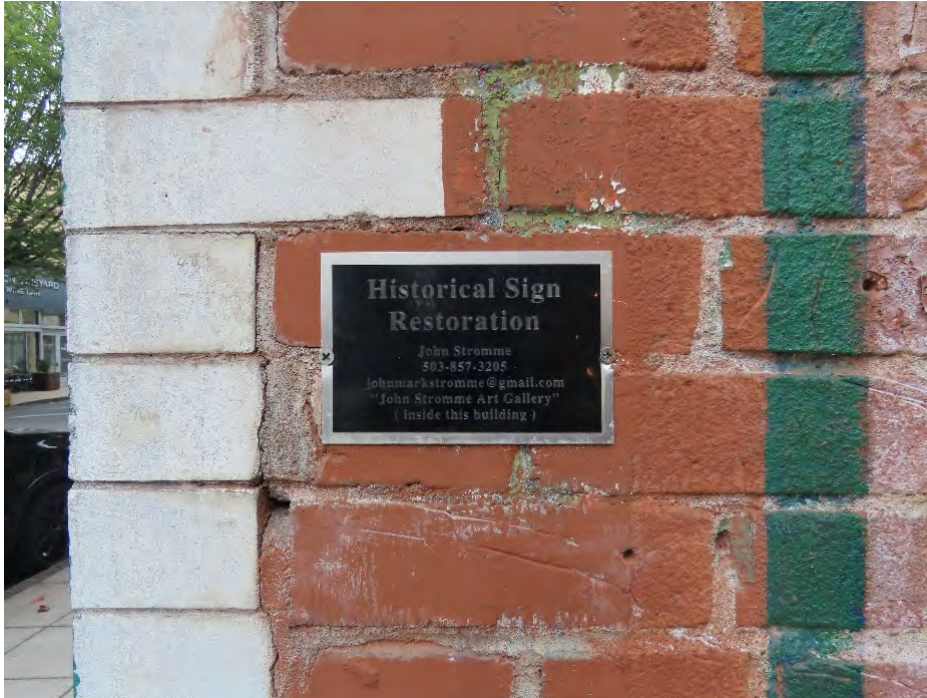
Photo 23. East elevation detail at southeast corner, unpainted white face brick at left (ARG, October 2022).

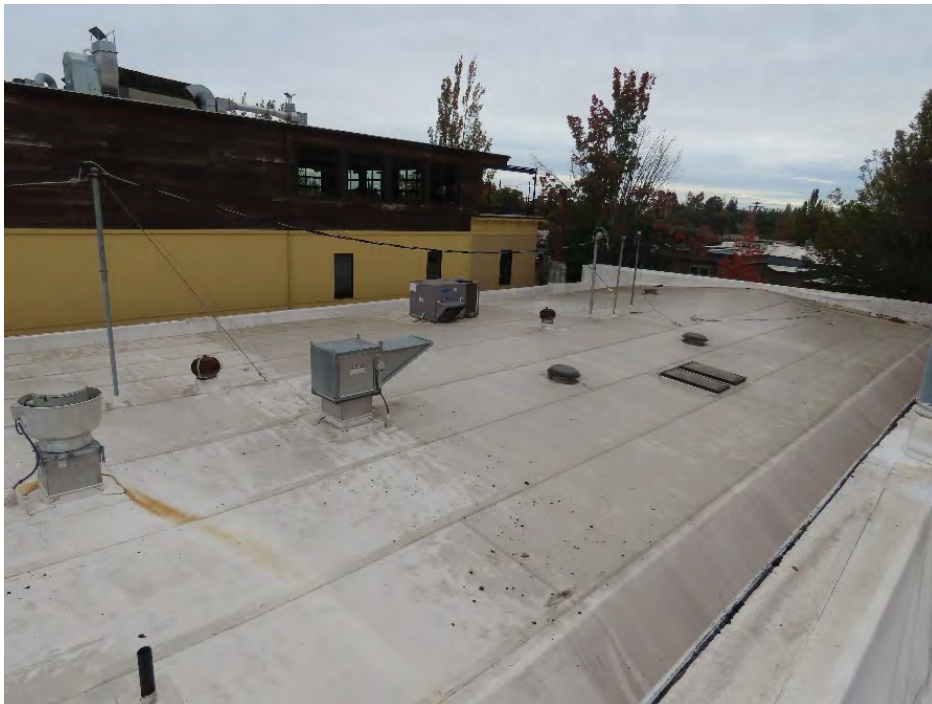
Photo 24. Roof overall view looking south (ARG, October 2022).

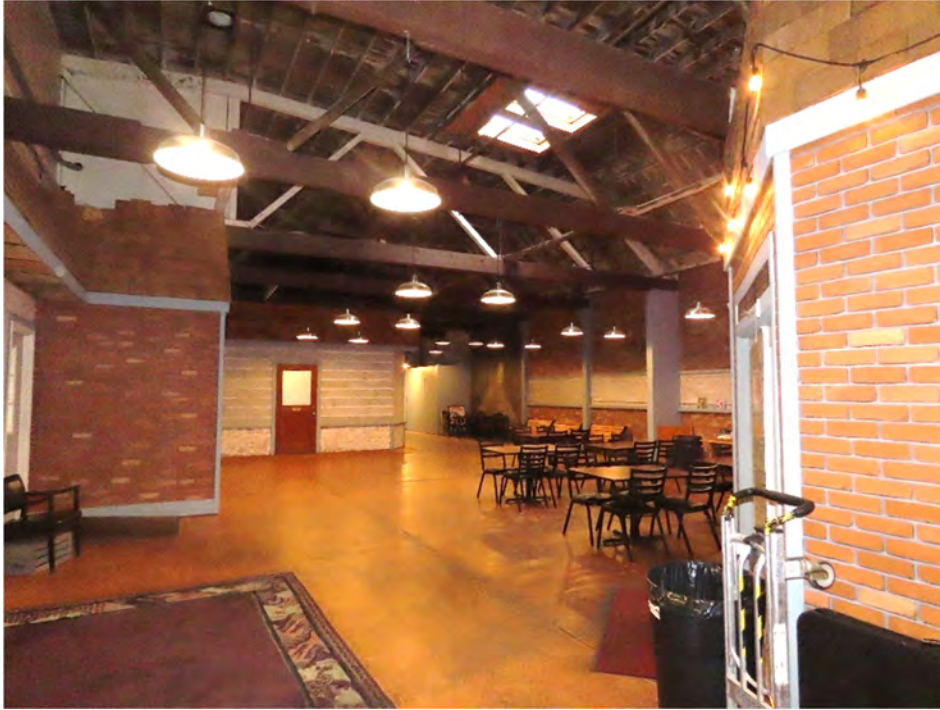
Photo 25. Interior view with wood trusses above (ARG, October 2022).

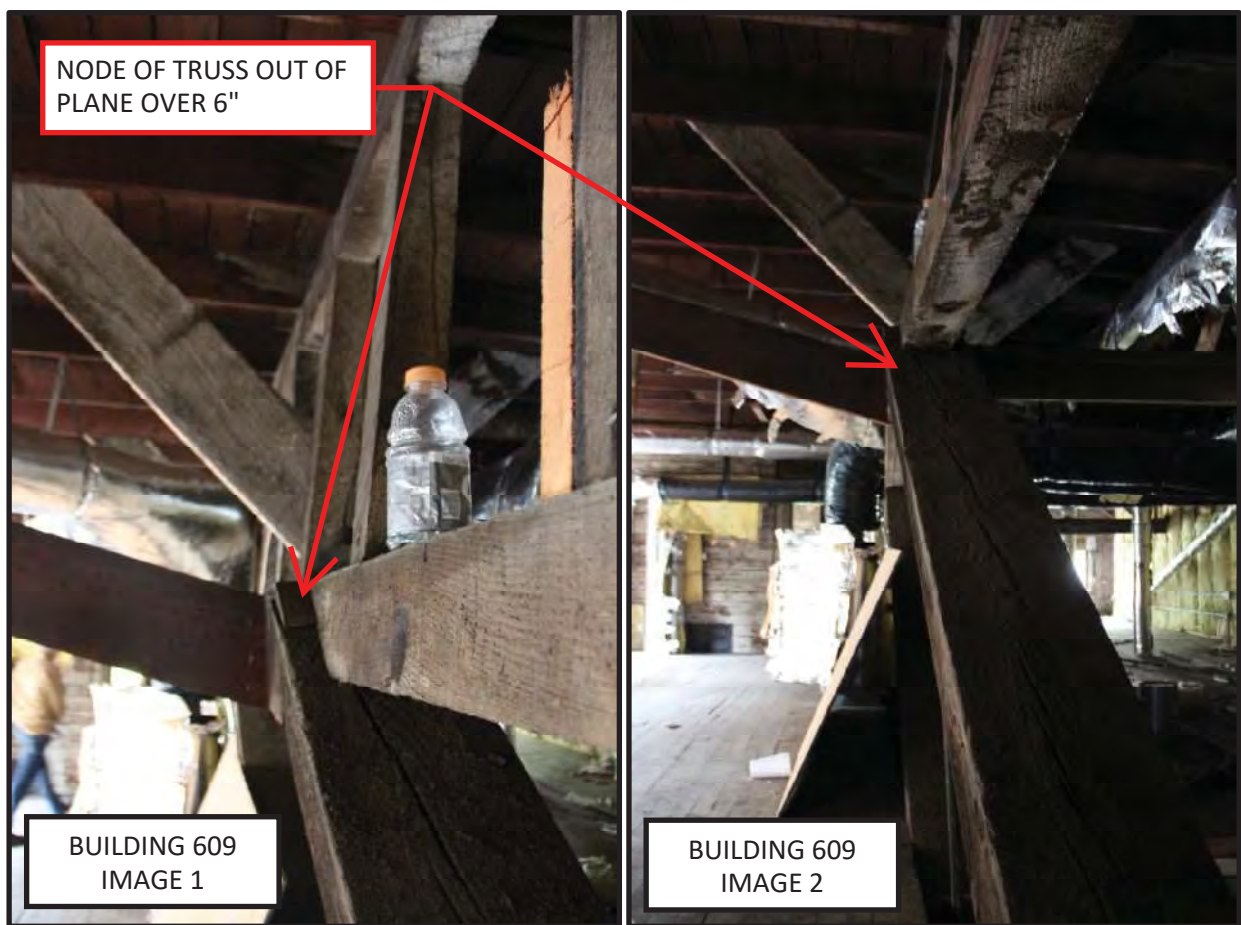
- The emergent concerns specifically noted in the original report are:
 - ✓ Building 609 – The most southern roof truss in the building has a top chord node that is out of plane by over 6 inches. This represents a significant structural concern and should be evaluated further with possible remedial actions should the building remain. The remedial action includes installing a new girder and columns to support the truss thereby removing mezzanine and roof loading from the truss.

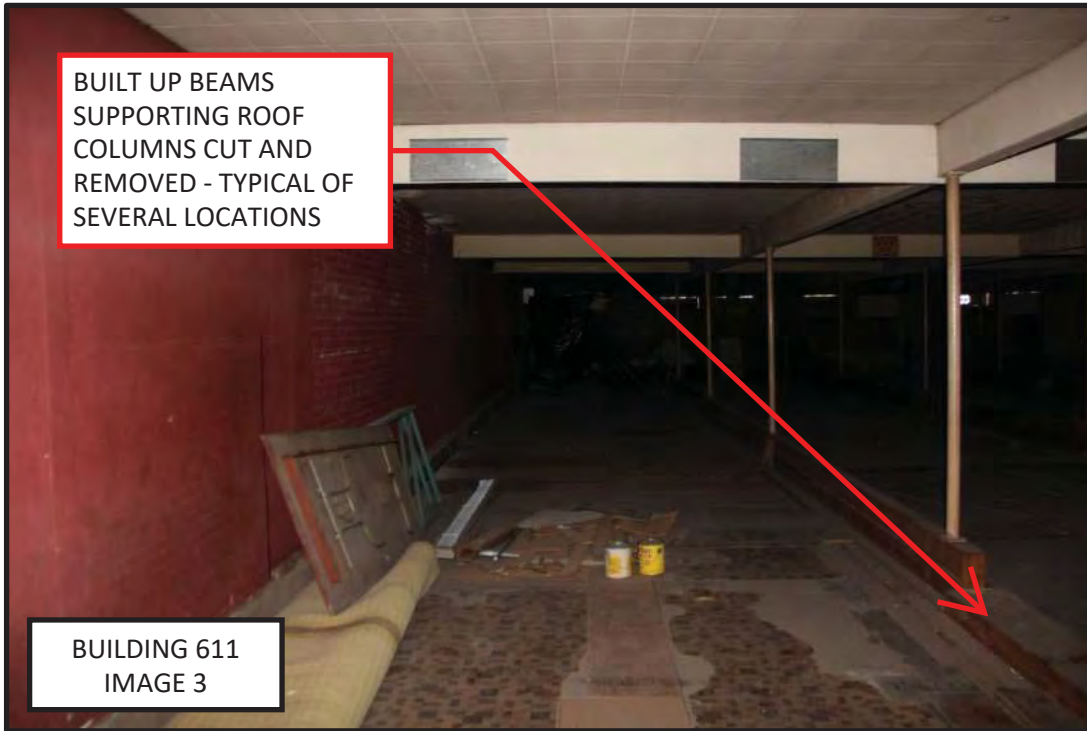
- ✓ Building 619 – The bearing points of the trusses are deteriorated along the west wall and supplemental support has been framed under the trusses. This condition exists at the connection to the 611 Building and is the result of water penetration along the north south valley between the building.

If we were in a position to advise the building owner, we would recommend that these items be addressed in the very near future. While the finding is that “The Historic Resource is not a hazard to the safety of the public,” the emergent concerns are significant and should be addressed in the very near future.

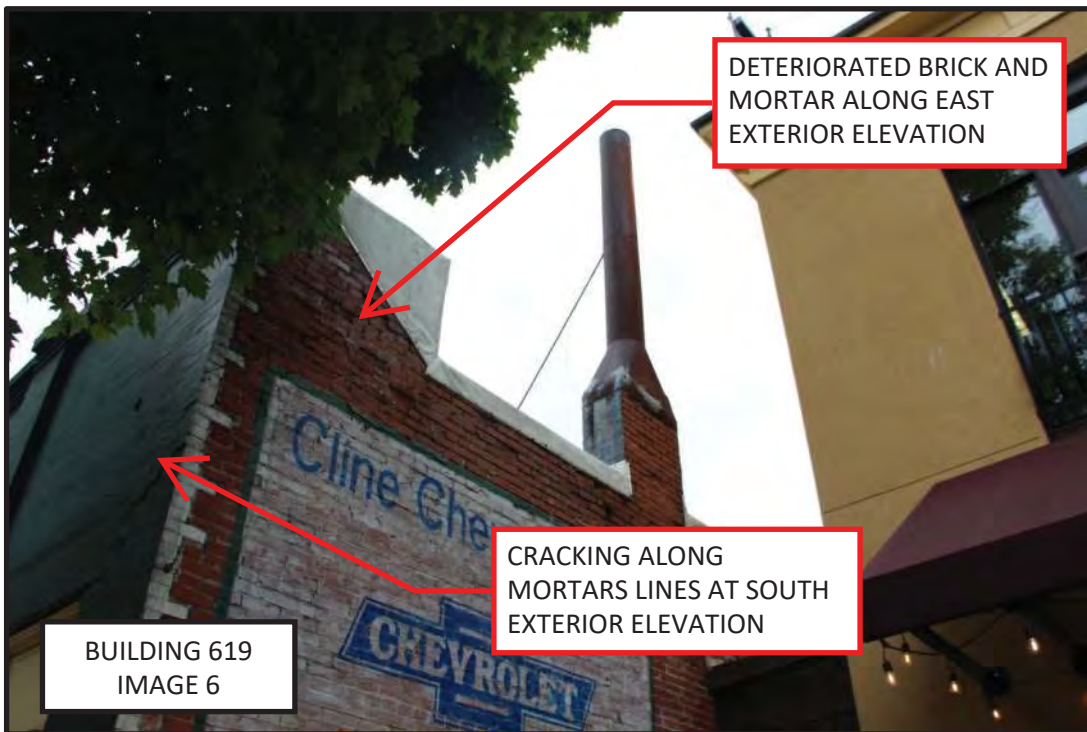
- ✓ All Buildings – overall condition of brick and mortar in various locations in each building requires repair.

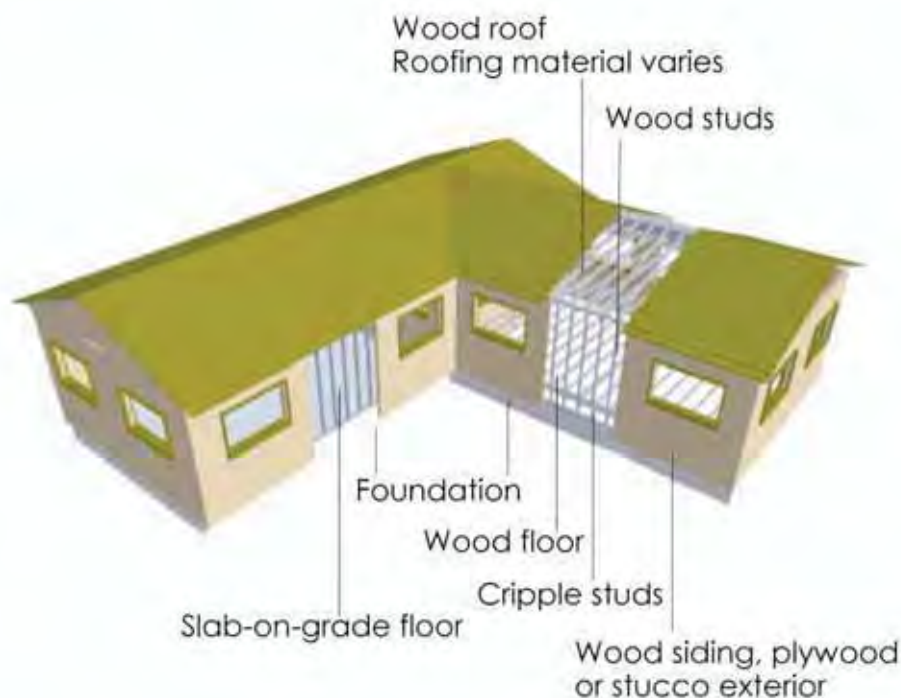
**Figure 5.1-1: Building Type W1: Wood Light Frames
One- and Two-Family Detached Dwelling**

Building Type **W1** consists of one- and two-family detached dwellings of one or more stories. Floor and roof framing are most commonly wood joists and rafters supported on wood stud walls (called woodframe or wood light-frame). The first floor may be slab-on-grade or a raised framed floor. Lateral forces in **W1** buildings are resisted by woodframe diaphragms and shear walls. Chimneys, where present, consist of solid brick masonry, masonry veneer, or woodframe with internal metal flues. Although materials for detached one- and two-family dwellings vary beyond woodframe, this chapter will focus on this most common type of construction. Figure 5.1-1 provides one illustration of this building type.

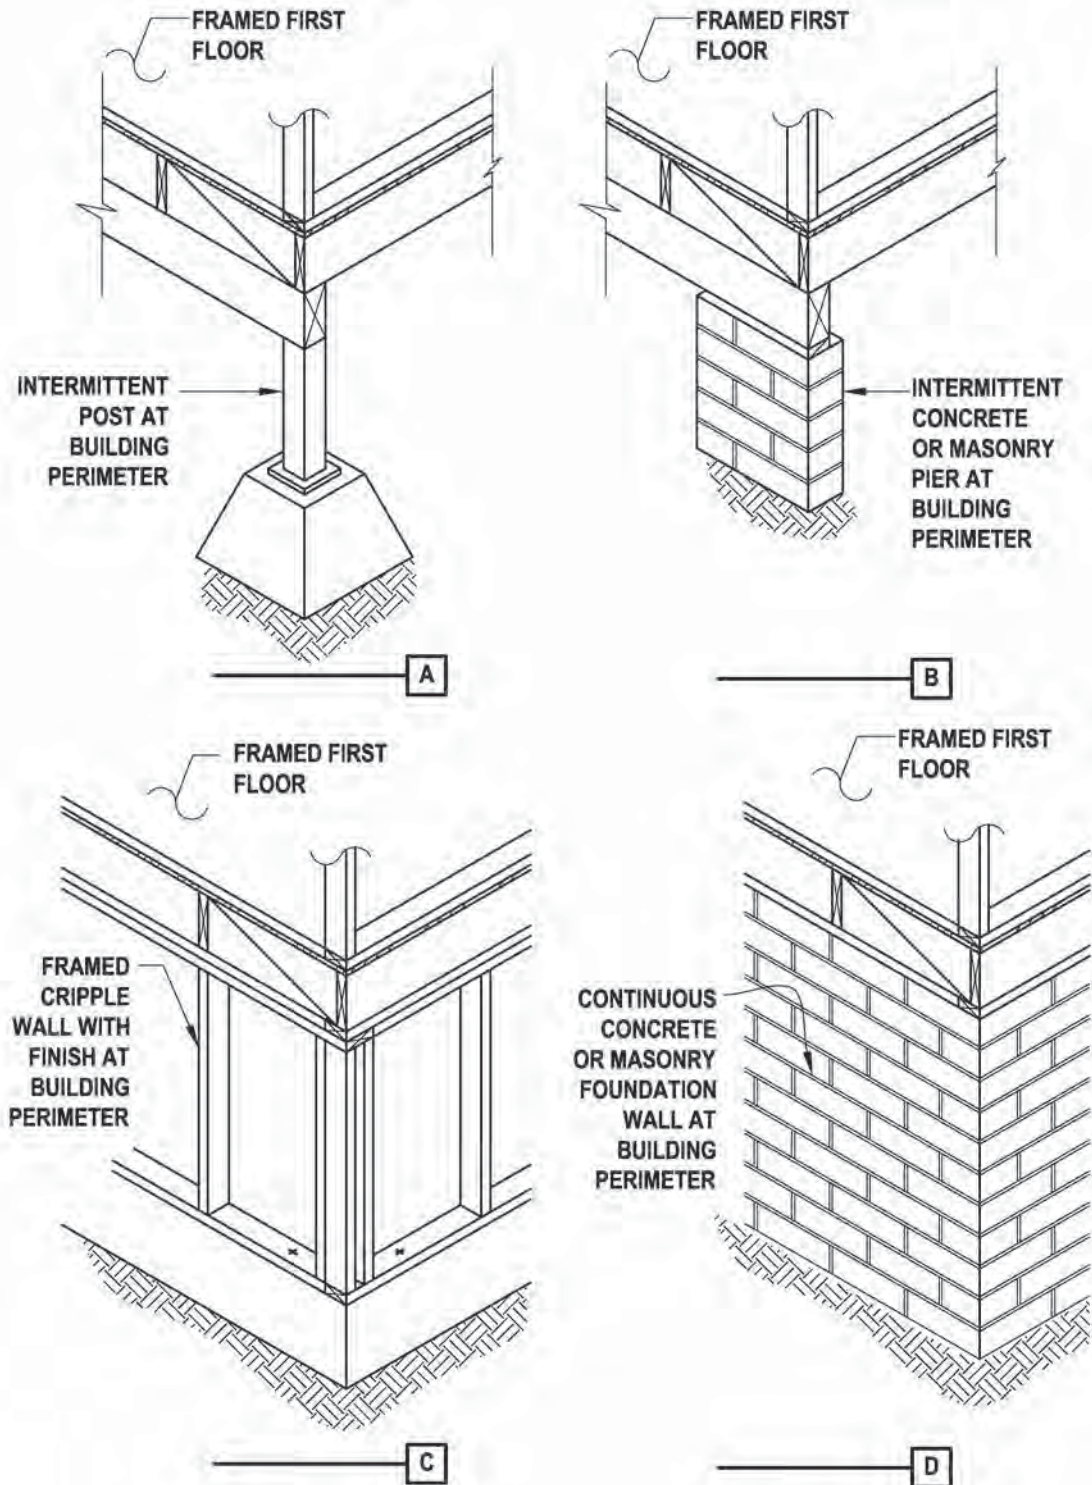
Figure 5.1-2: Systems Between First Framed Floor and Grade – Level Lot Sites

The dynamic response of **W1** buildings is very short period due to the stiffness of wall bracing and finish materials. Deflection and inelastic behavior occur primarily in the walls, while the floor and roof diaphragms remain close to elastic. Likewise, damage is mostly seen in the walls rather than the floor or roof systems.

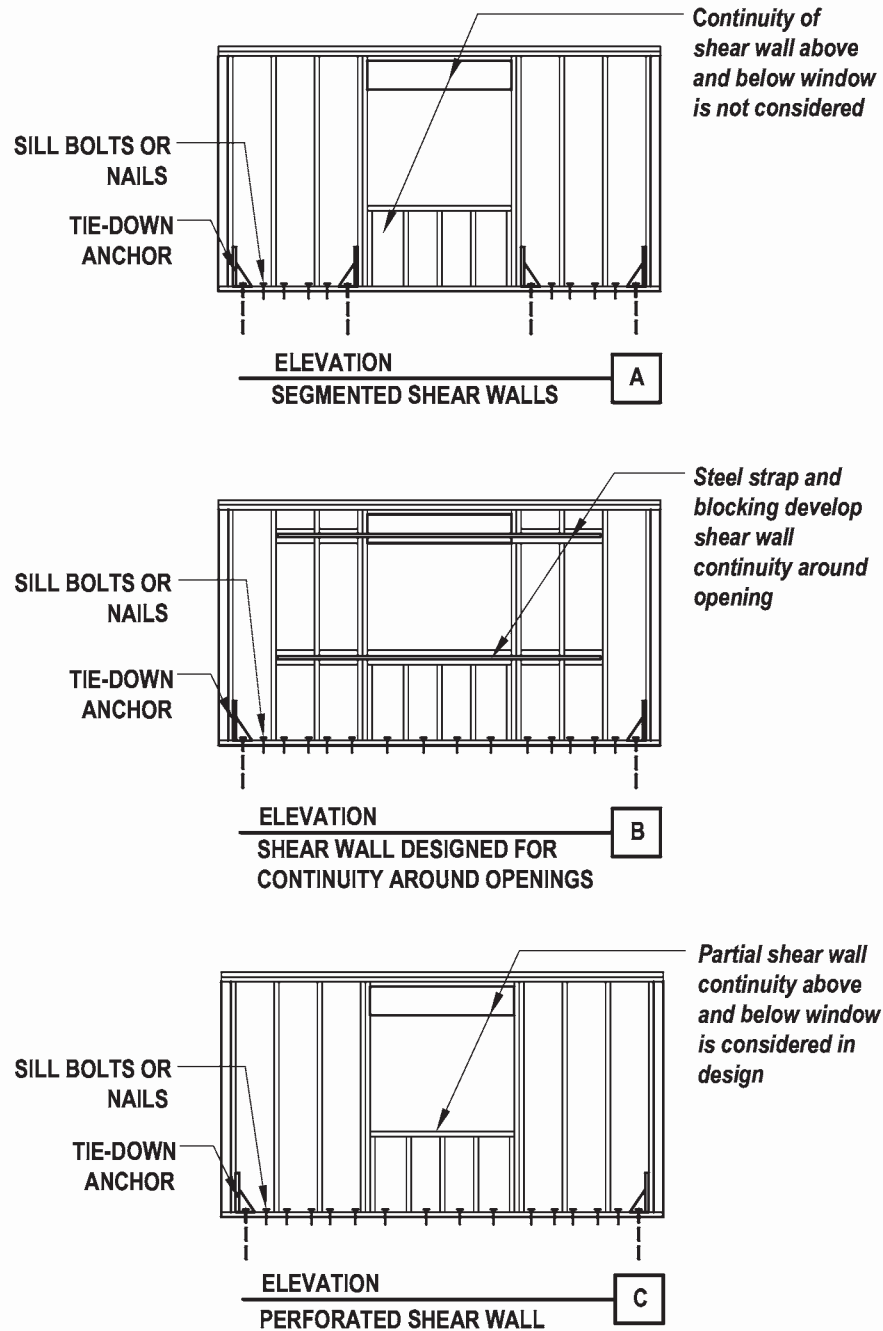
Figure 5.4.1-1: Shear Wall Design Methods

In order for shear walls to function as part of the structural system, it is necessary to design for transfer of in-plane load from the diaphragm being supported into the wall top and transfer of in-plane and overturning loads out at the wall base. In addition, the size and aspect ratio need to be adequate to meet demand, and significant disruptions over the height of the wall should be minimized. These considerations guide preferable locations for shear walls.

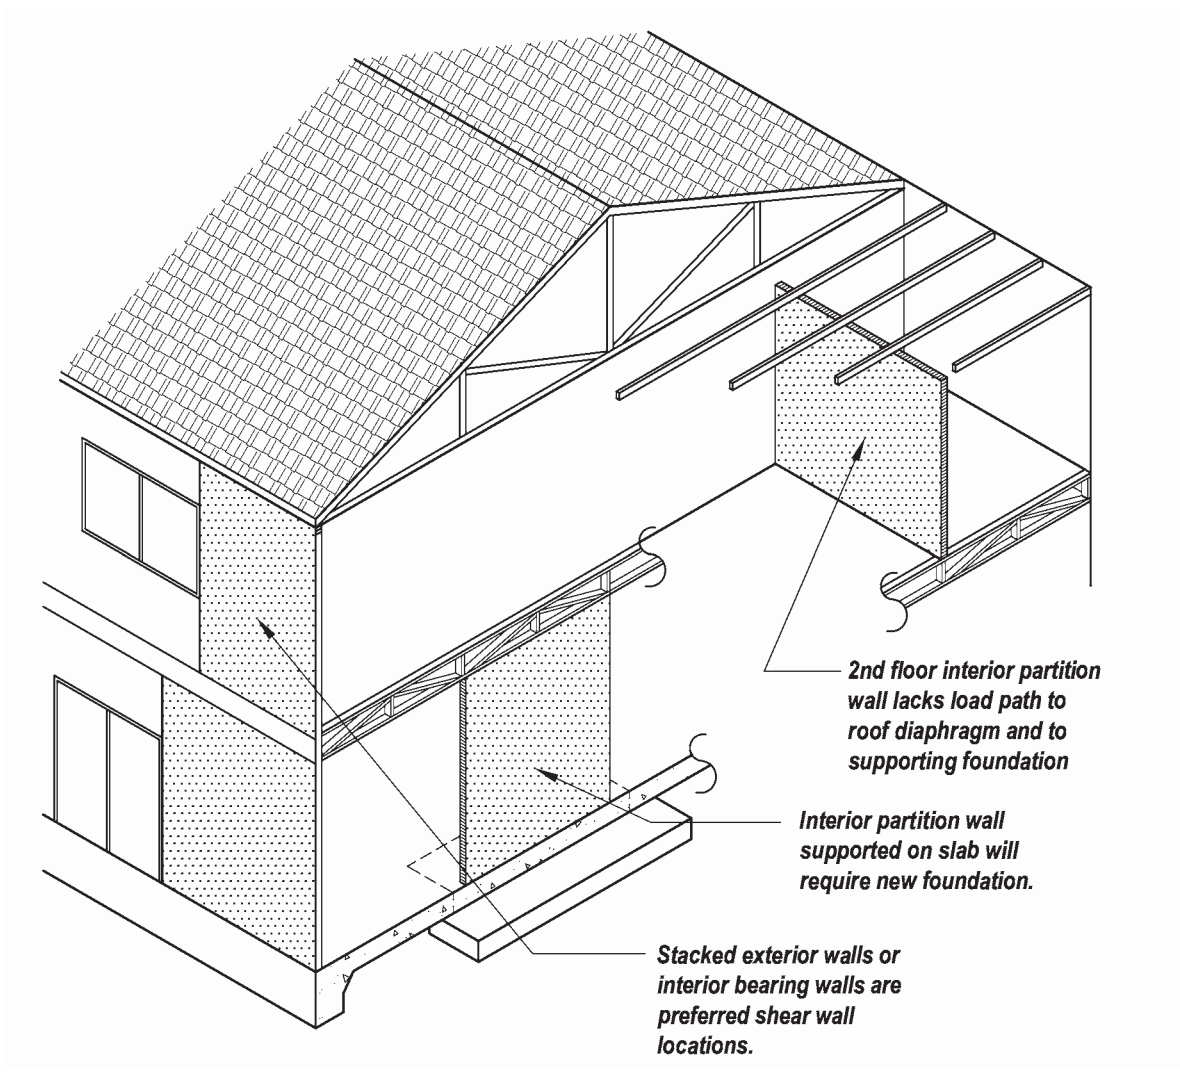
Figure 5.4.1-2: Preferred and Less Preferred Shear Wall Locations

(low roof framed into side of wall). Most of these conditions can be addressed with additional load path detailing, however, at greater cost and disruption. Interior bearing walls, like exterior walls, generally have inherent continuity of load path at wall top and bottom.

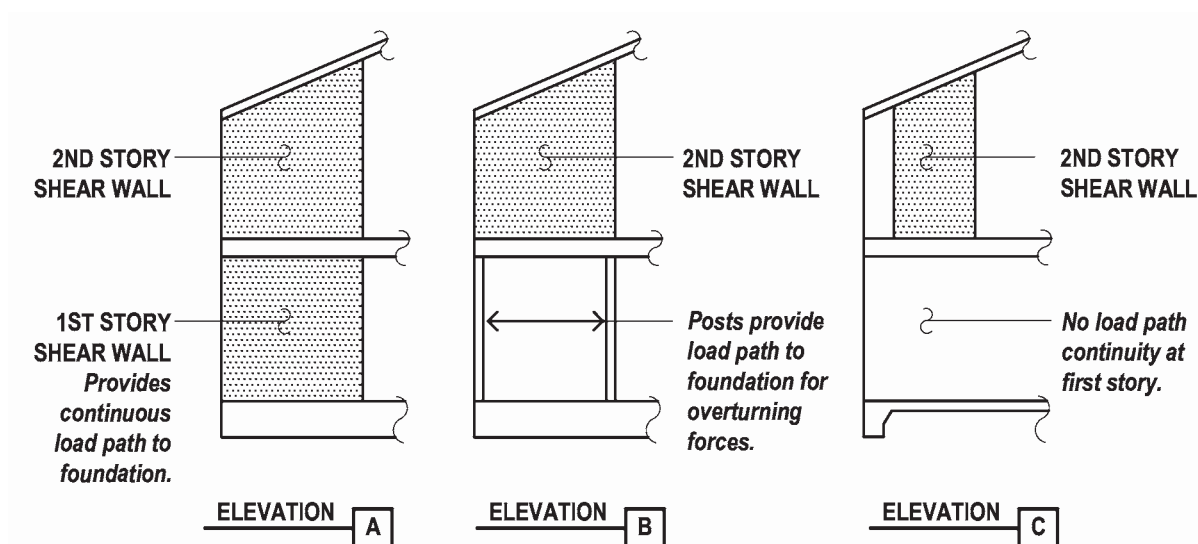
Figure 5.4.1-3: Overturning Support Conditions for Upper Story Shear Walls

The addition of shear walls is often most needed in portions of residences where existing walls are too slender to provide effective bracing. Use of properly detailed wood structural panel shear walls assists in making slender shear walls effective in providing resistance. It may become necessary, however, to reduce window openings in order to provide adequate lengths of shear wall.

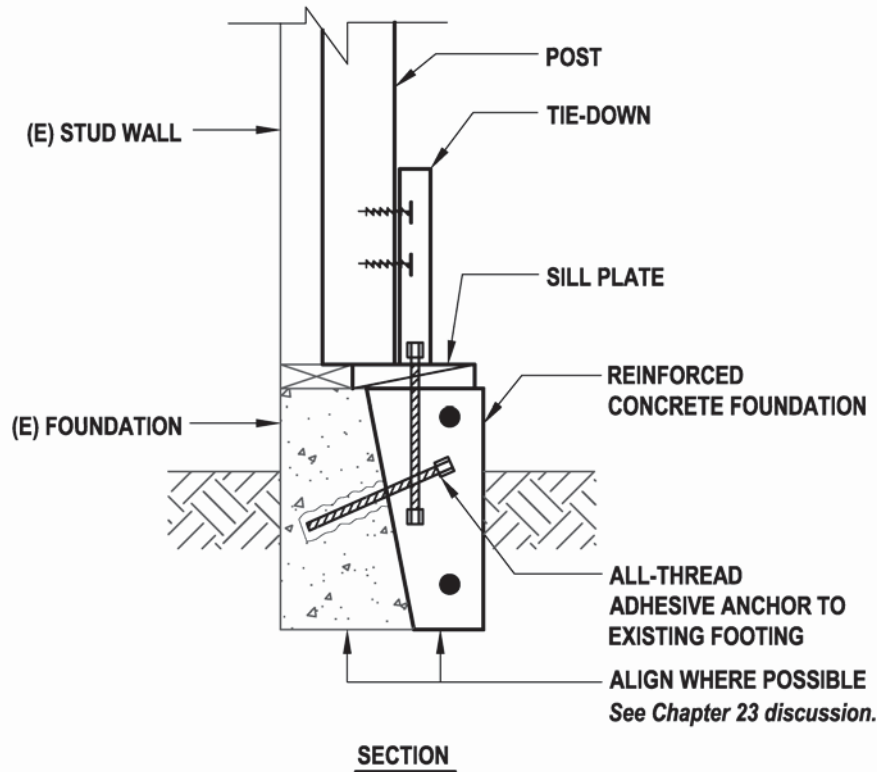
Figure 5.4.1-4: New Continuous Foundation Cast Along Side Existing to Provide Capacity for Tie-Down Anchor

General: A few topics deserve general consideration before getting into the specifics of shear wall detailing, including shrinkage, predrilling, wood species, corrosion issues, and condition assessment of existing buildings. Shrinkage of wood framing members is an issue that must be considered in design of both new and existing wood buildings. Shrinkage of wood framing as it drops to equilibrium moisture content is accommodated in new construction every day. Whether in new construction or rehabilitation, the primary concern is differential shrinkage where members subject to shrinkage might act in a system with members subject to lesser shrinkage, no shrinkage, or possibly even slight swelling. In rehabilitation, new framing members subject to shrinkage may need to be added in parallel to members that are already at equilibrium moisture content. Shrinkage in the length of framing members is negligible. The primary shrinkage of concern is in the width of members. With a combination of radial and tangential directions, shrinkage on the order of 6% or $\frac{3}{4}$ " in 12 inches is reasonably possible. This could mean a gap of $\frac{3}{4}$ inches developing between blocking and the diaphragm above in a shear transfer or similar connection, greatly reducing the resistance provided.

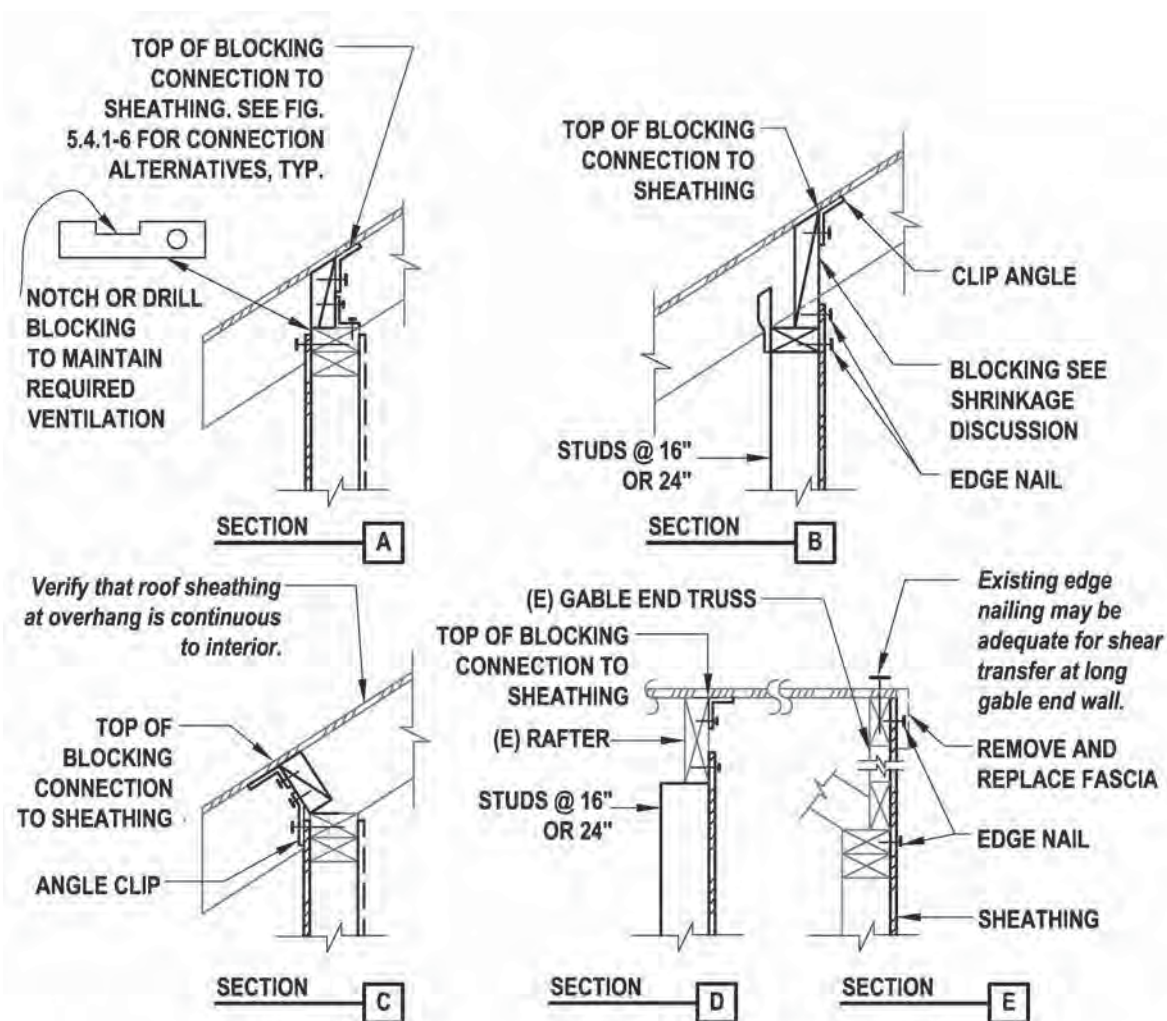
Figure 5.4.1-5: Load Path from Roof Diaphragm to Top of Shear Wall

Figure 5.4.1-5 shows a series of top of shear wall details where the shear is being transferred from a roof diaphragm into the top of the wall. Since most diaphragms in residential construction are not blocked, the unit capacity of the new shear wall is likely to be higher than the unit

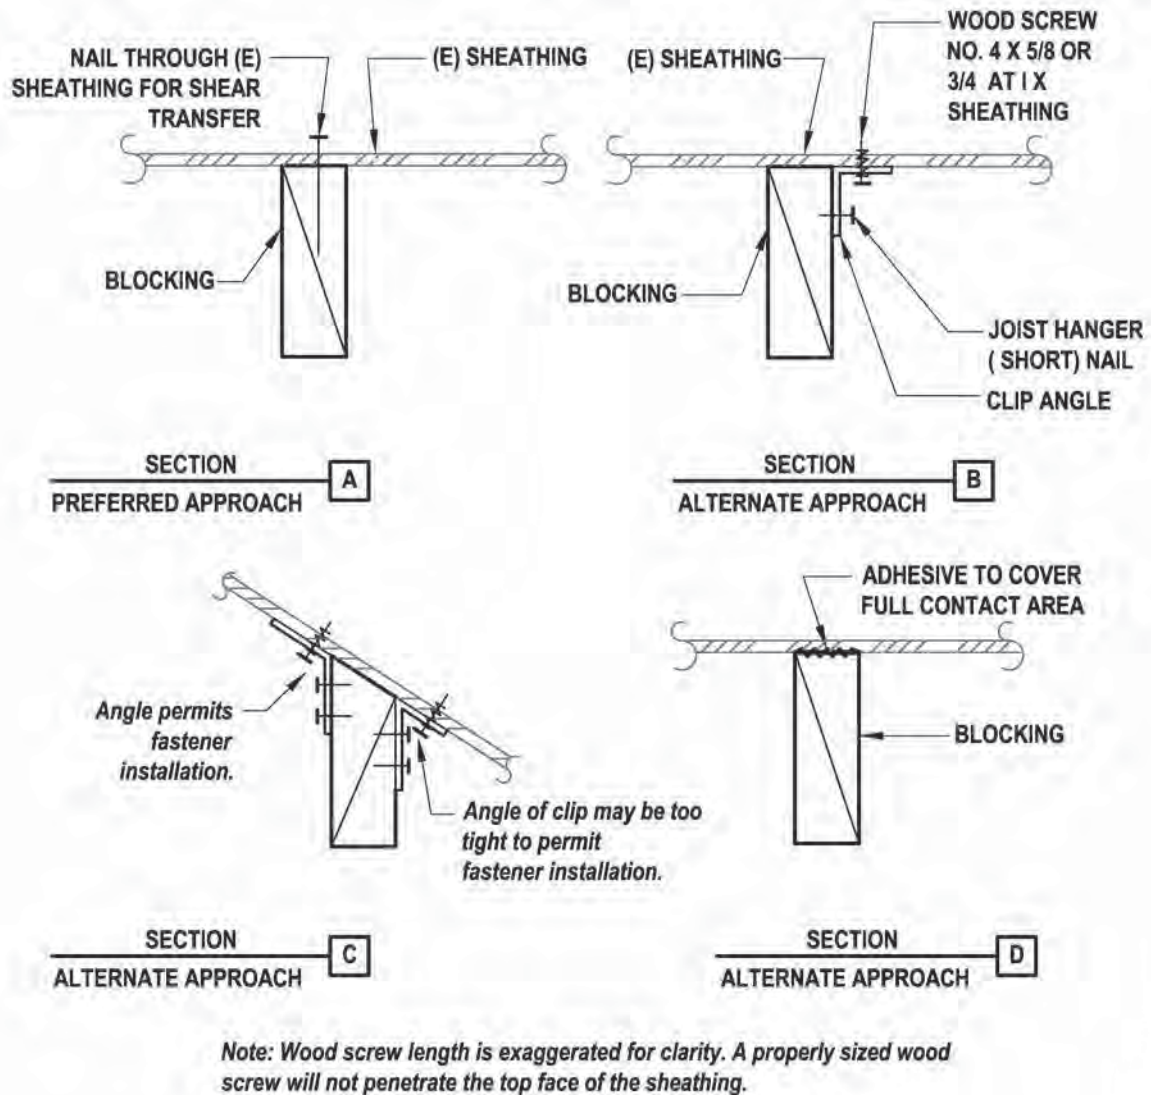
Figure 5.4.1-6: Attachment of Blocking to Existing Sheathing

find the best method of attaching new steel moment frames to existing wood buildings. The specimens used 12-inch deep joists and blocks in two 16-inch bays and tested angle clip connections monotonically and cyclically and adhesive connections monotonically. Due to the geometry of the test specimen, overturning behavior was significant. Both methods of attachment increased the load capacity beyond that for minimum framing nailing. The attachment of the blocking to the sheathing was not a controlling factor in any of the tests.

Where unit shears are low and a nailed sheathing to framing connection is not possible, connection of sheathing to framing using steel clip angles provides a possible alternative (Figures 5.4.1-6B and 5.4.1-6C). The clip angle is generally attached to the framing with nails and to the sheathing with wood screws. NDS requires a minimum penetration of six times the wood screw diameter into the sheathing (note that the length of the screw point is included when

Limited testing of the connections shown in Figures 5.4.1-6B and 5.4.1-6D occurred in the CUREE-Caltech Woodframe Project (Mosalam et al., 2002). The purpose of the testing was to

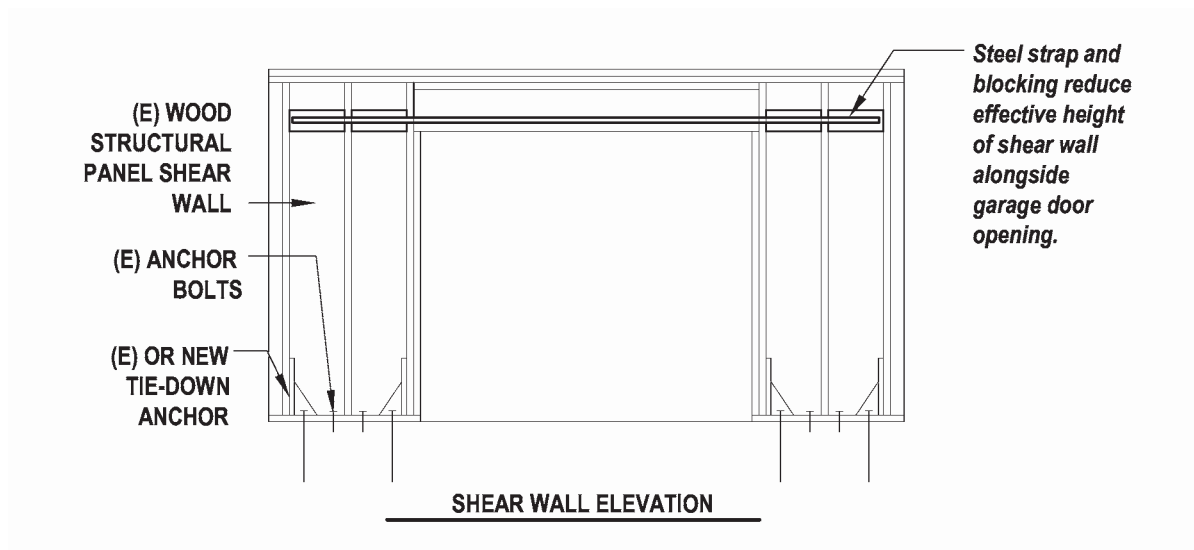
Figure 5.4.1-13: Reduction of Slender Shear Wall Effective Height

Reduction of slender shear wall height: Shear walls at the sides of garage doors and other large openings are often very slender and, therefore, develop significant overturning forces. One easy and relatively inexpensive approach of modestly reducing overturning forces and increasing wall stiffness is shown in Figure 5.4.1-13. A steel collector strap is run across the full length of the wall near the bottom of the door header. This strap will effectively reduce the shear wall height to the height of the door opening; in addition, limited moment fixity may develop at the wall top. The strap is nailed to the header and to blocking added in line with the bottom of the header.
