Architectural
Resources Group

609, 611, and 619 NE 3rd Street
McMinnville, Oregon

Historic Resource Assessment
November 2022

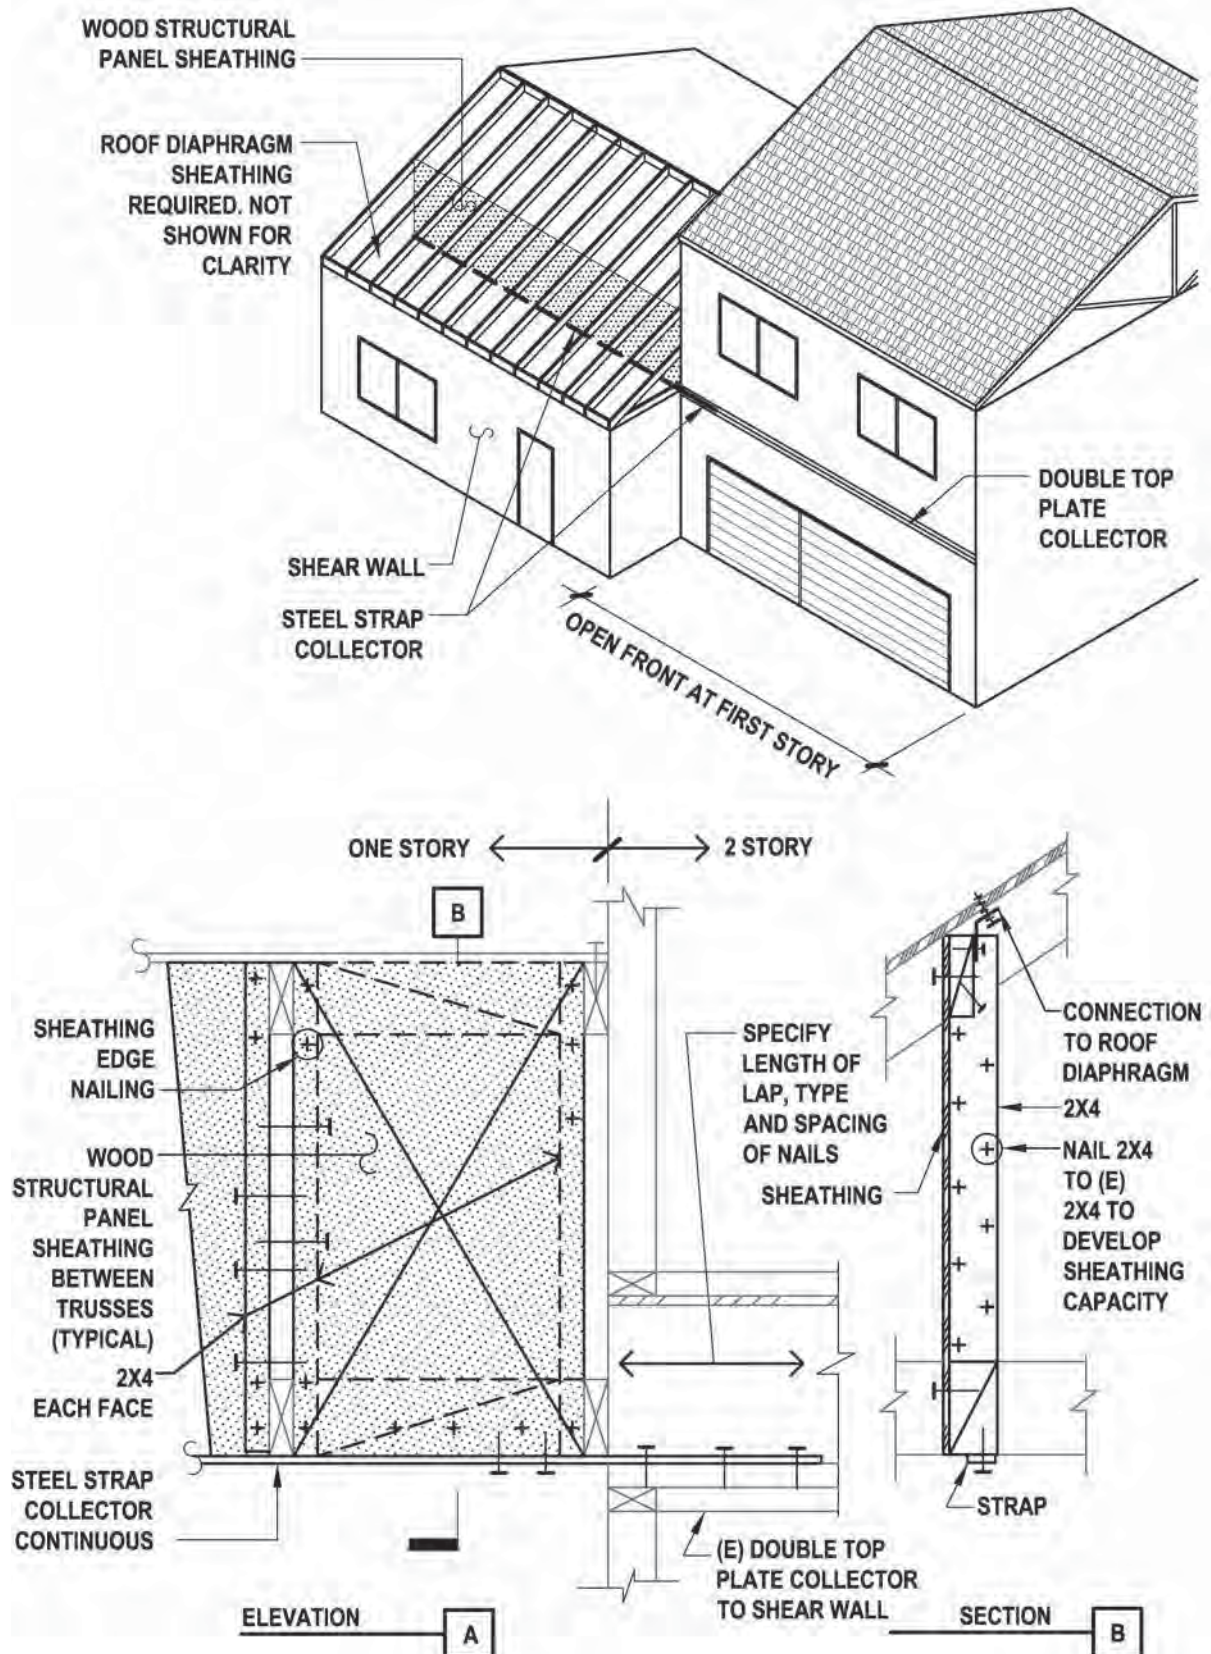
Figure 5.4.2-1: Collector from Garage Open Front to Adjacent Dwelling

Figure 5.4.2-1 shows one of several possible methods of providing a collector. In the illustrated approach, a steel strap ties the top plates from the garage open-front to wood structural panel sheathed infill panels between the roof trusses in the one-story portion of the building. The infill panels transfer the load from the truss bottom chord up to the roof diaphragm, where loads can be carried to the shear walls. In Figure 5.4.2-1, a vertical eccentricity exists between the collector

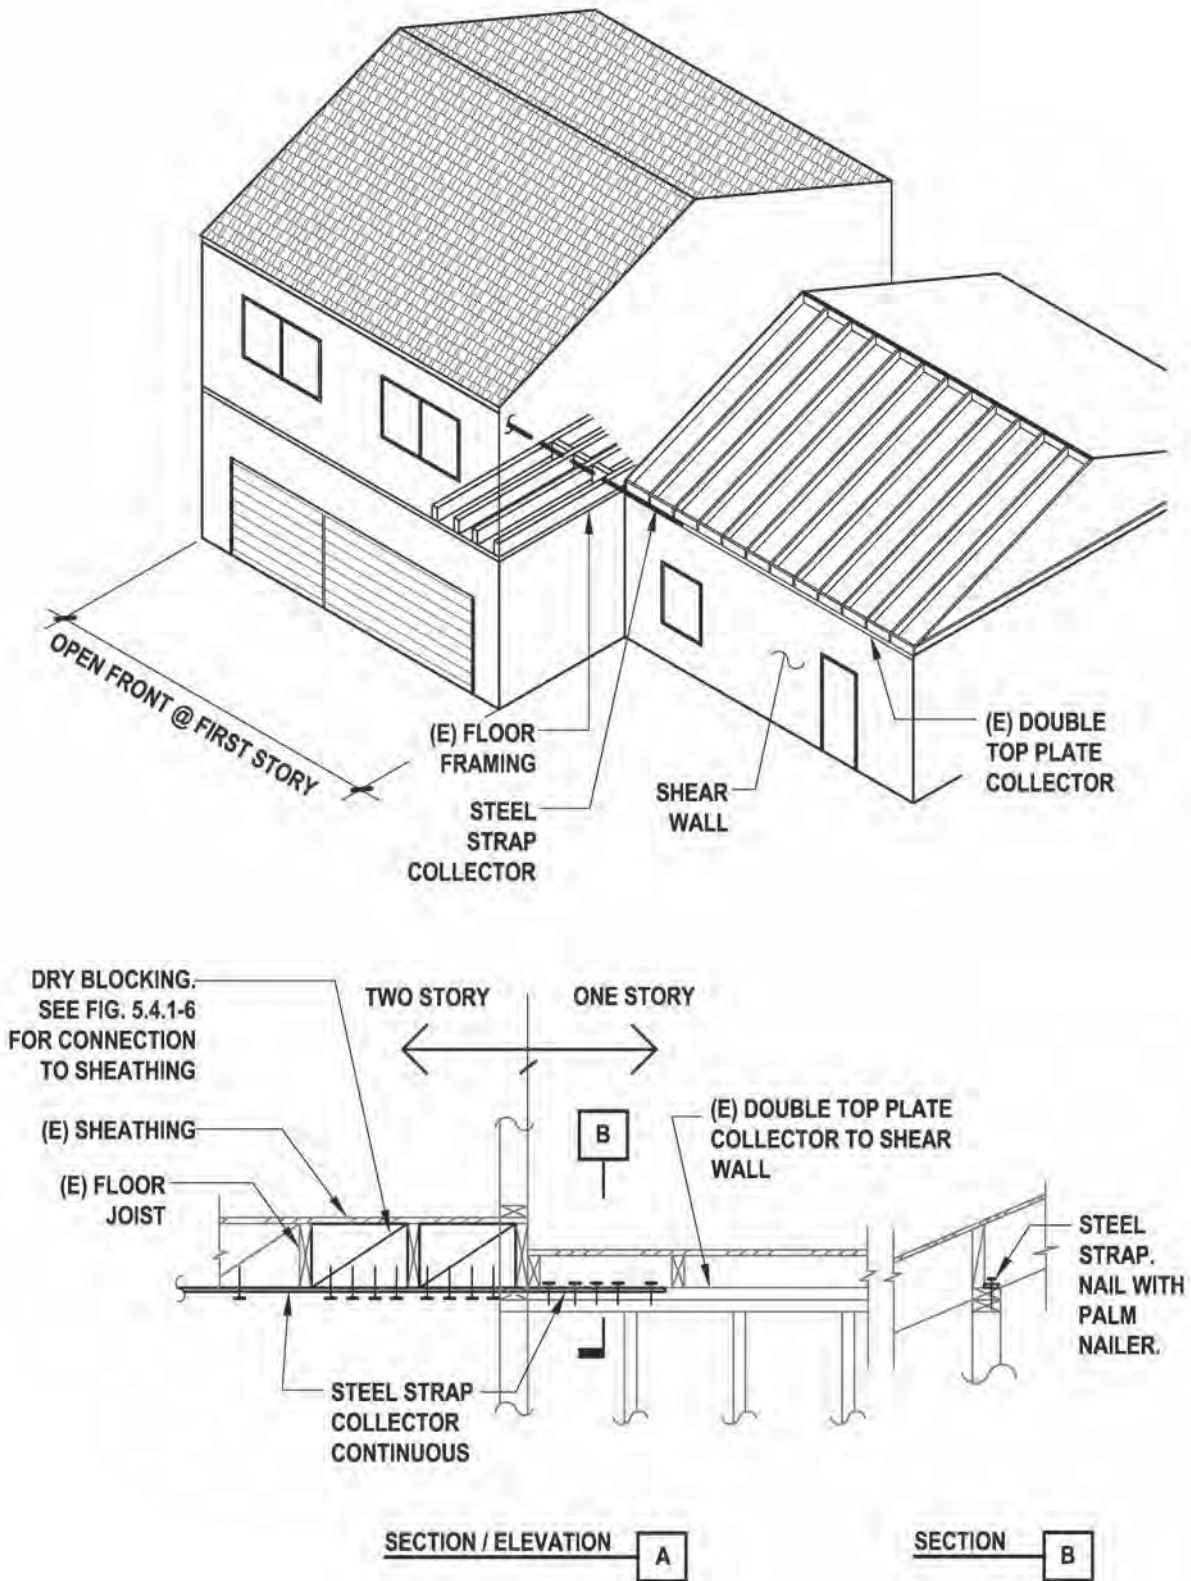
Figure 5.4.2-2: Collector from Garage Open Front to Adjacent Dwelling

General design: Collector connections like the ones illustrated in Figures 5.4.2-1 and 5.4.2-2 are often complex, and they can include both vertical and horizontal offsets between bracing lines. Rehabilitation is seldom inexpensive, and alternatives such as added shear walls should always be considered. If used, however, collectors should help to mitigate differential movement between the one-story and two-story portions of the building and to reduce resulting damage. The collector will most often but not always need to resist both tension and compression.

level and the roof diaphragm in the one-story portion. This eccentricity is resolved by continuing the sheathing infill panels for the full width of the one-story building so that the vertical reaction can be resisted at the exterior walls. An alternate approach would be to install a wood structural panel ceiling diaphragm on the underside of the roof trusses, in which case no vertical eccentricity would exist.

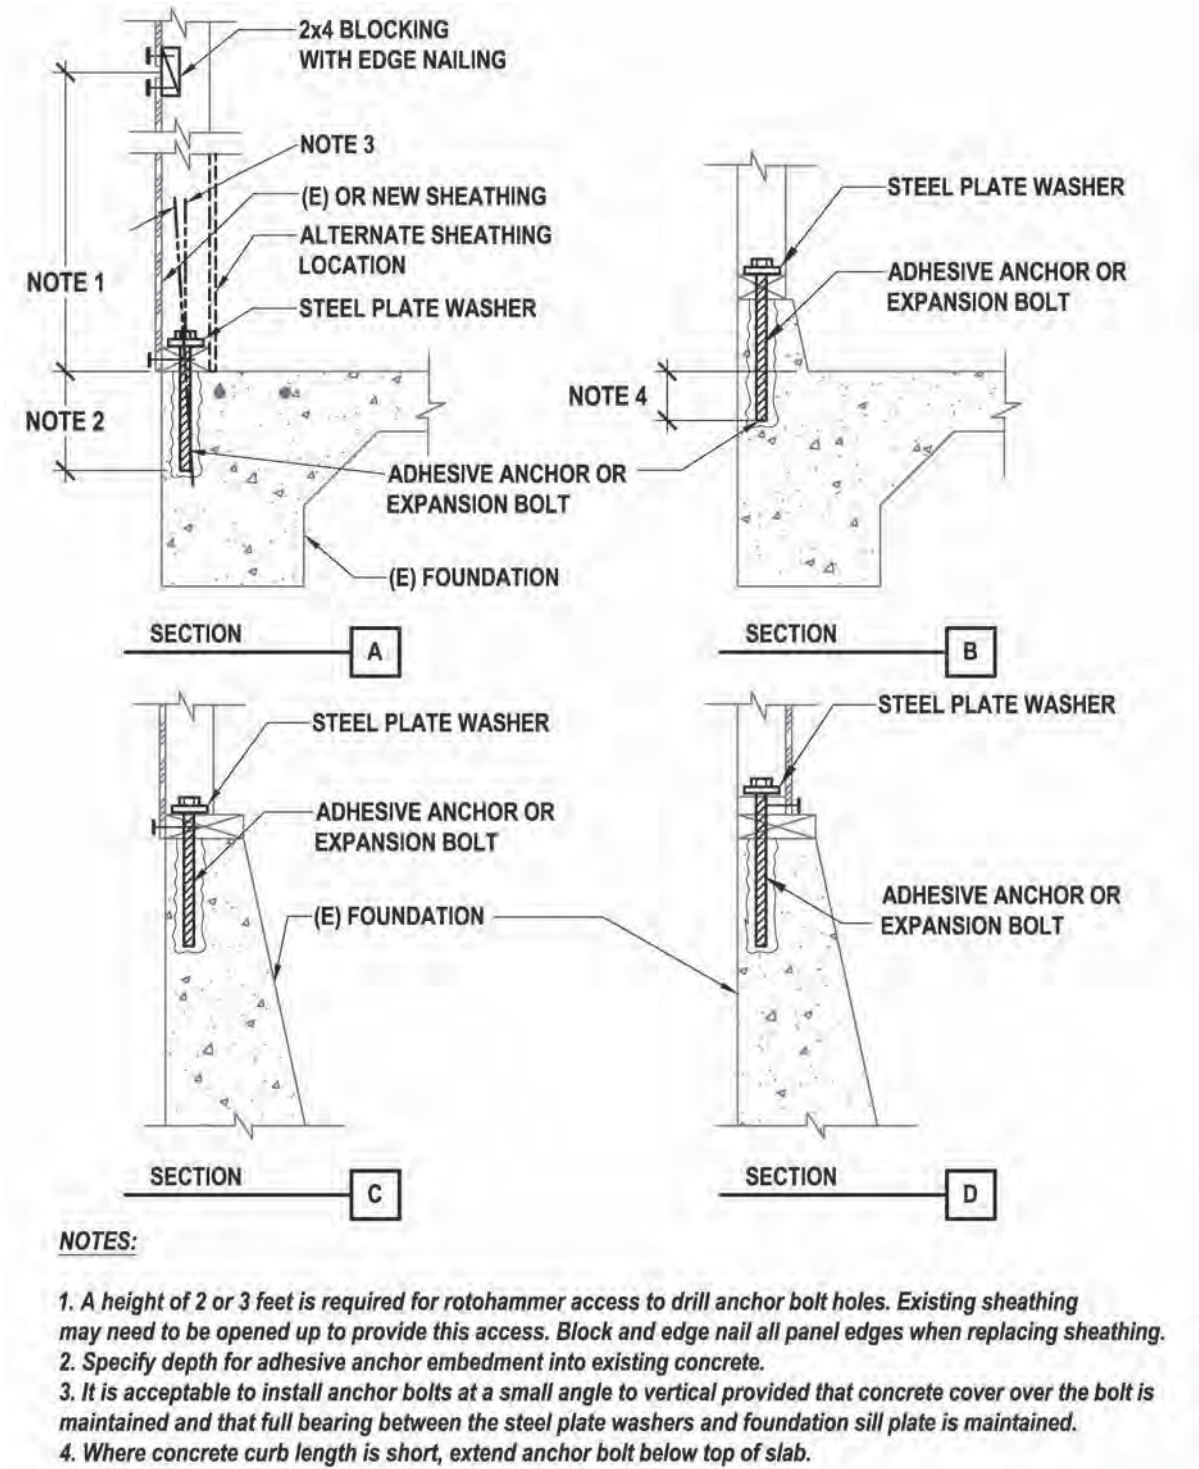
Figure 5.4.3-1: Added Anchor Bolt at Existing Concrete Foundation

Addition of anchor bolts is often not possible with a crawlspace configuration due to inadequate vertical clearance for a rotary-hammer to drill down into the top of the foundation. Figure 5.4.3-3 illustrates some of the alternate proprietary anchors that can be used for these configurations. Although shown with stud walls above the foundation sill plate, these connections work equally

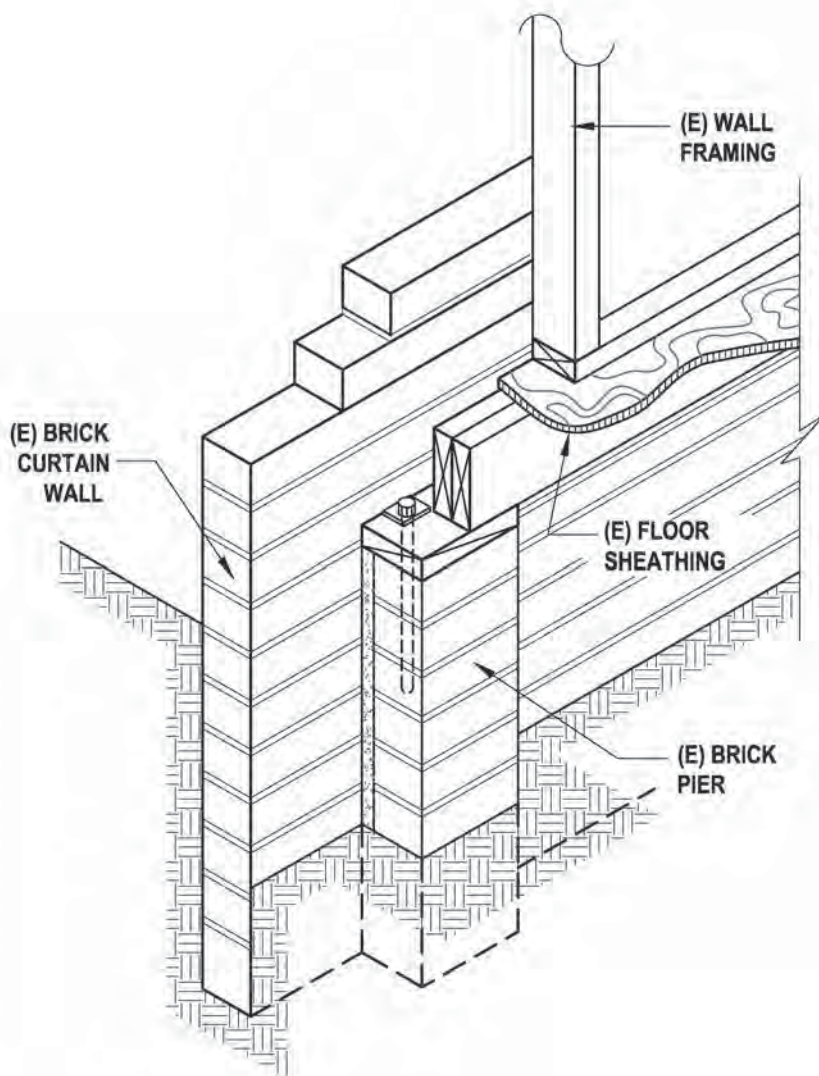
Figure 5.4.3-4: Pier and Curtain Wall Foundation System with Inadequate Load Path Between Shear Walls and Foundation

Pier-and-curtain wall foundations (Figure 5.4.3-4) are used in some areas of the southern United States. As-built anchorage for shear transfer between the wood framing and foundation is generally minimal to non-existent. Rehabilitation of anchorage to this type of foundation is not known to have been undertaken to date. One possible approach is a continuous steel angle from the underside of the floor framing to the inside face of the single-wythe curtain wall, anchored to the curtain wall with veneer anchors and to the wood with nails or screws. Care would need to be taken in drilling for veneer anchors. An alternate approach would be new concrete or masonry foundations from pier to pier, allowing use of cast-in anchor bolts to the foundation and nailed or screwed connections to the wood framing.

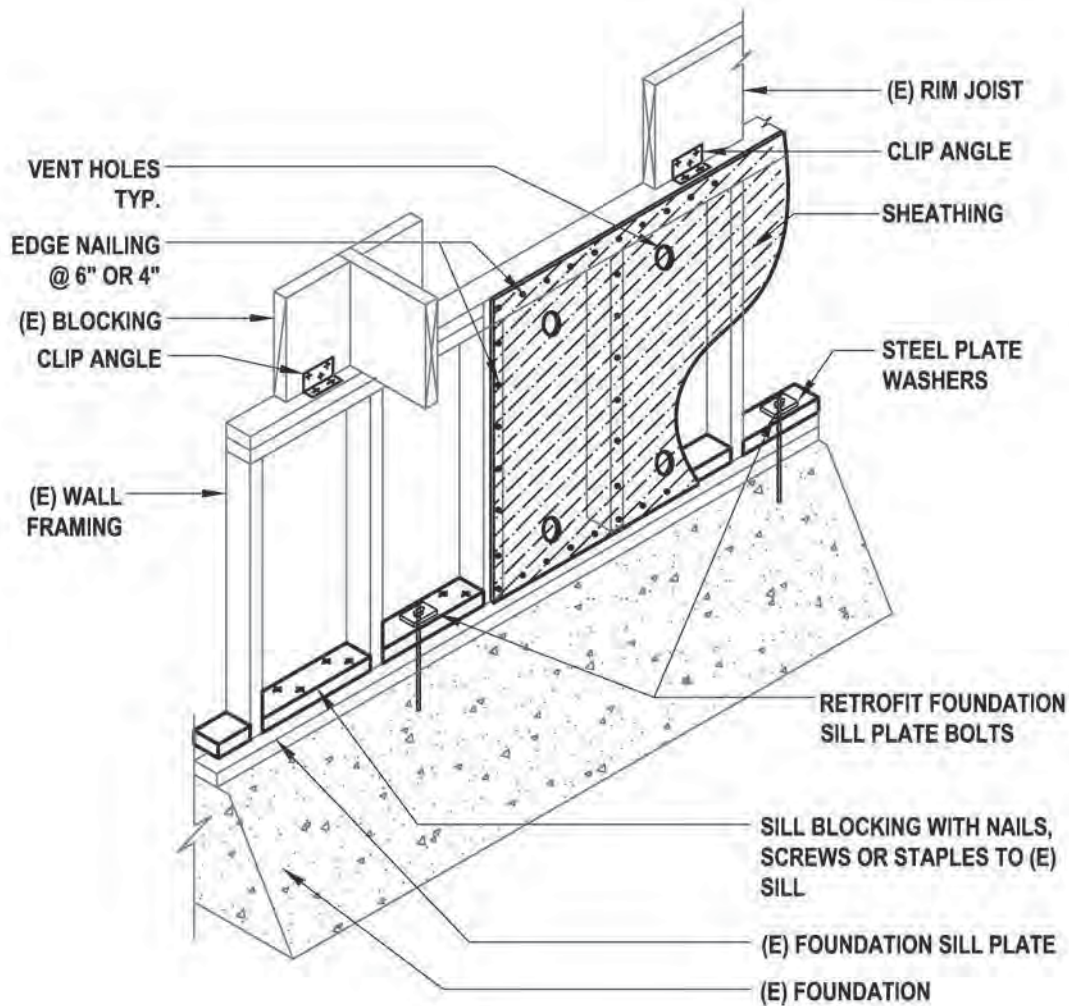
Figure 5.4.4-1: Cripple Wall Enhancement

Where cripple walls are 14 inches tall or less, wood structural panel sheathing may no longer provide reliable bracing of the studs, and splitting of the studs becomes a more significant concern. For this configuration, use of solid blocking between studs is recommended in lieu of sheathing.

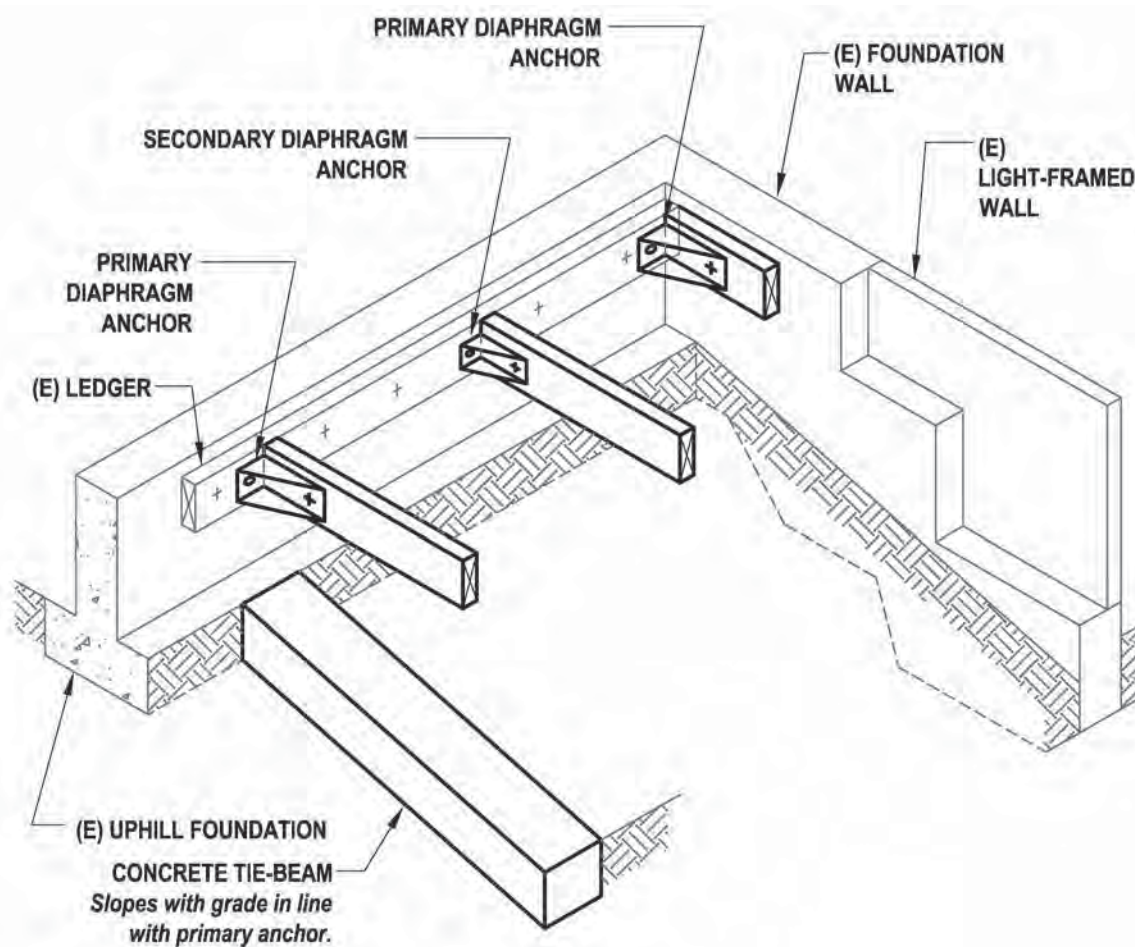
Note. Diaphragm anchor prevents existing ledger from pulling off at uphill foundation.

Figure 5.4.5-2: Anchorage of Floor Diaphragm Framing to Uphill Foundation in a Hillside Dwelling

Alternate bracing approaches: Steel concentric braced frames have sometimes been used in lieu of primary anchors at exterior stepped foundation walls (the right hand end wall in Figure 5.4.5-2). When this approach has been used, there is often only a single diagonal brace member at each foundation line, acting in tension for seismic loads towards the hill and in compression for seismic loads away from the hill. This does not conform to code requirements for braced frame design in which a balance of tension and compression resistance is required. If this approach is taken, conservatism in estimating brace and anchorage forces is recommended, to avoid premature failure and compensate for limited energy dissipation capacity.

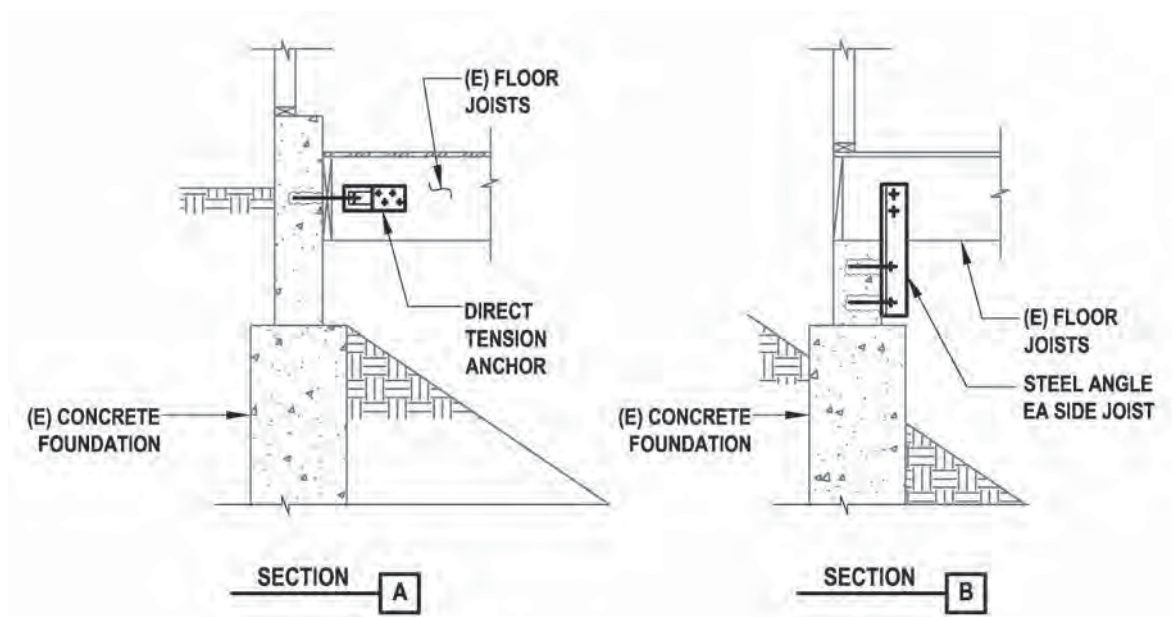
Figure 5.4.5-3: Connections for Anchorage to Uphill Foundation

The configuration tested is similar to Figure 5.4.5-3A. Figure 5.4.5-3B is another commonly used configuration. Care has to be taken to make the steel angle stiff enough to protect the framing connection to the uphill foundation.

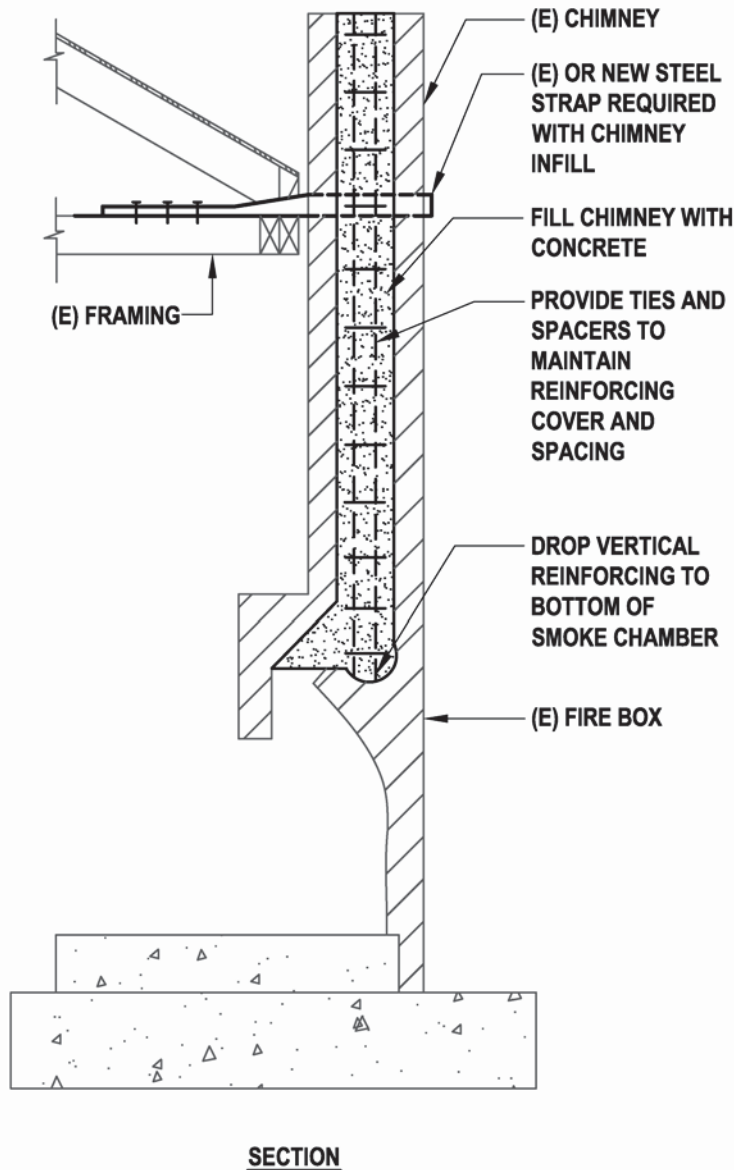
Figure 5.4.6-1: Infill and Bracing of Masonry Chimney

Figure 5.4.6-1 illustrates a possible scheme for filling in a vulnerable chimney with reinforced concrete. Reinforcing is placed in the chimney down to the smoke chamber. Most fireplace geometries will make it impractical to extend the reinforcing down further. Ties and spacers are recommended to hold the reinforcing at adequate clearances off of the flue wall so that bond is adequate to develop the reinforcing. Wheel-type spacers, sometimes put on tie or spiral reinforcing in drilled-pier foundations, could help with placement. Figure 5.4.6-1 shows the concrete extending to the damper location. Where possible, reinforcing and filling the fire-box would improve the strength and continuity of the infill. Anchorage of the chimney to floor, roof and ceiling levels needs to be provided in conjunction with chimney infilling. Filling the chimney will reduce the falling hazard of an unreinforced chimney, by providing strength and

stiffness continuity at the commonly seen weak points (roof line and transitions in width). Filling the chimney may reduce, but is unlikely to eliminate damage. This rehabilitation measure is most often used for buildings of historical significance where there is a strong desire to maintain the current appearance. In some cases the height of very tall chimneys are reduced prior to filling with concrete. Use on chimneys already in poor condition due to deterioration or foundation movement is not recommended. Placement of grout between the flue liner and masonry is also recommended where this grout is completely missing or has significant gaps.

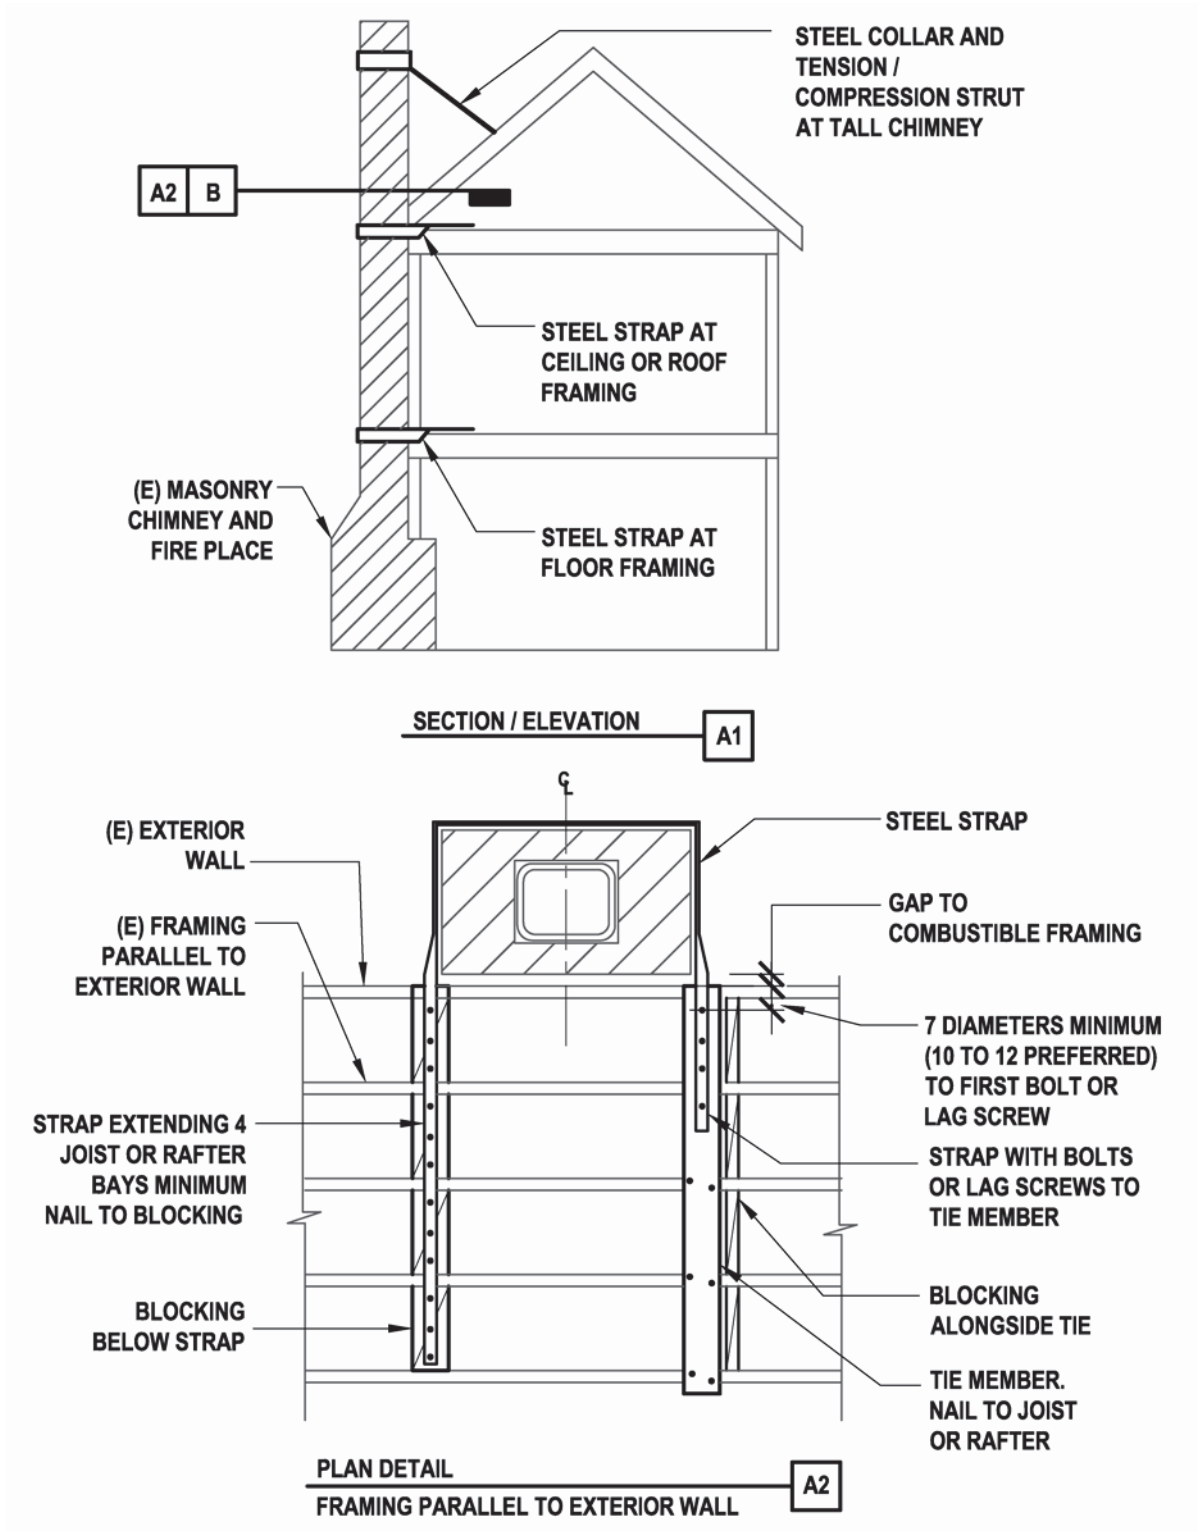
Figure 5.4.6-2A: Bracing of Masonry Chimney

Anchorage of a strap or other tie to an existing masonry chimney should be avoided where possible and otherwise approached with caution. Expansion anchors cause splitting tensile stresses that can result in cracking of the masonry. Adhesive anchors change properties under elevated temperatures that might be experienced during use of the chimney.

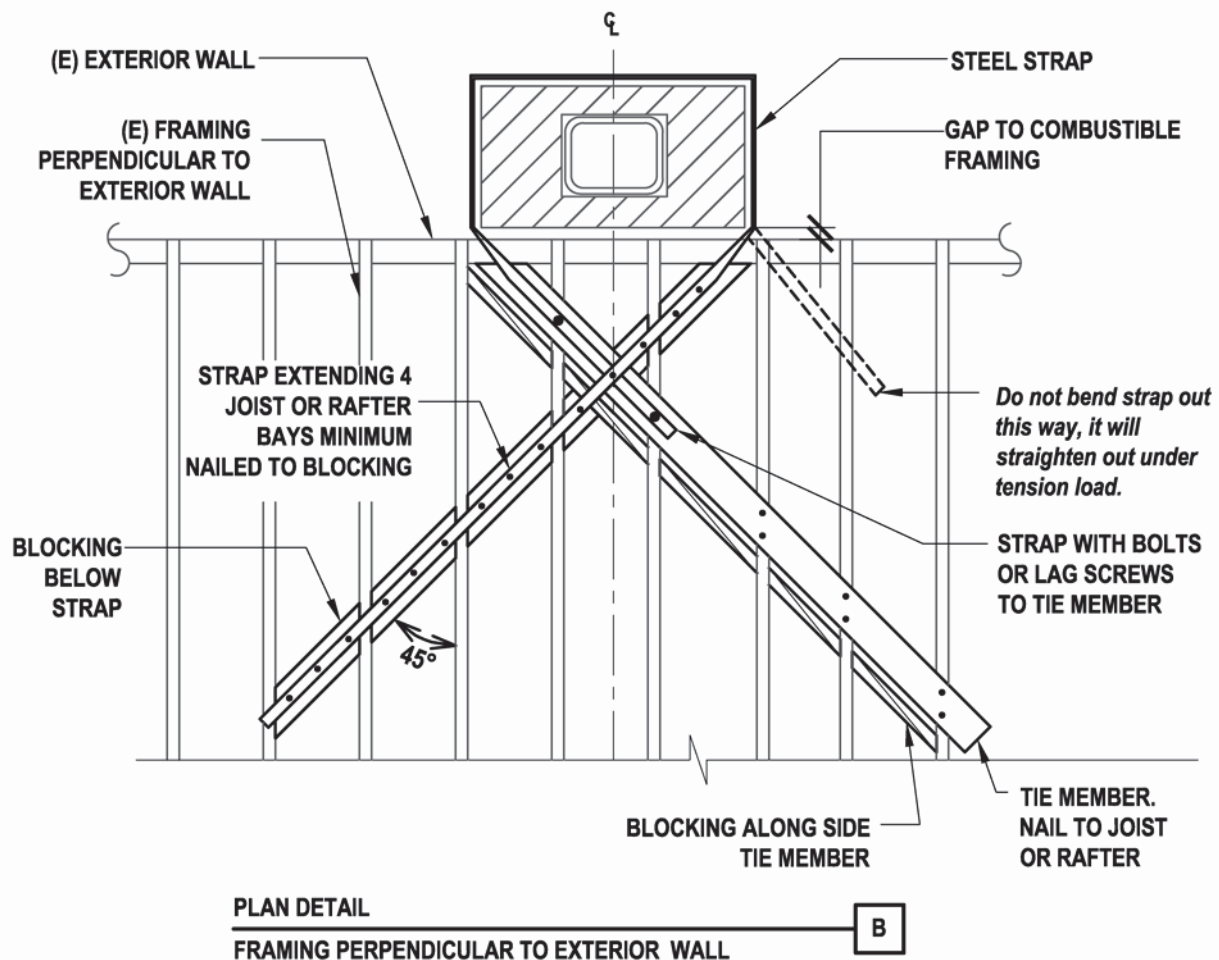
Figure 5.4.6-2B: Bracing of Masonry Chimney

Figure 5.4.6-2 illustrates anchorage of an exterior masonry chimney to floor, roof and ceiling framing. This detail is an adaptation of prescriptive information for new construction in the IBC (ICC, 2003a) and the *Masonry Fireplace and Chimney Handbook* (Amrhein, 1995). The steel strap is intended to keep the chimney from falling away from the building. In order to do this, the strap must be anchored into existing floor and roof framing with a capacity and load path adequate to resist forces from the chimney. Anchorage to wall studs or a single framing member will not accomplish this. It is often difficult and disruptive to anchor far enough into the building to develop required capacity. Figure 5.4.6-2 is intended for small to medium size chimneys common in single-family residences. Large and irregularly configured chimneys require additional consideration.

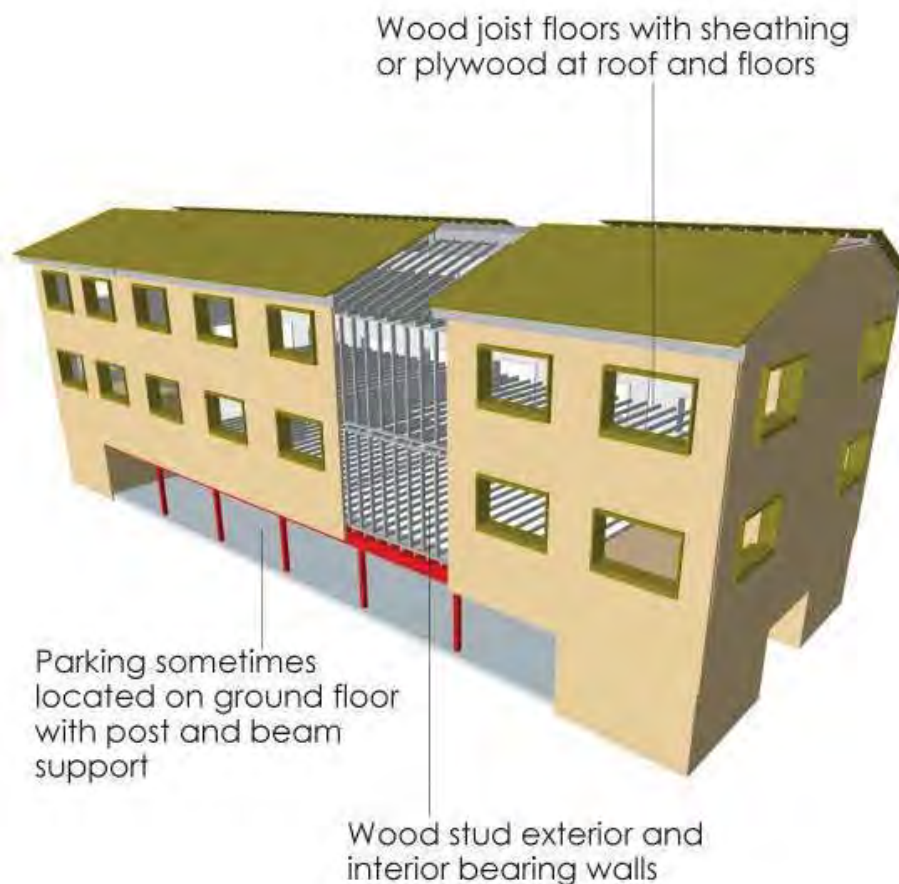
Figure 6.1-1: Building Type W1A: Multistory Multi-Unit Residential Woodframes

Building Type **W1A** is similar to Building Type **W1** in use of woodframe wall, floor and roof construction, but includes large multi-family, multistory buildings. In **W1A** buildings, second and higher stories are almost exclusively residential use, while the first story can include any combination of parking, common areas, storage, and residential units. Post and beam framing often replaces bearing walls in non-residential areas. Multi-family residential buildings with commercial space at the first story are included in building Type **W1A** due to similar building characteristics. Lateral forces in **W1A** buildings are primarily resisted by wood diaphragms and shear walls. Figure 6.1-1 provides an illustration of this building type.

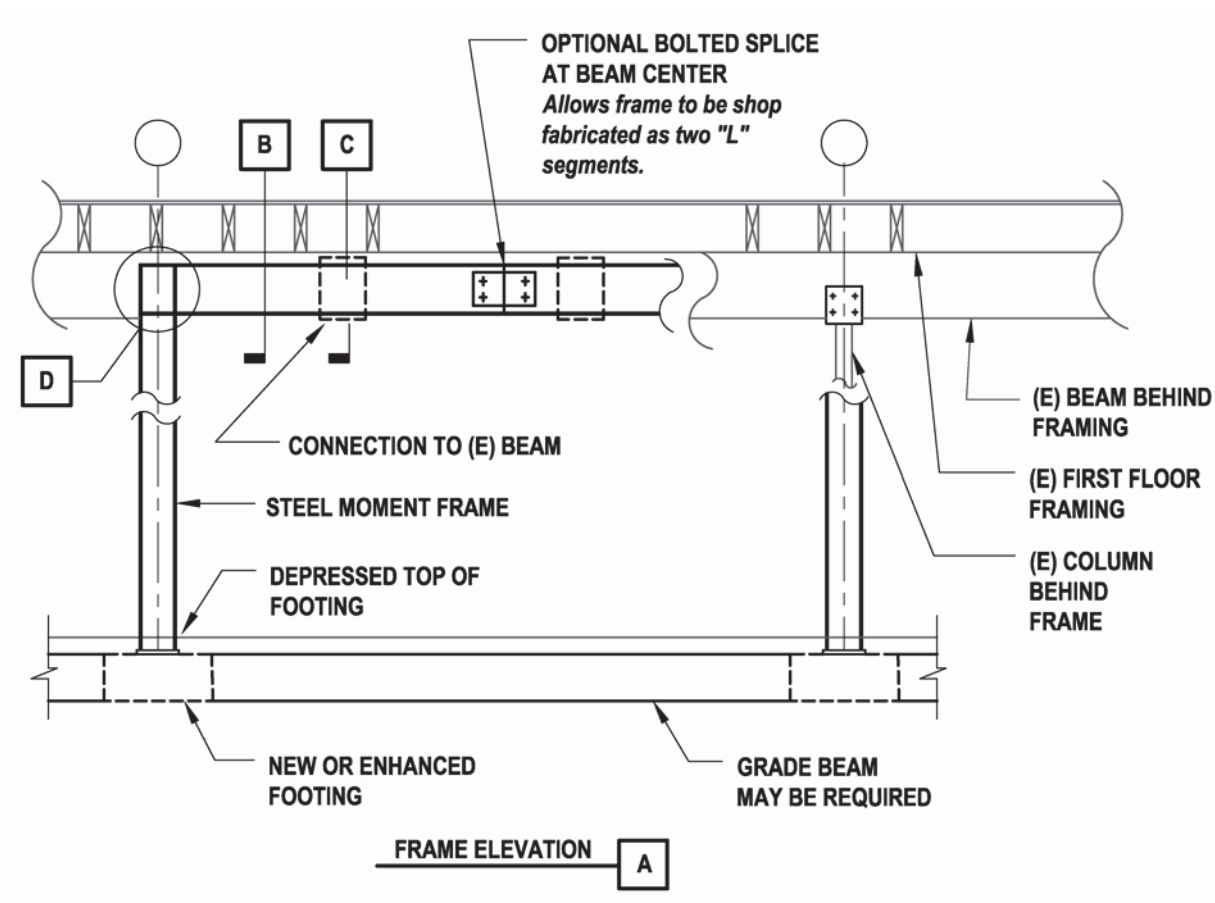
Figure 6.4.1-1A: Elevation of Steel Moment Frame in W1A Building

Figure 6.4.1-1A illustrates an elevation of a typical single-bent steel moment frame added immediately in front of existing beams and columns. Such frames might be added at every second or third framing bay across the building front. Moment frames can be brought to the job site in a complete beam plus two-column bent or in two L-shaped pieces with a field-bolted splice at beam mid-span. The use of two L-shaped pieces allows the critical beam to column connections to be welded in the fabrication shop with better access and quality control. The height required to tilt the frame into place is the factor most commonly governing whether frames are fabricated in one or two pieces. A new foundation will often be required to support the moment frame. This can either be an isolated footing at each end or a continuous footing.

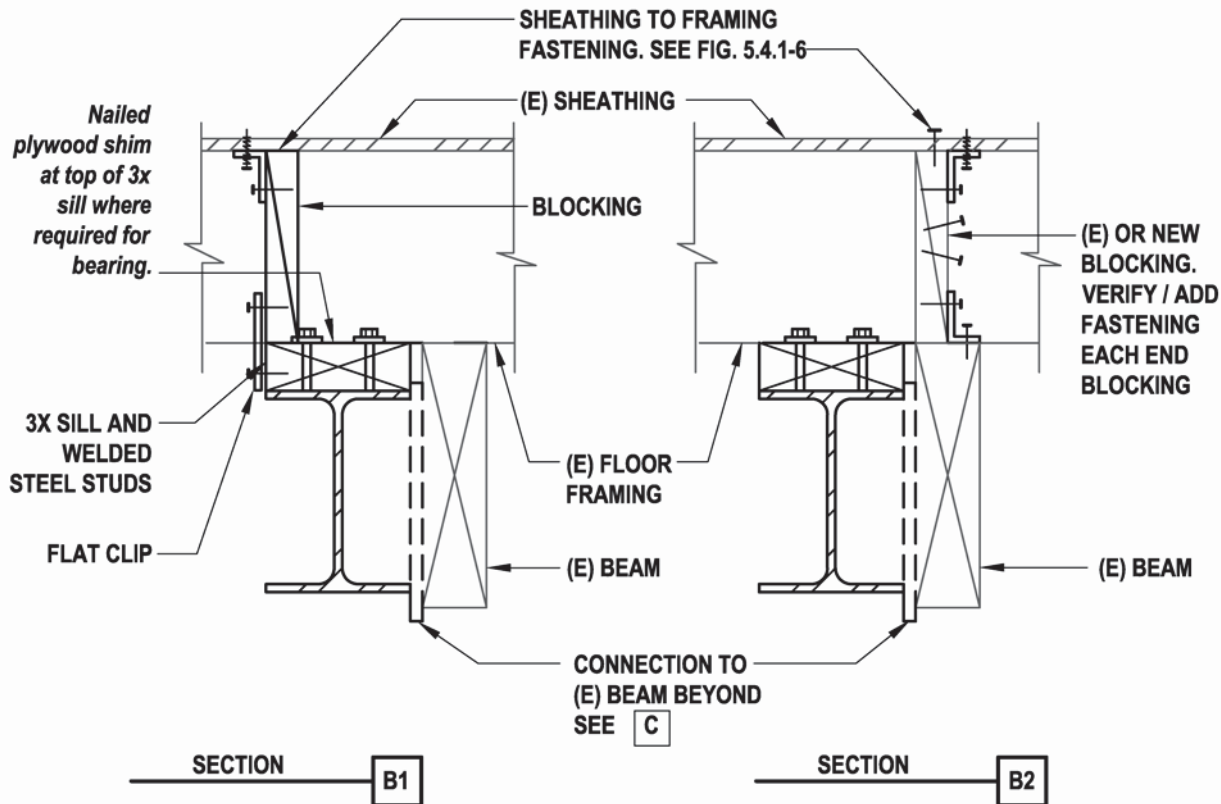
Figure 6.4.1-1B: Shear Transfer Between Moment Frame Beam and Diaphragm

Figures 6.4.1-1B, 6.4.1-1C and 6.4.1-1D illustrate possible connections. See discussion of collectors and shear transfer in the *Design Considerations* section. A number of detailing considerations discussed in Section 5.4.1 are applicable to frame connection to the existing wood building. In particular, detailing must accommodate shrinkage and possible swelling of wood, and alternate fasteners to existing sheathing may be needed.

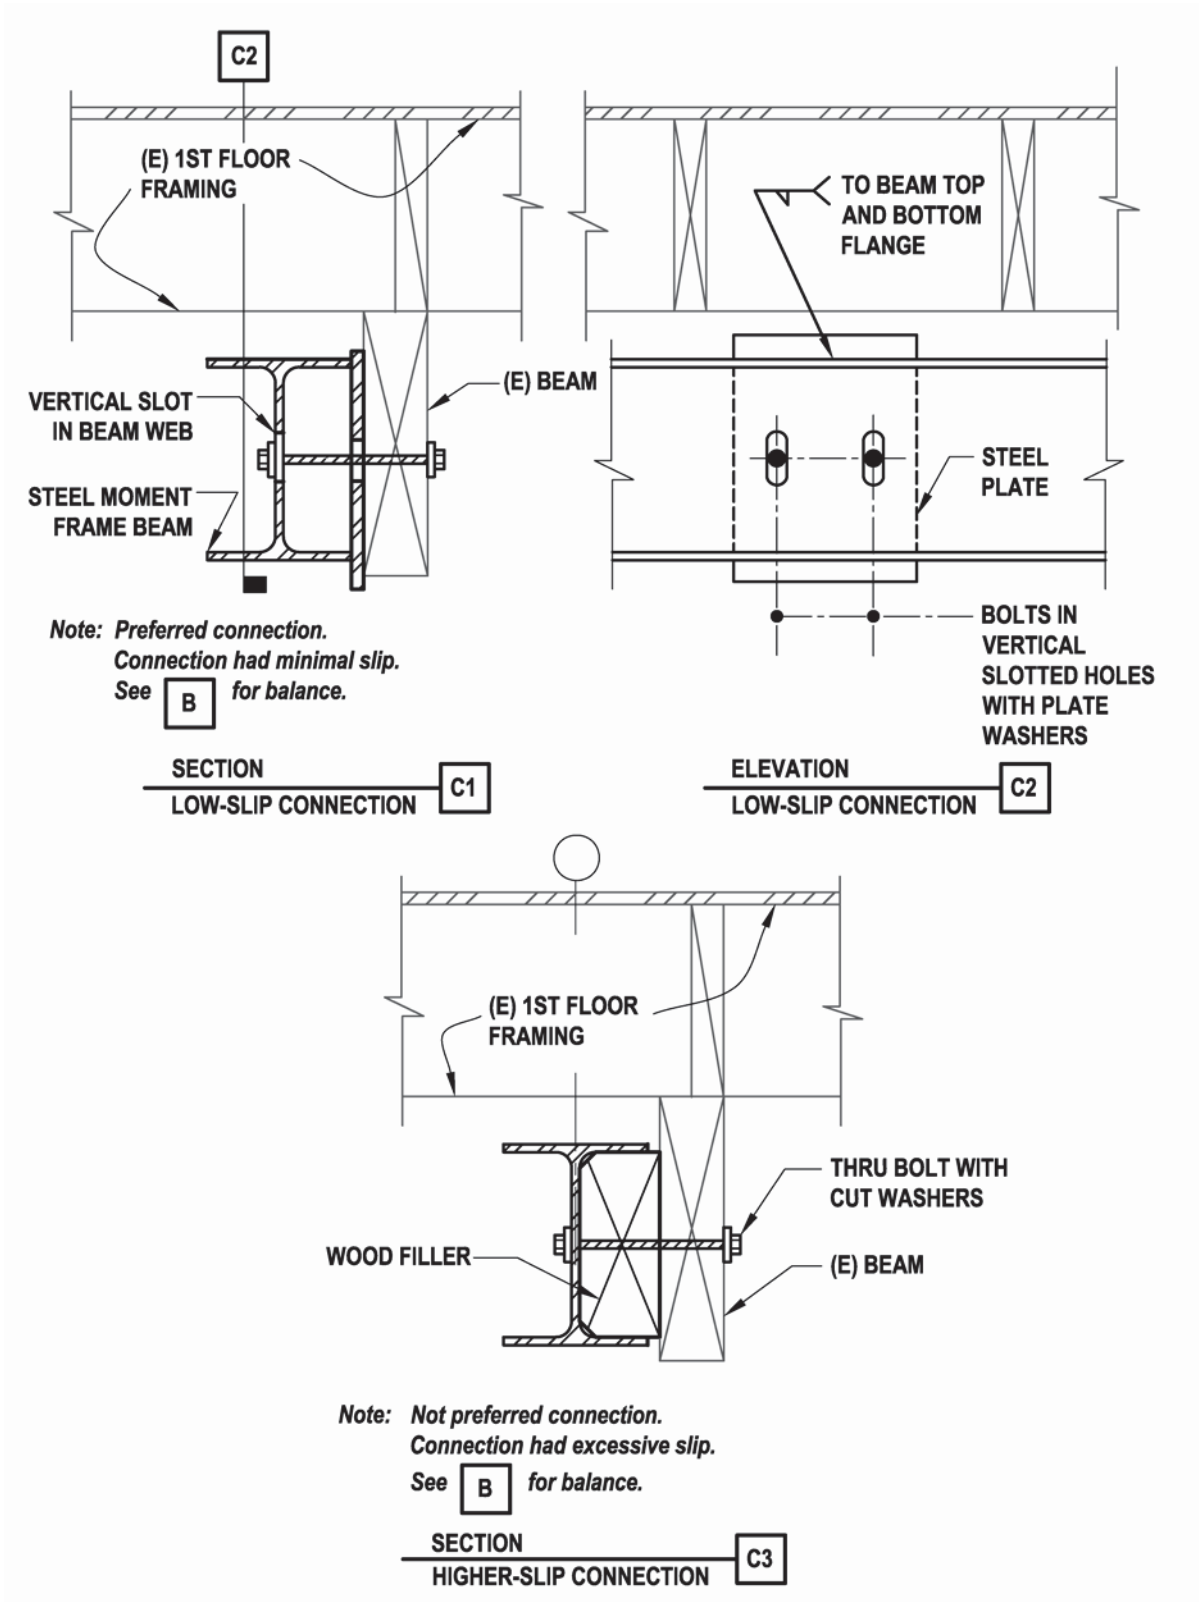
Figure 6.4.1-1C: Shear Transfer from Moment Frame Beam to Collector

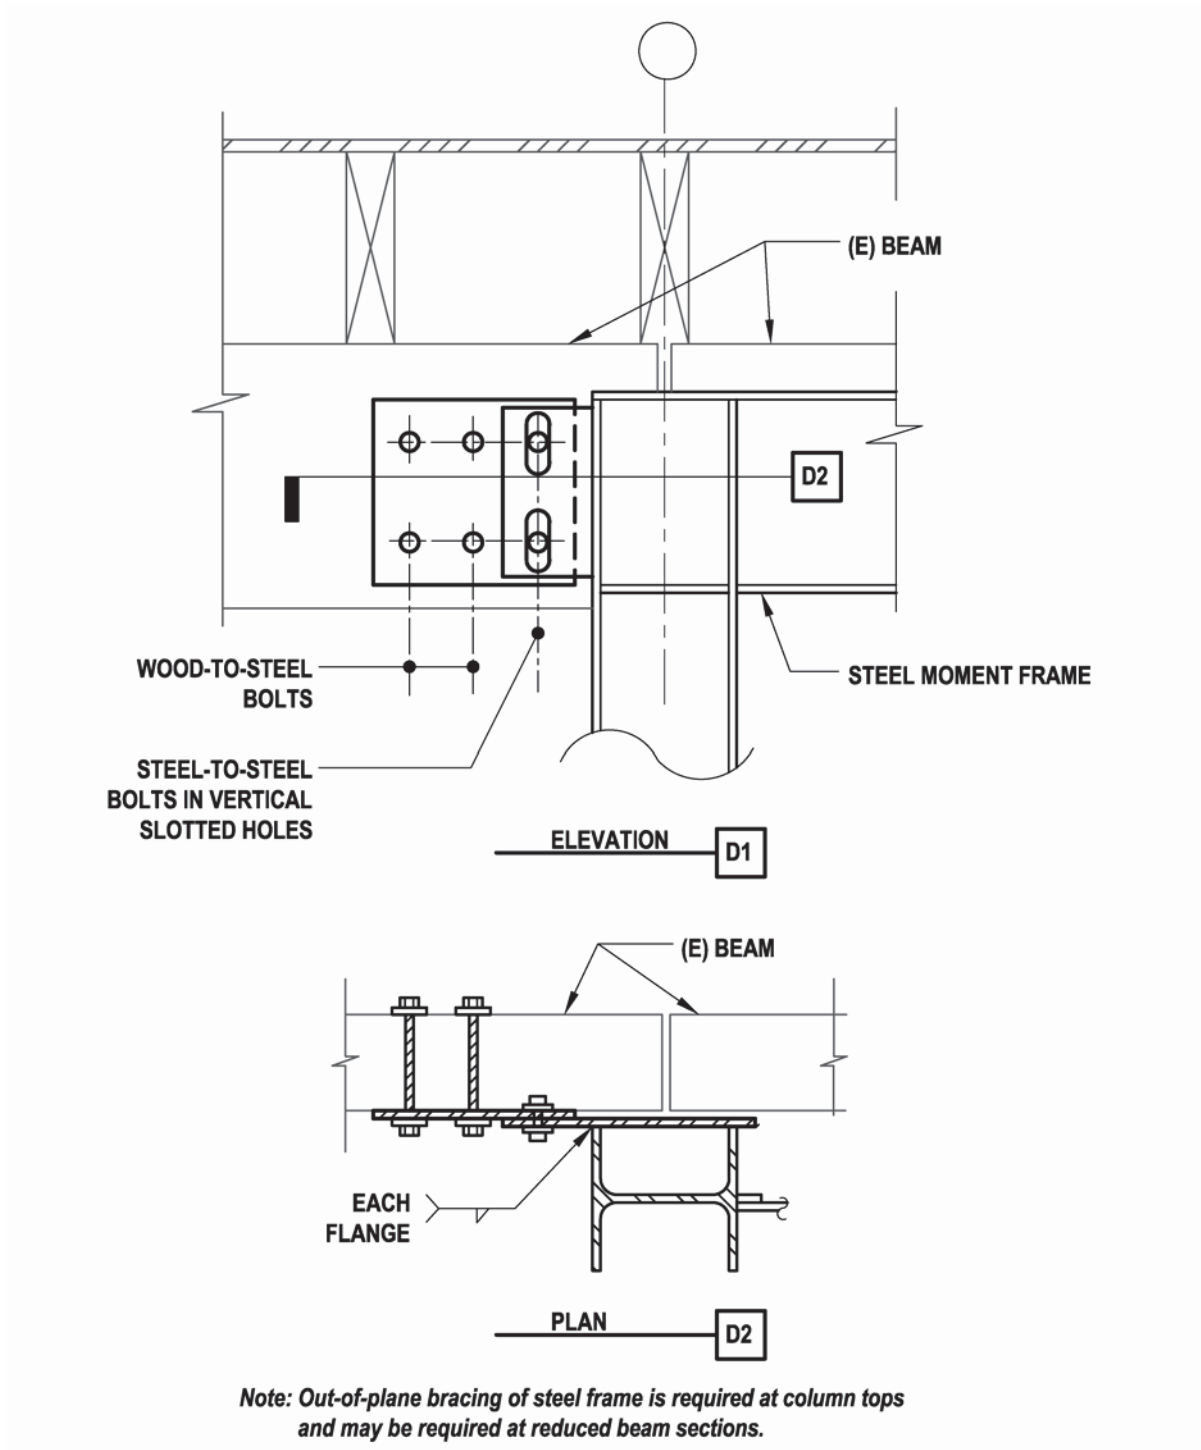
Figure 6.4.1-1D: Shear Transfer from Moment Frame Beam to Collector
