Architectural
Resources Group

609, 611, and 619 NE 3rd Street
McMinnville, Oregon

Historic Resource Assessment
November 2022

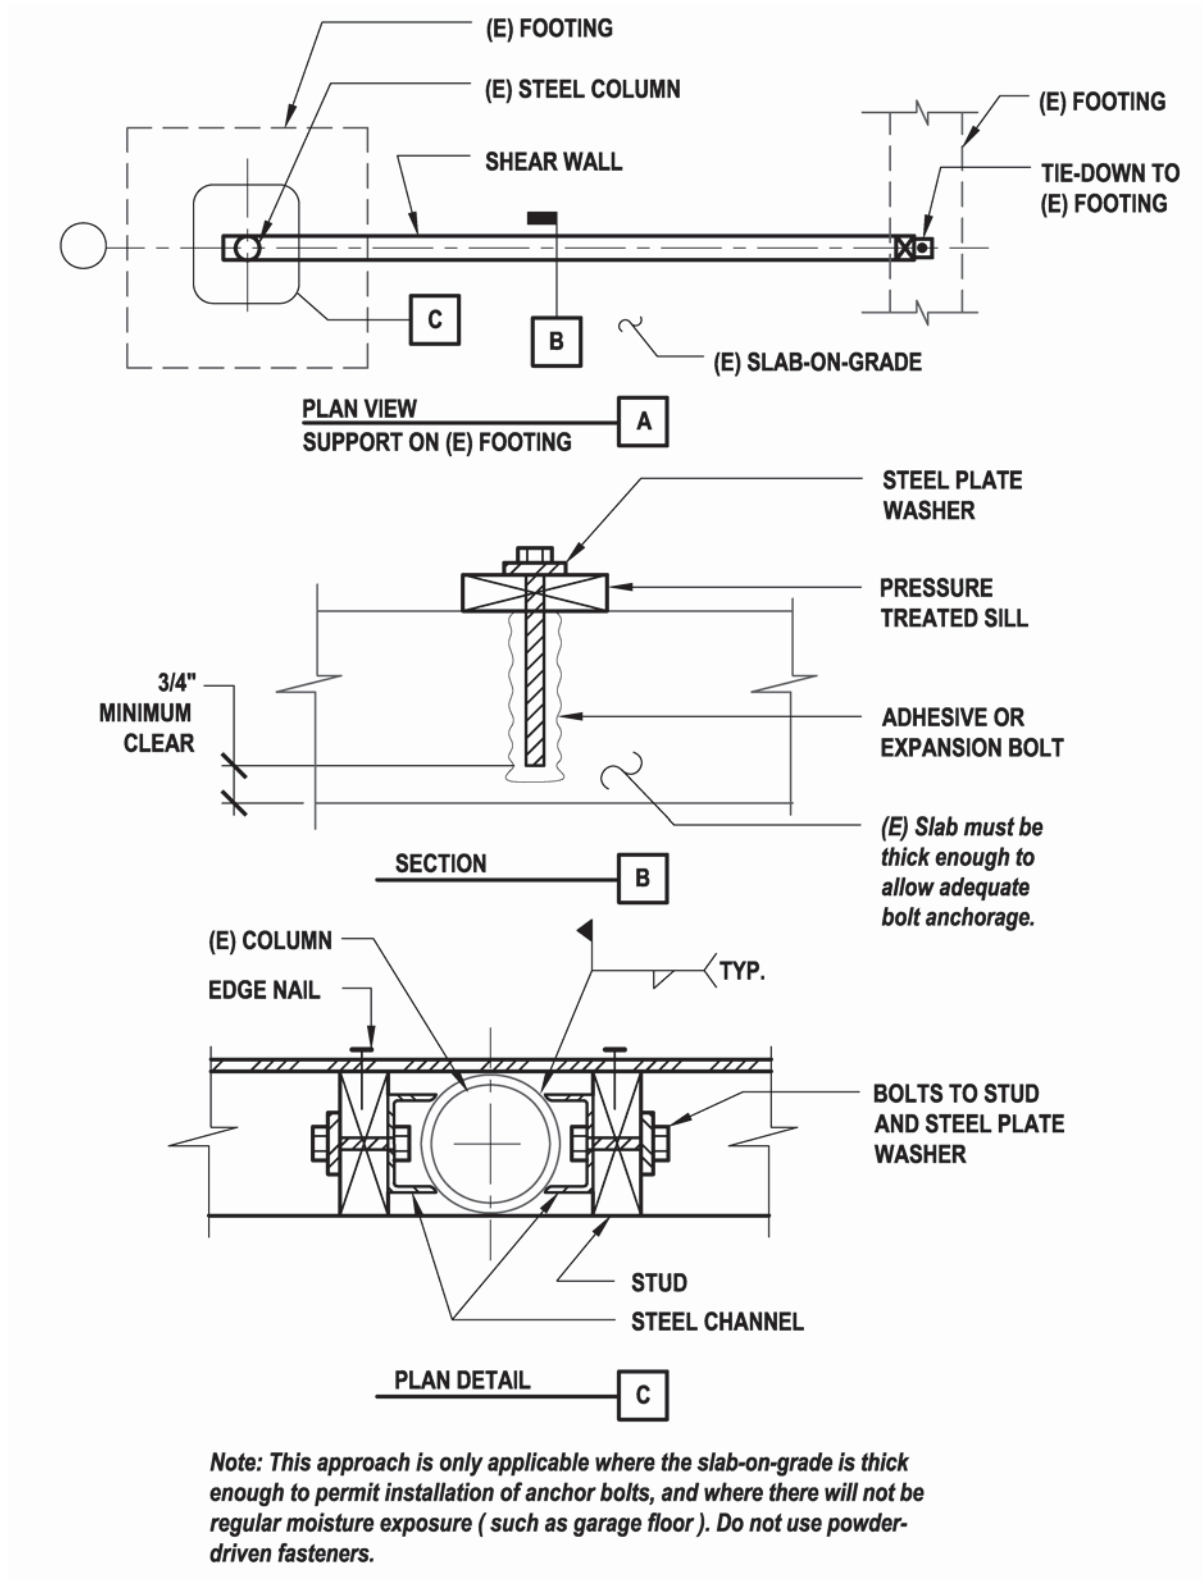
Figure 6.4.2-1: Added Shear Wall Supported on Existing Foundation and Slab

Figure 6.4.2-1 shows a shear wall located so that it can use the dead load carried by a building column to resist uplift at the left hand side and an existing bearing wall foundation at the right

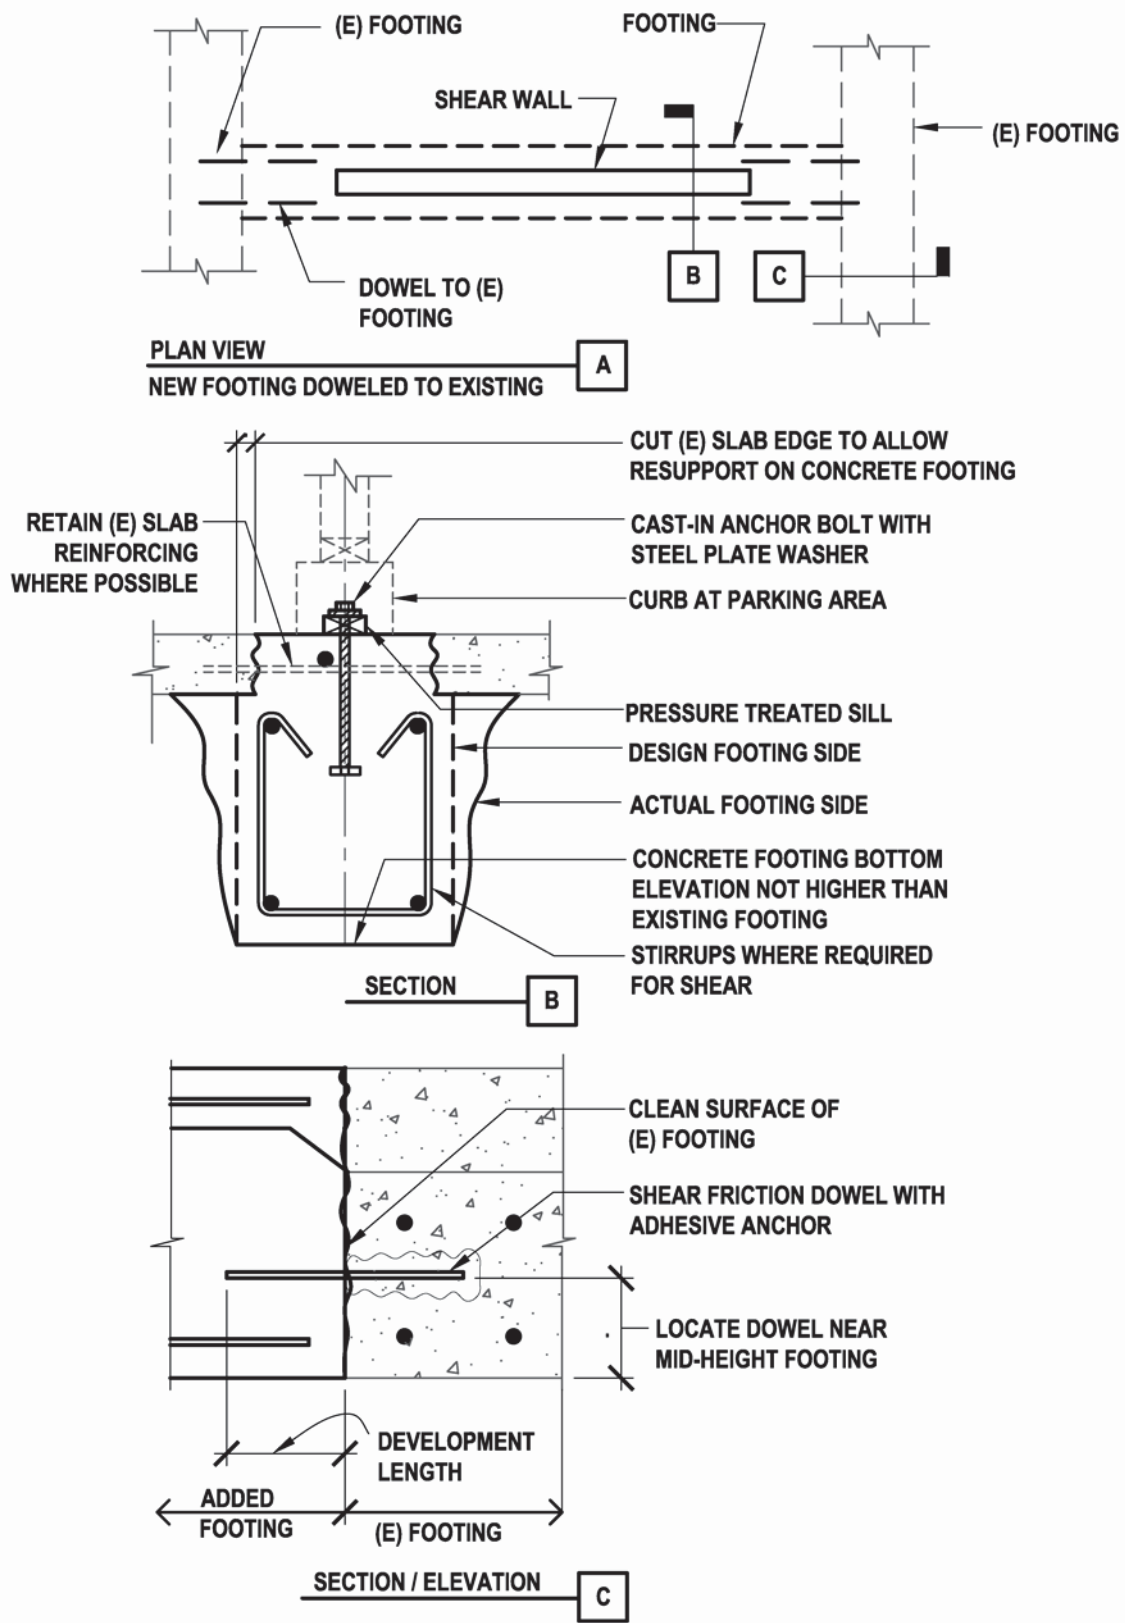
Figure 6.4.2-2: Added Shear Wall Supported by New and Existing Footings

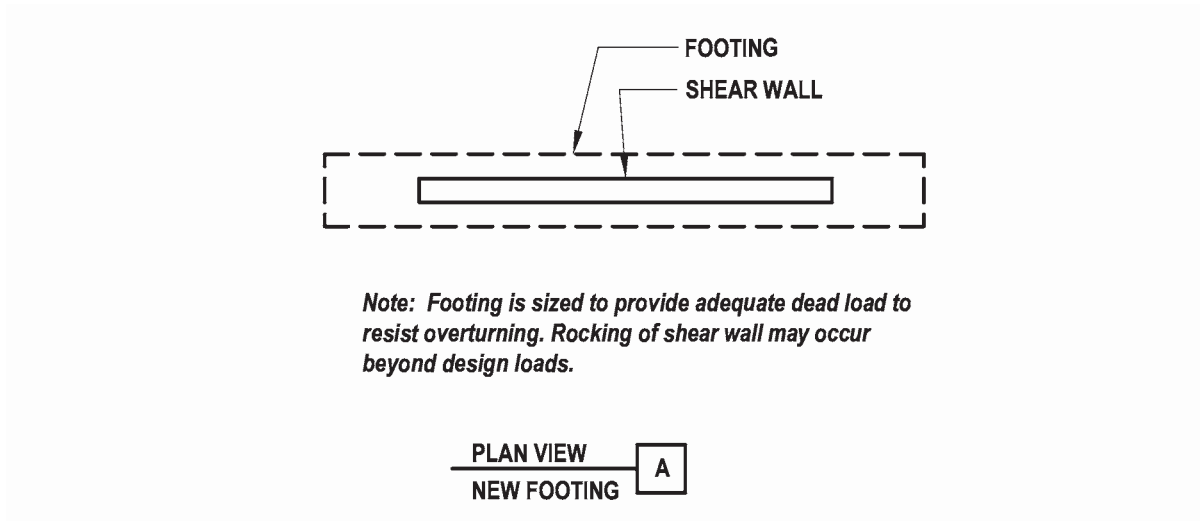
Figure 6.4.2-3: Added Shear Wall Supported on a New Footing

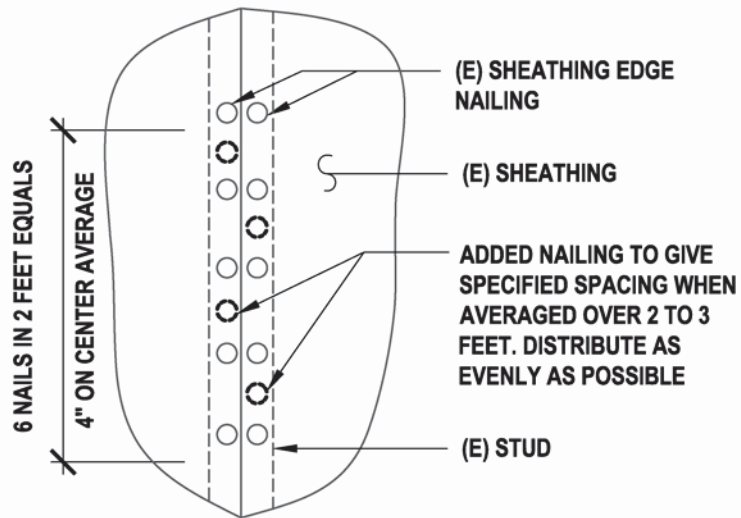
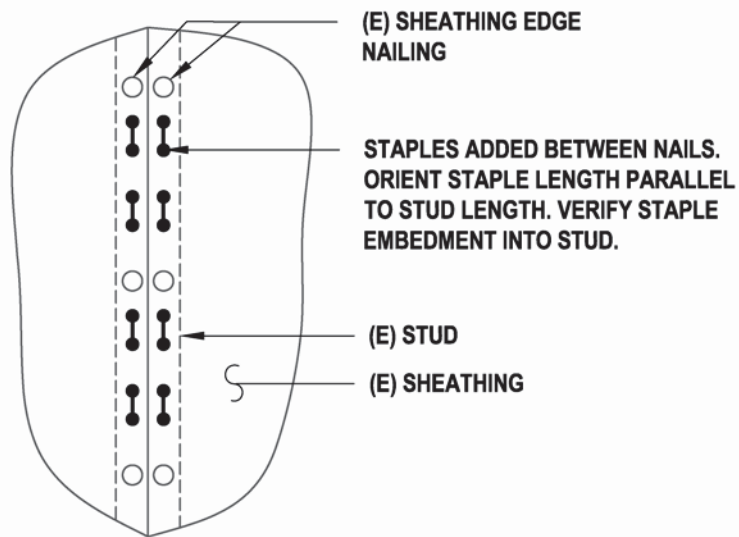
ELEVATION
RENAILING A

ELEVATION
ADDED STAPLES B

Note: These details are only applicable for modest increases in shear wall capacity that do not increase detailing requirements.

Figure 6.4.2-4: Enhanced Shear Wall Sheathing Fastening

Other approaches to enhancing shear wall capacity include the overlaying of new wood structural panel sheathing over existing sheathing and addition of fastening (added nails or staples) to existing sheathing. Figure 6.4.2-4A illustrates the addition of nails to increase shear wall capacity. New nails do not need to be added between every existing nail pair. It is acceptable to space them out to every second or third nail pair, as long as the average over two to three feet meets the needed spacing. It is desirable to distribute added nails as evenly as possible over the height of the wall. Too many nails can reduce performance: additional detailing requirements may be triggered, the wall overstrength will be increased, and demand on anchorages will be increase. Additionally, if not symmetrically placed, added nails can reduce the capacity of the shear wall (Cobeen, Russell and Dolan, 2004).

Figure 6.4.2-4B illustrates the addition of staples. Staples are placed with their long direction parallel to the stud longitudinal direction in order to maintain edge distance in the stud and sheathing. It has been noted that workers placing staples have very little feel for whether the staple penetrates the stud, or is off the stud and only penetrates the sheathing (called a “shiner”). For this reason, careful attention to staple placement is required. This is only an acceptable approach when very modest increases in capacity are required, such that changes in detailing are not required (load path connections into and out of the shear wall, etc.). To date practice has been to waive the requirement for 3x framing at abutting panel joints when stapled shear walls are used. This is because the staples are thought to significantly reduce splitting of the wood

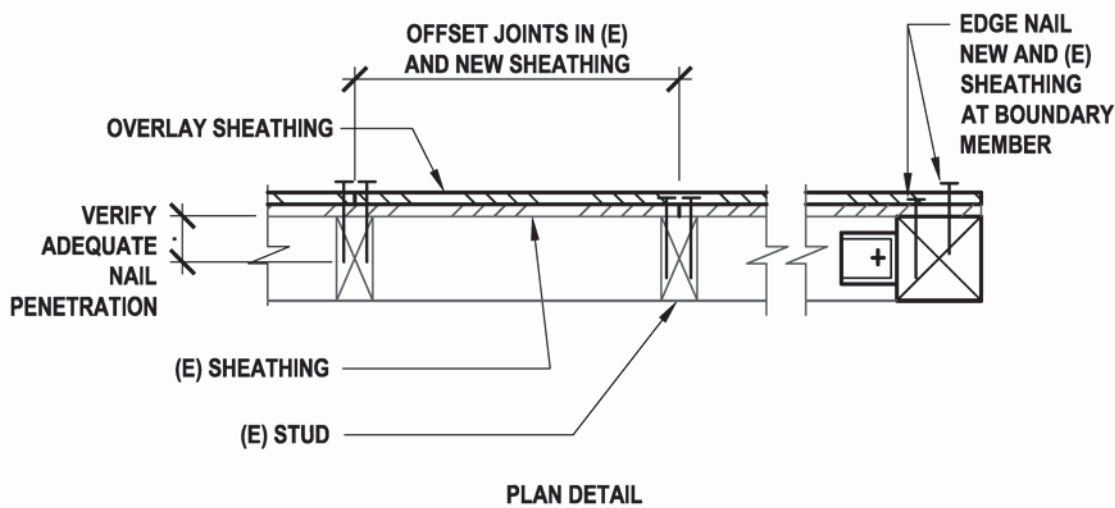
Note: See design considerations for cautions in use of overlays.

Figure 6.4.2-5: Enhanced Shear Wall With Sheathing Overlay

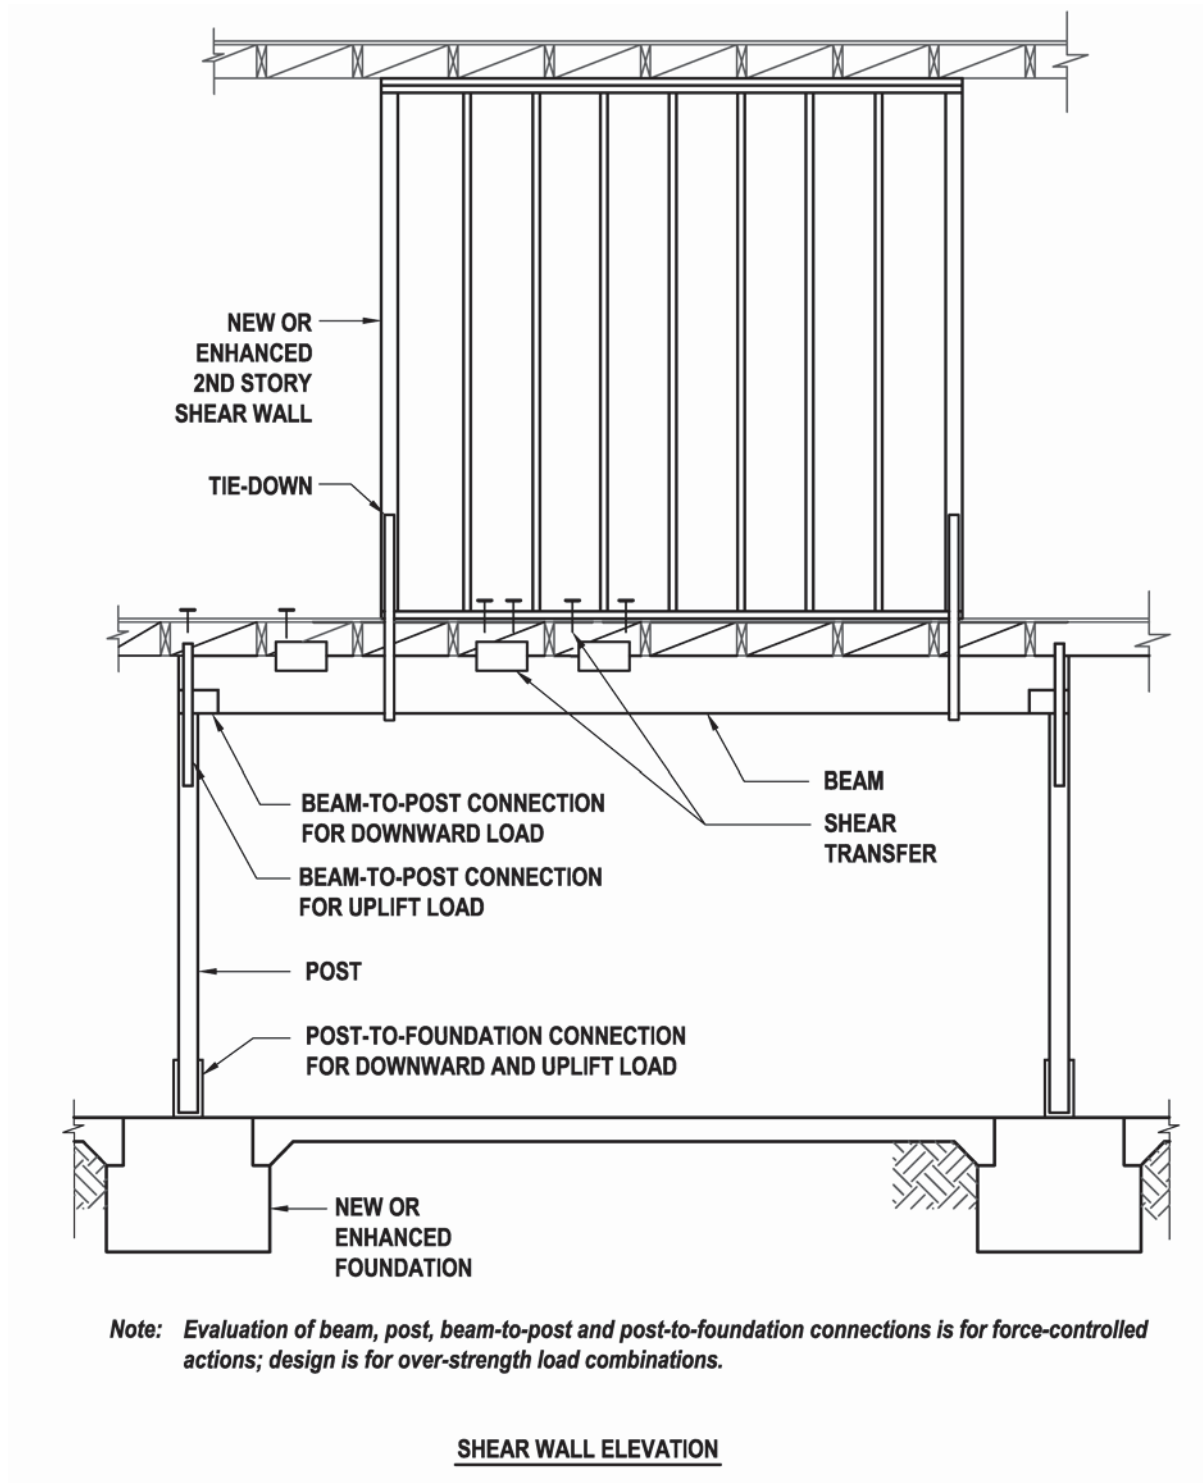
Figure 6.4.3-1: Enhanced Overturning Support for Upper Story Shear Wall

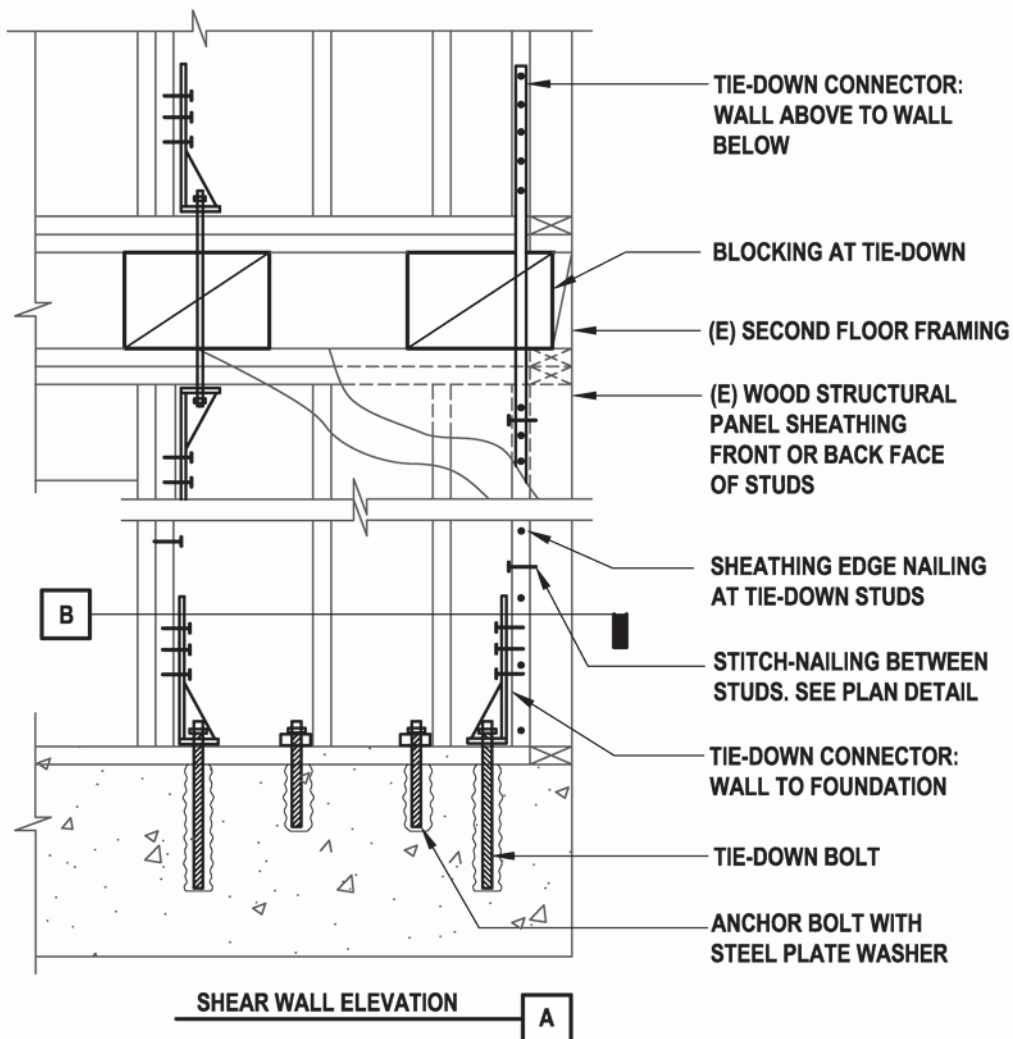
Figure 6.4.4-1A: Shear Wall Elevation with Enhanced Overturning Detailing

Figure 6.4.4-1A illustrates a shear wall elevation with commonly used tie-down connectors for a slab-on-grade condition. Figure 6.4.4-1B illustrates fastening to develop a load path between the tie-down connector and the shear wall sheathing edge nailing. For sheathing and framing conditions other than those shown, similar fastening must be provided to complete the load path.

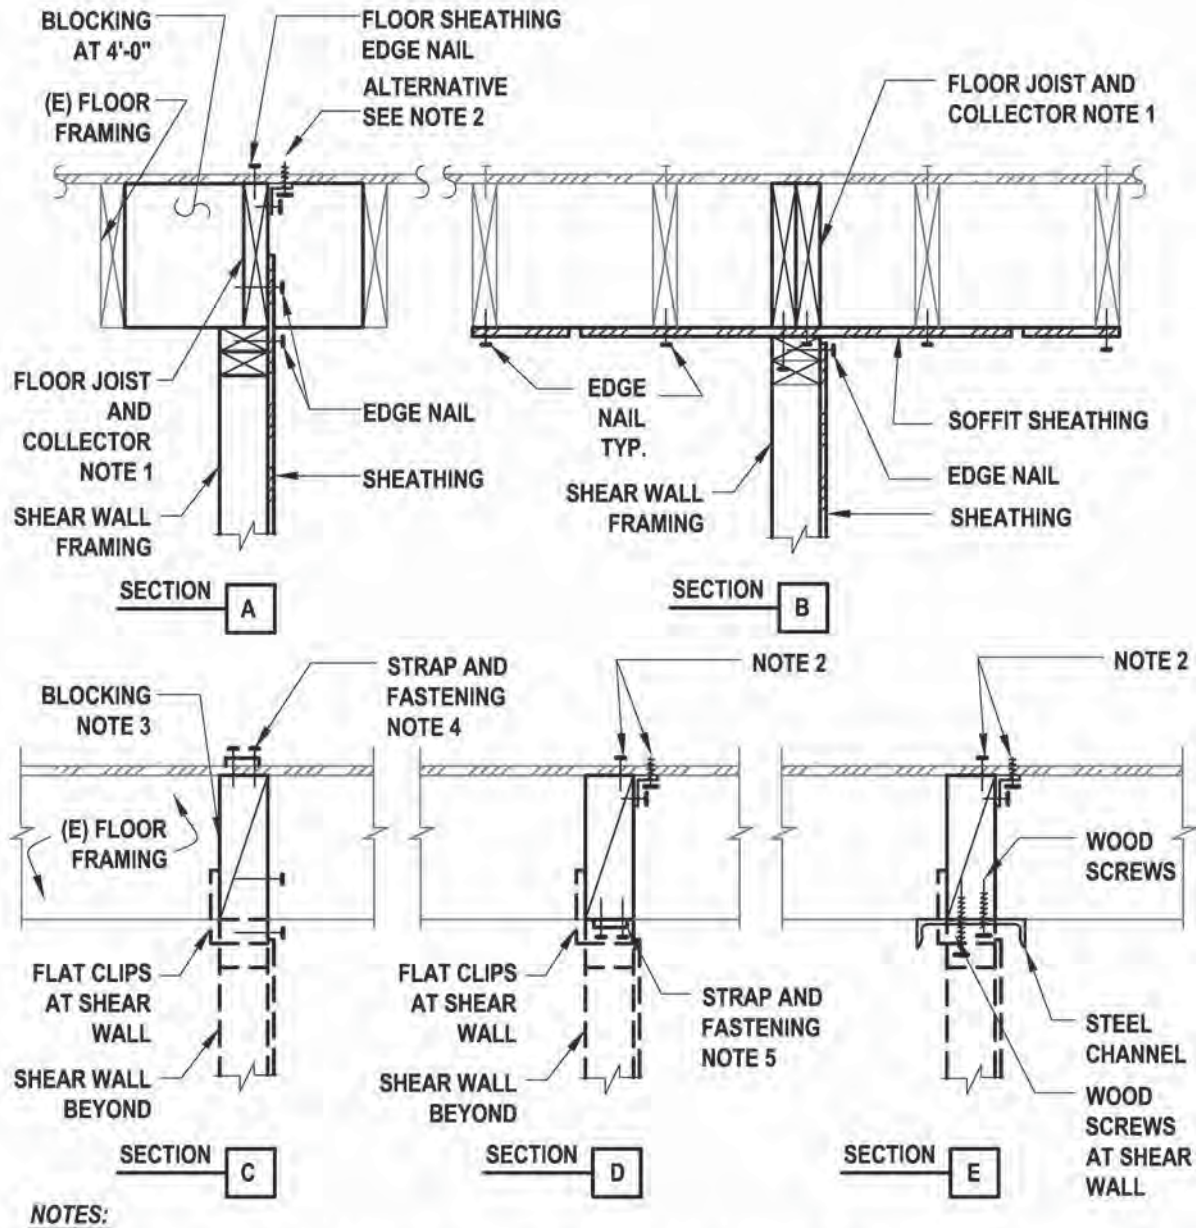
Figure 6.4.5-1 illustrates collectors transferring load into the top of a new or enhanced shear wall. Figures 6.4.5-1A and 6.4.5-1B show new or existing framing parallel to the wall used as a collector. Detail A assumes that fastening of the diaphragm sheathing to framing exists or can be provided. Load transfer to the diaphragm can occur over the length of the new or existing

NOTES:

1. Where existing framing falls at new wall location use existing joist, otherwise add joist/collector. Where existing or added floor joists act as the collector, provide tension and compression connection at all breaks in floor joists over the required collector length.

Where the top of the existing diaphragm sheathing cannot be accessed for additional sheathing nailing, sheathing added at the ceiling soffit can help distribute forces into the existing diaphragm, as shown in Figure 6.4.5-1B.

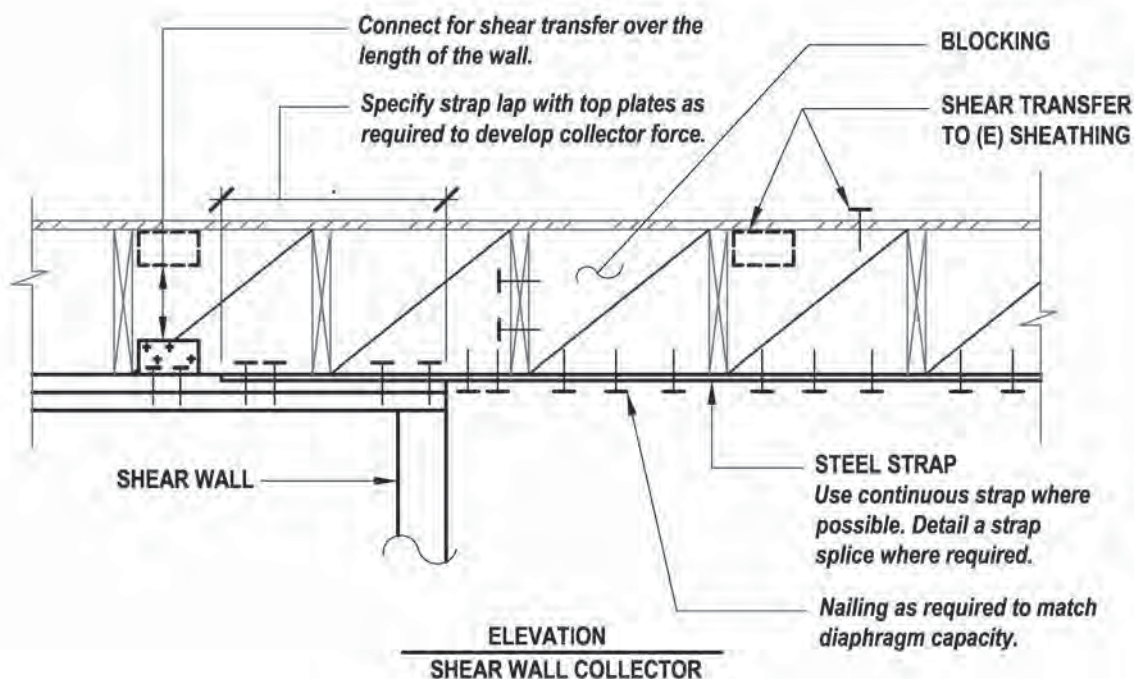
Figure 6.4.5-3: Collector Using Added Blocking at Framing Perpendicular to Shear Wall

Where framing runs perpendicular to the framing direction, there is sometimes little choice but to use steel straps for tension and blocking or framing members for compression, as shown in Figure 6.4.5-3. Unless the straps are reasonably stiff and blocking is installed tight, significant deformation could occur in the collector, resulting in limited efficiency for transferring loads. Although this type of collector is used commonly in new construction and rehabilitation, little is known about its effectiveness and resulting building performance. Conversely, however, significant distress in diaphragms in **W1A** buildings has only been seen at significant changes in geometry such as re-entrant corners (Schierle, 2002). If collectors are to be installed, it is recommended that they be made as stiff and tight-fitting as possible. Sizing of the collector member using overstrength forces or as force-controlled actions will help keep the collector stiff, therefore increasing likely performance.

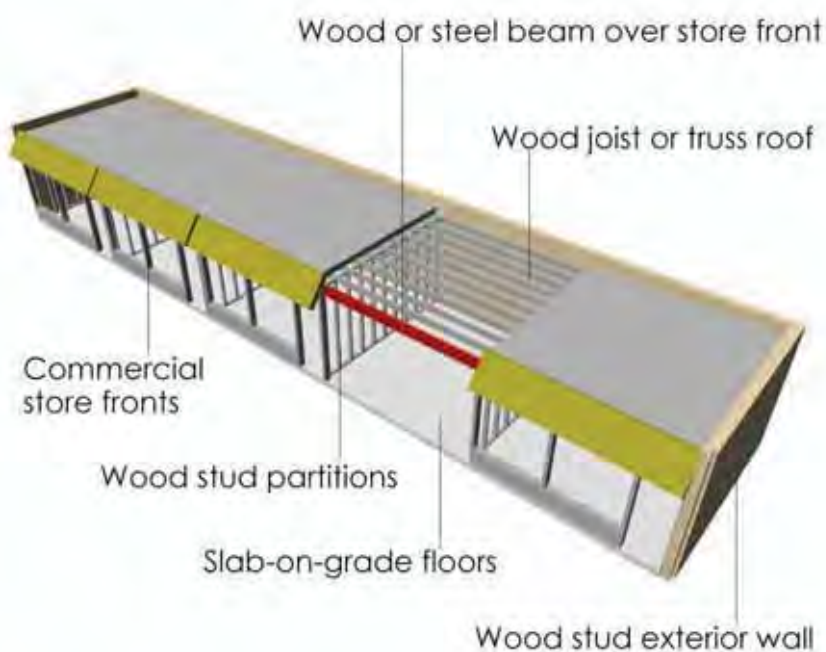
Figure 7.1-1: Building Type W2: Woodframes, Commercial and Industrial

Building Type **W2** consists of commercial, institutional, and smaller industrial buildings constructed primarily of wood framing. Most **W2** buildings have first floor slab-on-grade construction; however, woodframe floors supported on foundation walls or cripple walls occur. The upper floor and roof framing consist of wood joists and can include wood or steel trusses, beams, and columns. Post and beam framing is common at interior and at storefronts or garage openings. Lateral forces are resisted by woodframe diaphragms and shear walls. In older buildings, steel rod bracing systems may also be used in place of diaphragms. In newer buildings, wood shear walls are sometimes used in combination with isolated concrete or masonry shear walls or steel braced frames or moment frames. Figure 7.1-1 provides one illustration of this building type.

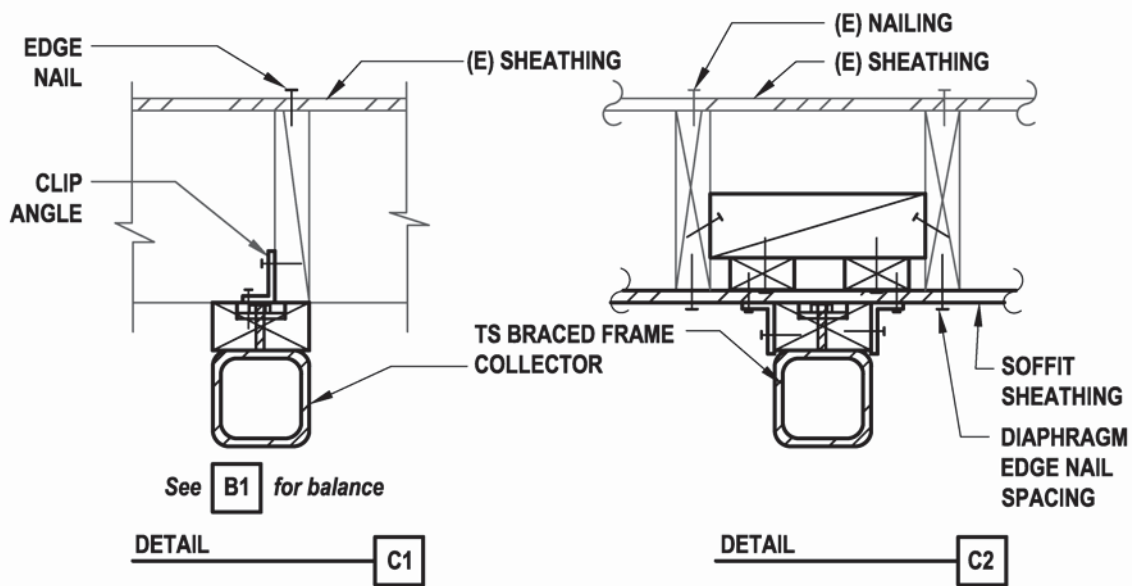
Figure 7.4.1-1C: Shear Transfer and Collector for Steel Braced Frame

Figures 7.4.1-1C1 and 7.4.1-1C2 illustrate collector members and their connection to framing perpendicular and parallel to the frame. These details are discussed further in Section 7.4.2.

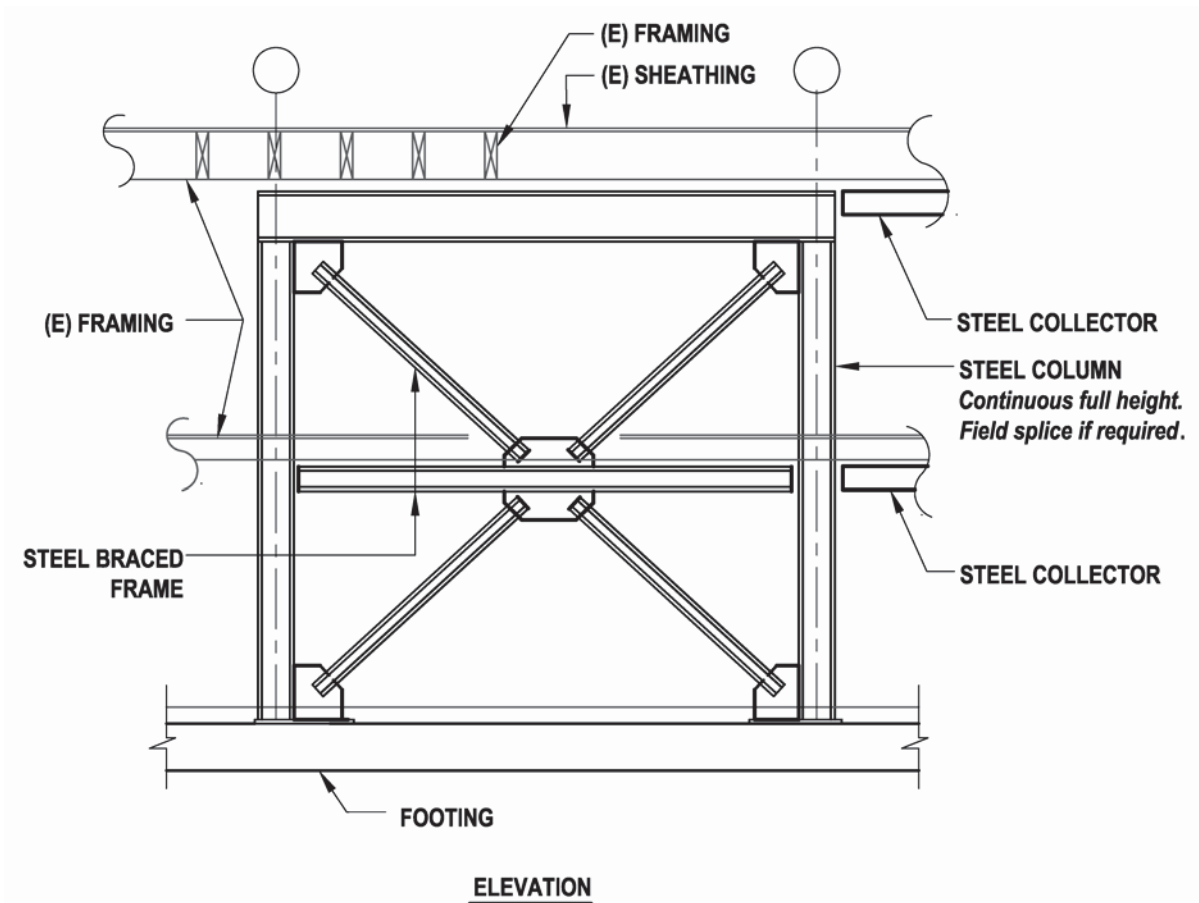
Figure 7.4.1-2: Two-Story Steel Braced Frame in a W2 Building

Figure 7.4.1-2 illustrates a two-story steel braced frame added in a **W2** building. Significant in this detail is that the second floor is opened up allowing the braced frame to run continuous over the two-story height. Installing a separate frame at each story would lead to unmanageable connection details; the two-story configuration provides the strongest and stiffest solution. Shear

transfer, collectors, and frame member bracing need to be provided at the second floor as well as the roof.

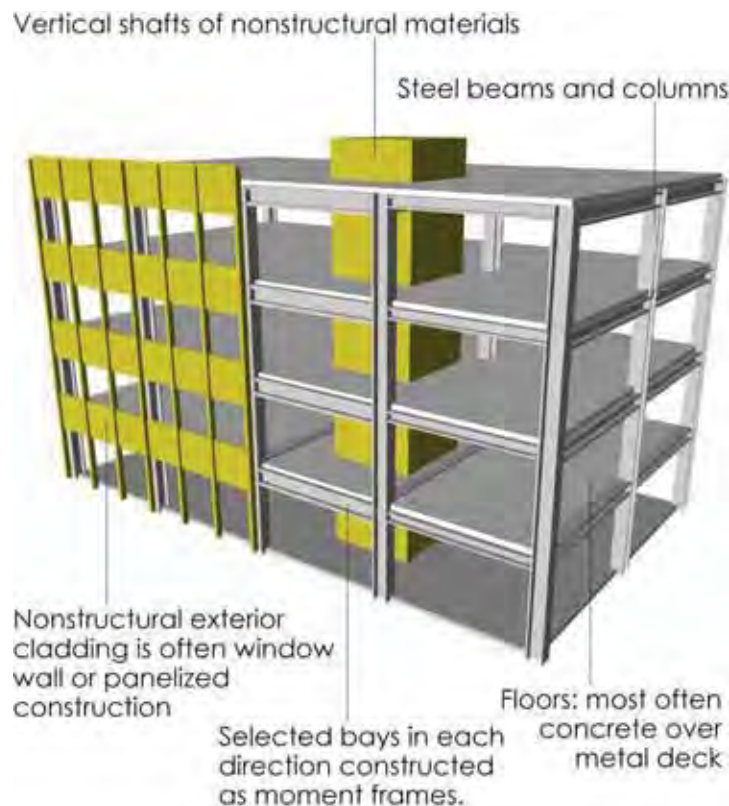
Figure 8.1-1: Building Type S1: Steel Moment Frames

Building Type **S1** consists of an essentially complete frame assembly of steel beams and columns. Lateral forces are resisted by moment frames that develop stiffness through rigid connections of the beam and column created by angles, plates, and bolts, and/or by welding. Moment frames may be developed on all framing lines or only in selected bays. It is significant that no structural walls or steel braces are provided. Floors are cast-in-place concrete slabs or concrete fill over metal deck. These buildings are used for a wide variety of occupancies such as offices, hospitals, laboratories, and academic and government buildings. Figure 8.1-1 shows an example of this building type.

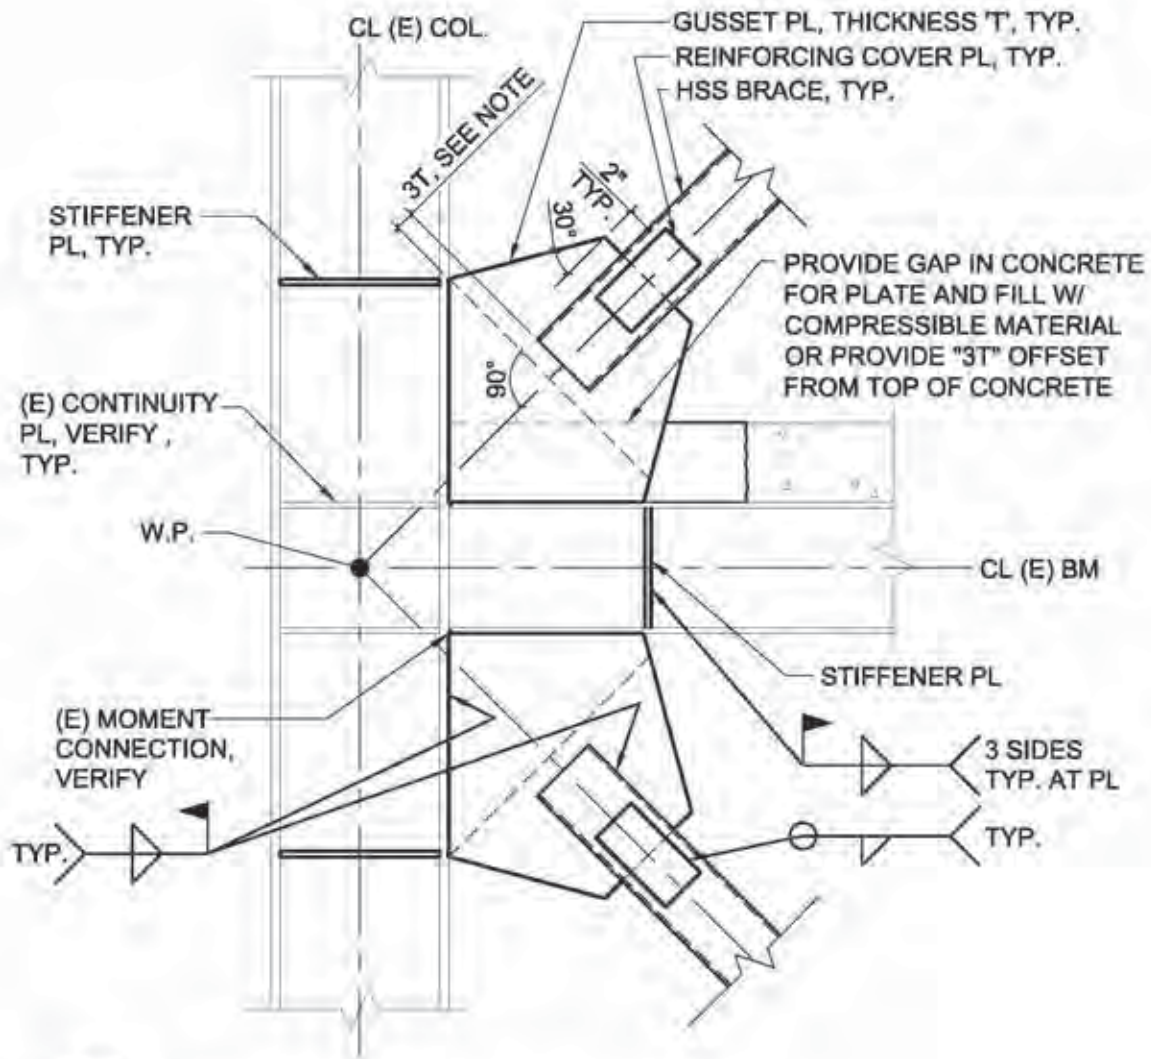
Figure 8.4.1-1: HSS Brace at Existing Beam-Column Connection in SCBF

Note:
 AISC recommends $2T$ to allow for restraint-free plastic rotations.
 $3T$ is shown here to accommodate overcutting of HSS slots.

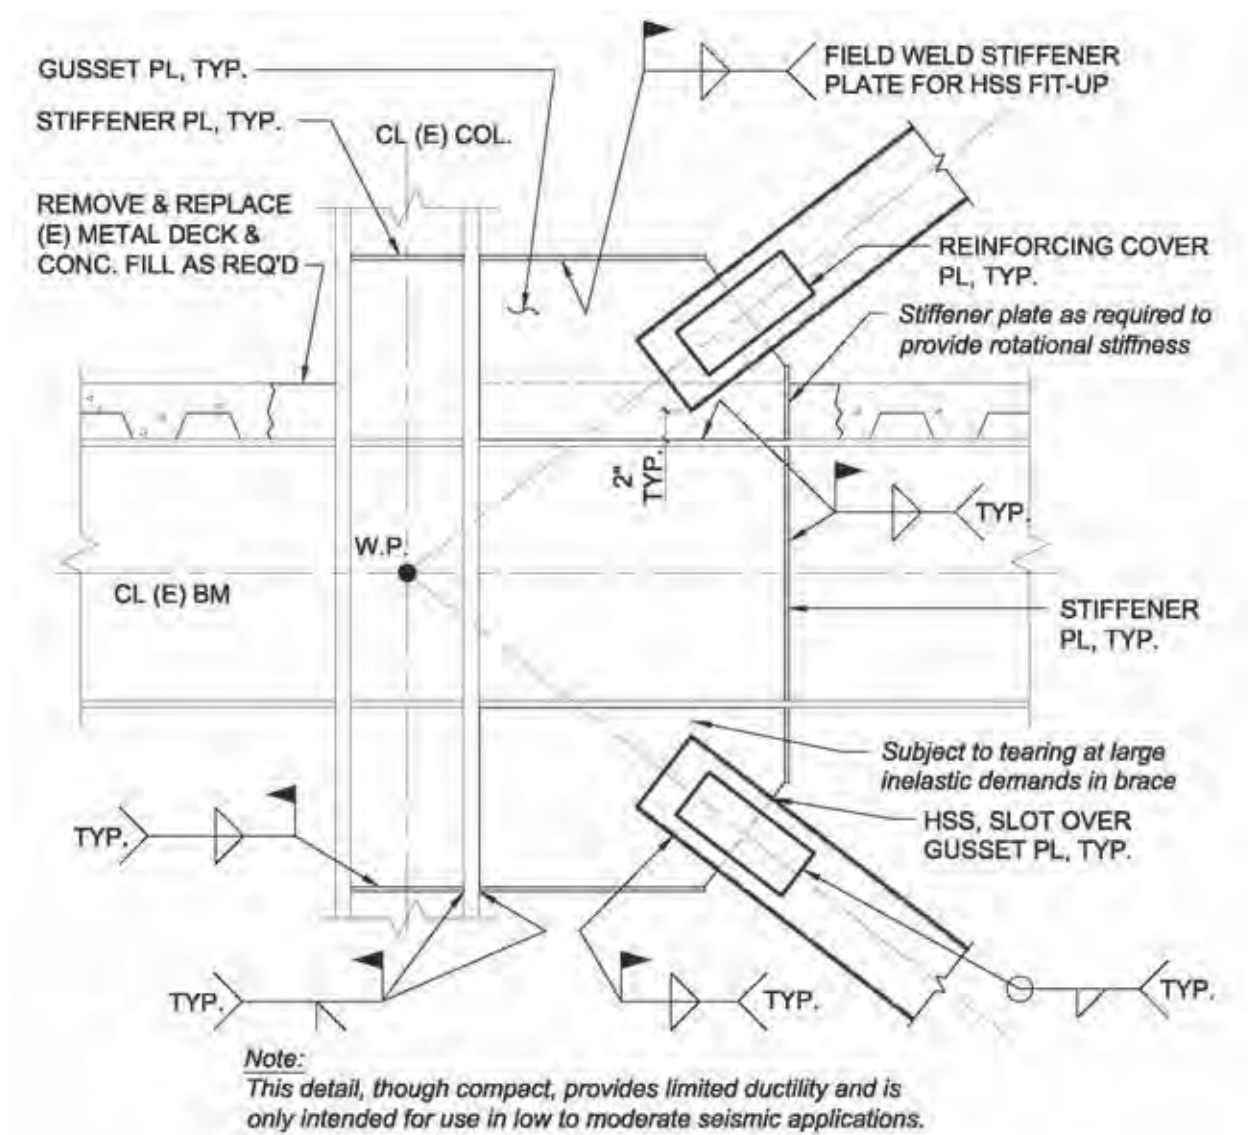
Figure 8.4.1-2: HSS Brace at Existing Beam-Column Connection in Ordinary CBF

For low to moderate seismic applications, Figure 8.4.1-2 shows a more compact connection. An example of a W-shape used as a brace and welded directly to the beam and column is shown in Figure 8.4.1-3. The two latter connections do not allow for restraint-free plastic rotations out-of-plane and should be used primarily in situations where in-plane buckling of the braces govern or

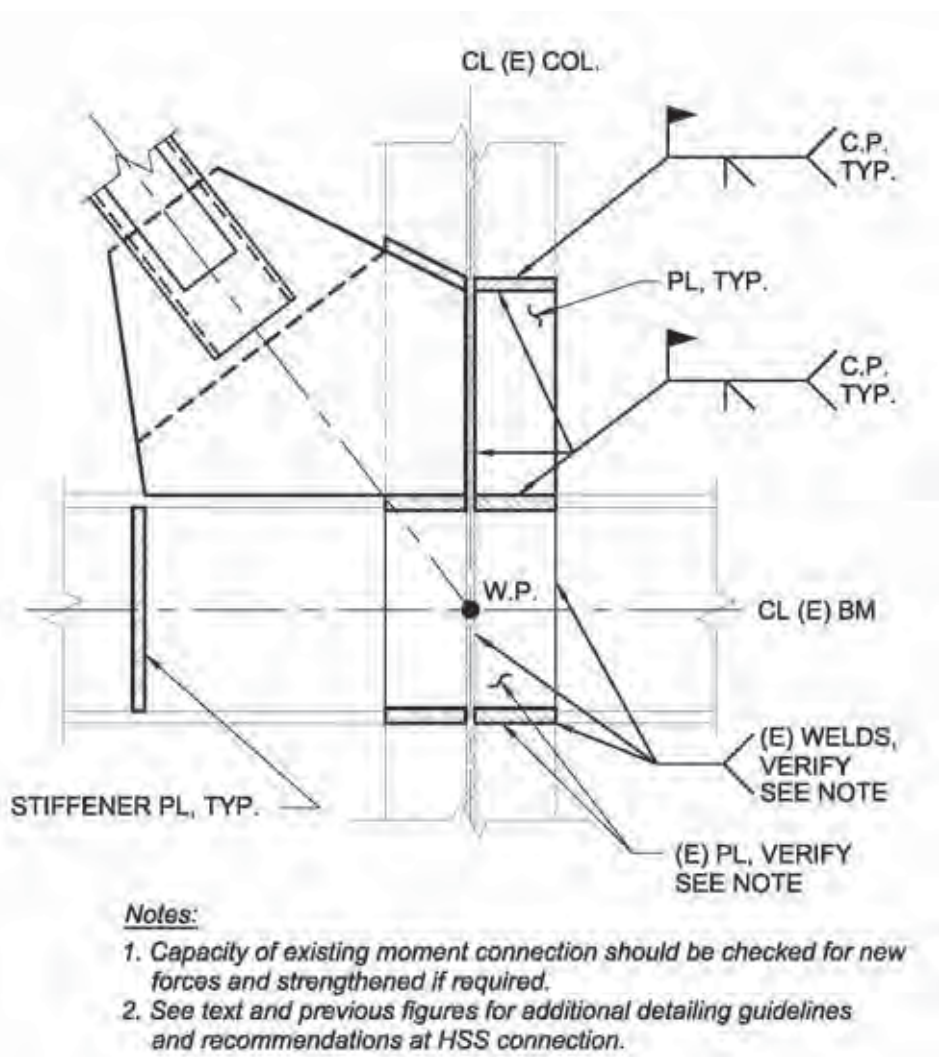
Figure 8.4.1-3: HSS Braced at Existing Beam-Column Connection

ductility demands are low. In addition, the connection shown in Figure 8.4.1-3 requires extensive field welding and could present fit-up issues if field dimensions are not verified on a case-by-case basis.

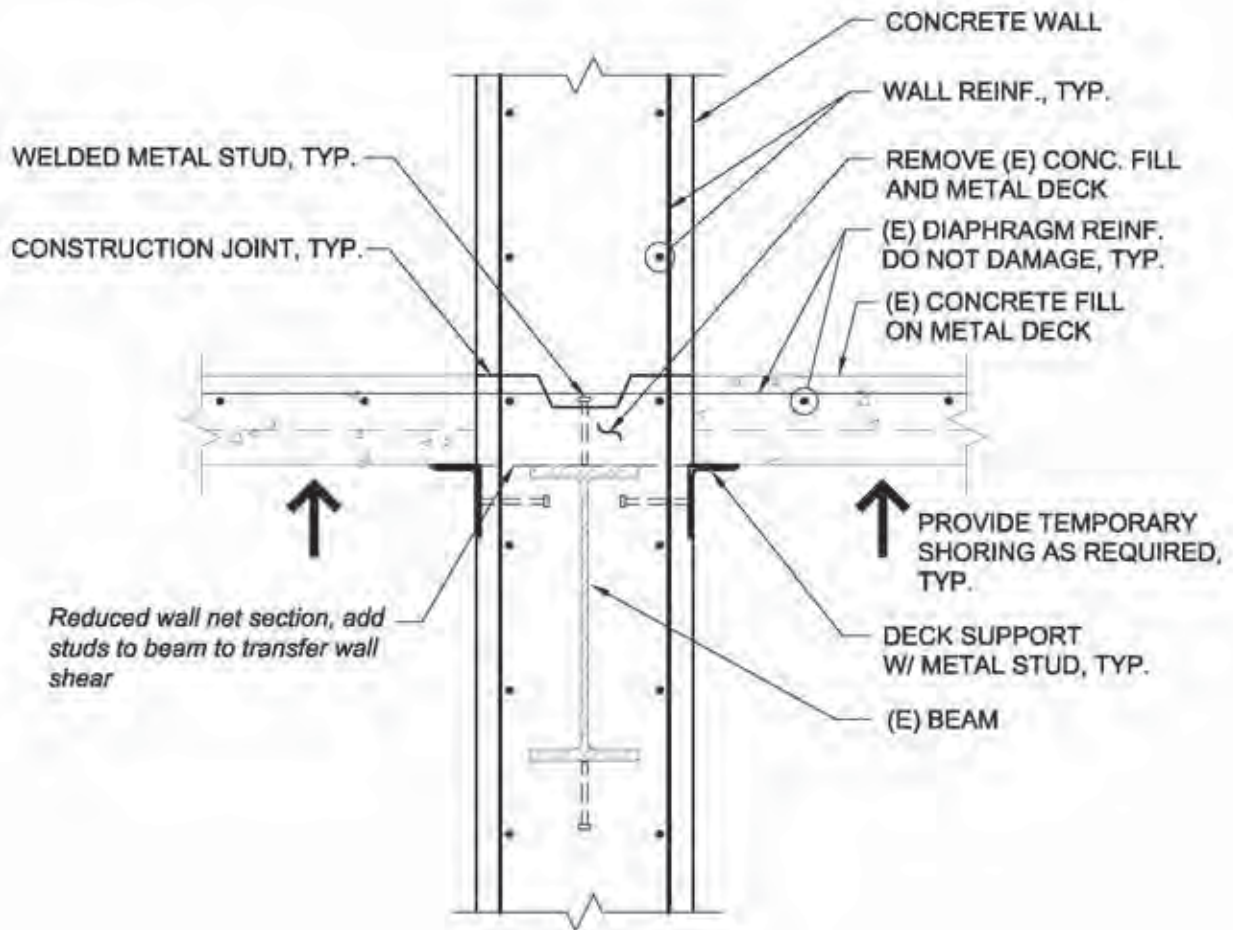
Figure 8.4.2-1: Cast-in-Place Concrete Wall at Existing Beam

Note:
Offset wall to one side of beam if additional room required for vibrating equipment or for shotcrete construction.

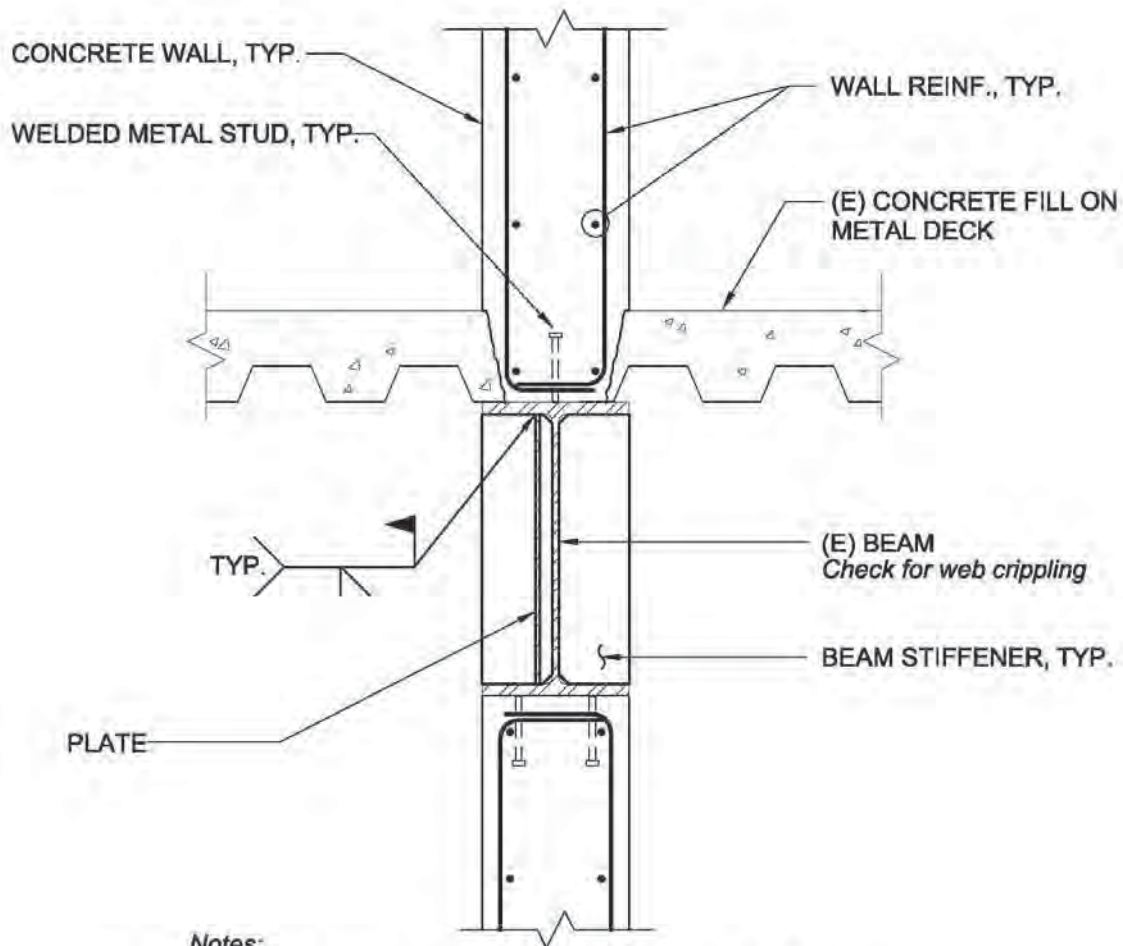
Figure 8.4.2-3: Discontinuous Wall at Existing Beam

1. Detail is appropriate for shotcrete construction and more problematic for cast-in-place concrete construction due to concrete placement and vibrating challenges.
2. Shear in wall is transferred entirely through studs.
3. For deck perpendicular to beam condition, number of metal studs limited by deck flute spacing.

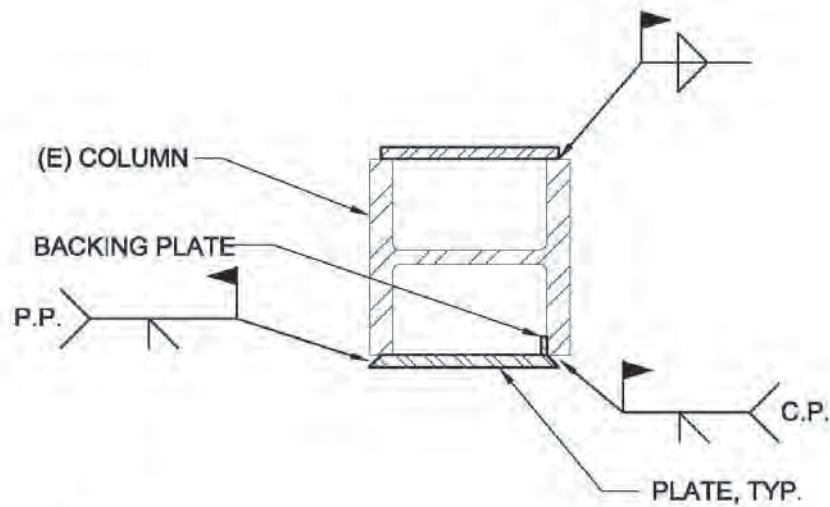
Figure 8.4.3-2: Box Section at Existing Column

Note:
Welds shown indicate alternate possibilities of plate attachment.
