Architectural
Resources Group

609, 611, and 619 NE 3rd Street
McMinnville, Oregon

Historic Resource Assessment
November 2022

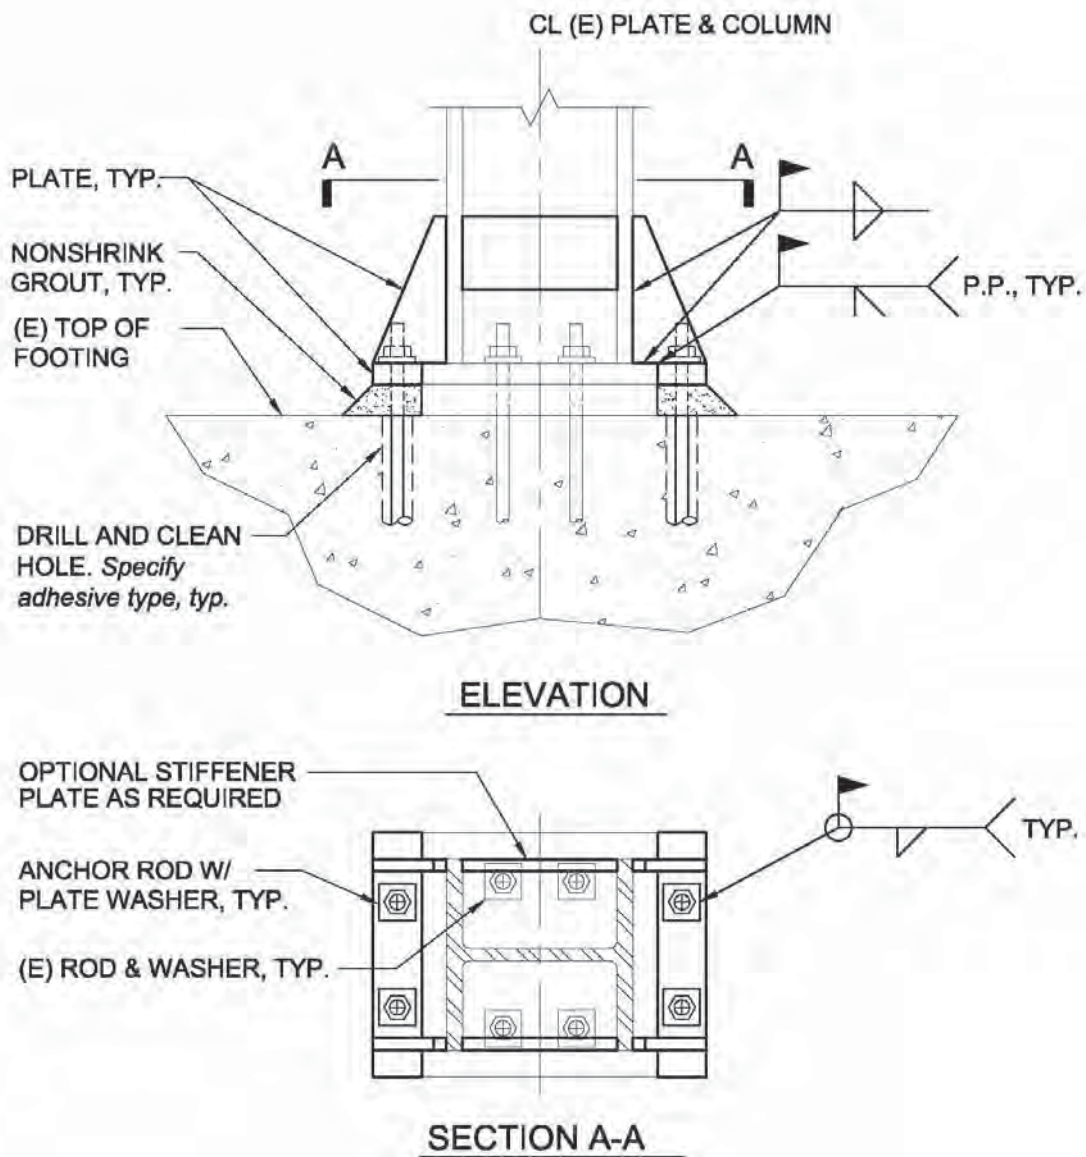
Figure 8.4.5-1: Modified Base Plate to Increase Uplift Capacity

hole large enough in an existing footing to accommodate a bolt head or nut, manufacturers of grouts and adhesives sometimes limit the size of the hole for a given rod diameter in which its product can be used as an infill. In this case, the tensile force has to be developed entirely through bond. For bond development, the rod has to be threaded or some other means of mechanical anchorage has to be provided along the rod. Anchor rods are not typically used to transfer shear to the foundation because the mechanism for shear transfer is difficult to define and still subject to debate. If unavoidable, several factors should be considered, including bending of the rod through the oversized hole in the base plate and shear and tension interaction on the rod. If the column shear force is being distributed between both new and existing rods, note that the holes for the existing rods are likely to be oversized and welded plate washers should be verified or provided.

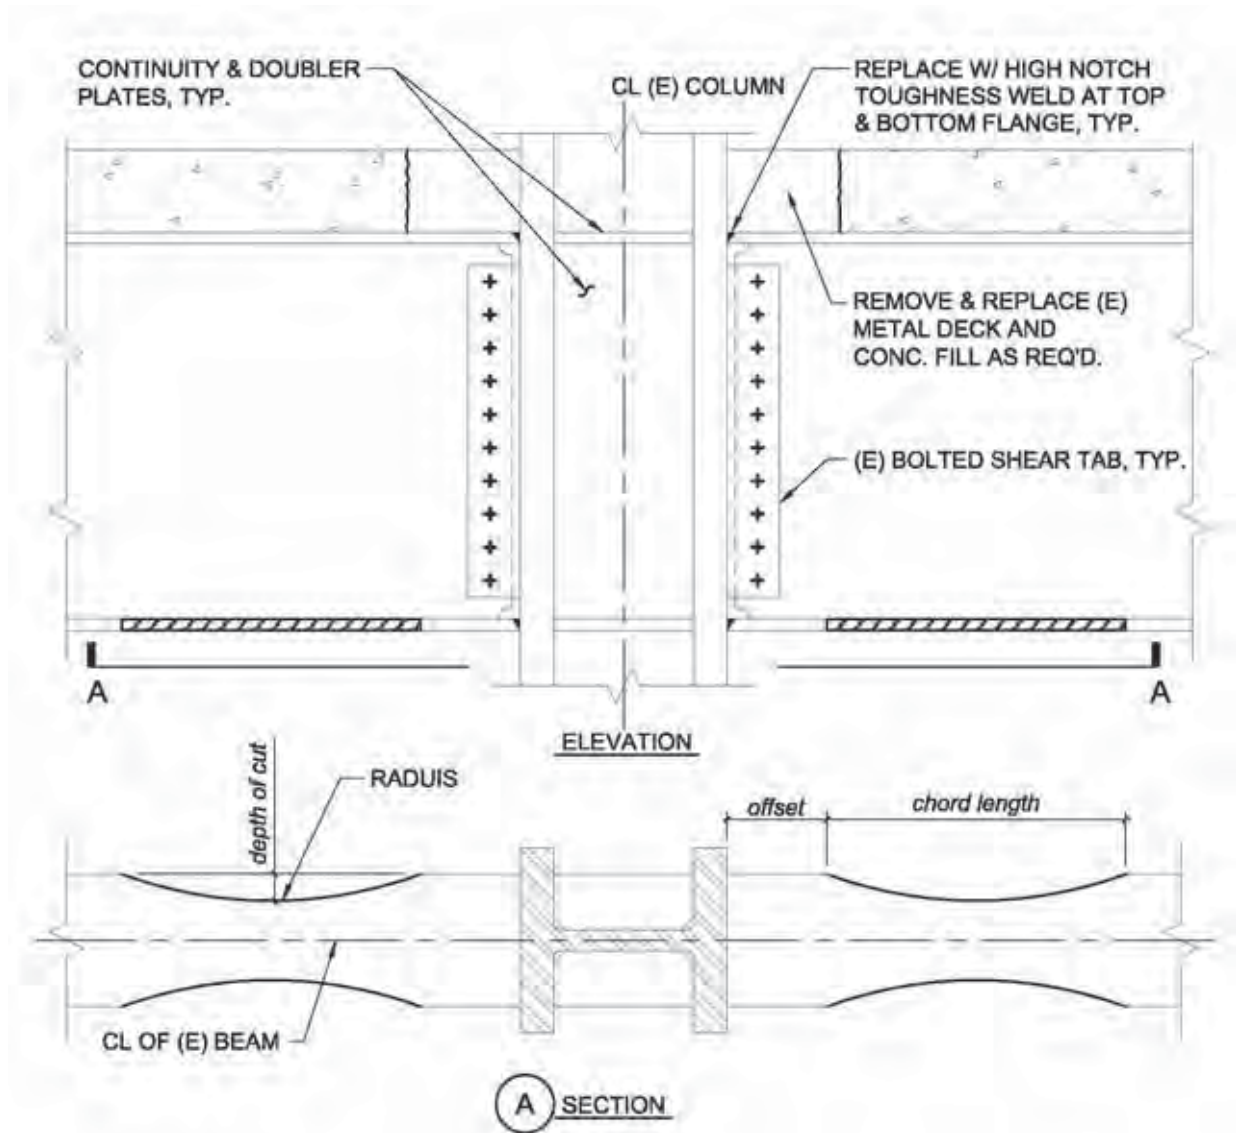
Figure 8.4.6-1: Reduced Beam Section at Bottom Flange of Existing Beam
(adapted from AISC Design Guide 12)

length of the cut should also be long enough to control the inelastic strains along the RBS. The radius of the cut is a function of its depth and the chord length. See *AISC Design Guide 12* for specific recommendations and guidelines for selecting these dimensions.

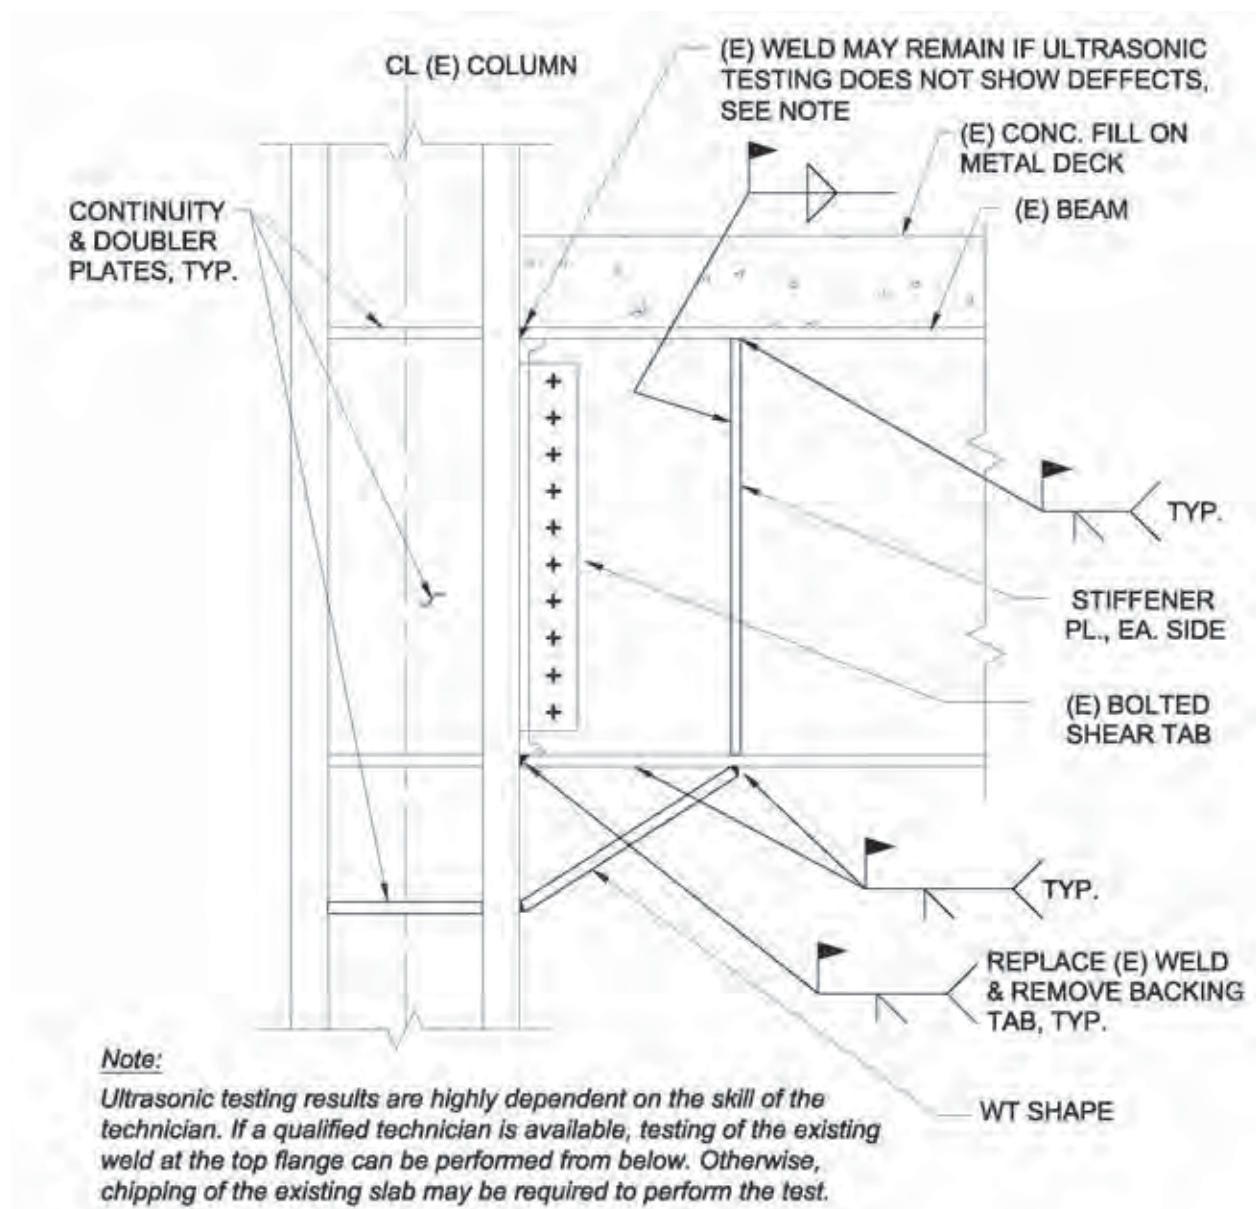
Figure 8.4.6-2: Welded Haunch at Bottom Flange of Existing Beam
(adapted from AISC Design Guide 12)

Welded haunch (Figure 8.4.6-2): Haunches can be cut from WT- or W-shapes. Typically, the haunch flange is groove welded to the beam and column flanges while the haunch web is fillet welded to these elements. Experimental programs have consistently used the same haunch geometry—length and depth approximately one half and one third that of the beam depth,

respectively. The haunch flange is sized to resist most of the shear force from the beam. The haunch web size can be established to achieve equilibrium. At the intersection of the beam and haunch flanges, web stiffeners should be provided for the beam. Similarly at the column, add continuity plates to align with the haunch flange.

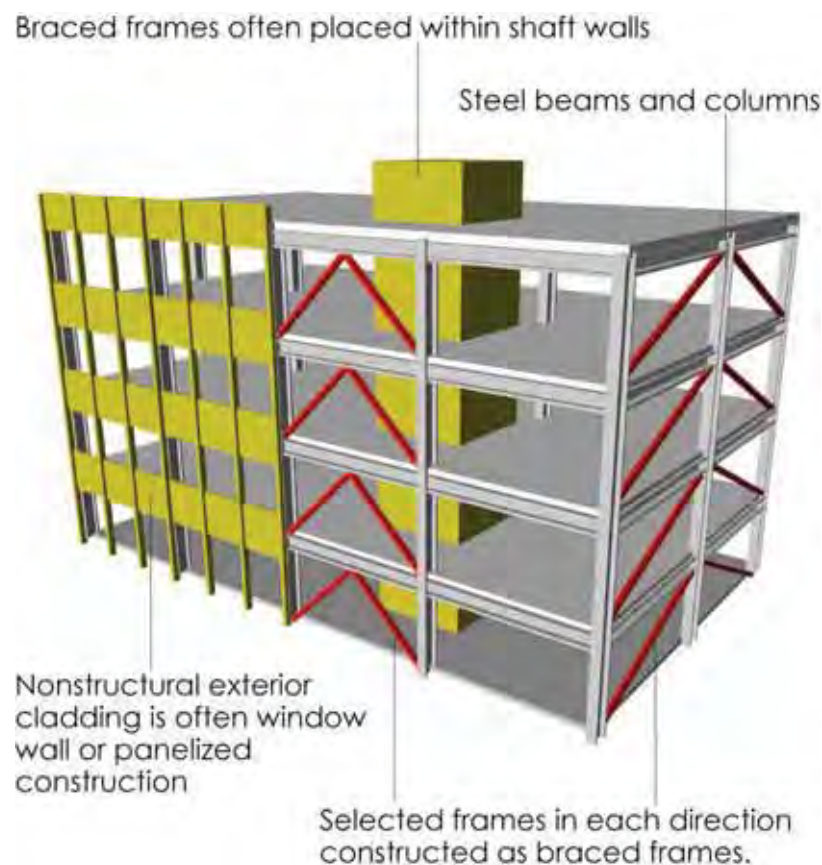
Figure 9.1-1: Building Type S2: Steel Braced Frames

Building Type S2 consists of a frame assembly of steel beams and columns. Lateral forces are resisted by diagonal steel members placed in selected bays. Floors are cast-in-place concrete slabs or concrete fill over metal deck. These buildings are typically used for buildings similar to steel moment frames, although more often for low-rise applications. Figure 9.1-1 shows an example of this building type.

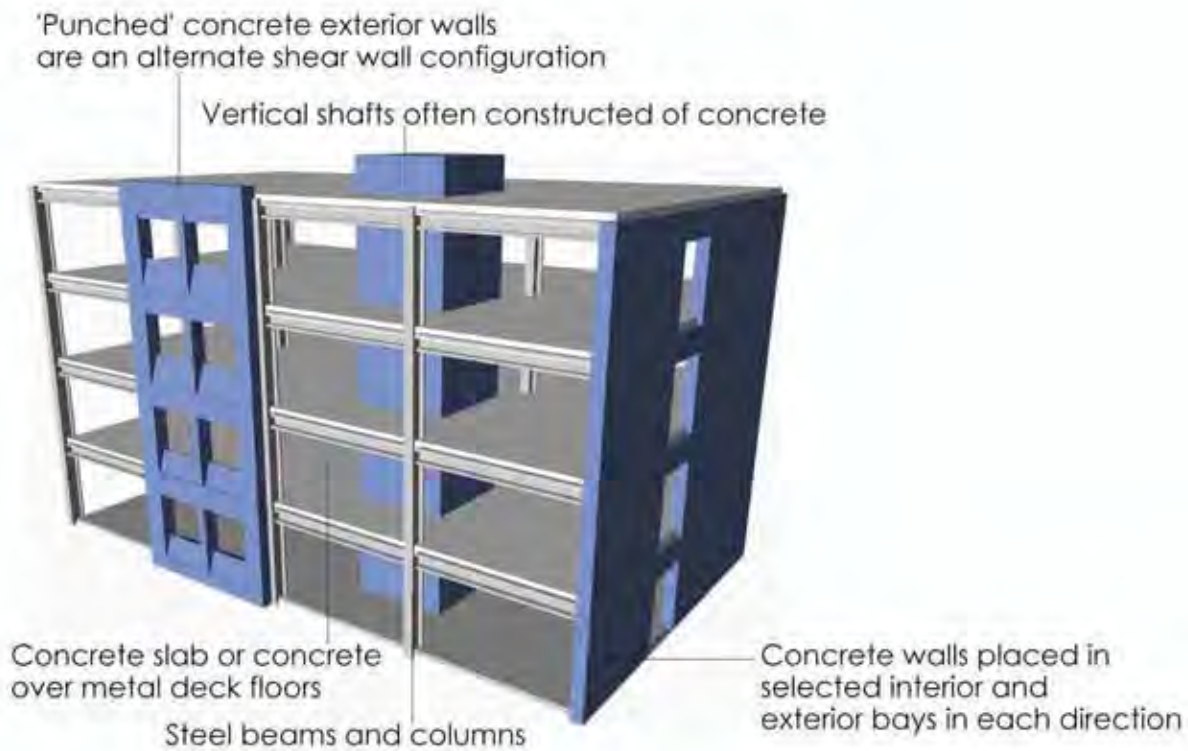
Building Type S4 consists of an essentially complete frame assembly of steel beams and columns. The floors are concrete slabs or concrete fill over metal deck. These buildings feature a significant number of concrete walls effectively acting as shear walls, either as vertical transportation cores, isolated in selected bays, and/or as a perimeter wall system. The steel column and beam system may act only to carry gravity loads or may have rigid connections to act as a moment frame to form a dual system. This building type is generally used as an alternate for steel moment or braced frames in similar circumstances. These buildings will usually be mid- or low-rise. Figure 10.1-1 shows an example of this building type.

Figure 10.1-1: Building Type S4: Steel Frames with Concrete Shear Walls

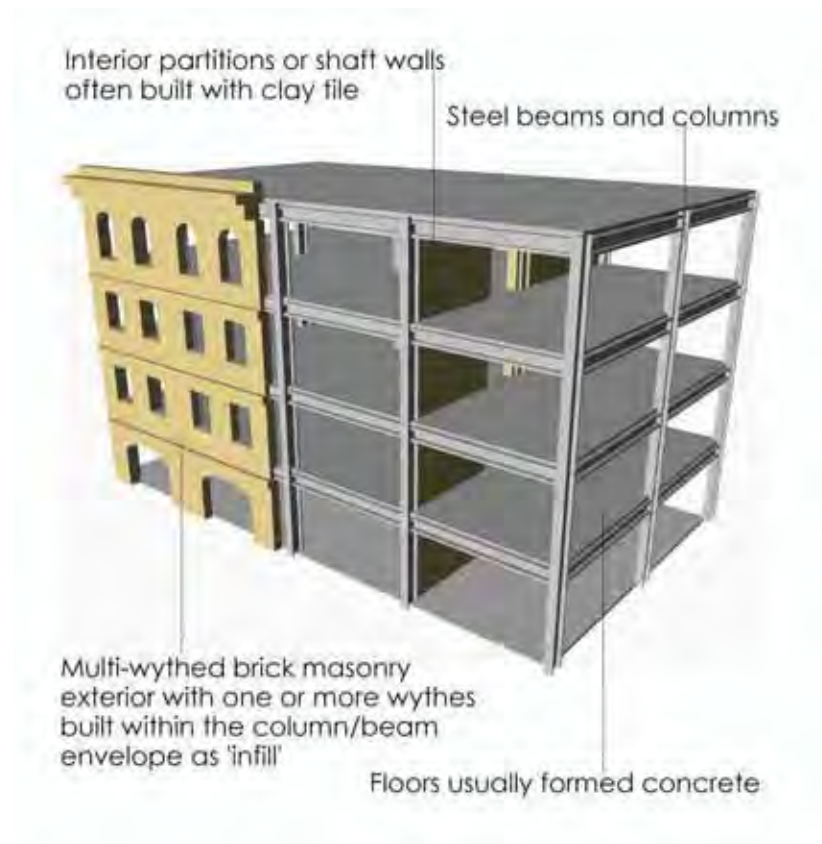
Building Type S5 is normally an older building that consists of an essentially complete gravity frame assembly of steel floor beams or trusses and steel columns. The floor consists of masonry flat arches, concrete slabs or metal deck and concrete fill. Exterior walls, and possibly some interior walls, are constructed of unreinforced masonry, tightly infilling the space between columns and between beams and the floor such that the infill interacts with the frame to resist lateral movement. Windows and doors may be present in the infill walls, but to effectively act as a shear resisting element, the infill masonry must be constructed tightly against the columns and beams. The steel gravity framing in these buildings may include truss spandrels or knee braces on the exterior walls, or partially restrained beam-column connections in a more extensive pattern. The steel frame also is often cast in concrete for fireproofing purposes. The buildings intended to fall into this category normally feature exposed clay brick masonry on the exterior and are common in commercial areas of cities with occupancies of retail stores, small offices, and hotels. Figure 11.1-1 shows an example of this building type.

Figure 11.1-1: Building Type S5: Steel Frames with Infill Masonry Shear Walls

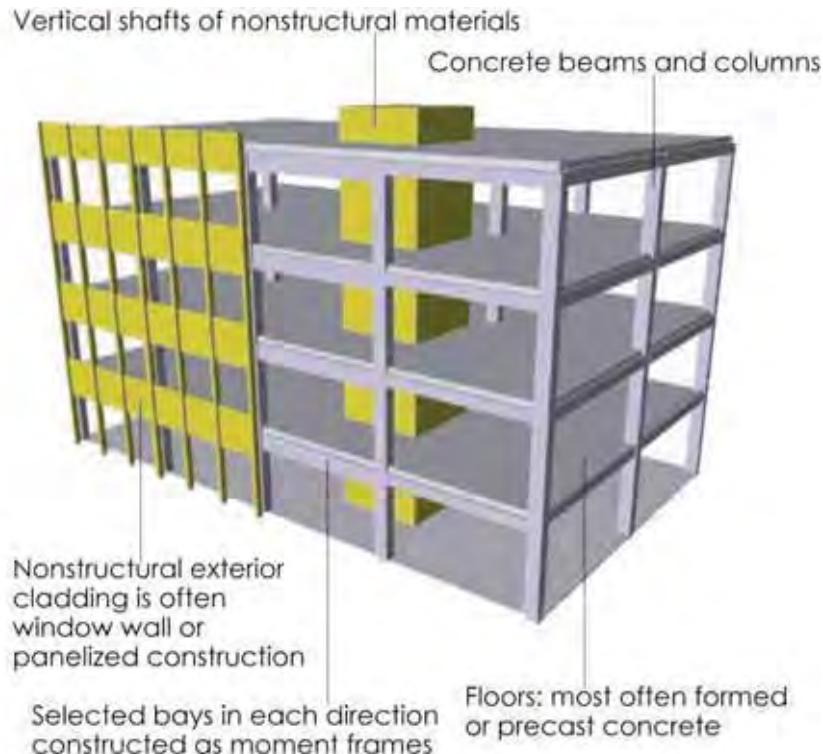
These buildings consist of concrete framing, either a complete system of beams and columns or columns supporting slabs without gravity beams. Lateral forces are resisted by cast-in-place moment frames that develop stiffness through rigid connections of the column and beams. The lateral force-resisting frames could consist of the entire column and beam system in both directions, or the frames could be placed in selected bays in one or both directions. An important characteristic is that no significant concrete or masonry walls are present, or that they are adequately separated from the main structure to prevent interaction. Some buildings of this type have frames specifically designed for lateral loads, but also have interacting walls apparently unaccounted for in the design. These buildings could be classified as moment frames and the wall interaction would immediately be considered a seismic deficiency. Alternately, these buildings could be classified as Building Type C2f (Shear Wall with Gravity Frames). Older concrete buildings may include frame configurations that were not designed for lateral load, but if no walls or braces are present, the frames become the effective lateral force system and should be included in this building category. Buildings of this type that include integral concrete or masonry walls on the perimeter should be considered as Building Type C2f or C3. Floors may be a variety of cast-in-place or precast concrete. Buildings with concrete moment frames are generally used for most occupancies listed for steel moment frames, but are also used for multistory residential buildings.

Figure 12.1-1: Building Type C1: Concrete Moment Frames

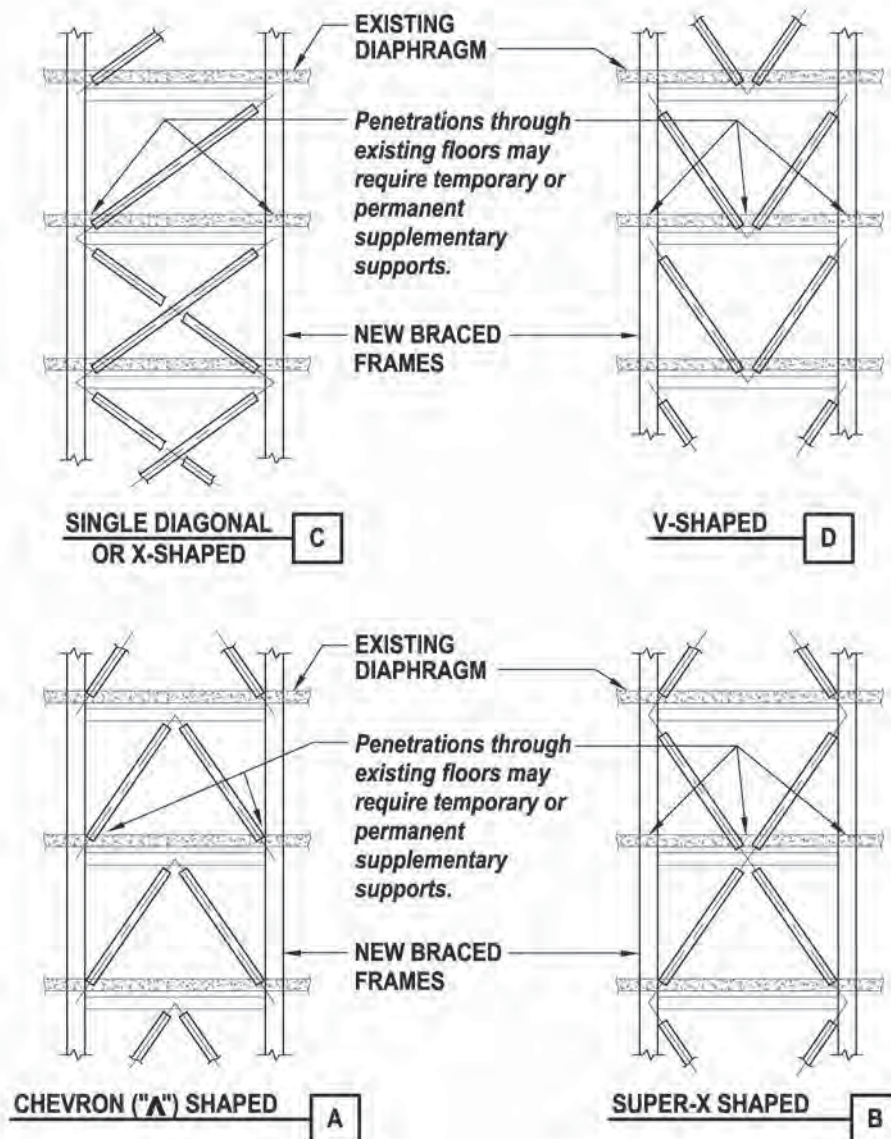
Figure 12.4.1-1: Typical Braced Frame Configurations

New steel horizontal elements are similarly needed to facilitate the connections of the diagonal and to transfer forces from each floor into the frame. These steel elements are generally placed below the floor and roof diaphragms or adjacent to beams or spandrels. The diagonal steel braces may be placed in any of the commonly used configurations indicated in Figure 12.4.1-1;

single diagonal or X-shaped, V-shaped, chevron (inverted-V) shaped, or “super-X” shaped (a combination of chevron and V braces in alternate stories forming a two-story X shape). Two-story X-bracing has the advantage over V- or inverted-V-bracing should a compression brace buckle. In the latter configurations, the remaining tension brace has an unbalanced vertical component that has to be resisted by the beam. For an X-bracing configuration, even if a compression brace buckles, the force in the remaining tension brace is transmitted directly to the tension brace on the opposite side of the beam.

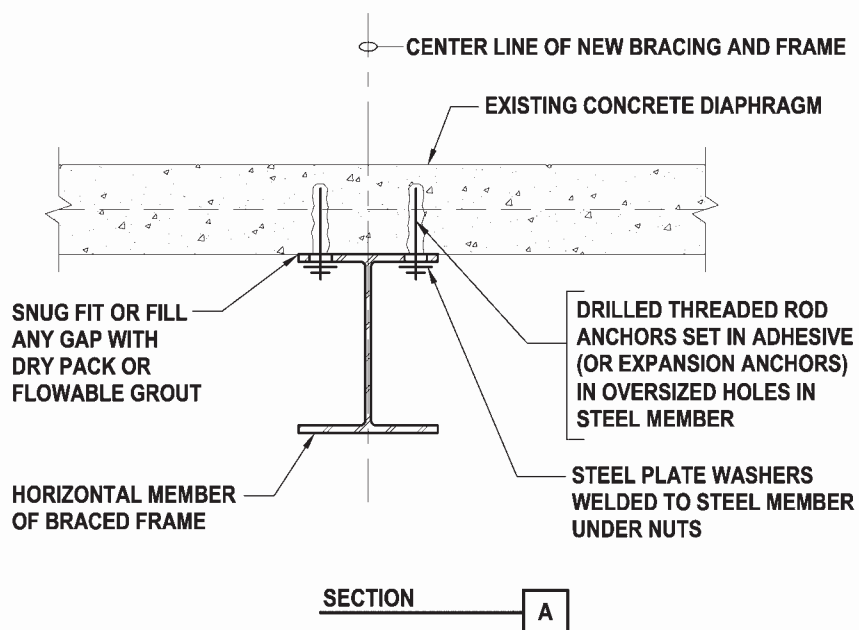
Figure 12.4.1-2A: Typical Connection to Concrete Diaphragm

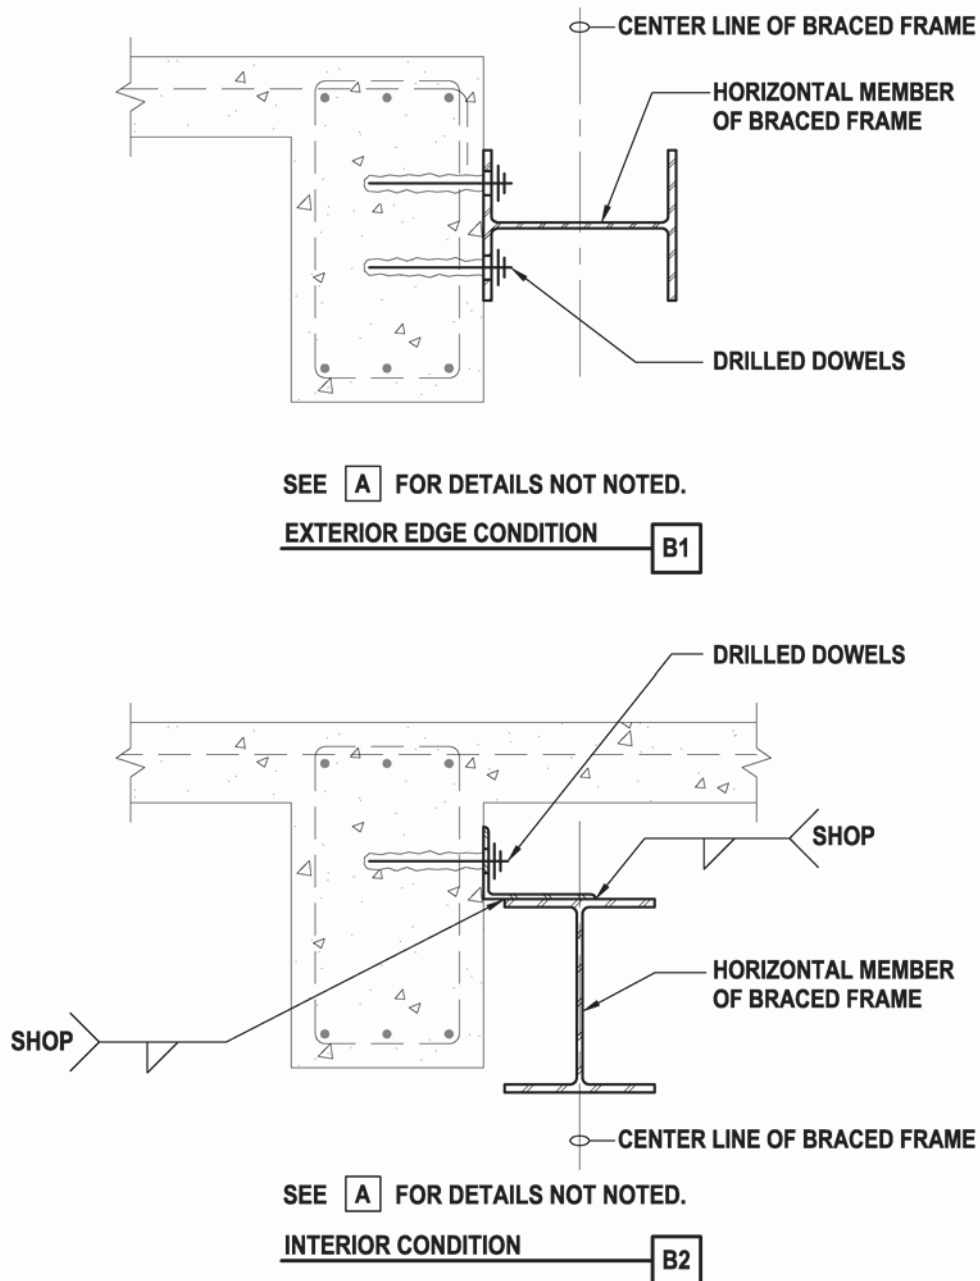
Figure 12.4.1-2B: Typical Connection to Existing Concrete Beam

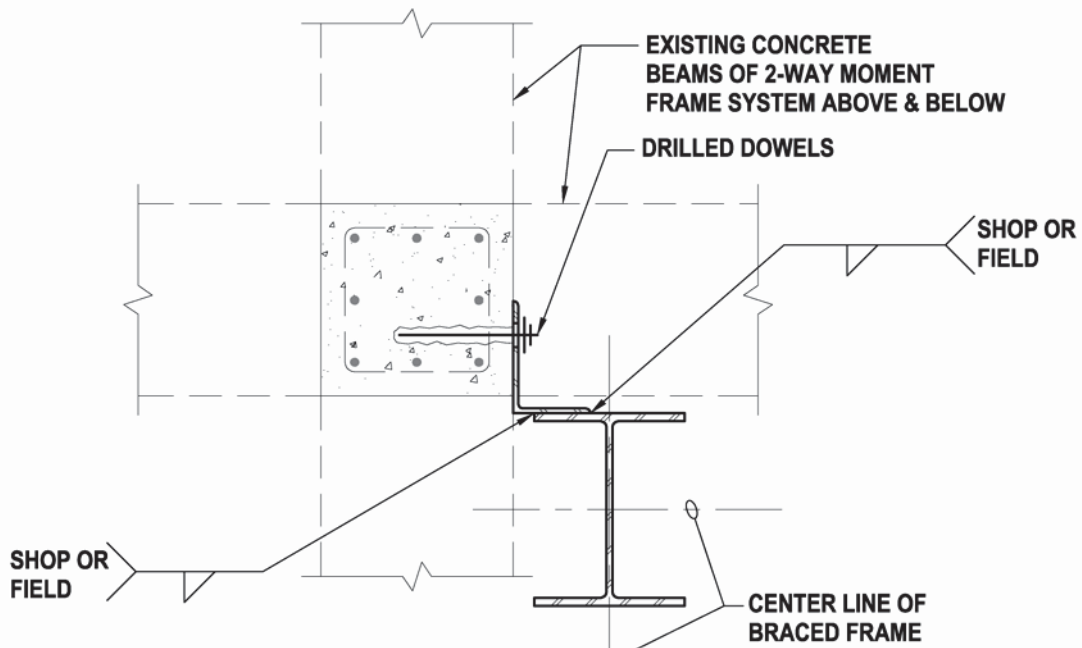
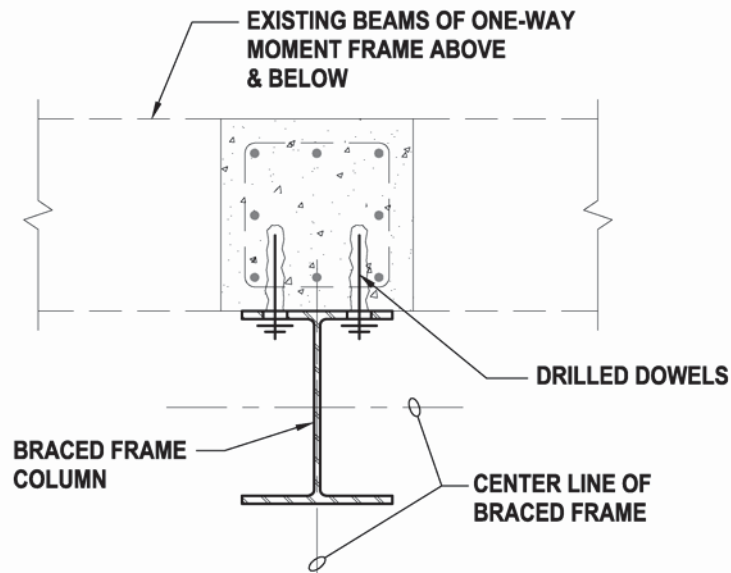
PLAN - TWO-WAY MOMENT FRAME CONNECTION C1

PLAN - ONE-WAY MOMENT FRAME CONNECTION C2

Figure 12.4.1-2C: Typical Connection to Existing Concrete Column

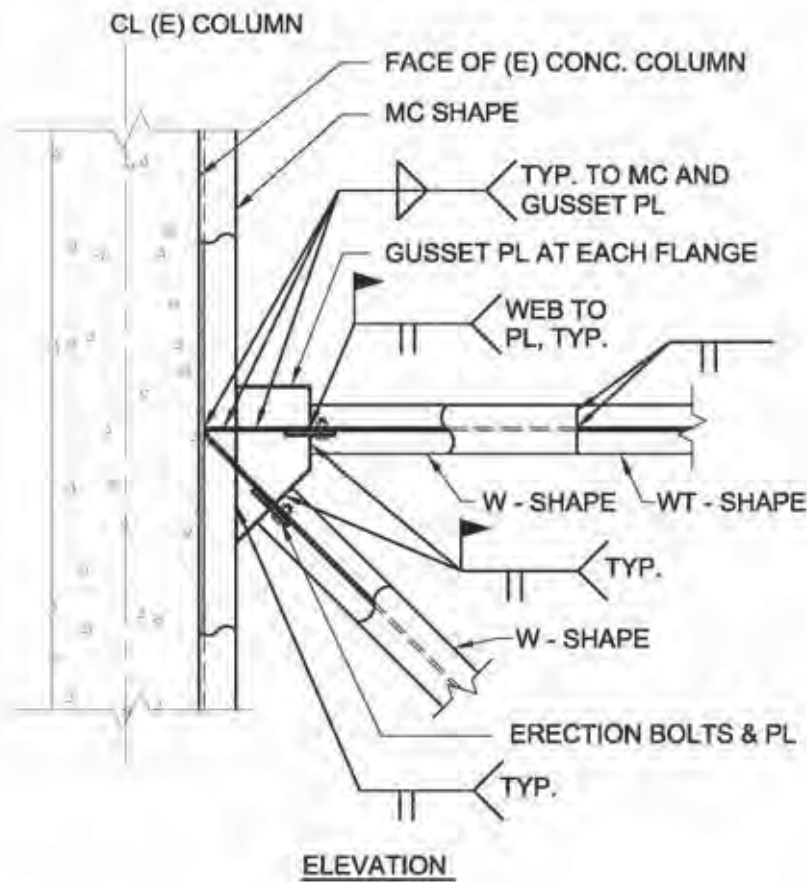
Figure 12.4.1-3: Test Specimen Connection Detail for Braced Frame

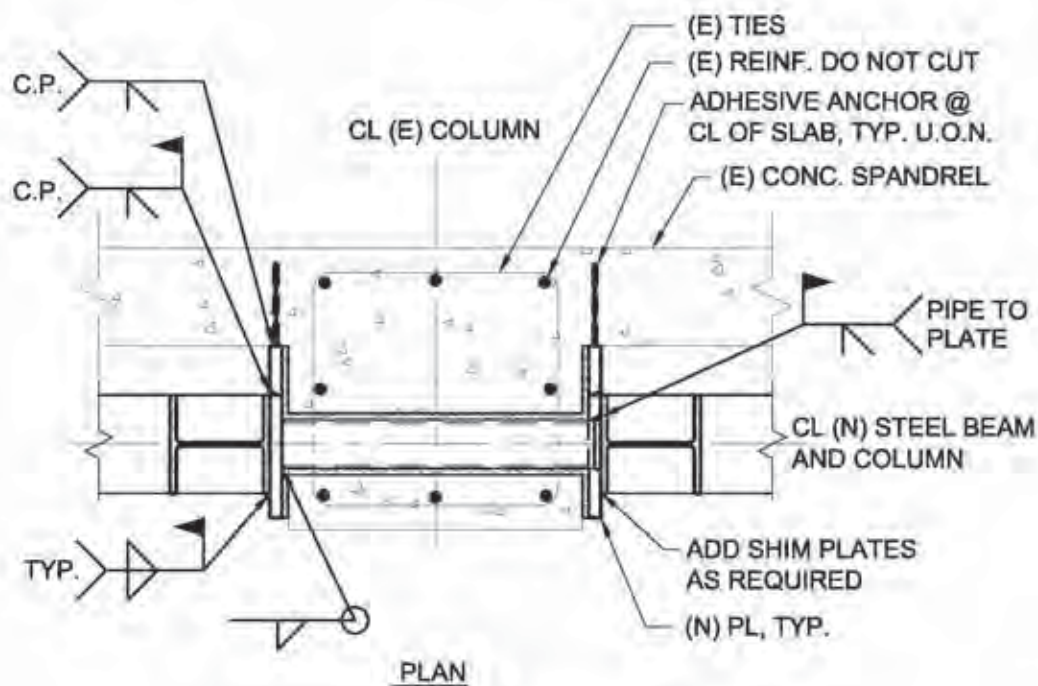
Installation Procedure:

1. Install adhesive anchor and plate on each side of column.
2. Core hole for pipe through column.
3. Install pipe with shop welded plate on one side.
4. Install plate with hole and weld to pipe.
5. Weld cap plate to pipe.
6. Weld plate attached to pipe to plate attached to adhesive anchor.
7. Fill pipe and annular space solid with nonshrink grout.

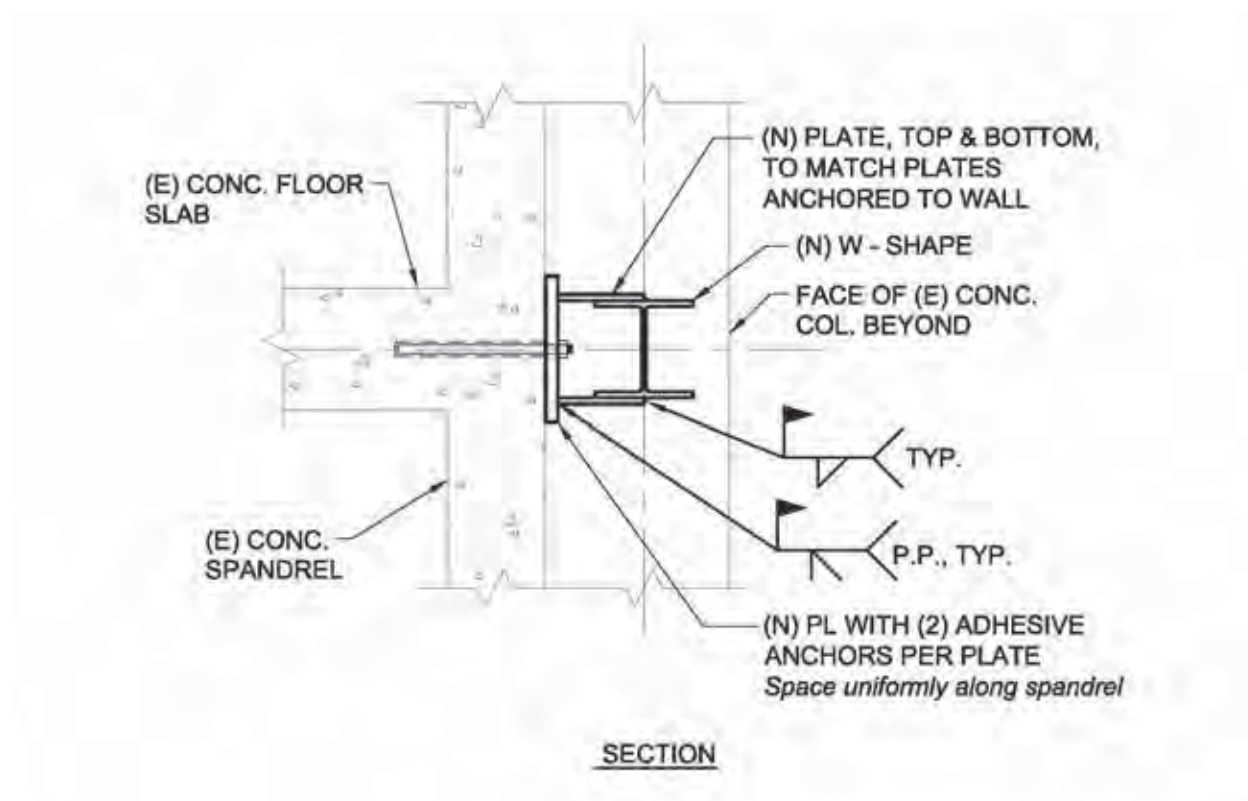
Figure 12.4.1-5: Braced Frame to Slab Connection

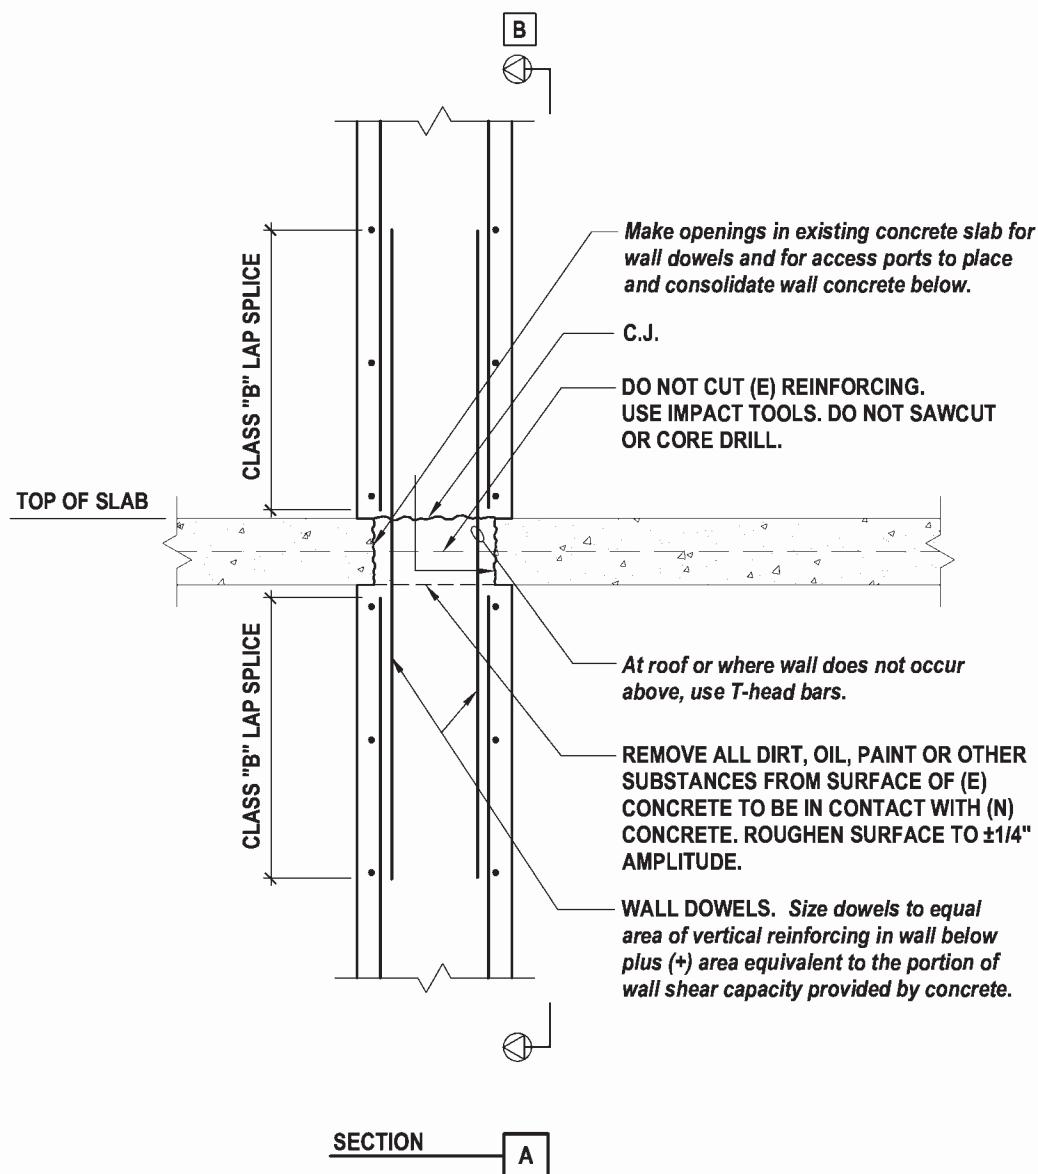
Typical details of this connection for a new cast-in-place concrete wall below an existing concrete flat slab are shown in Figures 12.4.2-1A and 12.4.2-1B. The vertical dowels must be sufficient to transfer forces from the existing diaphragm and from the new wall above (if it exists), to the lower wall. Shears can also be transferred across this joint with large diameter

Figure 12.4.2-1A: Concrete Wall Connection to Concrete Slab

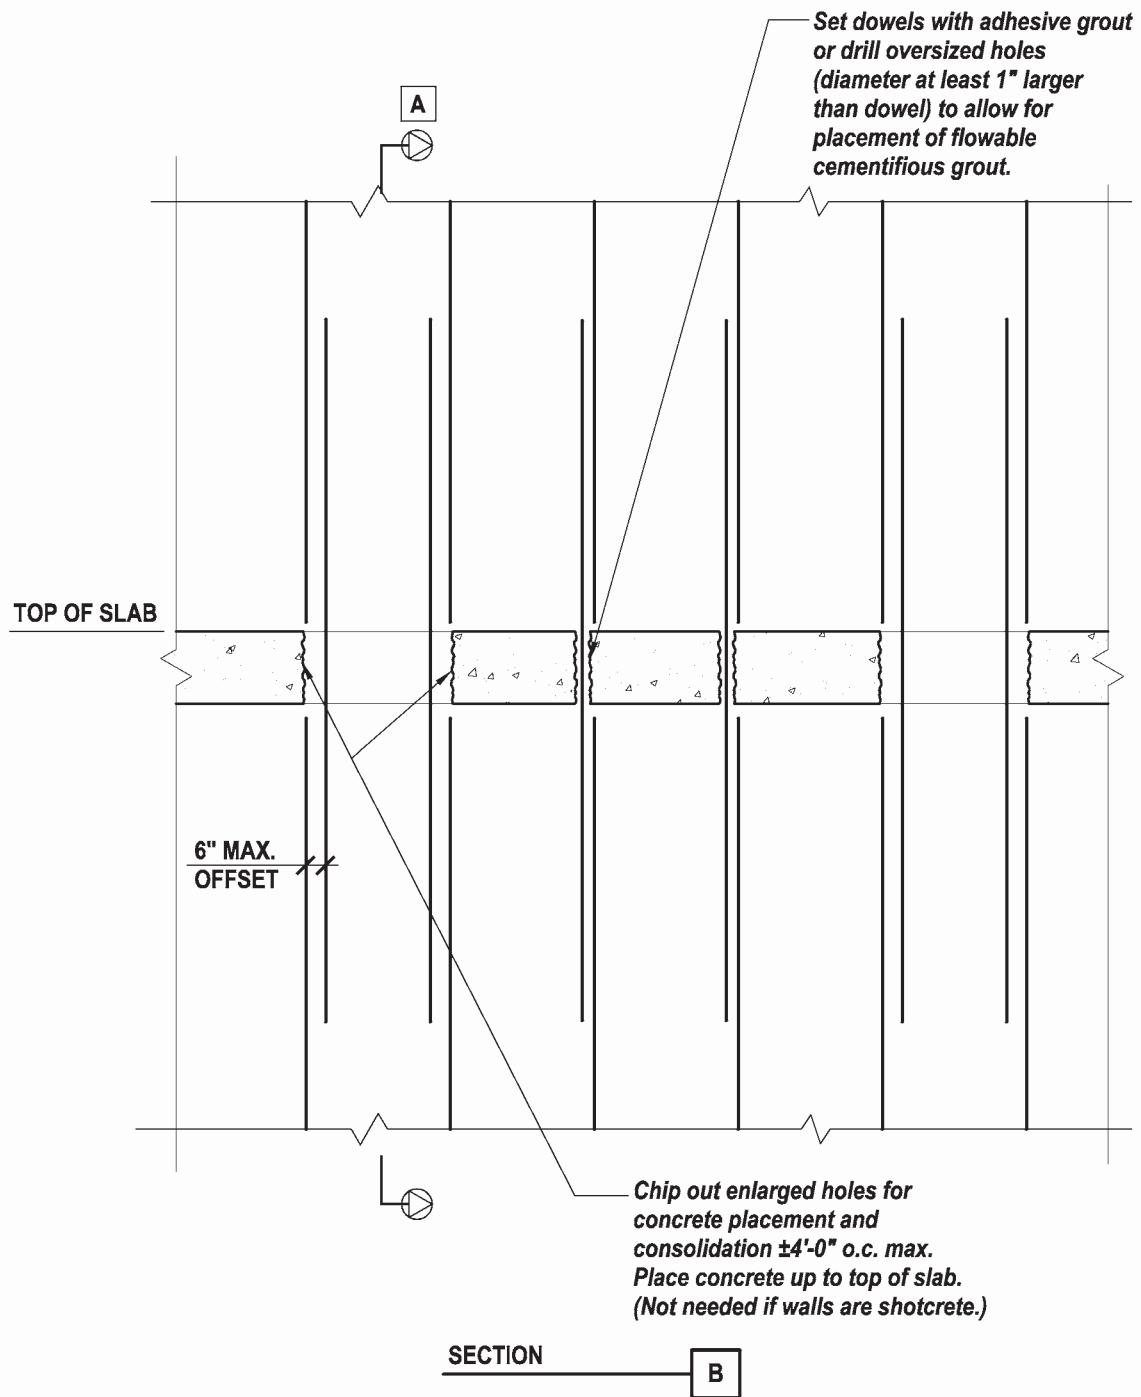
Figure 12.4.2-1B: Concrete Wall Connection to Concrete Slab – Partial Elevation View

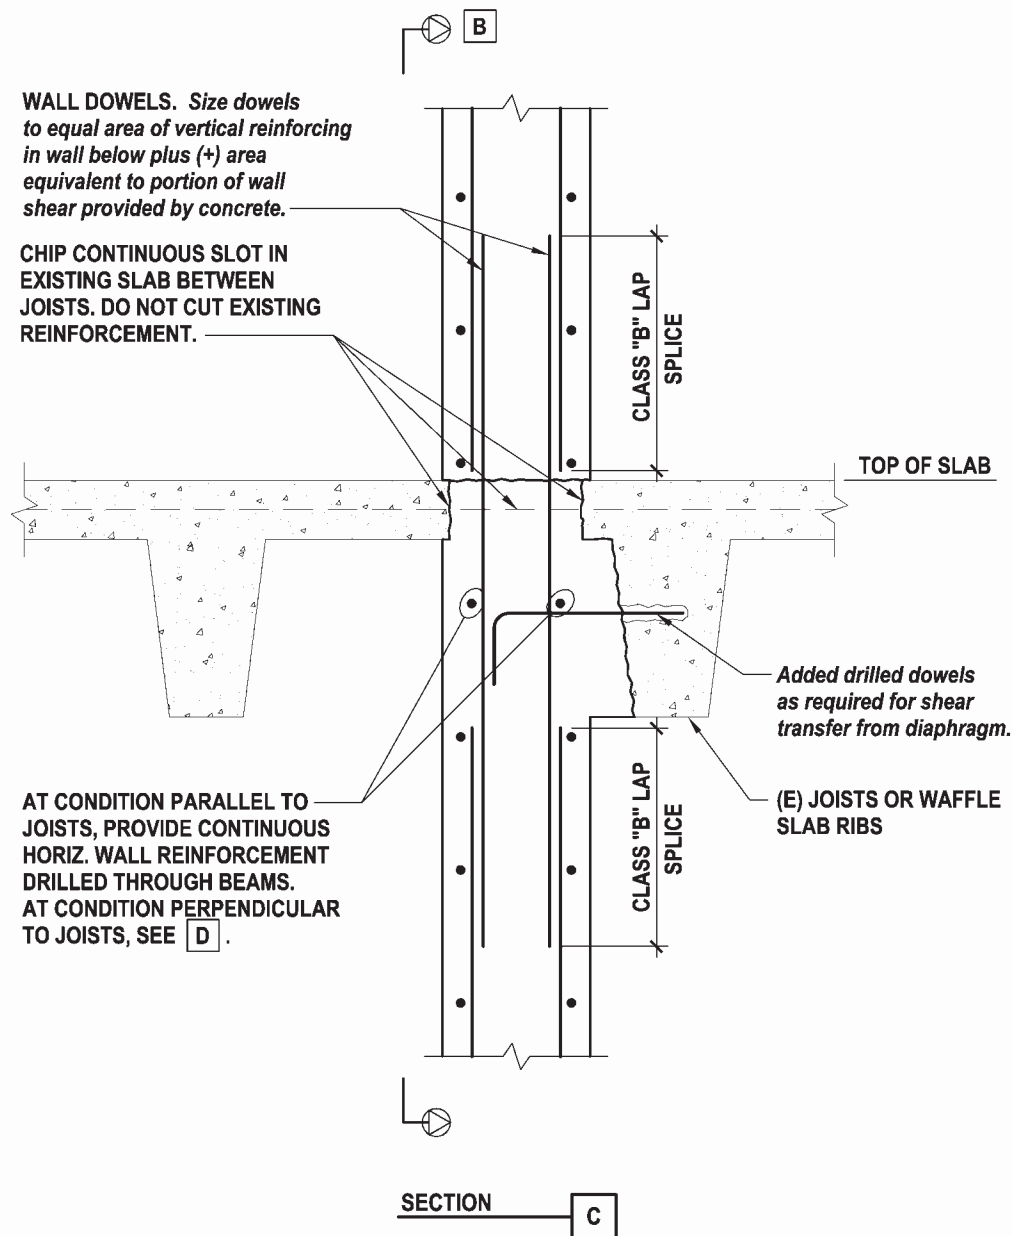
Figure 12.4.2-1C: Connection of Concrete Wall to Concrete Joists or Waffle Slab

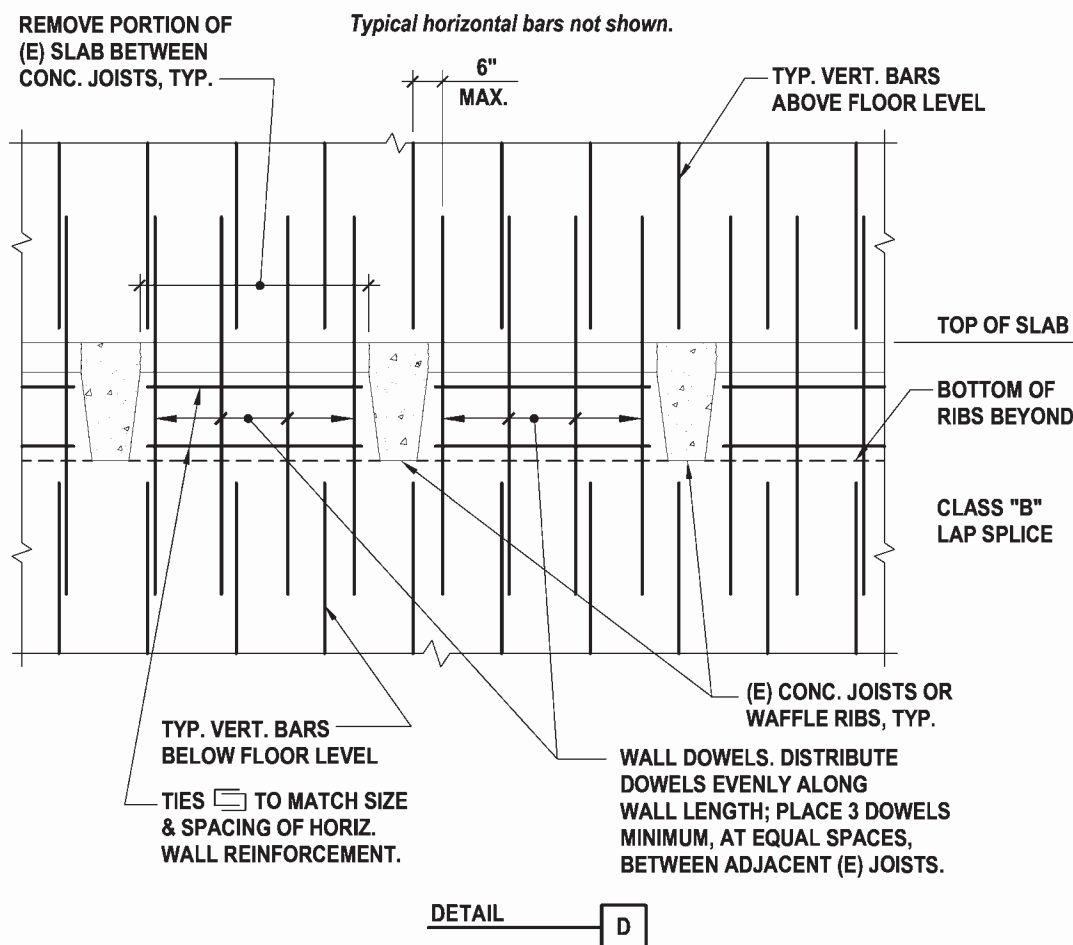
Where the new wall is perpendicular to the joists, or at a waffle slab condition, the slab can be removed between the ribs as indicated in Figure 12.4.2-1D. Since installation of continuous horizontal wall bars through the perpendicular ribs is generally not possible, installation of one or two horizontal hoop ties may be required at the upper portions of the wall between the ribs. For CMU wall construction, the masonry will stop below the joists or ribs, and the large vertical gap up to the slab, between the ribs, will be completed with poured concrete.

Figure 12.4.2-1D: Concrete Wall Connection to Waffle Slab – Partial Elevation View

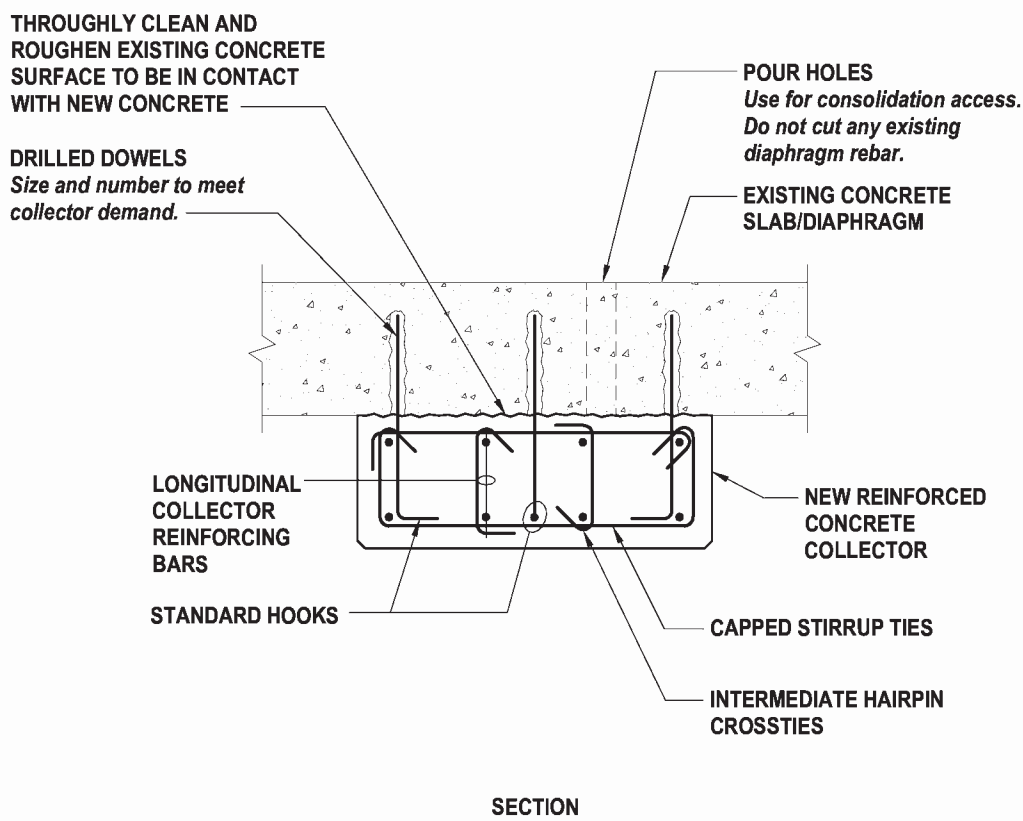
Connection of a reinforced concrete collector to existing concrete diaphragms or collectors: A typical detail of the installation of a new reinforced concrete collector to the underside of an existing concrete slab diaphragm is shown in Figure 12.4.3-1. The primary considerations are to provide a good bond between the new and existing concrete and to provide adequate access ports for concrete placement and consolidation. The contact surface must be thoroughly cleaned and roughened for good shear transfer performance. It is best to place concrete from above through pour ports made in the diaphragm. The ports will need to be at least 4 inches in diameter. Care must be taken to locate existing diaphragm reinforcement before cutting the ports to avoid cutting any bars in what is likely to be a lightly reinforced slab.

Figure 12.4.3-1: Concrete Collector at Concrete Slab
