Architectural
Resources Group

609, 611, and 619 NE 3rd Street
McMinnville, Oregon

Historic Resource Assessment
November 2022

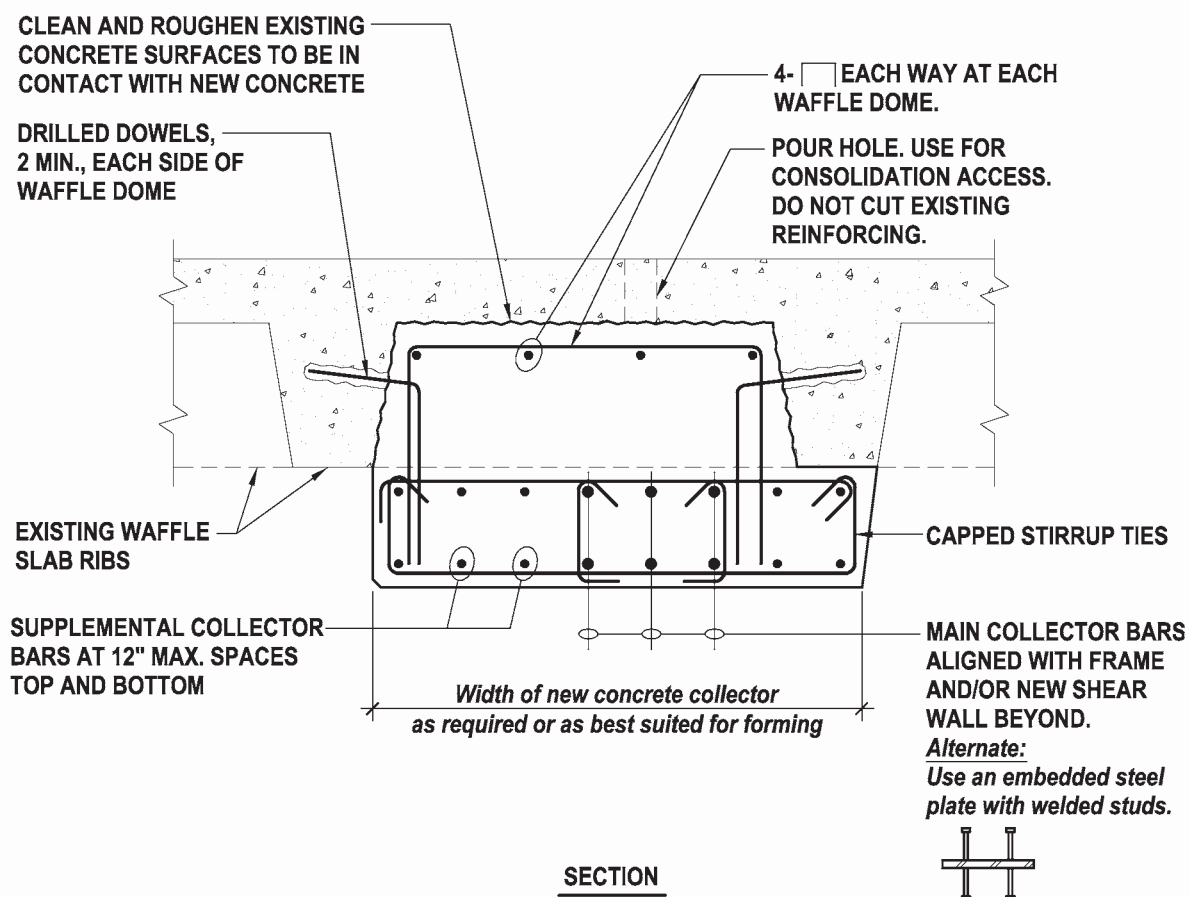
If the existing floor or roof diaphragm is a waffle or pan joist system, the continuous collector will almost always be placed below the ribs, as shown in Figure 12.4.3-2, to avoid excessive drilling and rebar splicing. In this condition, the voids between the ribs, above the dropped collector, will be filled with reinforced concrete. Advantages of this condition are that the drilled dowels can be installed into the sides of the ribs instead of the relatively thin cover slab, and making pour ports through the slab is likely to be less problematic. Also, although the new collector may weigh more in this condition, the waffle or joist ribs are much more likely to have adequate strength to support the added weight.

Figure 12.4.3-2: Concrete Collector at Waffle Slab

In any of these collector configurations, a significant portion of the main reinforcement can be provided by a steel plate instead of by bar reinforcement (refer to Figure 12.4.3-2). This option may be best for conditions of very high loads, where installation of a high strength steel plate may be preferred over placement of many large bars.

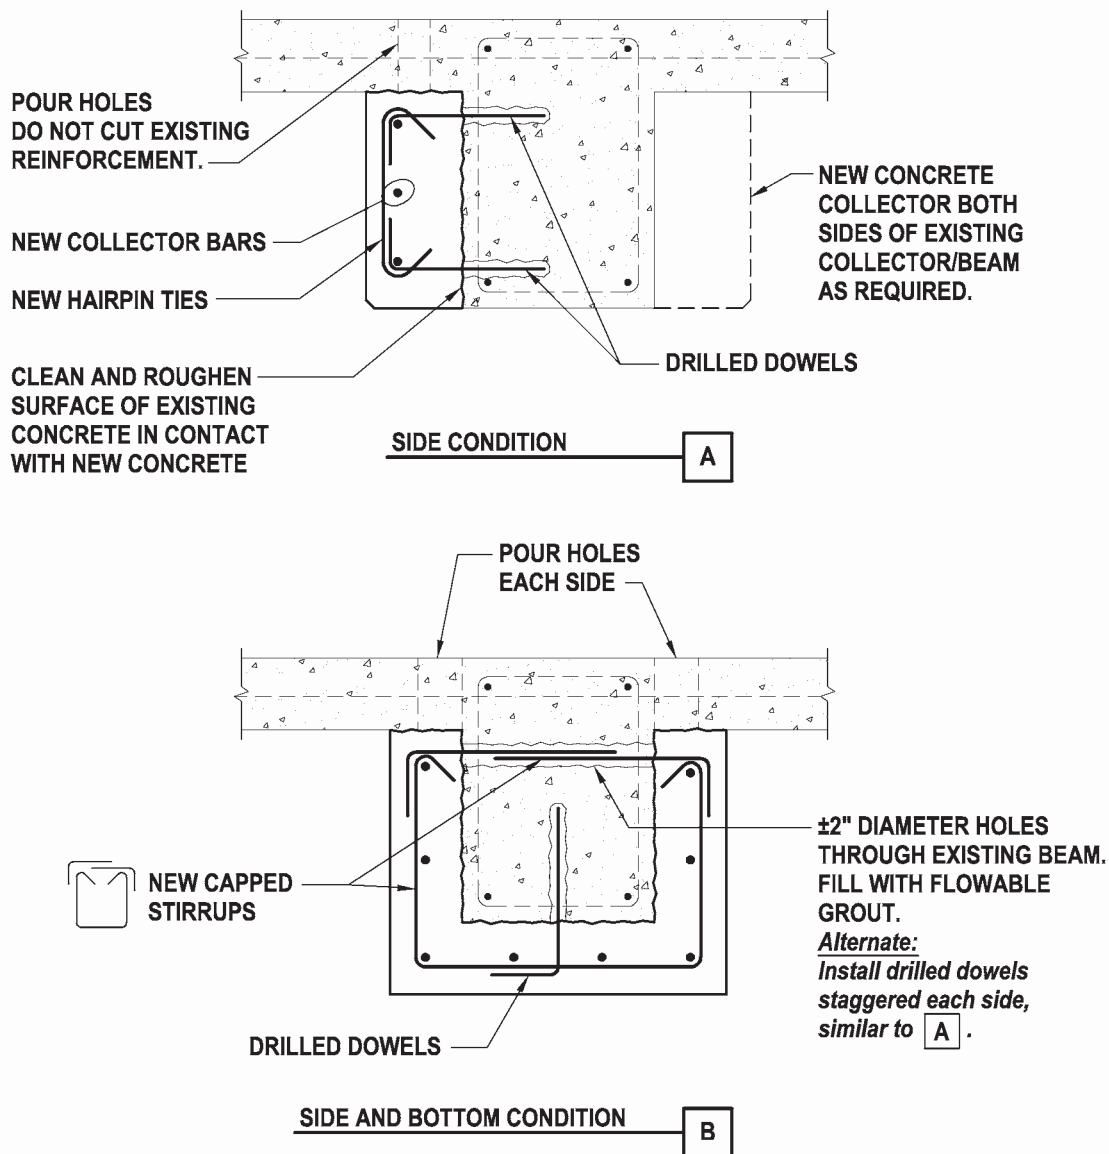
In many cases, the new collector will occur along an existing beam or girder line. Often, this will occur if the task is to strengthen a diaphragm edge chord or if the new walls occur at the building's exterior. Figure 12.4.3-3 shows two generic conditions that can be used in this case. In this condition, the dowels will always be placed into the beam, and the combined beam-collector member will easily be designed support the added weight. However, special care should be taken to avoid cutting any beam stirrups or slab diaphragm reinforcement, especially at an exterior edge condition, with the pour holes.

Figure 12.4.3-3: Concrete Collector at Existing Beam

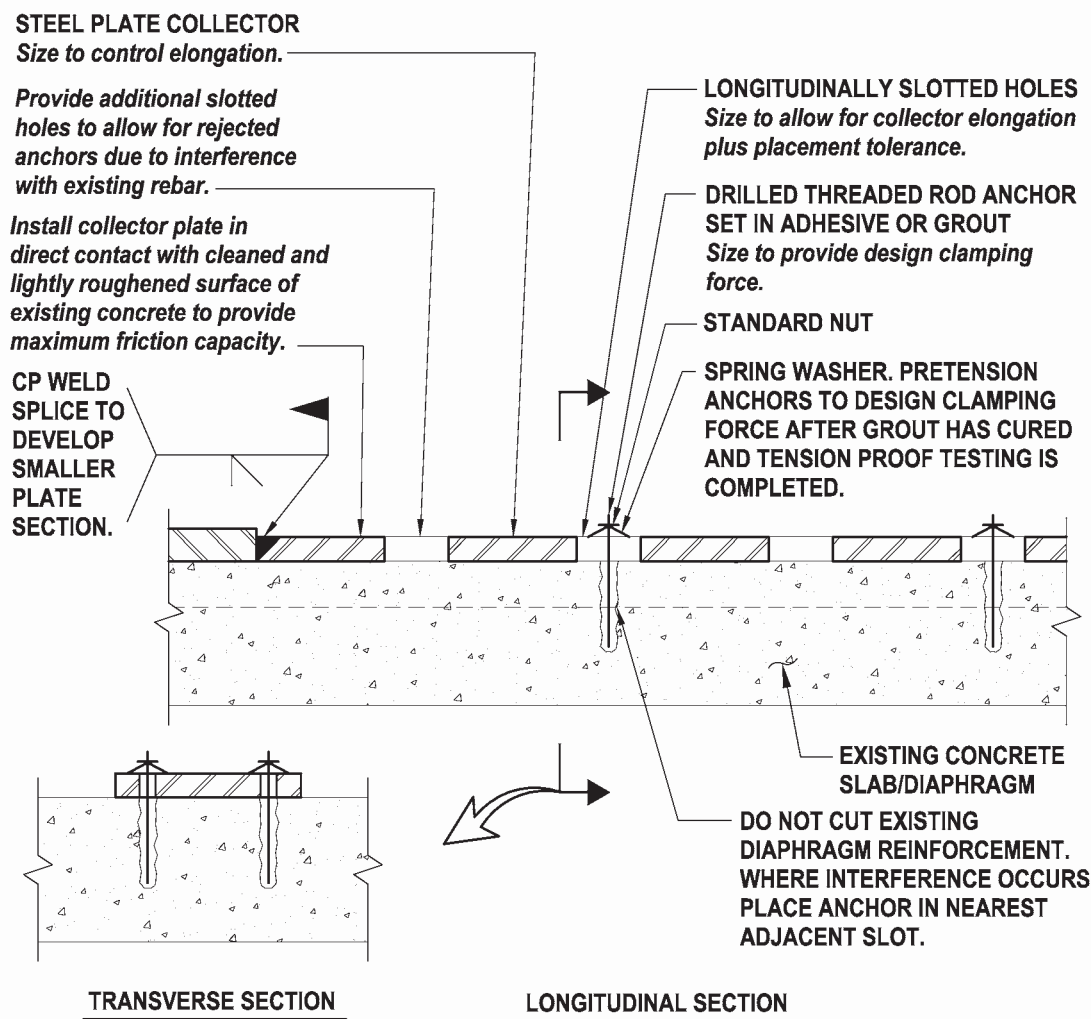
manageable sections, generally about 10 to 20 feet in length, and will be connected to the concrete diaphragm with drilled threaded rod anchors set in adhesive or epoxy. In almost all cases, the steel plates will be installed at the top of the diaphragm as shown in Figure 12.4.3-4. Although possible, it is extremely difficult to install heavy plate sections, connect the bolts and make the necessary welded splices from below.

Figure 12.4.3-4: Steel Plate Collector

very short. The strain deformation of a steel collector will vary from zero at its free end to a maximum at the connection to the wall or brace while the concrete diaphragm will not experience similar deformations. In effect, the steel collector will stretch like a very stiff rubber band relative to the concrete diaphragm. This relative deformation is difficult to accommodate, especially in relatively long collectors. To do that, several conditions must be considered. First, the various plate sections of the collector must be stepped in size so the strain is distributed relatively equally along the length of the collector. Second the plates must be sized to limit the maximum elongation to a reasonable amount of about one or two inches. Third, the threaded rod anchors must be installed in slotted holes to allow the design elongation to occur without bearing on and overloading the anchors. Fourth, to allow the slip to occur between the collector and diaphragm, load transfer must be accomplished by friction using specially calibrated spring washers to generate the appropriate clamping force in the anchors.

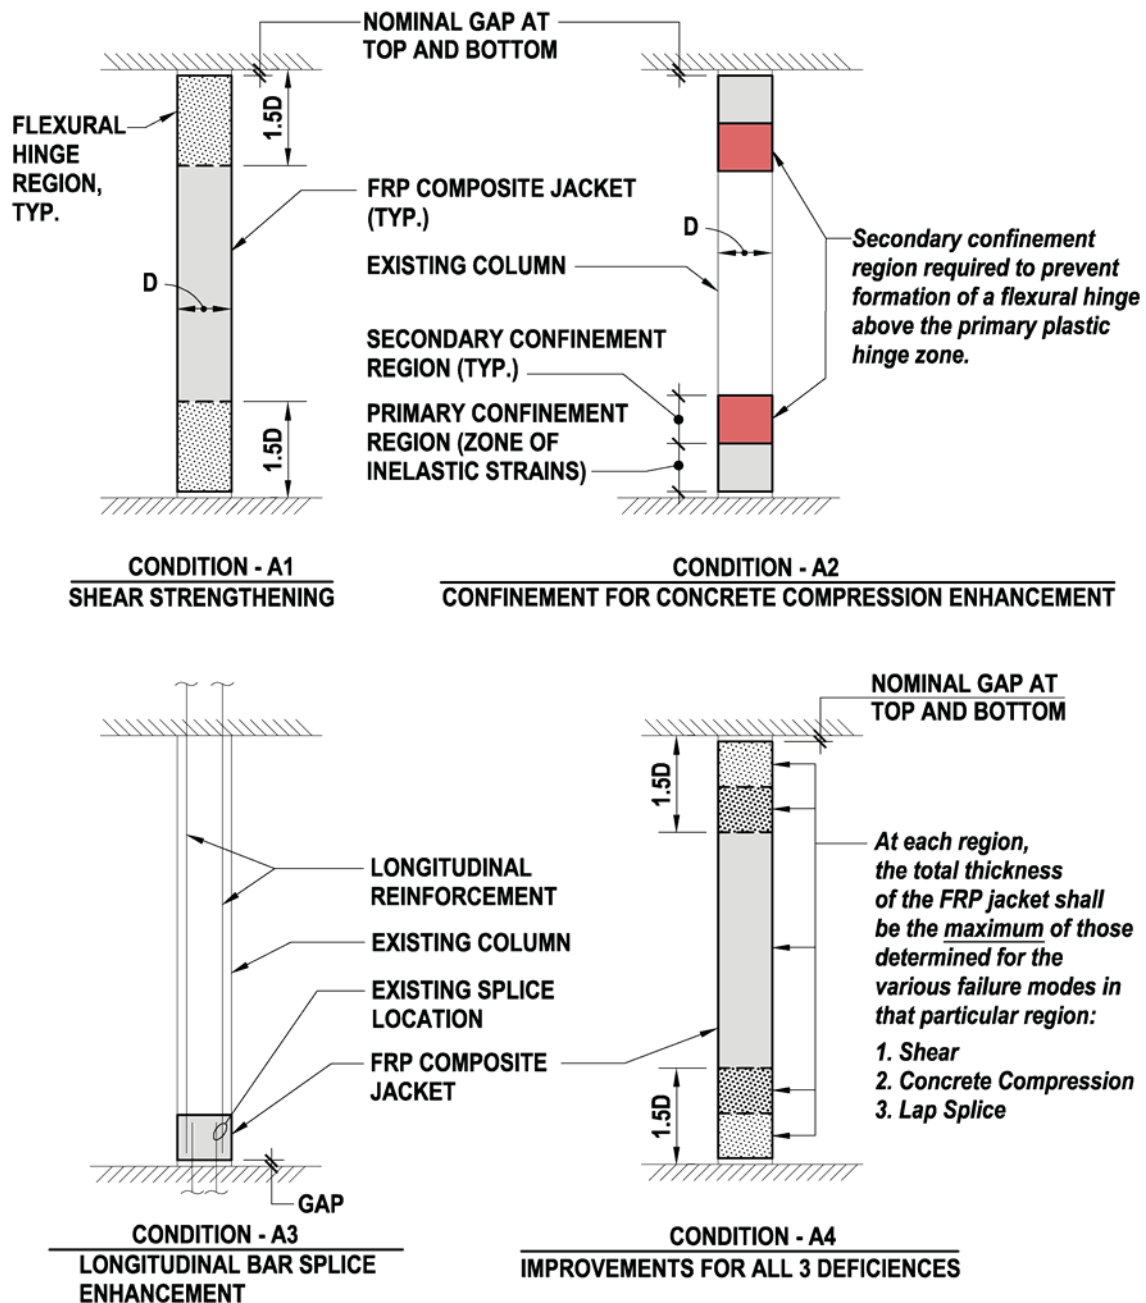
The FRP overlay thickness is determined for each of the three deficiencies; zones for these are shown in Figure 12.4.4-1A. As noted by Priestley, Seible, and Calvi (1996), the maximum of the three at any section should be provided; it should not be the sum, as reported in some other documents. This is because the lap-splice clamping action and compression concrete confinement occurs on opposite sides of the column, so the maximum requirement of the two will serve both well. Shear resistance of the FRP occurs along the column face parallel to shear load direction. The FRP anchors the concrete compression strut and is designed to maintain

Figure 12.4.4-1A: Seismic Retrofit of Columns Using FRP Composites

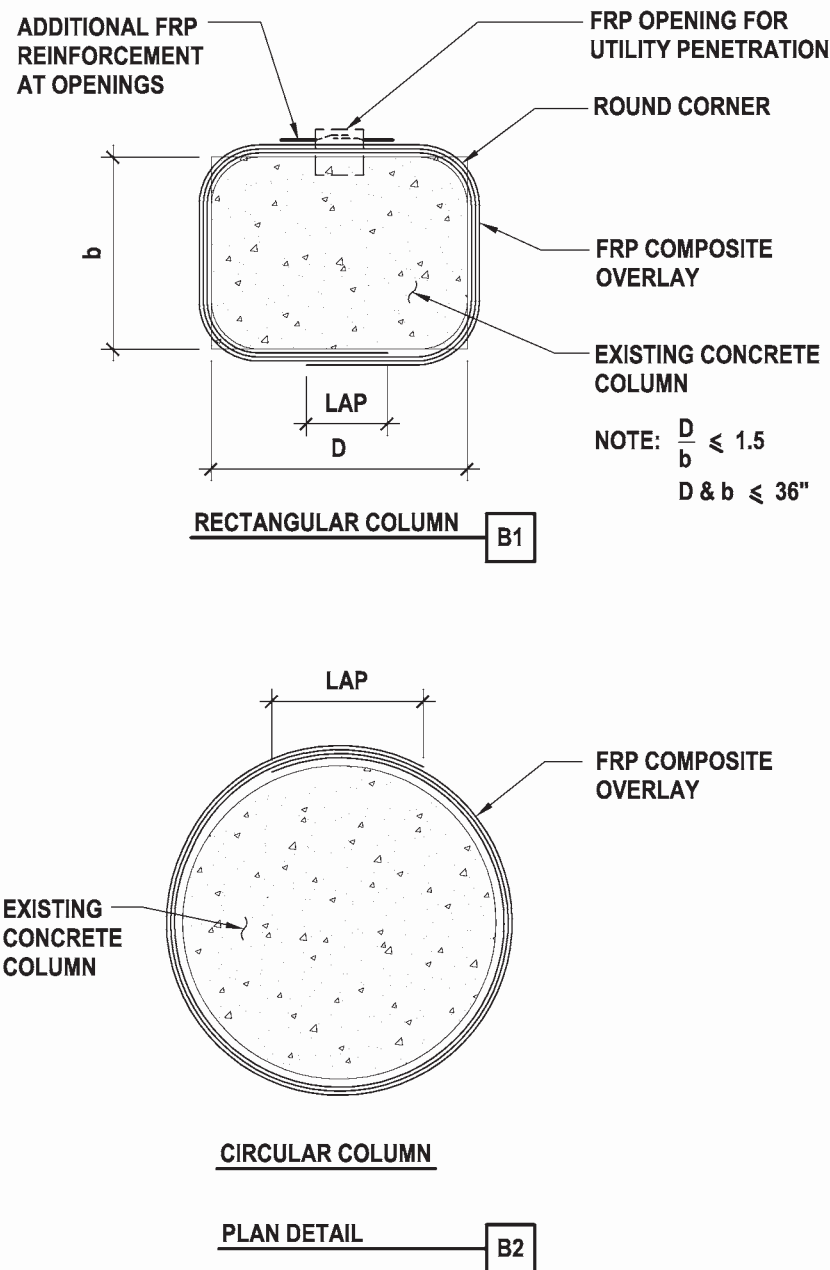
Figure 12.4.4-1B: Seismic Retrofit of Columns Using FRP Composites

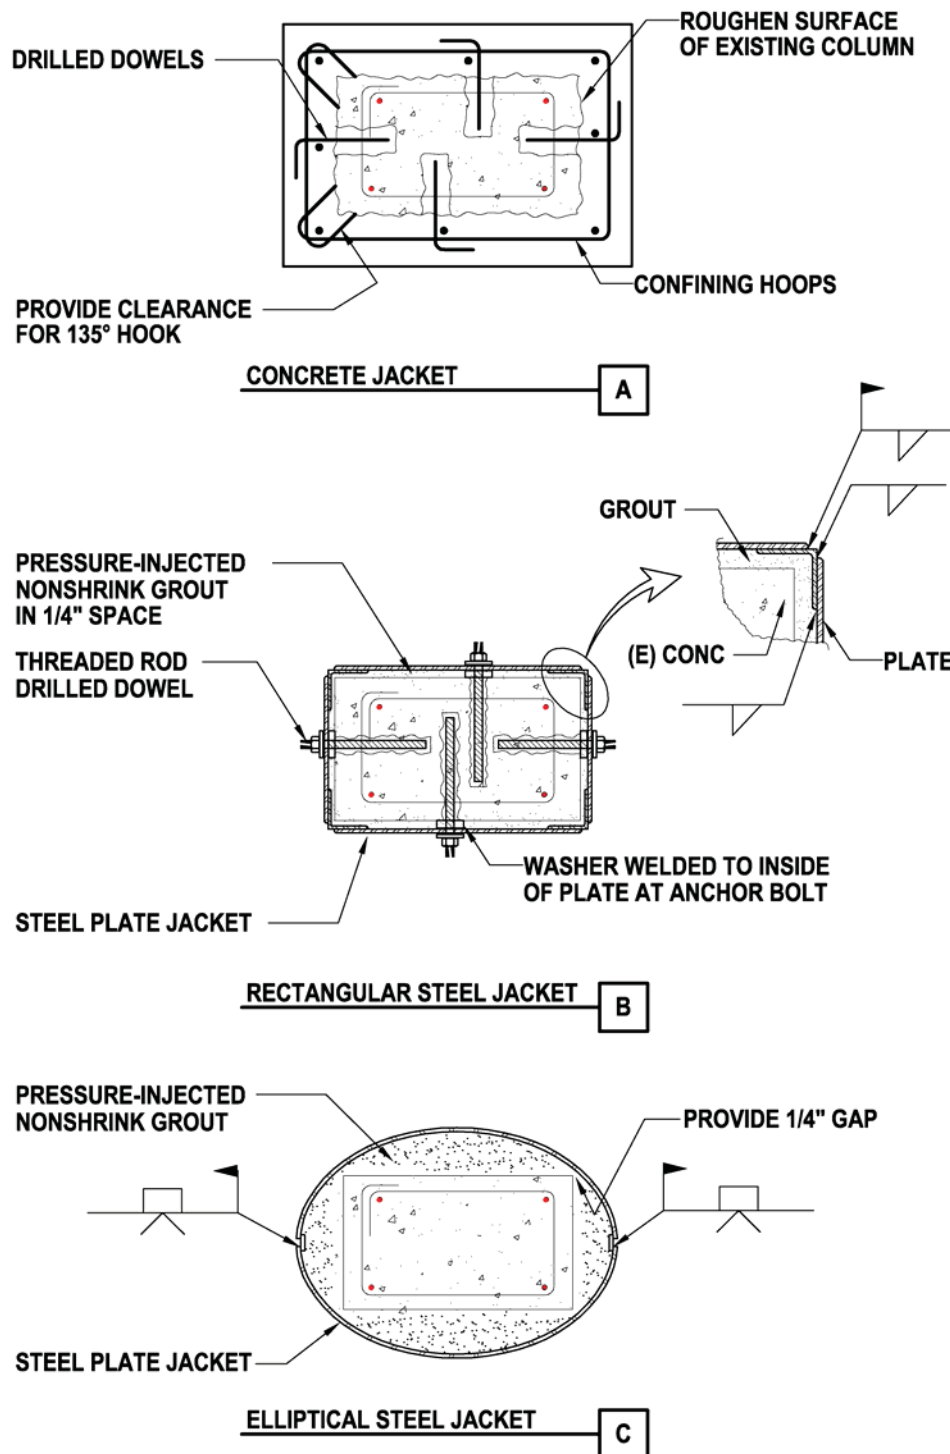
Figure 12.4.5-1 provides examples of concrete and steel jacketing for a rectangular column. Because FRP overlays have become more common, this section will focus on FRP overlays.

Figure 12.4.5-1: Concrete and Steel Overlays for Concrete Columns

Steel overlays: Steel overlays are typically 3/16” or ¼” thick and become quite heavy. Access and lifting issues in existing buildings can force the overlay to be broken down into pieces, increasing the amount of field welding necessary to join the pieces back together.

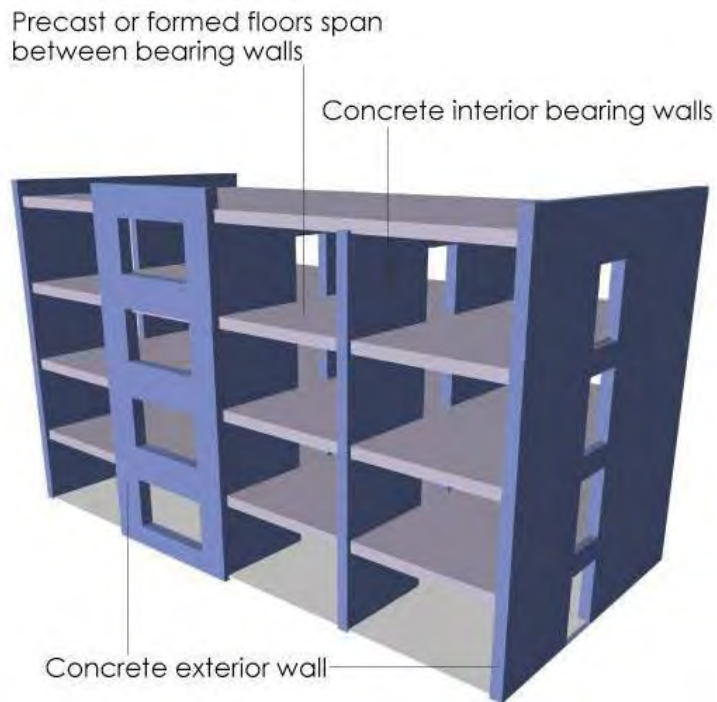
Reinforced concrete walls in a building will act as shear walls whether designed for that purpose or not. Therefore, cast-in-place concrete buildings that contain any significant amount of concrete wall will fall into this category. However, there are two distinctly different types of concrete wall buildings, those that contain an essentially complete beam/slab and column gravity system, and those that use bearing walls to support gravity load and have only incidental beam and column framing. In this document, these building types have been separated and are designated **C2f** for the gravity frame system and **C2b** for the bearing wall. This section covers the bearing wall type. In this type of building, all walls usually act as both bearing and shear walls. The building type is similar and often used in the same occupancies as Building Type **RM2**, namely in mid- and low-rise hotels and motels. This system is also used in residential apartment/condominium type buildings.

Figure 13.1-1: Building Type C2b: Concrete Shear Walls (Bearing Wall Systems)

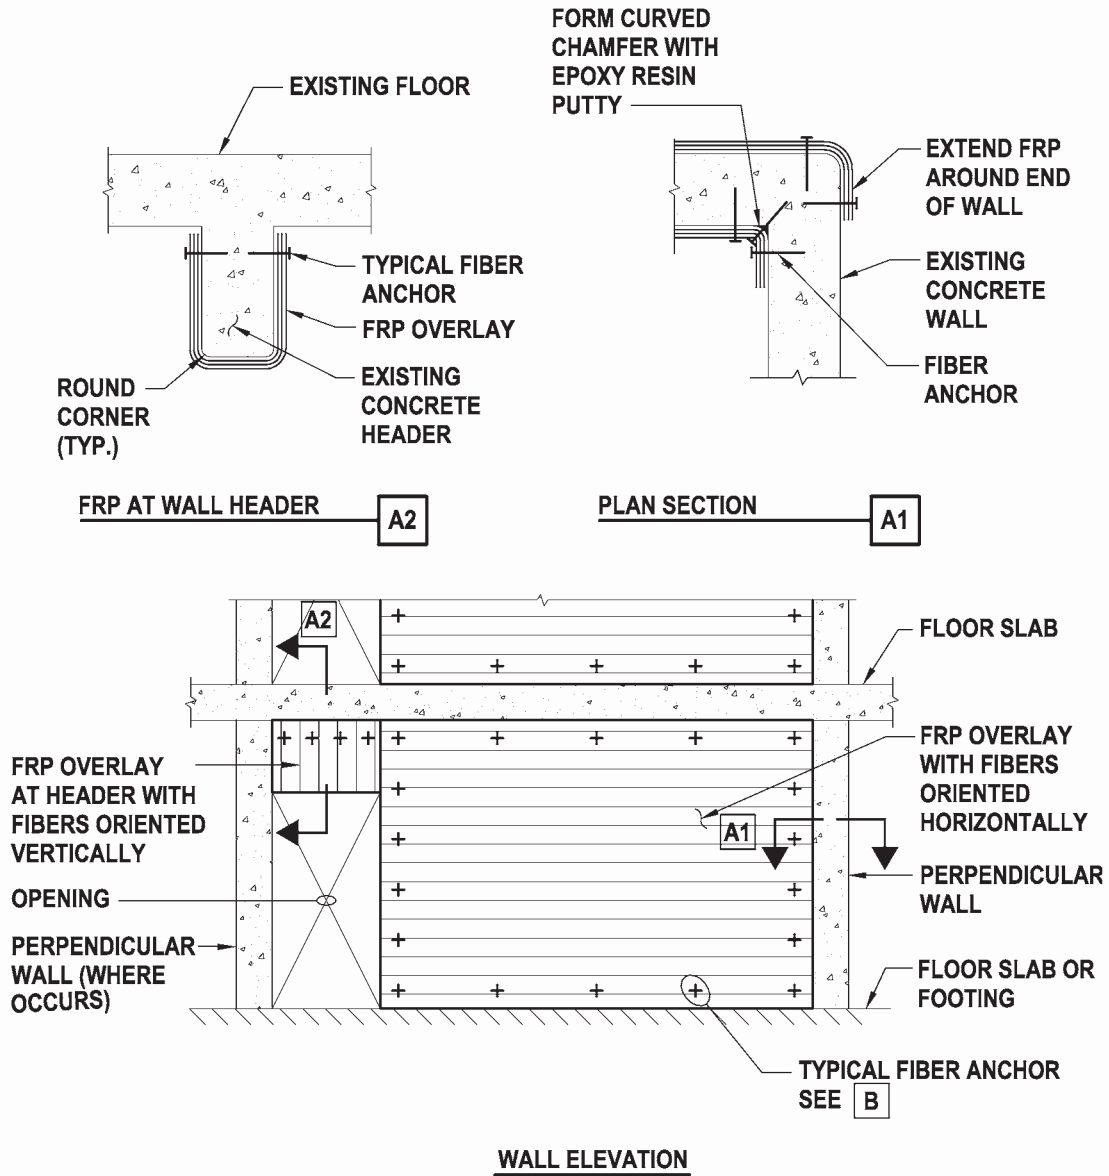
Figure 13.4.1-1A: Shear Strengthening of Concrete Shear Walls Using FRP Composite

The shear resistance contribution from the FRP is obtained in a similar manner to that used for wall reinforcement; the horizontal bars and FRP resist the horizontal shear (see Section 5.1 in Laursen, Seible, and Hegemier, 1995). The effective fiber area per unit width, and its contribution to shear resistance, is limited to the bond and anchorage strength capacity; providing additional fiber area will not provide additional shear capacity. Testing has been limited to mostly single and double layers of FRP per side of wall. Wrapping the material around the ends of the wall and/or providing fiber anchors will enhance the effectiveness of the overlay, particularly where cracks form, by increasing the anchorage and bond of the FRP to the substrate

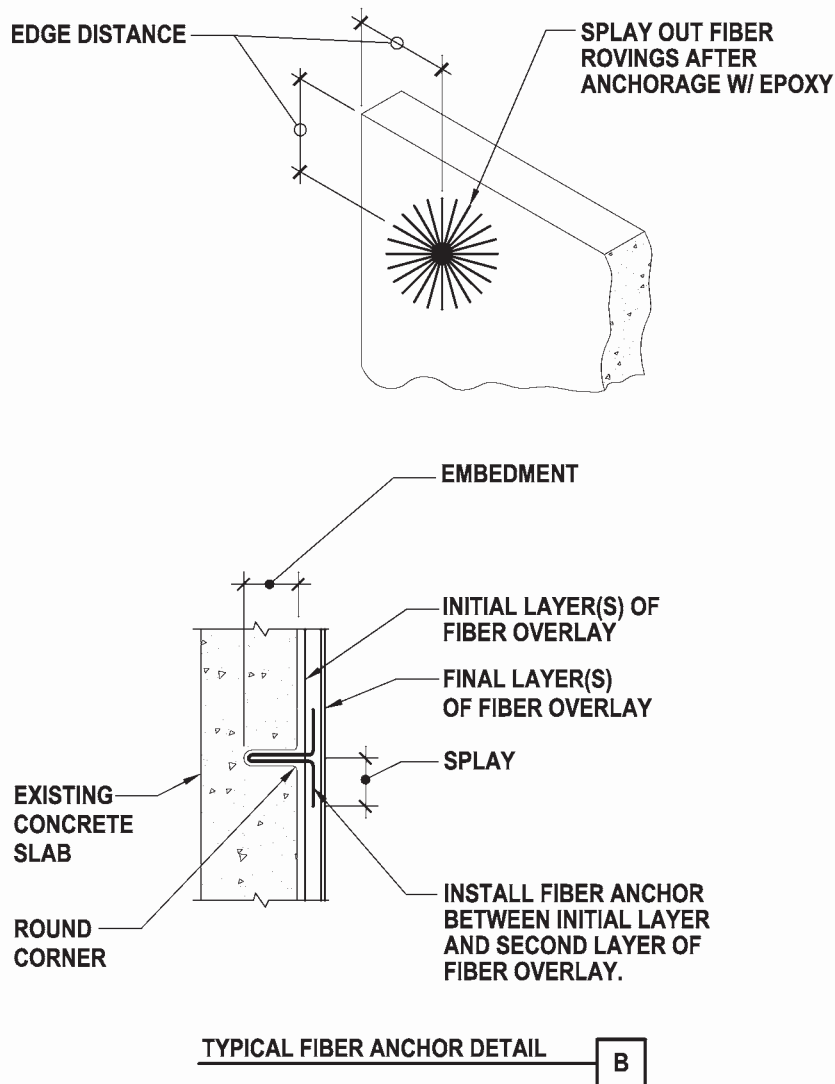
Figure 13.4.1-1B: Fiber Anchor Details

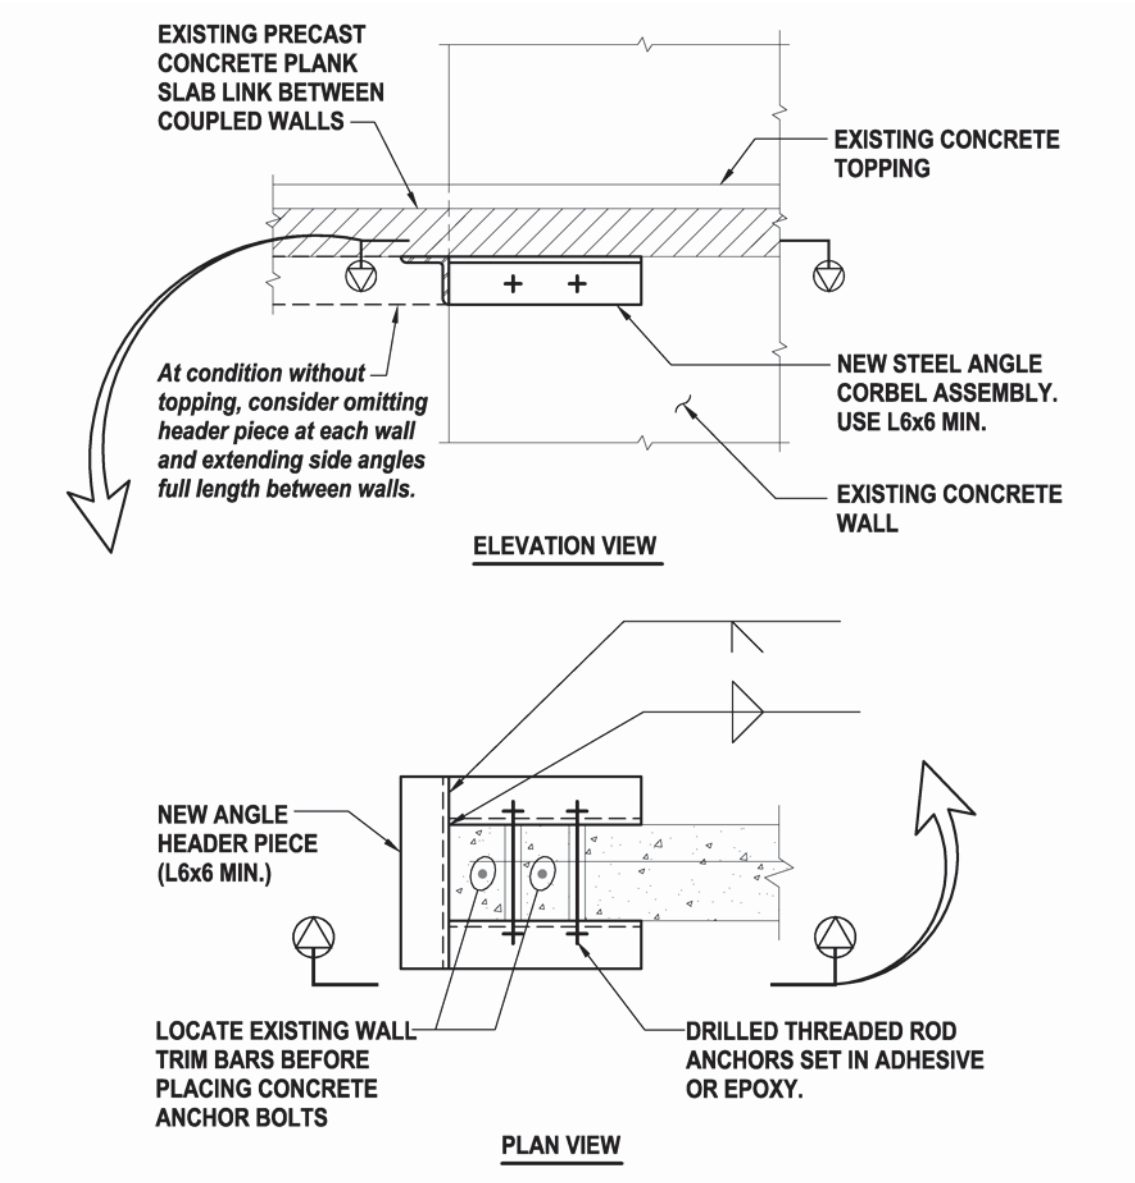
Connection of new corbel to existing concrete elements: A typical detail showing the installation of a new steel corbel is shown in Figure 13.4.2-1. The steel angle provides supplemental support for the coupling slab at the wall joint where the most damage is expected to occur. For a precast plank slab condition (as shown in the detail), especially without a cast-in-place topping, consideration should be given to extending the supplemental steel supports along the full length of the link between the coupled walls. Installation of drilled anchors into the bottom of the

Figure 13.4.2-1: Typical Corbel at Linking Slab

planks may be considered. However, it may be difficult to avoid both prestressing tendons and hollow core voids. Consider use of screen-tube anchors (see Chapter 21) if voids cannot be avoided.

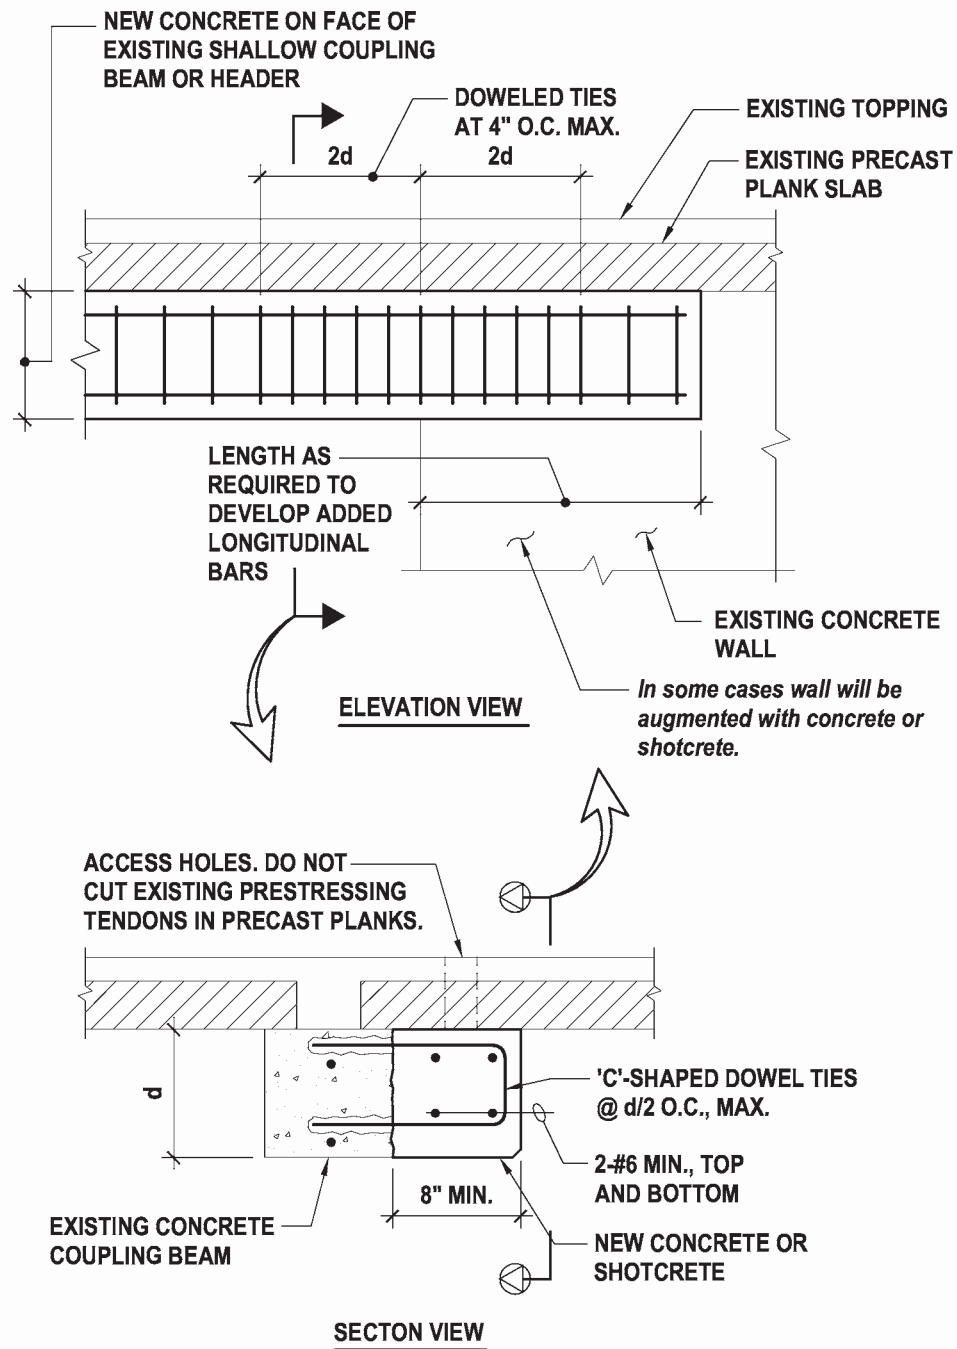
Connection of new concrete to the existing concrete beam and adjacent walls: Figure 13.4.2-2 shows an elevation and section view of a typical augmentation of a relatively shallow coupling beam or header. The surface of the existing concrete should be thoroughly cleaned and roughened to provide a good bond and interaction between the existing and new portions of the

Figure 13.4.2-2: Typical Strengthening of Shallow Coupling Beam

composite member. The new concrete should be extended along the walls far enough to develop the longitudinal bars. If cast-in-place concrete is used, access holes will be required through the slab for placement and consolidation. Care must be taken to avoid damage to any prestressing tendons in the precast planks. Figure 13.4.2-3 shows typical details for installation of X-shaped rebar cages at deeper coupling beams or headers. The new concrete should be thick enough to allow placement of the crossing longitudinal reinforcement cages inside of the confining beam ties.

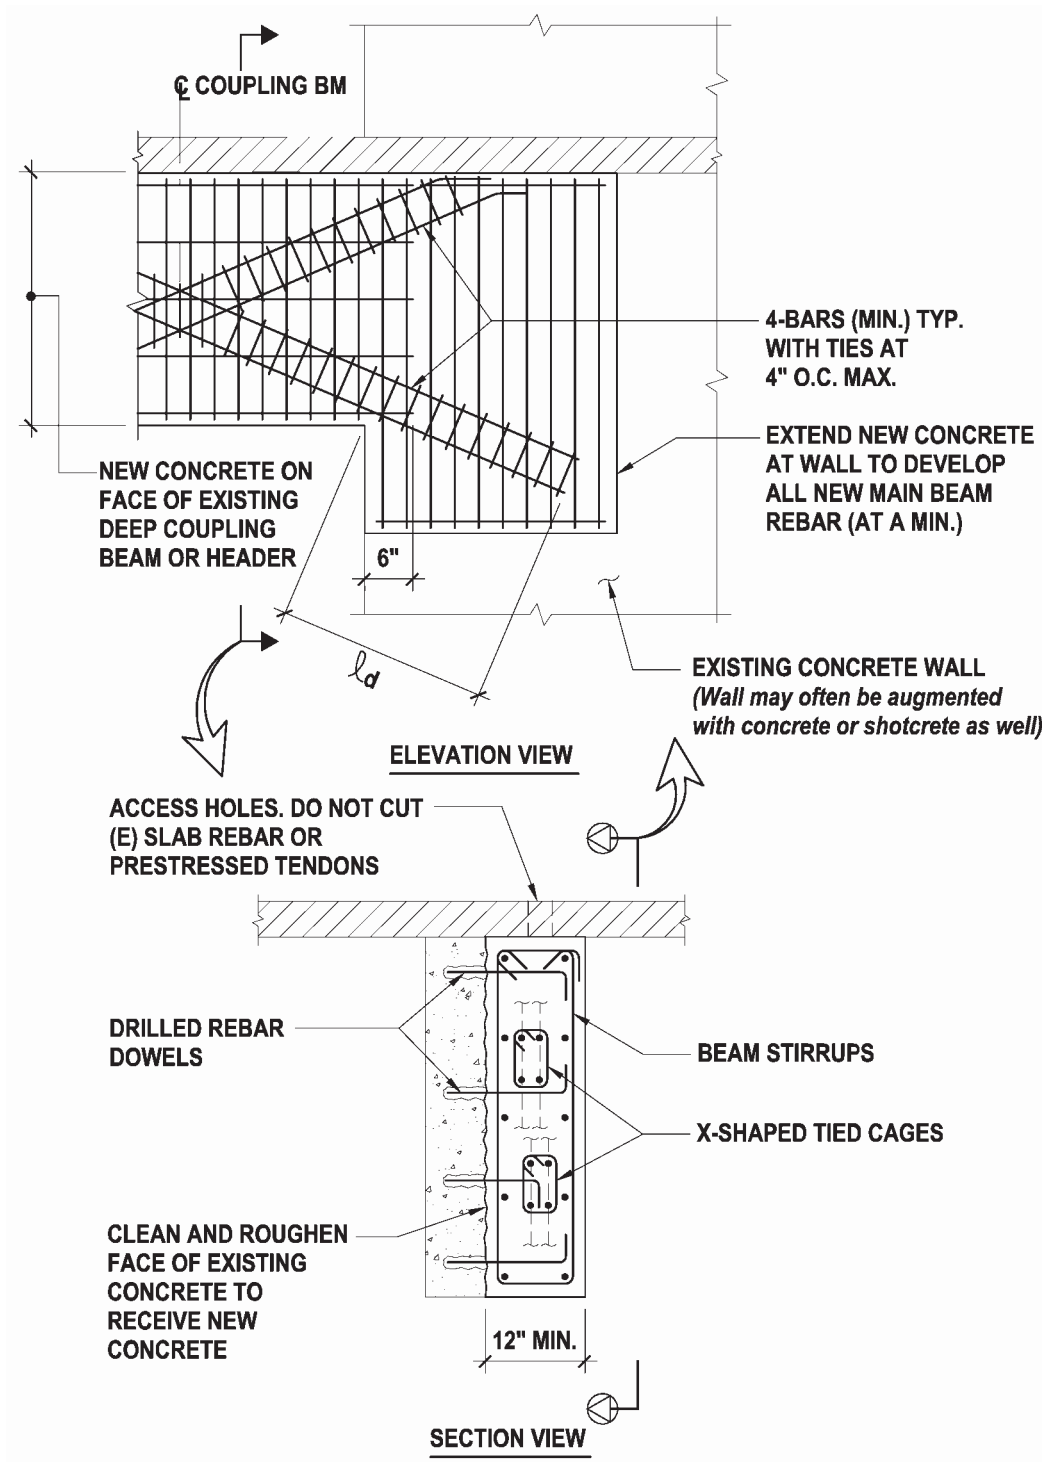
Figure 13.4.2-3: Strengthening of Deep Coupling Beam

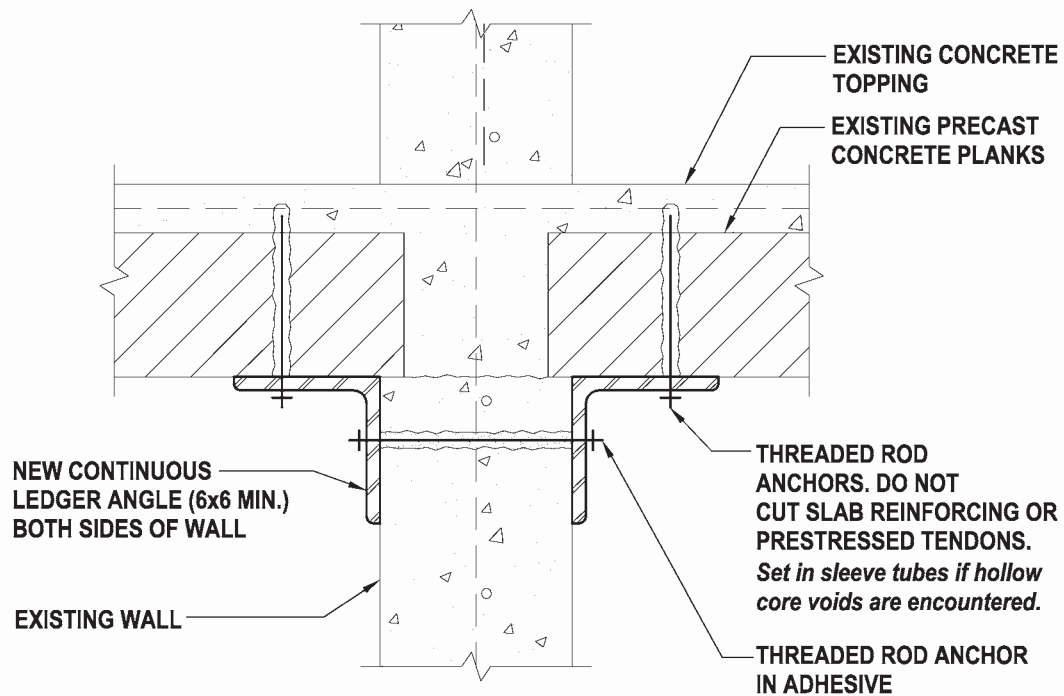
Vertical anchors into slab may be omitted if joint shear need not be augmented.

Figure 13.4.3-1: Added Support and Shear Strength at Slab-Wall Joint

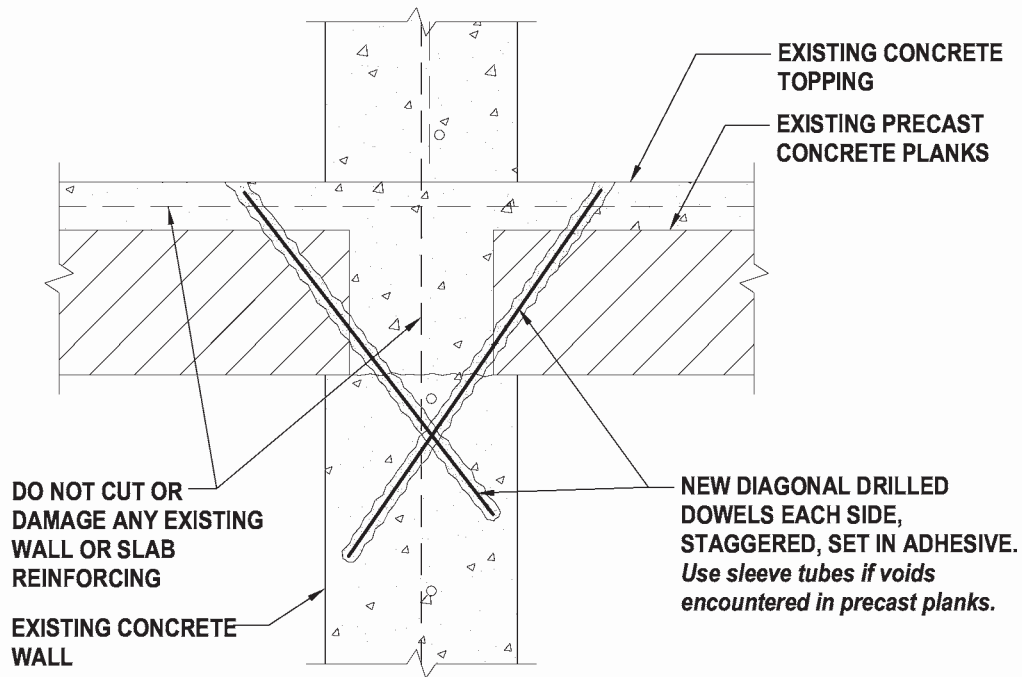
Figure 13.4.3-2: Added Shear Capacity at Slab-Wall Joint

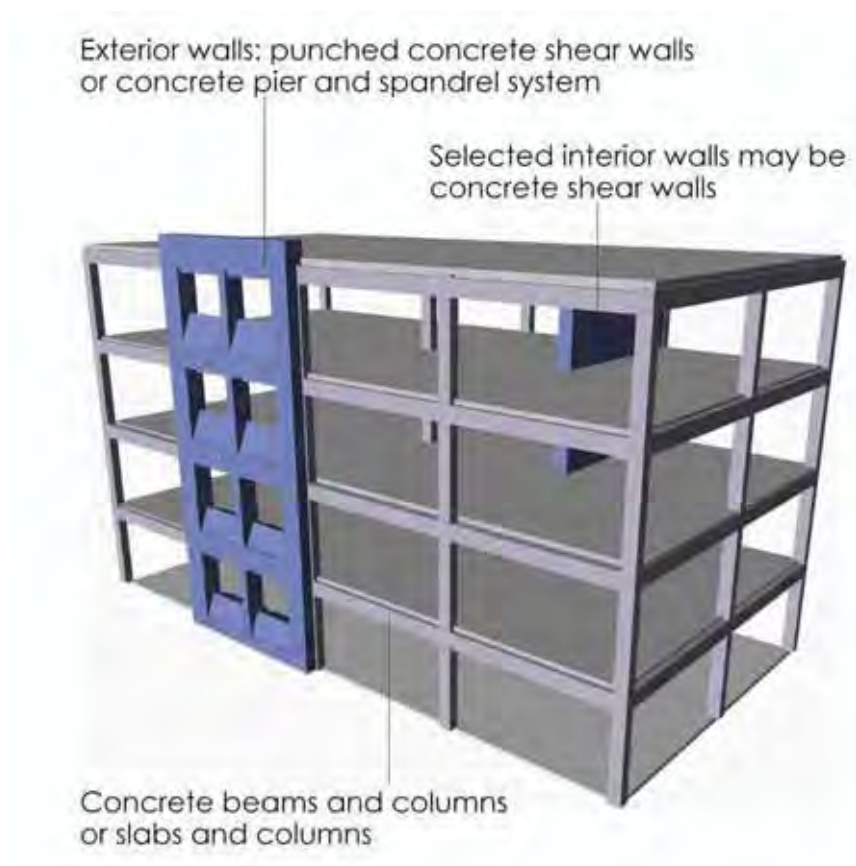
Reinforced concrete walls in a building will act as shear walls whether designed for that purpose or not. Therefore, concrete buildings that contain any significant amount of concrete wall will fall into this category. However, there are two distinctly different types of concrete wall buildings: those that contain an essentially complete beam/slab and column gravity system, and those that use bearing walls to support gravity load and have only incidental beam and column framing. In this document, these building types have been separated and are designated **C2f** for the gravity frame system and **C2b** for the bearing wall. This section covers the building with gravity framing system. Although it is typically assumed that the gravity framing is not part of the lateral force-resisting system, the framing could add stiffness to the building, particularly near the top of taller buildings. This building type is very common and has been used in a wide variety of occupancies and in all sizes.

**Figure 14.1-1: Building Type C2f: Concrete Shear Walls
(Gravity Frame Systems)**

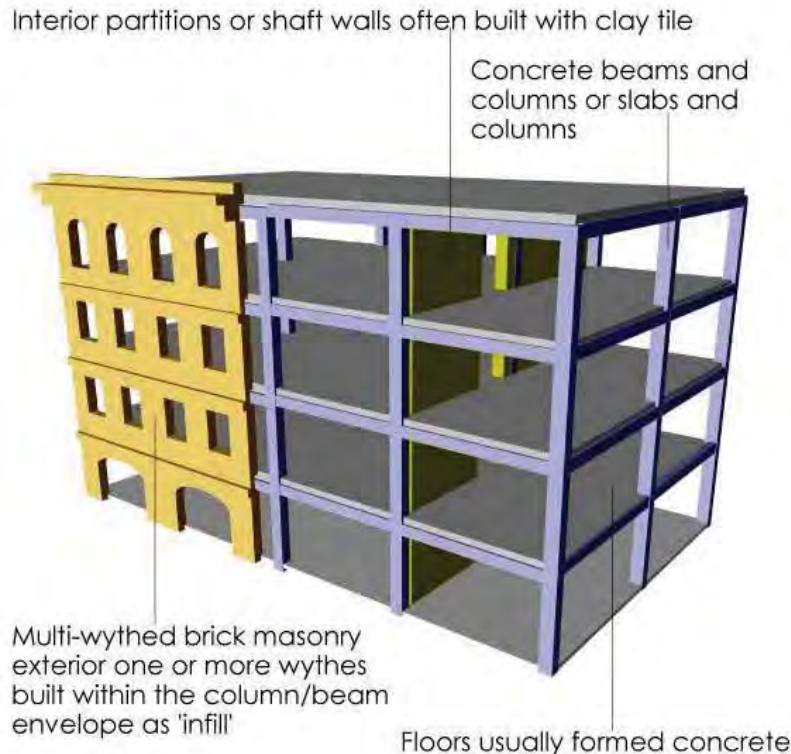
Building Type C3 is normally an older building that consists of an essentially complete gravity frame assembly of concrete columns and floor systems. The floors consist of a variety of concrete systems including flat plates, two-way slabs, and beam and slab. Exterior walls, and possibly some interior walls, are constructed of unreinforced masonry, tightly infilling the space between columns horizontally and between floor structural elements vertically, such that the infill interacts with the frame to form a lateral force-resisting element. Windows and doors may be present in the infill walls. The buildings intended to fall into this category often feature exposed clay brick masonry on the exterior. Figure 15.1-1 shows an example of this building type.

Figure 15.1-1: Building Type C3: Concrete Frames with Infill Masonry Shear Walls

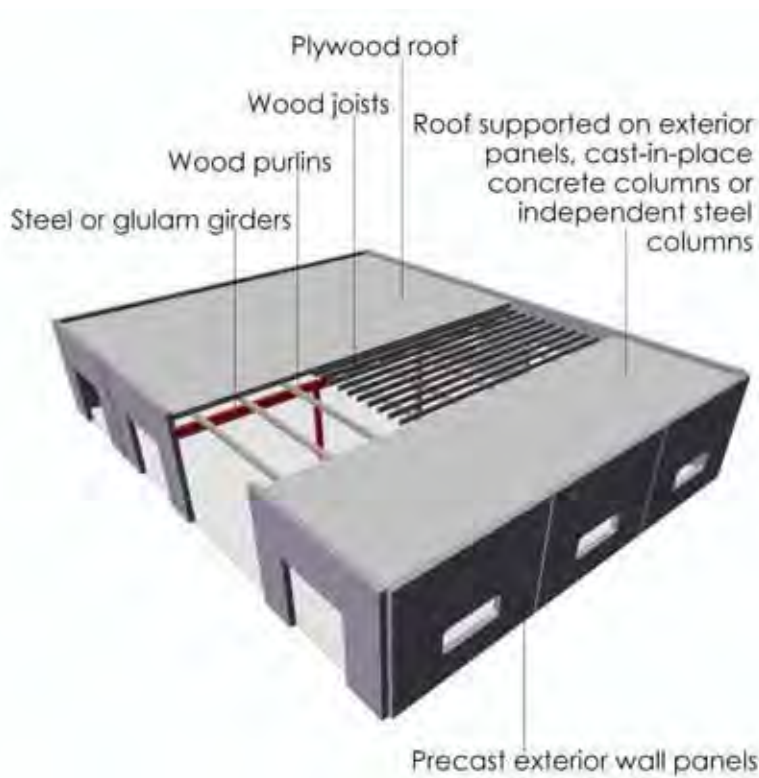
Building Type **PC1** is constructed with concrete walls, cast on site and tilted up to form the exterior of the building. **PC1** buildings are used for many occupancy types including warehouse, light industrial, wholesale and retail stores, and office. The majority of these buildings are one story; however, tilt-up buildings of up to three and four stories are common, and a limited number with more stories exist. For many years, tilt-up buildings have been primarily large box-type buildings with the tilt-up walls at the building perimeter; this is by far the largest group of **PC1** buildings in the U.S. inventory. In recent years, tilt-up construction has expanded to more varied uses and building configurations. Figure 16.1-1 illustrates one example of a **PC1** building.

Figure 16.1-1: Building Type PC1: Tilt-Up Concrete Shear Walls

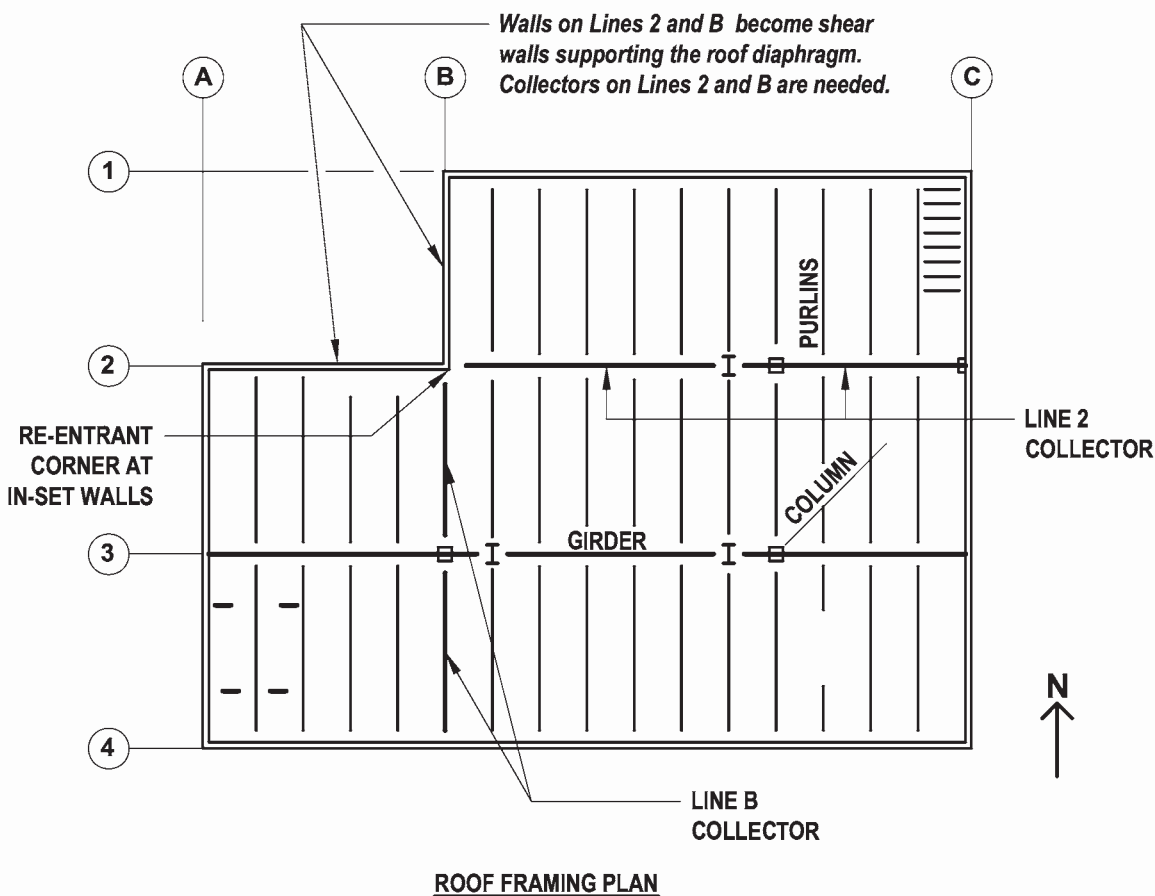
Re-entrant corners are reasonably common in large box-type **PC1** buildings, either due to in-set panels (Figure 16.3-1), or an L-shaped building plan. The in-set walls create a hard spot in the diaphragm, restraining it from the deflection required to transmit load to the end wall. In most cases, the in-set walls will have to be considered shear walls supporting the diaphragm. Where chords and collectors have not been provided at the re-entrant corner, the diaphragm has been seen to pull away from the wall, damaging gravity and lateral load connections. Rehabilitation at re-entrant corners requires the provision of adequate chords and collectors, shear transfer to the in-set wall panels, and possibly the strengthening of the diaphragm, wall panels, and connections to the foundation. In some cases, high earthquake loads in existing elements may make it necessary to add new vertical elements in line with the re-entrant corner. The *SEAONC Guidelines* suggest that there may be diaphragm continuity over this interior diaphragm support, increasing the diaphragm reaction to the in-set wall line. Alternately, it may be possible to allow the wall at the re-entrant corner to rock, or to separate the wall from the diaphragm allowing the diaphragm to span to the exterior wall. These approaches require complex detailing, however.

Figure 16.3-1: Plan of PC1 Building with Re-entrant Corner at In-set Panels
