Architectural
Resources Group

609, 611, and 619 NE 3rd Street
McMinnville, Oregon

Historic Resource Assessment
November 2022

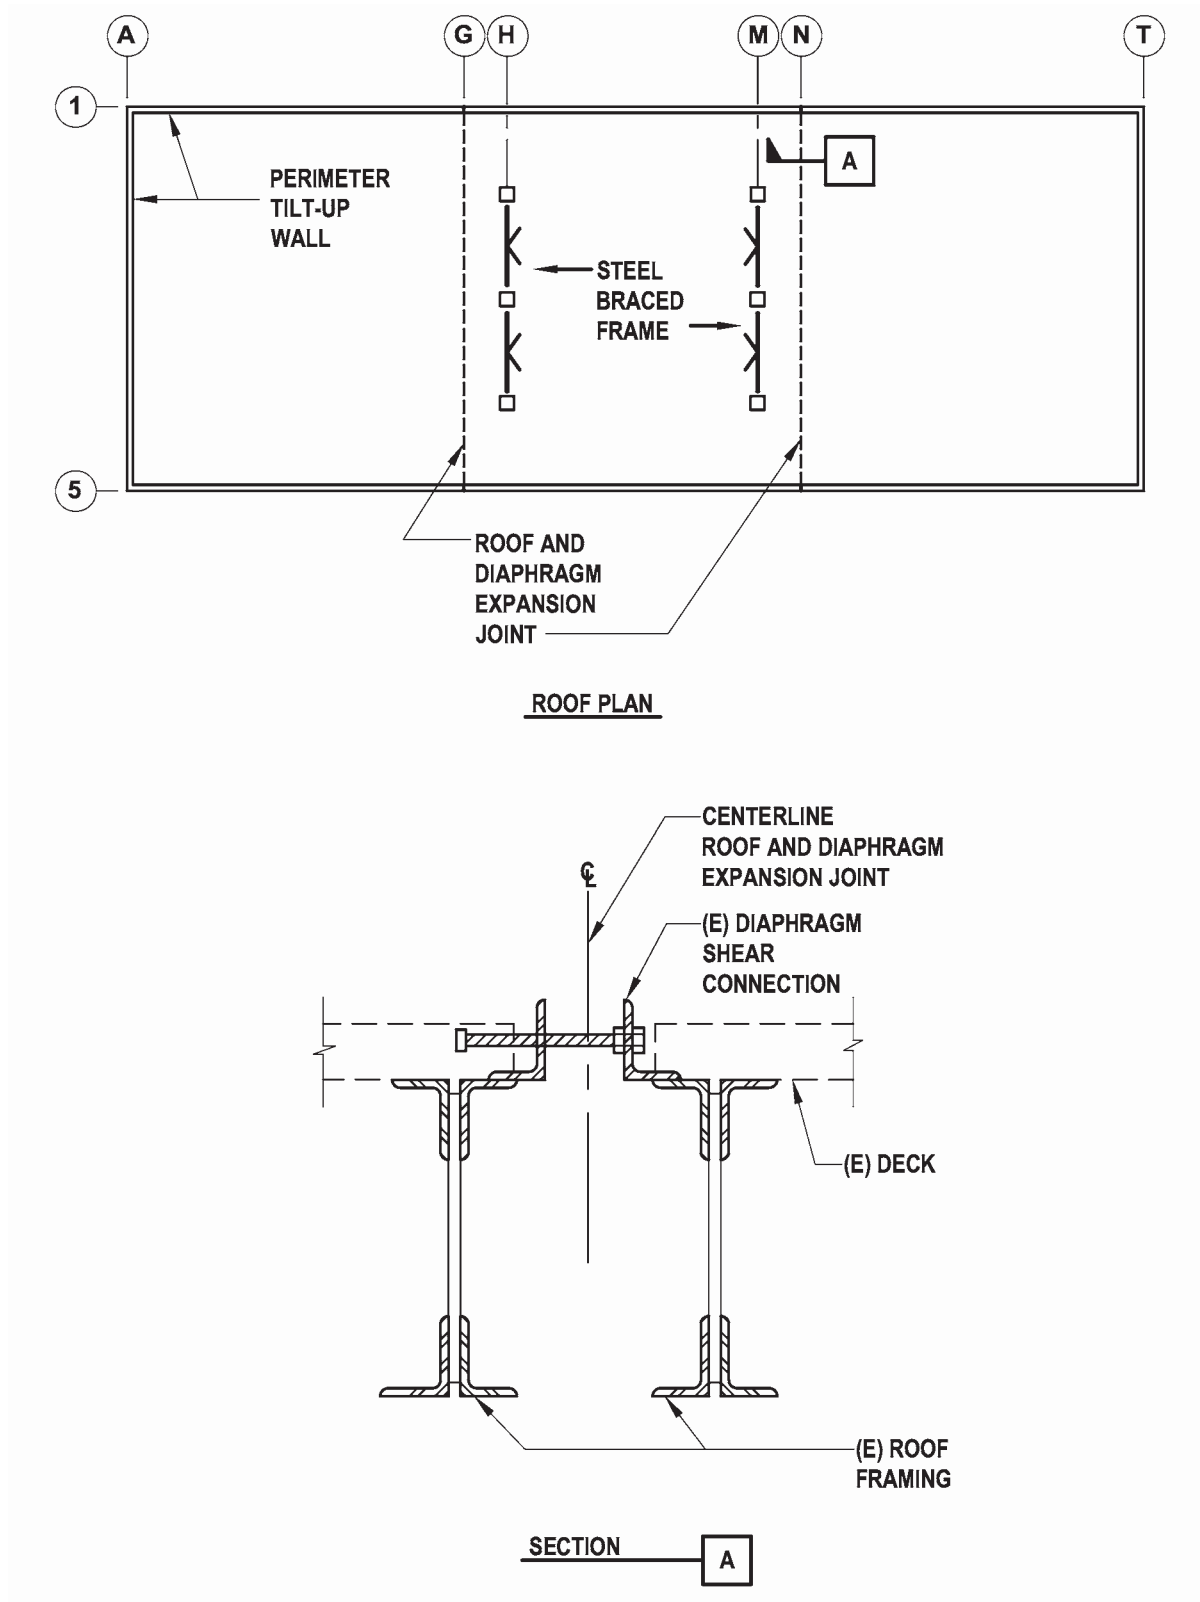
Some very large tilt-up buildings are constructed in configurations that resemble multiple buildings alongside each other, as seen in Figure 16.3-2. This figure illustrates a single large tilt-up building constructed in three sections, separated by roof expansion joints. Thermal movements in the steel deck diaphragms make the expansion joints necessary. If each of the three building sections were provided a complete lateral force-resisting system and separated by adequate seismic joints, this building configuration would be of little concern. As shown in Figure 16.3-2, however, building sections are often laterally braced off of adjacent building sections, using shear transfer through the expansion joint. This configuration raises concerns of

Figure 16.3-2: Plan and Detail of Large PC1 Building Constructed in Three Sections

deformation compatibility between the building sections under earthquake loading. Incompatible deformations are likely to significantly compromise shear transfer through the expansion joint. In addition, common details used for the expansion joint may not perform adequately under expected seismic forces. Details often involve significant eccentricities. The eccentricities may create forces in roof framing members that were not envisioned in the framing member design. The most direct approach to rehabilitation of this building type is the addition of vertical elements such that each building section is independently braced. Alternatively, the expansion joint connection can be improved such that it can reliably transfer anticipated earthquake forces while accommodating anticipated building movement.

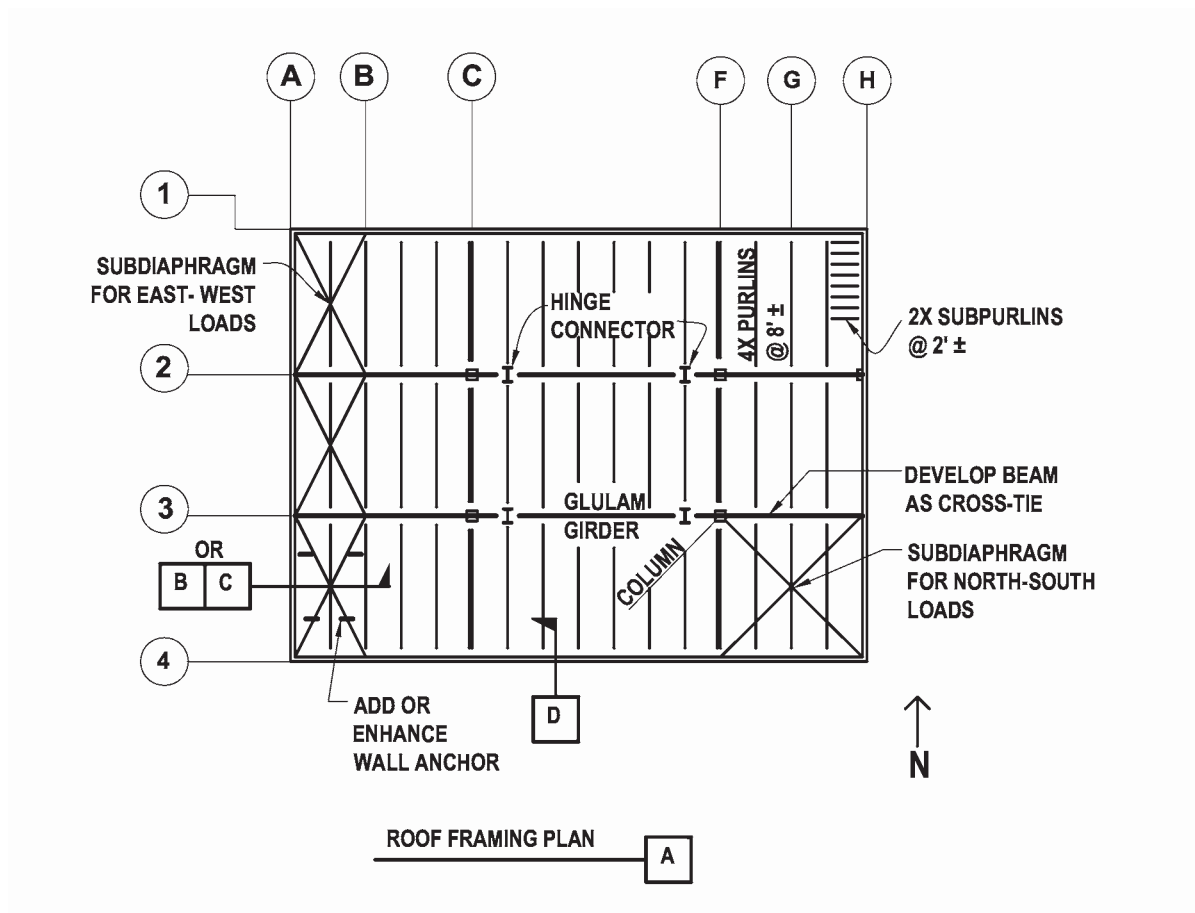
Figure 16.4.1-1A: Roof Plan with Wall Out-of-Plane Anchorage for Flexible Wood Diaphragm

Figures 16.4.1-1A and 16.4.1-1C do not show wall anchors attached to single existing 2x subpurlins. It is recommended that anchorage be to a 3x or wider member, or multiple 2x's as shown in Figure 16.4.1-1B. While it may be possible for a single 2x4 or 2x6 to be shown adequate in calculation, adequate installation and performance are extremely difficult to achieve.

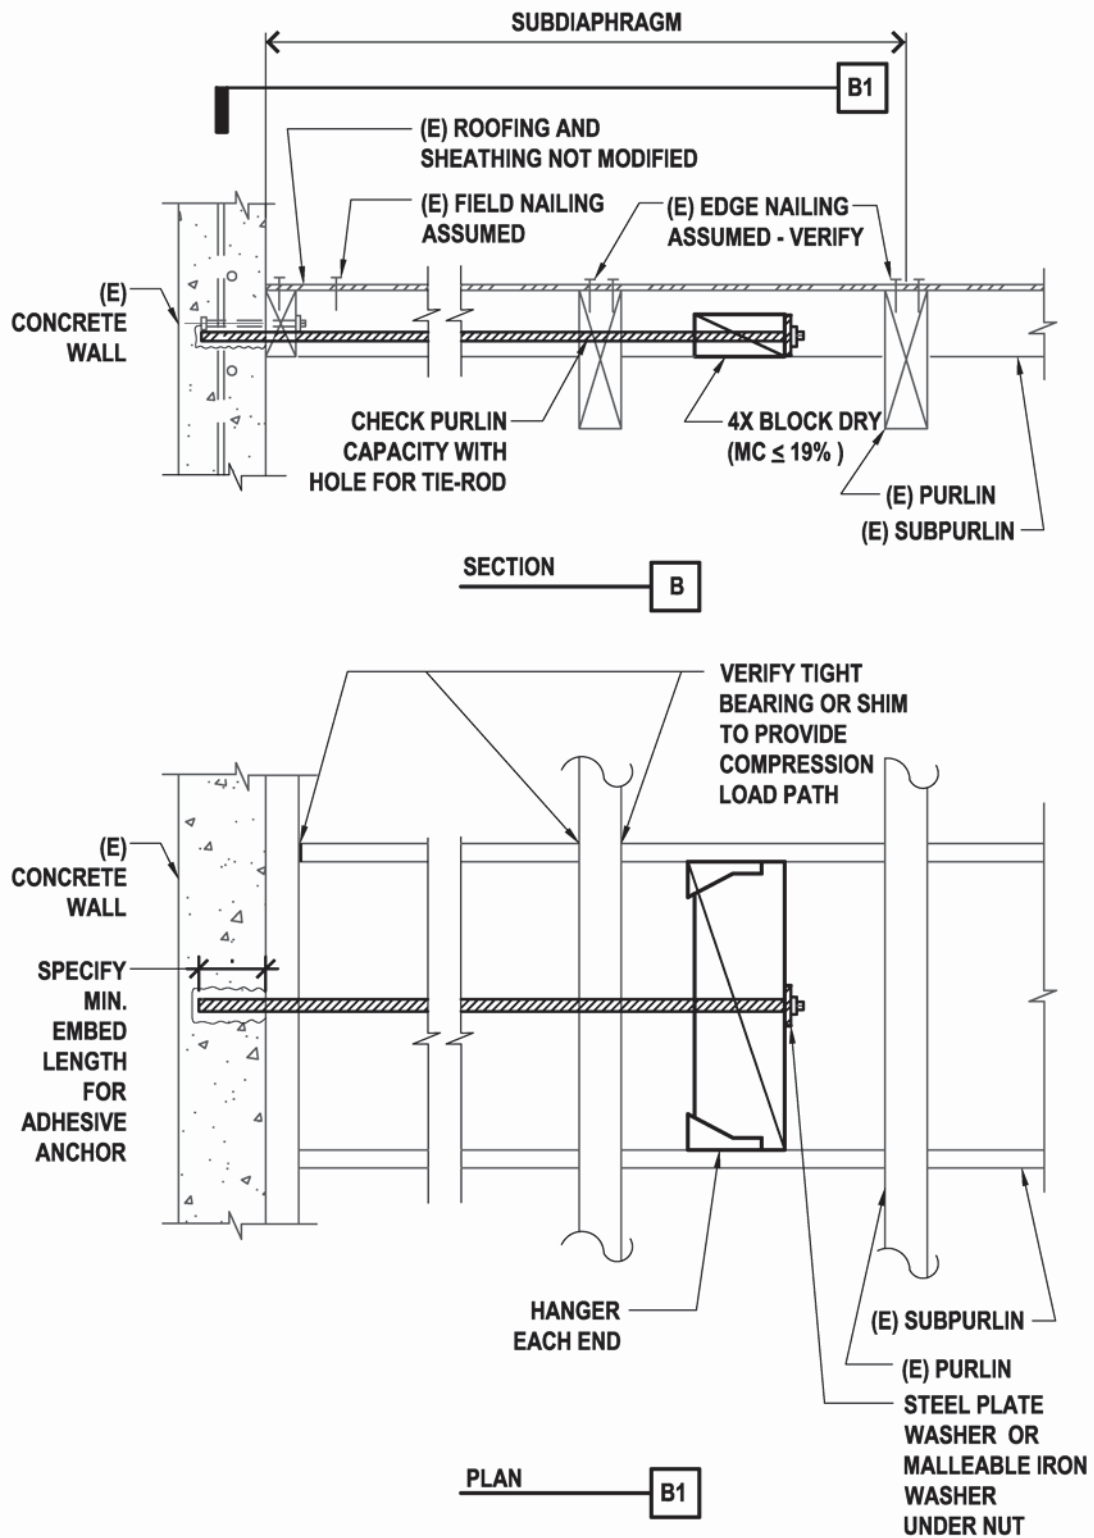
Figure 16.4.1-1B: Wall Out-of-Plane Anchorage for Flexible Wood Diaphragm at Subpurlins – Roofing Not Removed

The wall anchorage system needs to extend across the width of the subdiaphragm. In Figure 16.4.1-1C, this involves providing extra pairs of tie-down devices between subpurlins across the first purlin. Again, both tension and compression load paths are needed. The required subdiaphragm depth is determined from the number of nails required to transfer subdiaphragm forces into the main diaphragm. Depending on subdiaphragm requirements, additional tie-down pairs could be required across more purlins. Subdiaphragm requirements are discussed in Chapter 22.

Details 16.4.1-1B and 16.4.1-1C show work from top of the diaphragm. See Chapter 22 for alternates for working from below. Location of access needs to be decided early on in the design process and will drive both calculations and detailing of the rehabilitation work.

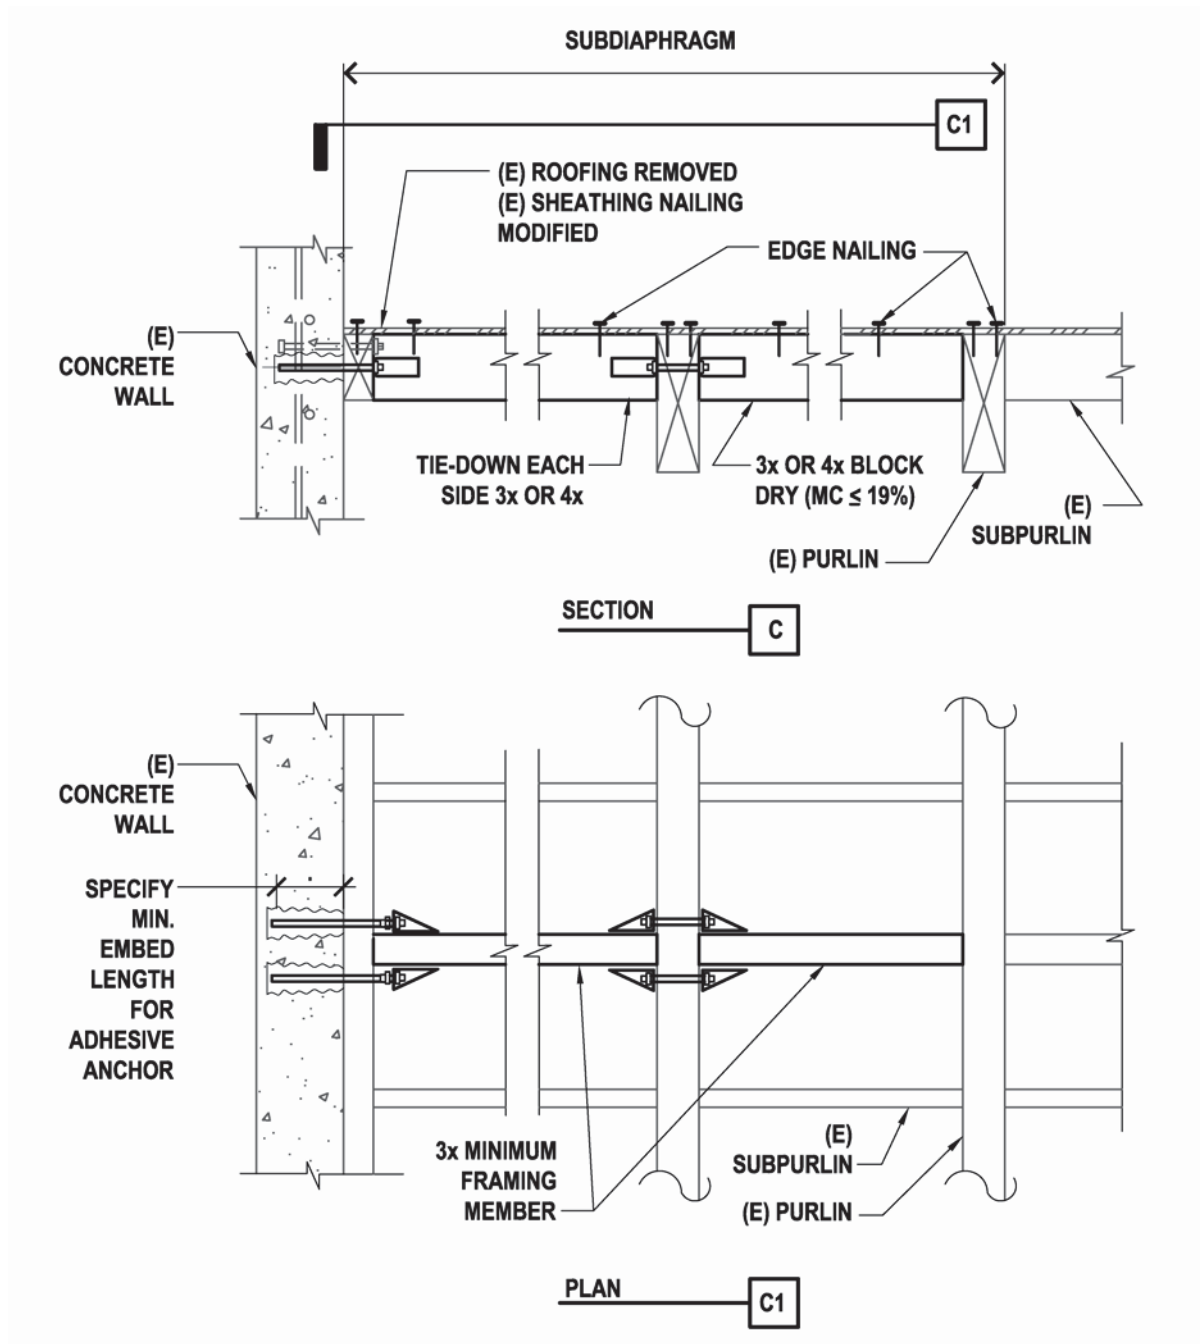
Figure 16.4.1-1C: Wall Out-of-Plane Anchorage for Flexible Wood Diaphragm at Subpurlins – Roofing Removed

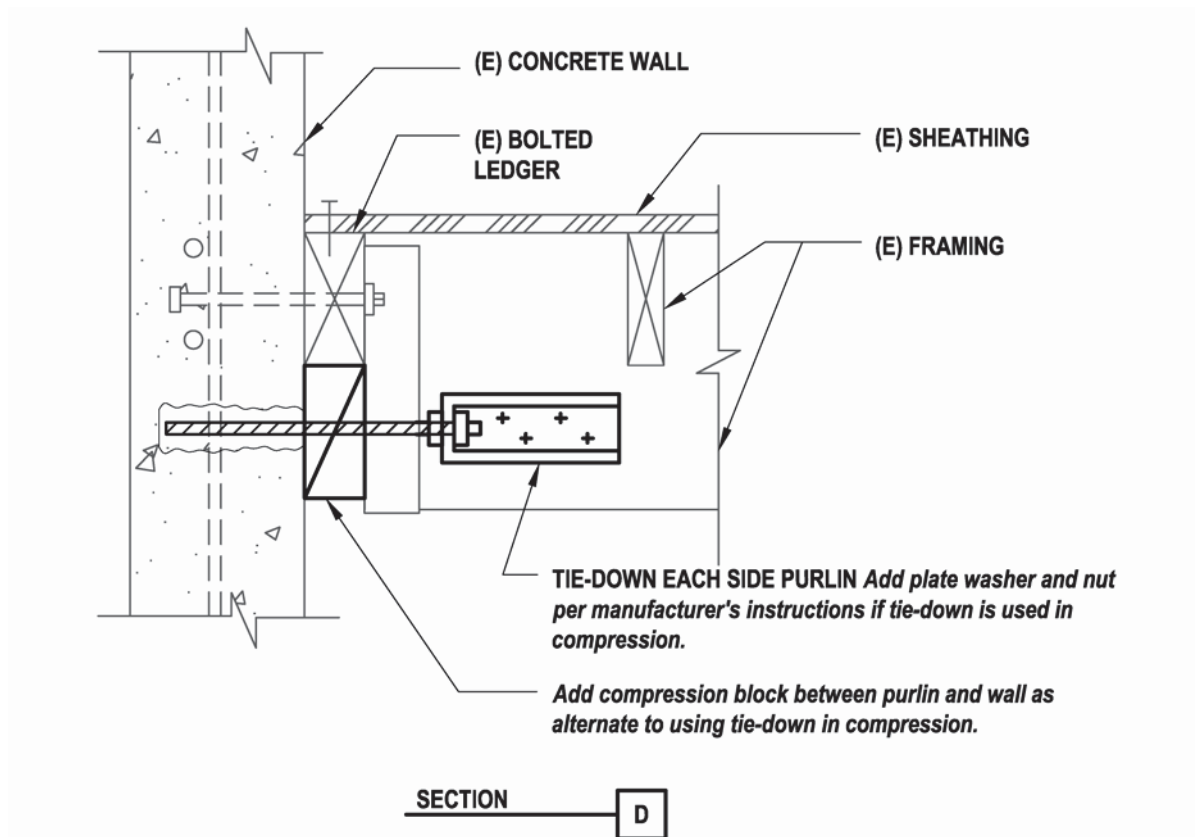
Figure 16.4.1-1D illustrates anchorage of the north and south walls to a purlin. In this case, the purlin is long enough to extend across the subdiaphragm width (extending between Lines 1-2 and 3-4), so additional pairs of tie-downs are not needed. As in previous details, both tension and compression load paths must be maintained.

Figure 16.4.1-1D: Wall Out-of-Plane Anchorage for Flexible Wood Diaphragm at Purlins

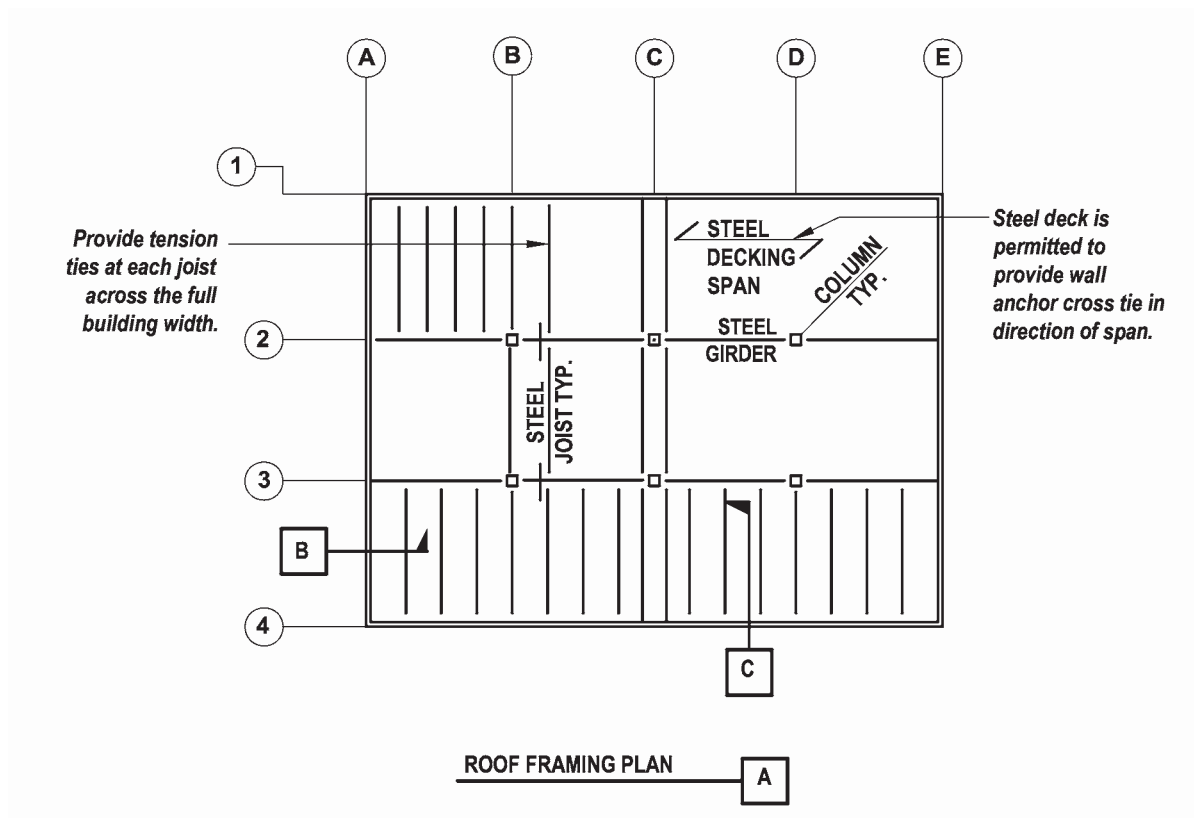
Figure 16.4.1-2A illustrates a similar roof plan for a **PC1** building with a steel deck diaphragm. It is important to note in this figure that subdiaphragms (as shown in Figure 16.4.1-1A) are not used. Instead, the steel deck provides a continuous cross-tie in the east-west direction, while in the north-south direction open web joists provide direct cross-ties across the entire diaphragm width at each wall anchor location. This is the primary approach used in new steel deck diaphragm construction. Subdiaphragm concepts can be applied to steel deck construction, but are not common.

Figure 16.4.1-2A: Roof Plan with Wall Out-of-Plane Anchorage for Flexible Steel Diaphragm

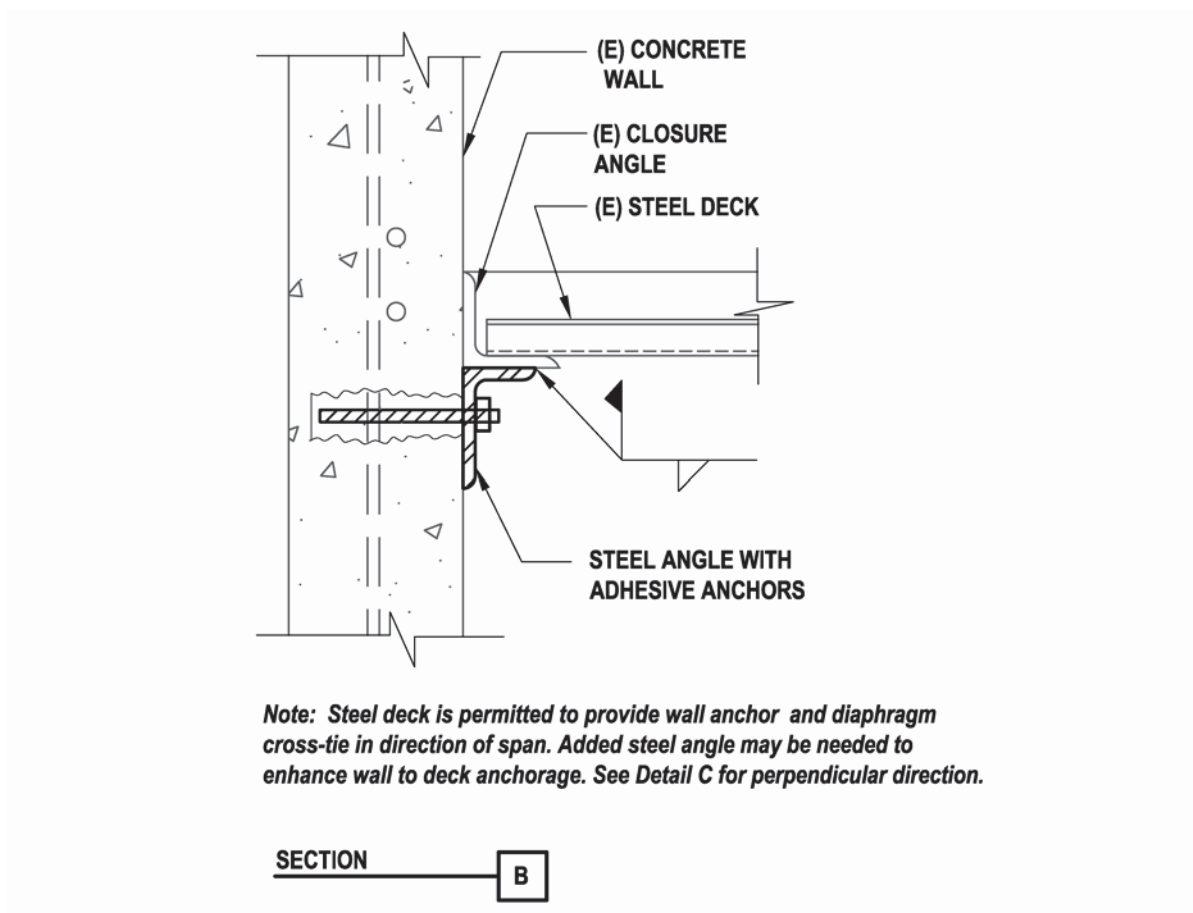
Figures 16.4.1-2B and 16.4.1-2C provide wall to diaphragm anchorage details. In Figure 16.4.1-2B, wall anchorage forces are transmitted to the steel deck. The deck section, deck edge fastening, and deck end splices need to be checked for wall anchorage tension and compression forces. Justification of the capacity may be by calculation or testing. The balance of the load path also needs to be checked and enhanced as required. In the detail shown, supplemental adhesive

anchors to the wall and a second ledger angle are provided. Prying action in the steel ledger angle needs to be considered in determining wall anchor forces.

Figure 16.4.1-2B: Wall Out-of-Plane Anchorage for Flexible Steel Diaphragm – to Decking for Load Parallel to Flutes

Compression forces can be carried in tie-down devices, if rated for compression by the manufacturer. Unsupported tie-down rod lengths must be kept short, and additional nuts and washers are needed to transfer compression. Again, wall anchorage loads need to be transferred into the decking. In this case existing welding or screwing of the decking is relied upon. If this fastening is not adequate, the roofing will need to be removed to allow additional fastening.

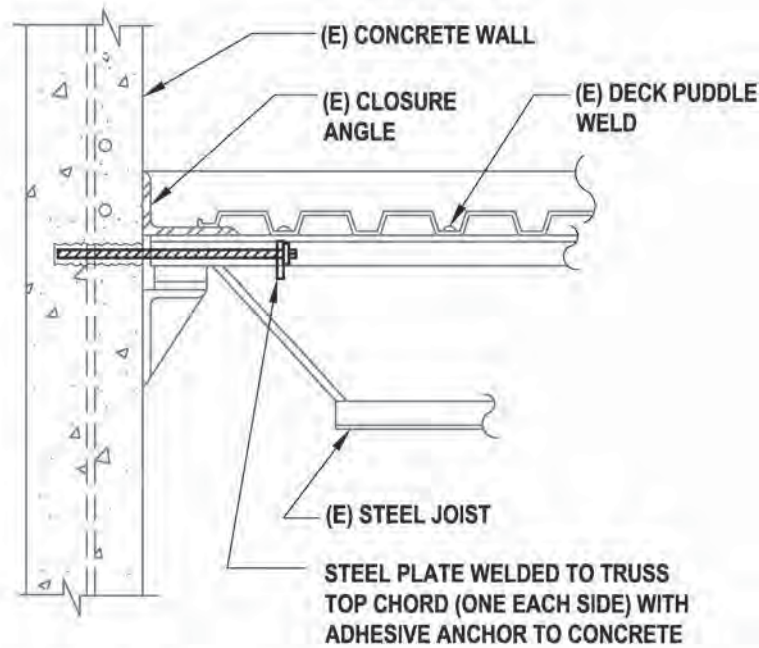
1. Verify that steel joist top chord is adequate for combined gravity and wall anchorage loads.
2. Provide double washers and nuts where required for compression loads.
3. Verify that steel deck connection to joist is adequate for wall anchorage loads.

Figure 16.4.1-2C shows wall anchorage to a steel open web joist. The wall anchorage connection may be through the joist seat in new construction; however, a supplemental anchor to the joist is likely needed in rehabilitation. The joist must be checked for wall anchorage forces and any applicable eccentricities. Details in Chapter 22 address joist to joist connections to complete the cross-tie.

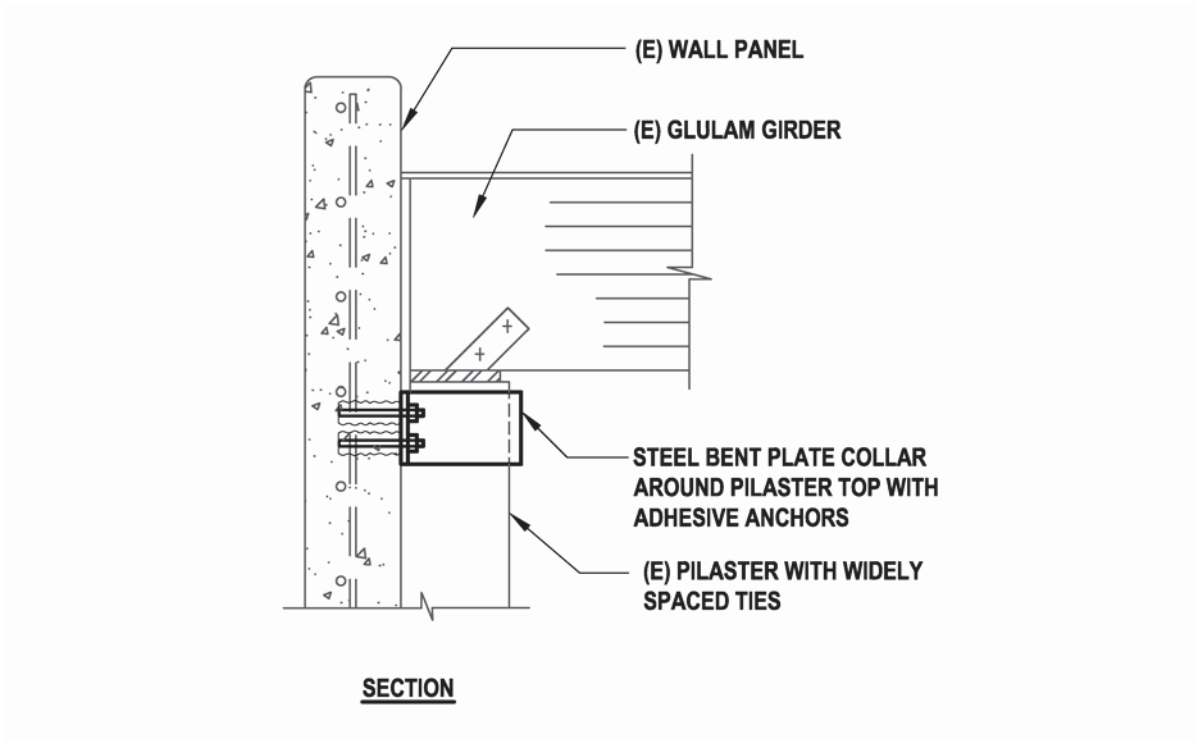
Figure 16.4.2-1: Enhanced Girder Connection – Collar at Pilaster
Adapted From SEAONC (2001)

Tilt-up walls may have pilasters supporting girder loads. In older tilt-up buildings, these are often cast-in-place pilasters, while in newer buildings pilasters are cast as part of the tilt-up panel. The pilaster acts as a wall stiffener, allowing the wall to span both horizontally and vertically under out-of-plane earthquake loading. This attracts more load to the pilaster, and the top of pilaster reaction for out-of-plane loading will be higher than at a typical wall anchor. The gravity load connection generally also serves as the girder-to-pilaster connection for out-of-plane loads. Two deficiencies are common with this connection: 1) inadequate confinement around anchor bolts embedded in the pilaster top and 2) inadequate connection to the girder. Tension loads on the connector have led to splitting of the column top, pulling away the wedge of concrete in front of the anchor bolts. In recent codes, the placement of three closely spaced ties at anchor bolts has been required to reinforce across the anticipated concrete crack. Where added ties have not been provided, a collar around the pilaster top can provide external reinforcement (Figure 16.4.2-1). The collar should be relatively stiff to minimize splitting of the concrete before load is taken up. The second issue is inadequate connection to the wood girder, including bolt capacity and placement. Where the girder seat connection to concrete is adequate or can be enhanced, inadequate bolt capacity can be mitigated with addition of bolt tabs (Figure 16.4.2-2). Alternately, it is possible to use new wall anchors from the girder to the wall, bypassing the girder seat (Figure 16.4.2-3). Again, this connection must be stiff.

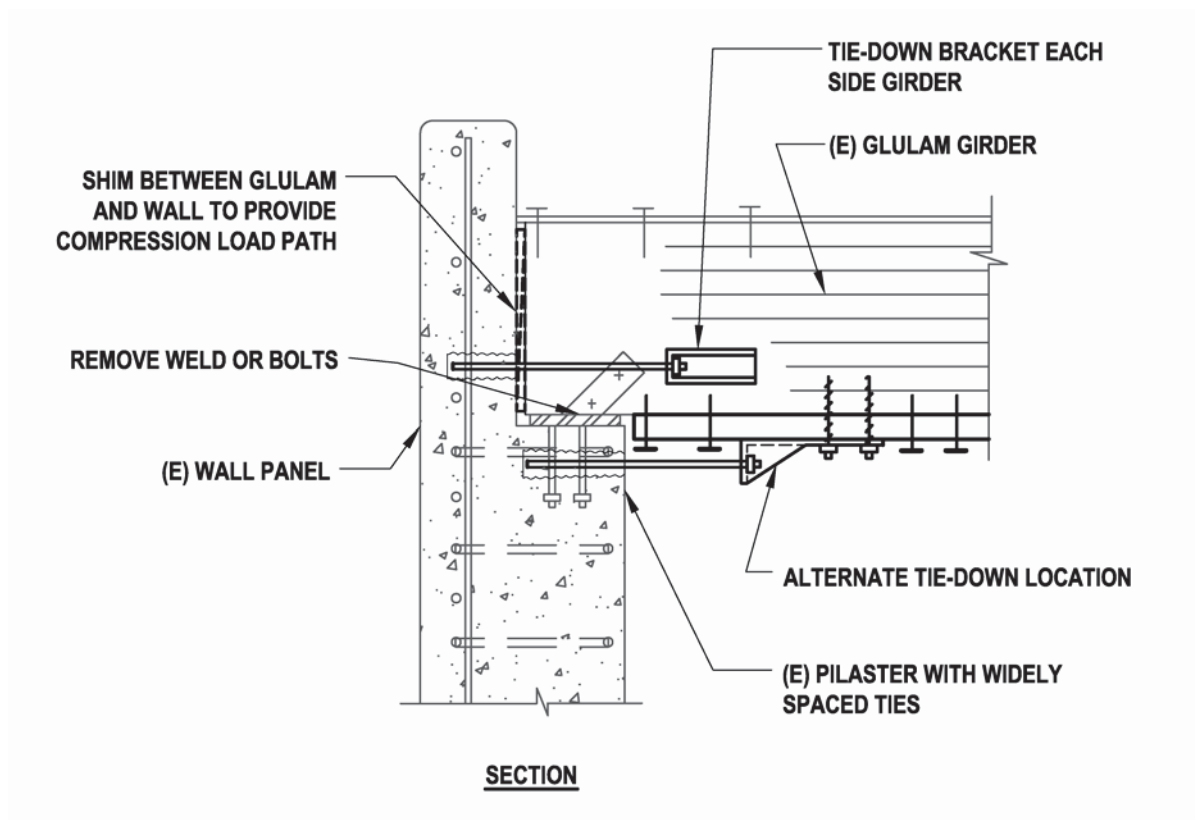
Figure 16.4.2-3: Enhanced Girder Connection at Pilaster
Adapted From SEAONC (2001)

Girders that are supported directly on a flat wall panel using a steel U-bracket bolted or welded to the panel (Figure 16.4.2-3) will also attract wall out-of-plane forces. As is true with wall pilasters, a girder and U-bracket are likely to provide a stiffer load path for wall out-of-plane loads than adjacent anchors. For this reason, use of a wall anchorage force greater than used for adjacent anchors is encouraged. The girder connection should have the ability to resist wall anchorage loads in combination with gravity loads. Anchorage of the bracket to the panel will often be adequate for both gravity and lateral loads; however, the bracket attachment to a wood girder will often not have the quantity or placement of bolts required for tension loads. Addition of steel tabs and bolts will add capacity and place bolts where end distances are adequate for tension loads. Where the steel connection to the concrete is not adequate, the out-of-plane anchor might bypass the existing connection and connect the girder directly to the wall. Figure 16.4.2-2 shows two approaches, one with a tie-down on each side of the girder and a second with a tie-down on the girder bottom. The out-of-plane wall anchor should be as stiff as possible to minimize damage to the gravity connection.

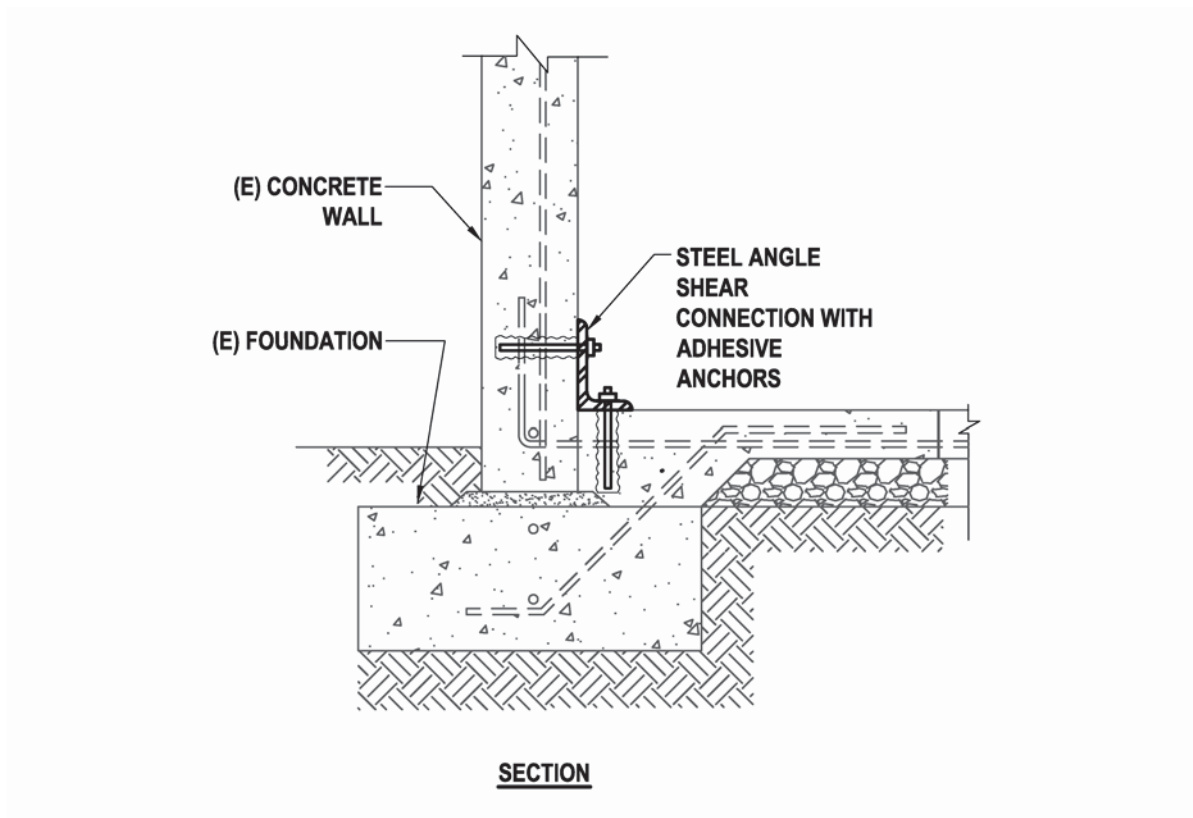
Figure 16.4.3-1: Enhancement of Tilt-up Panel Base Connection

Rehabilitation of base connections in PC1 buildings for in-plane and out-of-plane shear loads is most commonly accomplished by addition of steel angles and adhesive anchors between the wall panel and adjacent slab-on-grade. This is illustrated in Figure 16.4.3-1. In some instances, the slab-on-grade may not have been thickened adjacent to the tilt-up panel. When this is the case, it may be necessary to remove and recast a thicker pour strip in order to get adequate anchorage. The connection shown would flex if the wall were to uplift. Where uplift connection capacity is required, a direct tension connection of the wall to the footing below is recommended.

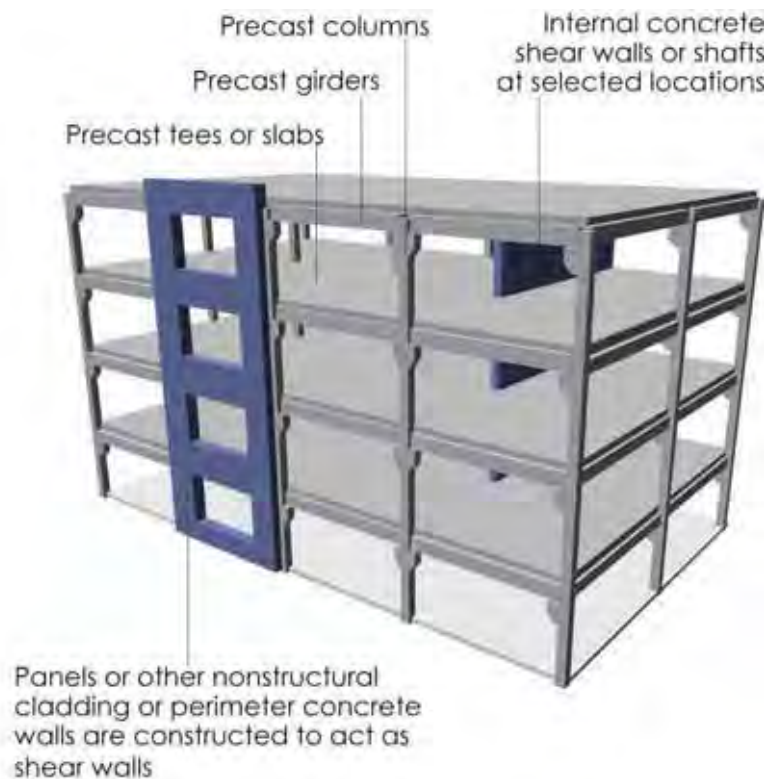
Figure 17.1-1: Building Type PC2: Precast Concrete Gravity Frames with Shear Walls

Buildings designated as **PC2** include wide ranging combinations of precast and cast-in-place concrete elements. Precast members may be limited to a floor system of hollow core or T-beam construction, or may include all elements of the gravity and lateral load systems. For this chapter, Building Type **PC2** includes concrete wall or frame buildings in which any of the horizontal or vertical elements of the lateral load system are of precast concrete, except for flexible diaphragm buildings which are addressed as Building Type **PC1** in Chapter 16.

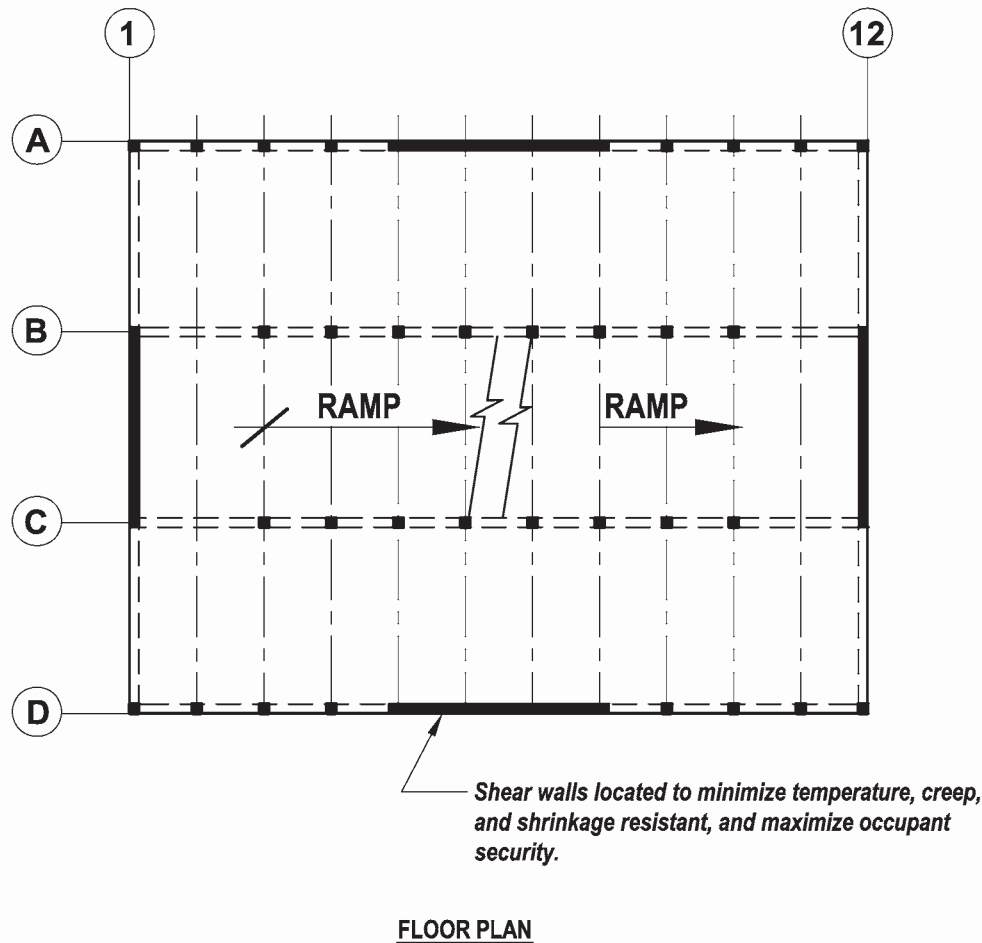
Figure 17.2-1: Plan of Common Parking Structure Configuration

Many parking structures have large plan areas, and considerations of security and restraint against temperature, creep, and shrinkage movement lead to concentration of the shear walls at the building perimeter near the center of each side (Figure 17.2-1). This configuration leads to long diaphragm spans with significant shear, moment, and collector demands. With these high demands, it is possible for the diaphragm, rather than the vertical elements to control building dynamic behavior. This is of concern in all systems, but particular in precast systems due to the lower level of inherent diaphragm continuity.

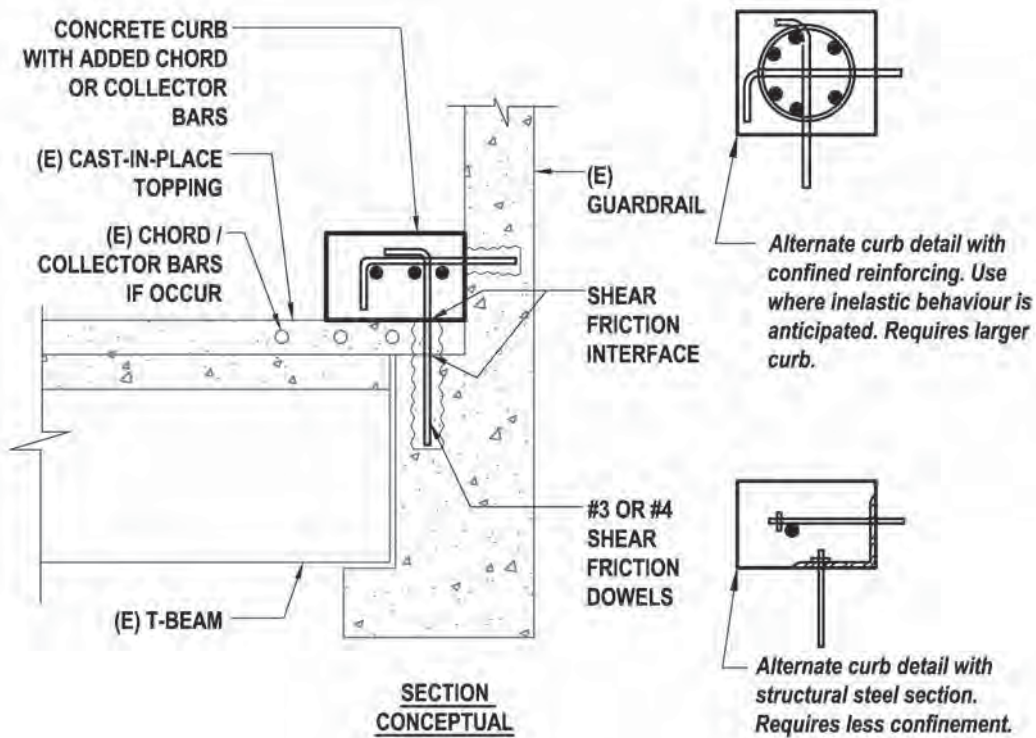
Figure 17.4.1-1: Added or Enhanced Chord or Collector at Floor Perimeter with Cast-In-Place Topping Slab

In diaphragms with cast-in-place topping slabs, existing chords and collectors are likely to be reinforcing bars at the edge of the cast-in-place slab and in line with shear walls. The most practical rehabilitation technique is addition of structural steel sections or reinforcing bars at the diaphragm boundary locations. Where boundary members occur at the perimeter of parking structures, it may be possible to encase the steel sections or reinforcing in new concrete curbs on top of the existing deck, as shown conceptually in Figure 17.4.1-1. Where boundary members extend across the floor plate where foot or vehicle traffic will occur, alternate chord and collector locations are required, as shown conceptually in Figures 17.4.1-2 and 17.4.1-3. For both chords and collectors, shear transfer capability between the boundary member and the structural diaphragm needs to be provided. Adhesive anchors or reinforcing dowels are the most likely

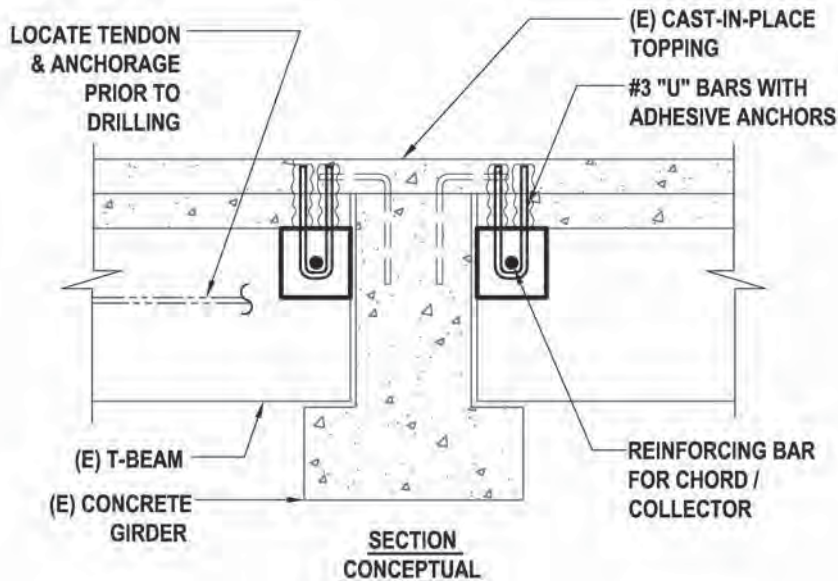
Figure 17.4.1-2: Added or Enhanced Chord or Collector at Floor Interior with Cast-In-Place Topping Slab

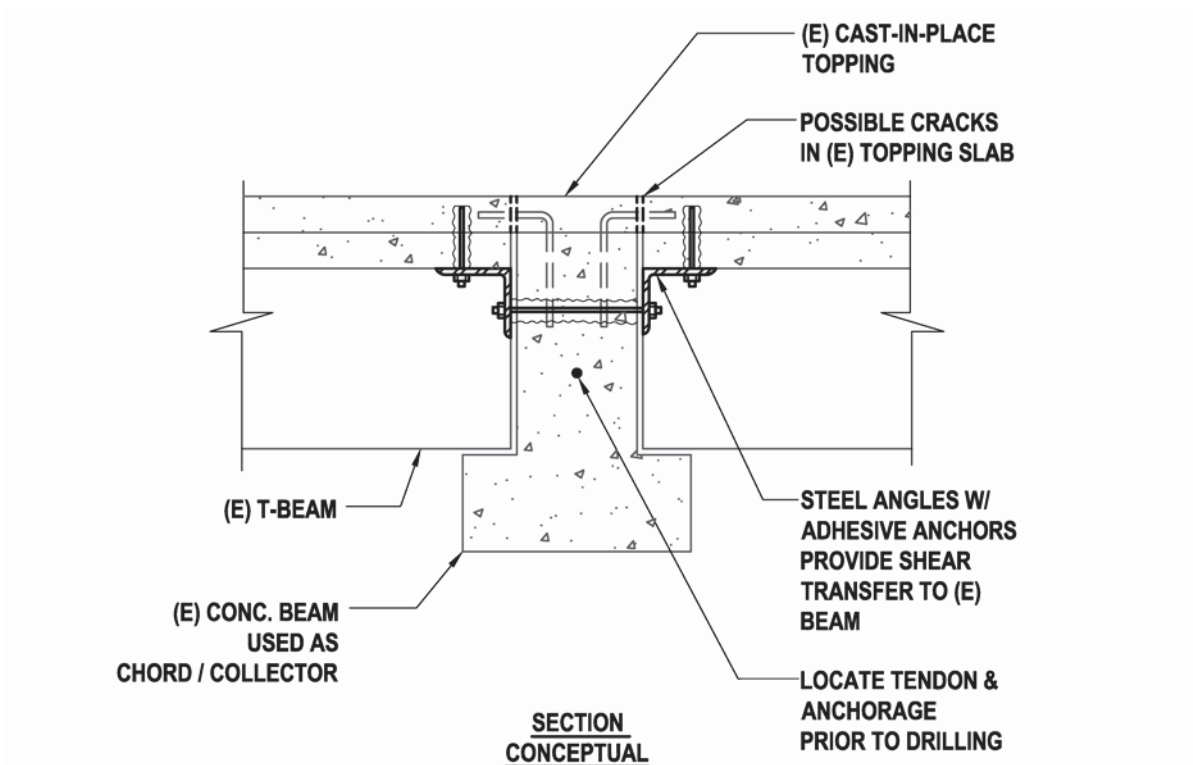
Figure 17.4.1-3: Added or Enhanced Chord or Collector at Floor Interior with Cast-In-Place Topping Slab

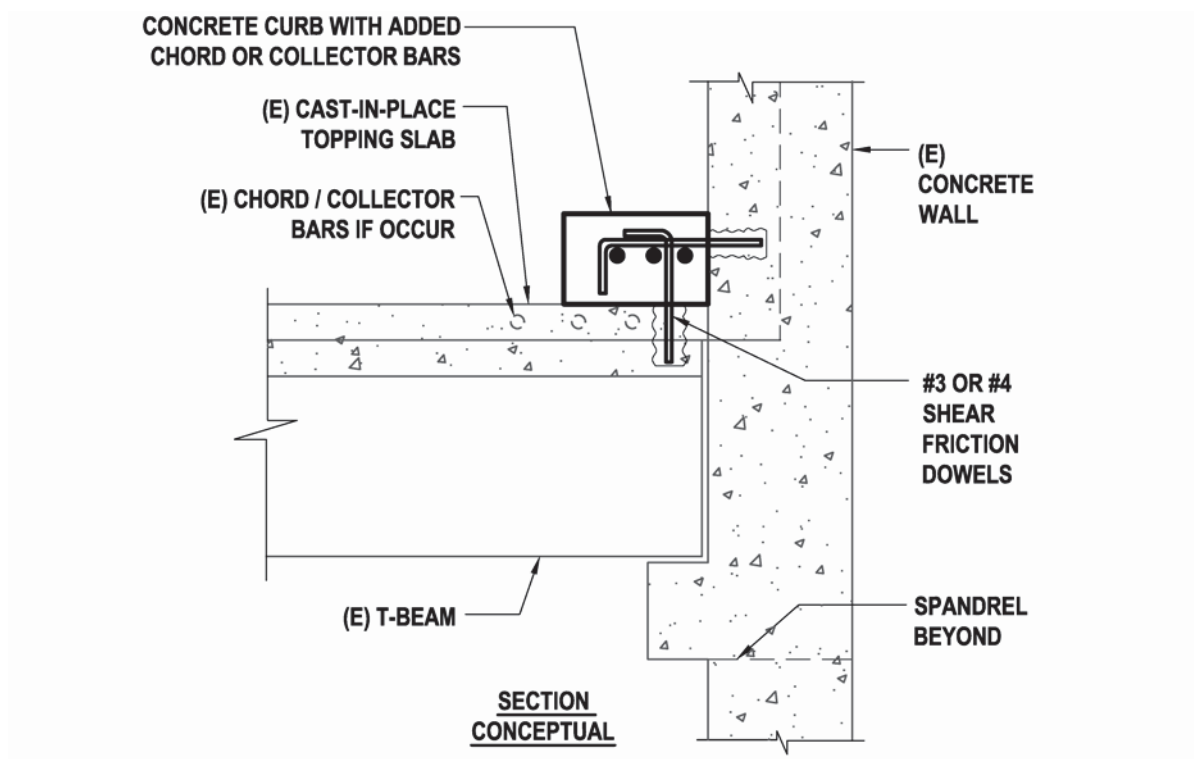
Figure 17.4.1-4: Added Collector Anchorage to Shear Wall with Cast-In-Place Topping Slab

methods of attachment. Chord and collector splices must also be detailed. For collectors, transfer of the collector force to the vertical elements of the lateral force-resisting systems is required. Figure 17.4.1-4 shows a conceptual approach where the chord/collector curb runs by the face of the shear wall and dowels in over the full shear wall length. Figure 17.4.1-5 illustrates considerations when collector steel is to be doweled into the end of an existing shear wall, which may not be advisable.

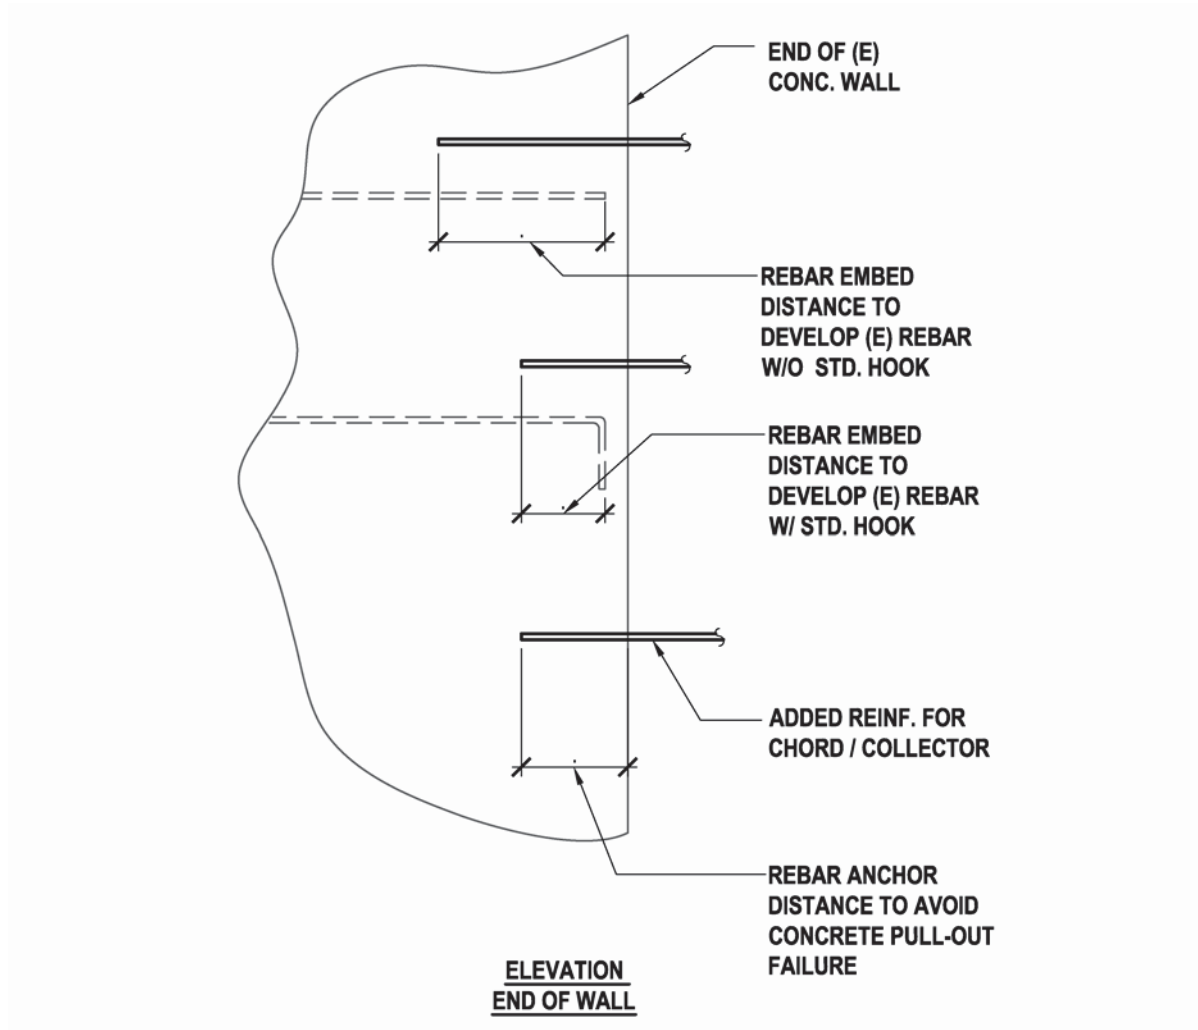
Figure 17.4.1-5: Rebar Embedment Considerations in Collector Anchorage to Existing Shear Wall

order to achieve this, careful consideration of the existing diaphragm configuration and shear strength is needed in order to determine what behavior can be achieved and what detailing approach is best. In long-span diaphragms, yielding of a chord member may be a preferred behavior in order to protect against in-plane shear failure. Where this is true, it should be anticipated that the chord member is likely to elongate in one or more locations under tension loading, opening up gaps between adjacent precast members. When loading reverses, compression will be carried by the chord member until gaps close. In order to prevent local buckling failure of the chord, it is advisable to either use a structural steel section that can be adequately braced against buckling with a reasonable adhesive anchor spacing, or provide confinement of reinforcing bars, as would be provided for a concrete column. These alternatives are shown at the right hand side of Figure 17.4.1-1. Both of these alternatives will be more costly and difficult to install. In diaphragm configurations where yielding of the chord and collector members can be avoided, providing additional reinforcing may be less costly than detailing for buckling restraint. Where this approach is taken, a careful evaluation of anticipated forces is needed. In general, it is the philosophy of ASCE 7 seismic provisions for inelastic behavior to be focused in vertical elements rather than collectors, allowing the vertical elements of the seismic force-resisting system to control building dynamic behavior. This may not be achievable in diaphragms where the collector serves as a chord for loading in the perpendicular direction, and avoiding shear failure is paramount. In this case, use of a detail that restrains buckling is recommended.
