Architectural
Resources Group

609, 611, and 619 NE 3rd Street
McMinnville, Oregon

Historic Resource Assessment
November 2022

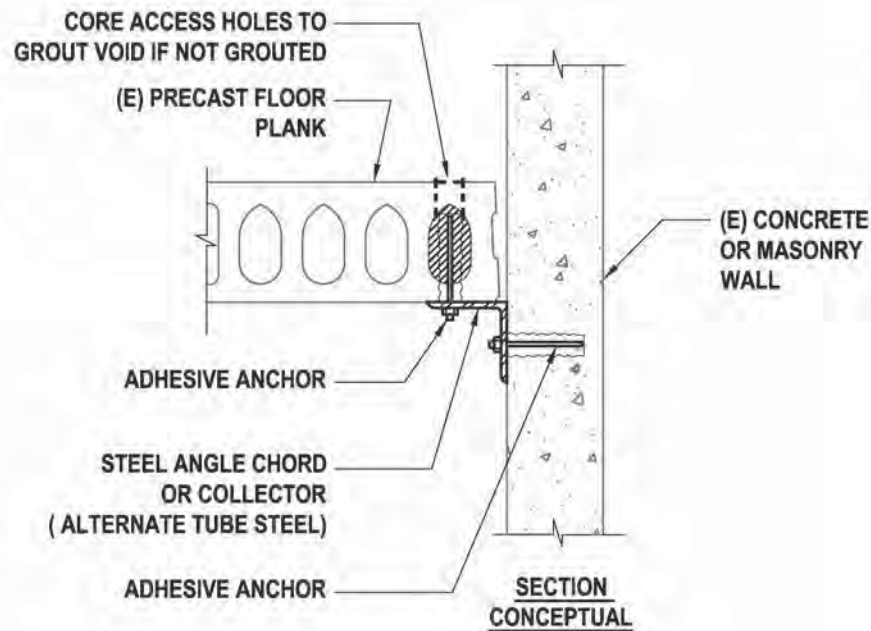
Figure 17.4.1-6: Steel Chord or Collector at Floor Perimeter without Cast-In-Place Topping

For the chord configurations shown in Figure 17.4.1-6, the existing original connection (if any) likely consists of intermittent cast-in embed plates and a welded plate connection. The capacity of anchors embedded in the concrete and welds would have been sized to meet load requirements (wind or earthquake) applicable at time of construction. Even if earthquake loading were considered, the need to allow for forces in excess of design levels, ductility, and energy dissipation likely would not have been considered. Because inelastic behavior in the precast walls and diaphragms is very unlikely, it must be anticipated that inelastic behavior will concentrate in the connections between members. With many existing connections, evaluation would likely identify failure of the anchors embedded in concrete as the weak link. This is an undesirable weak link due to lack of ductility. Unless extreme overstrength has been provided, to allow the connection to remain elastic, rehabilitation of the connections is needed in order to avoid this weak link. ACI 318 Appendix D (ACI, 2005) provisions for anchorage to concrete require that that design be governed by tensile or shear strength of a ductile steel element rather

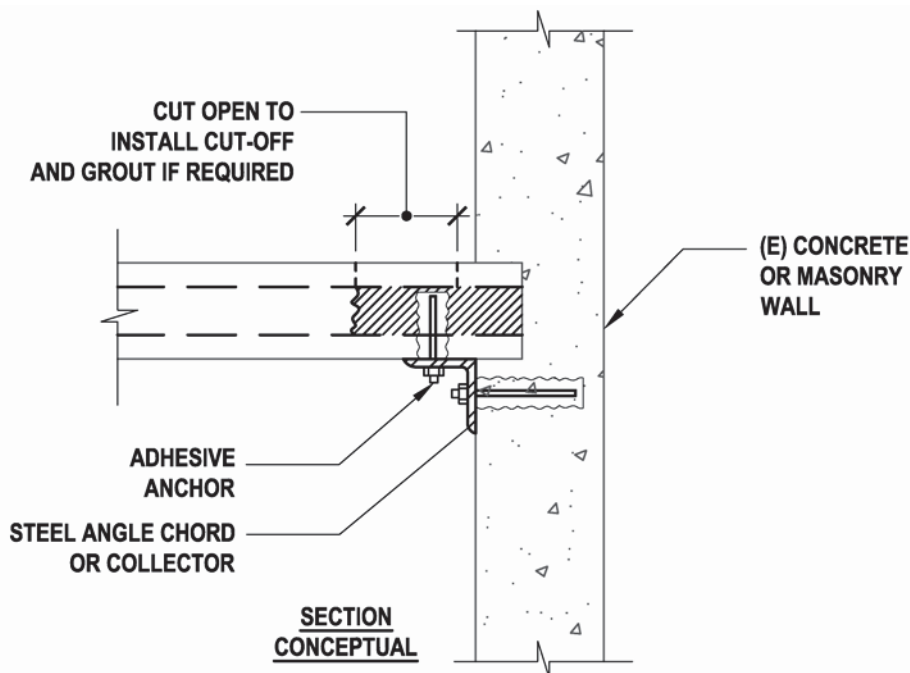
Figure 17.4.1-7: Steel Chord or Collector at Floor Perimeter without Cast-In-Place Topping

The deformation compatibility of the existing and added connections needs to be carefully considered. It may be desirable to design new connections to carry all forces, neglecting the contribution of the existing connections. In some cases it might even be desirable to cut the weld on the original connection to ensure that it will not carry load.

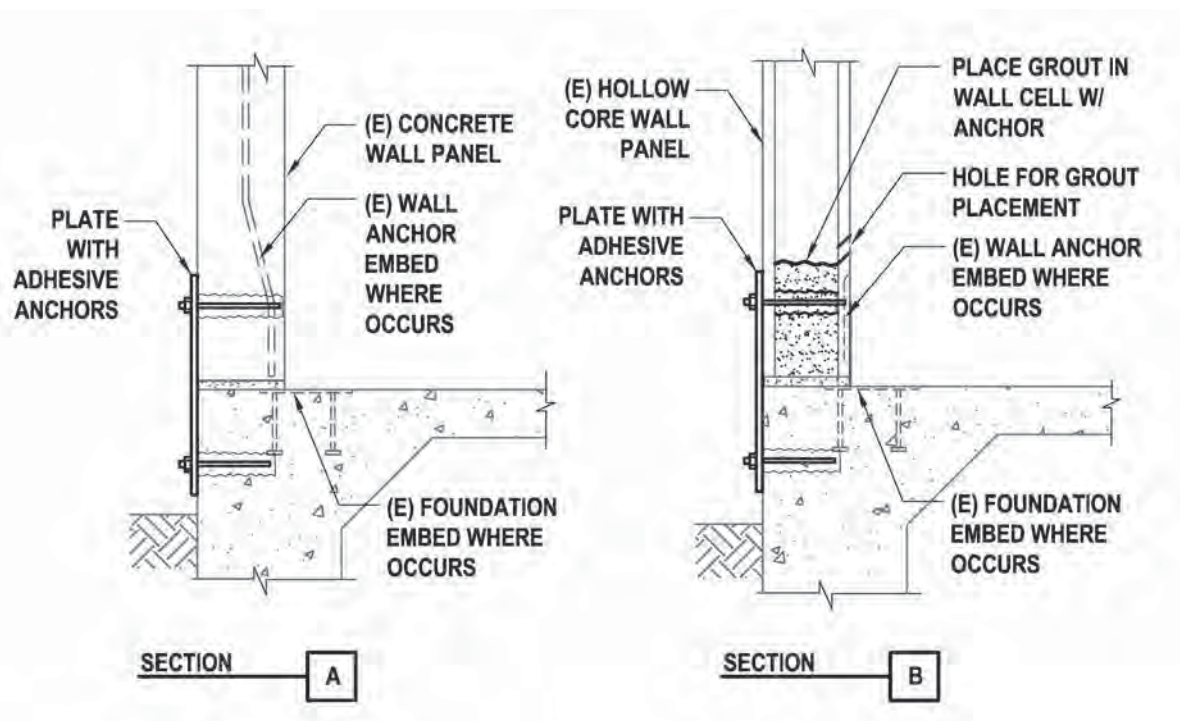
Figure 17.4.2-1: Added or Enhanced Precast Wall-to-Foundation Connection

Existing precast shear wall connections most often use cast-in embed plates and welded plate connections. The capacity of anchors embedded in the concrete and welds would have been sized to meet load requirements (wind or earthquake) applicable at time of construction. Even if earthquake loading were considered, the need to allow for forces in excess of design levels, ductility and energy dissipation likely would not likely have been considered. Because inelastic behavior in the precast walls and diaphragms is very unlikely, it must be anticipated that inelastic behavior will concentrate in the connections between members. With many existing connections, evaluation would likely identify failure of the anchors embedded in concrete as the weak link. This is an undesirable weak link due to lack of ductility. Unless extreme overstrength has been provided, allowing the connection to remain elastic, rehabilitation of the connections is needed in order to avoid this weak link. ACI 318 Appendix D (ACI, 2005) provisions for anchorage to concrete require that the design be governed by tensile or shear strength of a ductile steel element

rather the concrete capacity. This requirement is particularly appropriate for rehabilitation of connections in precast wall buildings. The deformation compatibility of the existing and added connections needs to be carefully considered. It may be desirable to design new connections to carry all forces, neglecting the contribution of the existing connections. In some cases, it might even be desirable to cut the weld on the original connection to ensure that it will not carry load.

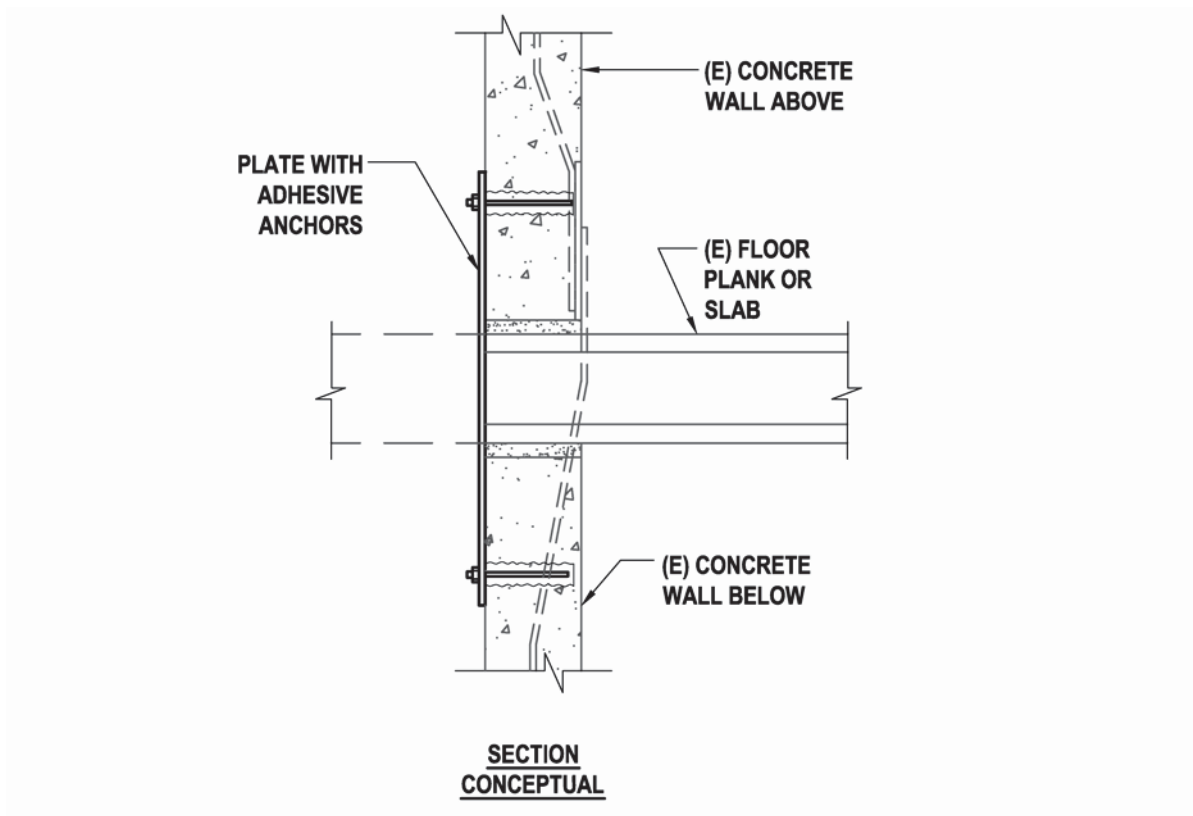
Figure 17.4.2-2: Precast Wall Connection

The new connections shown have both vertical and horizontal eccentricities that must be considered in design of the angle section and the anchors.

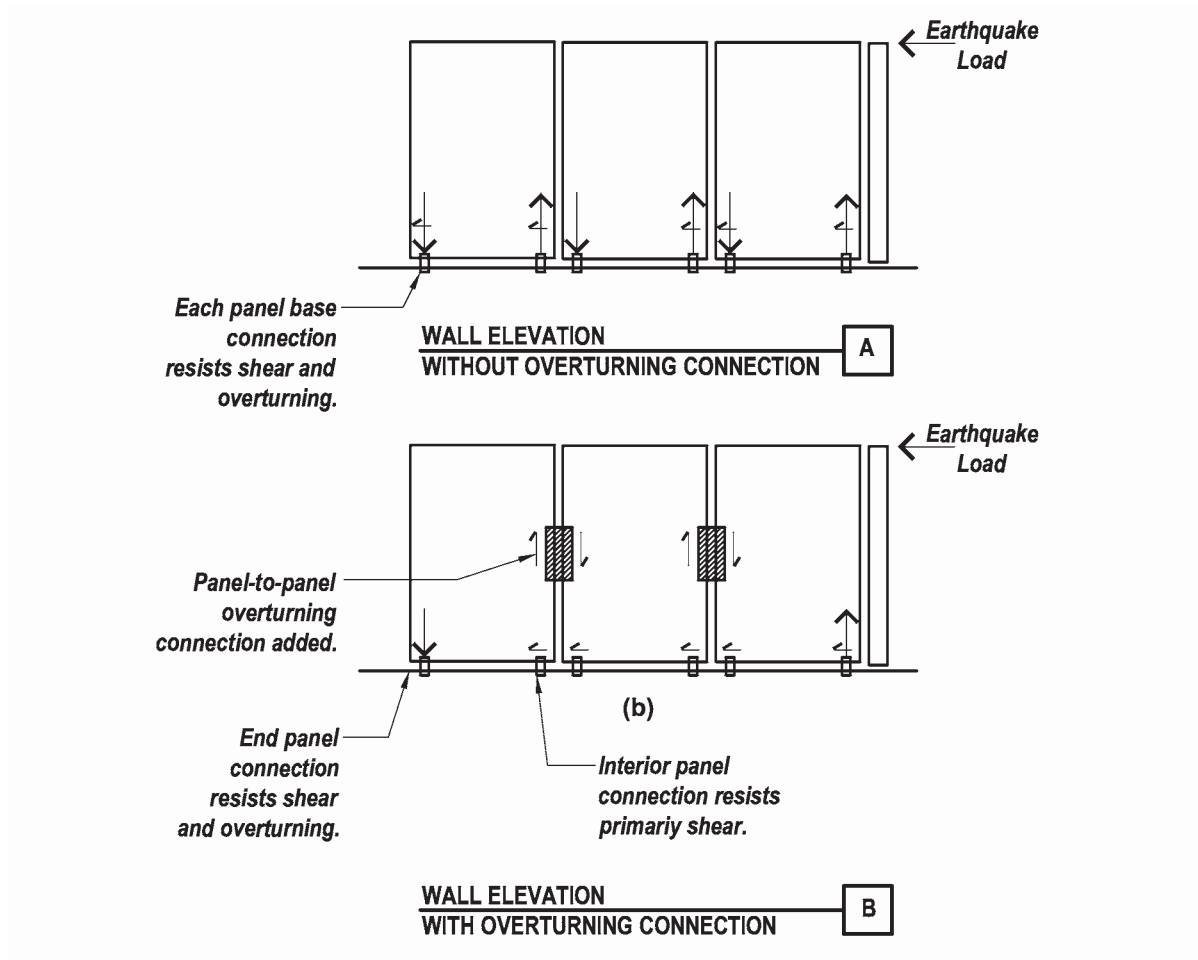
Figure 17.4.2-3: Modification of Demand on Anchors Through Use of Panel-to-Panel Connections

Anchorage to hollow core wall panels is more difficult than solid precast panels because the voids do not leave solid concrete sections large enough to meet embedment and edge distance requirements for adhesive anchors. For most anchorage, drilling grout access and inspection holes and filling the lower portion of the void with grout can provide a solid cell for anchor placement. Similar grouting of floor planks is sometimes used in new construction. For very light anchorage loads, it may be possible to use screen-tube adhesive anchors specifically designed for attachment to hollow masonry units. Along with low capacity, failure of this anchorage should be expected to have brittle behavior.

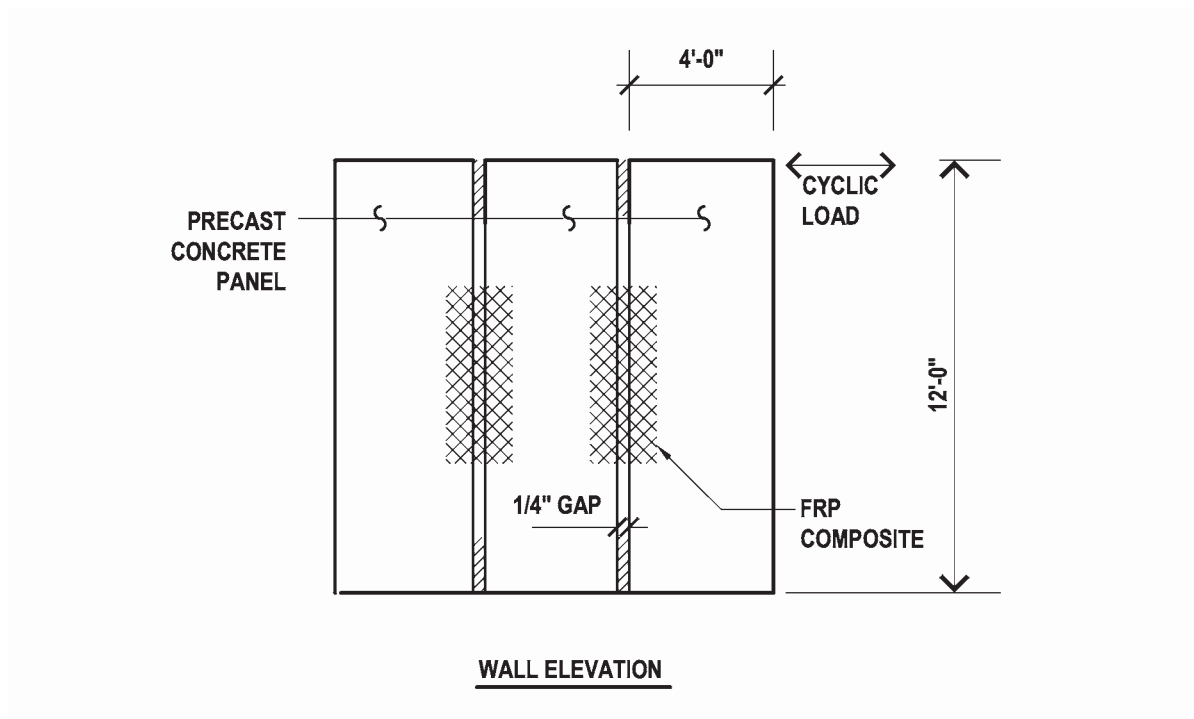
Figure 17.4.2-4: Panel Setup for Testing of FRP Panel-to-Panel Connections

Figure 17.4.2-4 illustrates an FRP composite connection between wall panels developed and tested at the University of Utah (Pantelides, Volnyy, Gergeley, and Reaveley, 2003) that would be applicable to this use. While various surface preparations and FRP applications were investigated, the researchers settled on use of a high-pressure water jet preparation of the concrete surface to expose aggregate, a bonding agent and dry lay-up of carbon fibers, and saturation with an epoxy resin. A lay up of six layers of 12k (12,000 threads per tow) carbon fiber reinforcing in a 16 inch by 48 inch rectangle on one face of the wall panels provided failure

loads on the order of 40 kips. The failures were sudden and brittle, indicating that design of this connection type should be considered force-controlled, and ductility should be provided in other connections or members. See Section 13.4.1 for general information on FRP composite overlays.

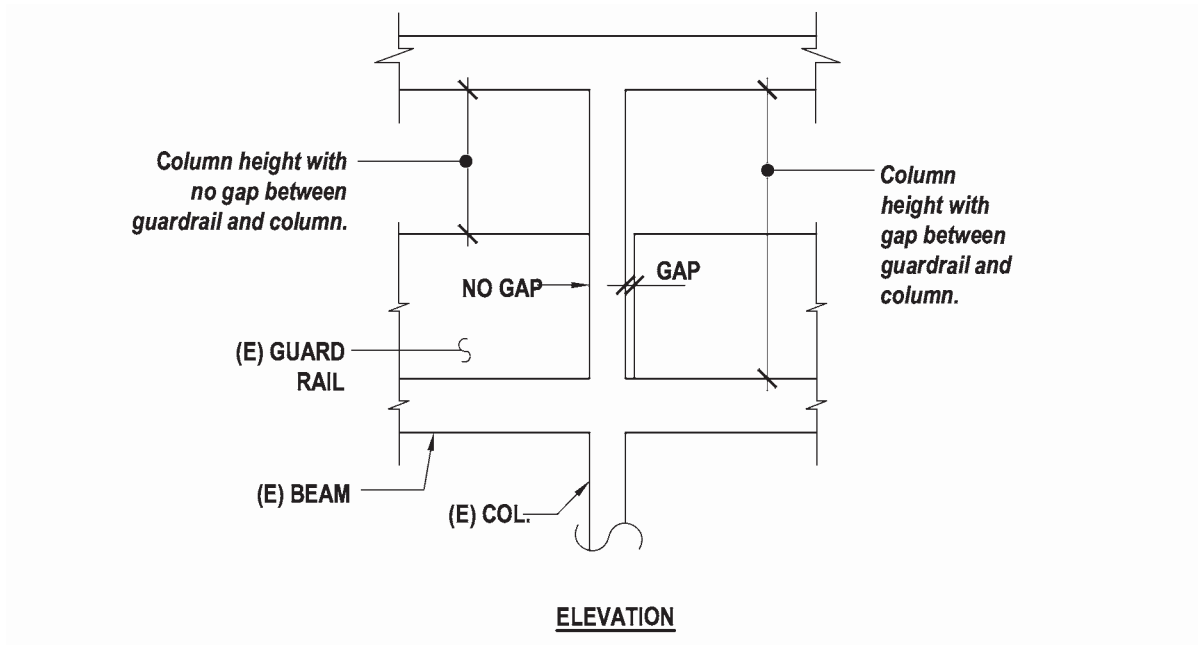
Figure 17.4.3-1: Accidental Reduction of Column Height Due to Guardrail

Figures 17.4.3-1, 17.4.3-2 and 17.4.3-3 illustrate unintended shortening and stiffening of columns, common in parking garages. The condition in Figure 17.4.3-1 is very easily mitigated by sawcutting the required gap between the column and the guardrail. The connection at the base of the guardrail may need to be improved as a result. The condition in Figure 17.4.3-2 can be improved by creating a hinge or joint in the column at the top of slab level. This will require shoring to take the load off of the column during modification, and the development of a shear and tension connection to the pedestal and footing. The condition in Figure 17.4.3-3 is difficult to address. Columns with this configuration are not easily confined. A solution that can minimize column shortening for new construction is to provide separate columns for the ramp and level floors. This approach could also be attempted for a retrofit, but would be costly.

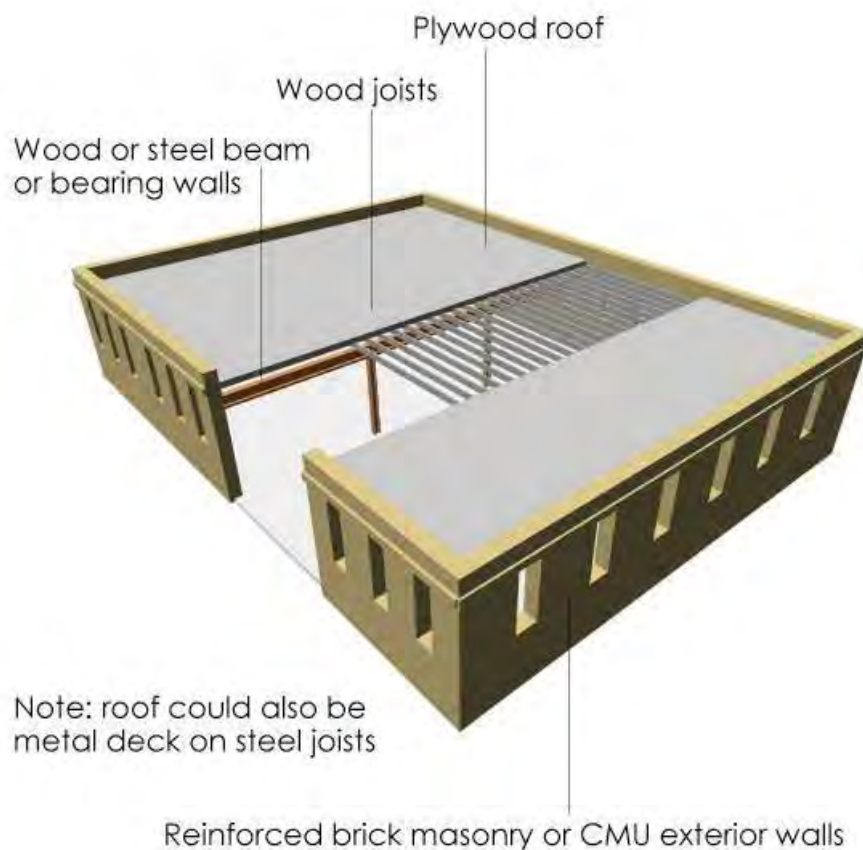
Figure 18.1-1: Building Type RM1t: Reinforced Masonry Bearing Walls

Building Type **RM1** is constructed with reinforced masonry (brick cavity wall or concrete masonry unit) perimeter walls with a wood or metal deck flexible diaphragm. For this document, Building Type **RM1** is separated into two categories. Chapter 19 describes **RM1u**, which is multistory, and typically has interior CMU walls and shorter diaphragm spans. This chapter covers **RM1t**, the large, typically one-story buildings with relatively open interiors that are similar to concrete tilt-ups. The exterior walls are commonly bearing, with an interior post and beam system of steel or wood. Older buildings of this type are generally small and used for a wide variety of occupancies. Recently, the building type has become commonly used for one-story warehouse and wholesale/retail occupancies similar to tilt-up (Building Type **PC1**) buildings. Figure 18.1-1 illustrates one example of the **RM1t** Building Type.

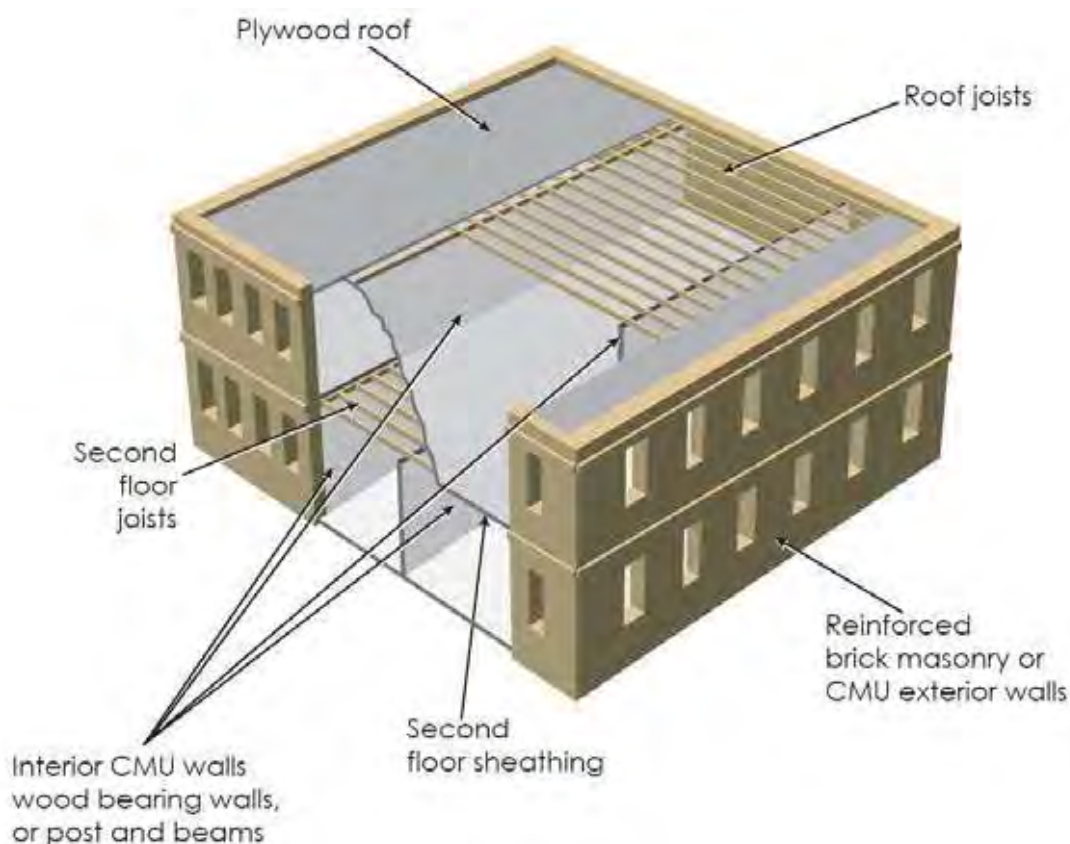
Figure 19.1-1: RM1u Building Type: Reinforced Masonry Bearing Walls

Building Type **RM1** takes a variety of configurations, but they are characterized by reinforced masonry walls with flexible diaphragms such as wood or metal deck. The walls are commonly bearing, but the gravity system also contains post and beam construction of wood or steel in interior or some façade locations. For this document, Building Type **RM1** is separated into two categories. Chapter 18 describes **RM1t**, the large, typically one-story buildings with relatively open interiors that are similar to concrete tilt-ups. This chapter covers **RM1u**, which is multistory, and typically has interior CMU walls and shorter diaphragm spans. It is similar to Building Type **URM** (Chapter 21) and has many of the same deficiencies. Figure 19.1-1 shows an example of this building type.

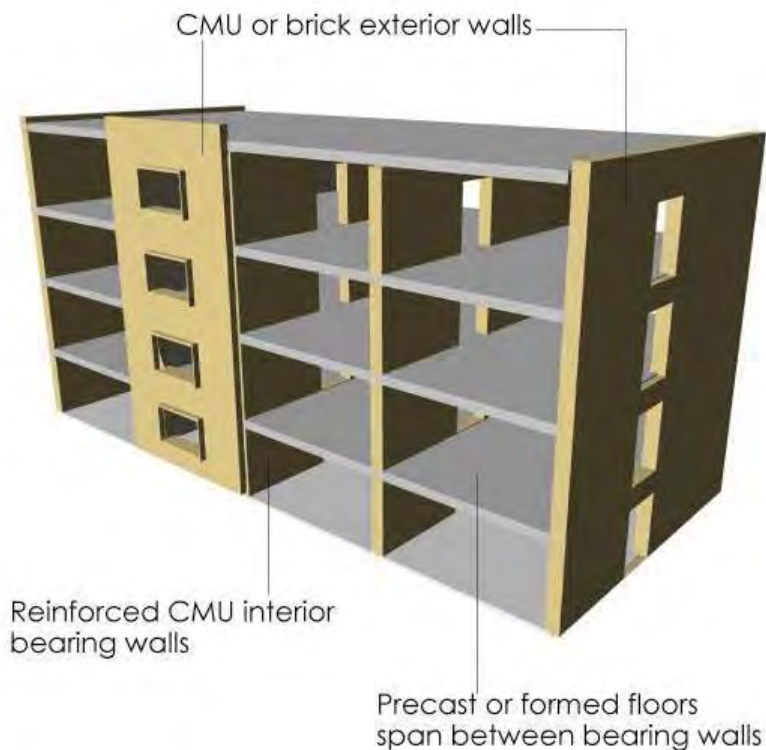
Figure 20.1-1: RM2 Building Type: Reinforced Masonry Bearing Walls

This building consists of reinforced masonry walls and concrete slab floors that may be either cast-in-place or precast. In this type of building, all walls usually act as both bearing and shear walls. The building type is similar and often used in the same occupancies as Building Type **C2b**, namely in mid- and low-rise hotels and motels. This system is also commonly used in residential apartment/condominium type buildings.

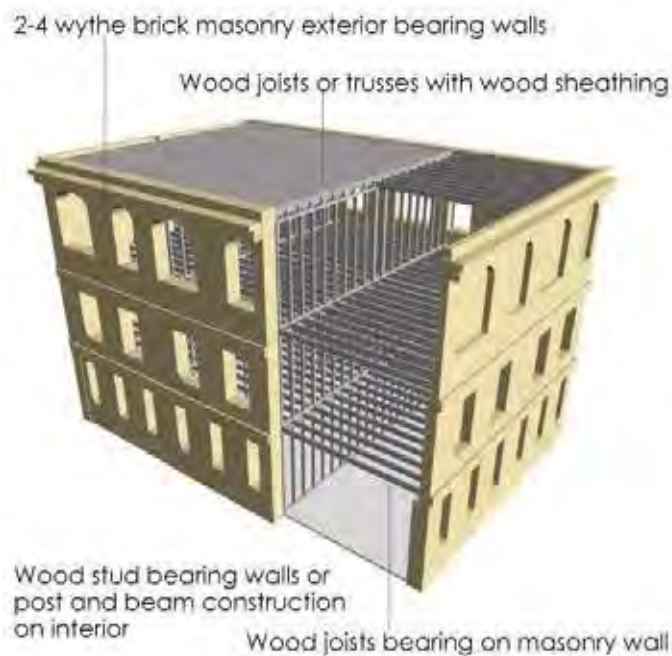
Figure 21.1-1: Building Type URM: Unreinforced Masonry Bearing Walls

Building Type **URM** consists of unreinforced masonry bearing walls, usually at the perimeter and usually brick masonry. The floors are typically of wood joists and wood sheathing supported on the walls and on interior post and beam construction. This building type is common throughout the United States and was built for a wide variety of uses, from one-story commercial or industrial occupancies to multistory warehouses to mid-rise hotels. It has consistently performed poorly in earthquakes. The most common failure is an outward collapse of the exterior walls caused by loss of lateral support due to separation of the walls from the floor and roof diaphragms. Figure 21.1-1 shows an example of this building type.

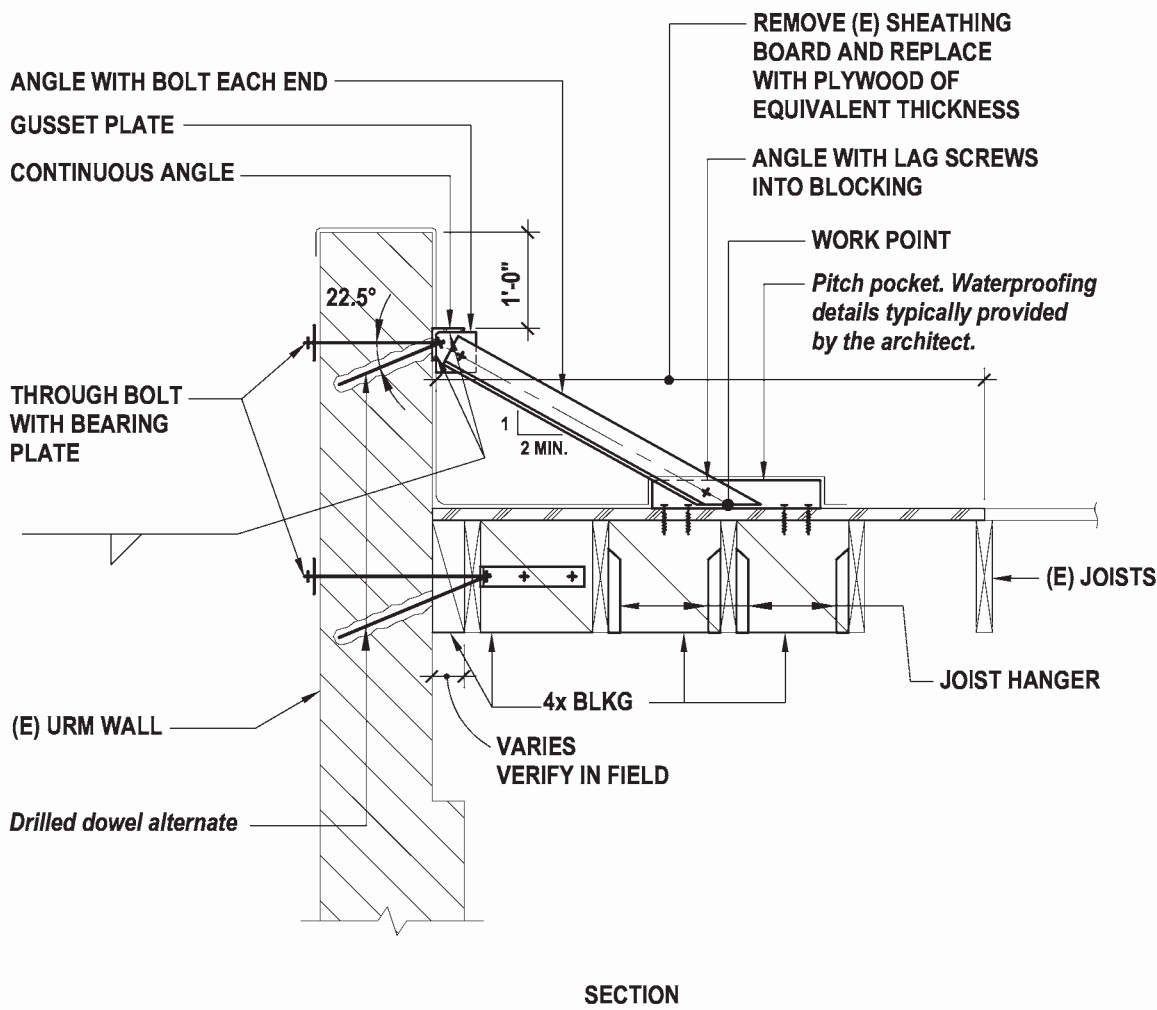
Figure 21.4.1-1: Parapet Bracing

Top angle: Figure 21.4.1-1 shows a continuous angle running between braces in the roof. This angle can be used to span between braces to reduce the number of bracing points. It also increases redundancy over a localized connection of the brace to the parapet.

Load in the roof framing: The vertical reactions at the base of the brace are typically resisted by roof framing. In Figure 21.4.1-1 the added blocking beneath the base of brace workpoint helps to engage three joists in resisting vertical loads. Tall parapets can generate substantial brace forces that existing wood roof joists may not be able to resist. Additional joists can be added, or more braces can be used to distribute the load. Horizontal loads from the brace are distributed by the blocking and new wood structural panel.

Load path: When parapet bracing/roof-to-wall tension anchorage is the only rehabilitation technique, the out-of-plane load path can be incomplete, particularly when the roof joists are perpendicular to the brace. A more complete rehabilitation strategy includes developing the parapet and tension anchorage forces back into the roof diaphragm through the use of subdiaphragms and cross-ties.

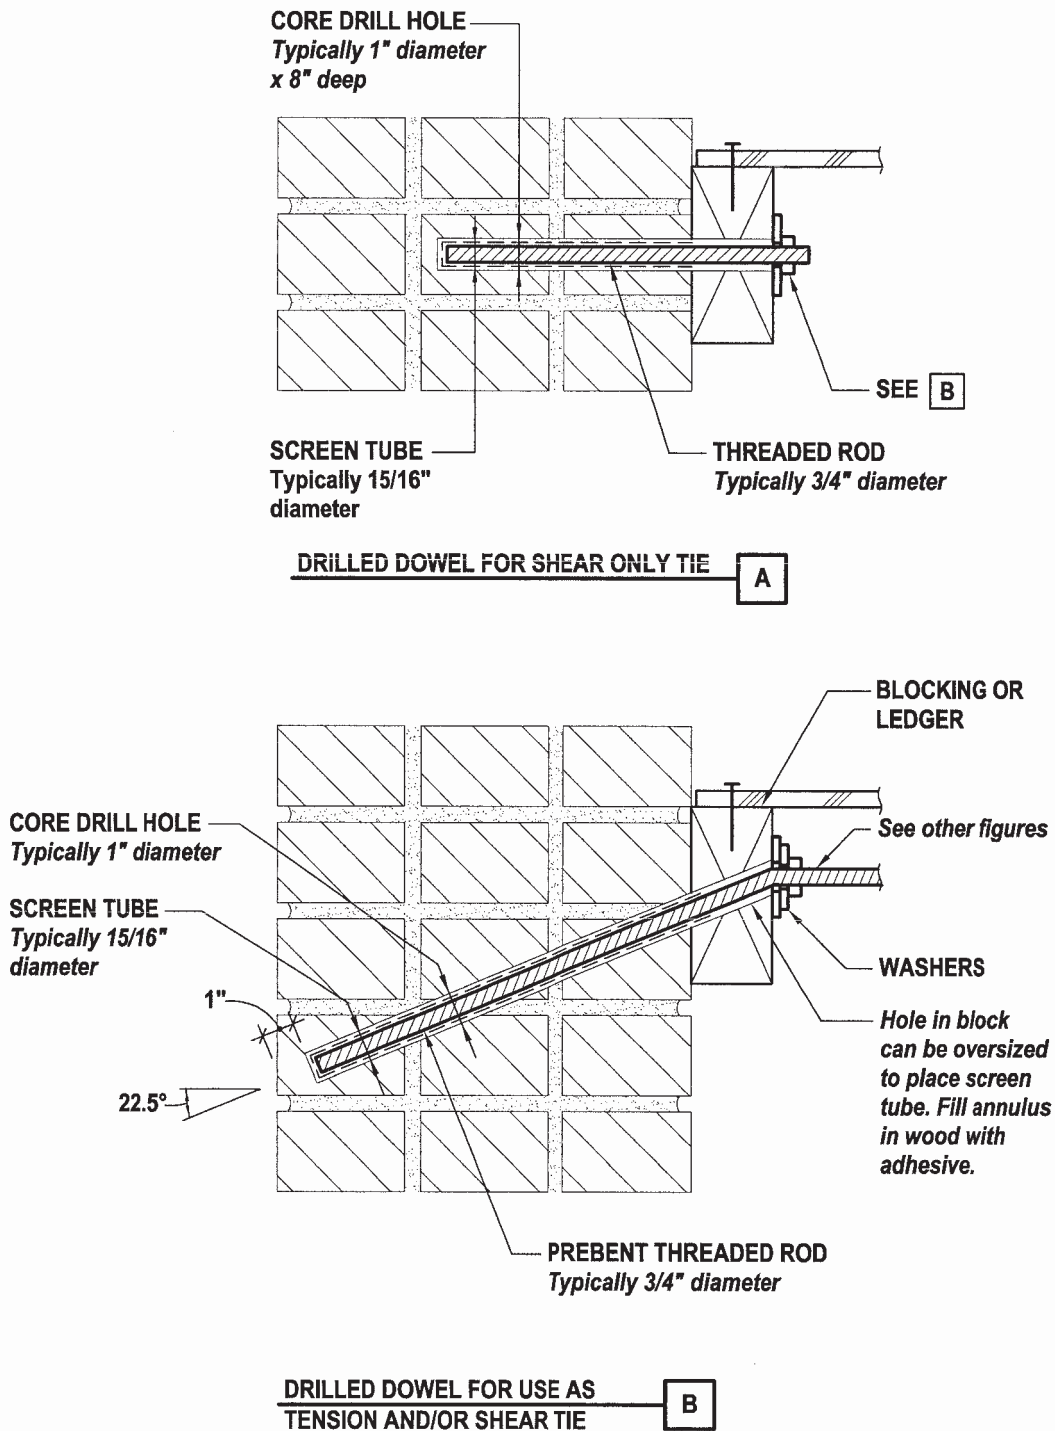
Figure 21.4.2-1: Drilled Dowels

Anchor types and capacities: The 1997 UCBC and 2003 IEBC provide prescriptive values for tension and shear bolts meeting certain requirements. These are for a 2-1/2” diameter hole filled with nonshrink grout approach that is typically no longer used. The ICBO and now ICC evaluation report process has standardized procedures for vendors supplying adhesive ties for use in brick masonry. Three installations are included in most vendors’ ICC Evaluation Service reports, and they have standardized installation techniques and capacities. Adapted versions of these installations are shown in Figures 21.4.2-1 and 21.4.2-2. Figure 21.4.2-1A shows a

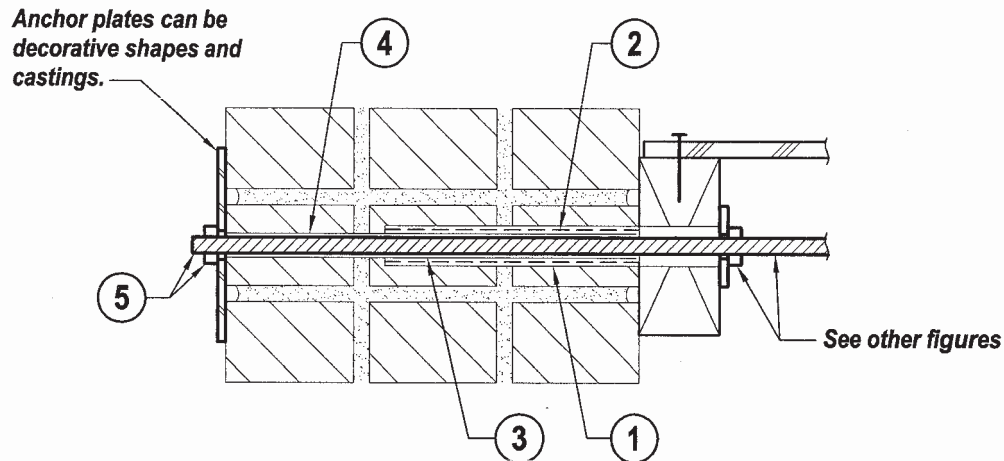
SEQUENCE OF INSTALLATION

- 1. CORE DRILL HOLE.**
Typically 1" diameter x 8" deep.
- 2. PLACE SCREEN TUBE WITH ADHESIVE.**
Typically 15/16" diameter x 8" deep with plug at end.
- 3. INSERT STEEL SLEEVE.**
Typically 13/16" outside diameter.
- 4. AFTER CURING, DRILL HOLE THROUGH PLUG AND REMAINING MASONRY.**
- 5. PLACE THREADED ROD AND ANCHOR PLATE.**
Typically 5/8" diameter and 6"x6"x3/8" respectively.

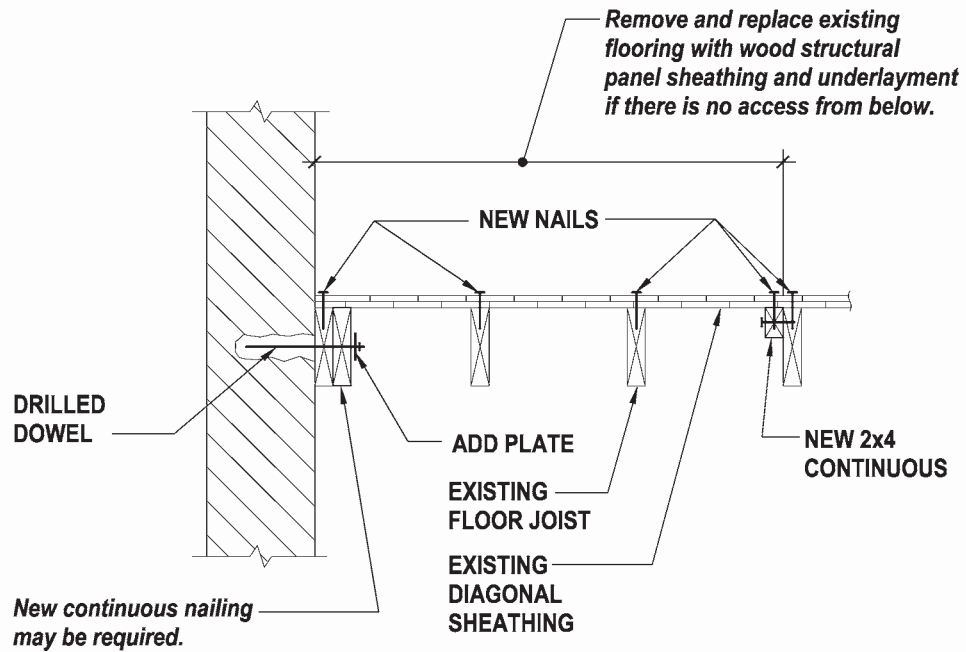
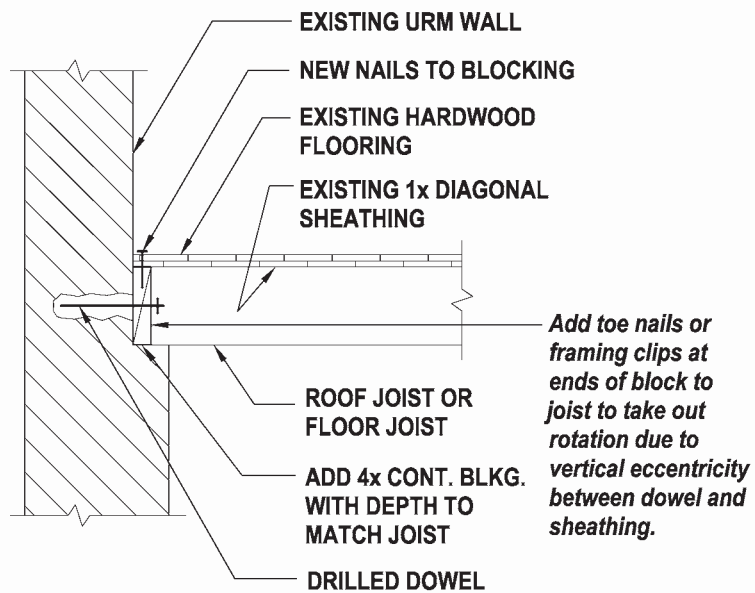
Figure 21.4.2-5: Floor-to-Wall Shear Anchors

JOISTS PARALLEL TO WALL

Note: See other details for tension tie requirements.

JOISTS PERPENDICULAR TO WALL

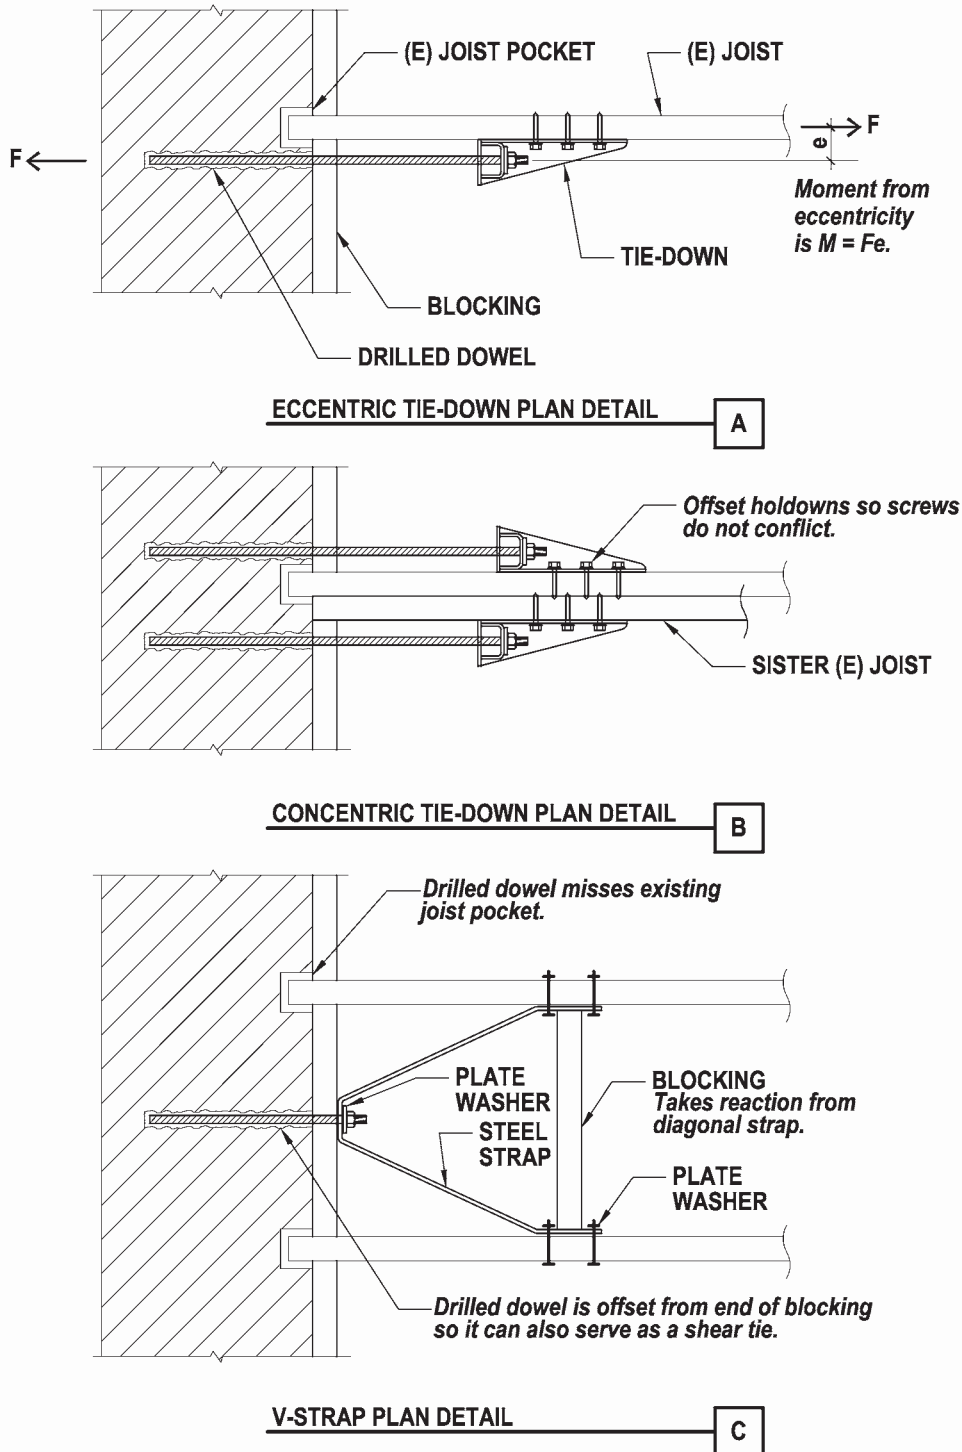
Figure 21.4.2-8: Tension Tie Connection Issues

Eccentricity: It is desirable to minimize the eccentricities in a connection. Figure 21.4.2-8 illustrates the issue and some alternate approaches with floor-to-wall tension ties. Figure 21.4.2-8A shows a common tension tie detail in plan view where a tie-down anchor is connected to the side of an existing joist. The plan offset between the drilled dowel at the center of the tie-down where load is applied and the center of the joist where it is resisted times the force is a moment that must be resisted by the joist in weak way bending. This stress can be quite significant. Figure 21.4.2-8B shows an alternative where two tie-downs are used to make a connection that is

more concentric. This detail, however, puts a large number of screws into the existing joist, so a sistered joist is shown. Adding the sister also permits the nailing into the diaphragm to be into each joist, reducing the nailing demand on the joists. Bolted tie-downs, instead of tie-downs with screws, can be used with through bolts placed in double shear. Traditional bolted tie-downs have greater slip than the more recent tie-downs using screws. There are proprietary connectors using tubes as tie-downs on each side without oversize holes that bolt eliminate eccentricity and reduce bolt slip. Both Figure 21.4.2-8A and 21.4.2-8B have dowels adjacent to the joist. This means the dowel will enter the wall next to or in the weakened area of joist pocket and at the end of new blocking used for shear transfer, where there is insufficient end distance to use the dowel as a shear tie. Figure 21.4.2-8C shows a V-strap detail where the drilled dowel is placed between joists, away from the joist pocket and with plenty of end distance. When the strap is in tension, forces perpendicular to the joists are produced that are resisted by the added blocking and plate washers.

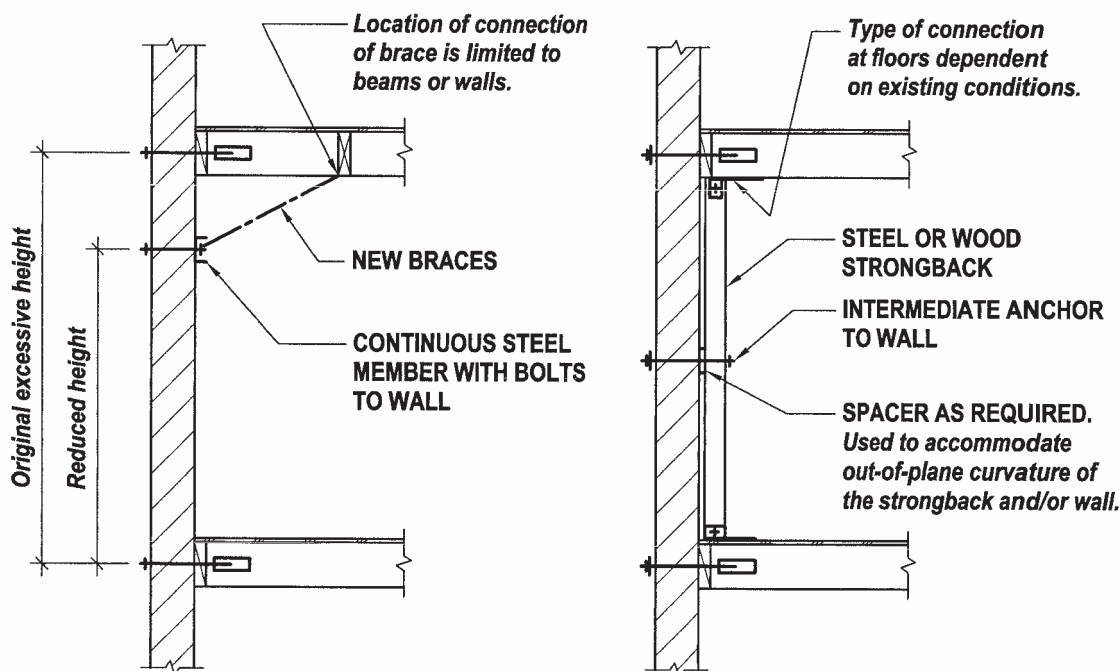
Note: See wall-to-diaphragm details for connection to walls.

DIAGONAL BRACE A

Spacing: For strongbacks, such as shown in Figures 21.4.3-1B and 21.4.3-2A, the maximum spacing requirements are set by the 1997 UCBC or 2003 IEBC at the minimum of 10 feet or half the unsupported height of the wall. For diagonal braces, the maximum spacing is set at 6 feet.

Stiffness: For strongbacks, such as shown in Figures 21.4.3-1B and 21.4.3-2A, the 1997 UCBC limits deflection of the wall at ASD demands to one tenth of the wall thickness. This is not a particularly stringent requirement. Say that the first story of a multistory building in Seismic Zone 4 is 13” thick and 18’ tall and its resulting h/t ratio of 16.7 exceeds the h/t limit of 16 in the UCBC. Bracing would be need to be stiff enough to keep deflections down to 10% of 13” or 1.3”. This is $L/166$, which is comparatively low to most masonry design requirements, which are typically $L/360$ or higher, up to even $L/600$. Kariotis (1982) notes that the goal of a flexible vertical brace is to keep the brace elastic and provide a predictable restoring force during cracked excursions of the masonry wall. For diagonal braces, the UCBC encourages detailing to minimize vertical deflections.

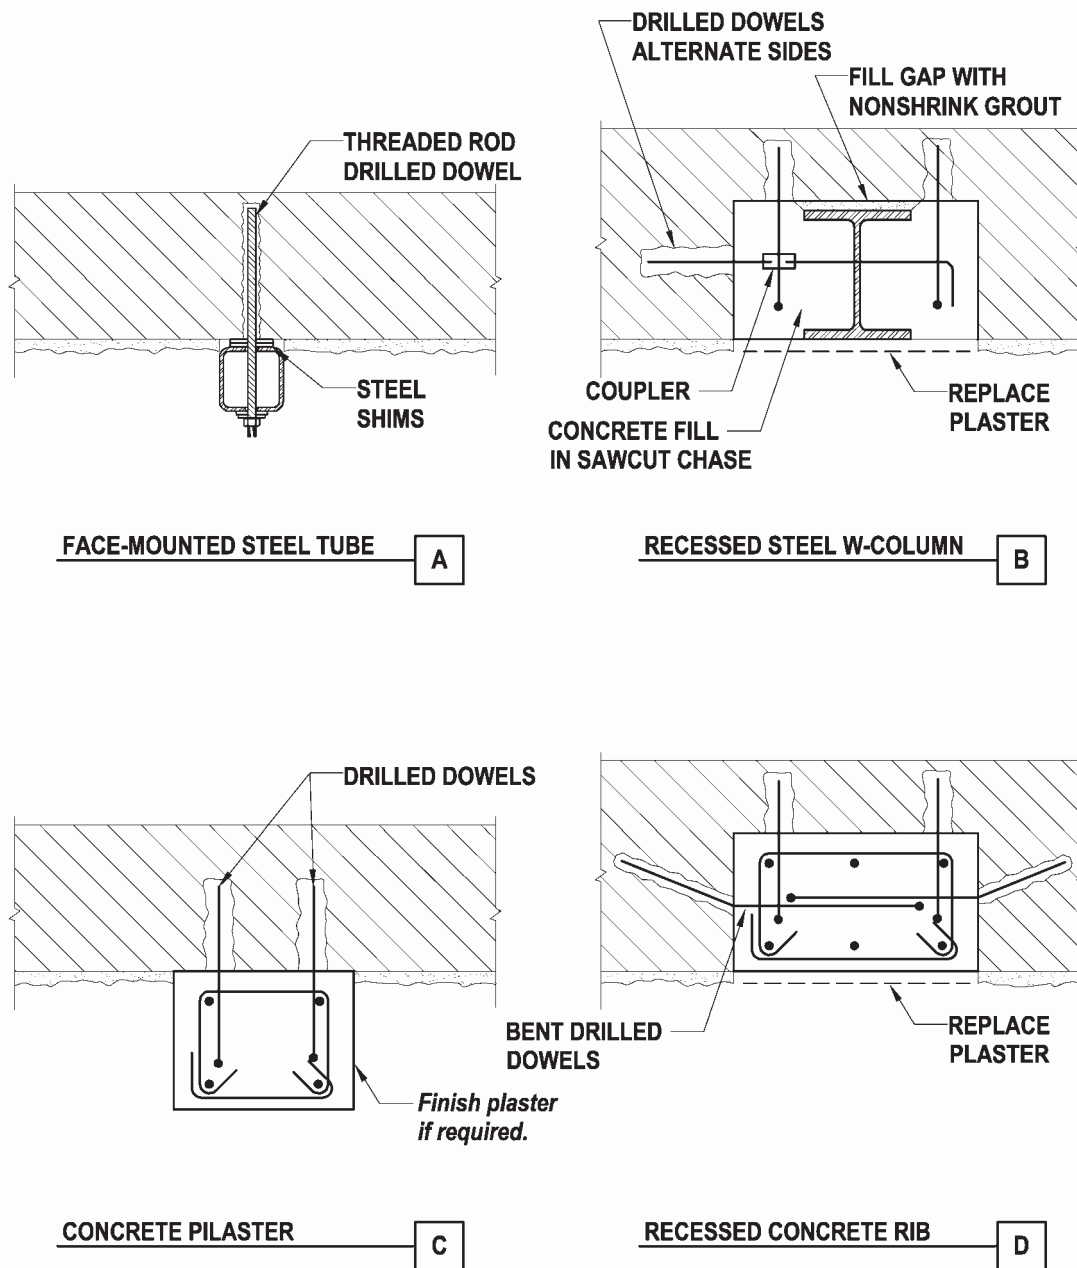
Figure 21.4.3-2: Vertical Bracing Alternatives

Recessed steel and concrete and surface-mounted concrete: Provisions in the 1997 UCBC and 2003 IEBC do not explicitly consider the approaches shown in Figures 21.4.3-2B, 21.4.3-2C and 21.4.3-2D. These approaches are unusual, but they can be used when a more sensitive aesthetic approach or higher loads are needed.

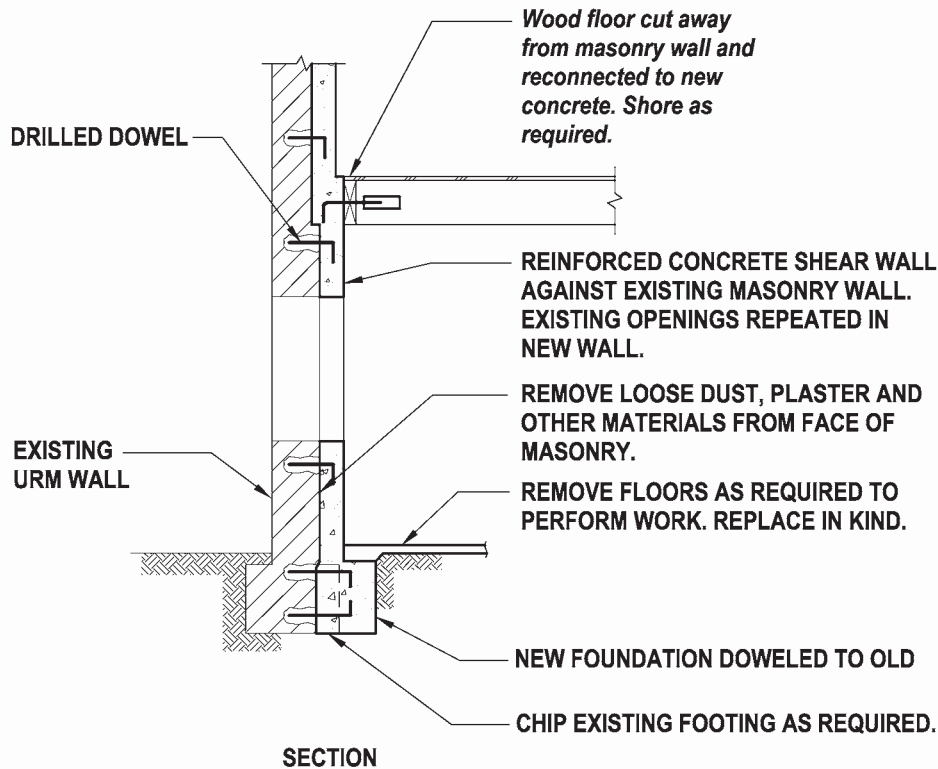
Figure 21.4.5-1: Concrete or Shotcrete Wall Overlay

Research basis: A fair amount of research in the use of shotcrete overlays on masonry has been done. A summary is given in El Gawady, Lestuzzi and Badoux (2004). Early diagonal tension testing was done by Kahn (1984), and more recently static cyclic tests were done by Abrams and Lynch (2001). Kahn (1984) showed significant increases in strength from the shotcrete and that adding drilled dowels between the shotcrete and masonry or an epoxy bonding agent did not lead

to significant improvements. A saturated masonry surface was recommended. Testing by Abrams and Lynch (2001) aimed at increasing the shear capacity to lead to flexural yielding of the tension bars in the shotcrete. Strength increased by about a factor of 3, but displacement capacity did not increase.

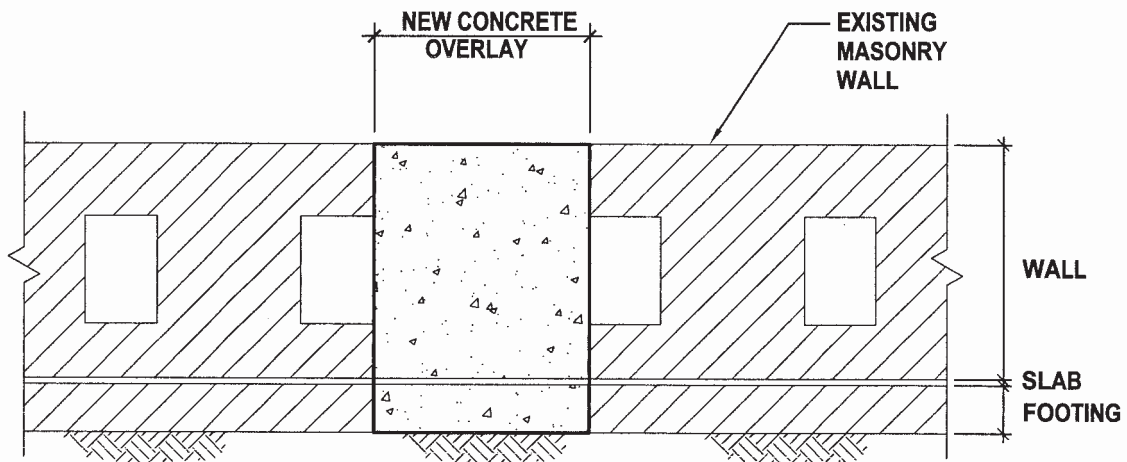
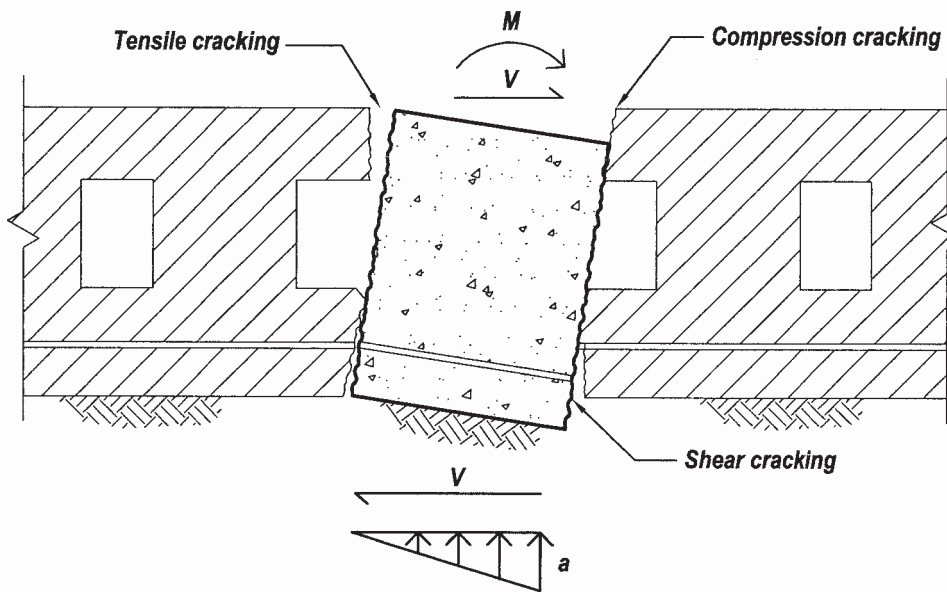
Figure 21.4.5-2A: Potential Damage at Ends of Narrow Concrete Overlay

LOCALIZED CONCRETE OVERLAY ELEVATION A1

DAMAGE DUE TO STIFFNESS INCOMPATIBILITY A2
