Architectural
Resources Group

609, 611, and 619 NE 3rd Street
McMinnville, Oregon

Historic Resource Assessment
November 2022

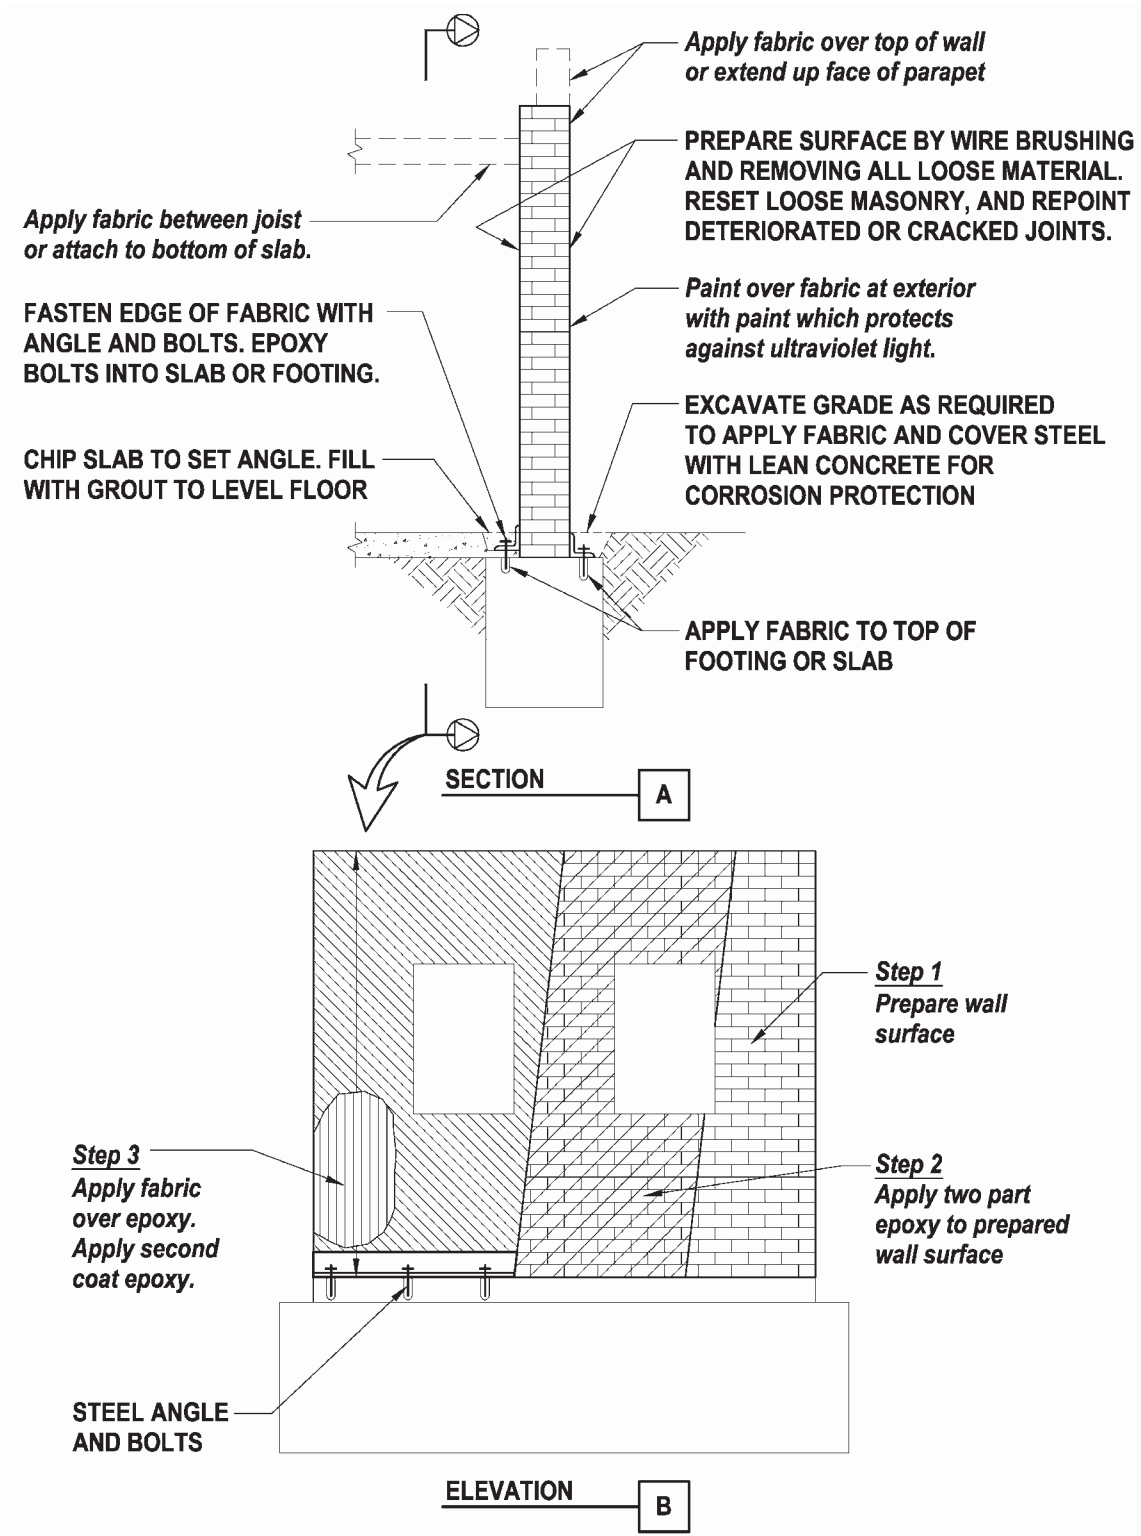
Figure 21.4.6-1: Fiber Composite Wall Overlay on URM Wall

Continuity of fiber at top and bottom: Providing load transfer with the fiber can be challenging, particularly at floor-to-wall interfaces. If the fiber is being used to resist out-of-plane loads and is transferring these loads back into the floor diaphragm, special details may be needed to turn the vertical fiber overlay into the horizontal diaphragm. Fiber cannot be bent at 90 degrees;

rather a radius is needed. Sometimes, steel reinforcing plates are used to stiffen the turns. If the fiber is being used to transfer in-plane loads from one story to the next, continuity past the floor is needed and will require special details as does shear transfer out of the diaphragm into the wall

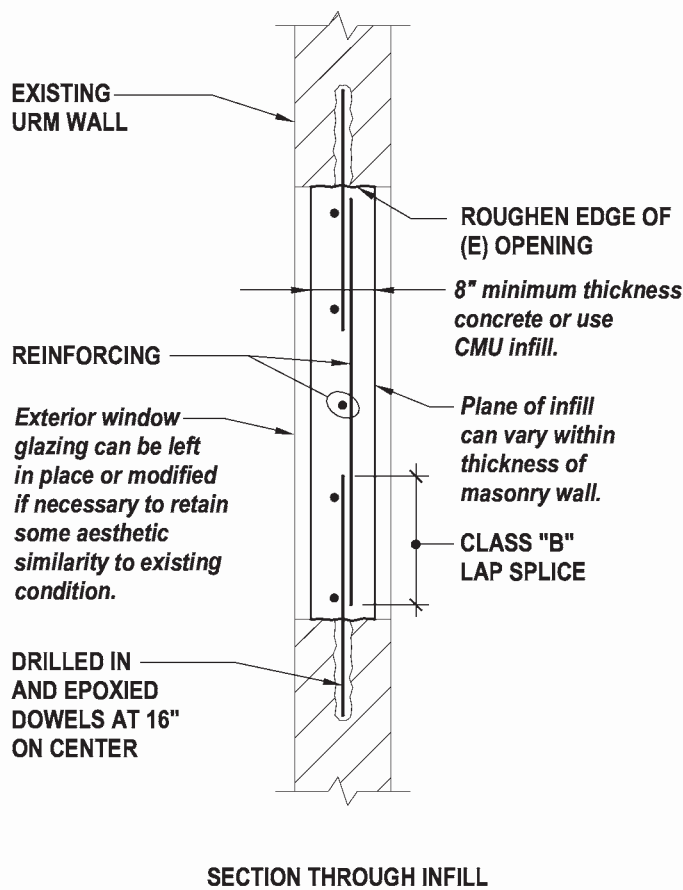
Figure 21.4.7-1: Infilling an Opening in a URM Wall

Window and door openings are filled to increase the shear capacity and reduce the shear stresses on the unreinforced masonry wall. The opening is typically filled with concrete, reinforced concrete masonry units, or reinforced clay brick, rather than with unreinforced masonry due to code concerns with adding unreinforced masonry. To provide adequate shear transfer between the existing wall and the new infill, the interface can be toothed, but more typically, drilled dowels are used. See Figure 21.4.7-1.

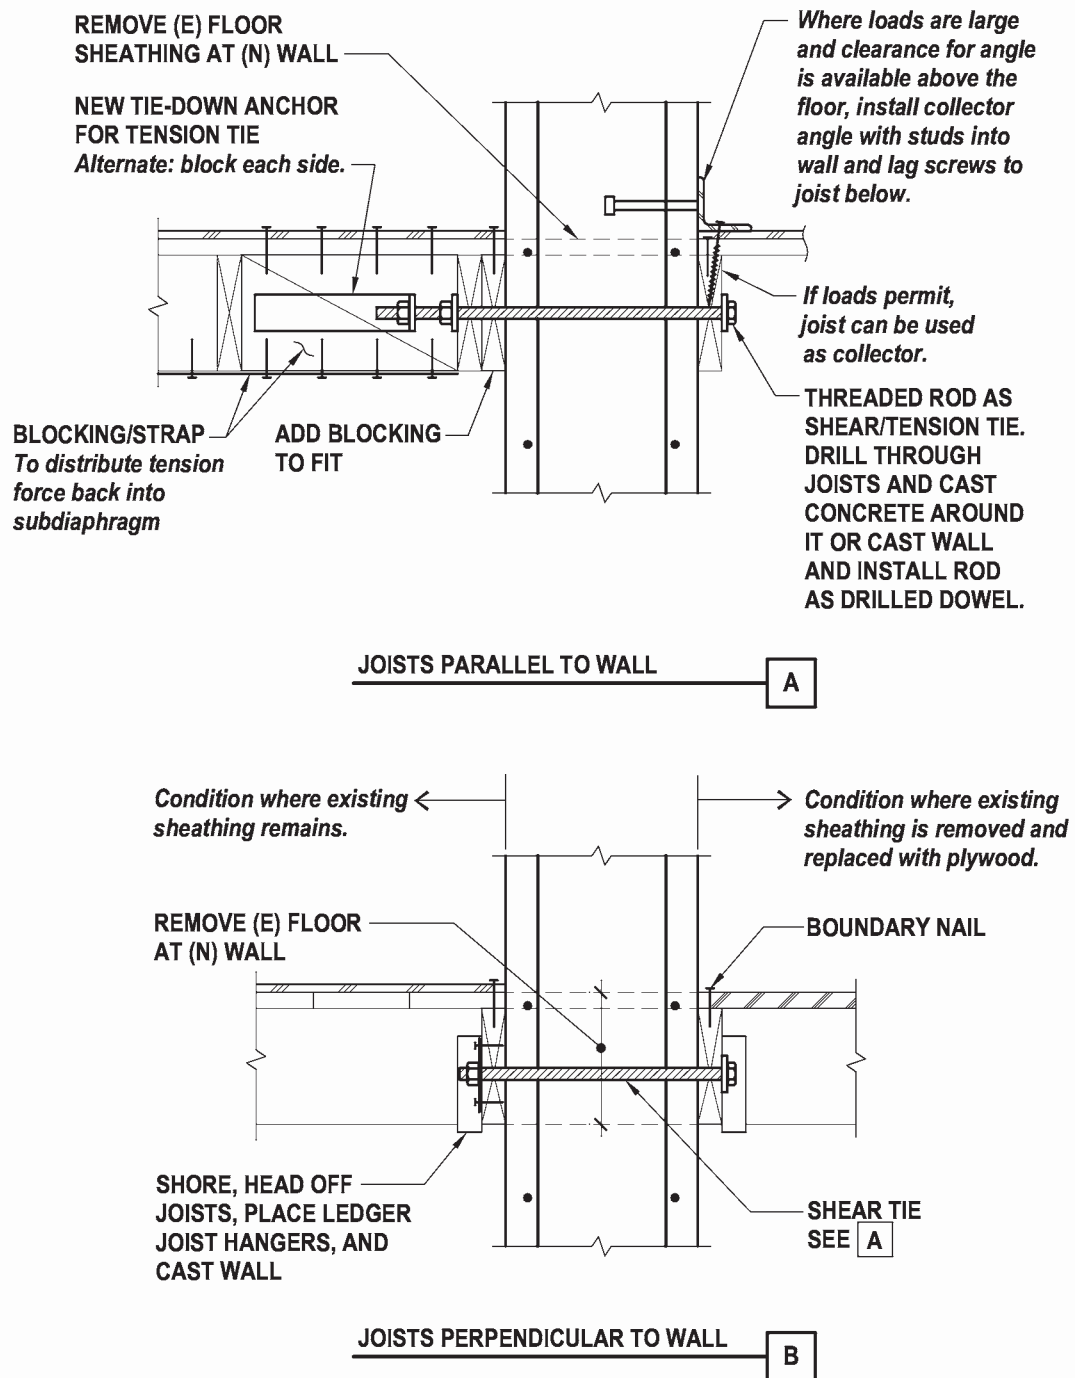
Figure 21.4.8-1: Connecting a New Concrete Wall to an Existing Wood Floor

In-plane shear transfer: In Figure 21.4.8-1, shear transfer from the diaphragm to the wall goes from the diaphragm boundary nailing to the ledger and through the threaded rod into the wall. A tight fit on the rod and ledger is needed. The ledger should be dry dimensional lumber or glulam material to minimize vertical shrinkage of the ledger. When the wall is not as long as the diaphragm (a very common occurrence), a collector attachment into the wall will be needed. Figure 21.4.8-1A shows a steel angle with headed studs cast into the wall and diaphragm-to-collector connections using lag screws. The steel could go above or below the floor. When loads are relatively low, wood members such as the ledger can be used as the collector.

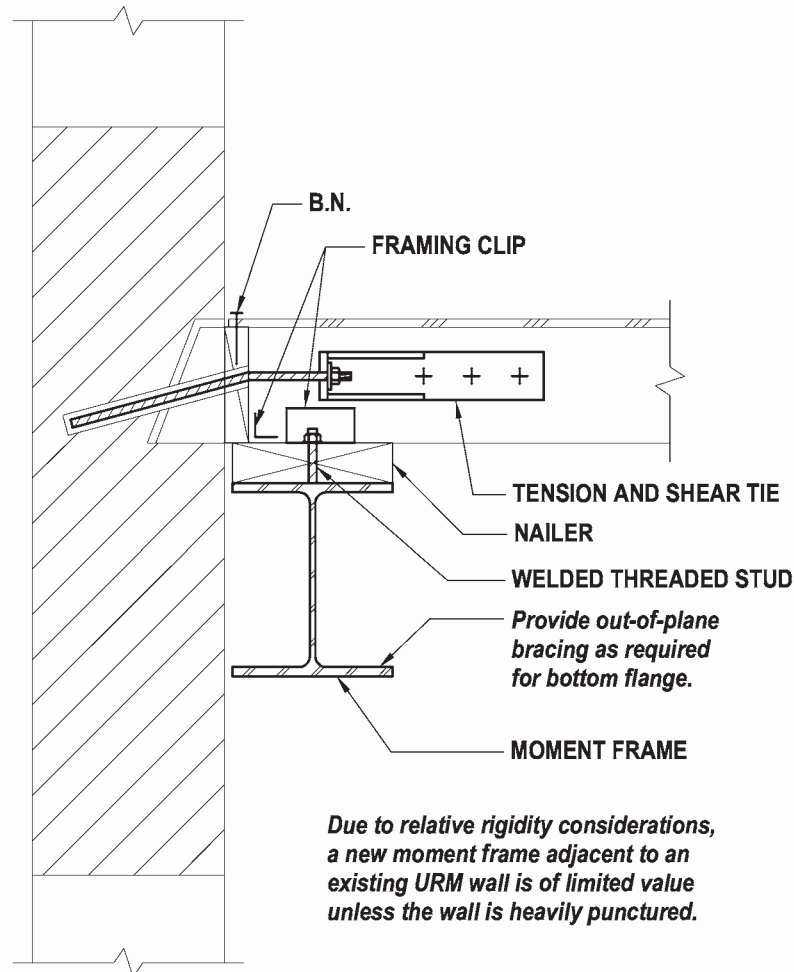
Figure 21.4.9-1: New Perimeter Steel Moment Frame to an Existing Wood Floor

When a moment frame is added into a **URM** building, it typically goes either just behind a highly punctured street front façade or at an interior location within the diaphragm. Figure 21.4.9-1 shows the perimeter condition; Figure 21.4.9-2 shows interior conditions. A moment frame retrofit at a **W1A** building with a soft story is discussed in Chapter 6.

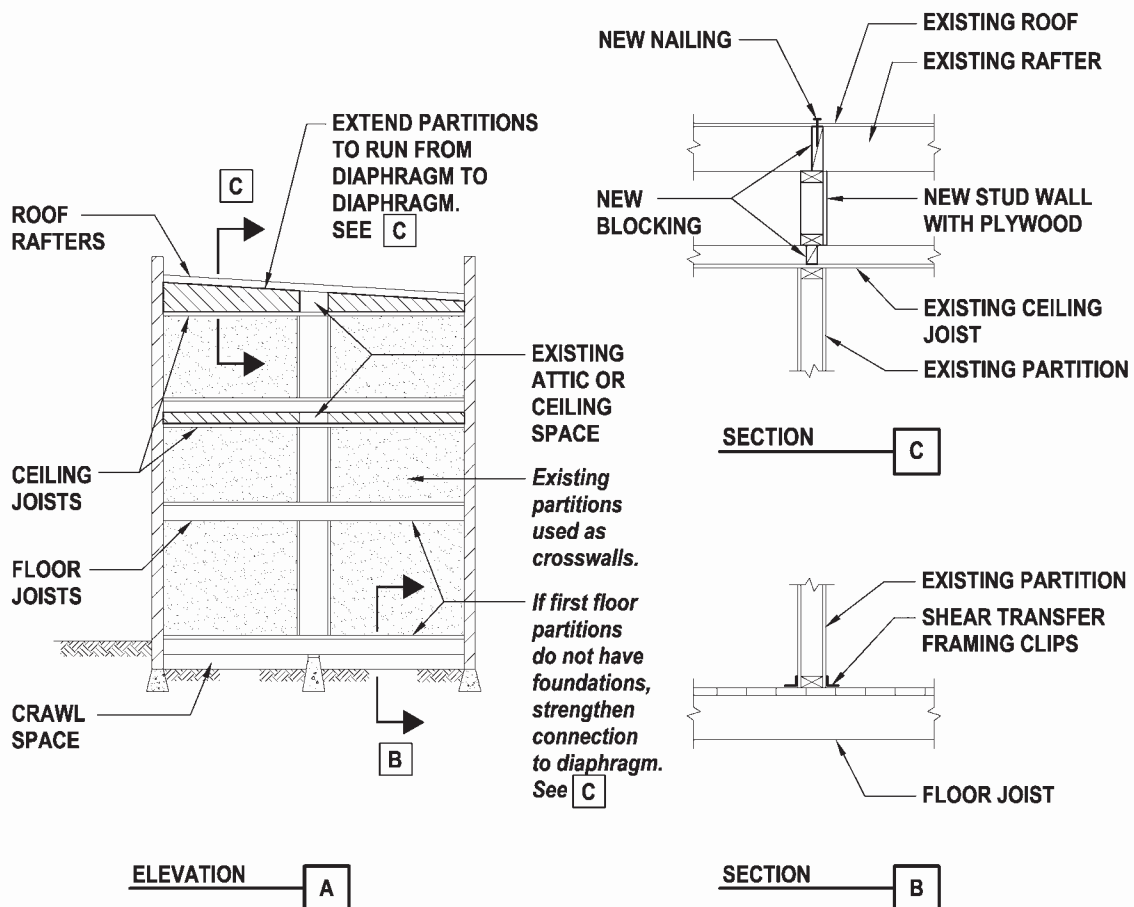
Figure 21.4.10-1: Strengthen Existing Crosswalls

IEBC and 1997 UCBC permit certain qualifying buildings to use the “Special Procedure” with crosswalls as an integral part of the procedure. There are three basic types of crosswalls: existing partitions with various sheathing materials, new partitions, and new steel moment frames. Existing partitions may be adequate without any rehabilitation or they may need strengthening if they are not connected to the diaphragms or have insufficient capacity. New wood structural panel partitions must also be connected to the diaphragm and meet certain minimum capacities. New moment frames must meet minimum strength and stiffness criteria. See Figures 21.4.10-1 to 21.4.10-3.

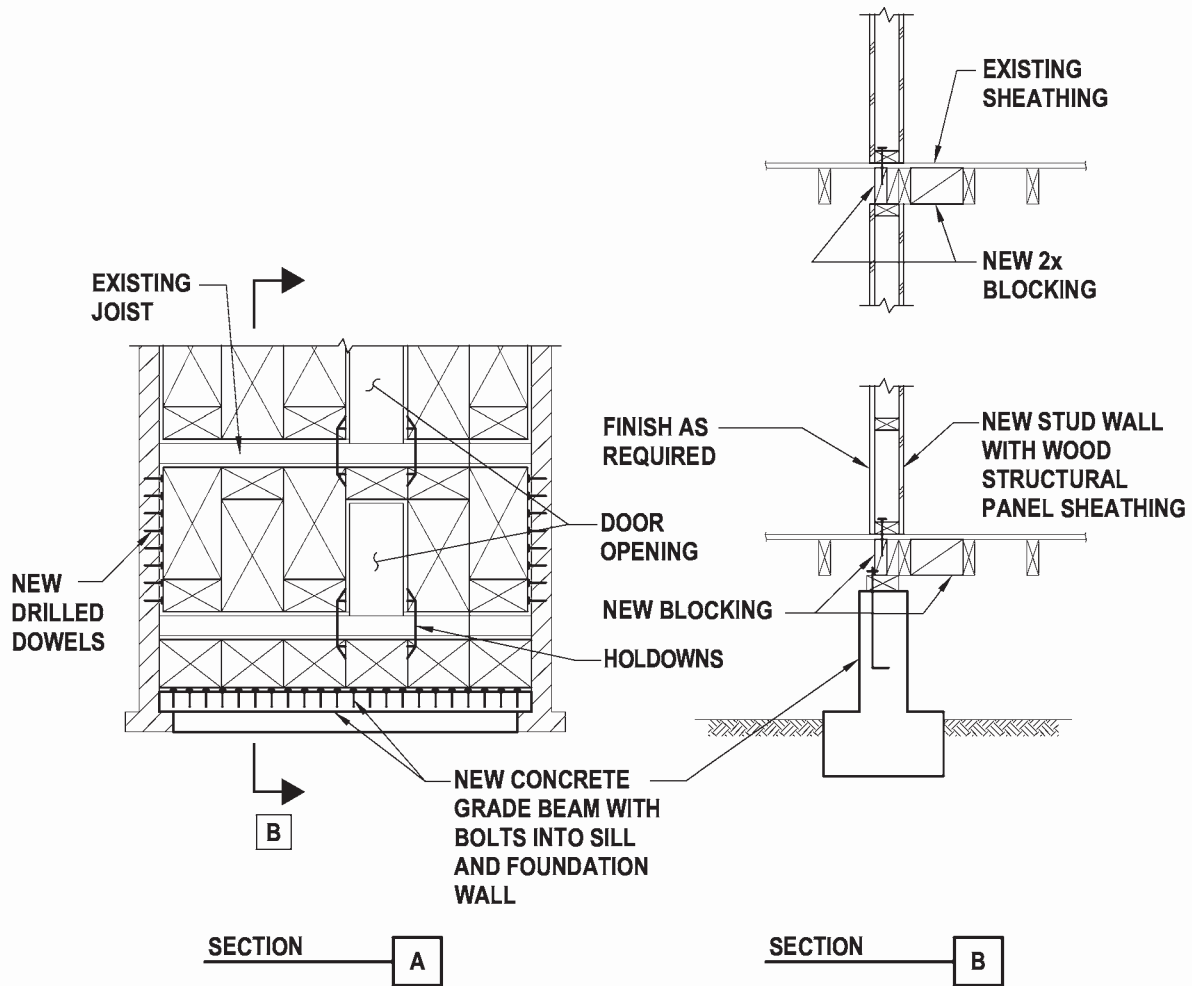
Figure 21.4.10-2: Add New Crosswalls

New crosswalls: New crosswalls will typically be done with structural wood panels and are similar to adding new wood structural panel shear walls. See Chapters 5 and 6 for additional information.

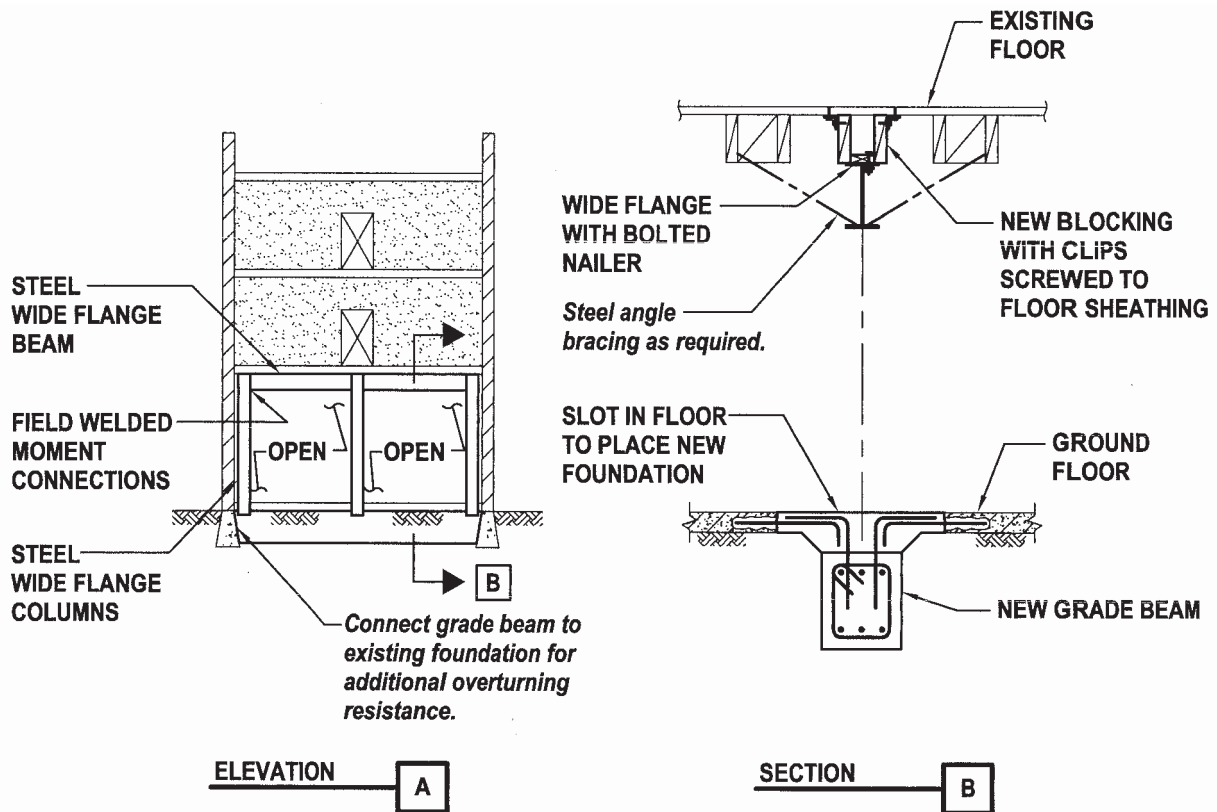
Figure 21.4.10-3: Add New Moment Frame as Crosswall

Steel moment frames: Adding moment frames for use as crosswalls is very similar to adding moment frames for use as new lateral force-resisting elements. See Section 21.4.9 for additional information.

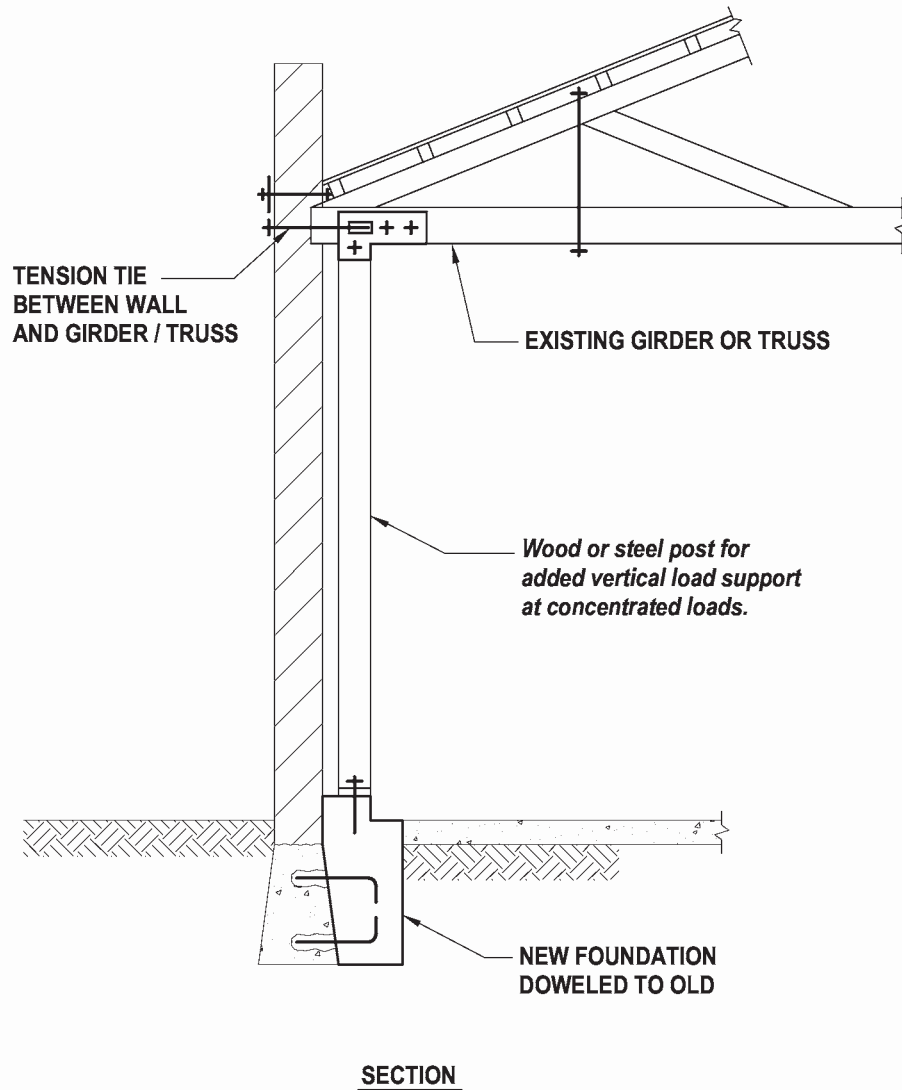
Figure 21.4.11-1: Supplemental Vertical Support

Independence of the support: The 1997 UCBC and 2003 IEBC both use the term “independent secondary columns” when referring to supplemental vertical supports. To some engineers, “independent” means separated from the wall. A post an inch or two away from the wall satisfies this requirement. To other engineers, “independent” simply means an alternative support, so that a ledger or pilaster on the wall is sufficient. In this scenario, the wall just beyond the damaged area is assumed to remain intact enough that gravity load resistance is not compromised. In Figure 21.4.11-1, a gap is shown.

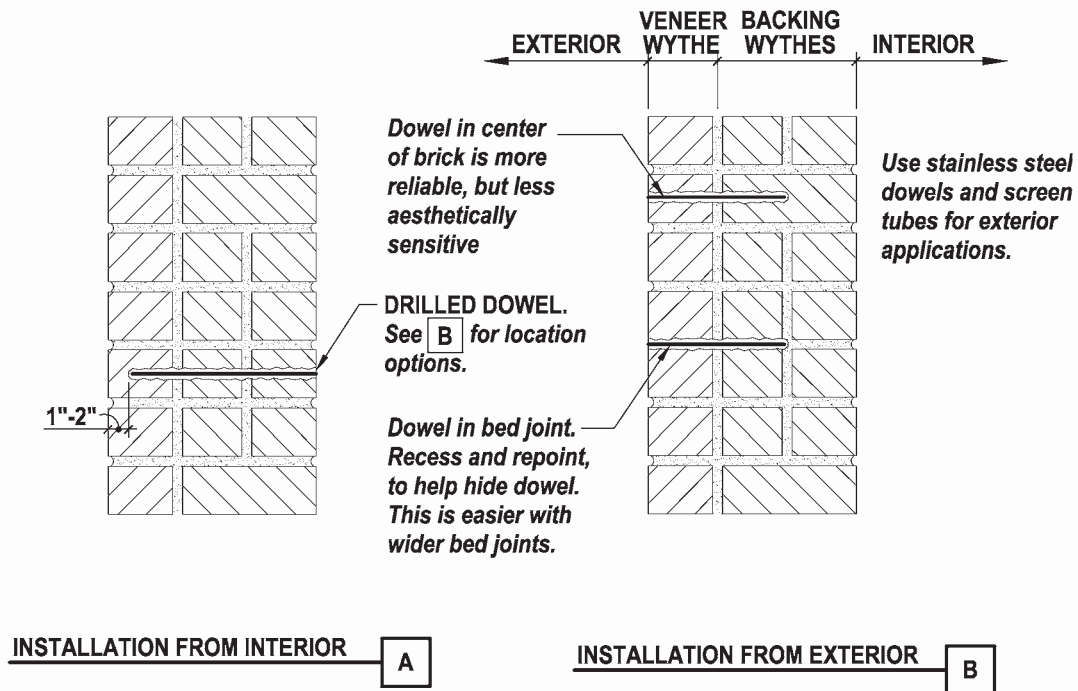
Figure 21.4.12-1: Veneer Ties in Brick Masonry

If the front or facing wythe of brick is not integrally tied into the interior wythes with header courses, it is considered a veneer. If sufficient metal veneer ties are not present to anchor the veneer to the backing wythe, new ties can be provided. Figure 21.4.12-1 shows anchorage using drilled dowels to connect the wythes, either from the exterior or interior, in a typical brick wall. Figure 21.4.12-2 shows anchorage between stone facing and brick backing.

Location of drilled dowel: The most reliable location of the drilled dowel is in the center of the brick, but this will cause the largest aesthetic impact. The dowel can be placed in the bed joint or bed and head joint intersection to minimize the impact. Recessing the tip of the dowel and covering the end with repointing mortar is recommended.

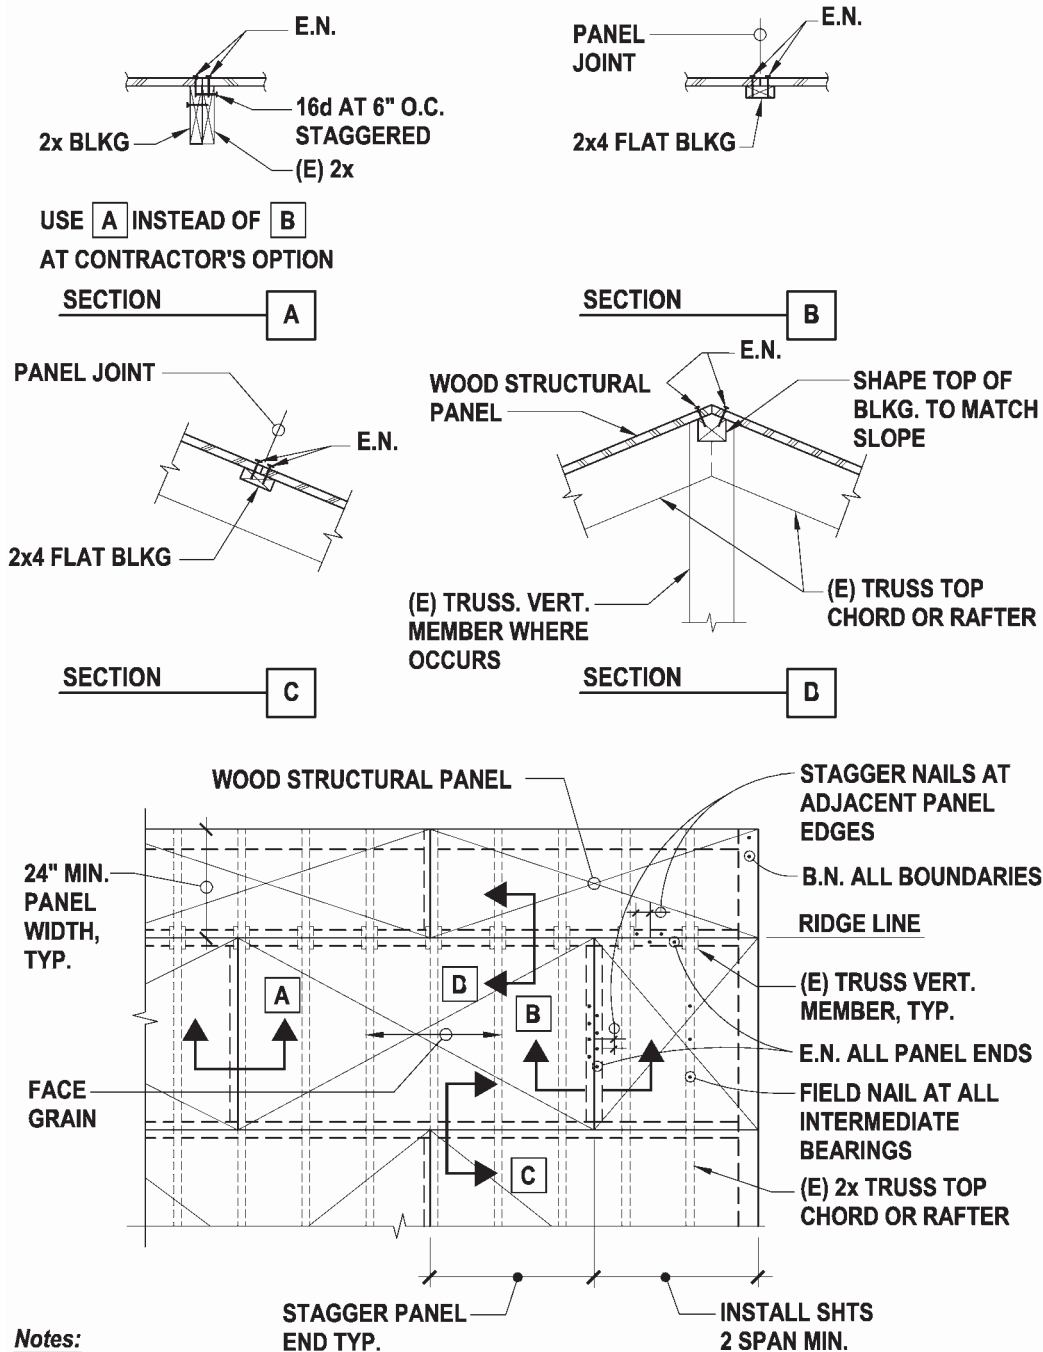
Figure 22.2.1-1: Remove and Replace Existing Wood Sheathing with Wood Structural Panel at a Roof

Each of these techniques aims to improve the shear strength and lateral stiffness of the existing diaphragm. Figure 22.2.1-1 shows the replacement of existing sheathing with new sheathing directly onto the existing joists. Figure 22.2.1-2 shows a wood structural panel overlay on existing straight sheathing floors or roofs when new blocking is added below the existing sheathing. Figure 22.2.1-3 shows an overlay when blocking is not added, and Figure 22.2.1-4 shows a similar overlay to use when the bottom of the existing sheathing is to remain exposed to view and penetrations through it would not be acceptable. Figure 22.2.1-5 shows how shear transfer can be made to get past an existing partition sill that is to remain in place.

1. Remove existing sheathing.
2. Use 3x and 4x blocking for higher capacity if necessary.
3. Use of **A** requires wood structural panels to be field cut to fit existing joist spacing. Detail **B** permits nominal wood structural panel size.

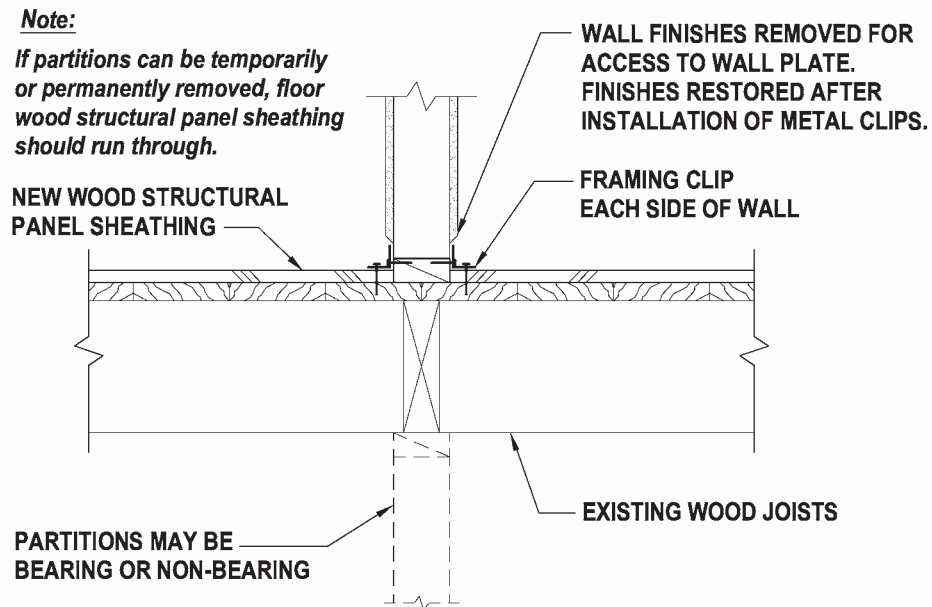
SECTION

Note: *This detail is for transfer of relatively low shear forces. When boundary nailing and higher capacity are needed, alternate details are required.*

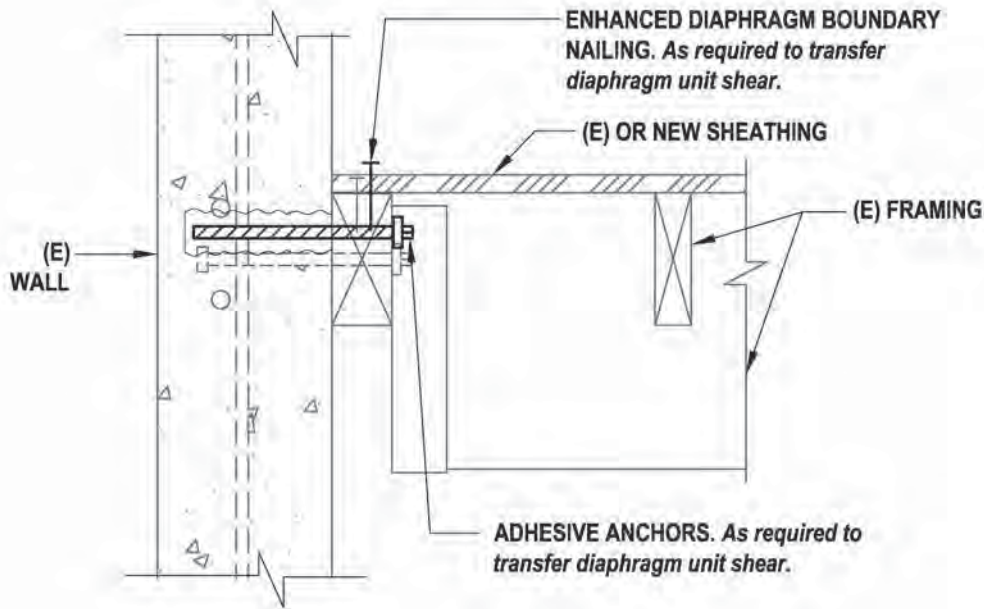
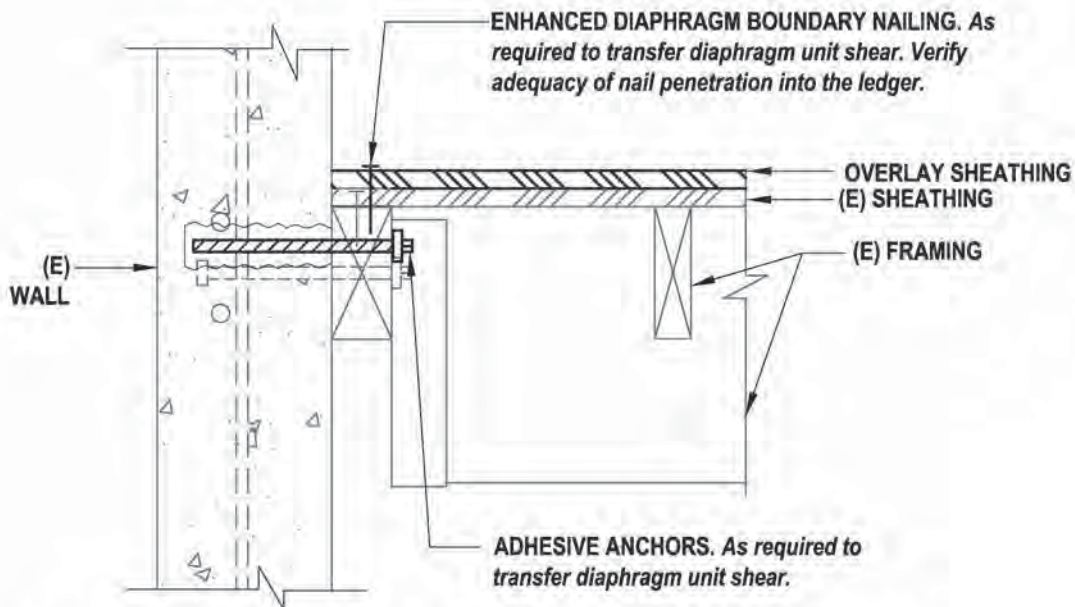
Figure 22.2.2-1: Enhanced Chord Member Fastening at Wood Diaphragm

Note: Load path from diaphragm sheathing to chord member must be adequate to transfer diaphragm unit shear. Special attention is needed if diaphragm nailing varies along the chord length. Anchorage for wall out-of-plane loads is not shown.

SECTION AT (E) WOOD LEDGER A

SECTION AT SHEATHING OVERLAY B

The new or enhanced chord member must be anchored into the diaphragm for unit shear transfer. Anchorage for shear transfer is also discussed in Section 22.2.3. As a wood sheathed diaphragm is loaded, slip will occur between the perimeter framing member and the sheathing. Fastening of the chord or chord enhancement should not inhibit this slip. If the slip is not permitted, premature failure at the opposite side of the sheathing panel could occur. This is not a concern with a welded steel deck diaphragm, which has limited slip.

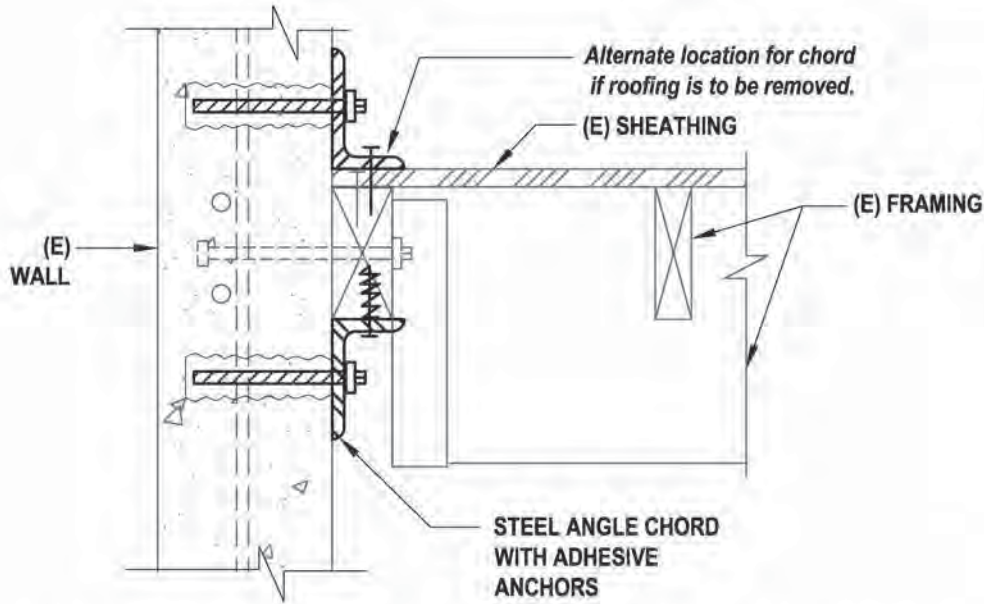
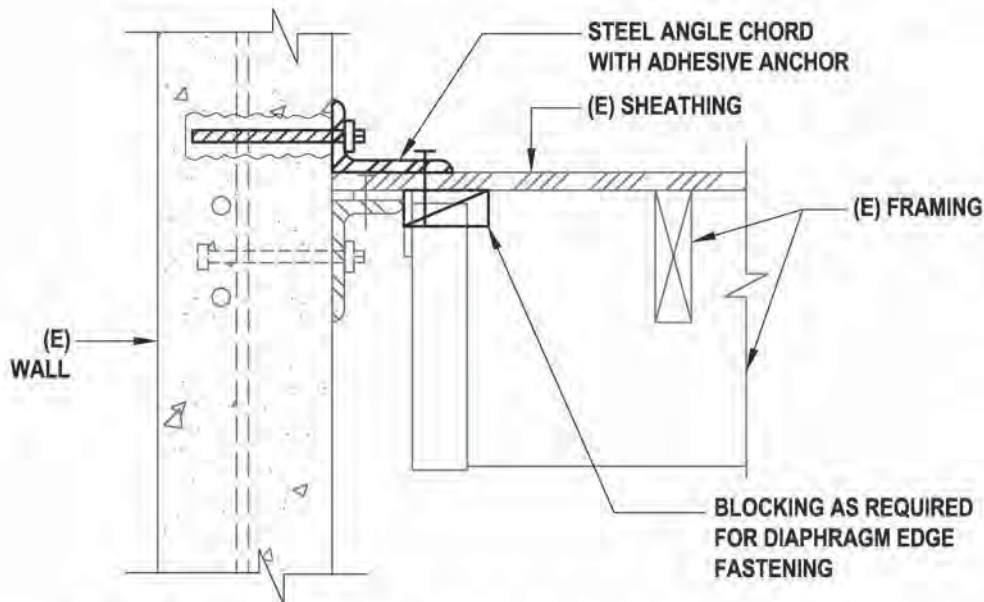
Figure 22.2.2-2: Enhanced Chord Member and Fastening at Wood Diaphragm

Note: Load path from diaphragm sheathing to chord member must be adequate to transfer diaphragm unit shear. Special attention is needed if diaphragm nailing varies along the chord length. Verify grout location at partially grouted wall. Anchorage for wall out-of-plane loads not shown.

SECTION AT (E) WOOD LEDGER A

Load path from diaphragm sheathing to chord member must be adequate to transfer diaphragm unit shear. Special attention is needed if diaphragm nailing varies along the chord length. Verify grout location at partially grouted wall. Anchorage for wall out-of-plane loads not shown.

SECTION AT (E) STEEL LEDGER B

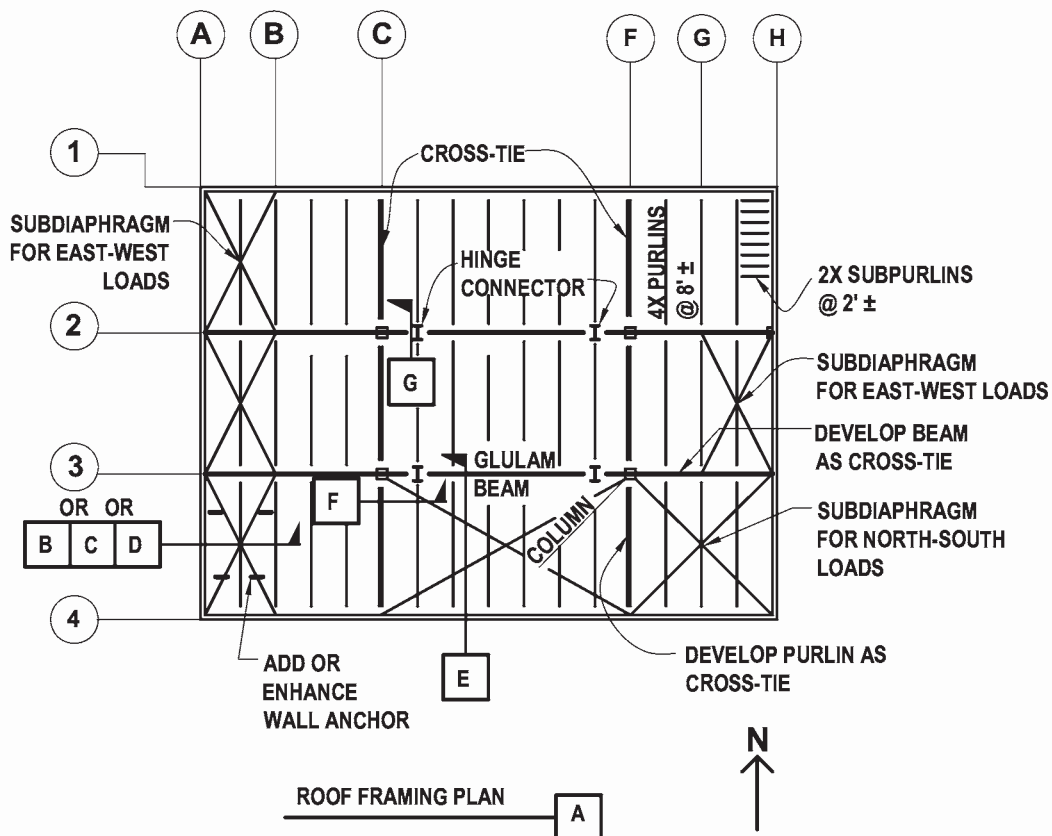
Figure 22.2.3-1A: Roof Plan with Diaphragm Cross-Tie System Using Subdiaphragms, Shown for Wood Diaphragm

Figure 22.2.3-1A illustrates a roof plan for a wood diaphragm that uses subdiaphragms as part of the cross-tie system. For loading in the east-west direction, subdiaphragms are provided between Lines A and B and Lines G and H. Similarly, for loading in the north-south direction, subdiaphragms are provided between Lines 1 and 2 and Lines 3 and 4. The depth of the subdiaphragm is selected based on the unit shear at the subdiaphragm reaction, as well as having a member available to act as a subdiaphragm chord. The wall anchor force is transferred into the subdiaphragm over the full subdiaphragm depth. For east-west loads subdiaphragms span between Lines 1 and 2, 2 and 3, and 3 and 4. Subdiaphragm reactions are resisted at the exterior walls at Lines 1 and 4, and interior cross-ties are provided on Lines 2 and 3. Boundary nailing must be provided for each subdiaphragm on Lines 1, 2, 3, 4, A and B. The cross-tie provides a continuous tie between exterior walls with a capacity not less than the subdiaphragm reaction. This pattern is repeated for subdiaphragms between Lines G and H, 1 and 2, and 3 and 4.

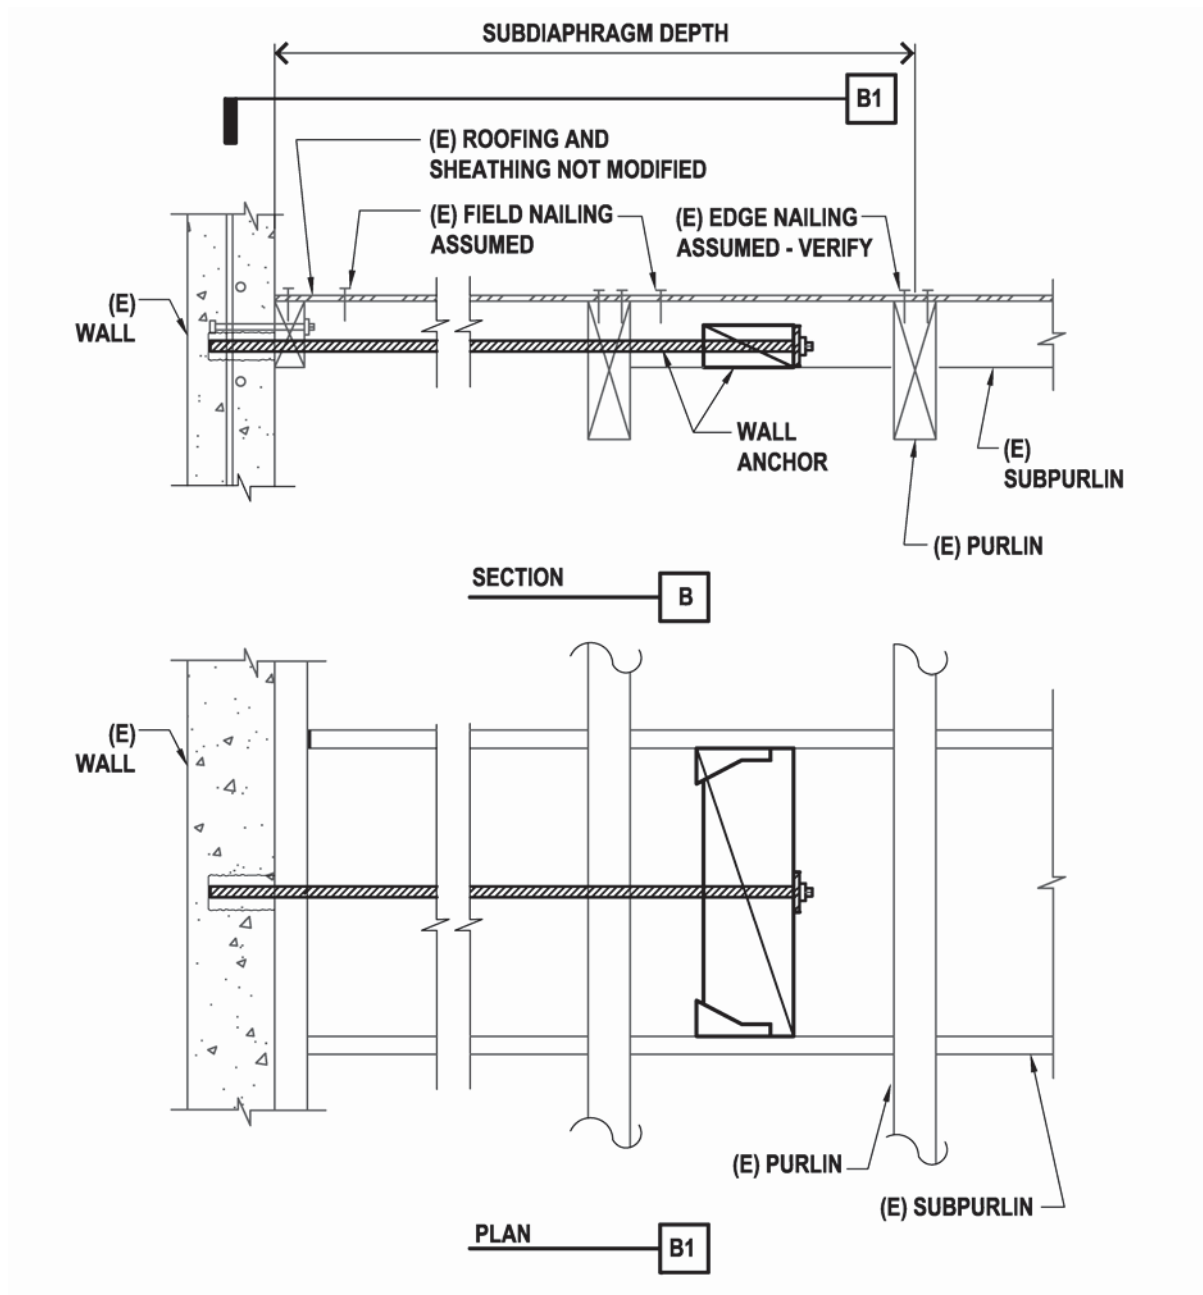
Figure 22.2.3-1B: Subdiaphragm for Flexible Wood Diaphragm – Roofing Not Removed

Figures 22.2.3-1B, 22.2.3-C, and 22.2.3-D depict sections through the subdiaphragm extending between Lines A and B. Figure 22.2.3-1B shows the assumed subdiaphragm where existing roof sheathing is not being modified. The subdiaphragm depth will be controlled by the capacity of the existing sheathing. The wall anchor engages each wall purlin across the subdiaphragm depth.

Existing subpurlin-to-sheathing nailing must be adequate to transfer the wall anchor force to the subdiaphragm. In Figure 22.2.3-1B the added wall anchor is located between existing subpurlins in order to engage more existing sheathing nailing. Sheathing fastening to subpurlins must be assumed to be field nailing unless edge nailing has been confirmed.

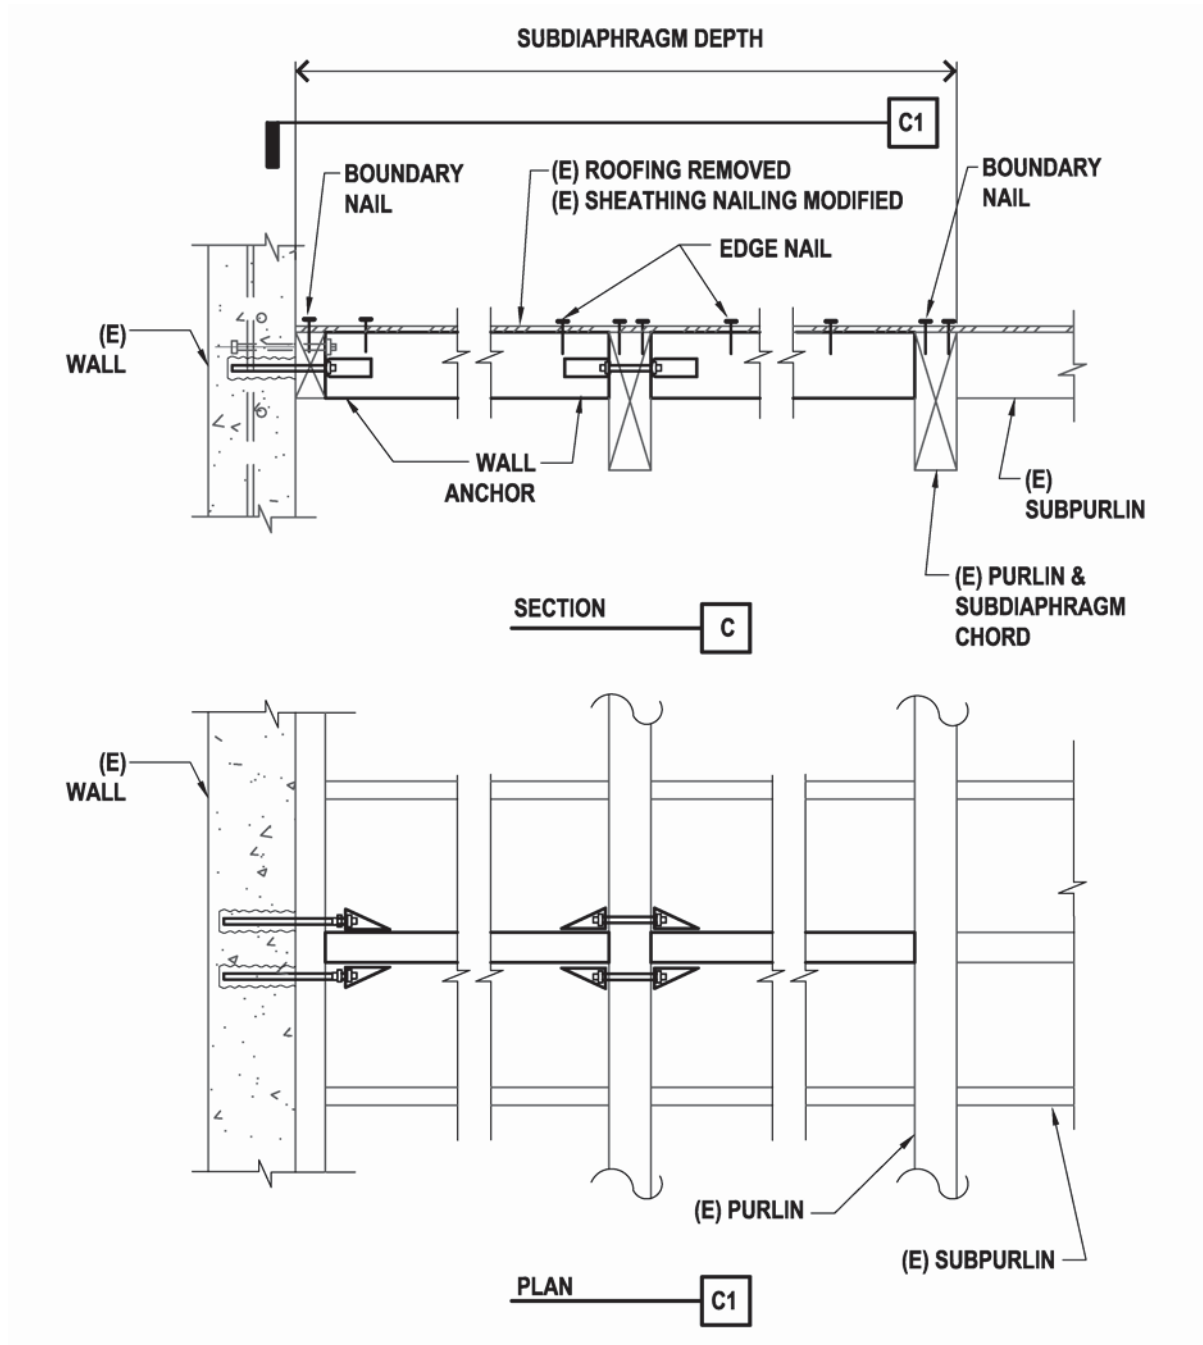
Figure 22.2.3-1C: Subdiaphragm for Flexible Wood Diaphragm – Roofing Removed

Figure 22.2.3-1C depicts a subdiaphragm where access from the top is assumed, and the subdiaphragm can be renailed to meet required demands. A new member is provided at the wall anchor. Tie-downs are added to carry the wall anchorage force across the entire subdiaphragm width. Figure 22.2.3-1D illustrates a third subdiaphragm alternative where new subdiaphragm sheathing is provided as a soffit at the underside of the roof framing. Wall out-of-plane anchorage is not shown, but would be similar to Figure 22.2.3-1C. Attention is needed to providing shear transfer into the main diaphragm at all subdiaphragm boundaries. See other chapters for additional discussion of wall anchorage.

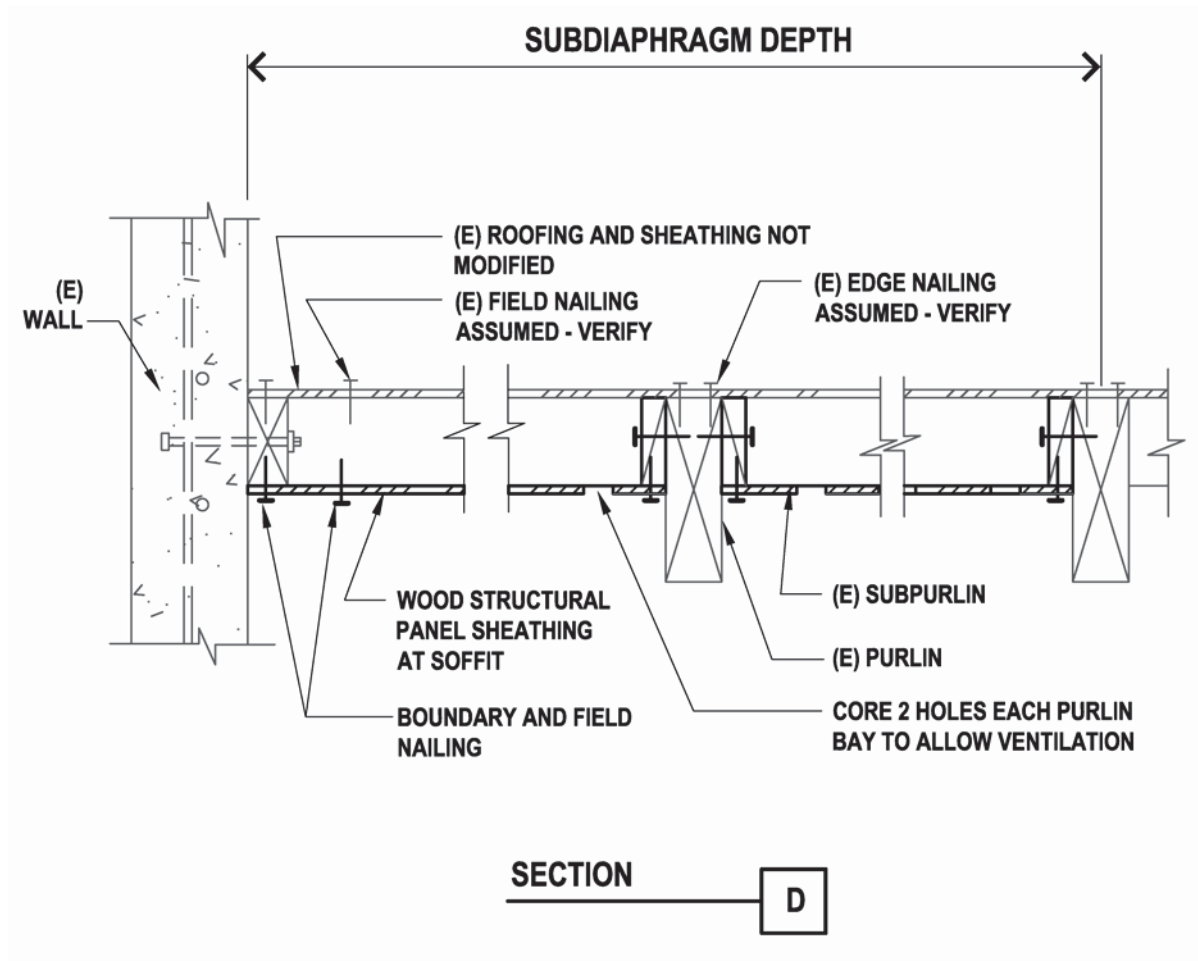
Figure 22.2.3-1D: Enhanced Wood Subdiaphragm with Added Wood Structural Panel Soffit
