Architectural
Resources Group

609, 611, and 619 NE 3rd Street
McMinnville, Oregon

Historic Resource Assessment
November 2022

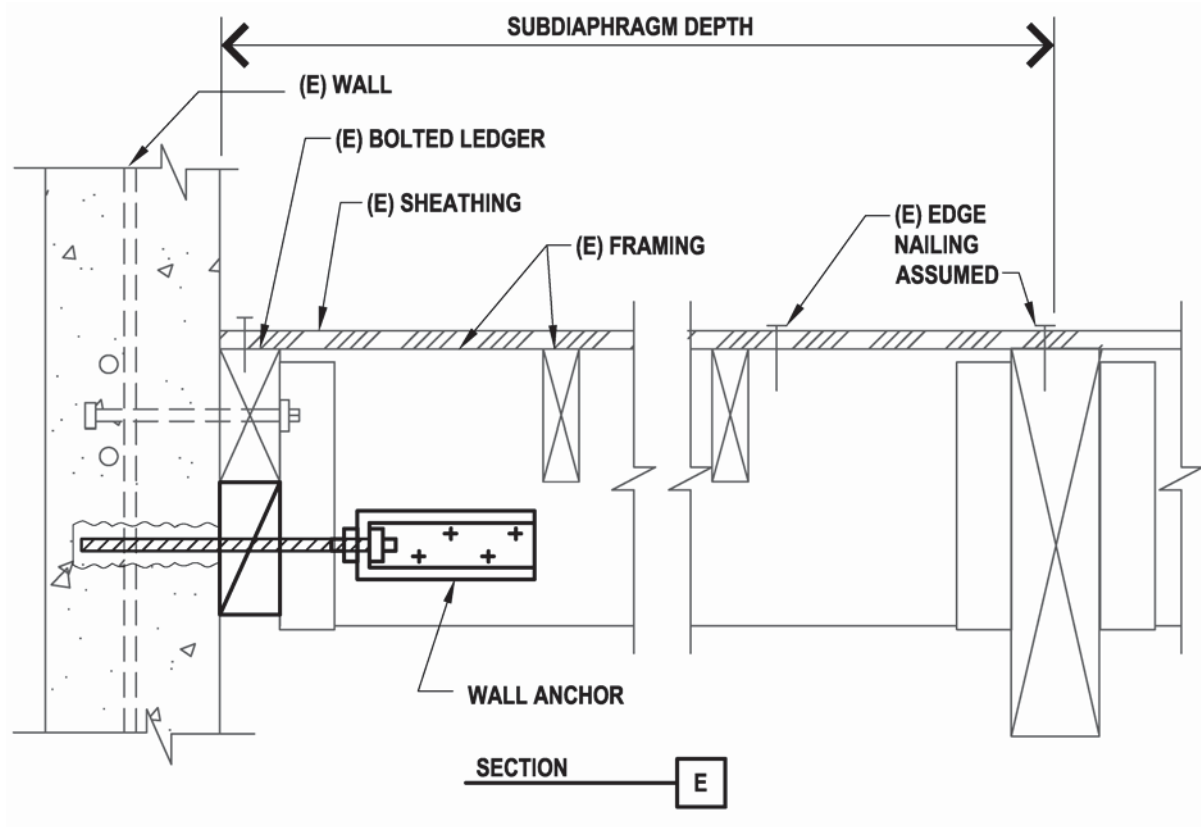
Figure 22.2.3-1E: Subdiaphragm for Flexible Wood Diaphragm at Purlins

Figure 22.2.3-1E illustrates anchorage of the north and south walls into subdiaphragms extending between Lines 1-2 and 3-4.

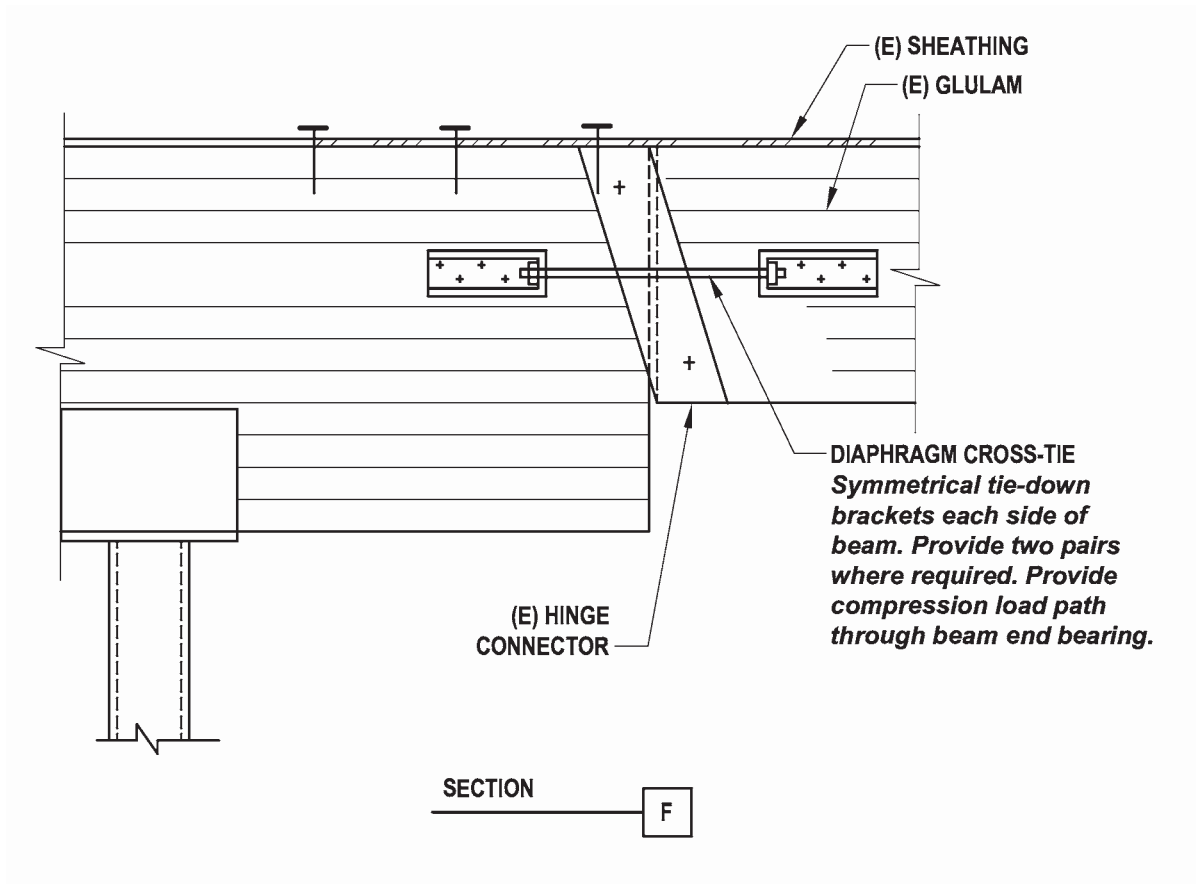
Figure 22.2.3-1F: Cross-Tie for Flexible Wood Diaphragm at Glulam Beams

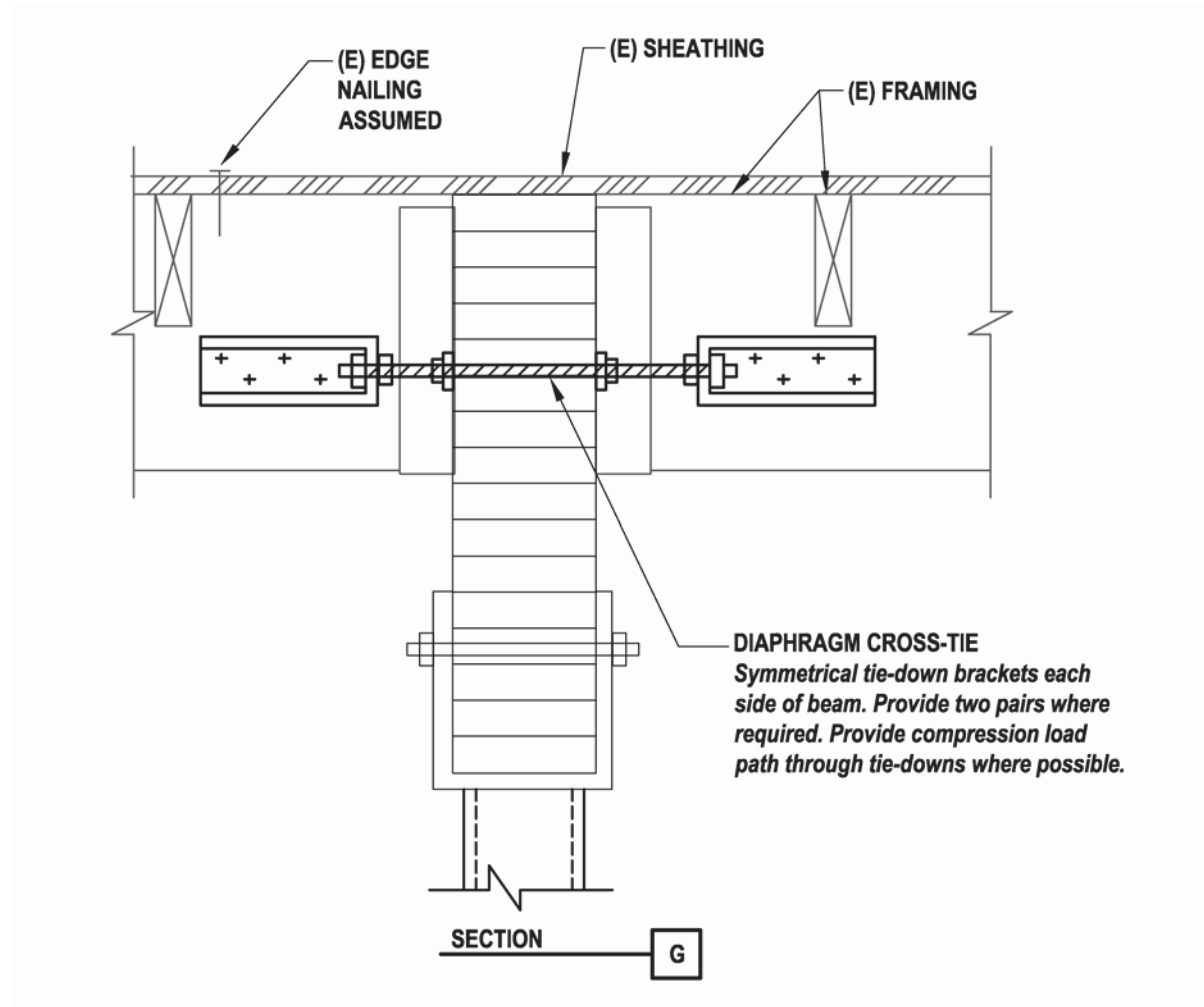
Figure 22.2.3-1G: Cross-Tie for Flexible Wood Diaphragm at Purlins

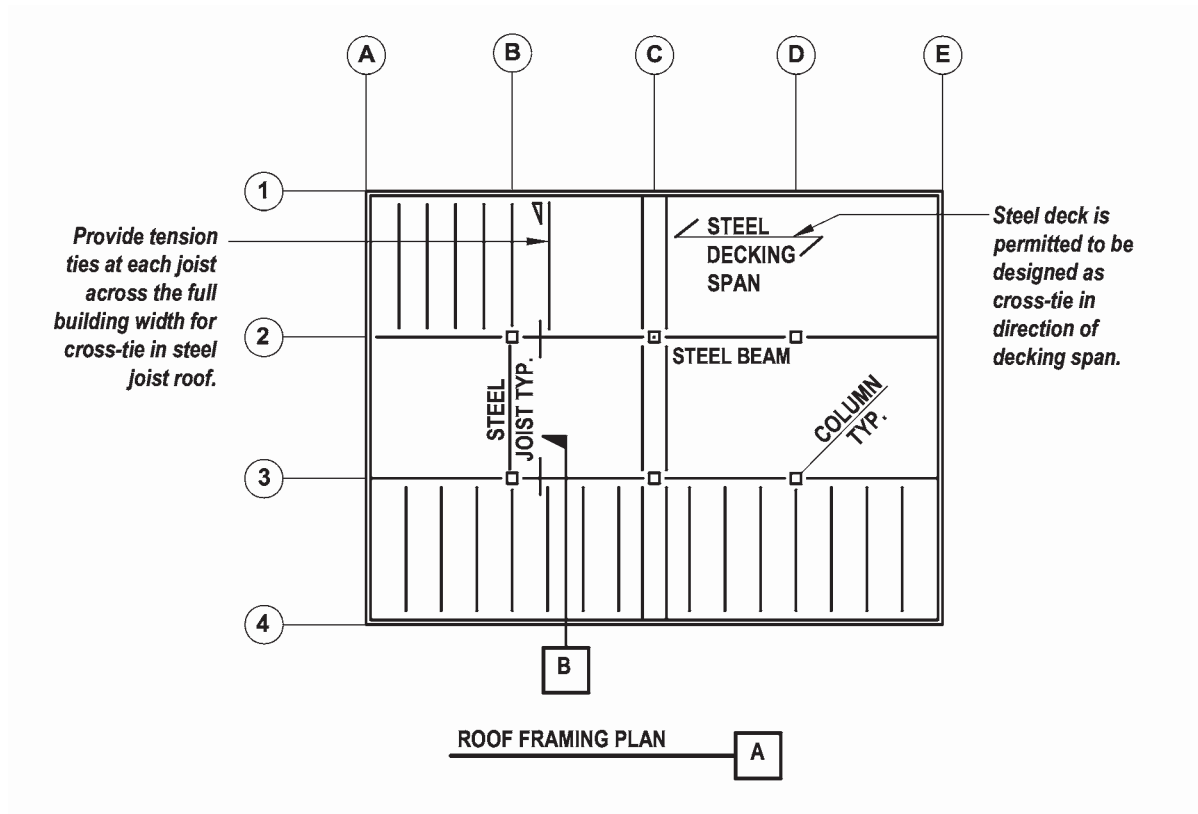
Figure 22.2.3-2A: Roof Plan with Diaphragm Cross-Tie System Using Direct Ties, Shown for Steel Diaphragm

Figure 22.2.3-2A illustrates a similar roof plan with a steel diaphragm. Figures 22.2.3-2B through 22.2.3-2D provide details. Instead of using subdiaphragms, direct ties are provided. Alternative connections locations for field welded connections between joists (Figures 22.2.3-2C and 22.2.3-2D) include the joist top chord, vertical and horizontal legs. The alignment of joists at support locations will greatly affect the connection detail used, so field determination of detail and alignment should be made. See Section 16.4.1 for additional discussion.

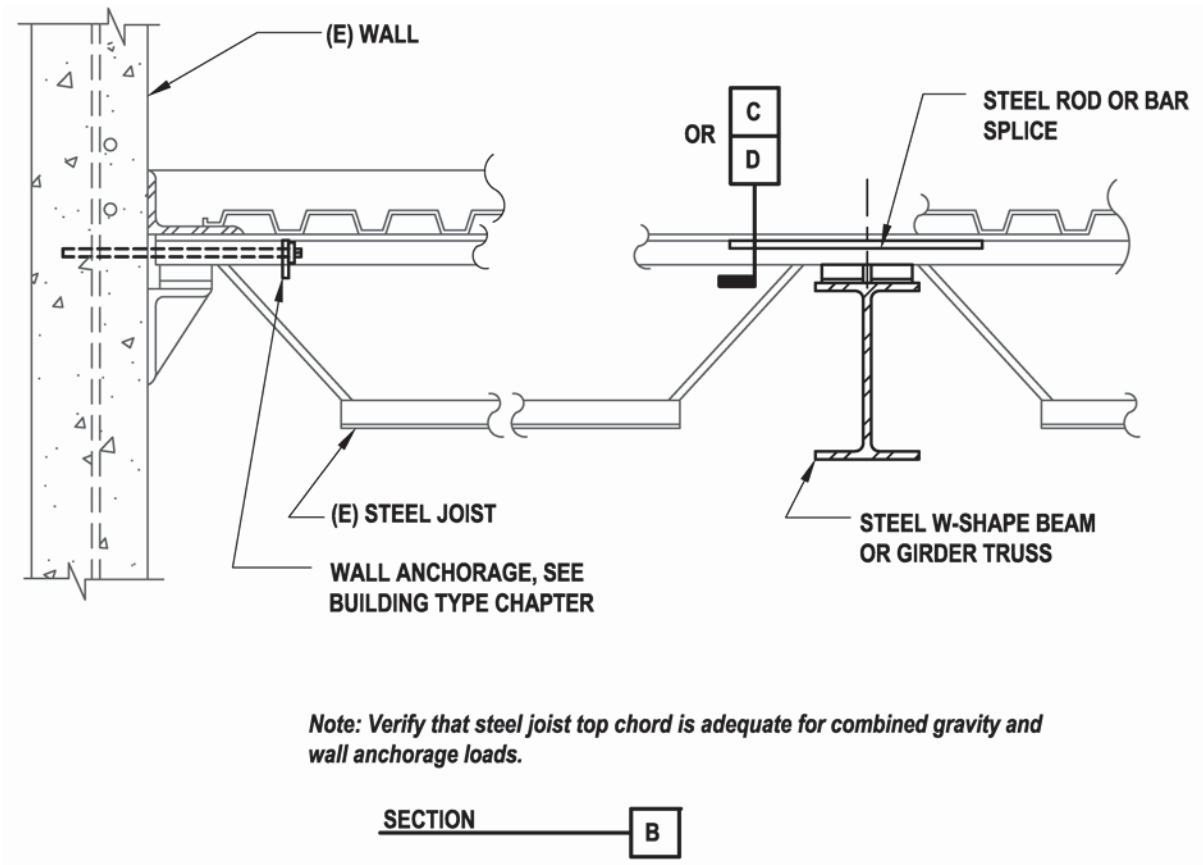
Figure 22.2.3-2B: Cross-Tie for Flexible Steel Diaphragm

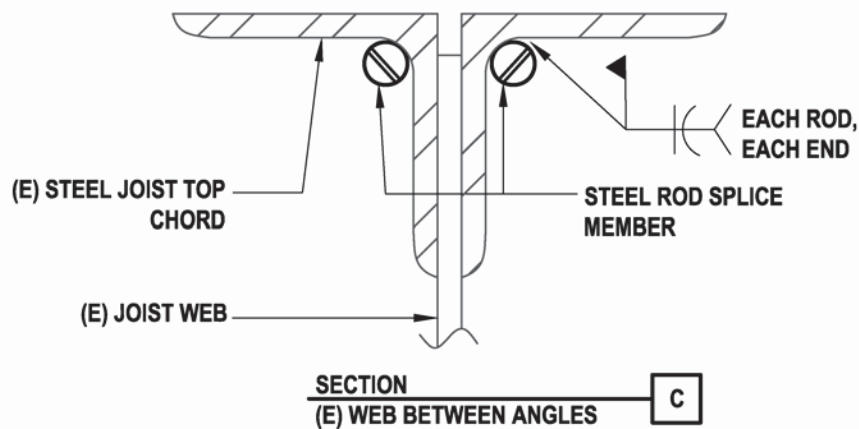
Figure 22.2.3-2C: Steel Open Web Joist Connection for Diaphragm Cross-Ties

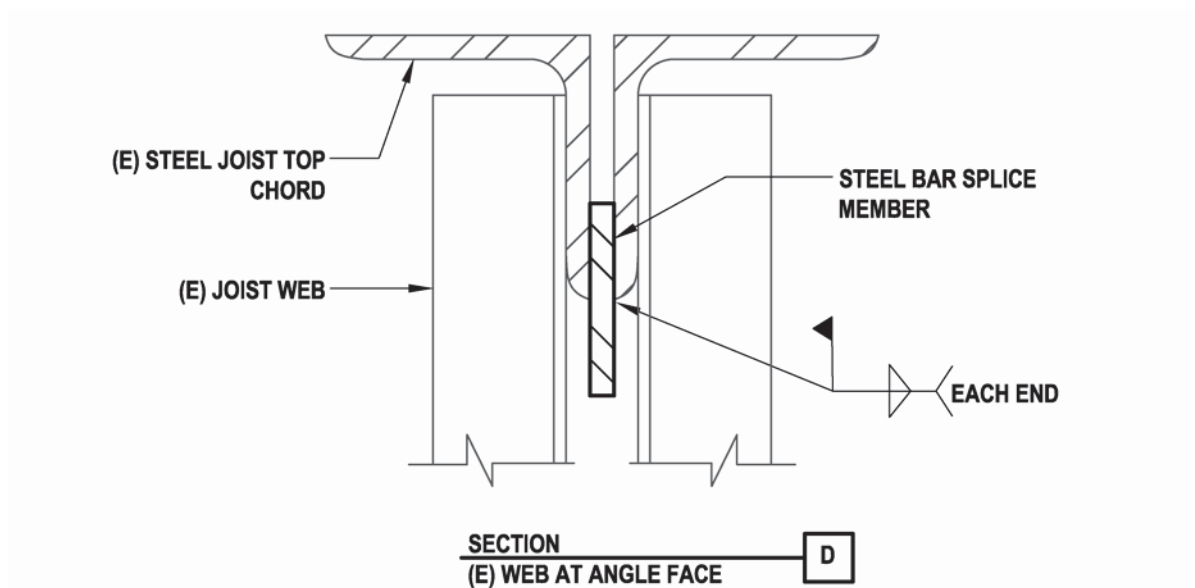
Figure 22.2.3-2D: Steel Open Web Joist Connection for Diaphragm Cross-Ties

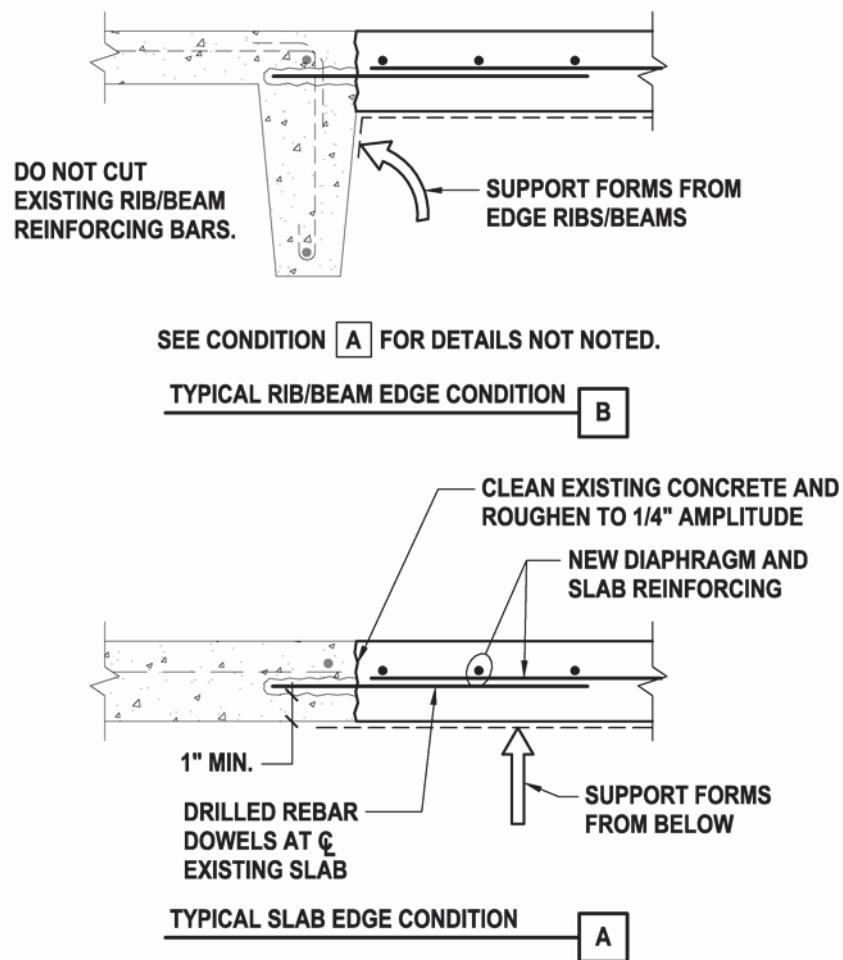
Figure 22.2.4-1: Typical Infill Opening in a Concrete Diaphragm

Connection to existing concrete floor and roof diaphragms: Typical details of a reinforced concrete (cast-in-place or shotcrete) infill are indicated in Figure 22.2.4-1. Sufficient dowels must be placed into the existing diaphragm slab on all sides of the opening to transfer the required shear demand to and from the infill section. Forms may be supported from the floor below or suspended from the surrounding floor or roof. This latter option is much more common for smaller openings or for openings surrounded by waffle ribs, pan joists or beams. Since the concrete infill will shrink relative to the surrounding slab, some care should be given to use shrinkage compensated mix.

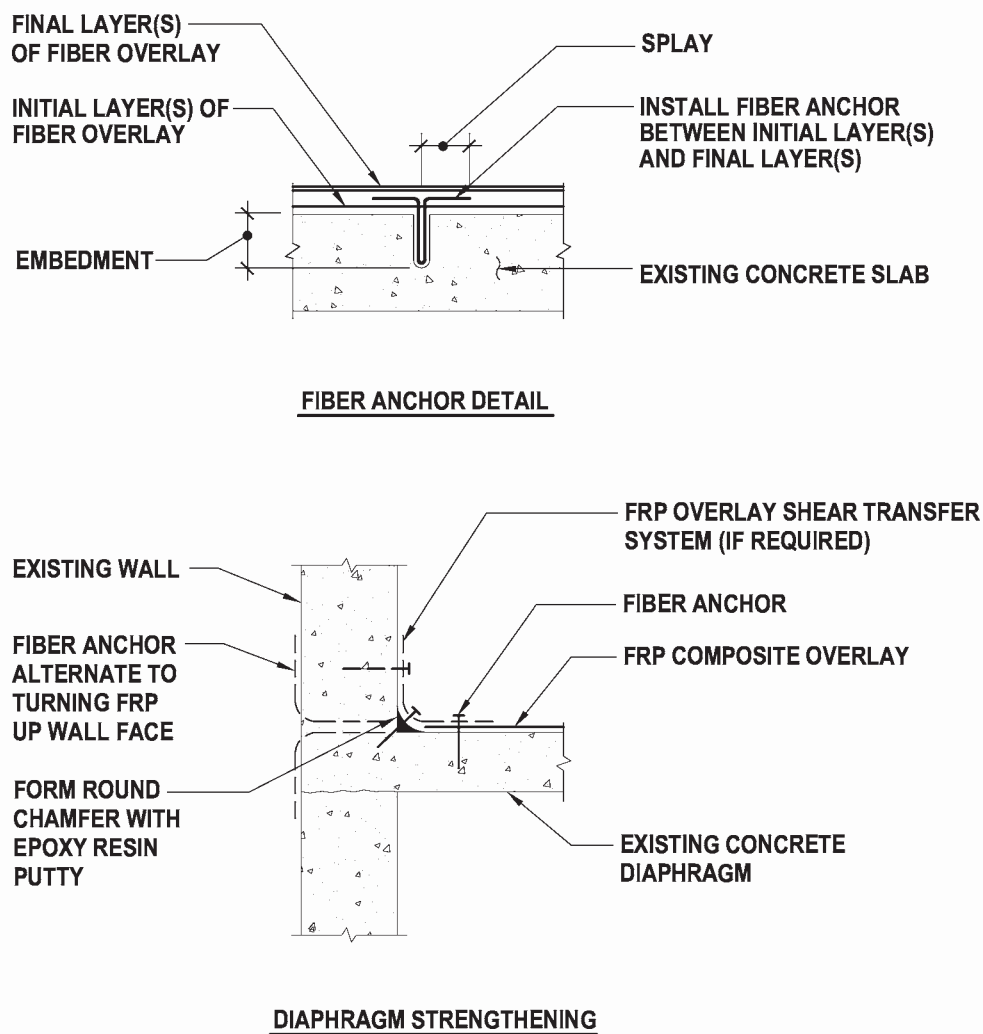
Figure 22.2.5-1: Shear Strengthening of Concrete Diaphragm Using FRP Composite

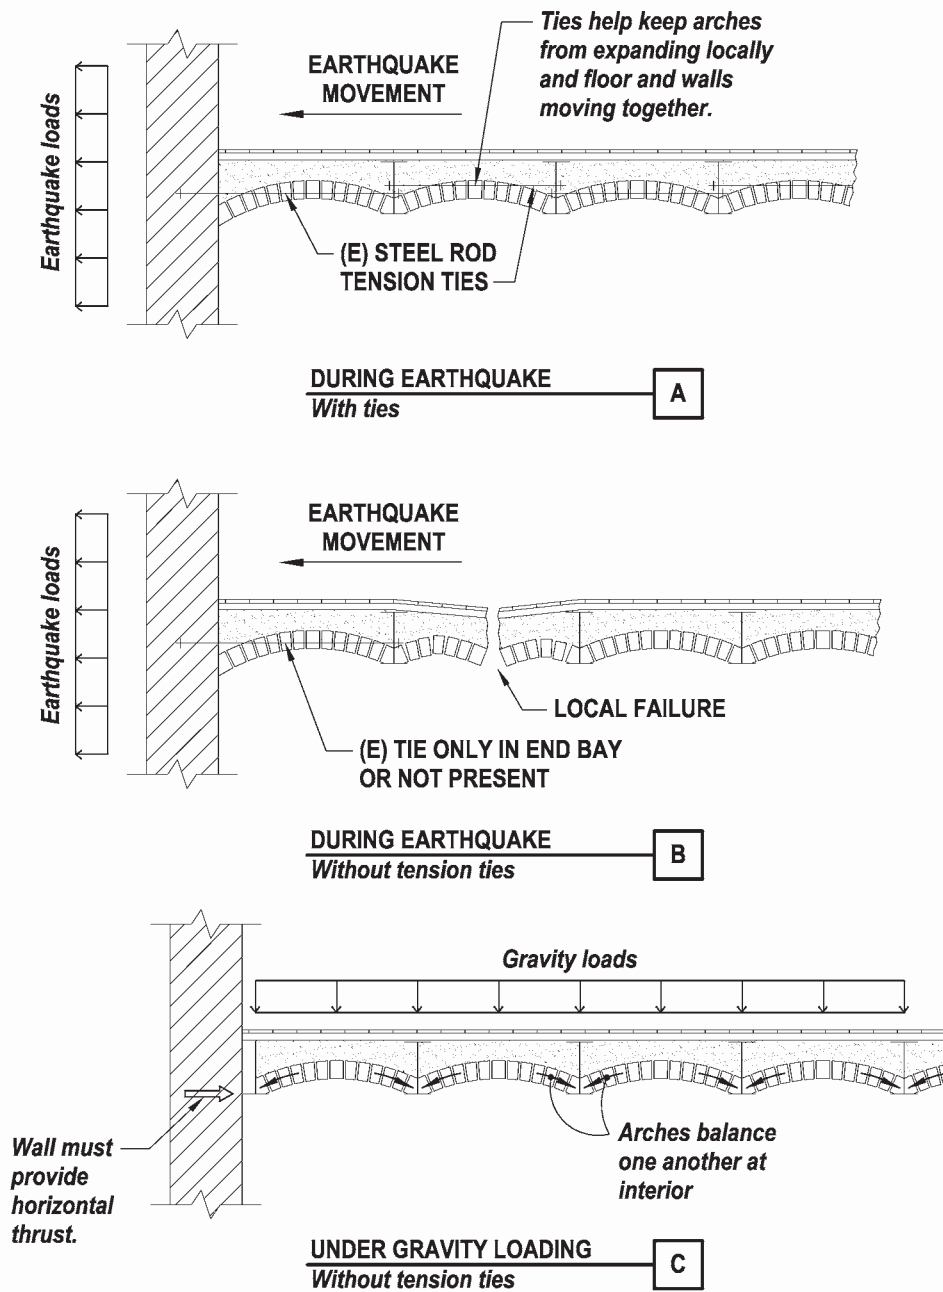
Figure 22.2.8-1: Failure Scenarios for Masonry Flat Arch Floors

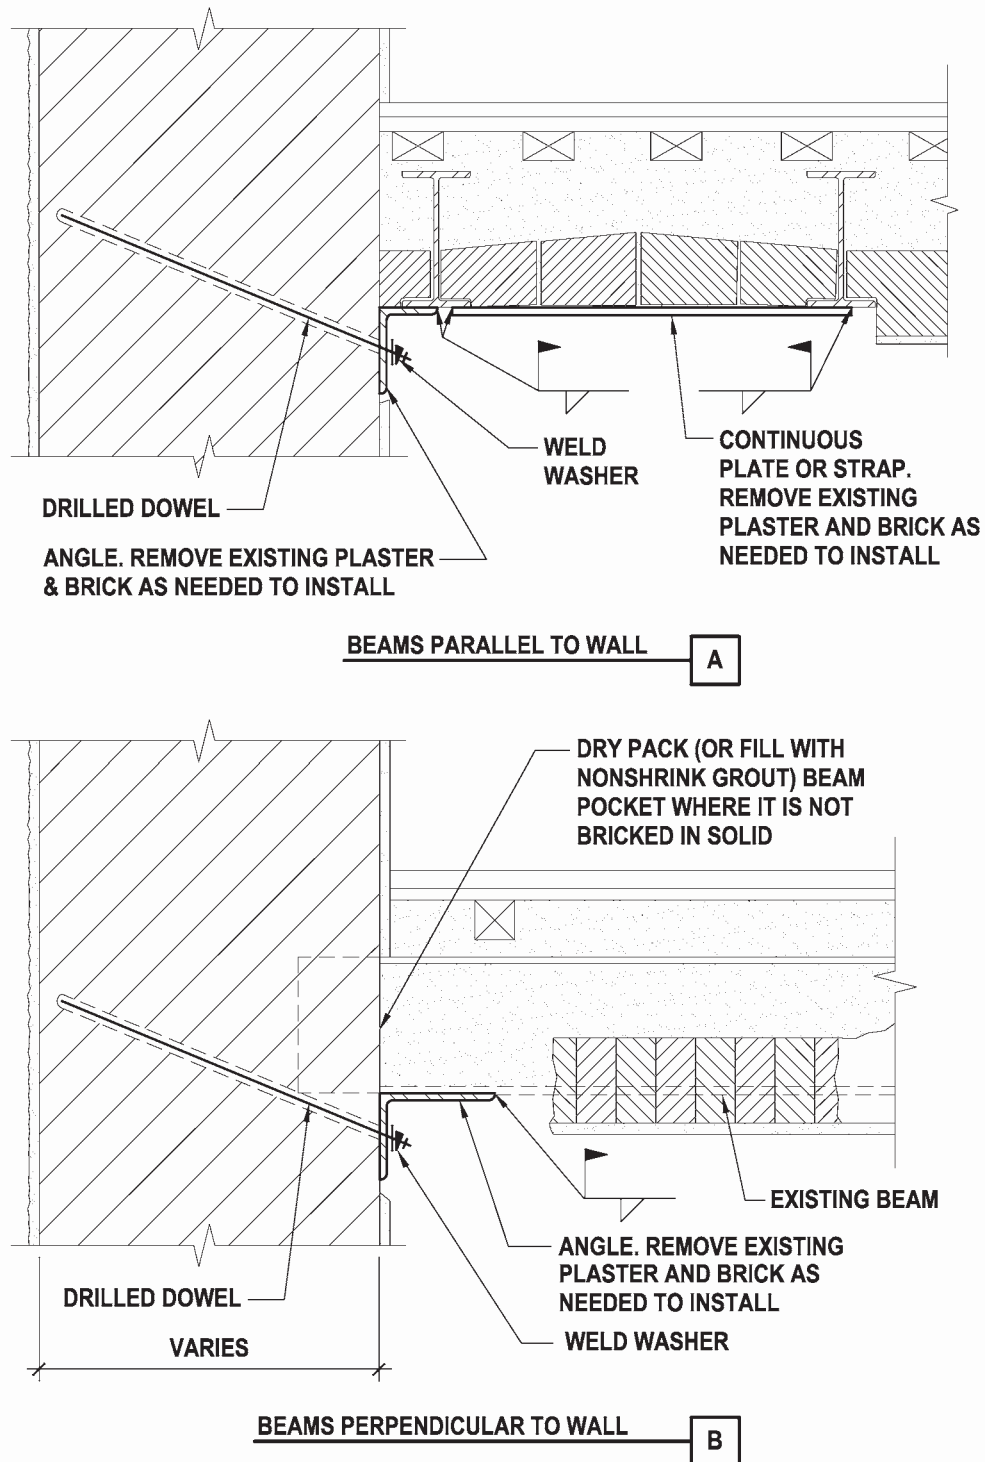
Figure 22.2.8-2: Add Wall-to-Diaphragm Ties and Chord for Masonry Flat Arch Floor - Access from Below the Floor

Wall-to-diaphragm tension ties: Figure 22.2.8-2 shows the addition of tension ties from the wall to the steel beams for conditions when the beams are perpendicular to the wall and when they are parallel. When beams are perpendicular, an angle and drilled dowel is sufficient. When beams are parallel, strapping back to joists inside the floor is necessary. Figure 22.2.8-3 shows an example of placing the strapping on top of the beams, in case this is the preferred location for work.

Chord: If the angle in Figure 22.2.8-2 is continuous, it can serve as a diaphragm chord.

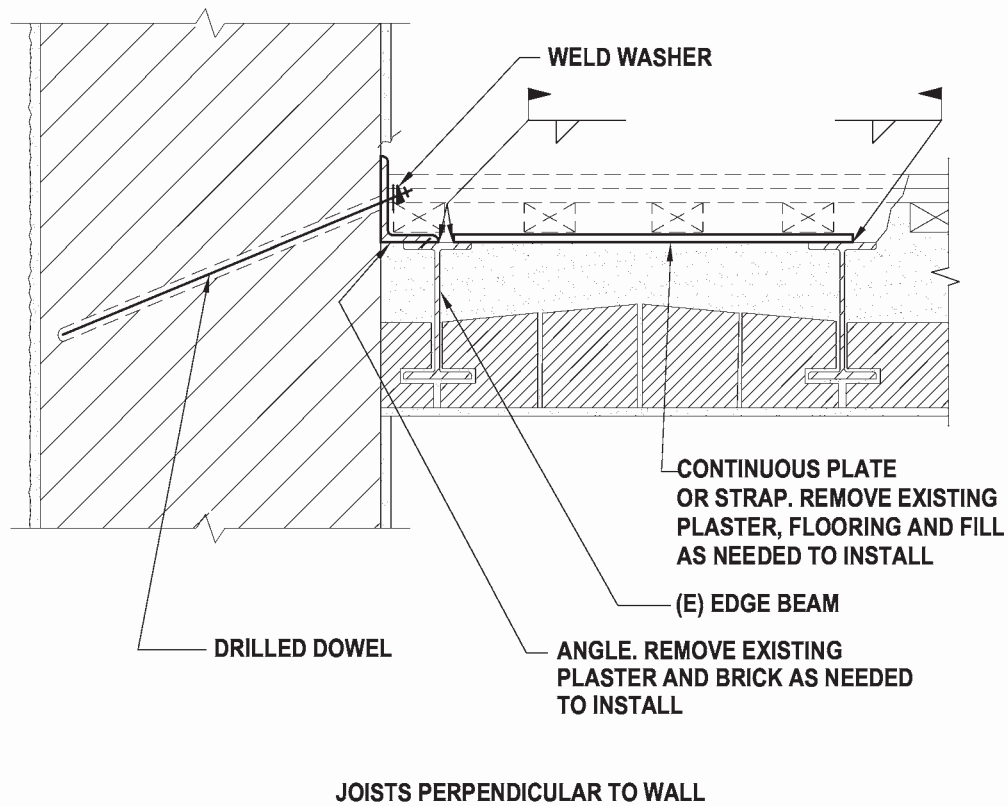
Figure 22.2.8-3: Add Wall-to-Diaphragm Ties and Chord for Masonry Flat Arch Floor - Access from Above the Floor

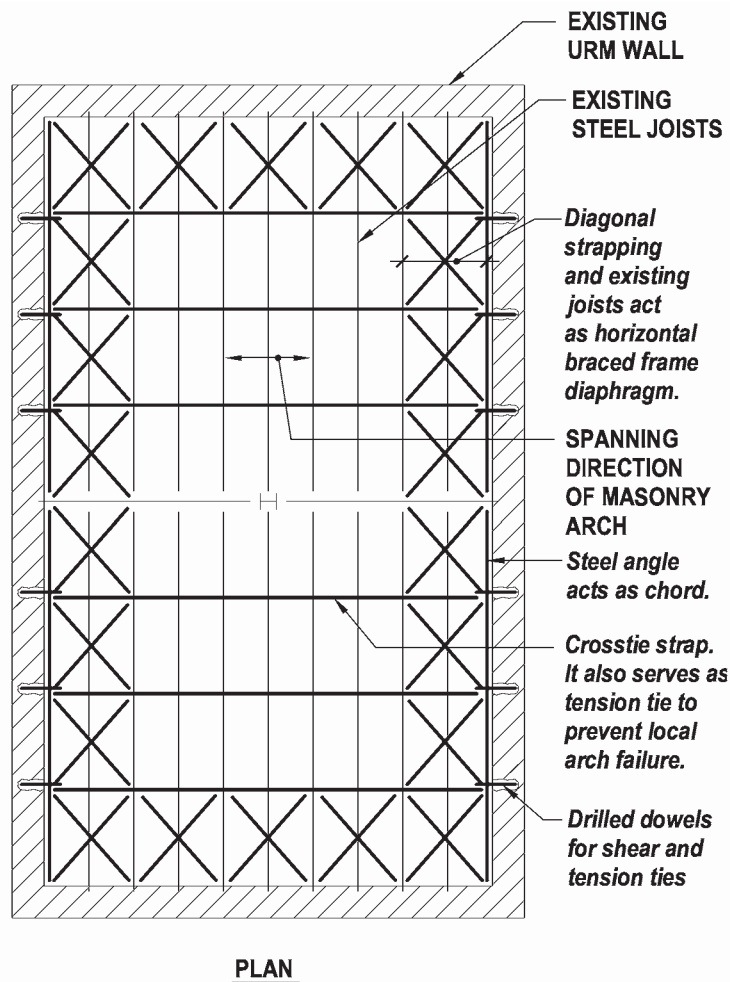
Figure 22.2.8-4: Masonry Flat Arch Floor Strengthening

Interior tension: While providing a tension tie for the case when the beams are parallel to the wall next to the wall is the most critical priority, it is desirable as well to continue the strapping all the way across the floor so local interior failure does not occur. Figure 22.2.8-4 shows the straps, plus notes the tension and shear ties and the chord.

Diaphragm strengthening: Figure 22.2.8-4 also shows how adding diagonal bracing can be combined with existing beams and straight to create a horizontal braced frame diaphragm.

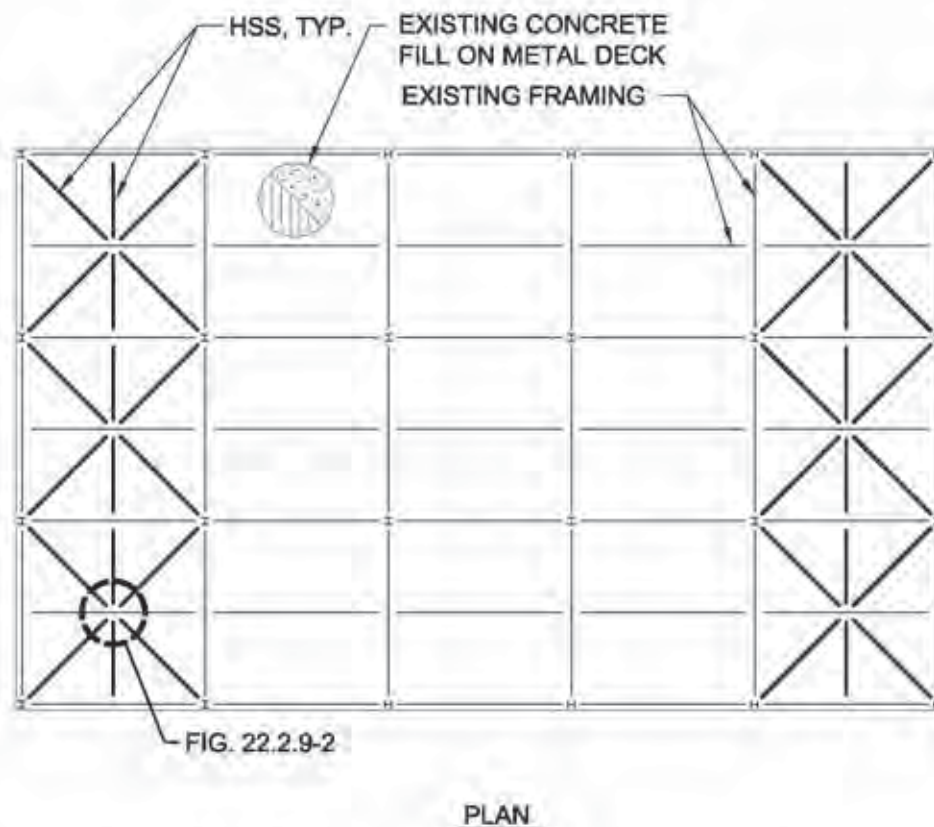
Figure 22.2.9-1: Diaphragm Strengthening using Horizontal Braced Frame

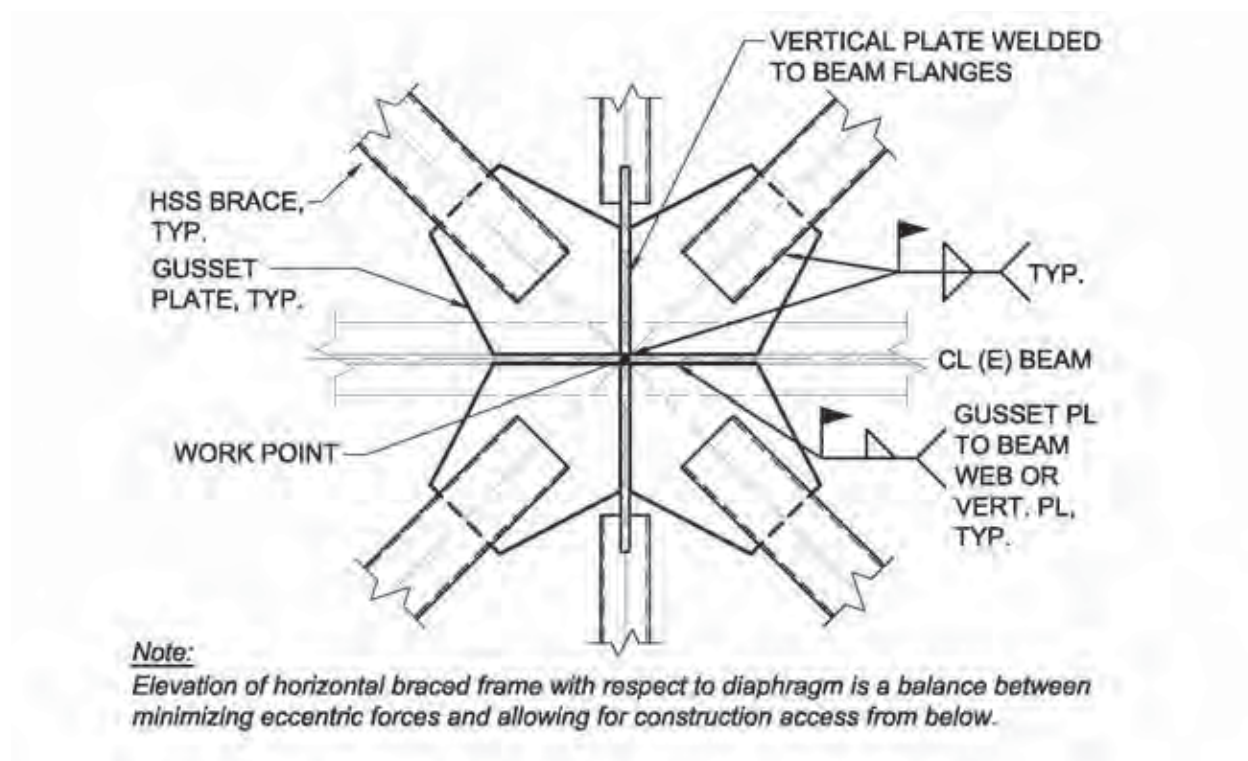
Figure 22.2.9-2: Horizontal Braced Frame Connection

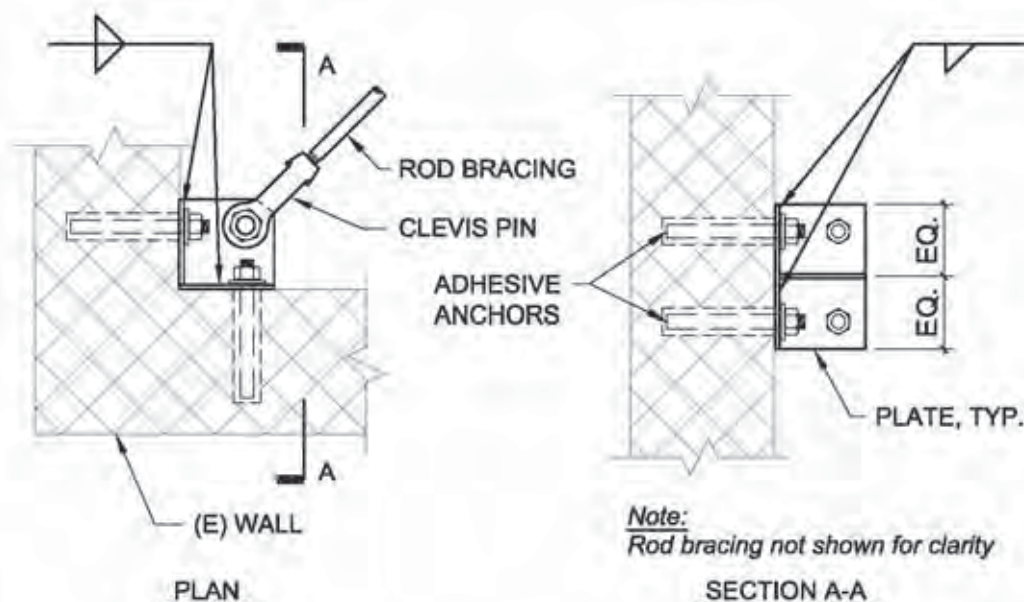
Figure 22.2.10-1: Tension Rod Connection at Wall

Tension rod bracing consist of rods that are spliced together by turnbuckles and connected to clevis pins at the ends. The clevis pins are bolted to typical gusset plates. Tension rods that are inadequate for the seismic demands should be replaced entirely since it would probably be more complicated to upgrade existing rods. Increasing the rod size also requires replacing the turnbuckles and clevis pins. Connections that are inadequate can be upgraded similarly as typical braced frame connections. An example of a typical rod connection to a concrete or CMU wall is shown in Figure 22.2.10-1. The connection to the wall should develop the strength of the rod.

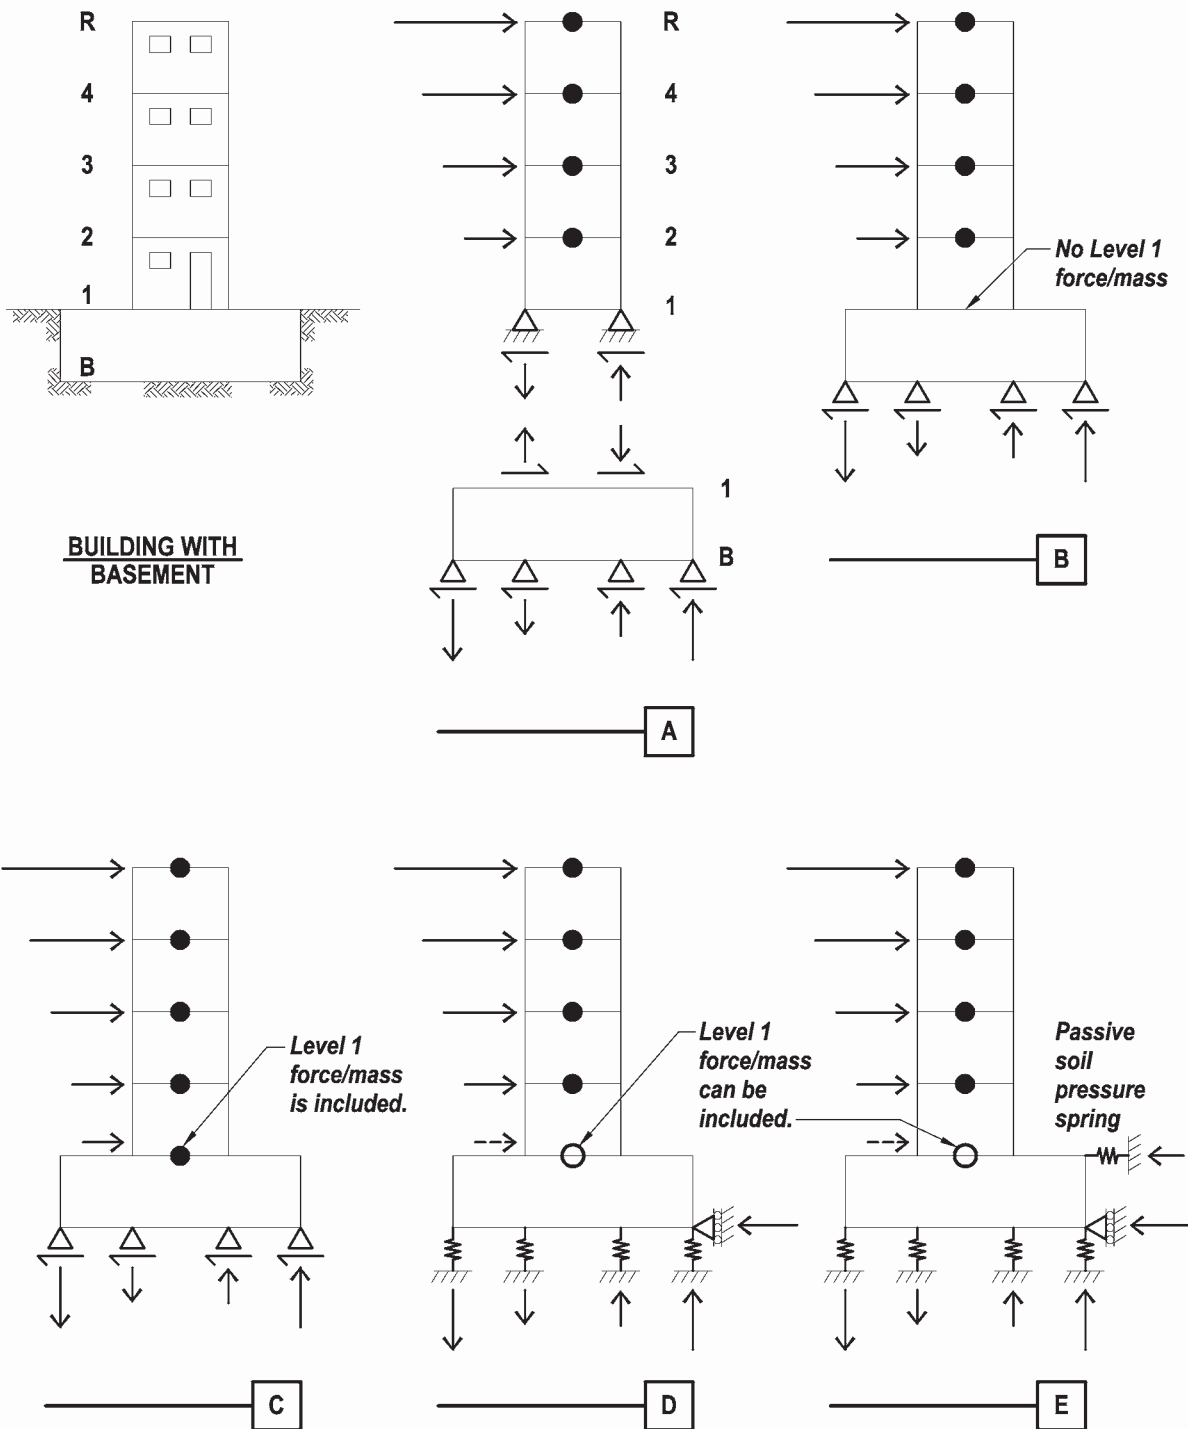
Figure 23.4-1: Modeling Approaches for Buildings with Basements

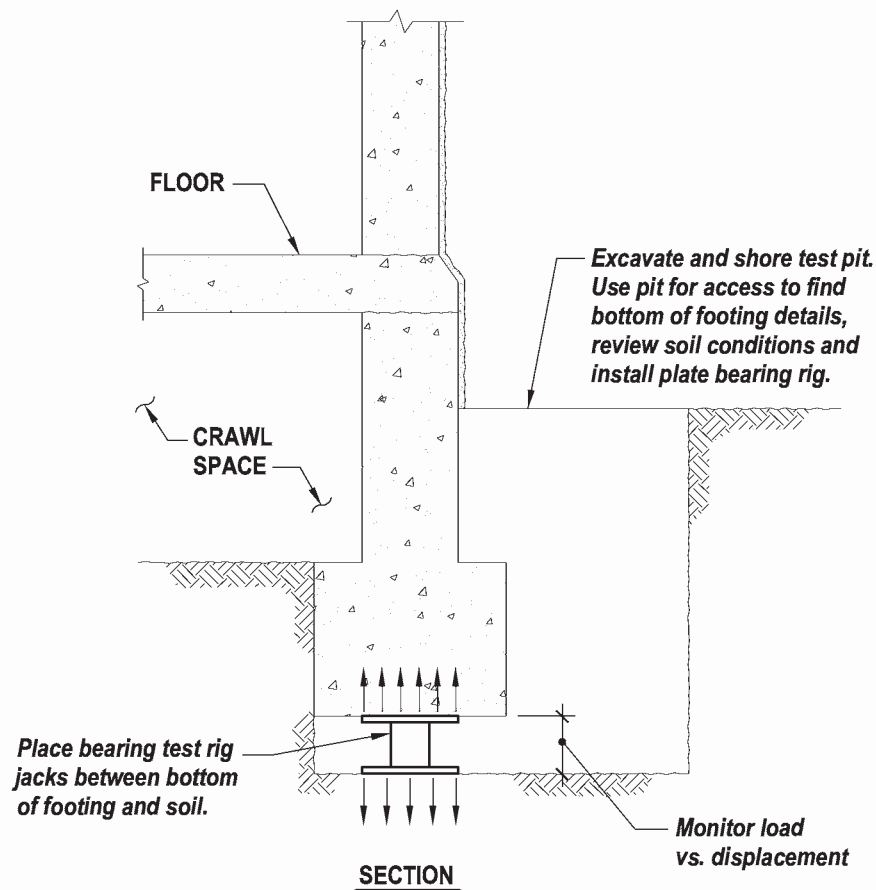
Figure 23.5.1-1: Plate Bearing Tests for In-Situ Bearing Capacity Determination

From the bottom of the pit, a rectangular mini-tunnel that extends from the exposed to the opposite edge of the foundation is dug underneath the foundation using handmining techniques. The tunnel has to be at least 18 inches wide in cross section to facilitate the placement of bearing plates and hydraulic jacks for the test. Sometimes, it is necessary to chip off excess concrete from the bottom of the foundation to create a flat surface for the placement of the upper bearing plate. Also, the bottom of the mini-tunnel must be prepared to create a flat surface for the lower bearing plate. The access pit and the mini-tunnel are depicted in Figure 23.5.1-1. It must be noted that sometimes it is more economical to dig the access pit from the crawl space side of the existing foundation in Figure 23.5.1-1.

The hydraulic ram and bearing plates are set up as depicted in Figure 23.5.1-1. The test is performed by imposing load incrementally on the soil below the lower bearing plate and measuring the corresponding deformations. The procedure has been standardized as ASTM D1194.

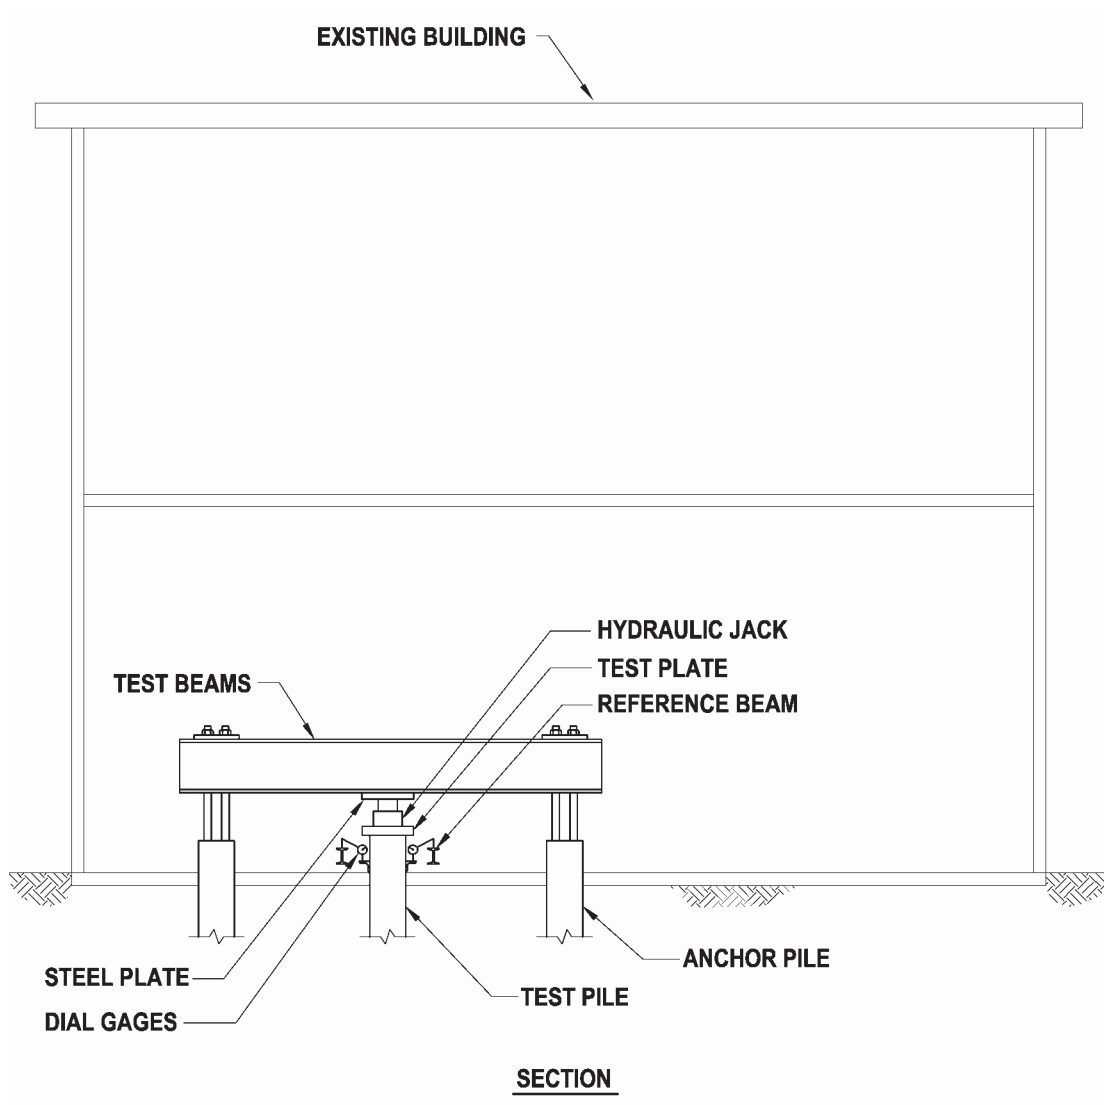
Figure 23.5.2-1: Static Pile Load Test in Compression

The reaction beam, the reference beam, hydraulic ram and dial gages are set-up as depicted in Figure 23.5.2-1 for compression tests and in Figure 23.5.2-2 for tension tests. The test is performed by imposing load incrementally on the soil below the lower bearing plate and measuring the corresponding deformations. The maximum test load is usually about 1-1/2 to 2 times the design load. The test can be performed in accordance with ASTM D1143 (for compression tests) and ASTM D3689 (for tension tests).

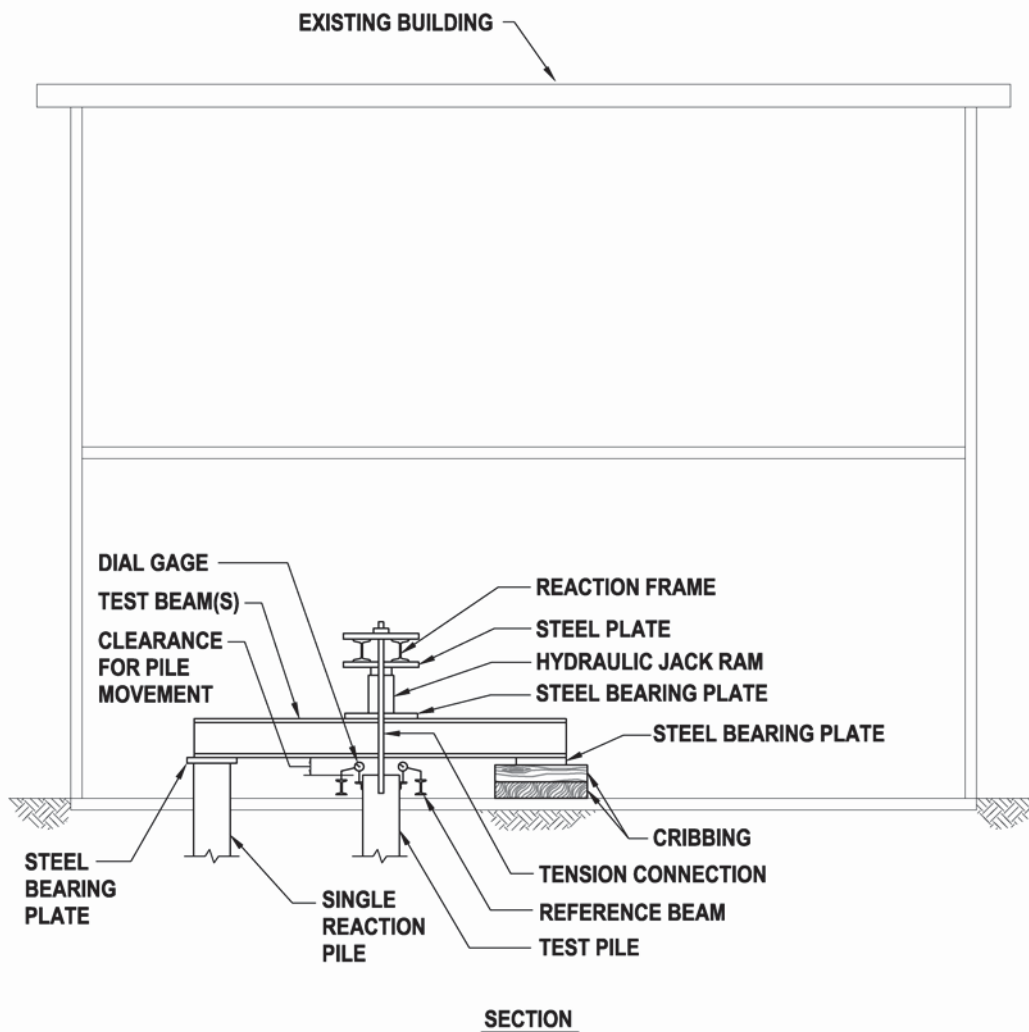
Figure 23.5.2-2: Static Pile Load Test in Tension

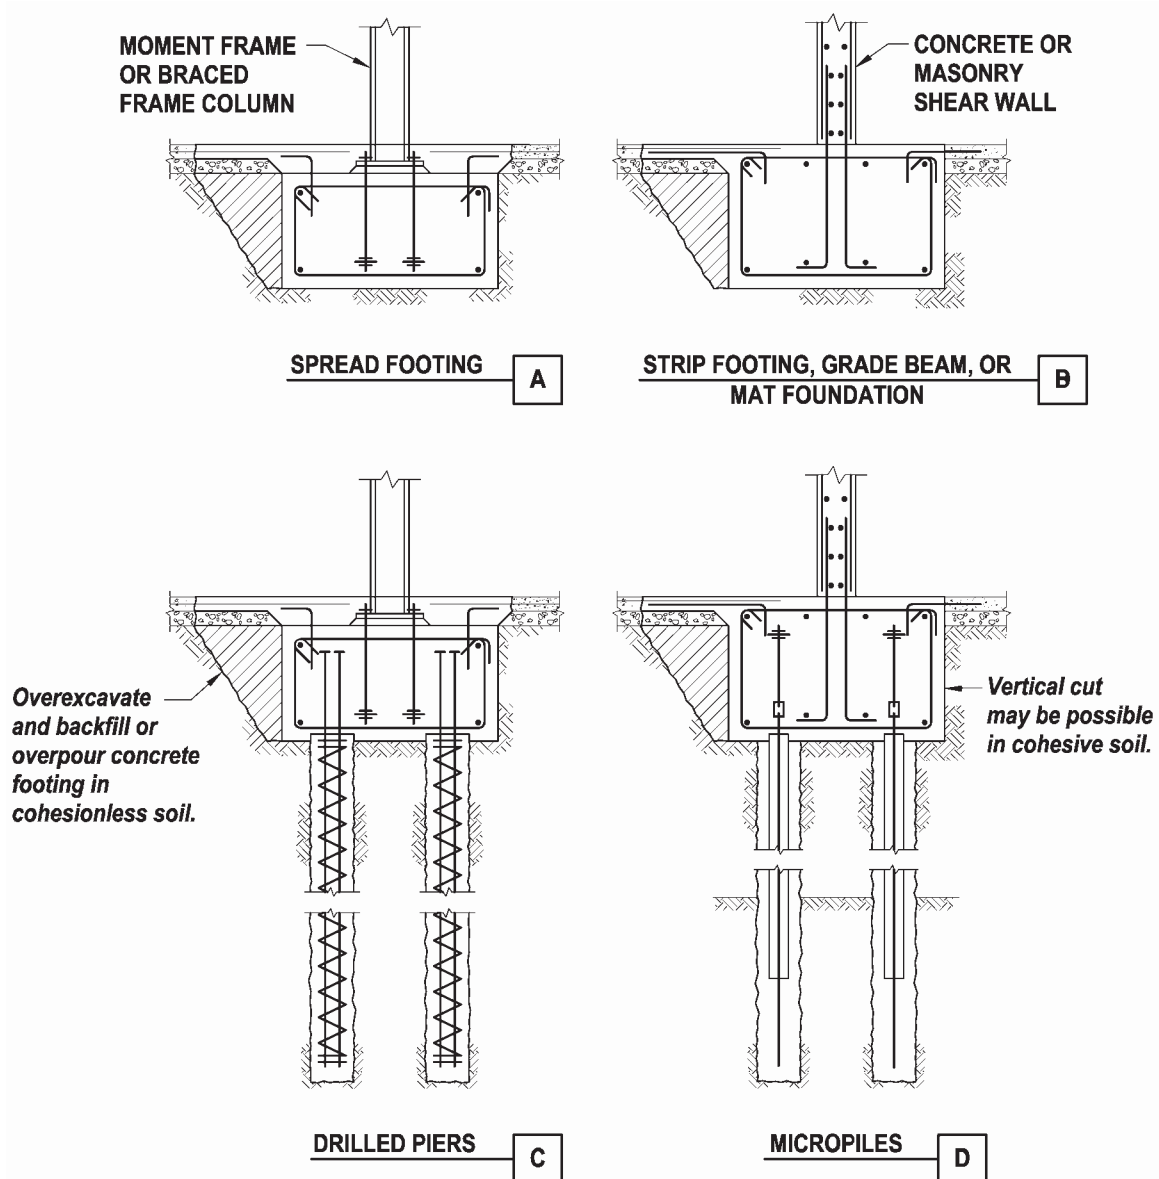
Figure 23.6.1-1: Types of New Foundations Commonly Used in Seismic Rehabilitation
