Architectural
Resources Group

609, 611, and 619 NE 3rd Street
McMinnville, Oregon

Historic Resource Assessment
November 2022

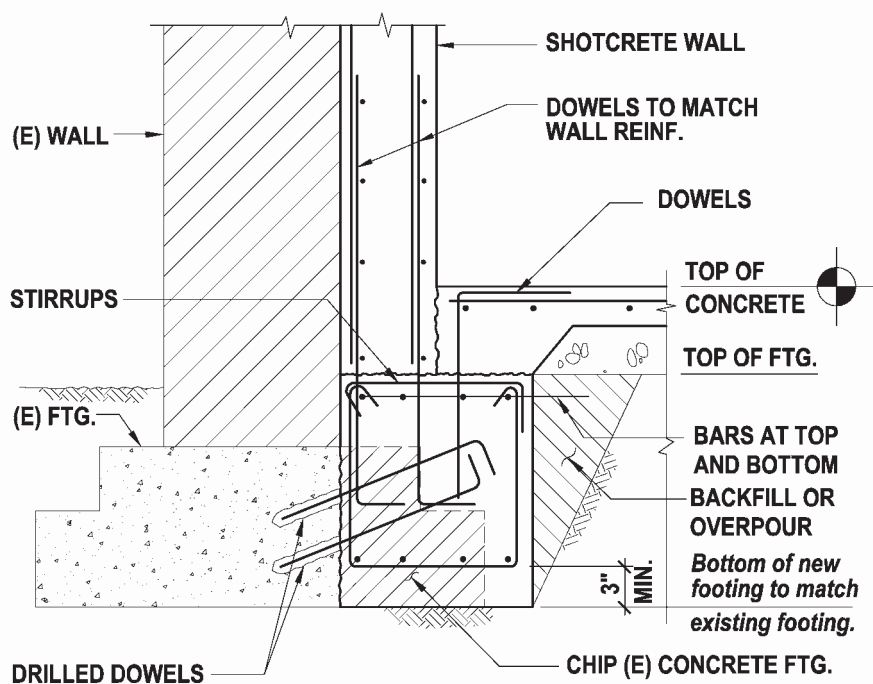
Figure 23.6.2-1: New Concrete Strip Footing Next to Existing Strip Footing

When a concrete overlay is placed against an existing wall, a new footing is typically needed. A common situation is the existing footing is a continuous strip footing and the new footing is either a strip footing or a grade beam. Figure 23.6.2-1 shows an example of a new concrete wall and footing against and existing unreinforced masonry wall and concrete strip footing.

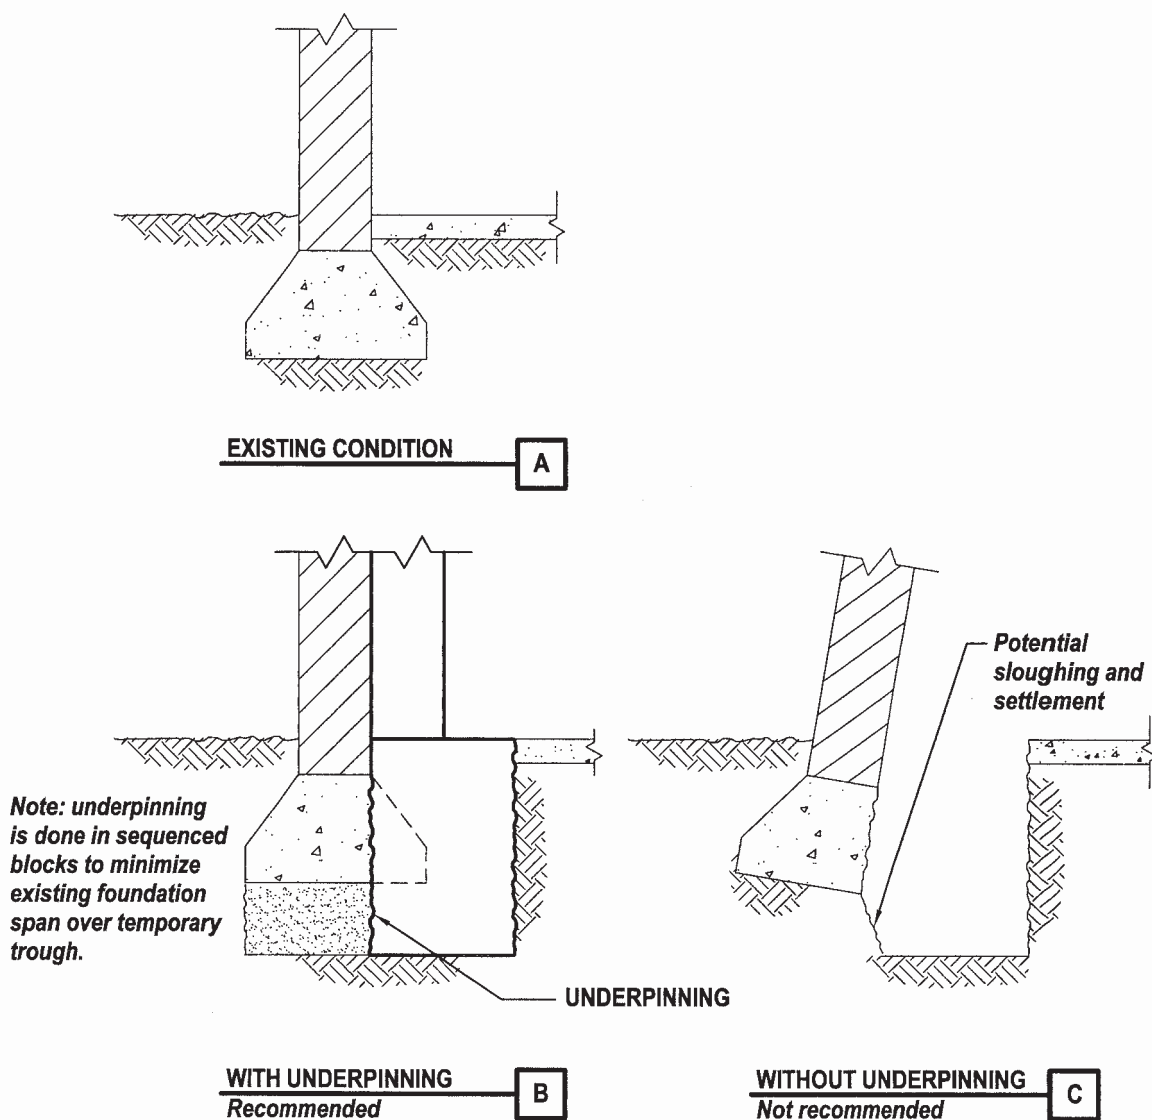
Figure 23.6.2-2: New Shallow Footing is Deeper than Existing Shallow Footing

New footing is deeper than existing footing: A key goal when adding a new footing is not to surcharge or undermine an existing footing. The best approach, then, is to match the new and old footing depths. This is, of course, not always possible. Figure 23.6.2-2 shows the situation when the new footing needs to be deeper than an existing footing. If excavation proceeds without underpinning, particularly in soils with minimal cohesion, soil can slough away from under the existing footing into the new excavation leading to damaging footing movement. Underpinning is used to address this situation. Underpinning means digging a series of short length pits separated by a sufficient distance, digging under the existing footing adjacent to the pit, adding concrete to the base of the final excavation depth, and then going back and completing the underpinning in between the initial pits. An alternative underpinning approach is to place long underpinning piers intermittently beneath the new footing to derive support at depth so that the typical new footing need not be deeper than the existing footing.

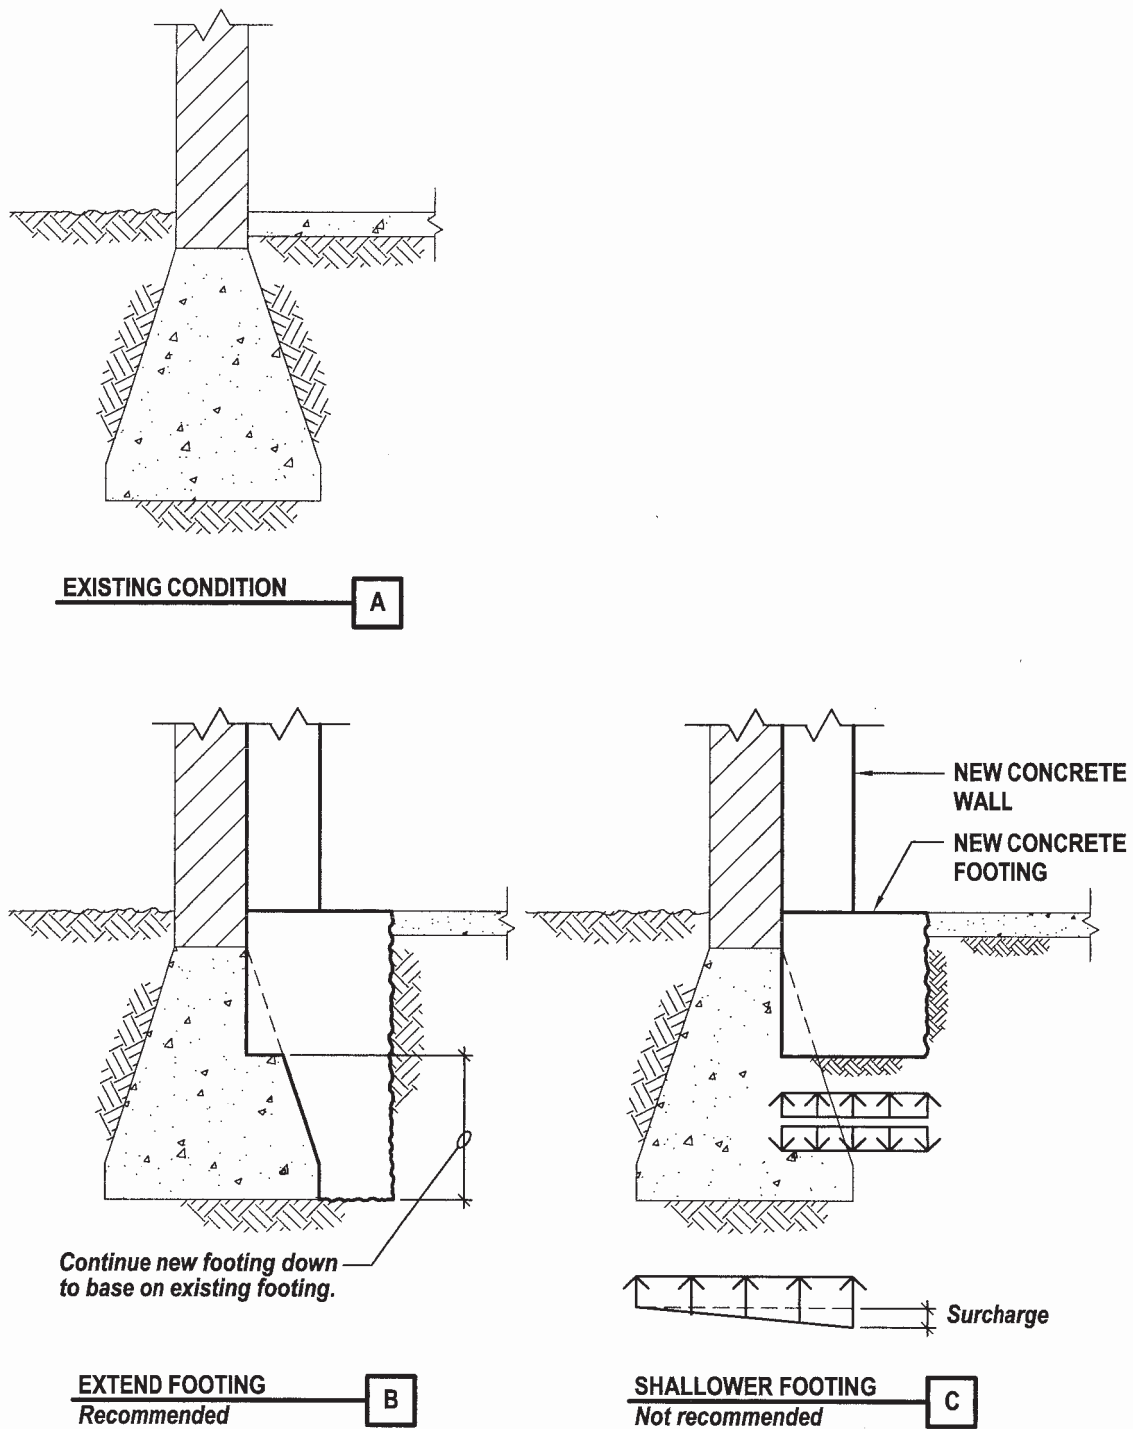
Figure 23.6.2-3: New Shallow Footing Does Not Need to be as Deep as Existing Shallow Footing

New footing does not need to be as deep as existing footing: Figure 23.6.2-3 shows the situation when the new footing does not need to be as deep. If the excavation is kept shallow, the new footing when loaded can impart additional and eccentric loads into the existing footing that may not be desirable. As a result, it is common to extend the bottom of the new footing down to match the depth of the existing footing. The extension is often lightly reinforced.

Existing footing is in the way: As Figures 23.6.2-1 to 23.6.2-3 show, the existing footing will often extend inboard from the existing wall underneath the new wall. To place the new footing, the existing footing often must be chipped away to develop a properly reinforced footing. This can be done with jackhammering or sawcutting. The capacity of the existing footing during the temporary condition where it is smaller and eccentrically loaded should be verified as adequate.

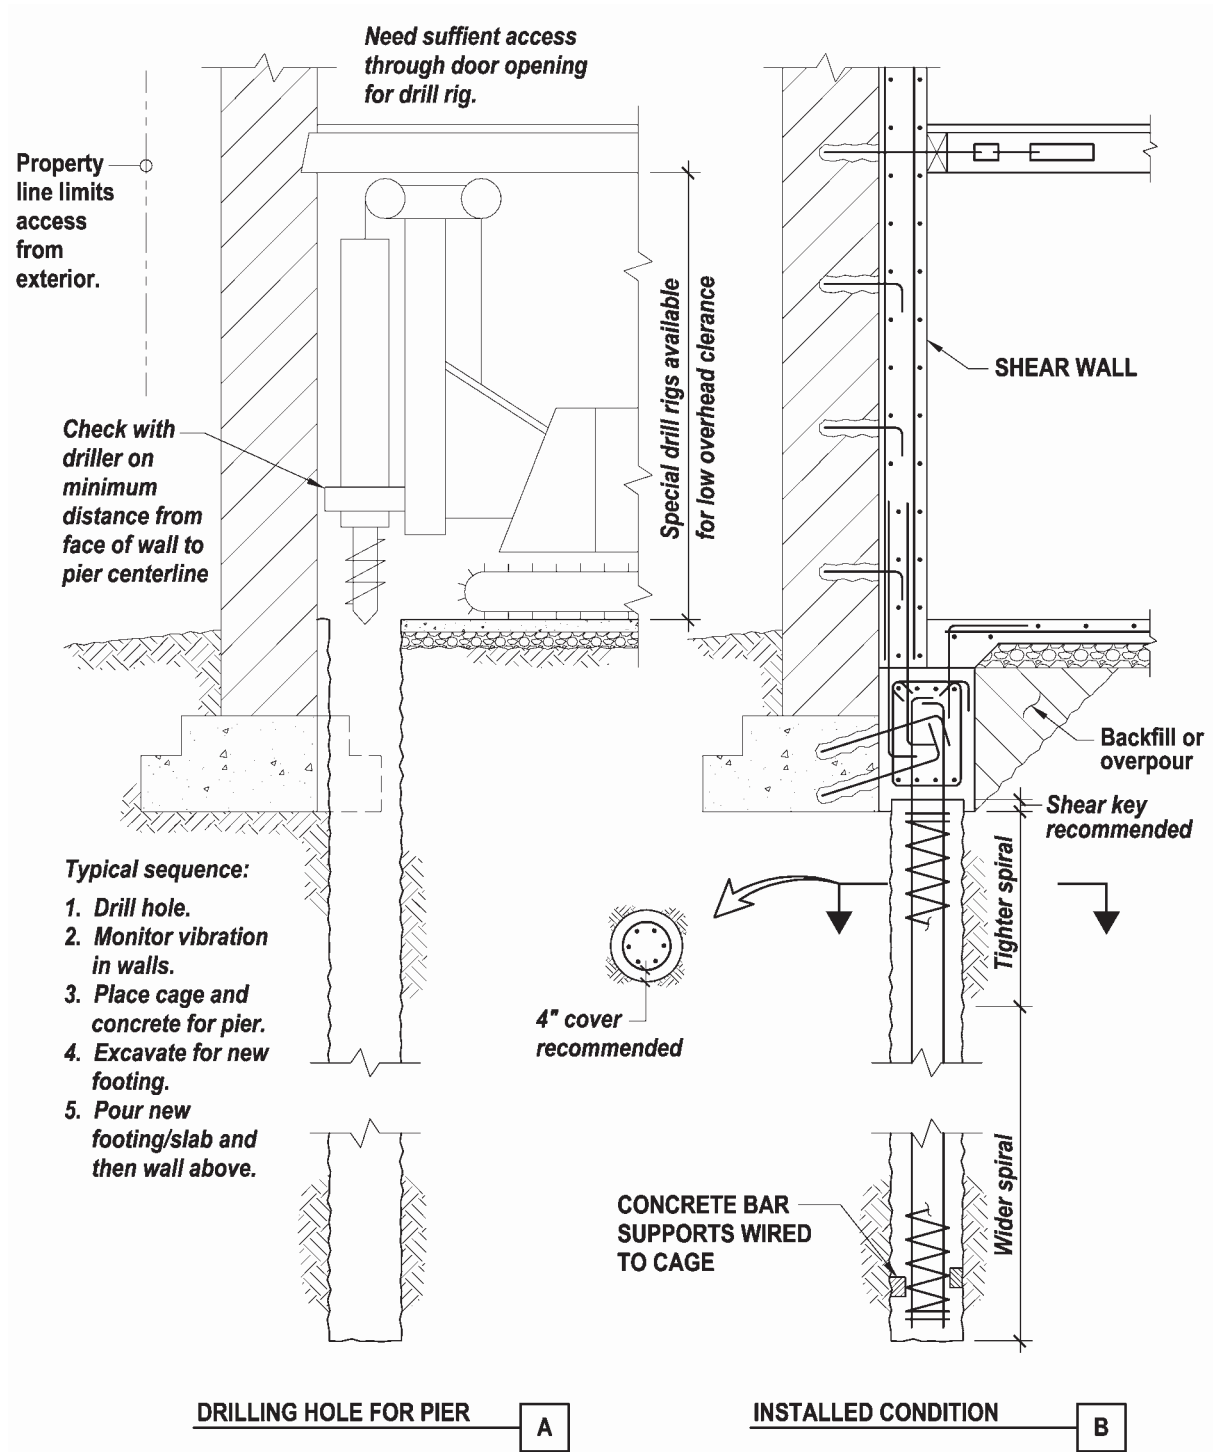
Figure 23.6.4-1: New Drilled Pier Next to Existing Strip Foundation

Adding a new deep foundation next to an existing foundation is occasionally done, such as drilled piers under a new wall next to an existing strip footing. Figure 23.6.4-1 shows an example of this technique. Drilling limitations can be significant, and they include access requirements for the drill rig, height restrictions for the drill rig, the offset needed to get the edge of the drill up against the existing wall, vibration during drilling, and utilities in the way of the drilling. Sometimes when the exterior face of the building is accessible, slanted drilling is done under the existing footing. Usually, the drilled piers are spaced at a sufficient distance that the existing footing and walls can span around or over the open hole. After the pier and new wall are installed and dowelled into the existing wall and footing, a composite system has been created. While many engineers simply take gravity in the existing spread footing, and overturning in the piers, live loads and earthquake loads are of course actually distributed throughout the system by relative rigidity.

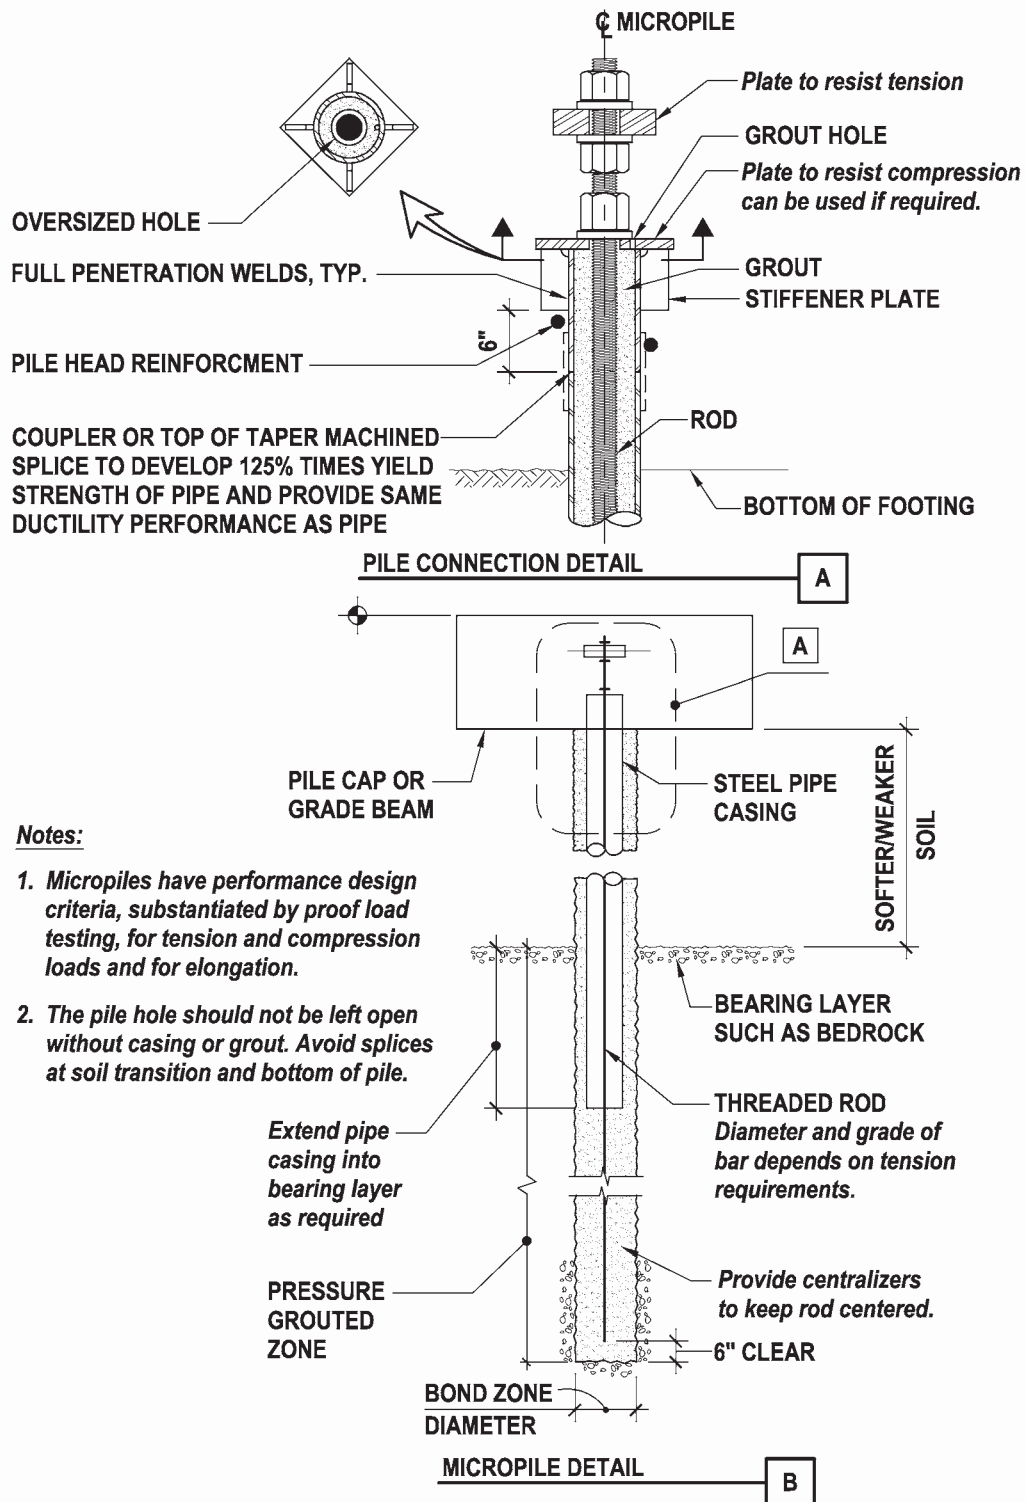
Figure 23.7.2.-2: Micropile Details

Depth of pipe and grouting: The pipe typically goes down into the bearing layer the requisite depth. The reinforcing bar usually continues deeper. Grouting fills up the hole at the base, the annulus around the pipe and the inside of the pipe. Post-grouting or secondary grouting can be used at the base to increase the bar capacity.

Strain limits at the top: To increase the length over which the bar is strained in tension, the top of bar below the anchorage plates are sometimes debonded with a greased PVC pipe.

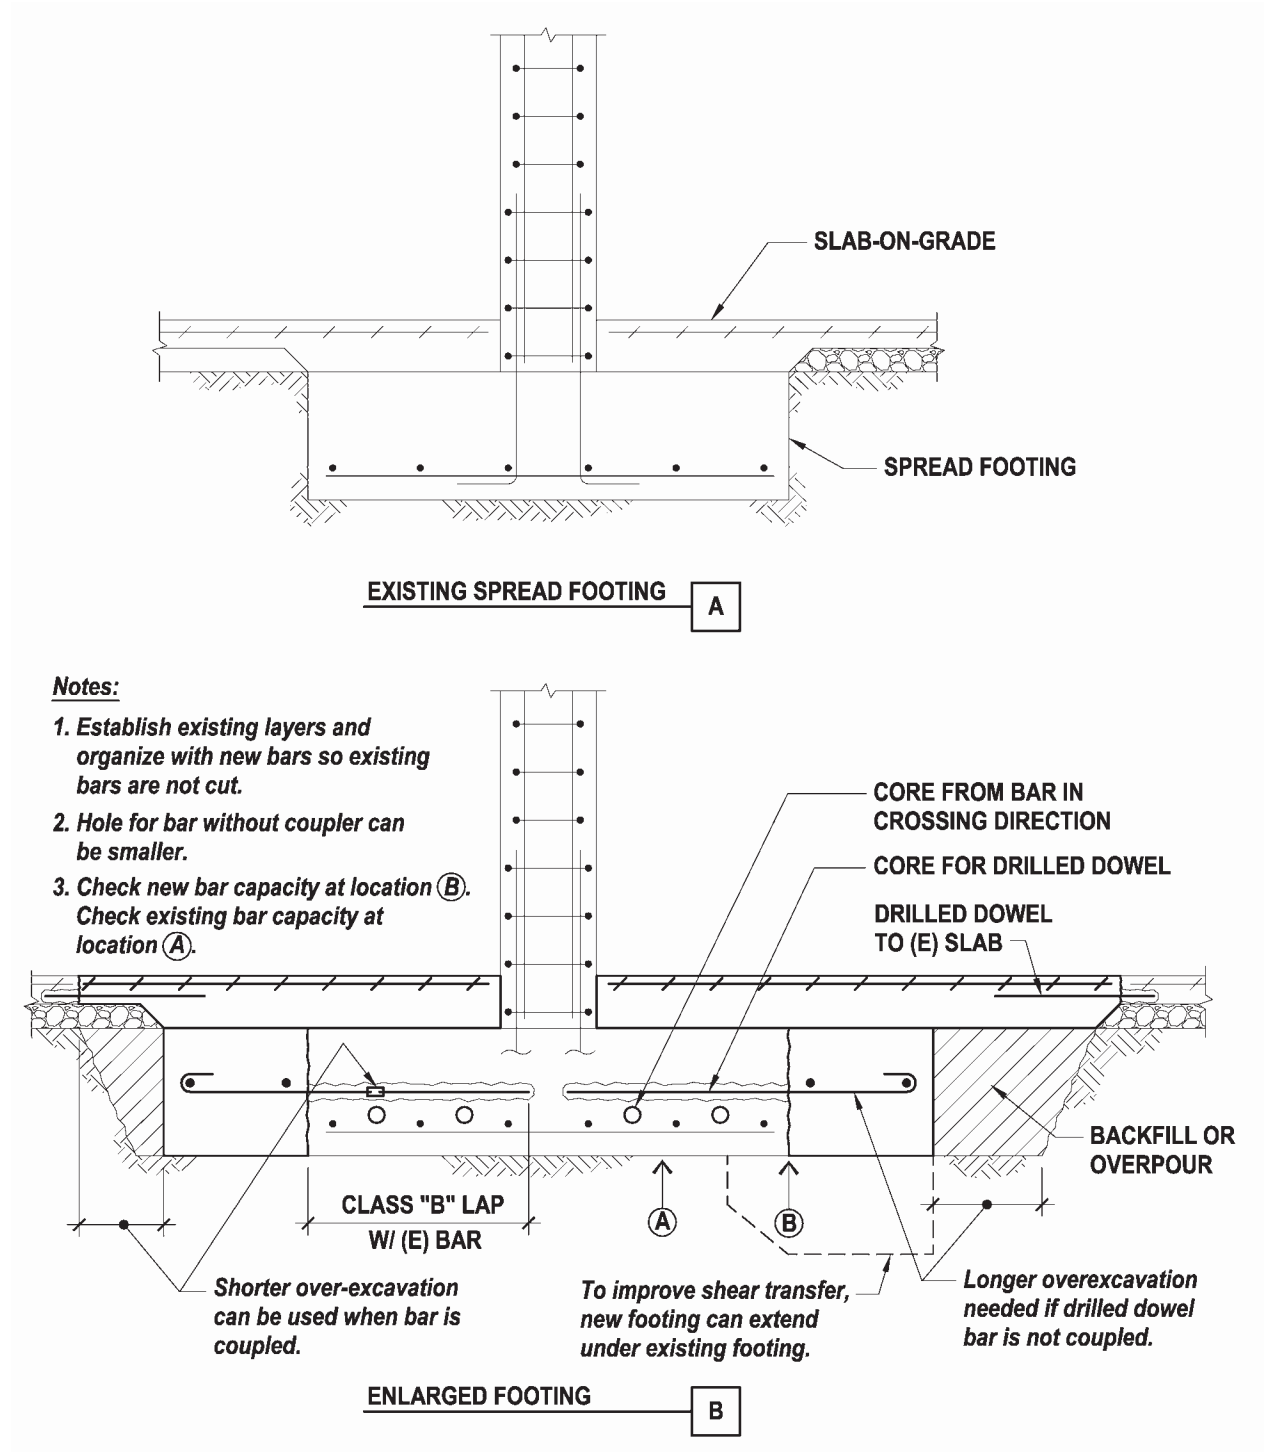
Figure 23.7.3-1: Enlarge Existing Spread Footing

Bending moment and shear checks in enlarged footing: Gaining large increases in compression capacity by enlarging an existing footing is often difficult given the limits of the existing footing. In Figure 23.7.3-1, reinforcing is drilled in from the sides, but does not go through to the other side. The shear capacity of the footing is not increased. The bending capacity has to be checked at critical locations “A” and “B”. Location A will typically govern. If sufficient capacity cannot be achieved, the footing can be replaced as shown in Figure 23.7.3-2.

Installing drilled dowels: Figure 23.7.3-1 shows two approaches for installing bars. On the left a coupler is used, permitting a smaller overexcavation past the footing, but triggering a hole large enough to accommodate the coupler. This is likely to force pressure grouting with nonshrink grout as the annulus will be too large for most adhesives like epoxy. On the right, a larger overexcavation is used and a single piece bar is installed.

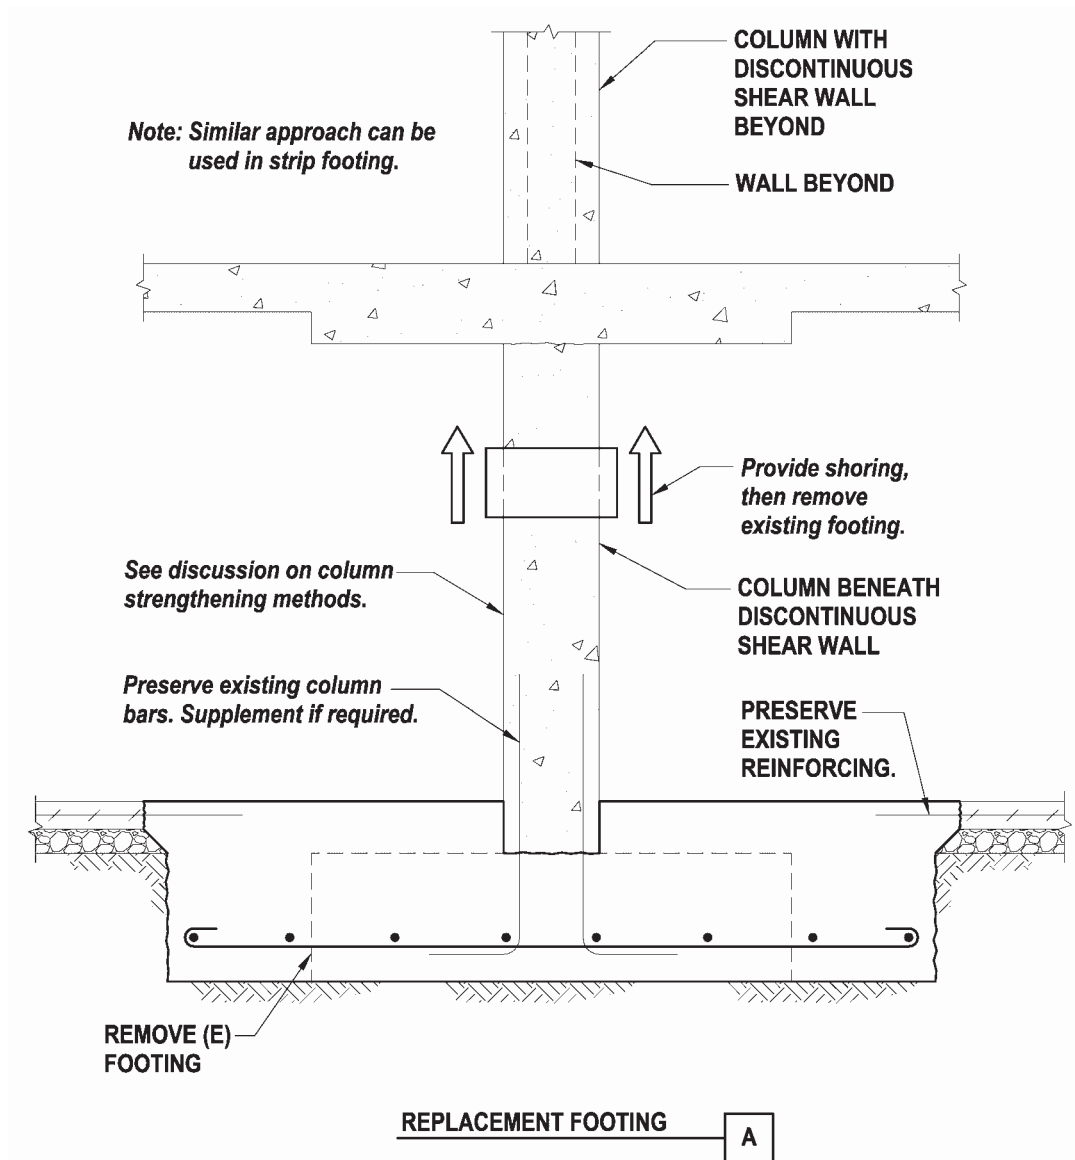
Figure 23.7.3-2: Replace Existing Spread Footing

Shoring: If the existing footing is replaced, shoring will be needed. It is critical that the base of footing be properly compacted and the new concrete be tightly placed beneath the existing column to minimize or eliminate any settlement when the shores are removed.

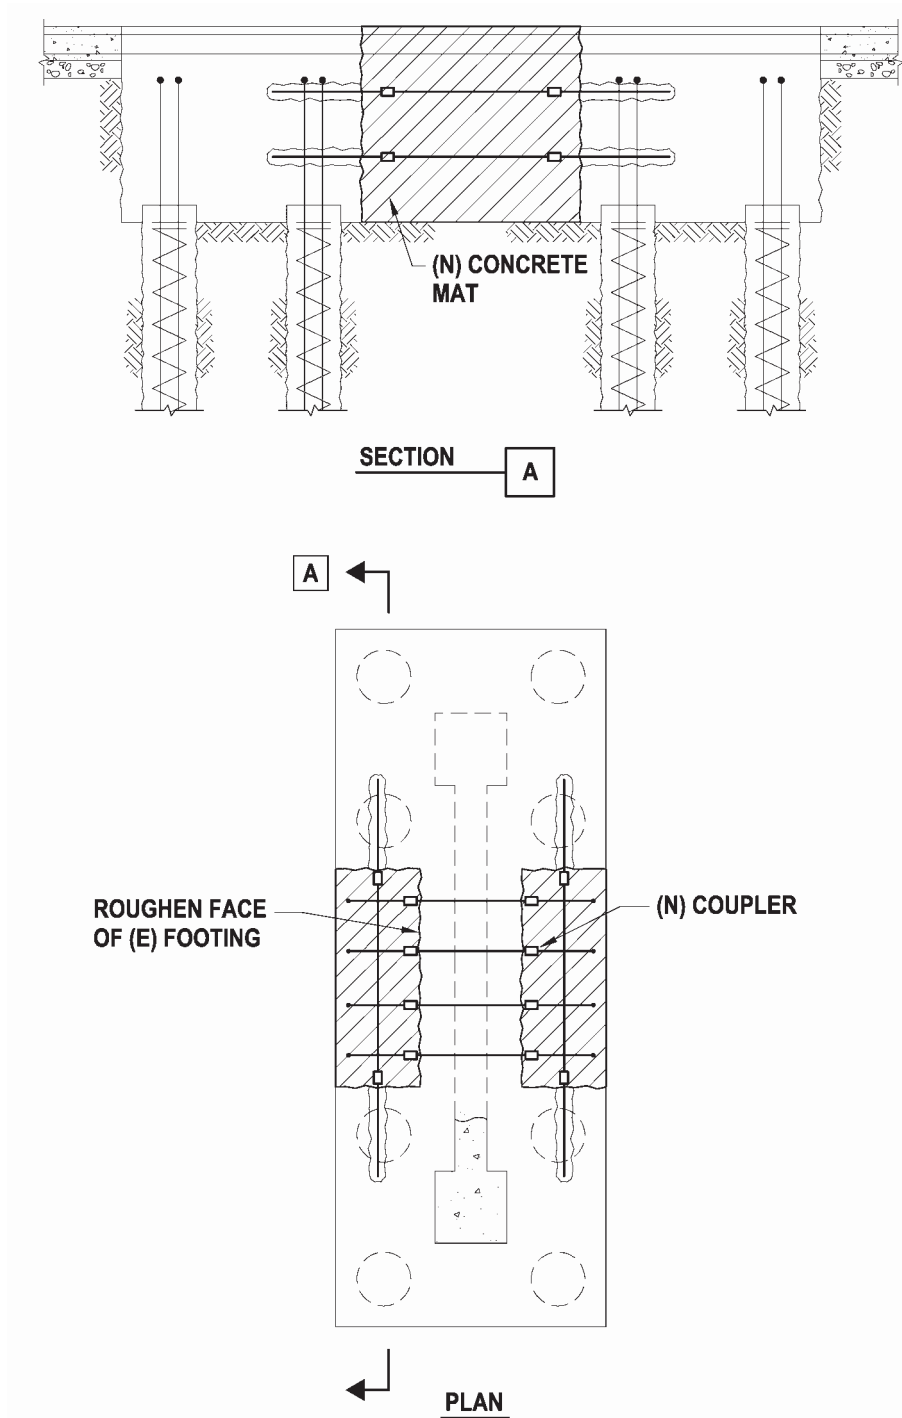
Figure 23.8.2-1: New Mat Foundation Between Existing Drilled Piers

piles or piers. Where competent bearing soil is within five feet of building ground floor, an alternative approach to installing new piles or piers is to widen and deepen the cap or grade beams atop the pier or pile or connecting adjacent piers or piers. Figure 23.8.2-1 shows an example of existing piers whose capacities are augmented by installing a mat between the piers.

Analysis: Several approaches to design are used. One is to assume that only the new mat foundation resists the new loads imposed by the retrofit scheme. This assumption is inaccurate. The most sophisticated approach is to model the soil under the new mat as a spring with stiffness that is different from that of the spring representing the existing piers. The analysis would show that new loads are supported by both the new mat foundation and the existing piers based on the relative stiffnesses of the two sets of foundation elements.

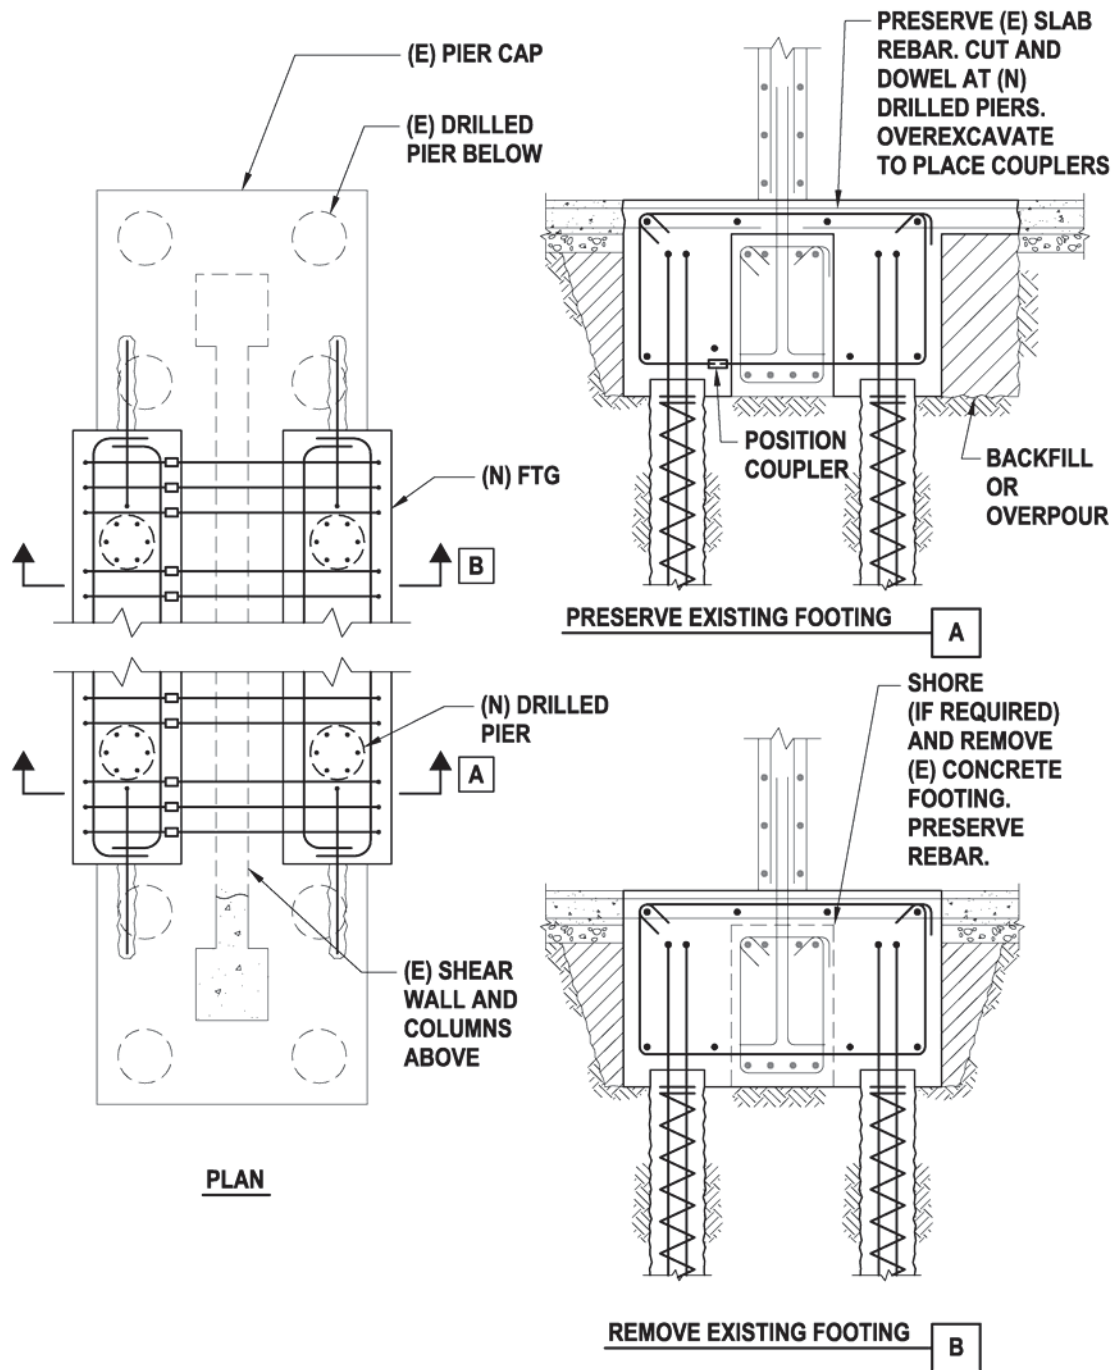
Figure 23.8.3.-1: Adding Drilled Piers to an Existing Drilled Pier Foundation

Relative rigidity: In Figure 23.8.3-1, all of the piers—new and existing—will participate in resisting axial and lateral demands and should be considered in modeling efforts. Demands in existing piers should be confirmed as adequate.

Pier cap/thickened footing: The concrete above the piers will likely require widening as shown in Figure 23.8.3-1. Either drilled dowels can be installed in the existing footing, or the footing can be demolished and replaced. With a shear wall above, the wall may be able to bridge across to the belled ends of the footing without any shoring.

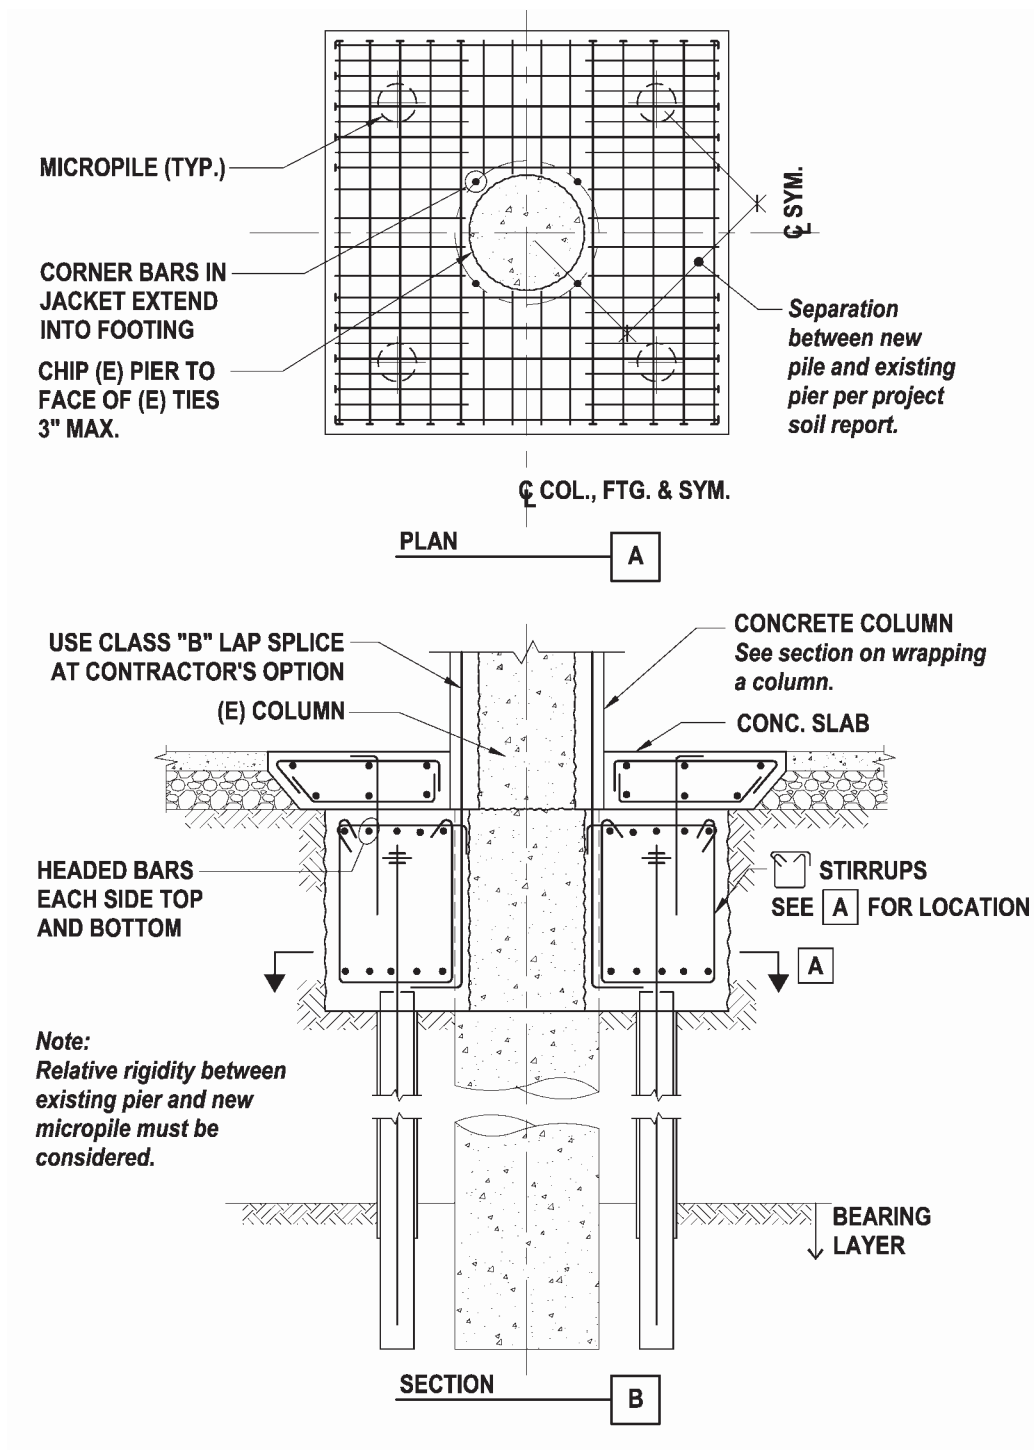
Figure 23.8.4.-1: Micropile Enhancement of an Existing Drilled Pier Footing

An existing isolated drilled pier footing supporting a braced frame column, moment frame column or concrete column under a discontinuous shear wall may lack sufficient compression capacity, tension capacity, or the existing pier reinforcing may be inadequate for lateral demands. Adding new micropiles provides supplemental capacity to reduce the demands on the existing drilled pier. Figure 23.8.4-1 shows an example.

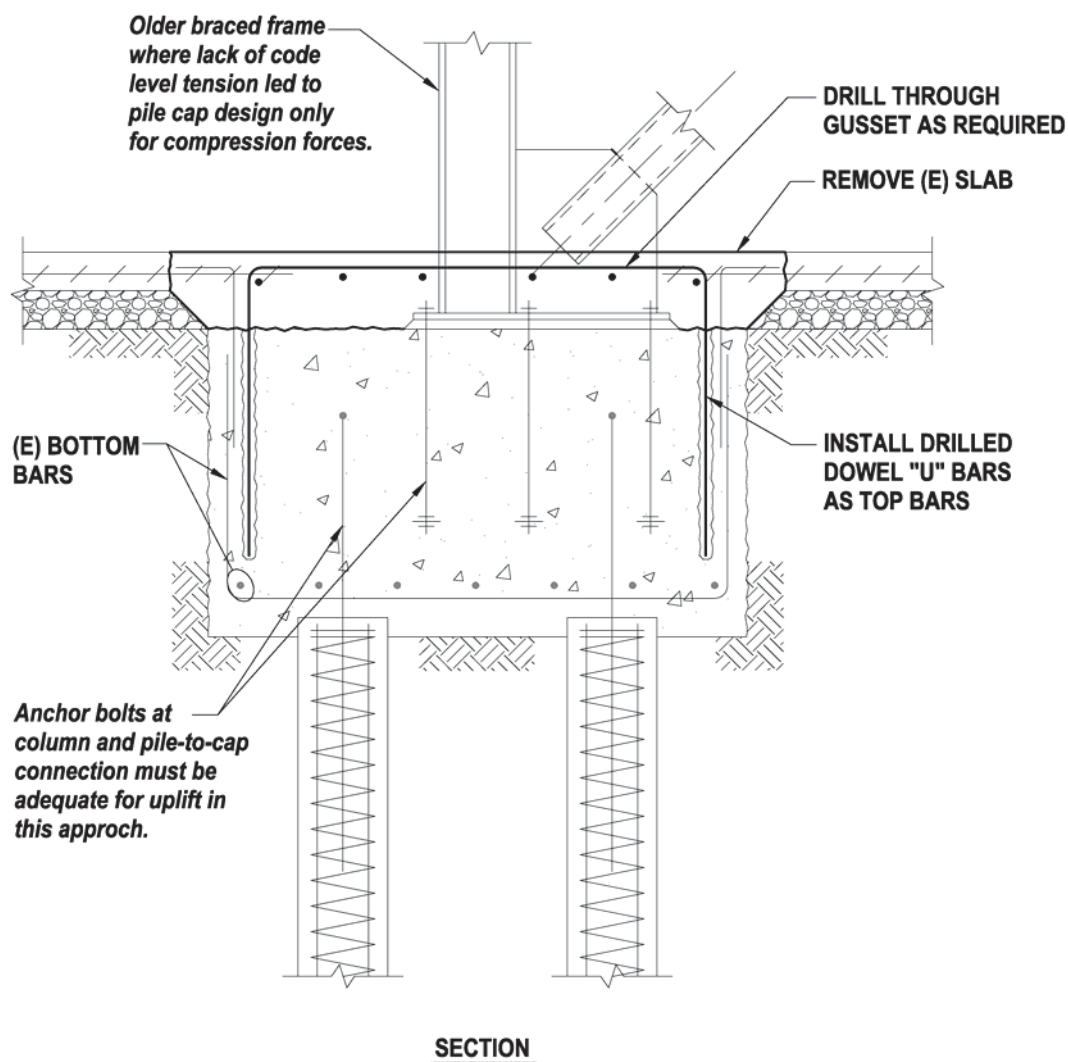
Figure 23.8.5-1: Adding Top Bars to an Existing Pile Cap

Anchorage of the pile to the pile cap: In Figure 23.8.5-1, it is assumed that the anchorage of the pile to the pile cap is adequate for uplift. If the foundation was not originally designed for uplift, only nominal anchorage between the pile and pile cap is likely to be found. This could be a single large bar or a bundle of two bars placed in a grouted hole in the top of the pile. It could be the pile reinforcing extended up into the pile cap. This would be more likely in end bearing piles where refusal is hit early and the top of the pile must be chipped down to the right elevation. It is important to realize that even a pile designed for a pin top with a central bar will resist moment unless special design considerations such as neoprene pads are added on top of the pile. This is highly unlikely in an older building. The tension in the pile anchorage under lateral loading has to be added to the uplift from the superstructure.

Anchorage of the column to the pile cap: In Figure 23.8.5-1, it is assumed that the anchorage of the column to the pile cap is adequate for uplift. If the foundation was not originally designed for uplift, anchor bolt embedments and diameters may not be sufficient.

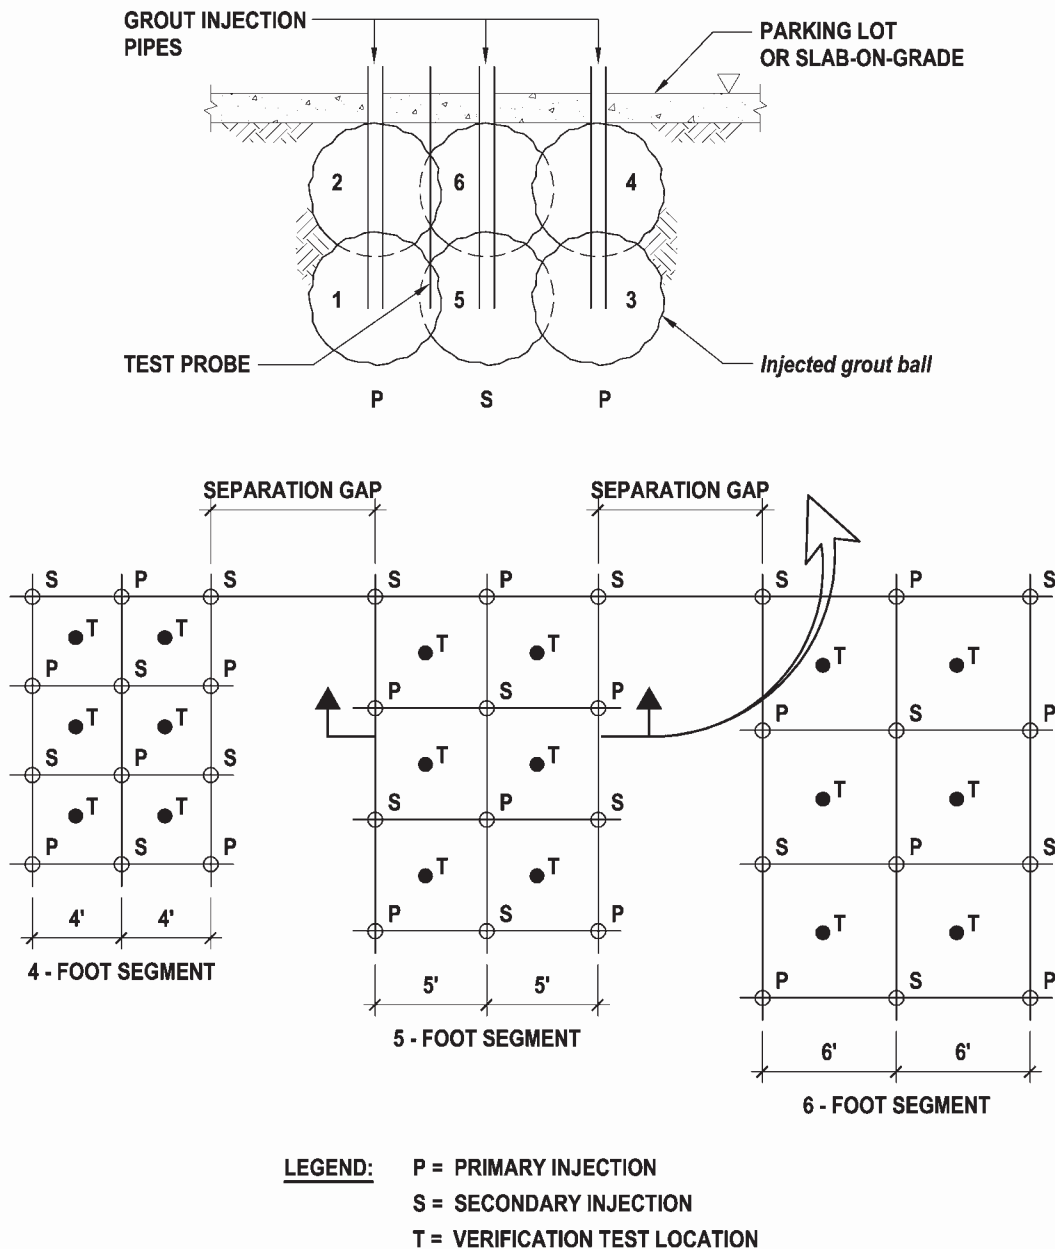
Figure 23.9.2-1: Compaction Grouting Under Existing Shallow Foundations – Pilot Test Program

To establish the relationship between the volume of grout and the level of densification, a pilot test program is performed in an open area adjacent to the existing building which will have compaction-grouted footings. The pilot test site is divided into segments where injection points at different spacings are laid out in a grid format as shown in Figure 23.9.2-1. In each hole,

grout is injected within the upper and lower limits of the zone to be grouted. The volume of grout injected in each hole is recorded. After grout injection is completed, the level of densification achieved in each segment of the pilot test area is verified by performing cone penetration or standard penetration tests at the test locations as depicted in Figure 23.9.2-1. The spacing and the corresponding volume of grout injected in each hole that produced the acceptable level of compaction is selected for production grouting underneath the shallow foundations. The injection point grid pattern will be similar to the pattern in a segment in Figure 23.9.2-1 with the test location coinciding with the center of a square footing or the centerline of a continuous footing. Note that a separation gap equal to three times the minimum spacing of four feet is placed between the segments to minimize the impact of one segment on the other.

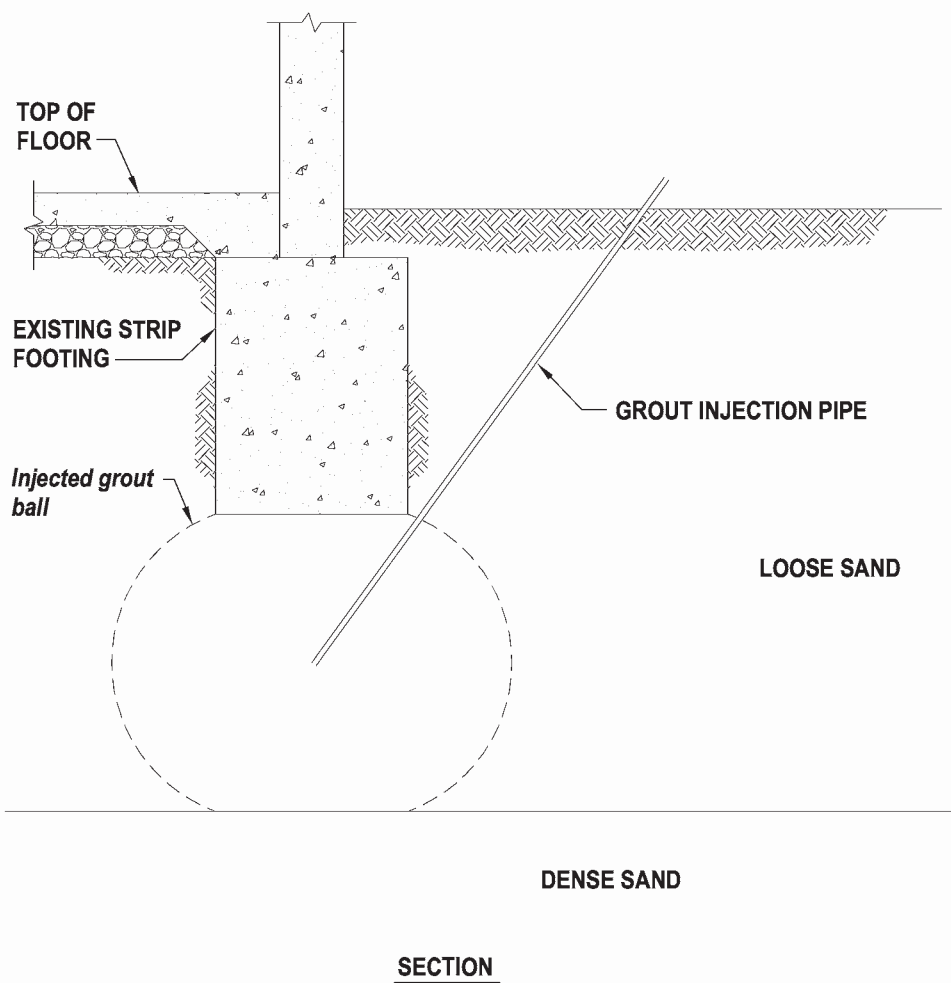
Figure 23.9.3-1: Permeation Grouting of Loose Sand Under Existing Shallow Foundation

Shallow foundations: The goal for the shallow foundation elements is to create a solidified mass of sandy soil below the footprint of the footing as a minimum. The solidified mass should extend from the bottom of the footing to the top of the dense sand layer as shown in Figures 23.9.3-1 and 23.9.3-2.

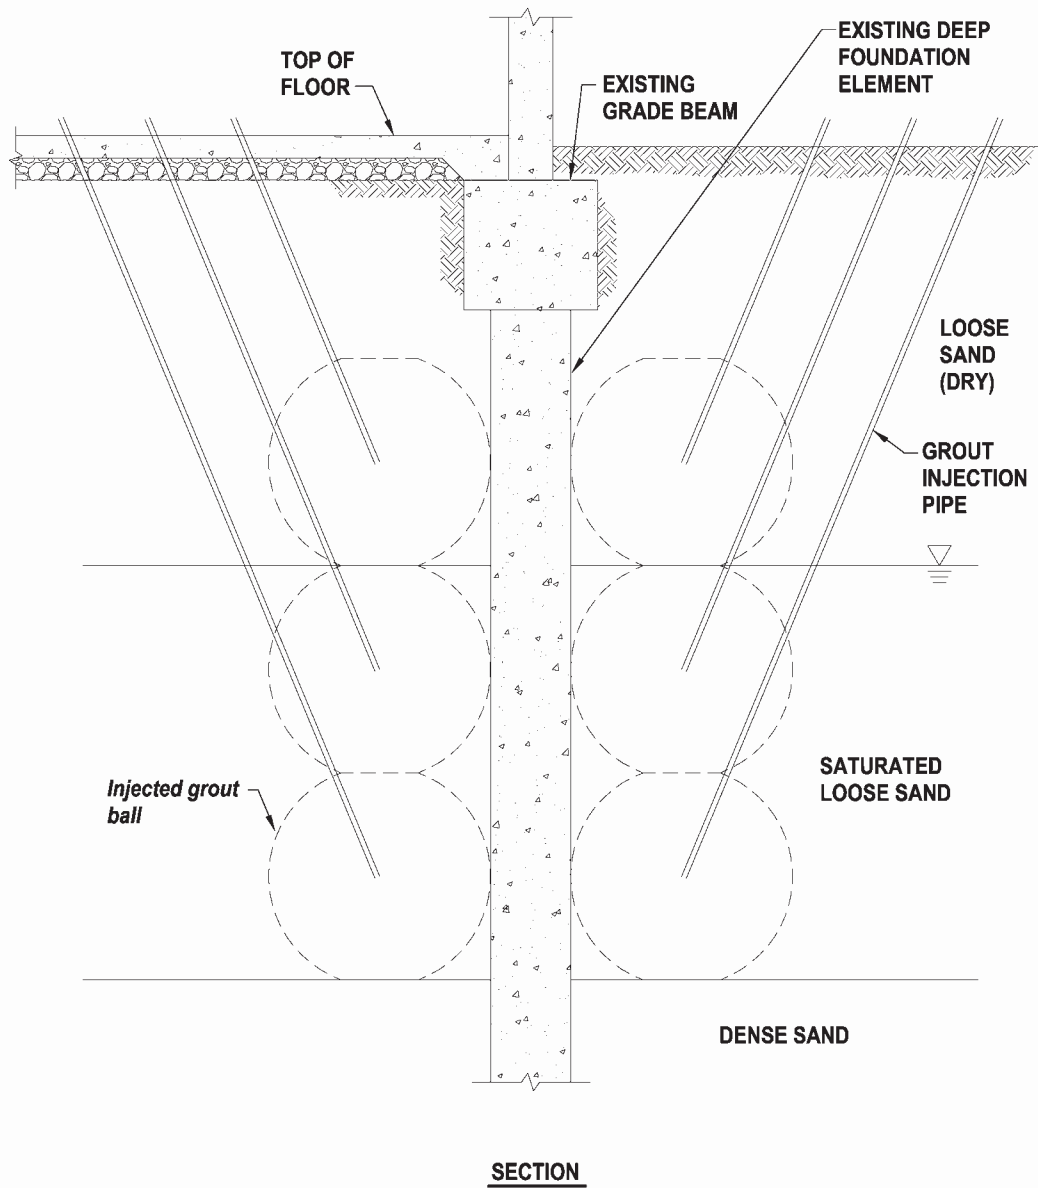
Figure 23.9.3-3: Permeation Grouting of Liquefiable Layer Around Existing Deep Foundation

Deep foundations: The goal for the deep foundation element is to create a zone of solidified sand around it. The injection points can be as close as three feet to the foundation elements. The zone of grouting should extend from the bottom of the grade beam or cap atop the deep foundation element to the top of the dense sand layer shown in Figure 23.9.3-3.
