Architectural
Resources Group

609, 611, and 619 NE 3rd Street
McMinnville, Oregon

Historic Resource Assessment
November 2022

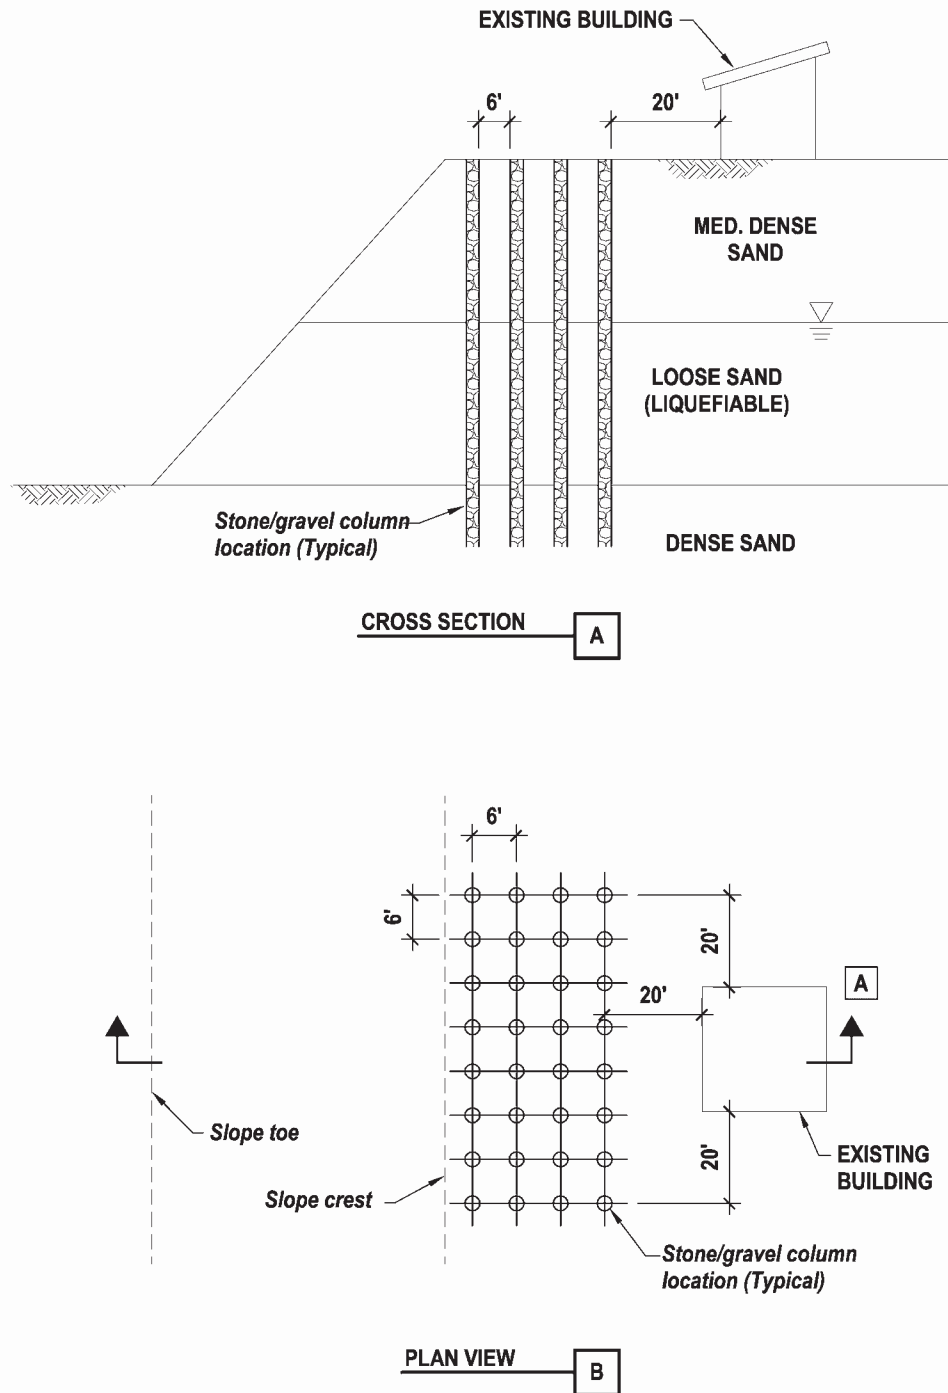
Figure 23.10.3-2: Mitigation Measure for Lateral Spreading – Stone/Gravel Column

The potential for lateral spreading can be mitigated by creating a stable mass of material near the open face. This can be accomplished by either densifying the layer of potentially liquefiable soil or solidifying the soil to prevent liquefaction. Techniques used to achieve this goal include compaction grouting (densifying) and permeation grouting (solidifying), which were described in Section 23.9. Alternately, vibrocompaction methods involving the installation of stone columns can be used to densify the potentially liquefiable layer as shown in Figure 23.10.3-2.

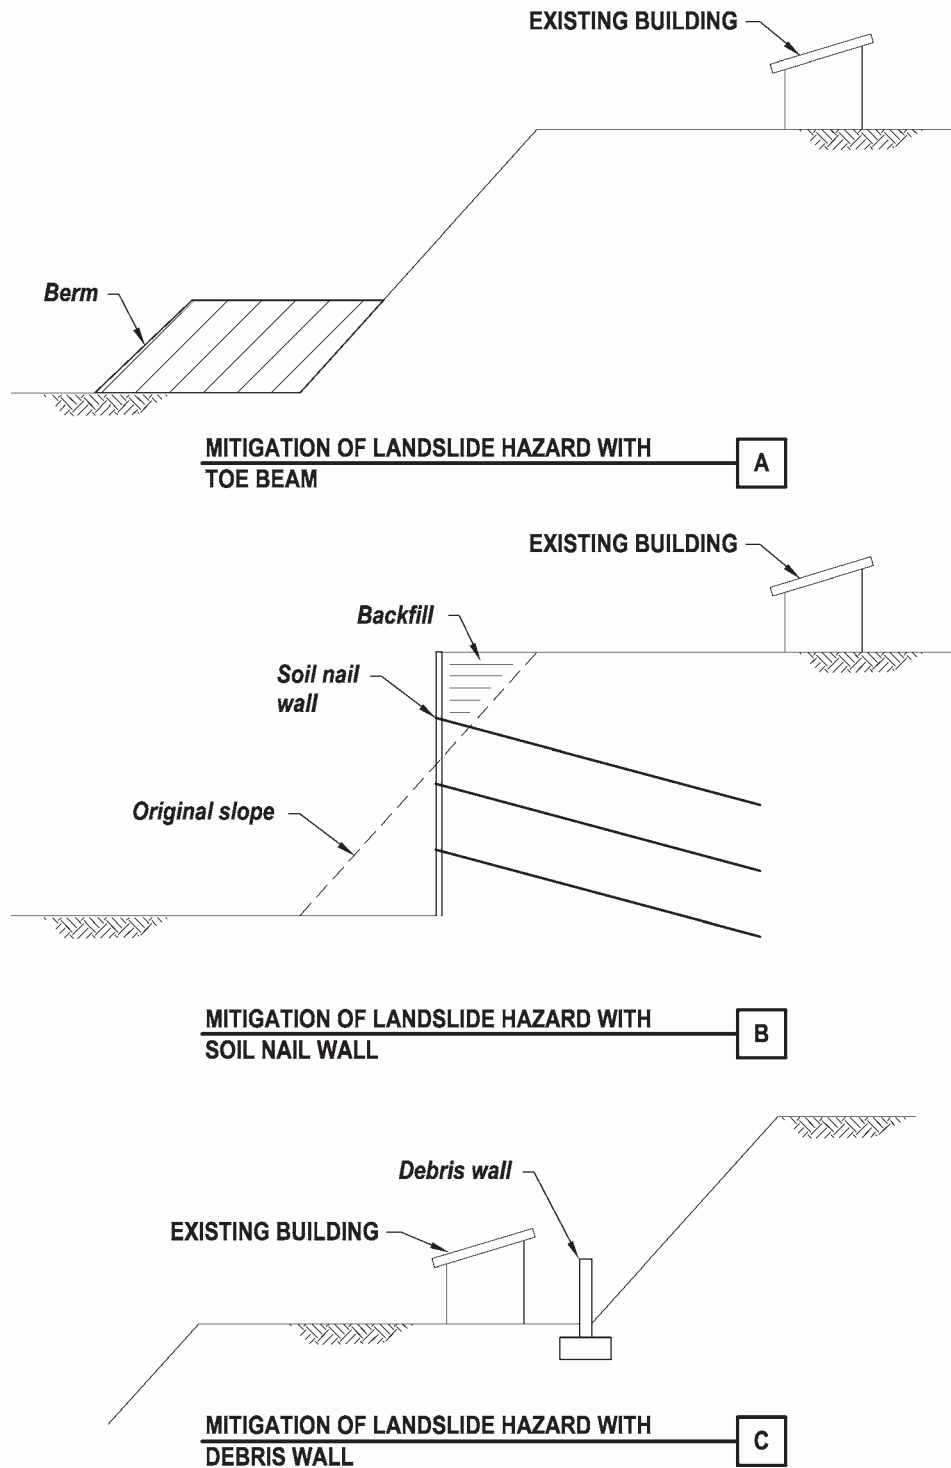
Figure 23.10.4-2: Mitigation of Landslide Hazards

Various mitigation schemes developed by the geotechnical engineer and engineering geologist can be implemented in each of the three scenarios. In the first scenario, potential mitigation measures include the construction of a stabilizing berm at the toe of the slope as shown in Figure 23.10.4-2A or the construction of a soil nail wall as shown in Figure 23.10.4-2B. In the second scenario, the existing foundation system can be enhanced to span or accommodate the estimated extensional fissures. In the third scenario, a debris wall, as shown in Figure 23.10.4-2C, can be built to protect the building or techniques in Figure 23.10.4-2B can be used to stabilize the slope.

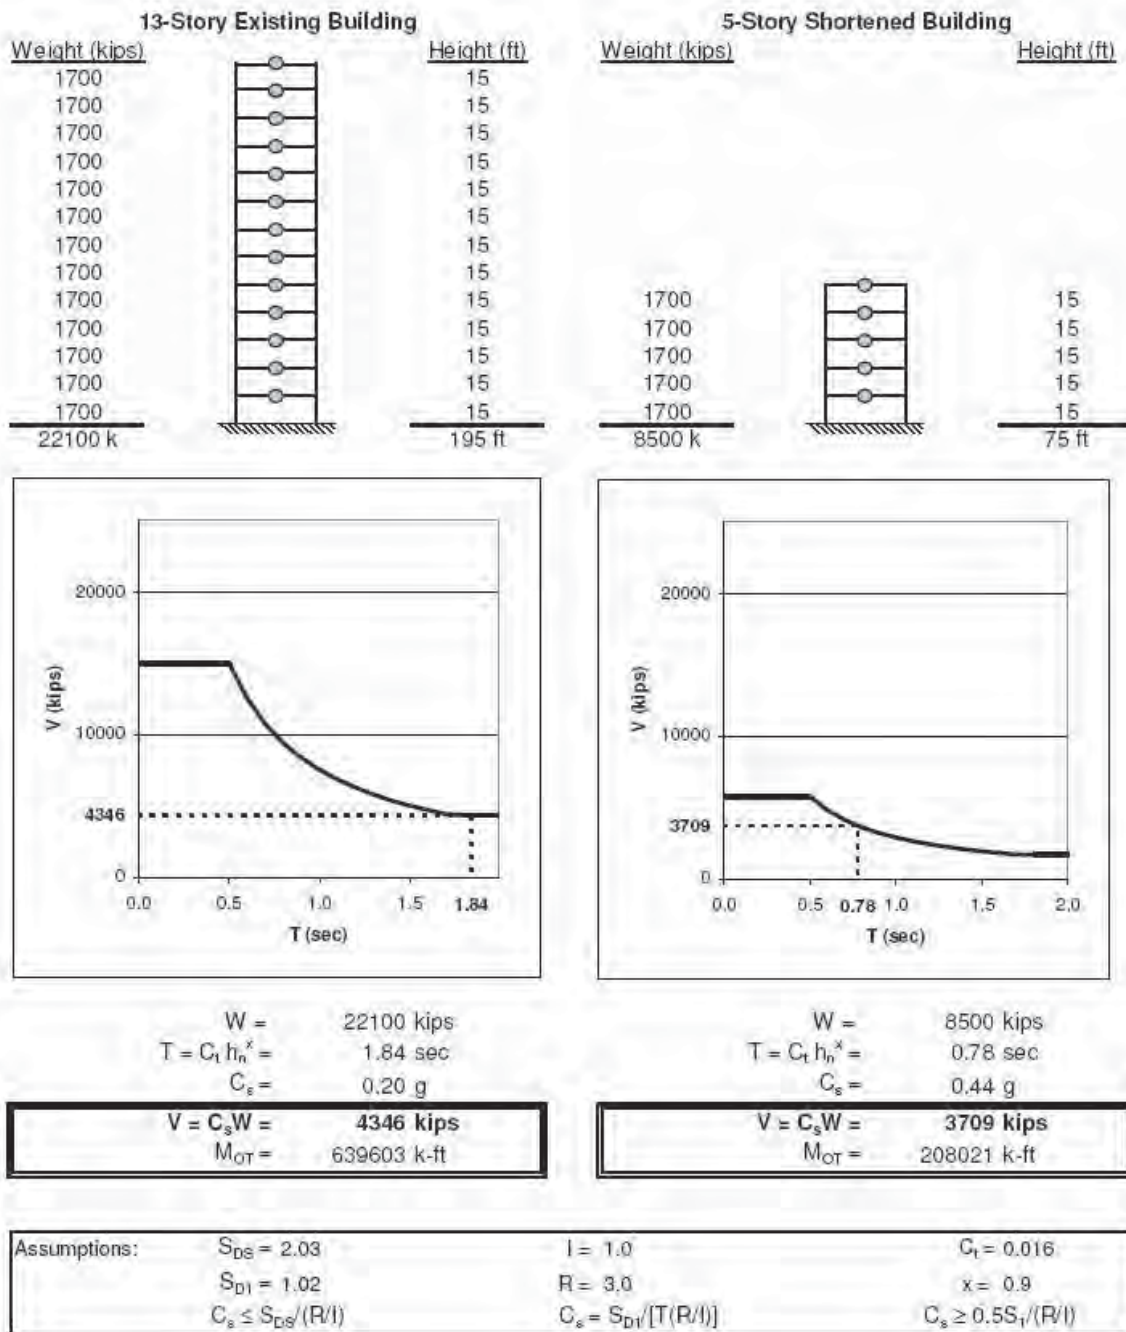
Figure 24.2-1: Generic Building Example of Decreasing Base Shear with Decreasing Height

The following examples in Figures 24.2-1, 24.2-2 and 24.2-3 illustrate how the removal of a building's upper stories may not significantly decrease the calculated base shear demand. All three examples assume a concrete moment frame system and employ ASCE 7-05 (ASCE, 2005) base shear equations. The first examines a generic model building with uniform story heights and masses, using the ASCE 7-05 approximate period calculation. The second examines a similar model building, in which additional weight is concentrated in the lower stories. The third examines a real building, using fundamental periods calculated from computer analysis. In all three examples, the removal of upper stories decreases global overturning demands but does not significantly decrease base shear demands.

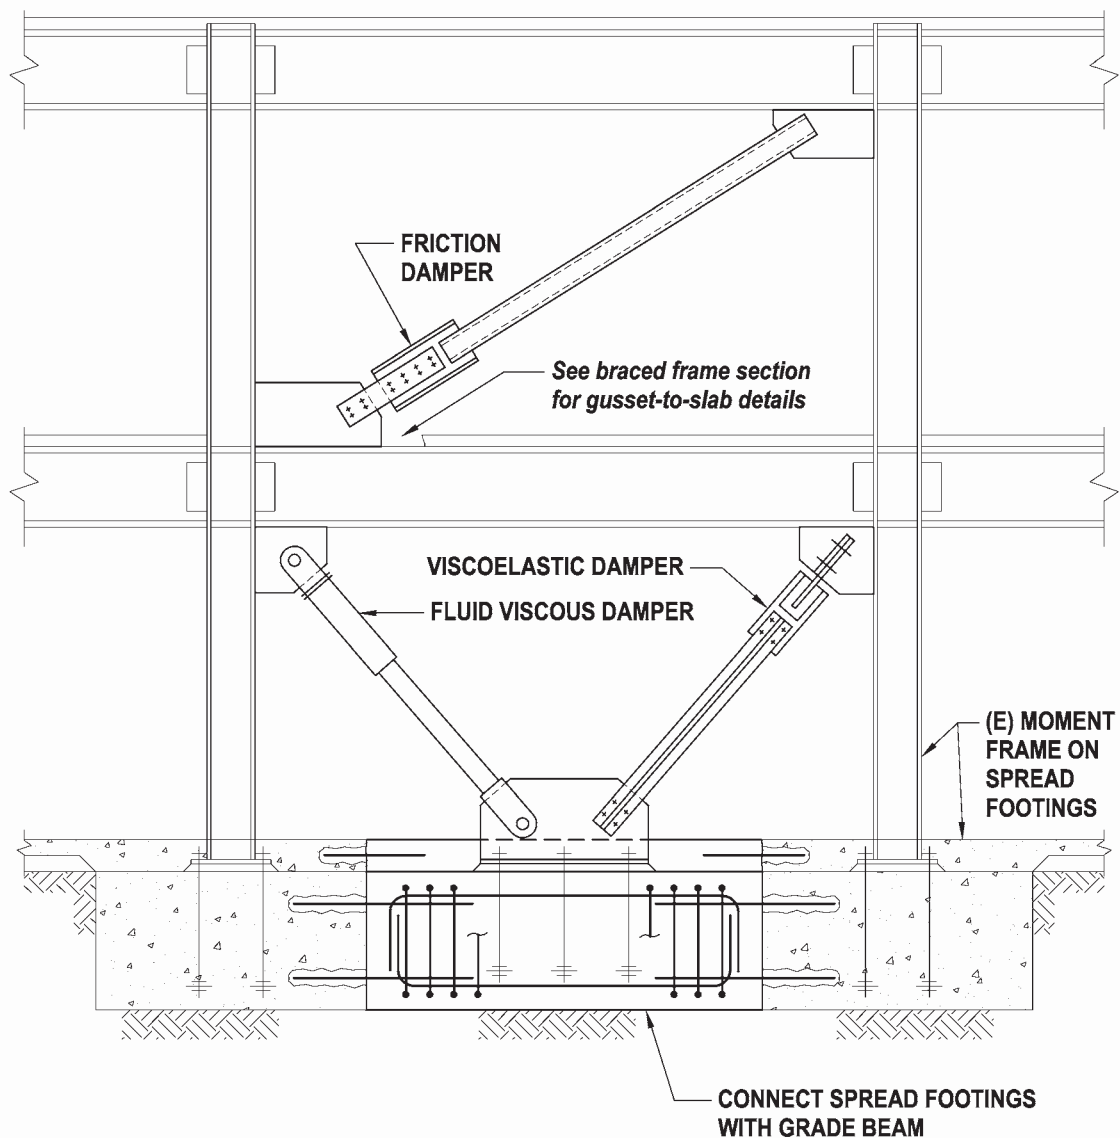
Figure 24.4-1: Damper Alternatives for Rehabilitating an Existing Moment Frame

System elements: Figures 24.4-1 and 24.4-2 show examples of adding damping devices in an existing steel moment frame building to minimize drifts and demands on the beam-column joints. Other dampers, such as wall dampers, are possible but not shown. The damper must be connected to the existing structure and potentially the foundation. Installing dampers is similar to installing braced frames. See Chapter 8 for detailed discussion on adding braced frames to a steel building and Chapter 12 for adding a braced frame to a concrete building. Some damper devices and orientations require out-of-plane bracing for stability, such as those shown in Figure 24.4-2.

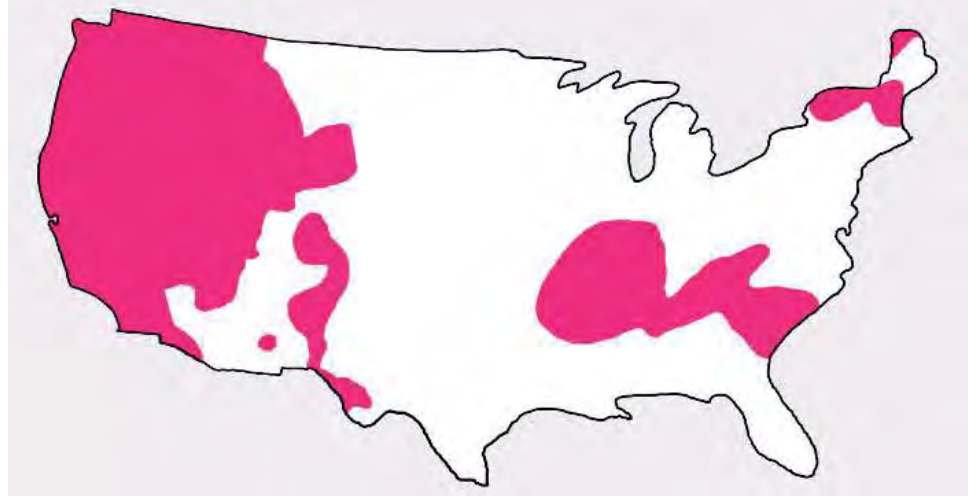
■ Figure 1. Approximate mapping of the areas of the United States where current building code regulations do not allow new construction with unreinforced masonry.

Figure 1 provides a general view of those areas of the U.S. where unreinforced masonry is not permitted for current construction.¹ This Figure serves as an initial guide to where some level of concern is warranted regarding the earthquake risks posed by these buildings. A local building department or a consulting structural engineer can provide more detailed guidance as to whether current seismic code provisions allow unreinforced masonry for a precise location, type of soil, and occupancy or use of a building. Even in regions where unreinforced masonry is currently allowed, older unreinforced masonry buildings may exist in a deteriorated

1. The *International Building Code*, promulgated by the International Code Council, obtains its seismic criteria for where particular types of structural systems can be used from ASCE 7-05, *Minimum Design Loads for Buildings and Other Structures* (ASCE/SEI 7-05 including Supplement No. 1), American Society of Civil Engineers, Reston, Virginia, 2006. The map in Figure 1 of this document is based on several assumptions, including: (1) Occupancies up through III in Table 1-1 of ASCE 7-05, which does not include fire stations, hospitals, or other essential facilities; (2) a short-period site coefficient, F_a , of 1.75 (Table 11.4-1), based on the mapped short-period Maximum Considered Earthquake (S_S); and (3) the design spectral short-period accelerations (S_{DS}) must be less than 0.33 for Seismic Design Category B to apply (Table 11.6-1), and with the above assumptions, the maximum S_S of 0.33 is rounded here to 0.3 for mapping purposes. For essential occupancies or for very soft soil, the red areas on the map would expand.

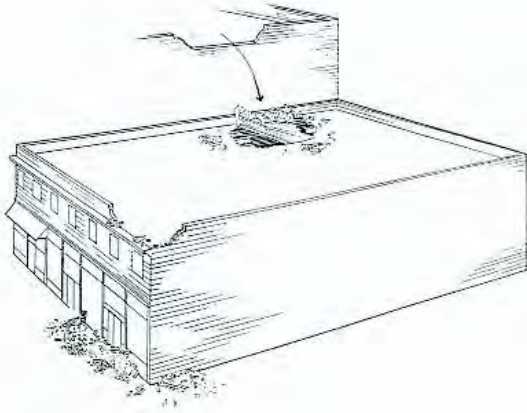
■ **Figure 2. Diagram illustrating the dangers of unreinforced masonry.**

When unreinforced masonry buildings begin to come apart in earthquakes, heavy debris can fall on adjacent buildings or onto the exterior where pedestrians are located. This diagram illustrates the failure of parapets, one of the most common types of unreinforced masonry building damage. This level of damage can occur even in relatively light earthquake shaking. —*Rutherford & Chekene*

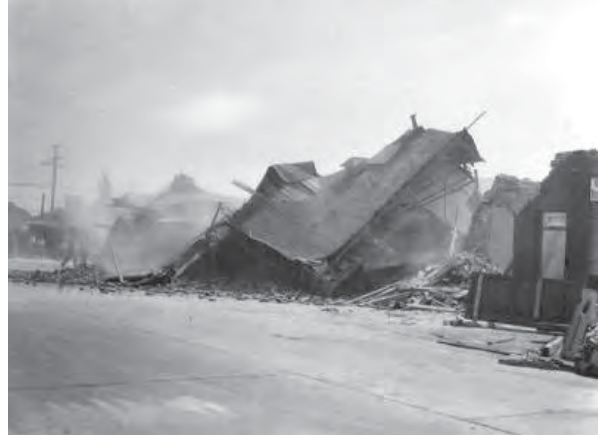
■ **Figure 3. Complete collapse of an unreinforced brick building.**

The most severe level of damage, with the greatest likelihood of fatalities, is complete collapse. After a few seconds of ground shaking in the 1933 Long Beach earthquake, the brick walls holding up the second floor and roof of this building broke apart. That not only caused the fall of hazardous brick debris—it also immediately led to complete collapse. —*Los Angeles Public Library*

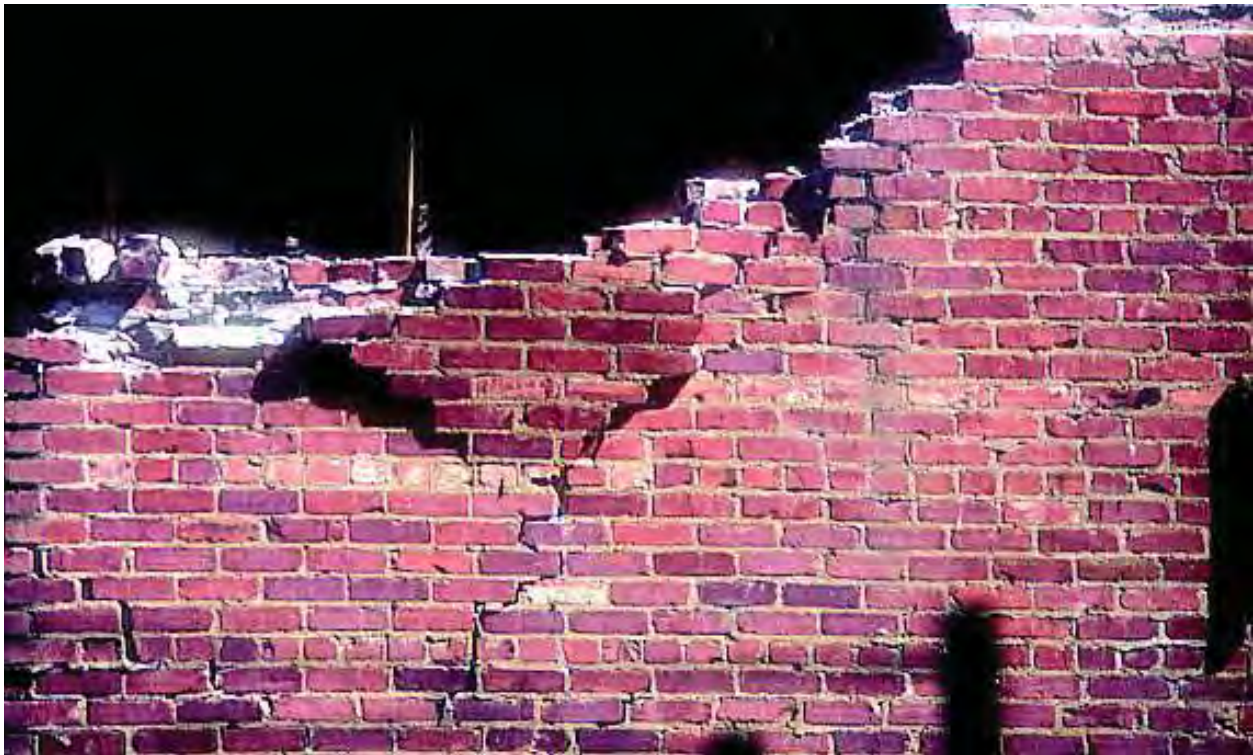
■ **Figure 6. Damaged URM wall in a red-tagged building, fated to be torn down or to undergo a multi-year closure for repairs and upgrading.**

Pre-earthquake retrofitting usually looks quite modest, compared to the comprehensive upgrading that building codes will require to repair a damaged, non-code-conforming building after an earthquake. —*Robert Reitherman*

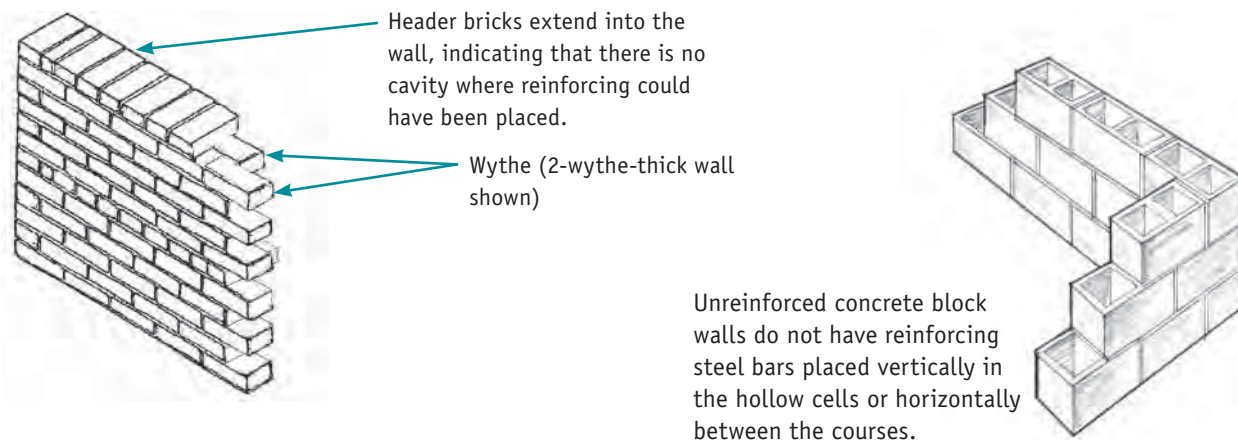
■ Figure 7. Components of unreinforced brick (left) and unreinforced concrete block (right) walls.

Masonry is made of earthen materials and includes the sub-types listed below. The most common unreinforced masonry materials used for the walls of buildings are the first two listed, brick and hollow concrete block, which are illustrated in Figure 7, Figure 8, and Figure 9.

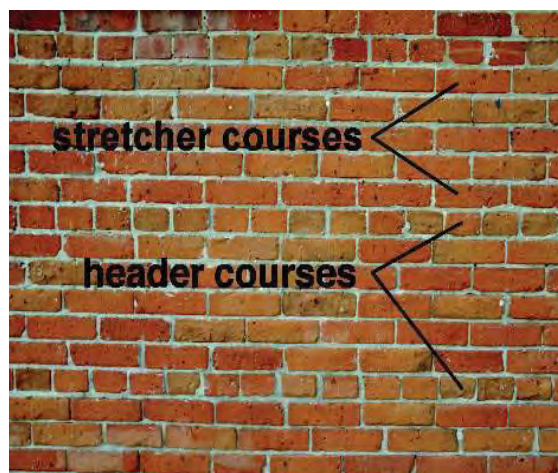
■ Figure 8. "Header" versus "stretcher" courses. The presence of header courses is usually the easiest way to tell if a brick wall is unreinforced.

A common type of unreinforced masonry wall in one- or two-story buildings is approximately a foot thick and uses a pattern of brickwork called “American bond.” In this pattern, most of the bricks are laid running parallel with the wall (these are known as stretchers). Approximately every sixth horizontal row, there will be a row of bricks with their ends rather than their sides visible (these are known as headers), as illustrated in Figure 7 and Figure 8. The header courses extend into the cross-section or thickness of the wall, and they provide a strong clue that the wall is unreinforced (because there is no empty space in the middle of the wall, where reinforcing and grout could have been placed). A form of hollow cavity unreinforced brick wall also exists, which has no bricks connecting outer and inner layers. This type of masonry work is done to provide some insulation and to keep rainwater from seeping through from the outside to inside of a building. There are many patterns of brickwork, although American bond is the most common one. While engineers and building departments evaluate the strengths of unreinforced masonry walls on their individual merits, all unreinforced masonry walls are essentially “guilty until proven innocent,” when it comes to earthquake resistance. Simple field testing methods can be used to measure existing masonry strength without damaging the wall.

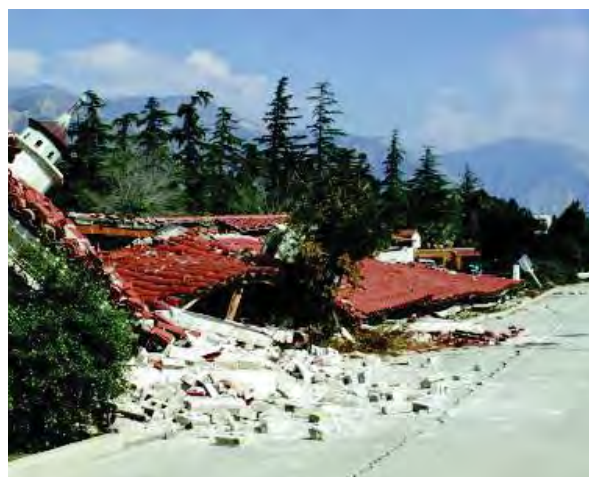
■ Figure 9. Complete collapse of an unreinforced concrete block building, 1971 San Fernando earthquake. —Karl Steinbrugge, NISEE, U.C. Berkeley

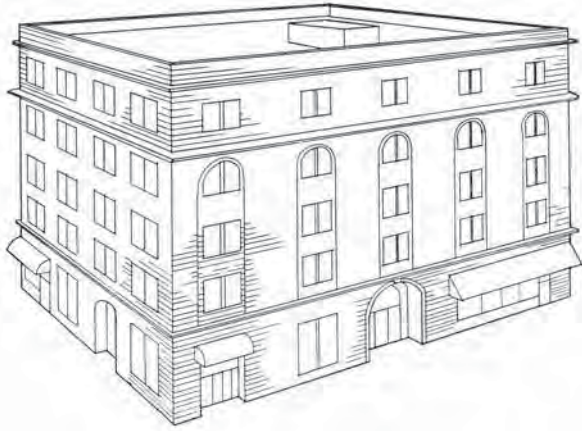
■ **Figure 10. Typical appearance of a multistory unreinforced brick building.**

When buildings are much taller than this, there is often also a steel or concrete frame, making an infill structure. —*Rutherford and Chekene*

The most common type of unreinforced masonry building in the United States is constructed of brick walls, with wood-frame floors and roof, as shown in Figure 10 and Figure 11. From the outside, one can observe that the spans over windows are short, and the walls are thick. The masonry walls around the exterior, and sometimes similar walls in the interior, bear up under the weight that is delivered to them by floor or roof beams. For this reason, they are called *bearing walls*. When the masonry is built into the rectangular openings or bays of a concrete or steel frame, with the frame holding up the masonry, then they are called *infill walls*. That kind of building requires its own special analysis and is not in the subject of this booklet.

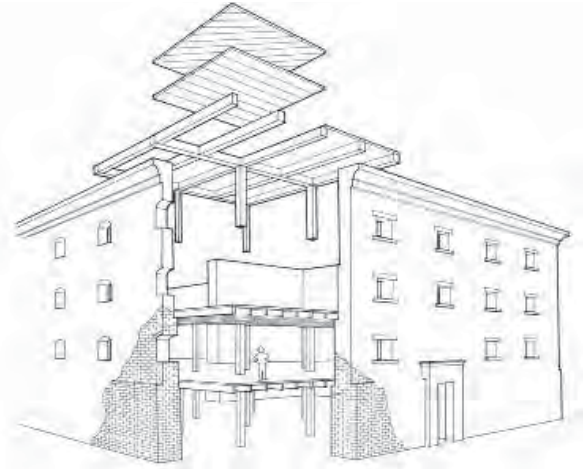
■ **Figure 11. Components of a URM building.**

Many larger unreinforced brick buildings have heavy timber columns and beams in the interior. The wooden posts and beams do not provide significant horizontal (earthquake) force resistance. —*FEMA 154, Rapid Visual Screening of Buildings for Potential Seismic Hazards: A Handbook*

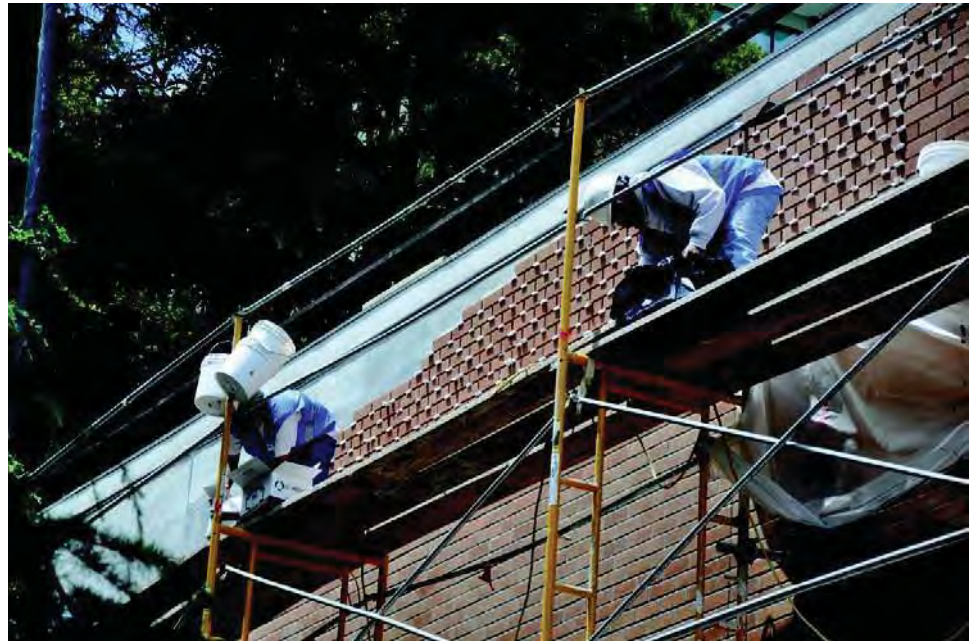
■ **Figure 12. Workers installing brick veneer.**

The individual pieces of veneer are being adhered to the reinforced concrete wall behind them. The result looks like a brick wall. —*Robert Reitherman*

Masonry veneer is usually composed of one layer of ordinary brick or of thinner brick that is applied to a supporting wall behind it, as shown in Figure 12. Veneer is typically about four inches (100 mm) or less in thickness. It may also consist of stone facing. The veneer is adhered to and literally hangs onto a wall behind it for vertical and horizontal support. Terra cotta, a ceramic material similar to brick

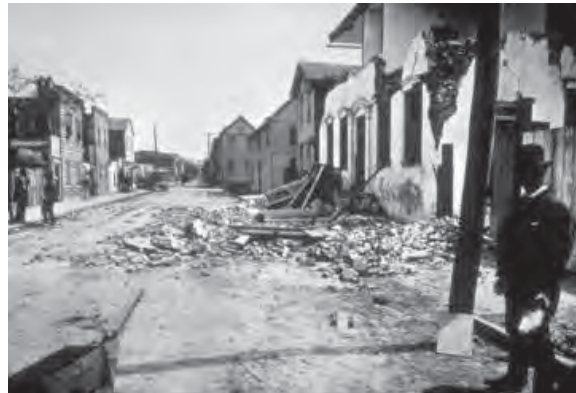
■ Figure 13. Debris resulting from the 1886 Charleston, South Carolina earthquake.
—NISEE, U.C. Berkeley

1886 Charleston Earthquake, South Carolina, M 7.7: Eighty-two percent of the brick buildings suffered more than minor damage, and 7% collapsed or were demolished.⁵ See Figure 13, illustrating the debris from collapsing second story masonry walls, which extends beyond the middle of the street.

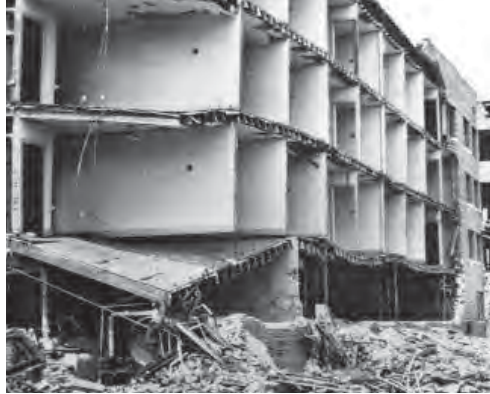
■ Figure 14. Heavily damaged Hotel Californian, 1925 Santa Barbara, California earthquake. —NISEE, U.C. Berkeley

1925 Santa Barbara Earthquake, Southern California, M 6.2: The most severe damage from this earthquake occurred among unreinforced brick commercial and residential construction and was a primary motivation for engineers in California to adapt seismic design ideas from Japan into the *Uniform Building Code*. Forty percent of the unreinforced masonry buildings were severely damaged or collapsed.⁶ See Figure 14, the Hotel Californian, in which extensive wood-frame and plaster partitions barely managed to hold the building up, after exterior brick walls failed.

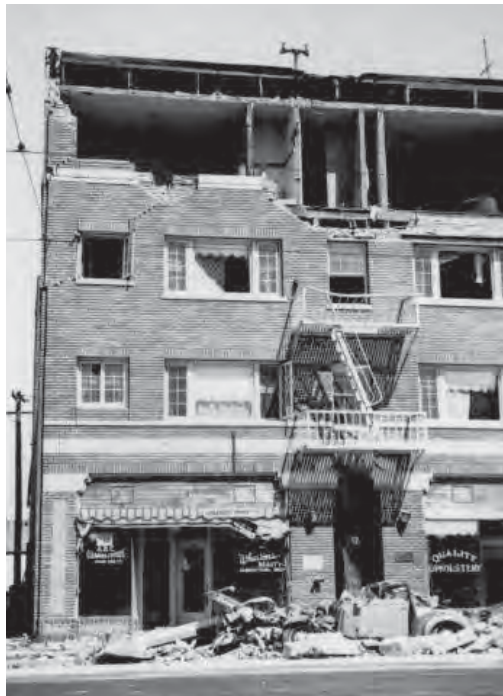
■ Figure 15. URM building damage, 1933 Long Beach, California earthquake. —Los Angeles County Public Library

1933 Long Beach Earthquake, Southern California, M 6.3: In the City of Long Beach (adjacent to the City of Los Angeles), 54% of the unreinforced masonry buildings ended up with damage that ranged from significant wall destruction to complete collapse. In 20% of the cases, damage fell in the categories of either damage to more than half the wall area, partial collapse, or complete collapse.⁷ See Figure 15, showing parapet (the short walls that often extend around the perimeter of a roof) and top story failure and the effect of the falling masonry debris.

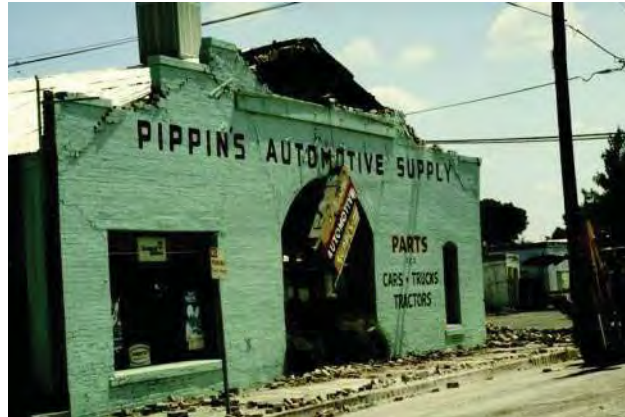
■ **Figure 16. URM building with end-wall failure, 1983 Coalinga, California earthquake.** *Robert Reitherman —NISEE, U.C. Berkeley*

1983 Coalinga Earthquake, Central California, M 6.2: Out of 37 unreinforced masonry buildings—the core of the Coalinga business district—only one escaped damage. Sixty percent were damaged to the extent of having more than half of their walls ruined, up to complete collapse.⁸ The entire downtown area was cordoned off, until badly damaged buildings could be demolished and the debris removed. See Figure 16, which illustrates a common form of damage, in which the gable (peaked roof) end wall falls.

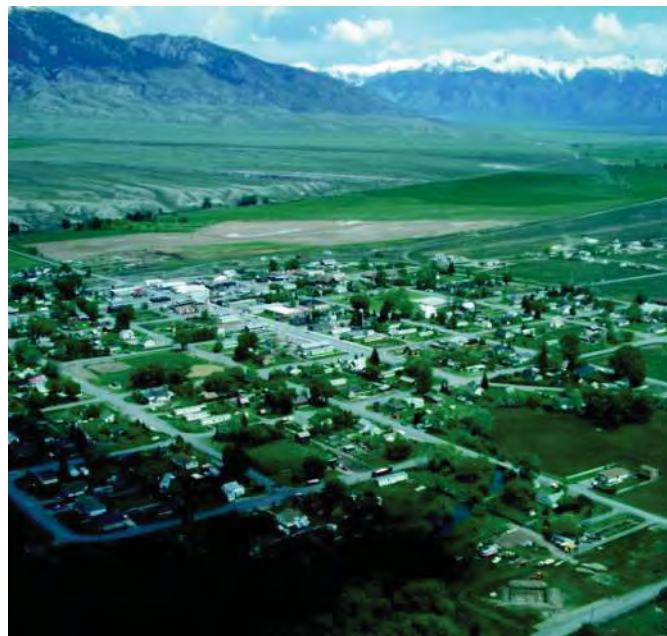
■ **Figure 17. Aerial view of heavily damaged Mackay, Idaho.** The unreinforced masonry buildings on the main commercial street of the small town were badly damaged in the 1983 Borah Peak, Idaho earthquake. —NISEE, U.C. Berkeley

1983 Borah Peak Earthquake, Idaho, M 7.3: In the town of Challis, Idaho, the only earthquake-related fatalities occurred when an unreinforced masonry wall fell on two children on their way to school. In Mackay, the town's main street buildings, built of unreinforced brick, concrete block, or stone, were all damaged, Eight required demolition. In relative terms, when compared to the size of the town (see Figure 17), this amount of damage constituted a large disaster.

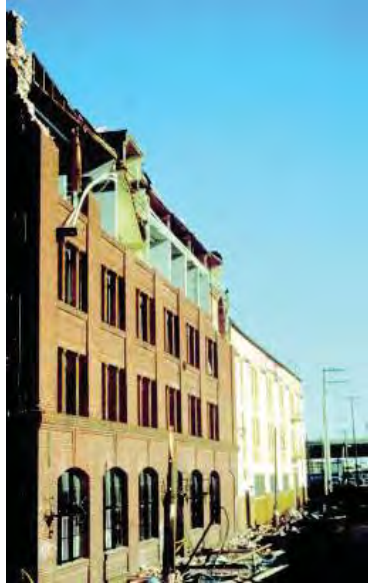
■ **Figure 18. Upper story wall collapse, with resulting fatalities.**

Five people were killed when the brick wall in the fourth story fell on top of cars and the sidewalk in the 1989 Loma Prieta earthquake. —James Blacklock, NISEE, U.C. Berkeley

1989 Loma Prieta Earthquake, Northern California, M 7.1: In this earthquake, 374 (16%) of the 2,400 unreinforced masonry buildings in the region experienced damage severe enough to require that they be vacated.⁹ The earthquake was centered 60 miles south of the San Francisco Bay Area, and the majority of these buildings were subjected to only light to moderate shaking. Figure 18 illustrates an upper-story failure of brickwork, which fell onto the sidewalk and cars below, killing five people.

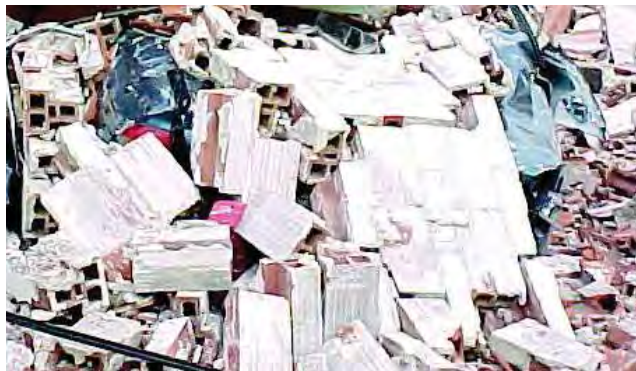
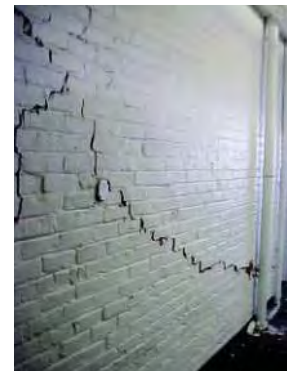
■ **Figure 19. URM building damage, 2001 Nisqually, Washington earthquake.**

At left, hollow clay tile debris from a collapsed wall; at right, diagonal “stair-step” cracking of a brick wall (the crack following mortar horizontal bed joint and vertical head joint lines), a sign of the wall’s inability to resist shear stress from in-plane forces. —André Filiatraut

2001 Nisqually Earthquake, Puget Sound Region, Washington, M 6.8: “URM buildings built before 1950 exhibited the poorest behavior. The most common damage included shedding of brick from parapets and chimneys. Other URM buildings exhibited diagonal ‘stair-step’ cracking in walls and piers, damage to walls in the upper stories, vertical cracking in walls, damage to masonry arches, and damage to walls as a result of pounding. In many cases, fallen brick resulted in damage to objects, such as cars and canopies, outside the building.”¹⁰ See Figure 19.

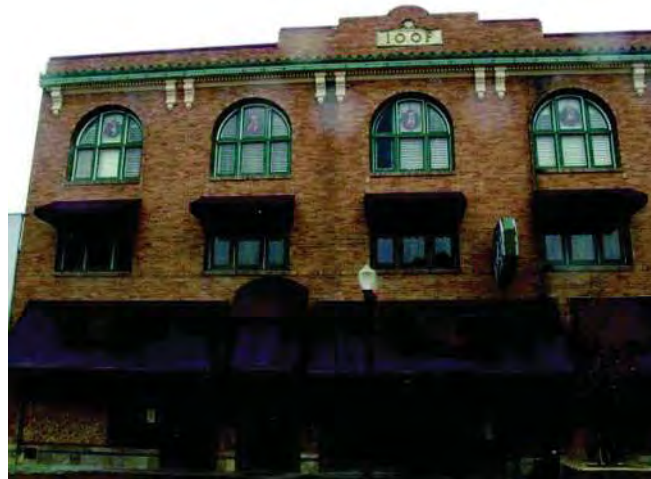
■ **Figure 20. Retrofitted URM building, 2003 San Simeon, California earthquake.**

Retrofitted prior to the earthquake, this unreinforced brick building experienced no damage. —*Janise E. Rodgers, NISEE, U.C. Berkeley.*

2003 San Simeon Earthquake, Central California, M 6.5: Of 53 unreinforced masonry buildings in Paso Robles, the nearest affected city, none of the nine that had been retrofitted experienced major damage. Many of the others were damaged so extensively that they were subsequently demolished. “During earthquakes unreinforced masonry buildings that have not been retrofitted continue to be the most dangerous buildings in California.” One building owner commented afterward: “I’m confident the building would have come down in the quake if we hadn’t done the retrofiting. There were times when we were bleeding so badly in paying for it, we wondered what in the heck we were doing. Now we know.”¹¹ See Figure 20. The two fatalities in the town were due to the collapse of an unretrofitted, unreinforced brick building.

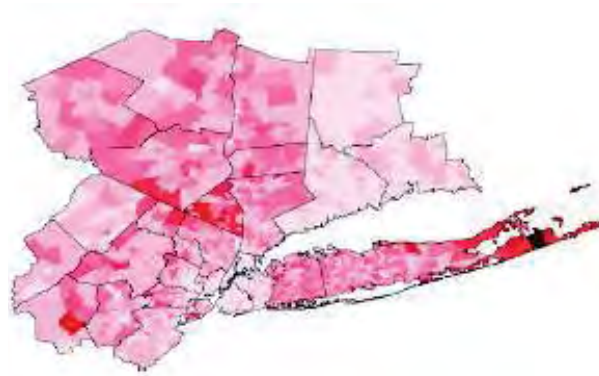
■ **Figure 22. The distribution of unreinforced masonry buildings in the greater New York City region.**

Maps such as this one, published by the New York City Area Consortium for Earthquake Loss Mitigation, relate seismic information to geographic and land use planning data.

impact reporting requirements that a retrofit program would trigger; city planning departments should be familiar with any such requirements. Figure 22 illustrates how an inventory of unreinforced masonry buildings can be overlaid with political and economic (building value) data.

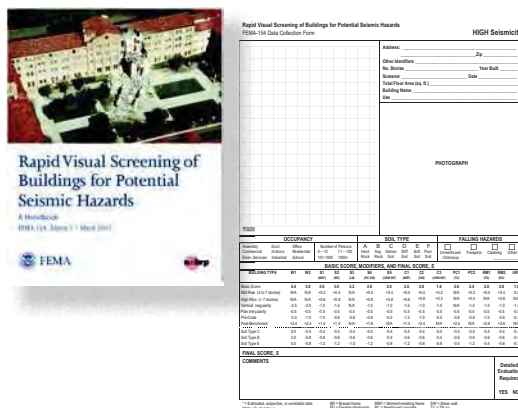
■ Figure 23. FEMA 154, a technical resource containing forms and standardized guidance on compiling an inventory. —FEMA 154, *Rapid Visual Screening of Buildings for Potential Seismic Hazards: A Handbook*

Most programs to reduce unreinforced masonry seismic risks share certain characteristics. First, they all need to include an inventory of buildings, which should be carried out early in the planning process. Conducting an inventory is not difficult, because unreinforced masonry buildings are among the easiest of construction types to identify. Building department, insurance industry, and tax assessor files can sometimes provide useful information. “Sidewalk surveys” that observe buildings from the outside are often sufficient. The FEMA 154 Handbook provides a “rapid visual screening” method that is applicable to a wide variety of buildings¹⁴ (see Figure 23). Section E.13 of Appendix E of the FEMA 154 Handbook provides

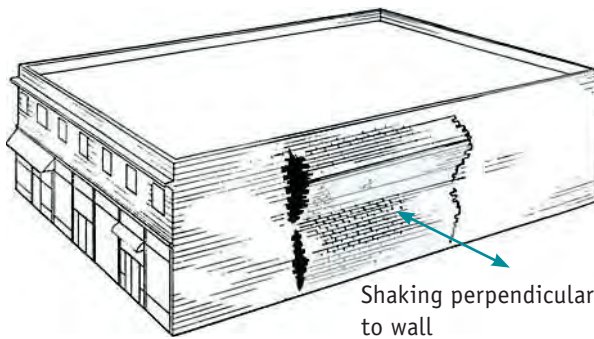
■ Figure 24. Out-of-plane failure of unreinforced masonry walls. —Rutherford and Chekene

Masonry materials are intrinsically strong when compressed under the usual gravity loads but are weak in resisting earthquake forces, which make materials flex and also shear; ‘shear’ describes the tendency for a portion of the wall to slide vis-à-vis the rest. When an earthquake shakes an unreinforced masonry building, it causes the building’s walls to flex *out-of-plane* (see Figure 24) and to shear *in-plane* (see Figure 25). Unreinforced masonry is weak in resisting both of those types

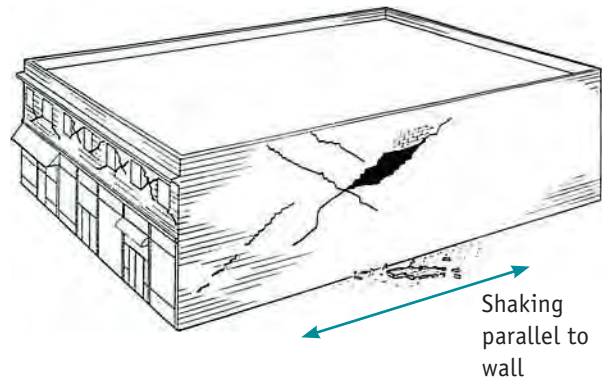
■ Figure 25. In-plane failure of unreinforced masonry walls. —Rutherford and Chekene

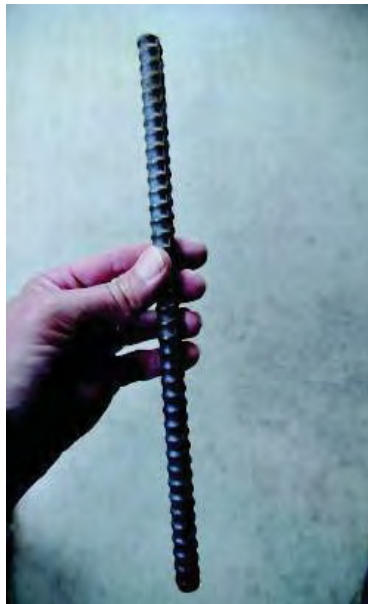
■ **Figure 26. A piece of #4 bar (a steel reinforcing bar that is 4/8 inch in diameter).**
A nickname for reinforcing bar is rebar.

Unreinforced masonry, as the name implies, is masonry without reinforcing. “Reinforcing” (see Figure 26) has a very specific meaning in this context. It refers to steel reinforcing bars (rebar), which vary in diameter from approximately 3/8 inch in diameter (9.5 mm, called a #3 bar) to an inch (25 mm) or more in diameter. A bar 4/8 inch in diameter is called a #4 bar, and so on. The bars have knobs or ridges along their length to increase their adhesion or bond with concrete or grout. Grout is essentially a very fluid form of concrete, with small pea-sized gravel instead of the larger aggregate in concrete.

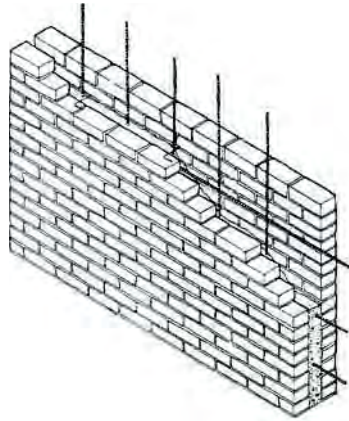
■ **Figure 27. Reinforced brick wall.** —FEMA 154, *Rapid Visual Screening of Buildings for Potential Seismic Hazards: A Handbook*

A reinforced masonry wall has a grid of horizontal and vertical steel reinforcing bars within the wall cross-section (see Figure 27). In reinforced brick construction, a hollow cavity is formed between an outer stack or wythe of bricks and an inner wythe, and the reinforcing is placed in this space. Grout is poured into the cavity, and when it sets, a monolithic structural sandwich forms, which is strong in resisting horizontal earthquake forces, both those forces perpendicular to and those parallel to the wall.

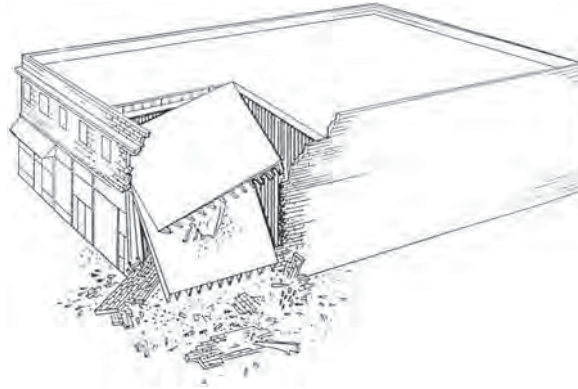
■ **Figure 28. Failure of roof-to-wall connection, with resulting collapse.** —*Rutherford and Chekene*

Individual structural elements, such as a wall and the roof, only perform adequately in earthquakes when these elements are strongly connected. The typical connection of the wood beams or joists to the unreinforced masonry walls, however, is very weak. A common construction detail used over the decades was to rest the end of a beam in a pocket or niche in the brick wall, with little or no steel hardware providing a strong, positive connection. When an unreinforced masonry building is shaken, the roof or floor framing can pull away from the walls. The walls need the roof to keep them from leaning too far and collapsing, while the roof needs the walls to support it, in order to keep from falling. Typical unreinforced masonry damage includes both the collapse of heavy masonry wall areas and the collapse of part or all of the roof or upper floors (see Figure 28).

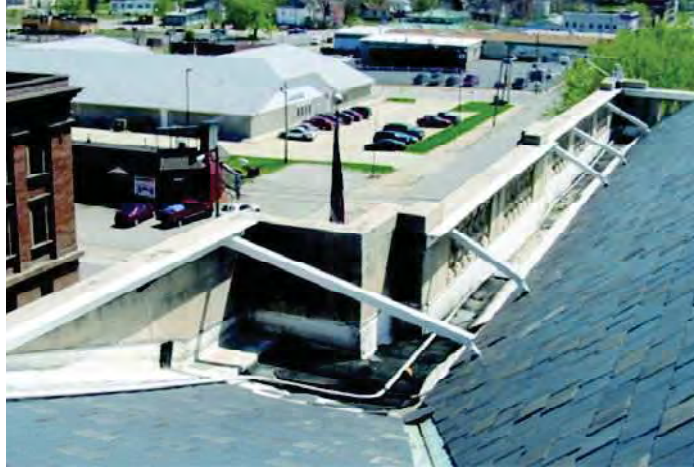
■ **Figure 29. Retrofit bracing of an unreinforced masonry parapet.**

Typically, diagonal bracing struts are installed behind the wall and anchored to the roof, as shown here, which makes them unobtrusive.

Usually retrofit that offers the biggest benefit relative to its costs is the anchorage of masonry parapets, those short walls that extend a few feet above a building’s roofline. Bracing or removing these parts of the building, along with other exterior masonry appendages such as cornices, effectively addresses the type of damage that can happen even in very light shaking. The most common type of bracing used is to bolt diagonal steel struts to the top of the parapet, with the bottom end of the struts anchored with bolts into the roof structure. Usually this does not change the building’s appearance from the street (see Figure 29).

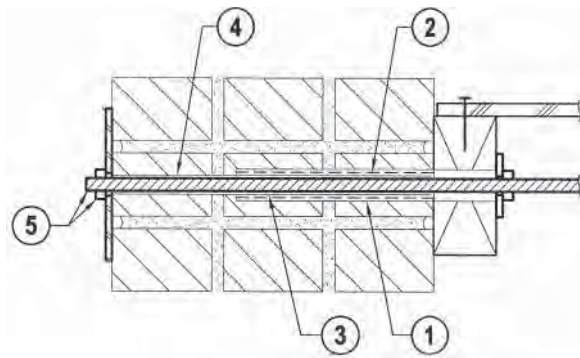
■ **Figure 30. Generic wall-diaphragm connection retrofit detail.** —FEMA 547, *Techniques for the Seismic Rehabilitation of Existing Buildings*

Parapet safety programs do not provide protection, however, against the collapse of the building itself. The first additional increment of seismic protection, beyond parapet and appendage bracing, is provided by bolting the walls to the roof and to any floors above the ground floor level. Long steel bolts are typically inserted into holes drilled in the wall and attached to a steel angle, which in turn is bolted to the side of a wooden joist. The end of the bolt on the outside of the wall requires a large washer (the size of a teacup saucer) to prevent it from pulling through in an earthquake (see Figure 30). In many communities that have enacted seismic ret-

rofit ordinances, the row of these washers running along the roofline indicates the presence of this kind of retrofit. Similar-looking steel washers may be part of an older building’s construction. In general, old, pre-seismic-code wall-joist anchors are not found to be adequate.

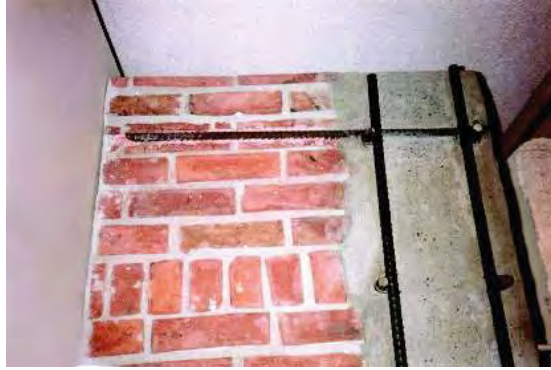
■ **Figure 31. California Capitol Retrofit.**

An exhibit shows a cut-away view of the reinforced concrete that is anchored into the brickwork with epoxied reinforcing bars. —*Robert Reitherman*

The next additional increment of earthquake protection is provided by conducting a more thorough engineering examination of the entire building structure. This examination might reveal the need to increase the horizontal stiffness of floors and the roof, which is typically accomplished by adding a layer of sheathing (sheets of plywood or oriented-strand board). New columns (posts) may be added that can hold up the floors and roof, even if portions of the bearing wall fail. The brick or concrete block walls themselves cannot be transformed into modern reinforced masonry construction. However, walls can be strengthened by several techniques, making them stronger, even if not as strong as new, reinforced masonry walls. One available technique is to add a layer of reinforced concrete to the inside or outside of the wall, as shown in Figure 31.

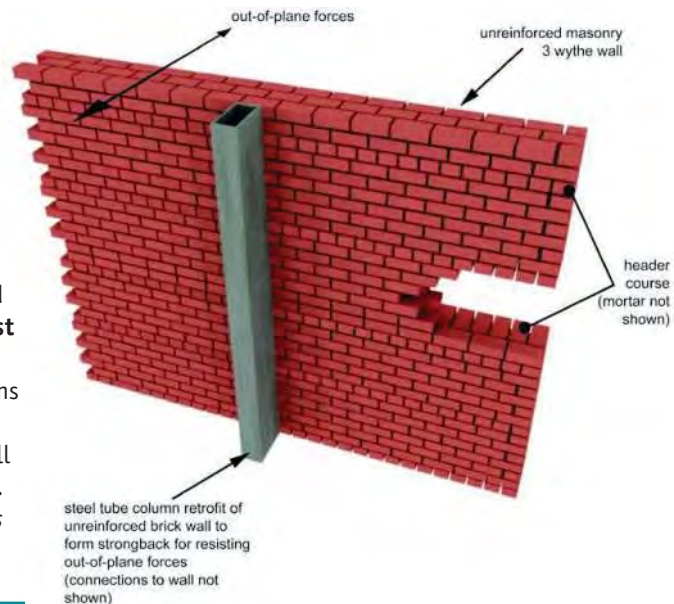
■ **Figure 32. A retrofitted lateral-force-resisting post (strongback).**

The strongback column spans from foundation to roof, serving to brace a brick wall against out-of-plane forces. —*Consortium of Universities for Research in Earthquake Engineering*

Another approach is to install columns attached to the walls, which act like splints or *strongbacks* that brace the wall against excessively bowing outward or inward (see Figure 32). Yet another wall strengthening method is to drill holes down through the wall from top to bottom, using machinery adapted from the oil well industry to insert a steel bar and grout. Interior partitions can also help to stiffen the overall box structure and can damp out or absorb its vibrations. Each retrofit brings its

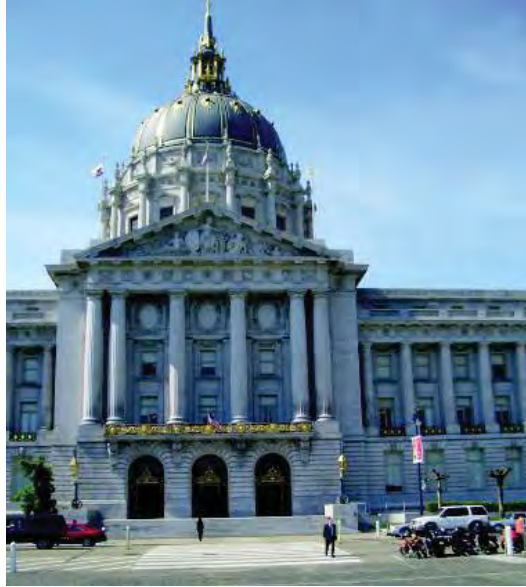
■ **Figure 33. The San Francisco City Hall seismic retrofit, which includes seismic isolators.** —*Robert Reitherman*

Seismic isolation devices can be employed in combination with any of the above techniques. These devices are “shock absorbers” manufactured for the specific purpose of being installed between a building’s superstructure and foundation; they soften and reduce the motion of the ground, as it comes up into the building structure. Prominent examples of this kind of retrofit being applied to prominent historic buildings that contain unreinforced masonry include the Salt Lake City and County Building and San Francisco City Hall (see Figure 33).
