Architectural
Resources Group

609, 611, and 619 NE 3rd Street
McMinnville, Oregon

Historic Resource Assessment
November 2022

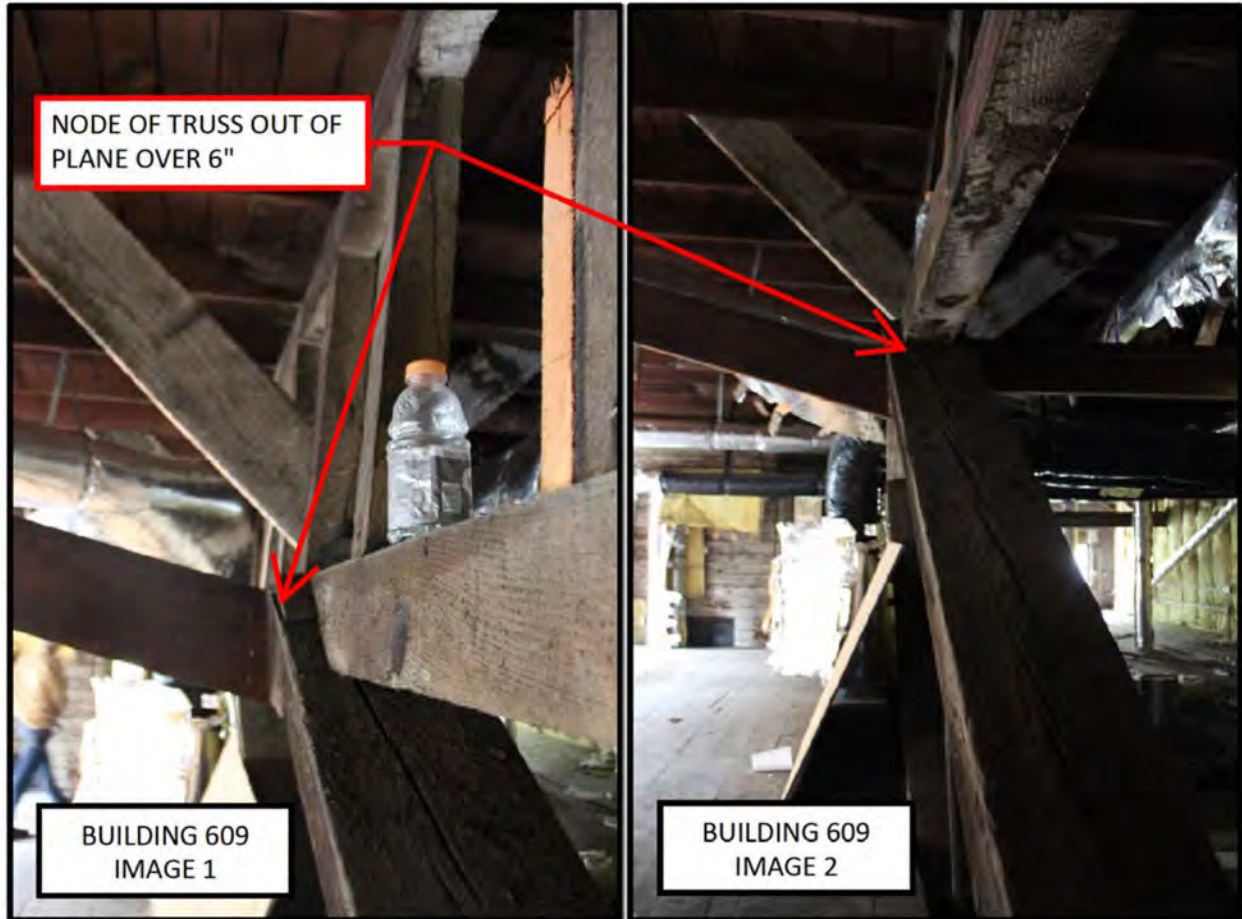
- The south brick wall at the 2nd level offices is deteriorating and the mortar is no longer sound
- There are multiple diagonal cracks following the mortar lines at the 2nd level offices (see Image 5)

- The 1st truss from the south elevation is displaced over 6 inches horizontally at the top which represents a significant structural concern (see Image 1 and 2)

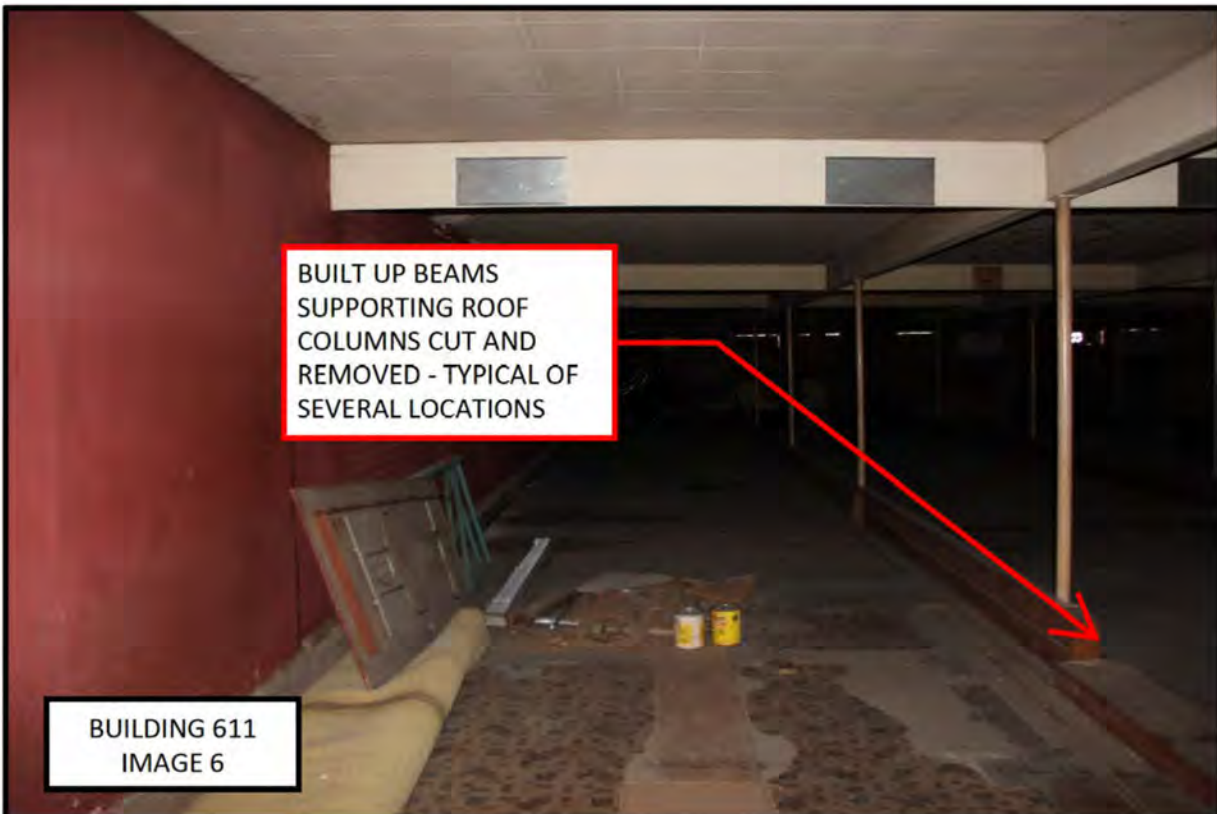
- At north and south walls the roof beams are supported by the perimeter brick walls
- In some cases, the built-up laminated beams across the floor have been cut and removed. This condition compromises the structure's ability to spread the concentrated roof load across the floor below (see Image 6)

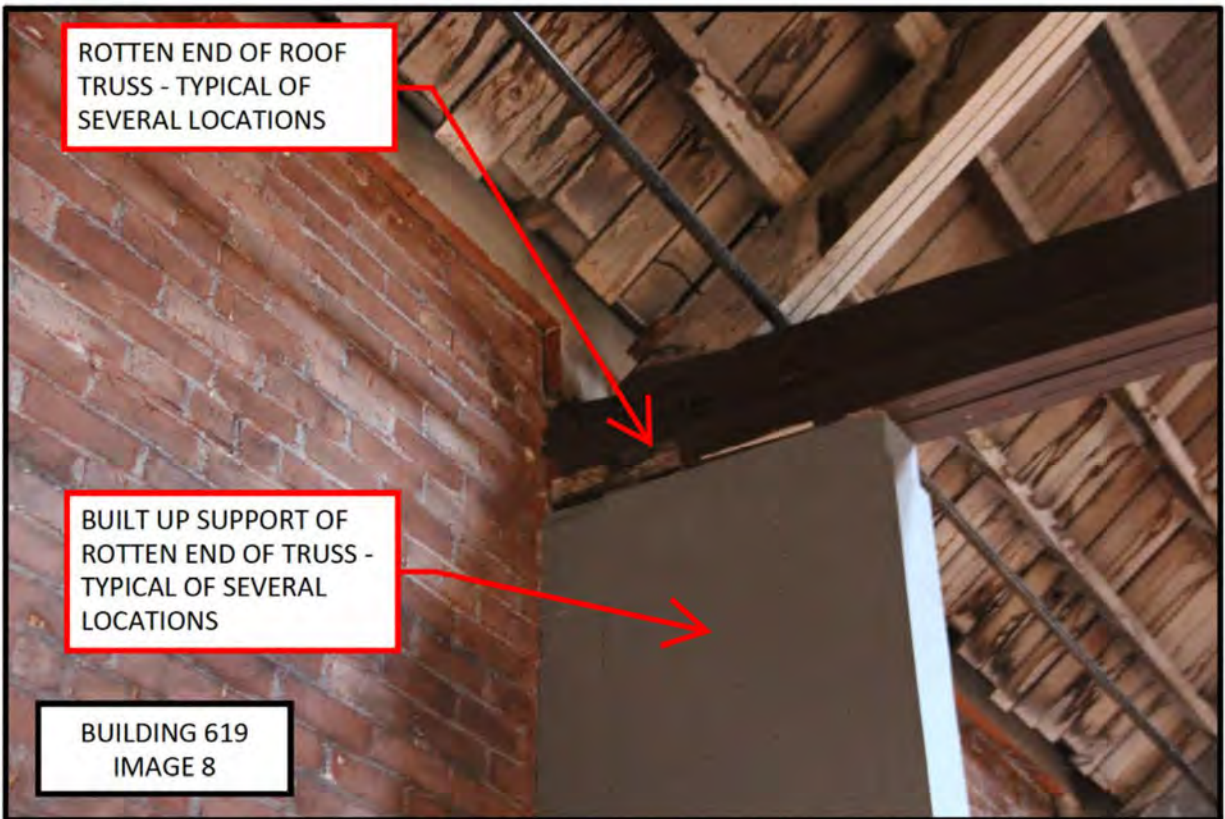
- Trusses constructed of 2x spanning east west, diagonal web members appear to be 4x or 6x dimensional members, vertical web members are steel rods
- Top chord is sloped steeply at then ends and then modestly sloped to the center of the truss at the ridge, the bottom chord of the truss is horizontal
- The bearing points of the trusses are deteriorated along the west wall and supplemental support has been framed under the trusses (see Image 8 and 9)
- This condition exists at the connection to the 611 Building and is the result of water penetration along the north south valley between the building

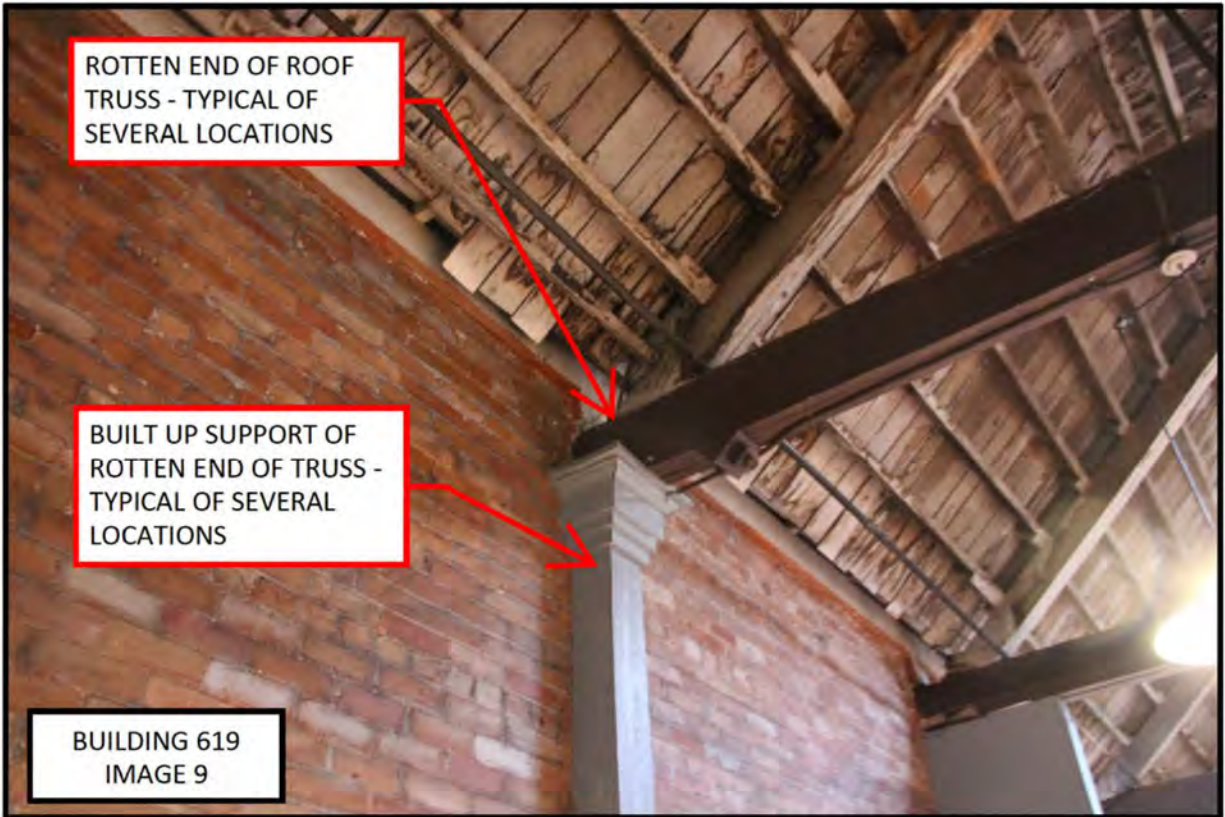
- There exist dimensional lumber framed ceilings over the existing retail space
- In the common are between the retail spaces is a high-volume space where the trusses and roof joists are visible

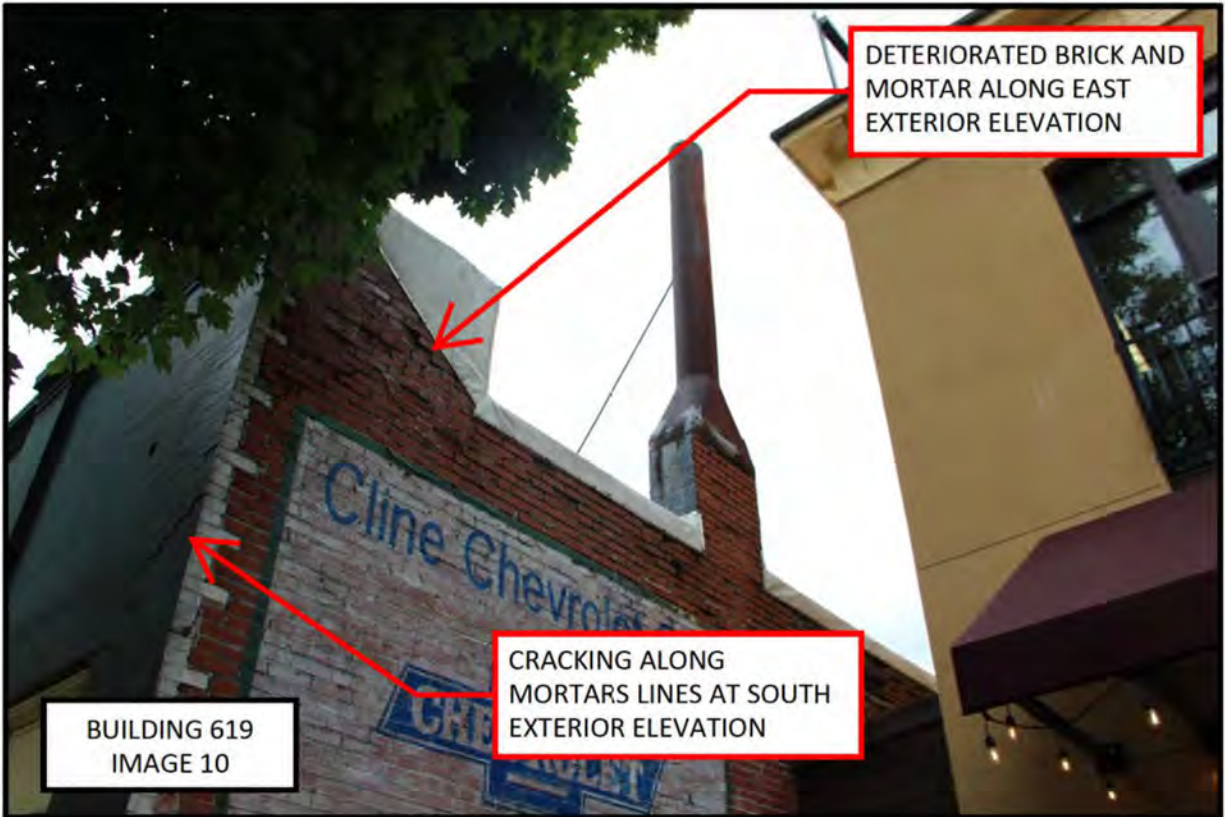
- The brick and mortar at south elevation show signs of deterioration and diagonal cracks along the mortar lines
- The east wall exterior has significant deterioration and is exposed due to the separation between the 619 Building and the recently constructed building to the east (see Image 10)
