## **EXHIBIT 1 - STAFF REPORT**

**DATE:** October 22, 2018  
**TO:** Historic Landmarks Committee Members  
**FROM:** Chuck Darnell, Senior Planner  
**SUBJECT:** HL 9-18 – Demolition Request – 180 NE 7<sup>th</sup> Street

A request for the demolition of a historic resource that is listed on the Historic Resources Inventory to be reviewed by the Historic Landmarks Committee.

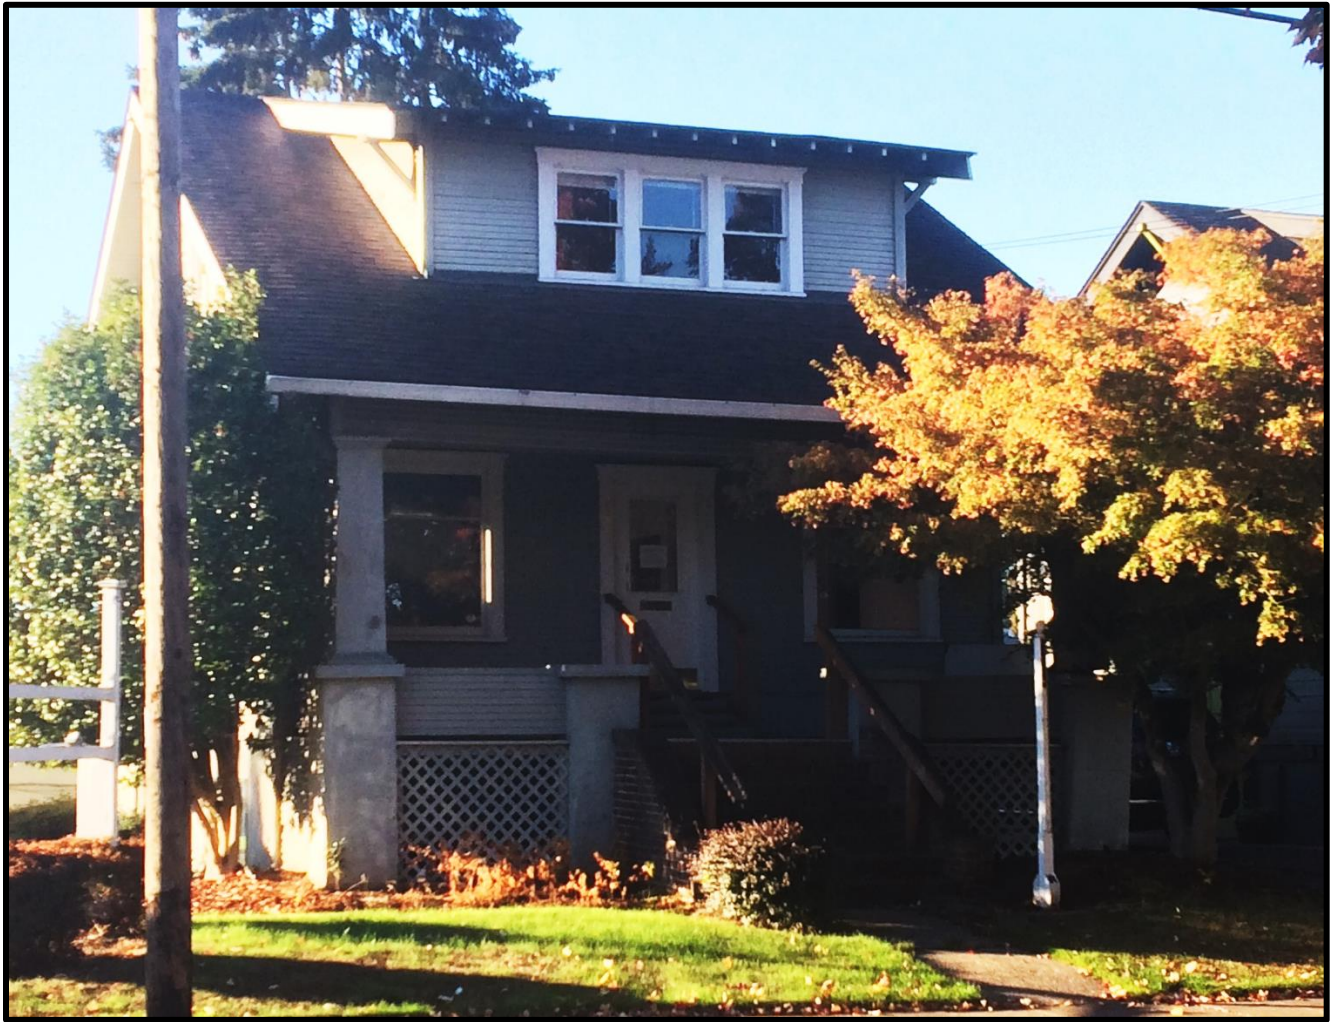
The structure as it exists today can be seen below:

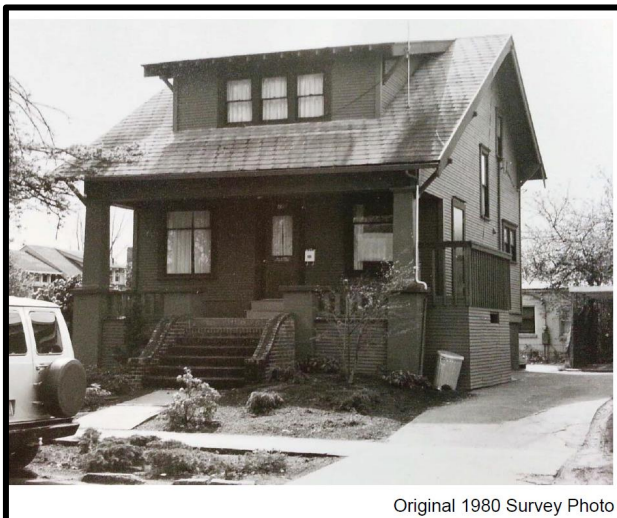
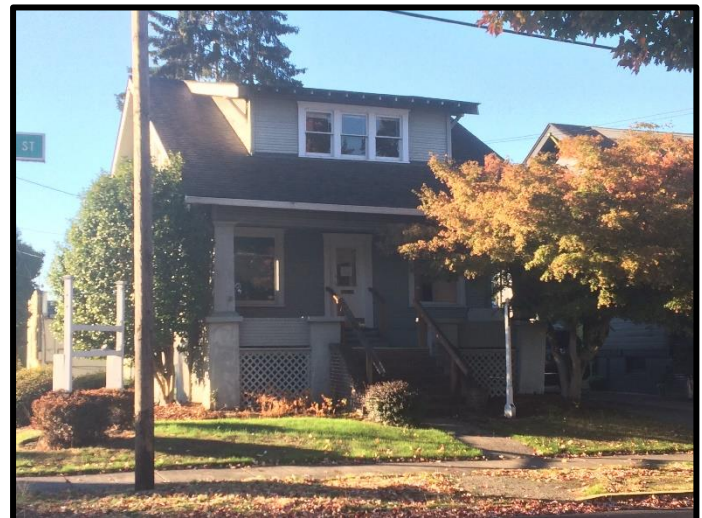
Original 1980 Survey Photo

The significant historic and architectural features that were described in the statement of historical significance on the Historic Resources Inventory sheet still exist on the historic resource today. Those include the “red brick steps” leading to the “full-width porch which is under the extending roof”, “boxed

pillars” on the porch, a “front dormer” with “three windows and shed roof”, a “rectangular bay with a shed roof” on the east side of the structure, a “back dormer” that “extends and is flush with the first story wall”, “beveled siding... with corner boards”, and roof brackets.

The applicant has noted that some of these features have deteriorated or been changed. Wooden handrails have been added to the red brick steps leading to the porch. The applicant has stated that the original pillars on the porch were round, but were boxed in at a later date. The beveled siding is still in place, but is in poor condition. The applicant also noted that the roof brackets as they were described in the Historic Resources Inventory sheet are not actually roof brackets, but are gussets to support the roof. However, these features still exist today and contribute to the character and significance of the historic resource. The boxed pillars existed at the time of the listing of the structure on the Historic Resources Inventory. The roof brackets, or gussets, are still in place and provide the decorative roof bracket feature that is evident on many Craftsman bungalows in McMinnville, even if they are not true, functional roof brackets. The overall form of the structure is still almost entirely the same, including the front dormer with a shed roof, a rectangular bay with a shed roof on the east side of the structure, and the back dormer that extends and is flush with the first story wall.

Historic resource as it existed in 1980 and currently (2018):

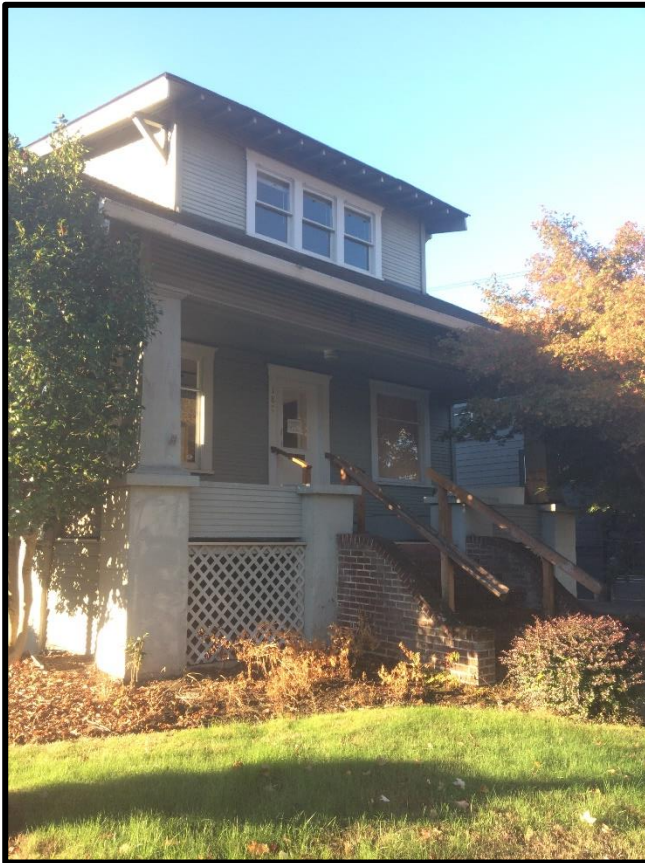
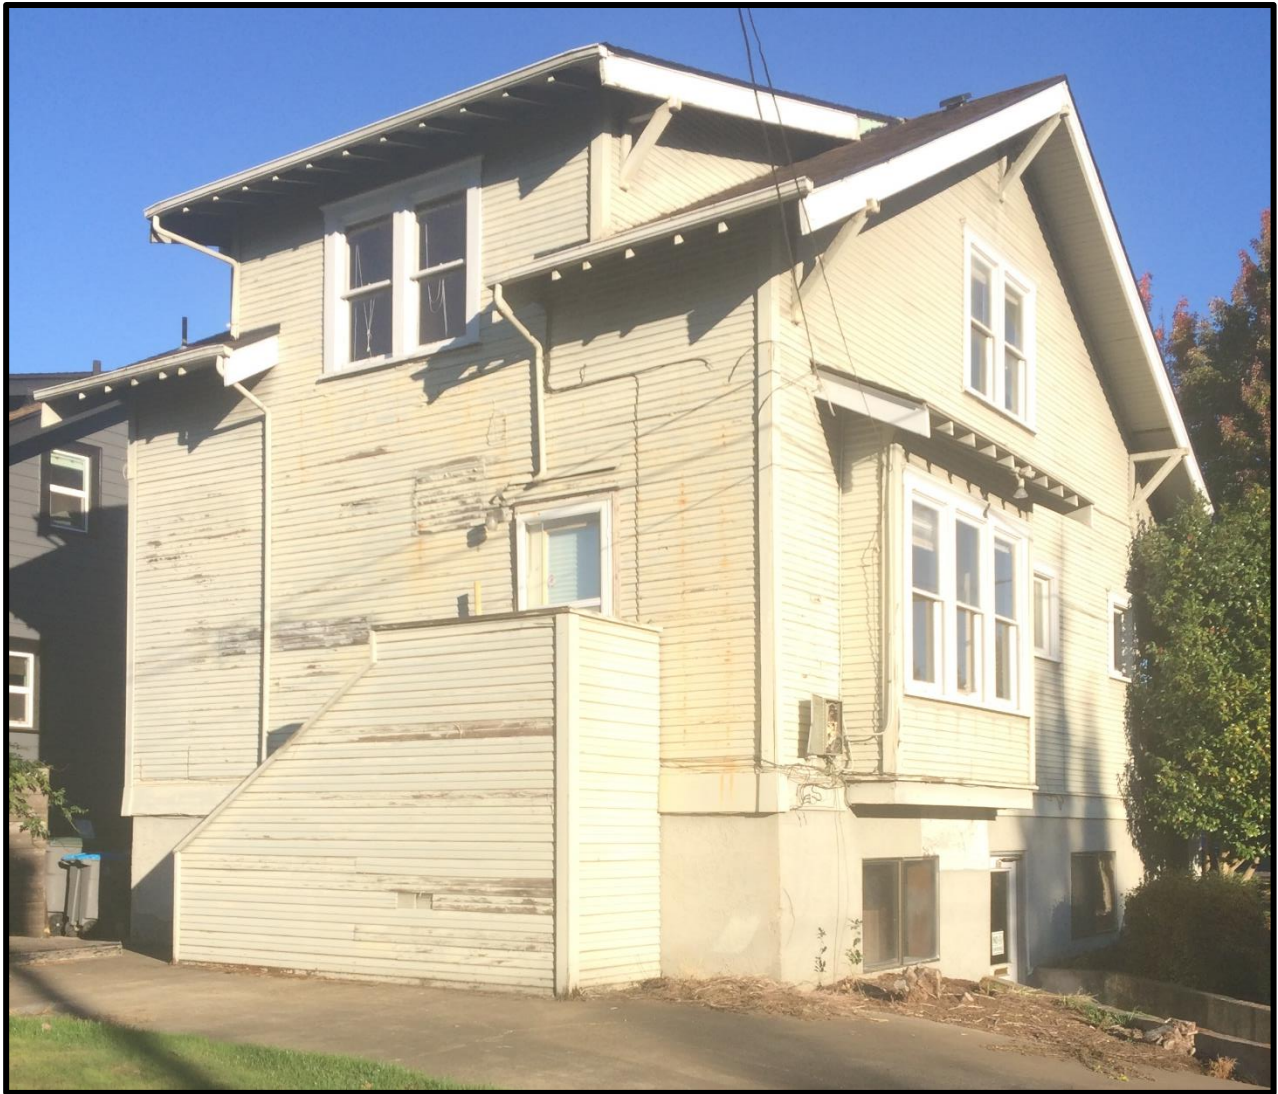
Close up views of the existing condition of overall architectural form and historic details including “red brick steps”, “full-width porch which is under the extending roof”, “boxed pillars” on the porch, a “front dormer” with “three windows and shed roof”, a “rectangular bay with a shed roof” on the east side of the structure, and a “back dormer” that “extends and is flush with the first story wall”:

Due to the overall architectural form and more detailed historic features still being in place, staff believes that the demolition proposal does not satisfy this review criteria, as the historic resource still retains much of the significance and historical value that existed at the time the resource was listed on the Historic Resources Inventory.

The applicant has provided photos serving as evidence of the existing physical condition of the historic resource. The structure has deteriorated due to failure to maintain the exterior and interior of the structure, and there are also some additions and renovations that may have been completed improperly. On the exterior of the structure, photos were provided showing damaged siding, rot damage in some of the wood features in the stairs, porch walls, and doors. Some of the additions to the main structure, such as stairs serving added entries, are in poor condition with wood rot and are separating from the main building. Photo #24 and photo #77 state that the front porch is not connected to the main structure and that the red brick steps are falling away from the porch.

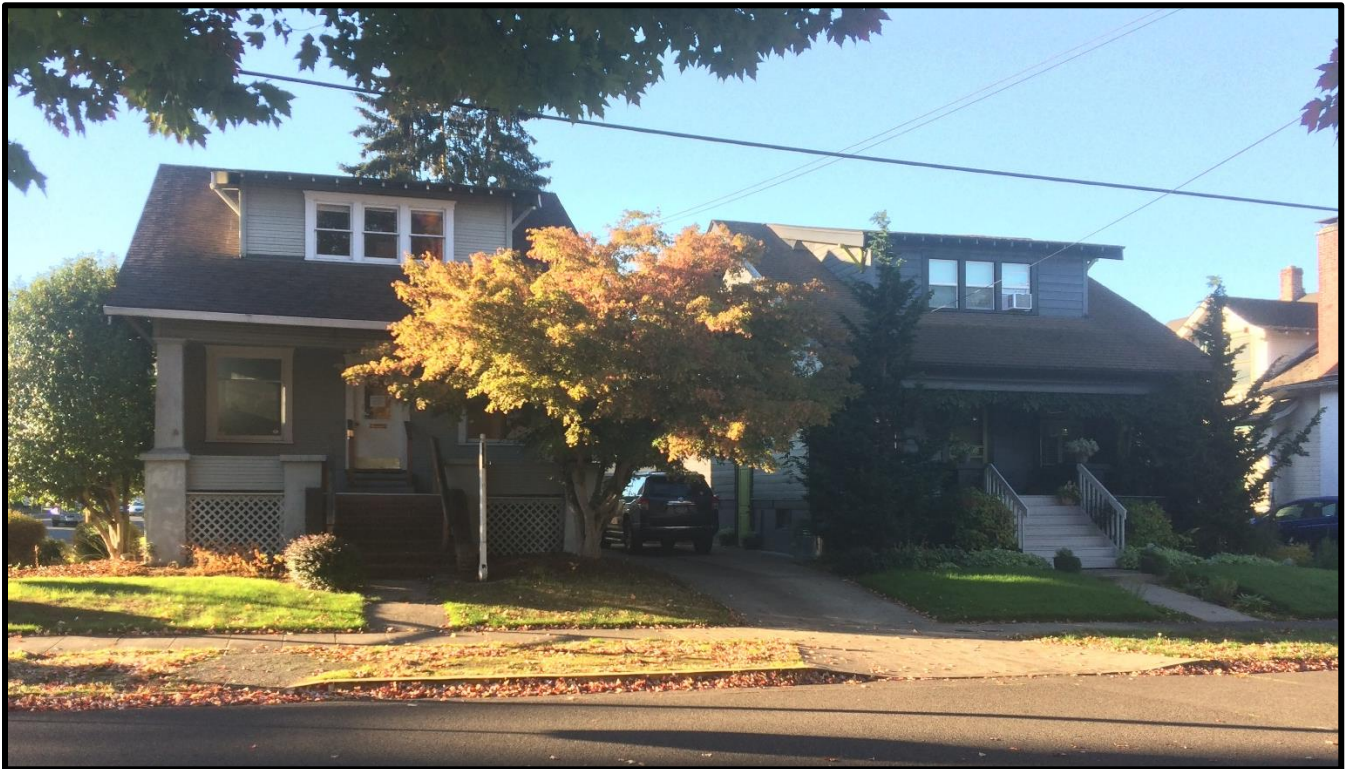
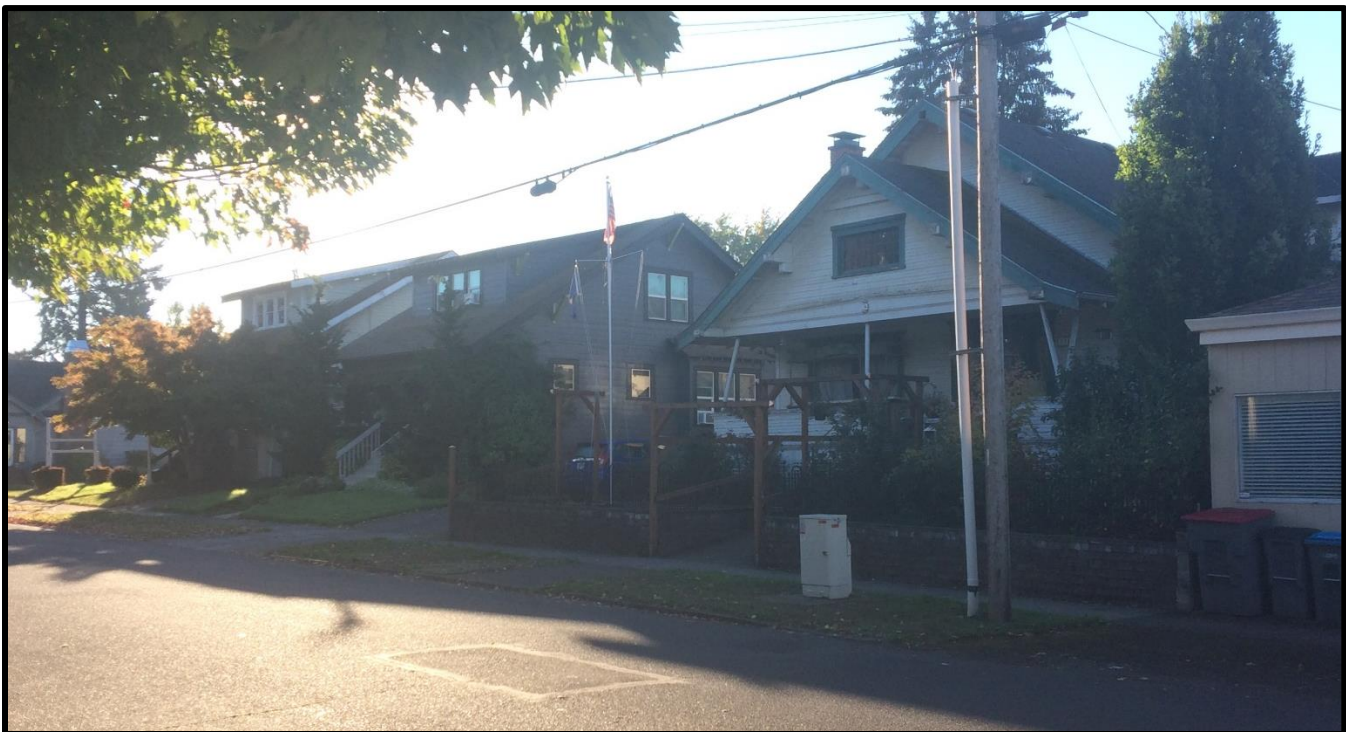
Staff believes that this continuity of existing historic resources creates a public interest in the preservation of the historic resource in question at 180 NE 7<sup>th</sup> Street. If the Historic Landmarks Committee finds that the existing structure has retained much of its historic significance and value in terms of its architectural form and historic character, as described in the description of the review criteria related to the historic resource’s value and significance above, the Committee could find that the resource being preserved would also be in the public interest due to the historic resource’s contribution to the historic character of the block on which it is located.

Photos of these historic resources are provided below:
