Certificate of Approval (~~Demolition, Moving or New Construction~~)

Property Address 618 NE 3rd Street McMinnville OR

Certificate of Approval Narrative, Demolition Structure at 618 NE Third Street, McMinnville

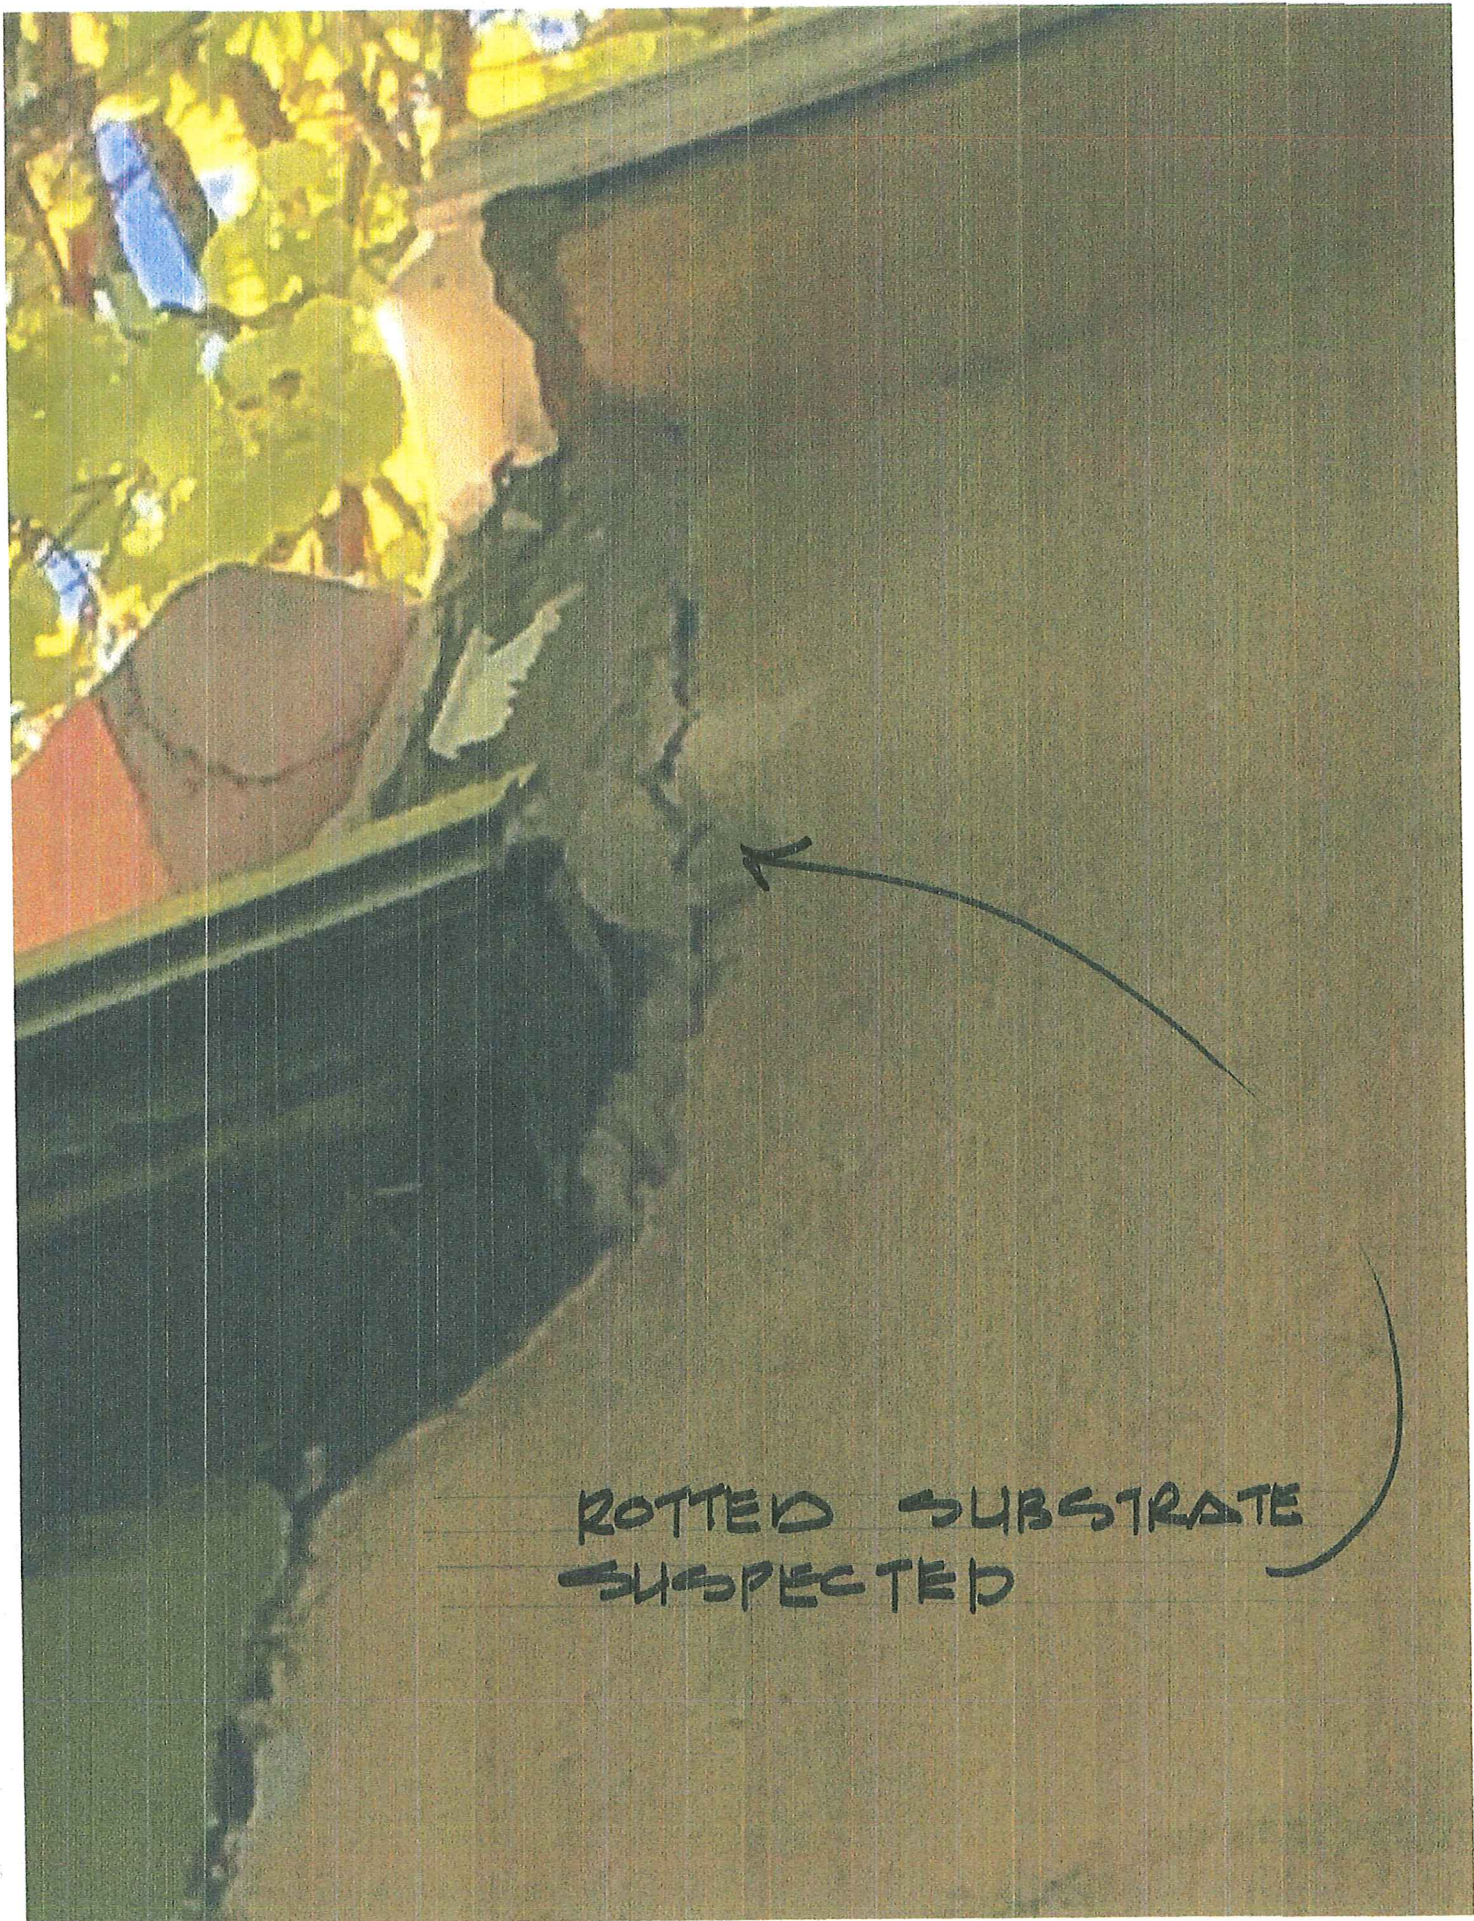
ROTTED SUBSTRATE
SUSPECTED

ROTTED FRAME

The street façade of the existing building is showing signs of rot as the result of poor detailing. Rot of window and door framing and sheathing was detected in areas shown in the attached photos. The extent of damage to the main structural framing is unknown and cannot be determined without further destructive investigation.

The street façade is showing signs of rot as the result of poor detailing. Rot of window and door framing and sheathing was detected in areas shown in the attached photos. The extent of damage to the main structural framing is unknown and cannot be determined without further destructive investigation.

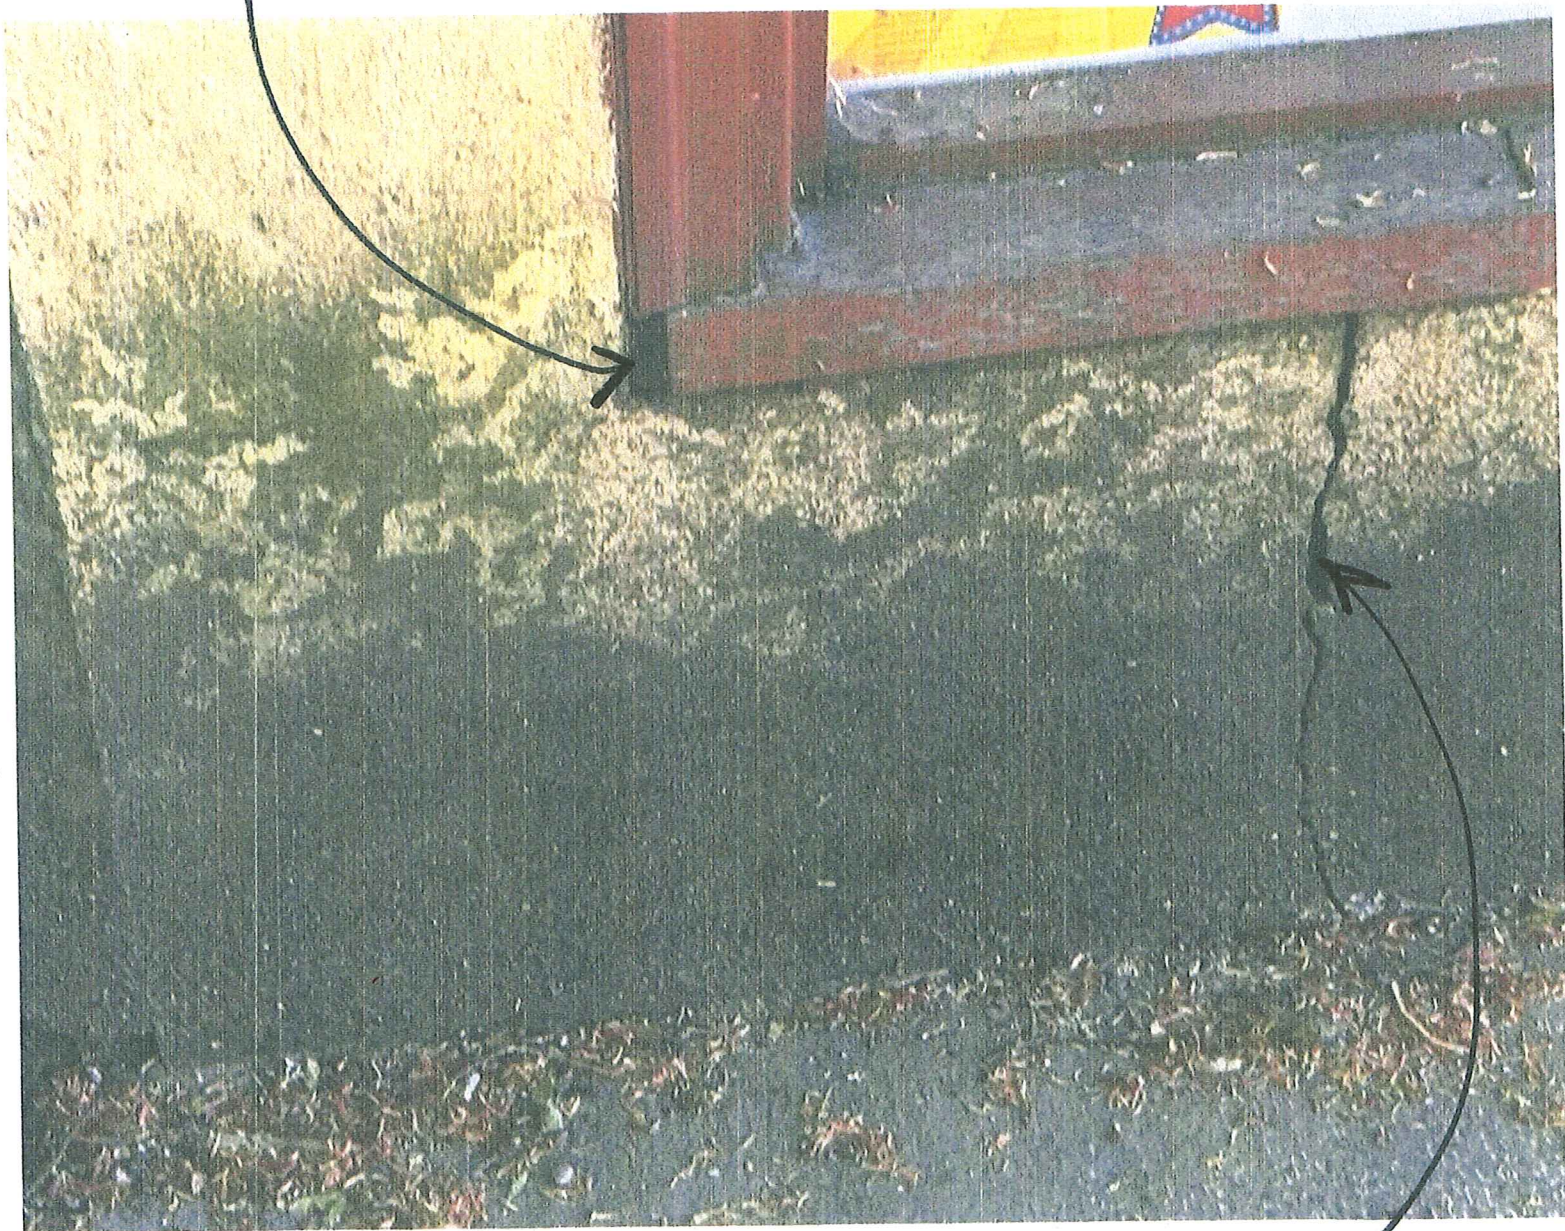
SUBSTRATE OK.

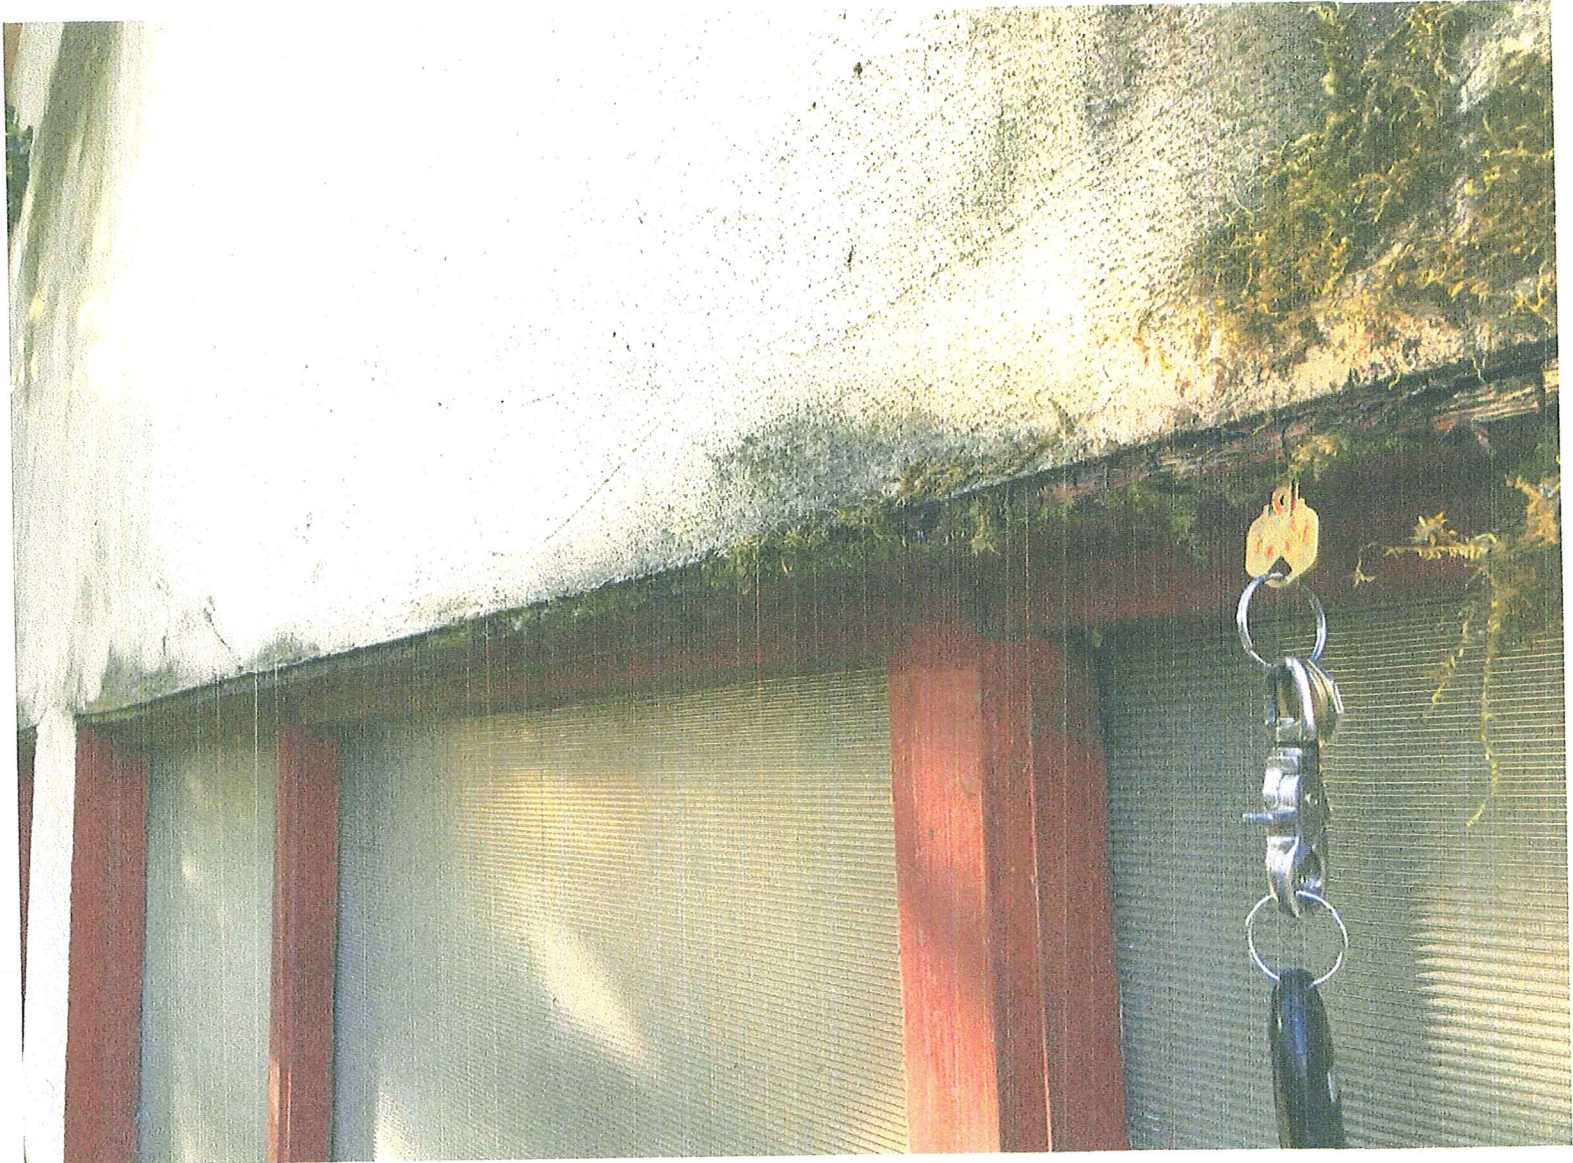
TRANSOM WINDOW HEAD

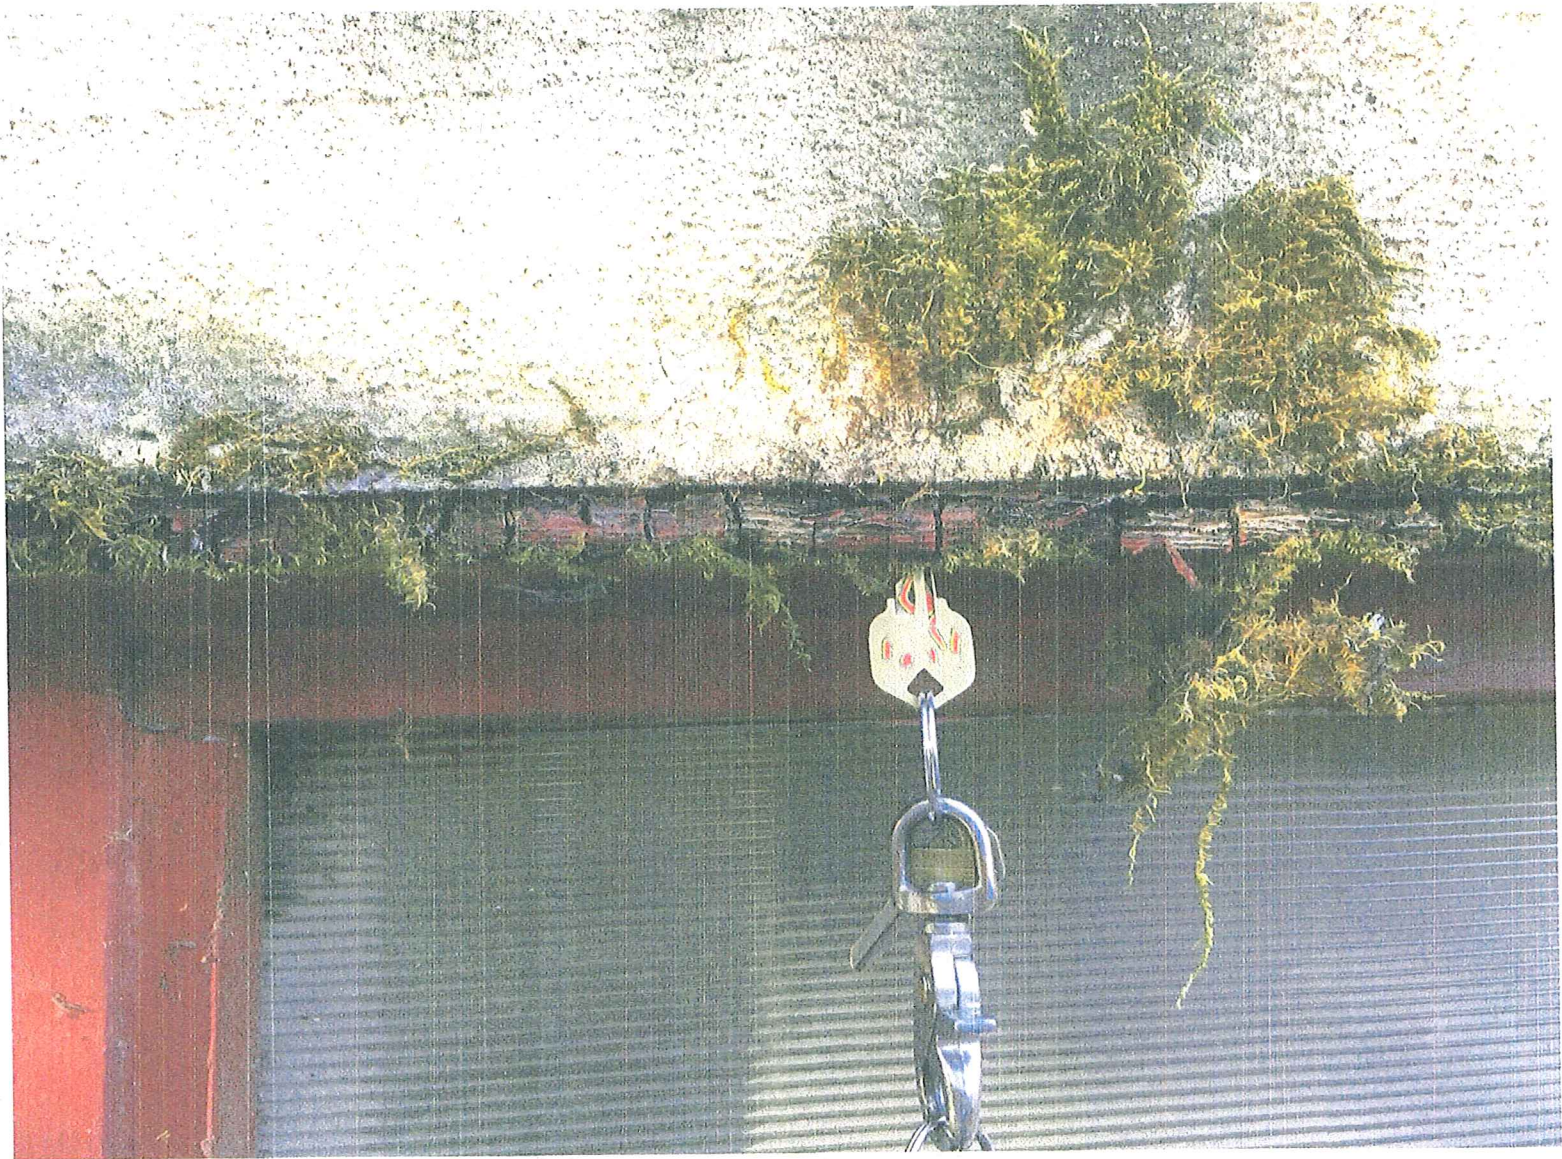
TRANSOM WINDOW HEAD
