CHAPTER 5

STRUCTURAL CONDITION DATA EVALUATION

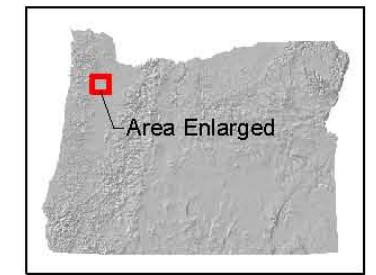
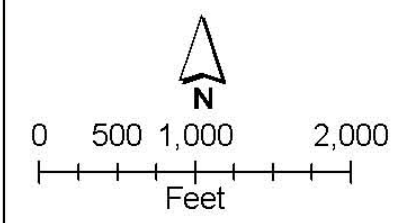
Figure 5-2
City Of McMinnville
Potential & Planned
Projects

Staff identified both planned maintenance projects (as indicated by an assigned budget) and potential maintenance projects, which do not yet have enough detail to assign costs. These have been summarized in Table 5-2, which describes project locations and descriptions. These areas are also generally shown on Figure 5-2. Only some of the listed potential project locations are shown in the figure, due to limited notes regarding project description and location.

PLANNED PROJECTS		
Project	Description	Figure 5-2 ID
643 NW 6 th Place	Mainline T replacement (6ft x 8 in pipe)	1
SE Davis St.& College St.	Mainline repair	2
240 SE Davis St. (at Lincoln St.)	Mainline repair; catch basin repair (combined w/ storm)	3
NE Evans & 4 th	Mainline repair (12” clay line); storm mainline repair	4
726 SE Villard Street	Mainline repair (6ft x 8 inch pipe)	5
807 SE Washington Street	Mainline & manhole replacement	6
1155 SW Blaine Street	Mainline repair (broken Y)	7
533 NW 12 th & 525 NW 12th	Separate & replace sanitary laterals	8
120 SE Irvine Street	Replace lateral	9
1110 NE 14 th Street	Replace lateral	10
1323 NE Kirby Street	Replace lateral	11
1329 NE Kirby Street	Replace lateral	12
1824 NE Ford Street	Repair mainline (backyard)	13
721 NE Davis & 328 NE 8 th	Separate & replace laterals	14
906 NE Second Street	Replace lateral	15
918 NE Second Street	Replace lateral	16
838 Shady Street	Separate from 834 Shady St. & install new laterals	17

129 SE Irvine Street	Replace lateral (from mainline to property line)	18
1425 NE 17 th Street	Replace mainline (20 ft. x 10 inch pipe)	19
POTENTIAL PROJECTS		
NE Second St.(between Ford & Galloway)	Mainline replacement (185 ft. x 8 inch pipe) & one manhole – downtown mainline	20
NE Third St. (between Ford & Galloway and Galloway & Irvine)	Mainline replacement (2 segments – 435 ft x 8 inch pipe) & one manhole – downtown mainline	21
NE 12 th (between Johnson & Kirby)	Mainline replacement (255 ft x 8 inch pipe, plus laterals)	22
135 NE Evans Street	Replace (141 ft x 12 inch pipe) between manhole I-8-41 & I-8-42. Replace mainline between manhole I-8-114E to I-8-152	23
SE Shady Street	Mainline replacement (300 ft. x 8 inch pipe) & lateral replacements	24
High School Basin Sewer Reconstruction II	Galloway area	25
Elm Street	Mainline replacement between NW 11 th St. and NW 21 st street including 10 manhole replacement.	26

It can be observed in Figure 5-2 that the correlation between the pipes identified by maintenance staff and those indicated by high structural ratings in the Hansen system is not great. One reason for this inconsistency is the defect types observed are not causing maintenance related problems. Cracks, ovaling, and leaking joint problems, for example, may not cause the blockages or service interruptions that result in maintenance projects.
