FACILITY CONDITION ASSESSMENT

City of McMinnville
231 Northeast Fifth Street
McMinnville, Oregon 97128
Mike Bisset

FACILITY CONDITION ASSESSMENT
OF
AQUATIC CENTER
138 NORTHWEST PARK DRIVE
MCMINNVILLE, OREGON 97128

February 11, 2019

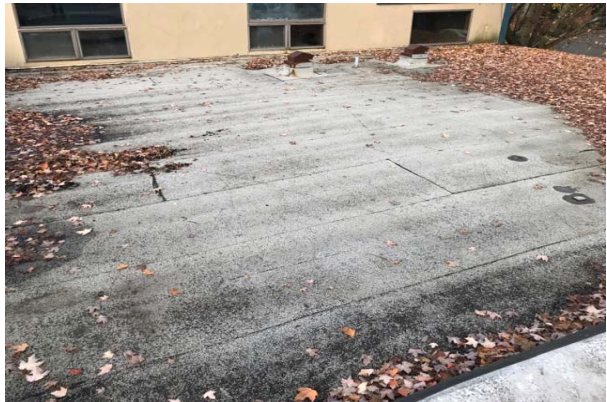
<p>Roof in Poor condition.</p> <p>Modified Bituminous Aquatic Center Roof</p> <p>Uniformat Code: B3011 Recommendation: Replace in 2019</p>	<p>Priority Score: 90.0</p> <p>Plan Type: Performance/Integrity</p> <p>Cost Estimate: \$11,700</p> <p>\$\$\$\$</p>
<p>Roofing at end of its useful life - AssetCALC ID: 1082583</p>

#22	MODIFIED BITUMEN ROOFING
-----	--------------------------
