FACILITY CONDITION ASSESSMENT

FACILITY CONDITION ASSESSMENT
OF
COMMUNITY CENTER
600 NORTHEAST EVANS STREET
MCMINNVILLE, OREGON 97128

February 8, 2019

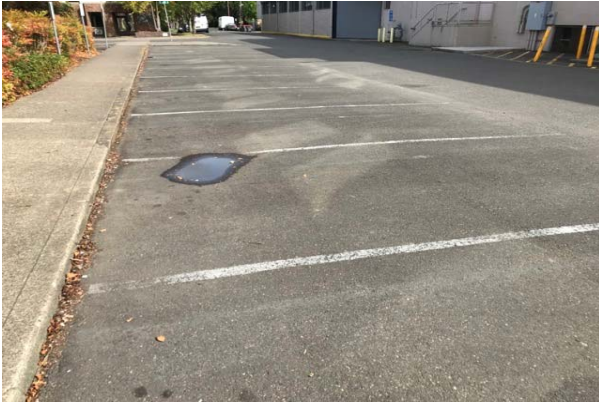
#7	PARKING AREA SOUTH PROPERTY EDGE
----	----------------------------------

The asphalt parking areas are in fair condition with some evidence of cracking and surface deterioration especially on the southeast parking lot, sealcoating and restriping will be required throughout. There was some cracking observed in the sidewalks and site ramps requiring repairs and sectional replacements during the evaluation period. The landscaped irrigation is reportedly no longer functioning normally and require replacement. There were areas along the west side of the building where the existing grade slopes towards the building causing, or exacerbating, leaking into portions of the basement.

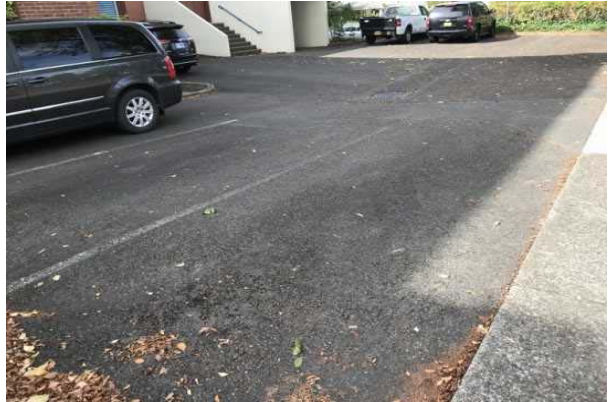
#8	PARKING AREA EAST PROPERTY EDGE
----	---------------------------------

Portions of the parking areas exhibit damage requiring mill and overlay
AssetCALC ID: 1018495

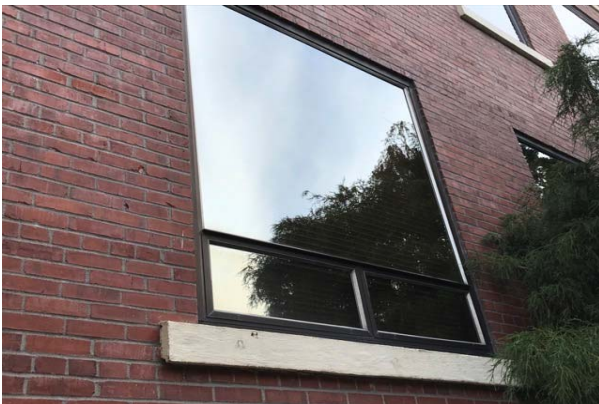
#15	EXTERIOR WINDOW
-----	-----------------

<p>Exterior Windows in Poor condition.</p> <p>Joint Caulking 0" to 1/2", 1-2 Stories Community Center Building Exterior</p> <p>Uniformat Code: B2011 Recommendation: Replace in 2018</p>	<p>Priority Score: 90.0</p> <p>Plan Type: Performance/Integrity</p> <p>Cost Estimate: \$5,000</p> <p>\$\$\$\$</p>

<p>Caulking notice to be missing and certain locations and some leaking reported - AssetCALC ID: 1018458</p>

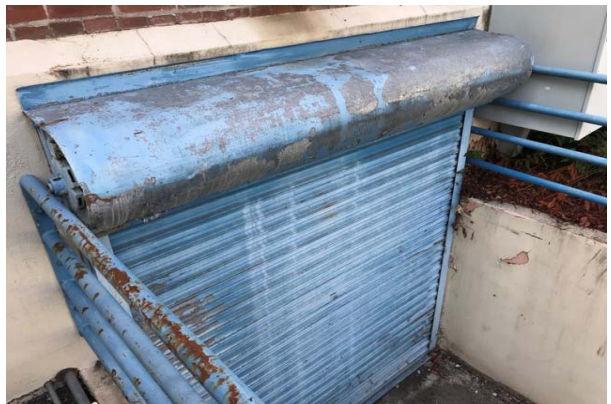
#16	OVERHEAD DOOR
-----	---------------

Steel Roll-Up 144 SF (Uniformat Code: B2034)
 Community Center Building Exterior, Southeast Corner
 Recommendation: **Replace** in 2020.
 Severe corrosion and daylight visible
 AssetCALC ID: 1018531

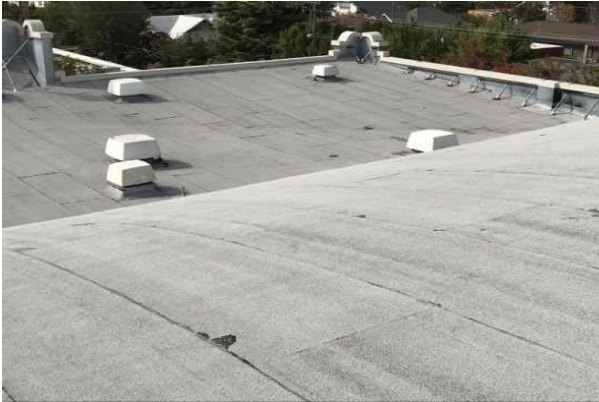
#19	ROOF, MODIFIED BITUMINOUS
-----	---------------------------

POC reported that there were a number of previous leaks and repairs - AssetCALC ID: 1018552

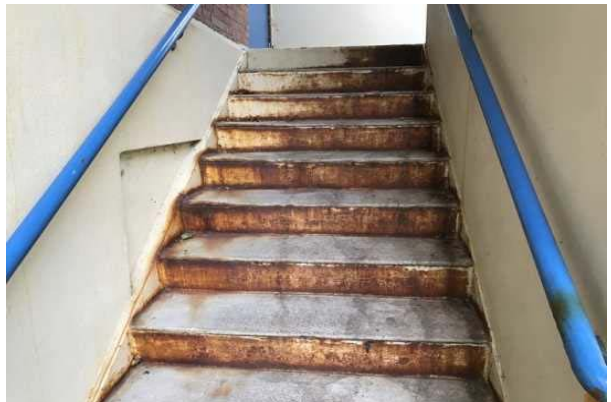
#24	EXIT STAIR
-----	------------

<p>Structural Flooring/Decking in Failed condition.</p> <p>Concrete Community Center Southwest Exit Stair</p> <p>Uniformat Code: B1012 Recommendation: Replace in 2018</p>	<p>Priority Score: 99.0</p> <p>Plan Type: Safety</p> <p>Cost Estimate: \$9,500</p> <p>\$\$\$\$</p>
<p>Metal pans on stair landings have corroded and failed and require immediate replacement - AssetCALC ID: 1018477</p>

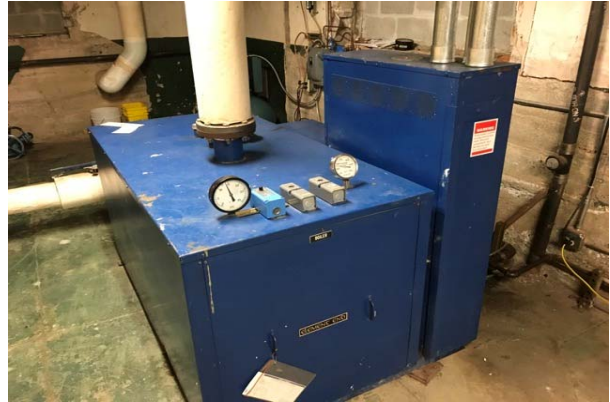
#26	HVAC BOILER
-----	-------------

Boiler in Failed condition.

Unit currently not operating due to heavy leaks - AssetCALC ID: 1018493

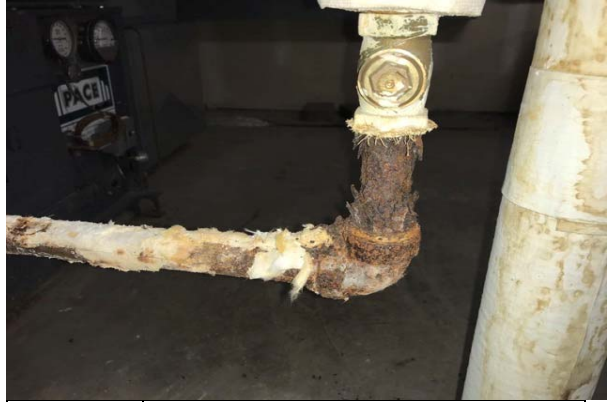
#32	HVAC SYSTEM HYDRONIC PIPING
-----	-----------------------------

HVAC System Piping Repairs in Poor condition.

Piping and valves are currently leaking and have significant rusted pipe locations.
 AssetCALC ID: 1032247

Copper (Uniformat Code: D3049)
 Community Center Boiler room
 Recommendation: **Replace** in 2018.
