FACILITY CONDITION ASSESSMENT

SENIOR CENTER
2250 NORTHEAST MCDANIEL
MCMINNVILLE, OREGON 97128

February 11, 2019

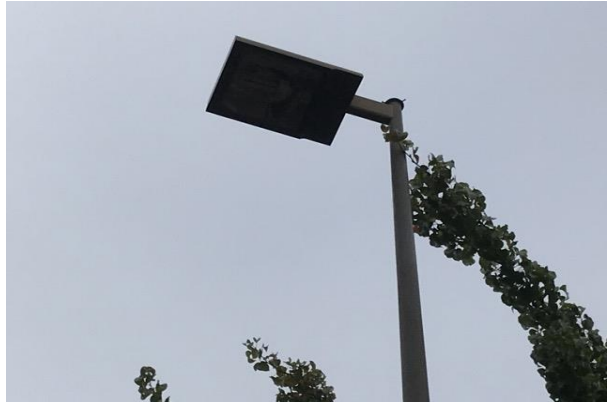
#14	POLE LIGHT, EXTERIOR
-----	----------------------

According to Pre-Survey Questionnaire, inadequate lighting in parking lot. This is an allowance for the installation of two more pole lights. - AssetCALC ID: 1088265

Uniformat Code: G4021
Recommendation: **Replace/Install in 2018**

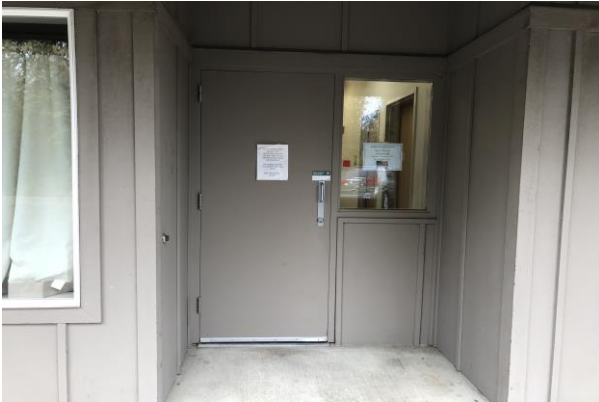
#21	EXTERIOR DOOR
-----	---------------

<p>Exterior Door in Poor condition.</p>	<p>Priority Score: 88.0</p>
	<p>Wood Solid-Core Senior Center Building Exterior</p>	<p>Plan Type: Performance/Integrity</p>
	<p>Uniformat Code: B2032 Recommendation: Replace in 2019</p>	<p>Cost Estimate: \$3,200</p>
		<p>\$\$\$\$</p>
<p>The exterior doors to the main panel board closets are at the end of their expected useful life, and are currently stuck closed due to broken strike plate. - AssetCALC ID: 1085847</p>

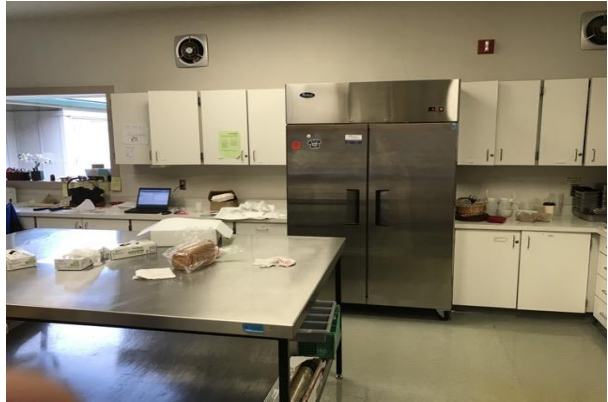
#32	KITCHEN
-----	---------

<p>Kitchen Fire Suppression System</p>	<p>Priority Score: 61.0</p>
	<p>Commercial Senior Center Kitchen Exhaust Hood</p>	<p>Plan Type: Modernization/Adaptation</p>
	<p>Uniformat Code: D4091 Recommendation: Replace in 2018</p>	<p>Cost Estimate: \$5,000</p>
		<p>\$\$\$\$</p>
<p>According to Pre-Survey Questionnaire, the kitchen fire suppression is been identified as a fire code violation. Currently a sprinkler head is installed in place of approved agent. - AssetCALC ID: 1088264</p>
