Property  
404 NE Irvine Street  
McMinnville, Oregon 97128

## Historic Resources Inventory Amendment

Photos of 404 NE Irvine Street

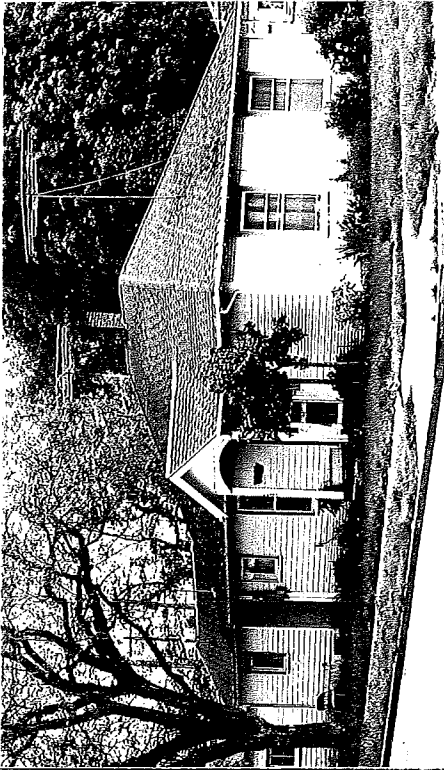
A one story medium hip roof structure with cornerboards and beveled wood siding; a single central interior chimney. All windows are corniced and are double hung sash with plain mouldings. The off center east entrance has a door with side lights; the door is corniced with plain moulding and has a projecting one bay pediment porch with plain barge board and a semi-circular arch. It is supported by wood pillars on a small wooden porch. The foundation is concrete. There is an attached low gable extension on the north which appears to be an original small separate apartment. There is also a small hip roof extension on the northeast corner. There is a detached beveled wooden garage.

- \_\_\_\_\_ 1. Holes in walls.
- \_\_\_\_\_ 2. Open cracks.
- x   3. Missing material in small area. roof
- \_\_\_\_\_ 4. Rotten sills or frames.
- \_\_\_\_\_ 5. Deep wear on stairs.
- \_\_\_\_\_ 6. Poor or no foundation.
