Architectural
Resources Group

609, 611, and 619 NE 3rd Street
McMinnville, Oregon

Historic Resource Assessment
November 2022

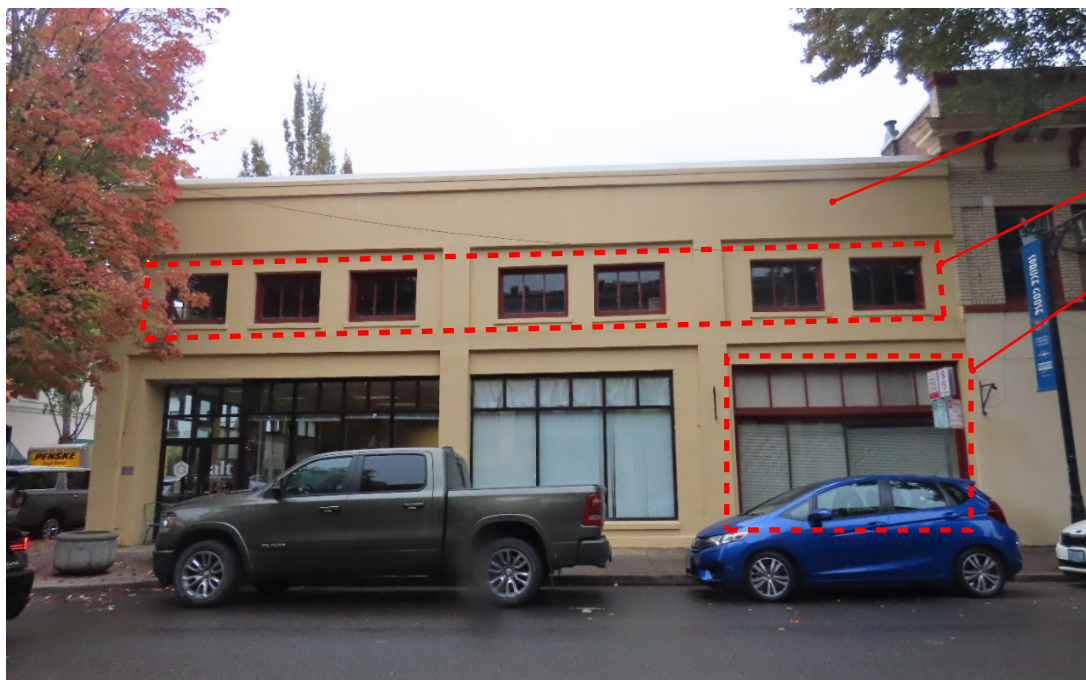
South Elevation facing NE Third Street, illustrating original features (ARG, October 2022).

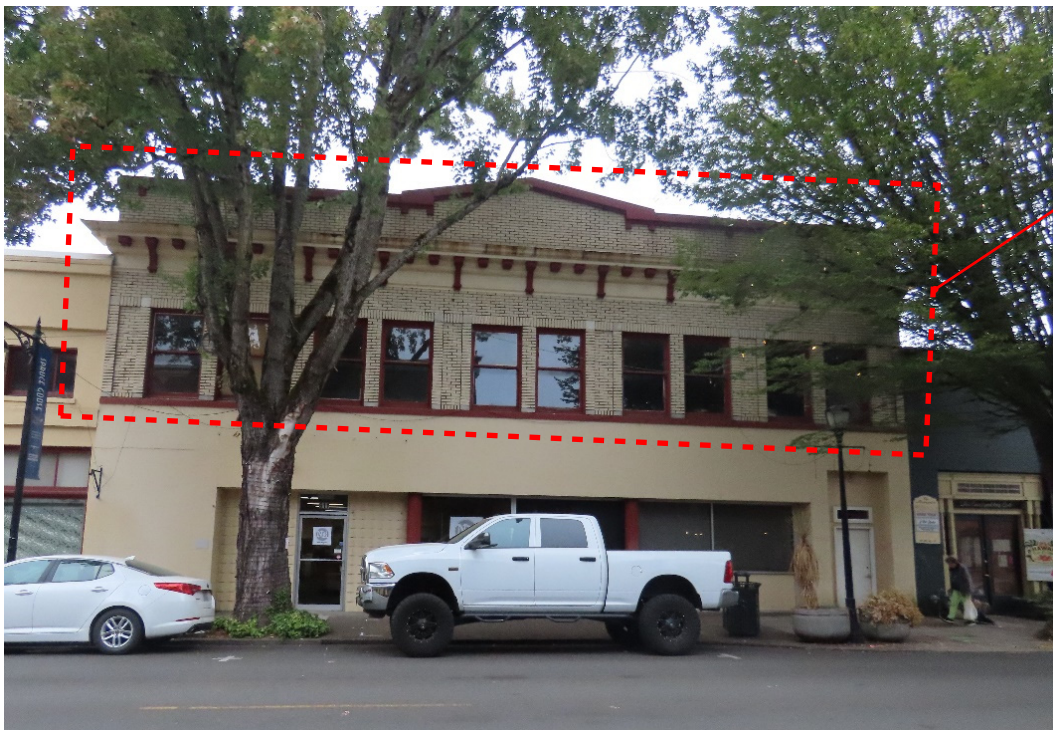
611 NE 3rd Street, current view (ARG, October 2022)

- Original wood windows, frames and sash
- Original brick and cast concrete elements
- Original pressed metal cornice

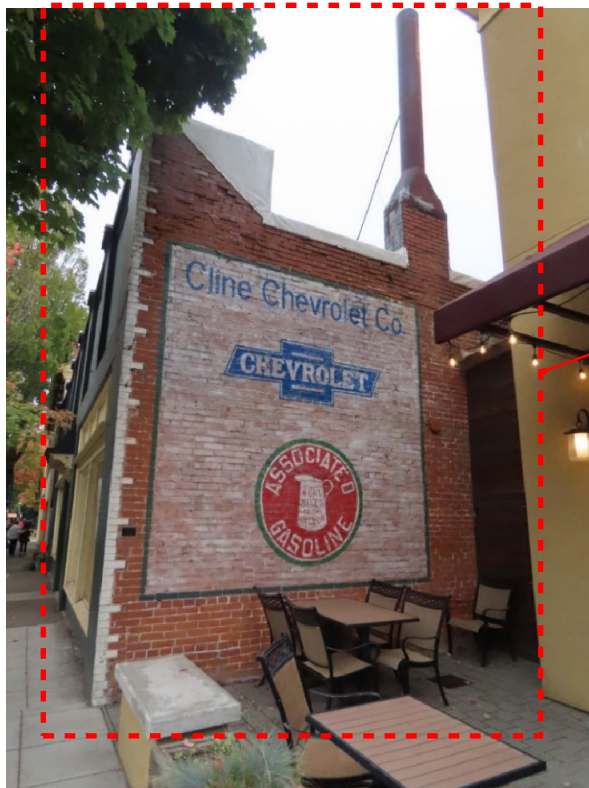
619 NE 3rd Street, Southwest corner, showing restored signage at east elevation (ARG, October 2022).

- The restoration of the painted signage at the east elevation is noted on a plaque at the corner of the building. Signage is in good condition.
- The original roof configuration remains. As noted for 611 NE 3rd Street, a sign at the roof indicates that the roofing is a Duro-Last Roof. Roofing replacement at all three buildings appears to have been done at roughly the same time, with the same roofing system. Roofing appears to be in good condition generally, and keeping water out of the building, although roofing material does not allow assessment of the substrate.

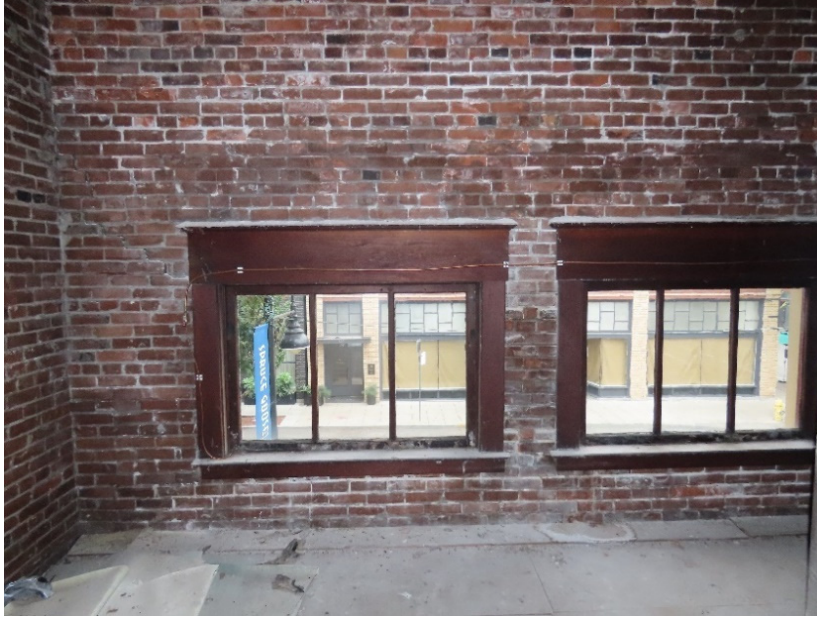
- The second-floor interior, at the south side of the building, is vacant and has been unused for a significant time period. As noted previously, the windows are in fair to good condition, including original millwork surrounds. Where plaster remains, it is in poor condition. Some areas of step cracking at mortar joints are located at the interior south brick wall near the southeast corner; this cracking was not seen at the exterior side of the masonry, and masonry displacement was not observed.

Photo 3. Second floor window, interior view, showing original millwork surrounds (ARG, October 2022).

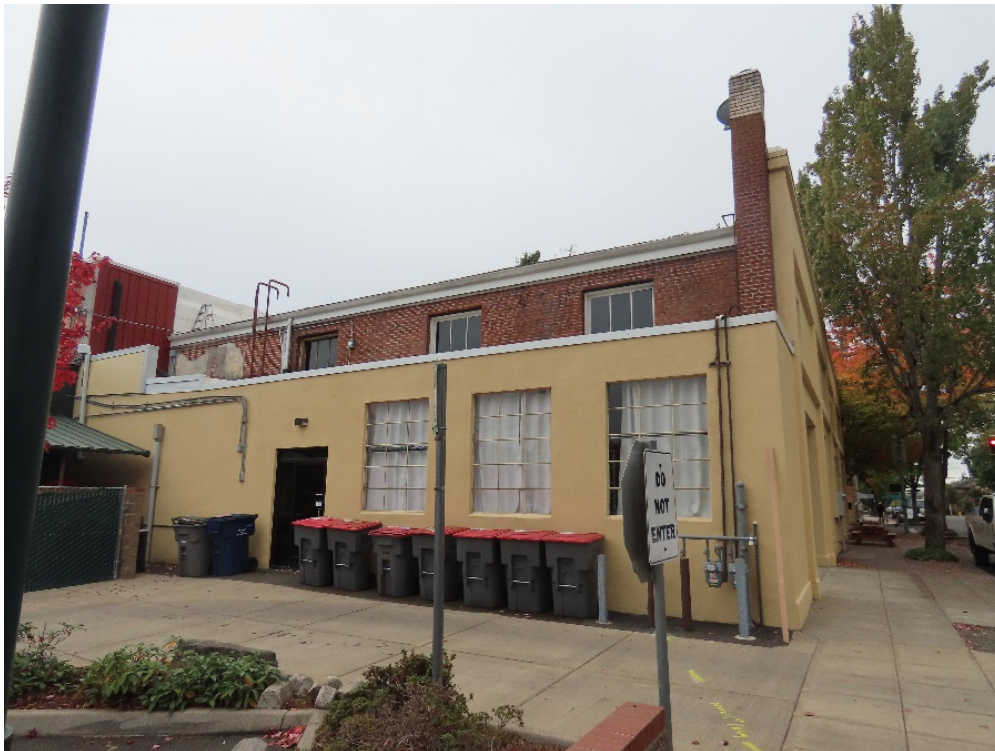
Photo 6. One-story north bay, rear elevation, showing original second floor windows, And steel windows at ground floor (ARG, October 2022).

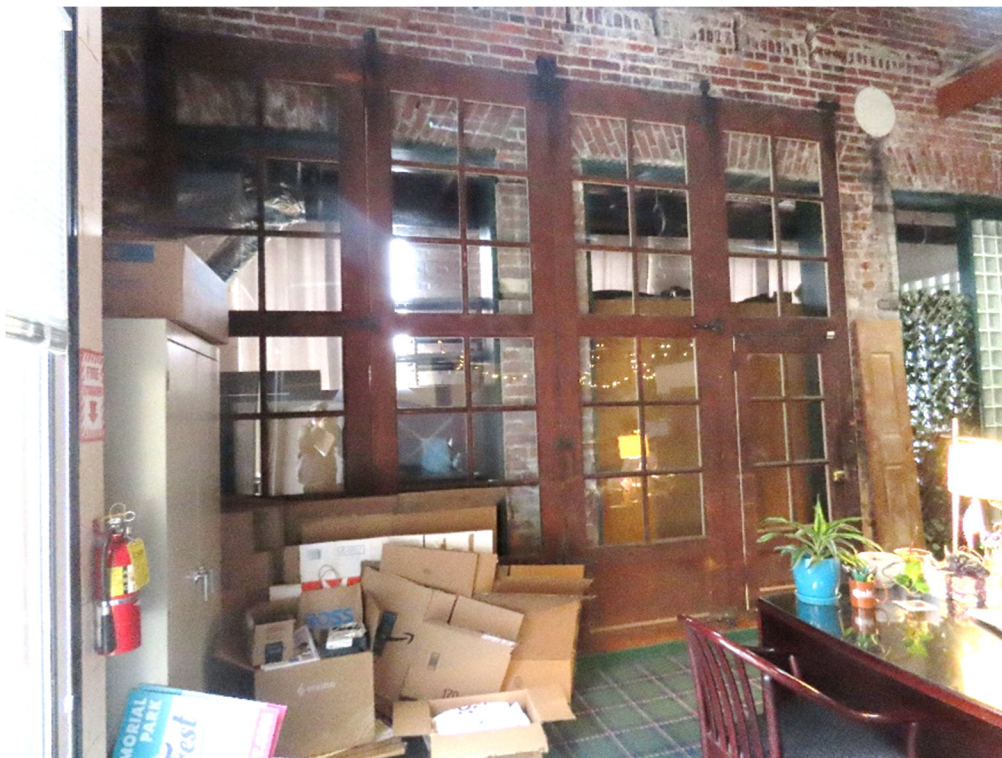
Photo 8. Wood door at NW corner interior, possibly relocated from an original storefront (ARG, October 2022).

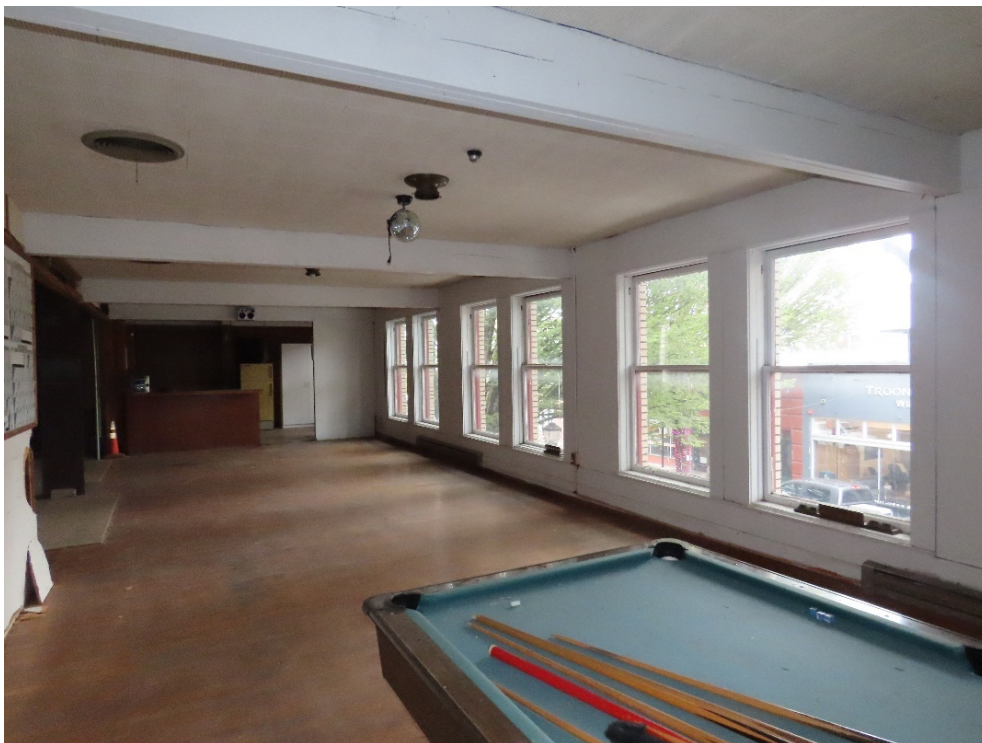
Photo 12. Second floor interior view of original wood windows (ARG, October 2022).

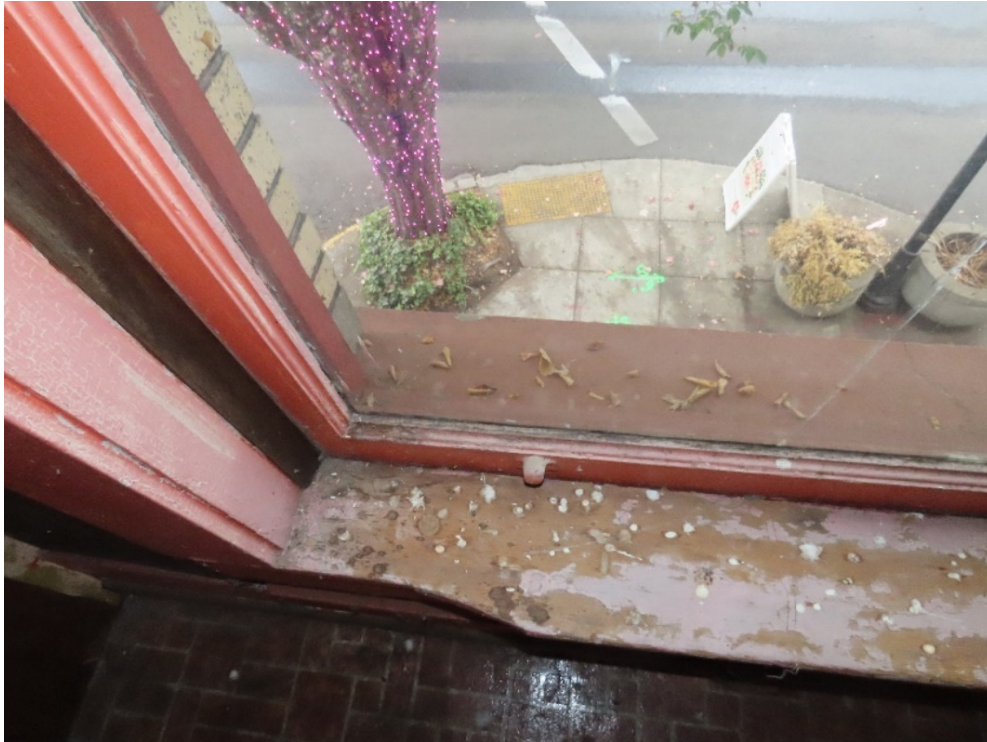
- All original elements of the south elevation remain intact at the second floor, and are generally in good condition. Minor paint failure was noted at the wood windows, and repair, prep and repainting of windows is recommended. One window has been covered at the interior side with plywood. The sheet metal cornice has areas of minor corrosion and should be prepped and repainted. Brick is in good condition, although areas of minor mortar deterioration were observed, and selective repointing of deteriorated areas of mortar is therefore recommended. Significant biological growth was observed at the top surfaces of the cementitious coping, and obscures conditions, although the cementitious material appears to be in good condition. Biological growth should be removed.

Photo 13. Detail, original second floor window (ARG, October 2022).

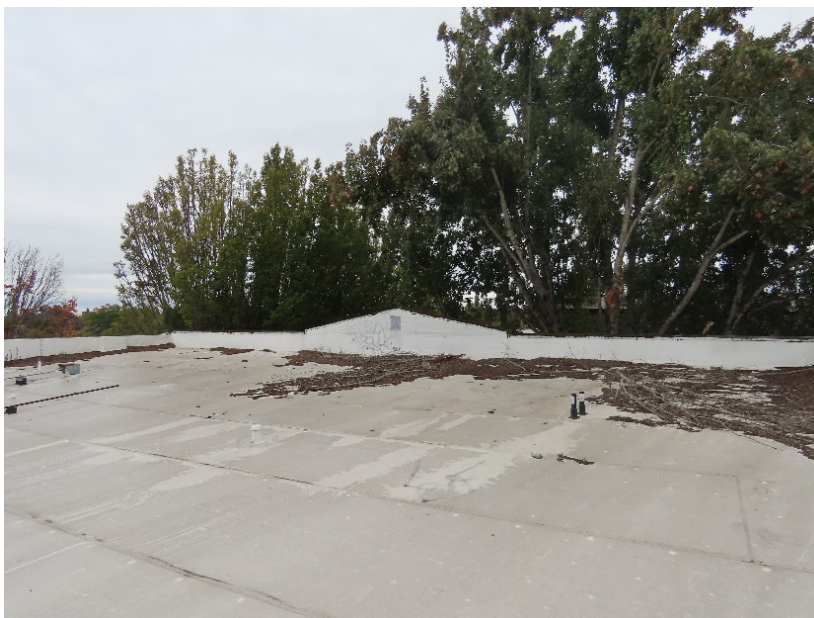
- The original roof configuration remains. As previously noted for 609 NE 3rd Street, a sign at the roof indicates that the roofing is a Duro-Last Roof. Roofing replacement at all three buildings appears to have been done at roughly the same time, with the same roofing system. Roofing appears to be in good condition generally, and keeping water out of the building, although details that wrap surfaces such as parapets and copings are atypical and do not allow assessment of the substrate. Significant areas of damaged ceiling finishes and areas of water infiltration are visible at the north end of the second floor, but it is unknown if water infiltration is active or if it pre-dates the roofing replacement. The roof surface drains to a drain at the rear, NW corner of the building, with an overflow scupper to an external leader emptying to the lower roof of 609 NE 3rd Street below. The roof drain is completely clogged, and it is therefore likely that during rain events water pools at this area of roofing, possibly infiltrating to the interior before reaching the overflow scupper. Leaf and branch debris at the south and north ends of the building is significant and should be removed as part of a regularly scheduled maintenance plan.

Photo 16. Roof looking south (ARG, October 2022).

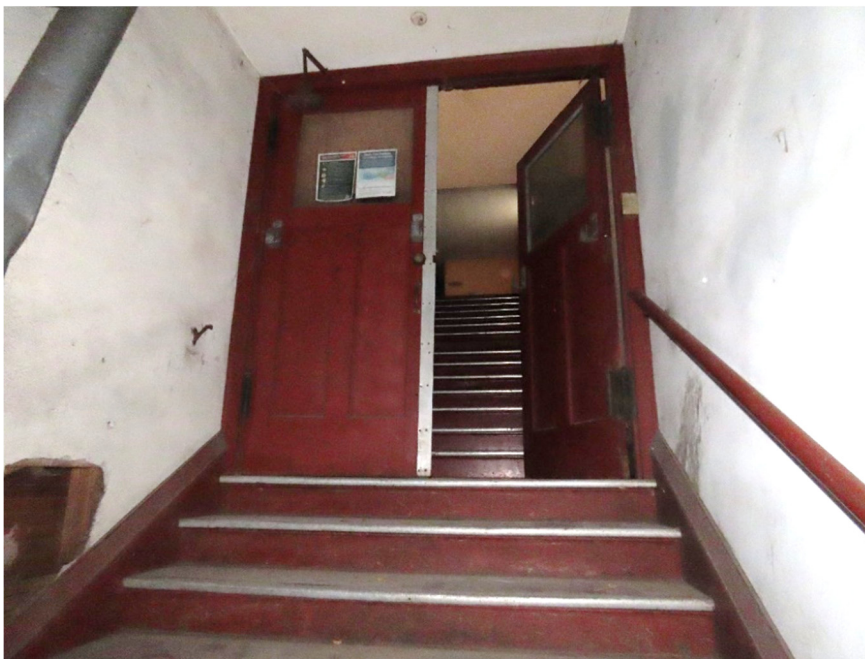
Photo 18. Original pair of doors at SE stair to second floor (ARG, October 2022).

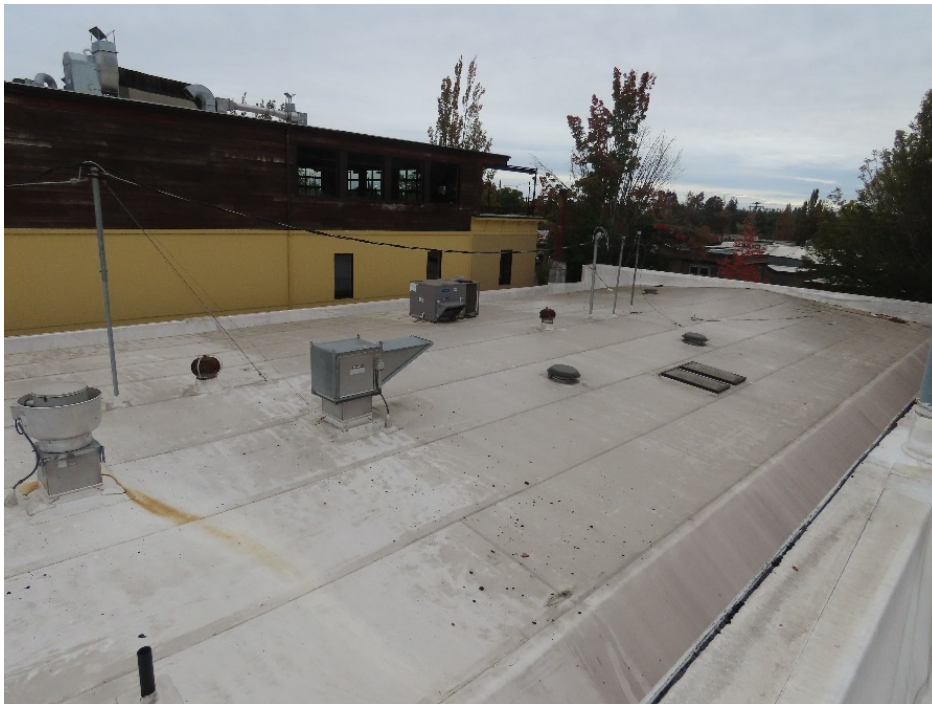
Photo 24. Roof overall view looking south (ARG, October 2022).

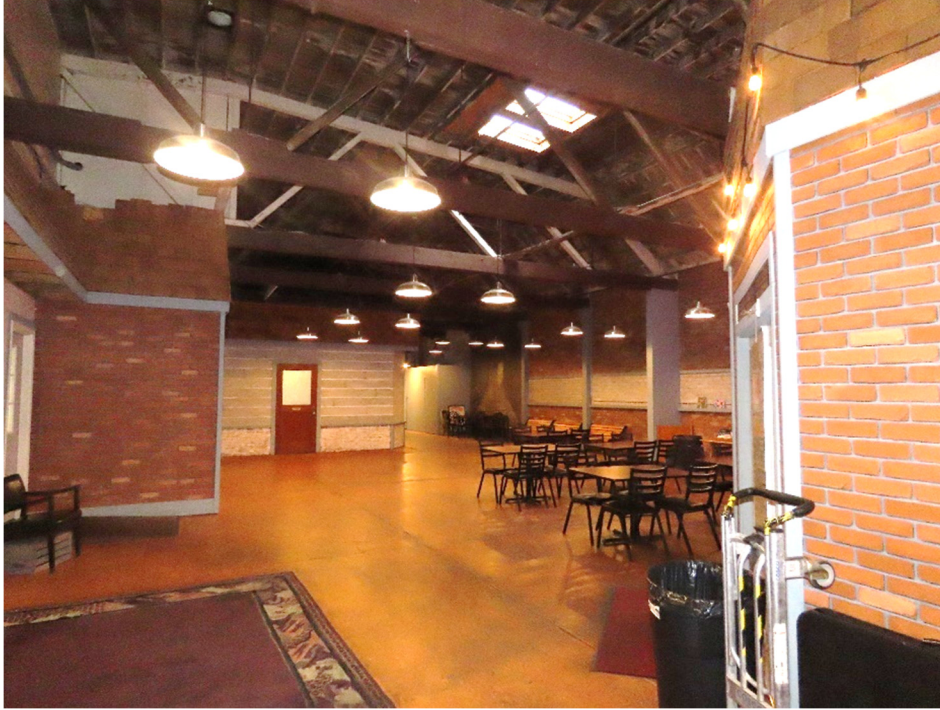
Photo 25. Interior view with wood trusses above (ARG, October 2022).
