Re: Documentation of Existing Building Structures

Project: Gwendolyn Hotel HHPR Structural Project OTA-07
609, 611 and 619 NE 3rd Street McMinnville Oregon

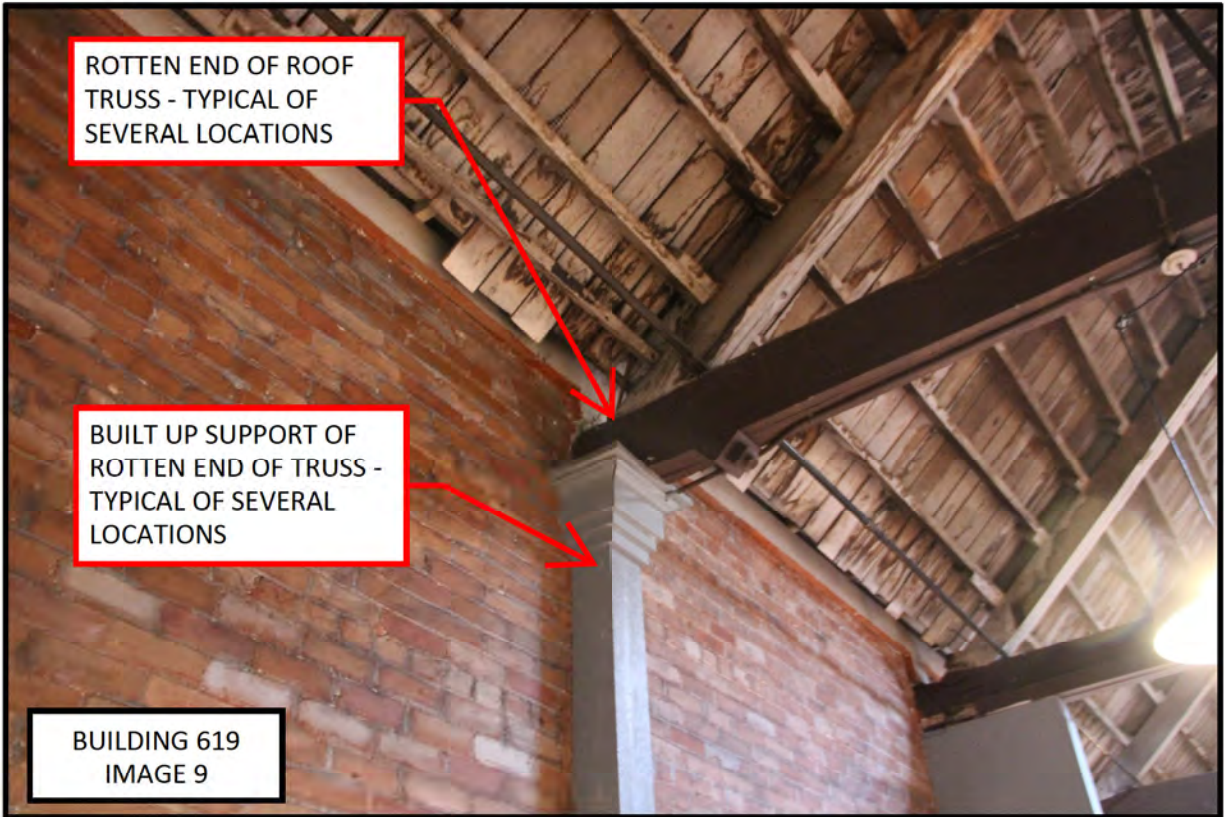
Ceiling Framing

- There exist dimensional lumber framed ceilings over the existing retail space
- In the common areas between the retail spaces is a high-volume space where the trusses and roof joists are visible
