SECTION 7

Hydraulic Analysis Results and Drainage Improvements

**City of McMinnville
Stormwater Drainage Master Plan**

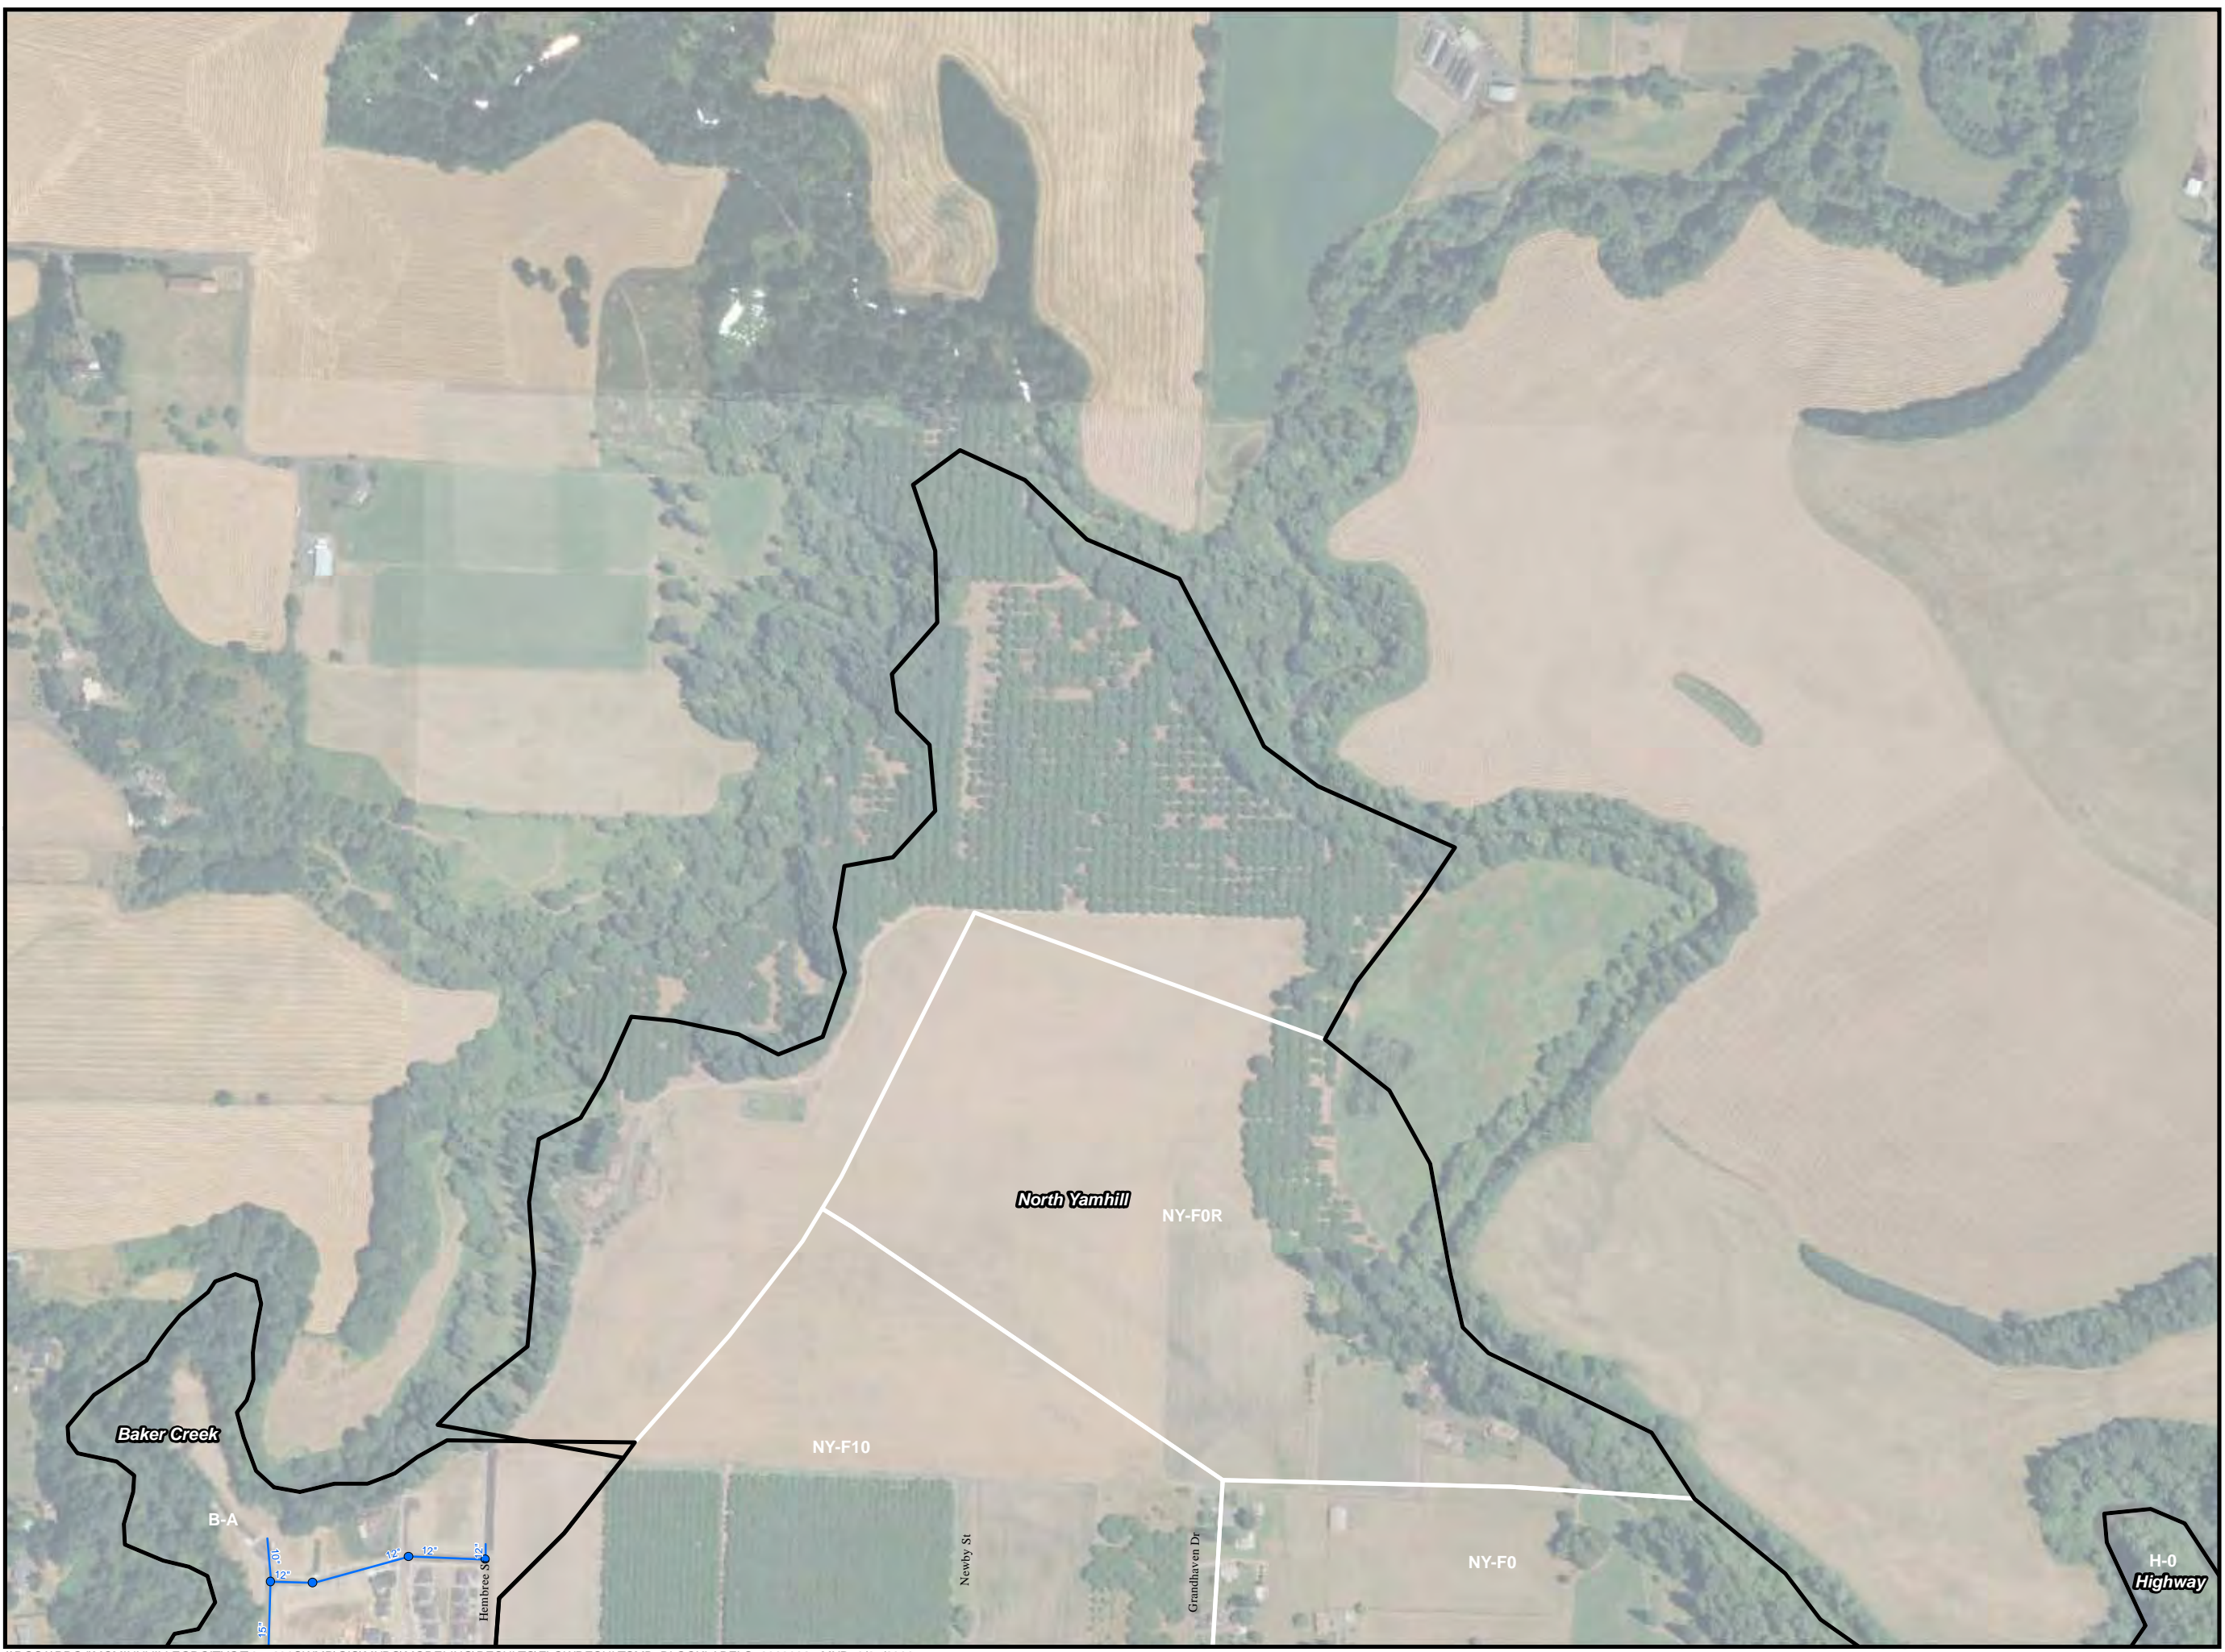
FIGURE 7-A3

HYDRAULIC RESULTS & RECOMMENDED IMPROVEMENTS

Modeled pipelines shown on these figures are color coded to indicate four levels of deficiency risk: very low, low, medium, and high. The figures show the following information for each of these pipe segments: existing 10-year storm event flow, future 10-year storm event flow, existing pipe diameter, and pipe diameter required to meet design criteria for full build-out flow condition. This is referred to as “replacement” pipe diameter, although improvements are not necessarily recommended in every case.

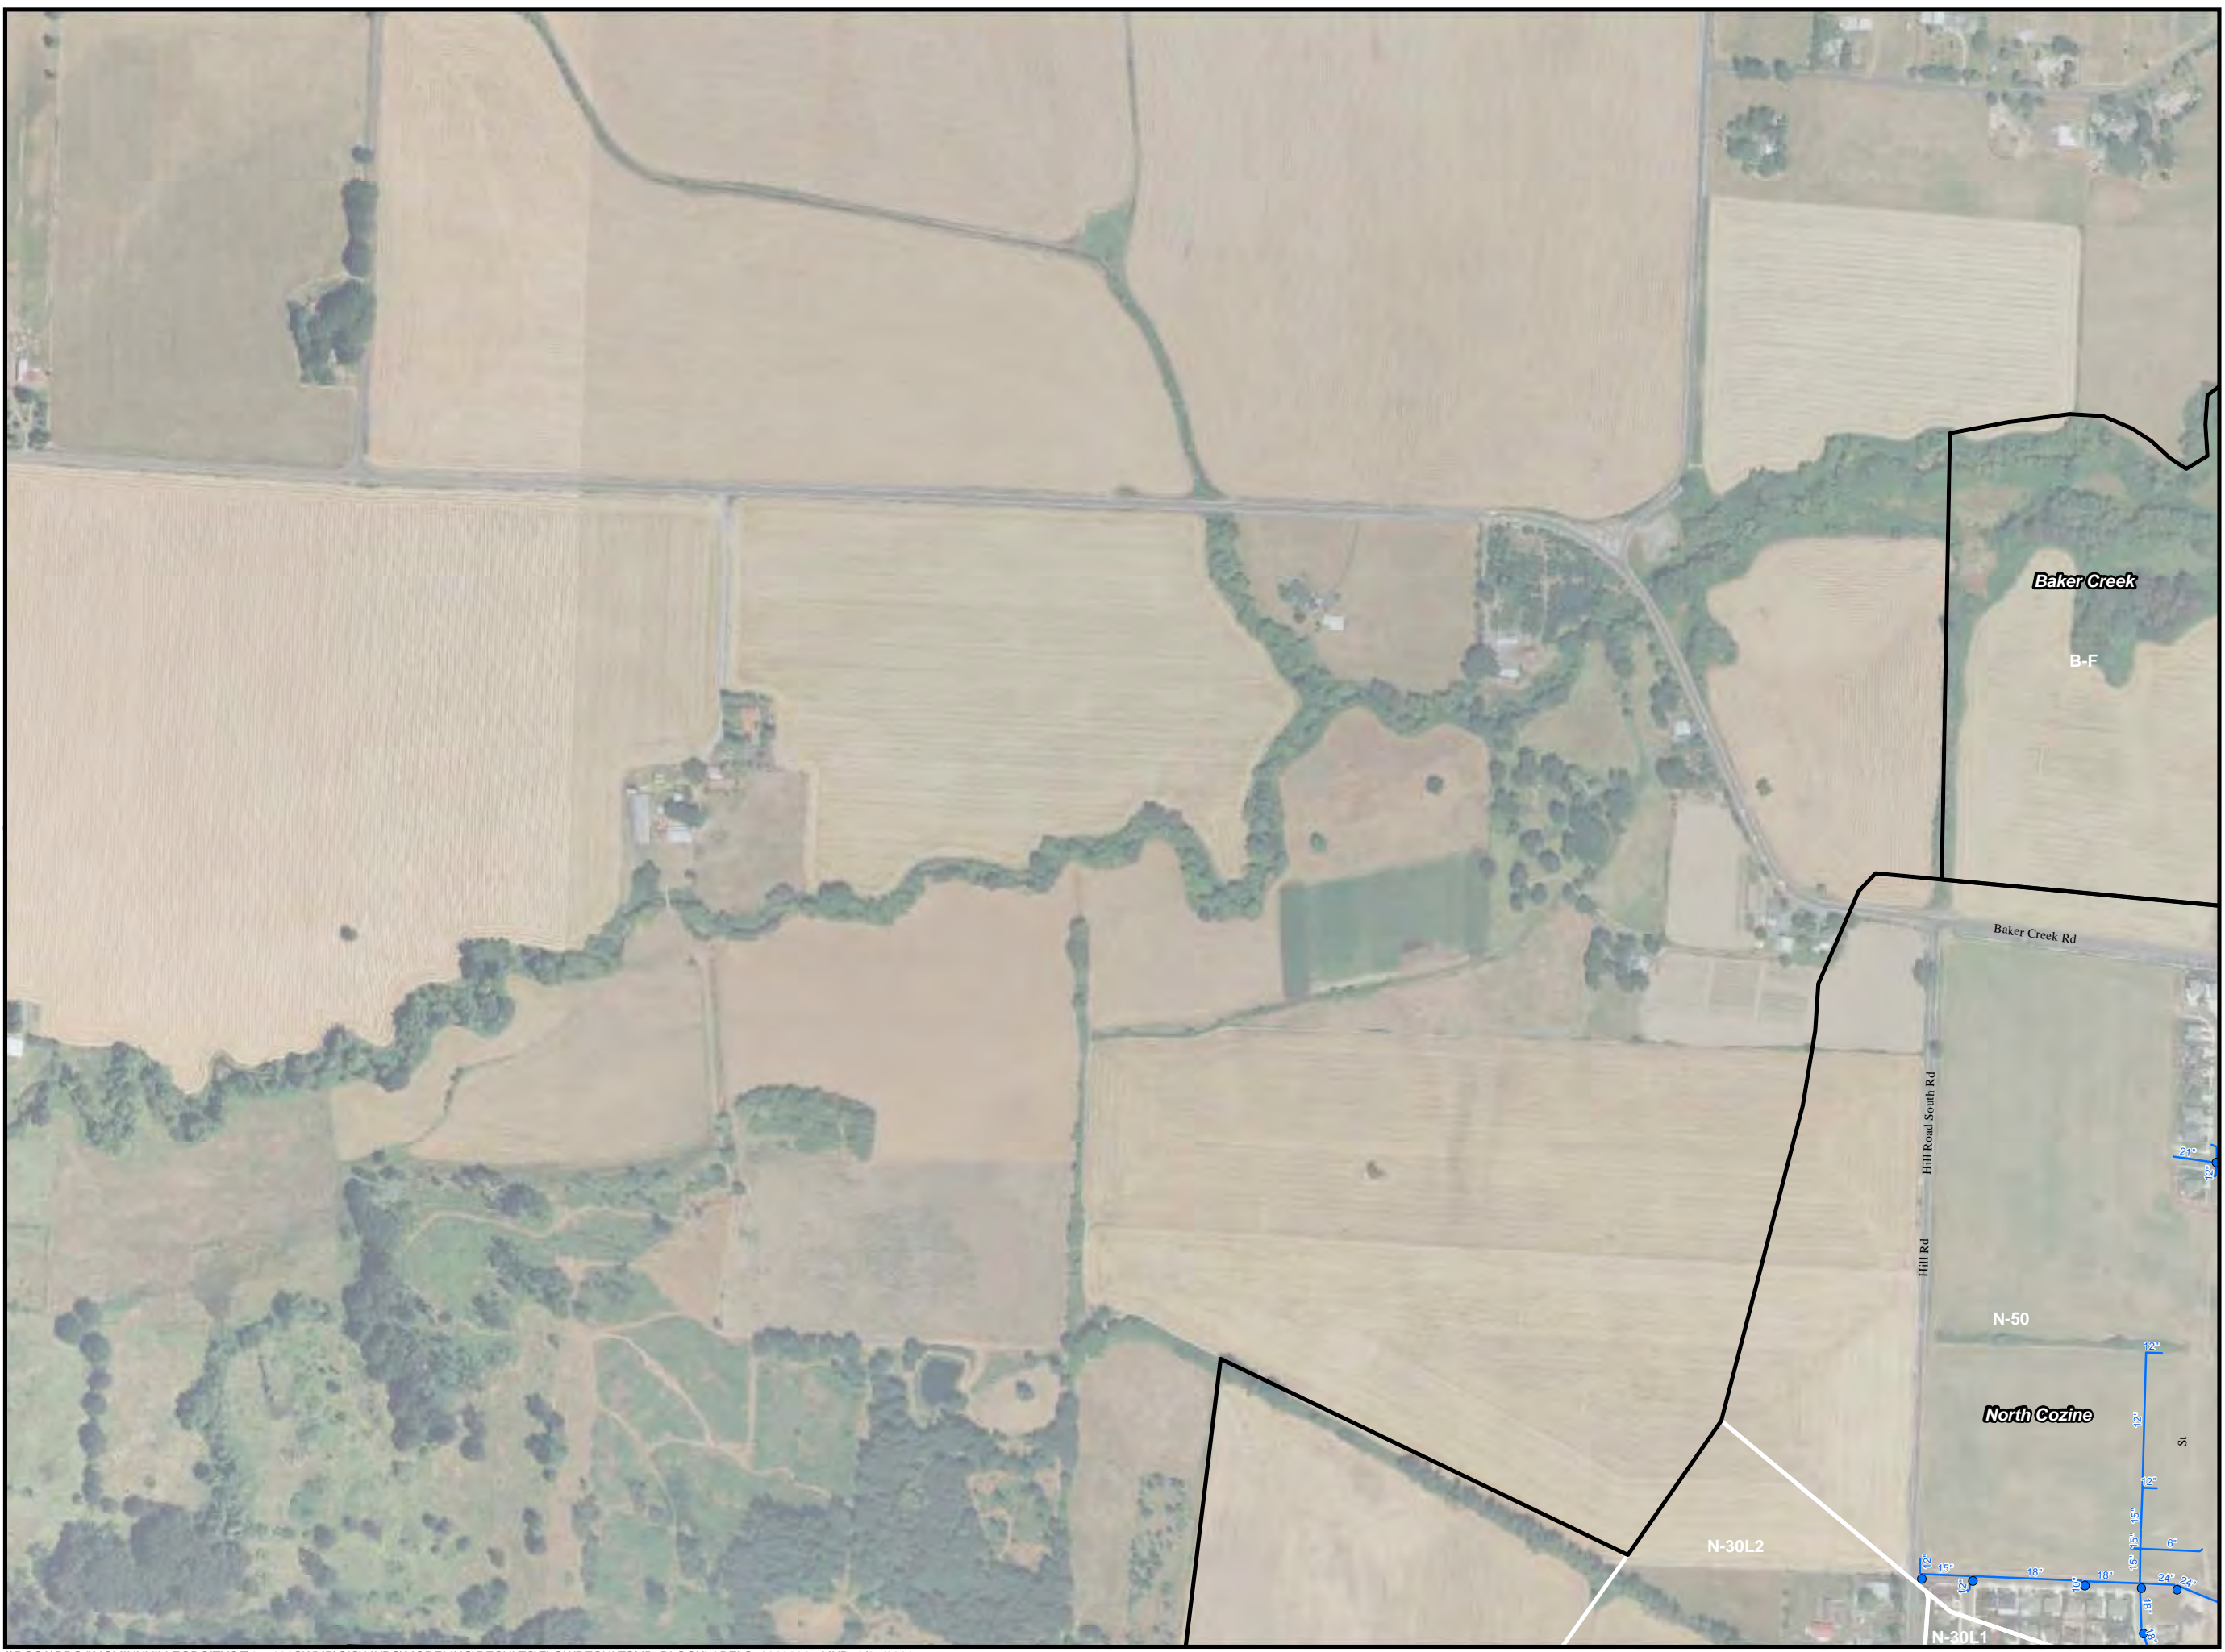
FIGURE 7-B1

HYDRAULIC RESULTS & RECOMMENDED IMPROVEMENTS

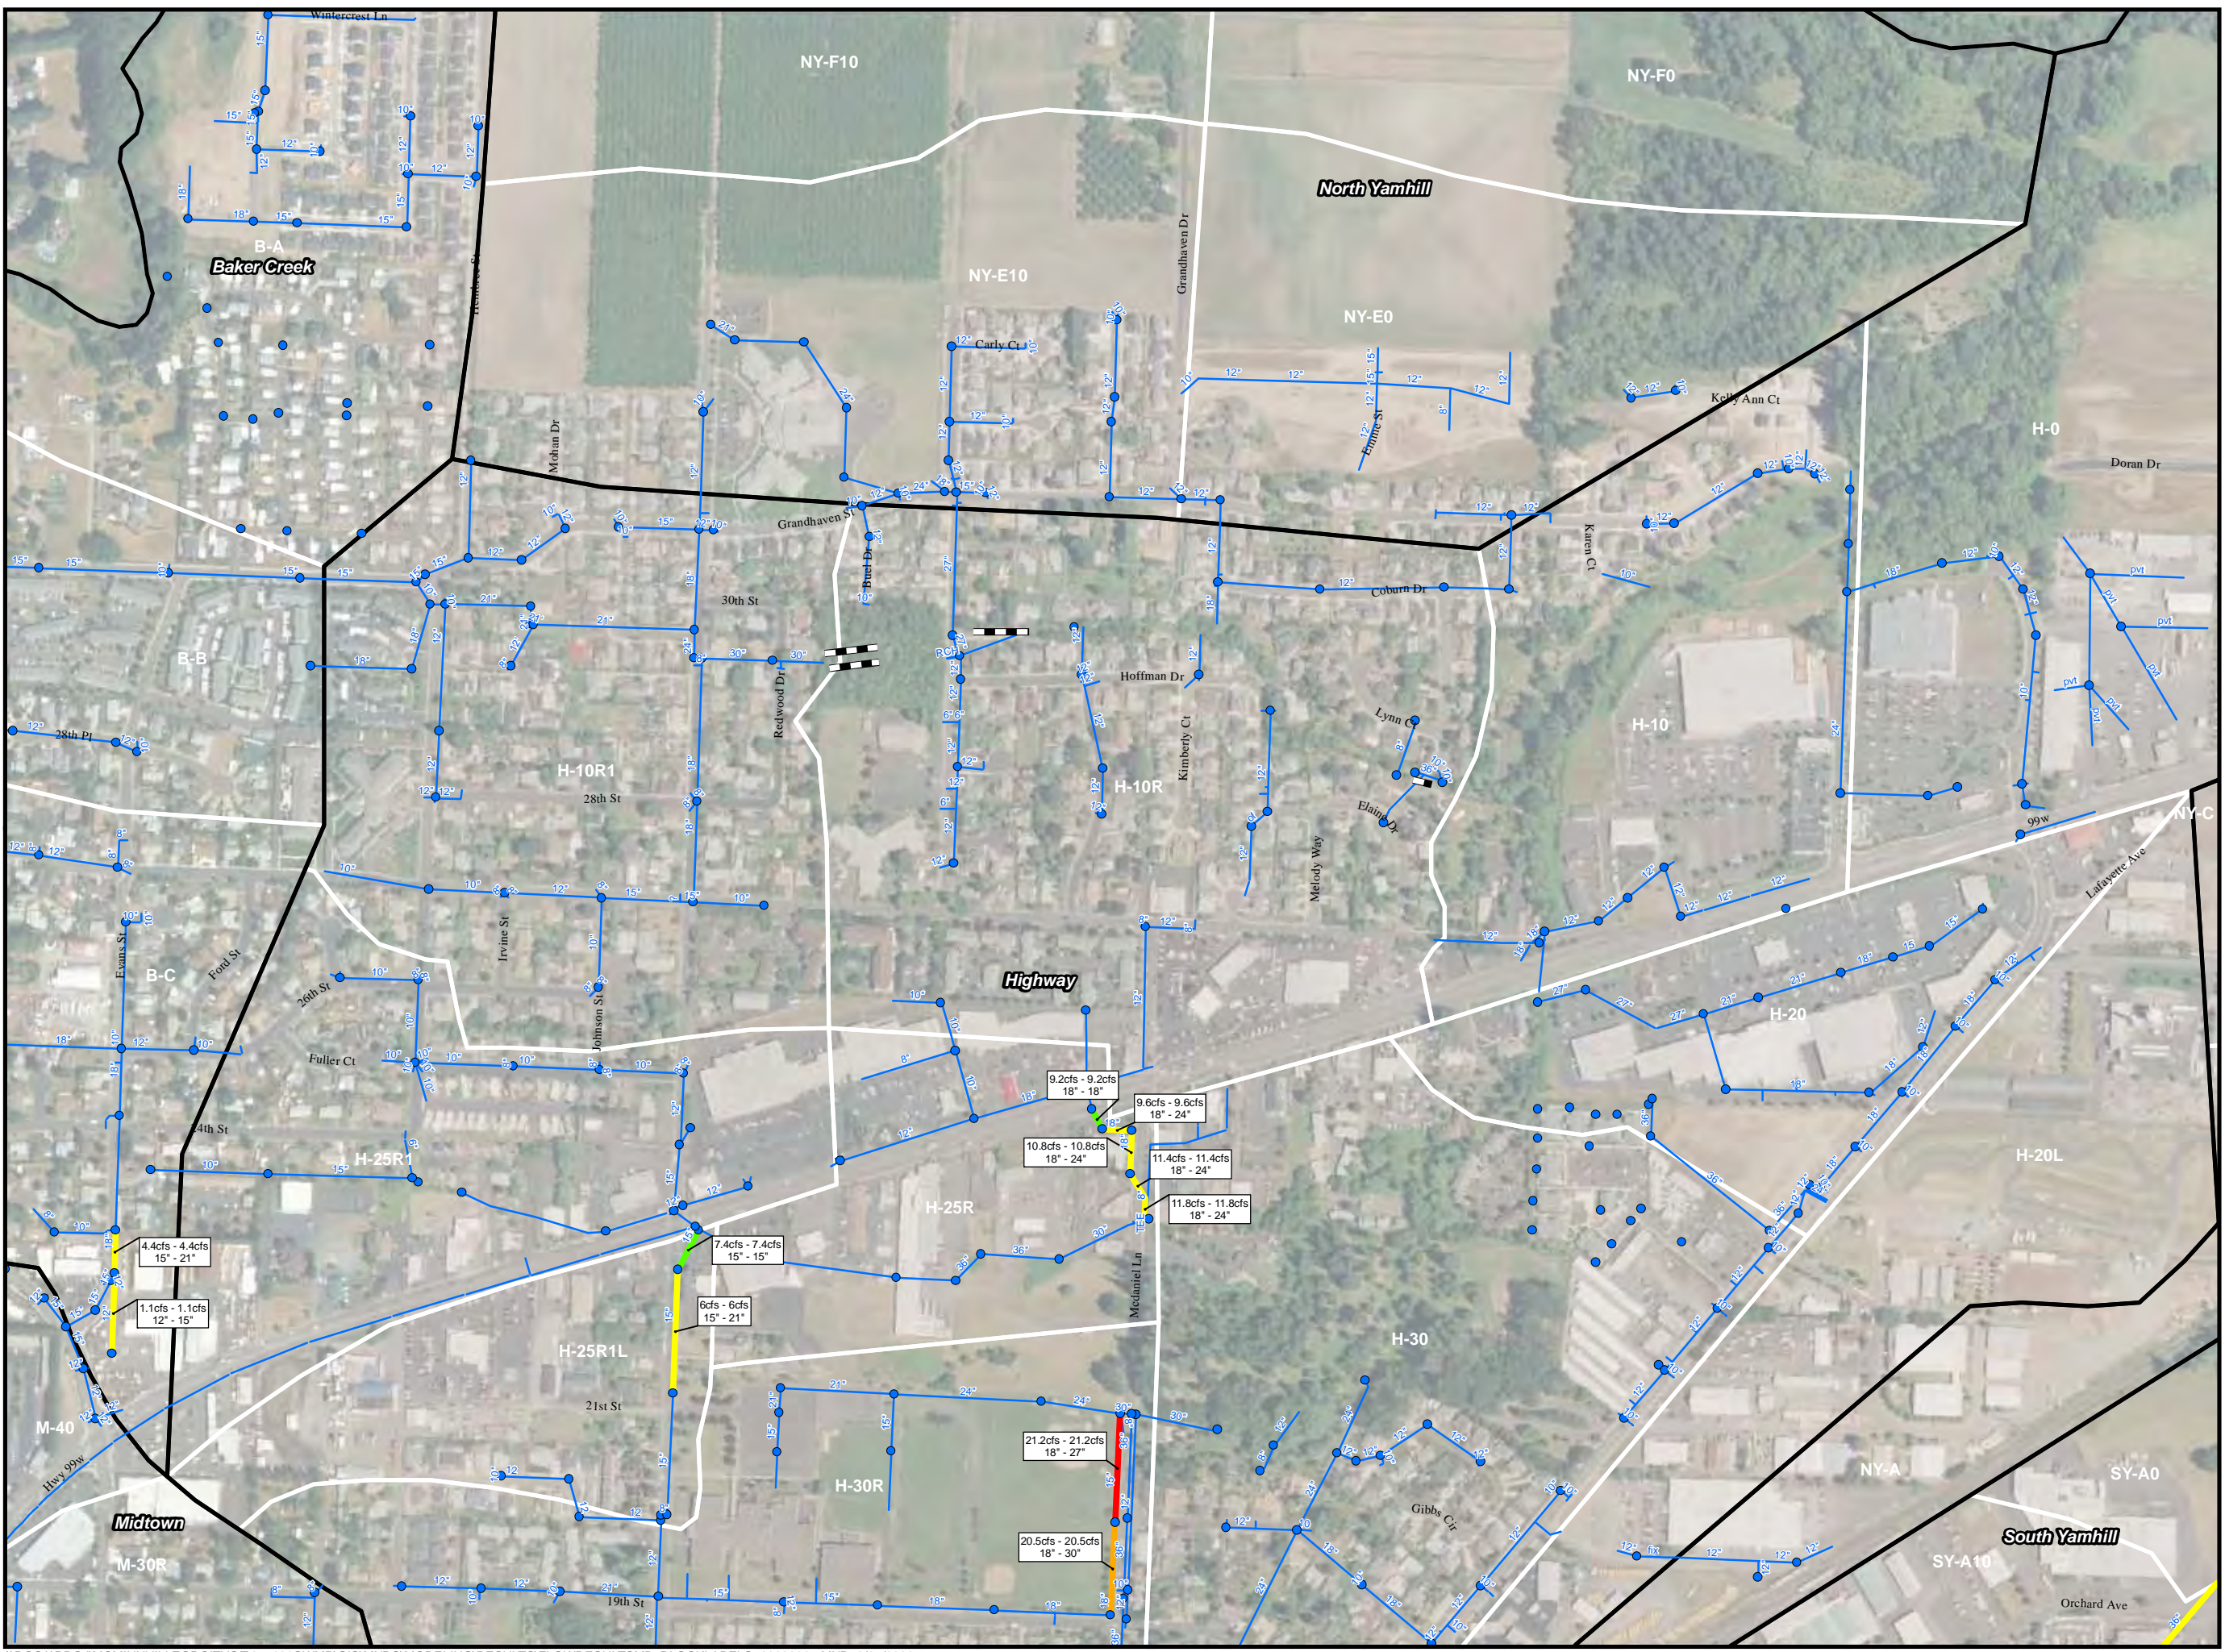
FIGURE 7-B3

HYDRAULIC RESULTS & RECOMMENDED IMPROVEMENTS

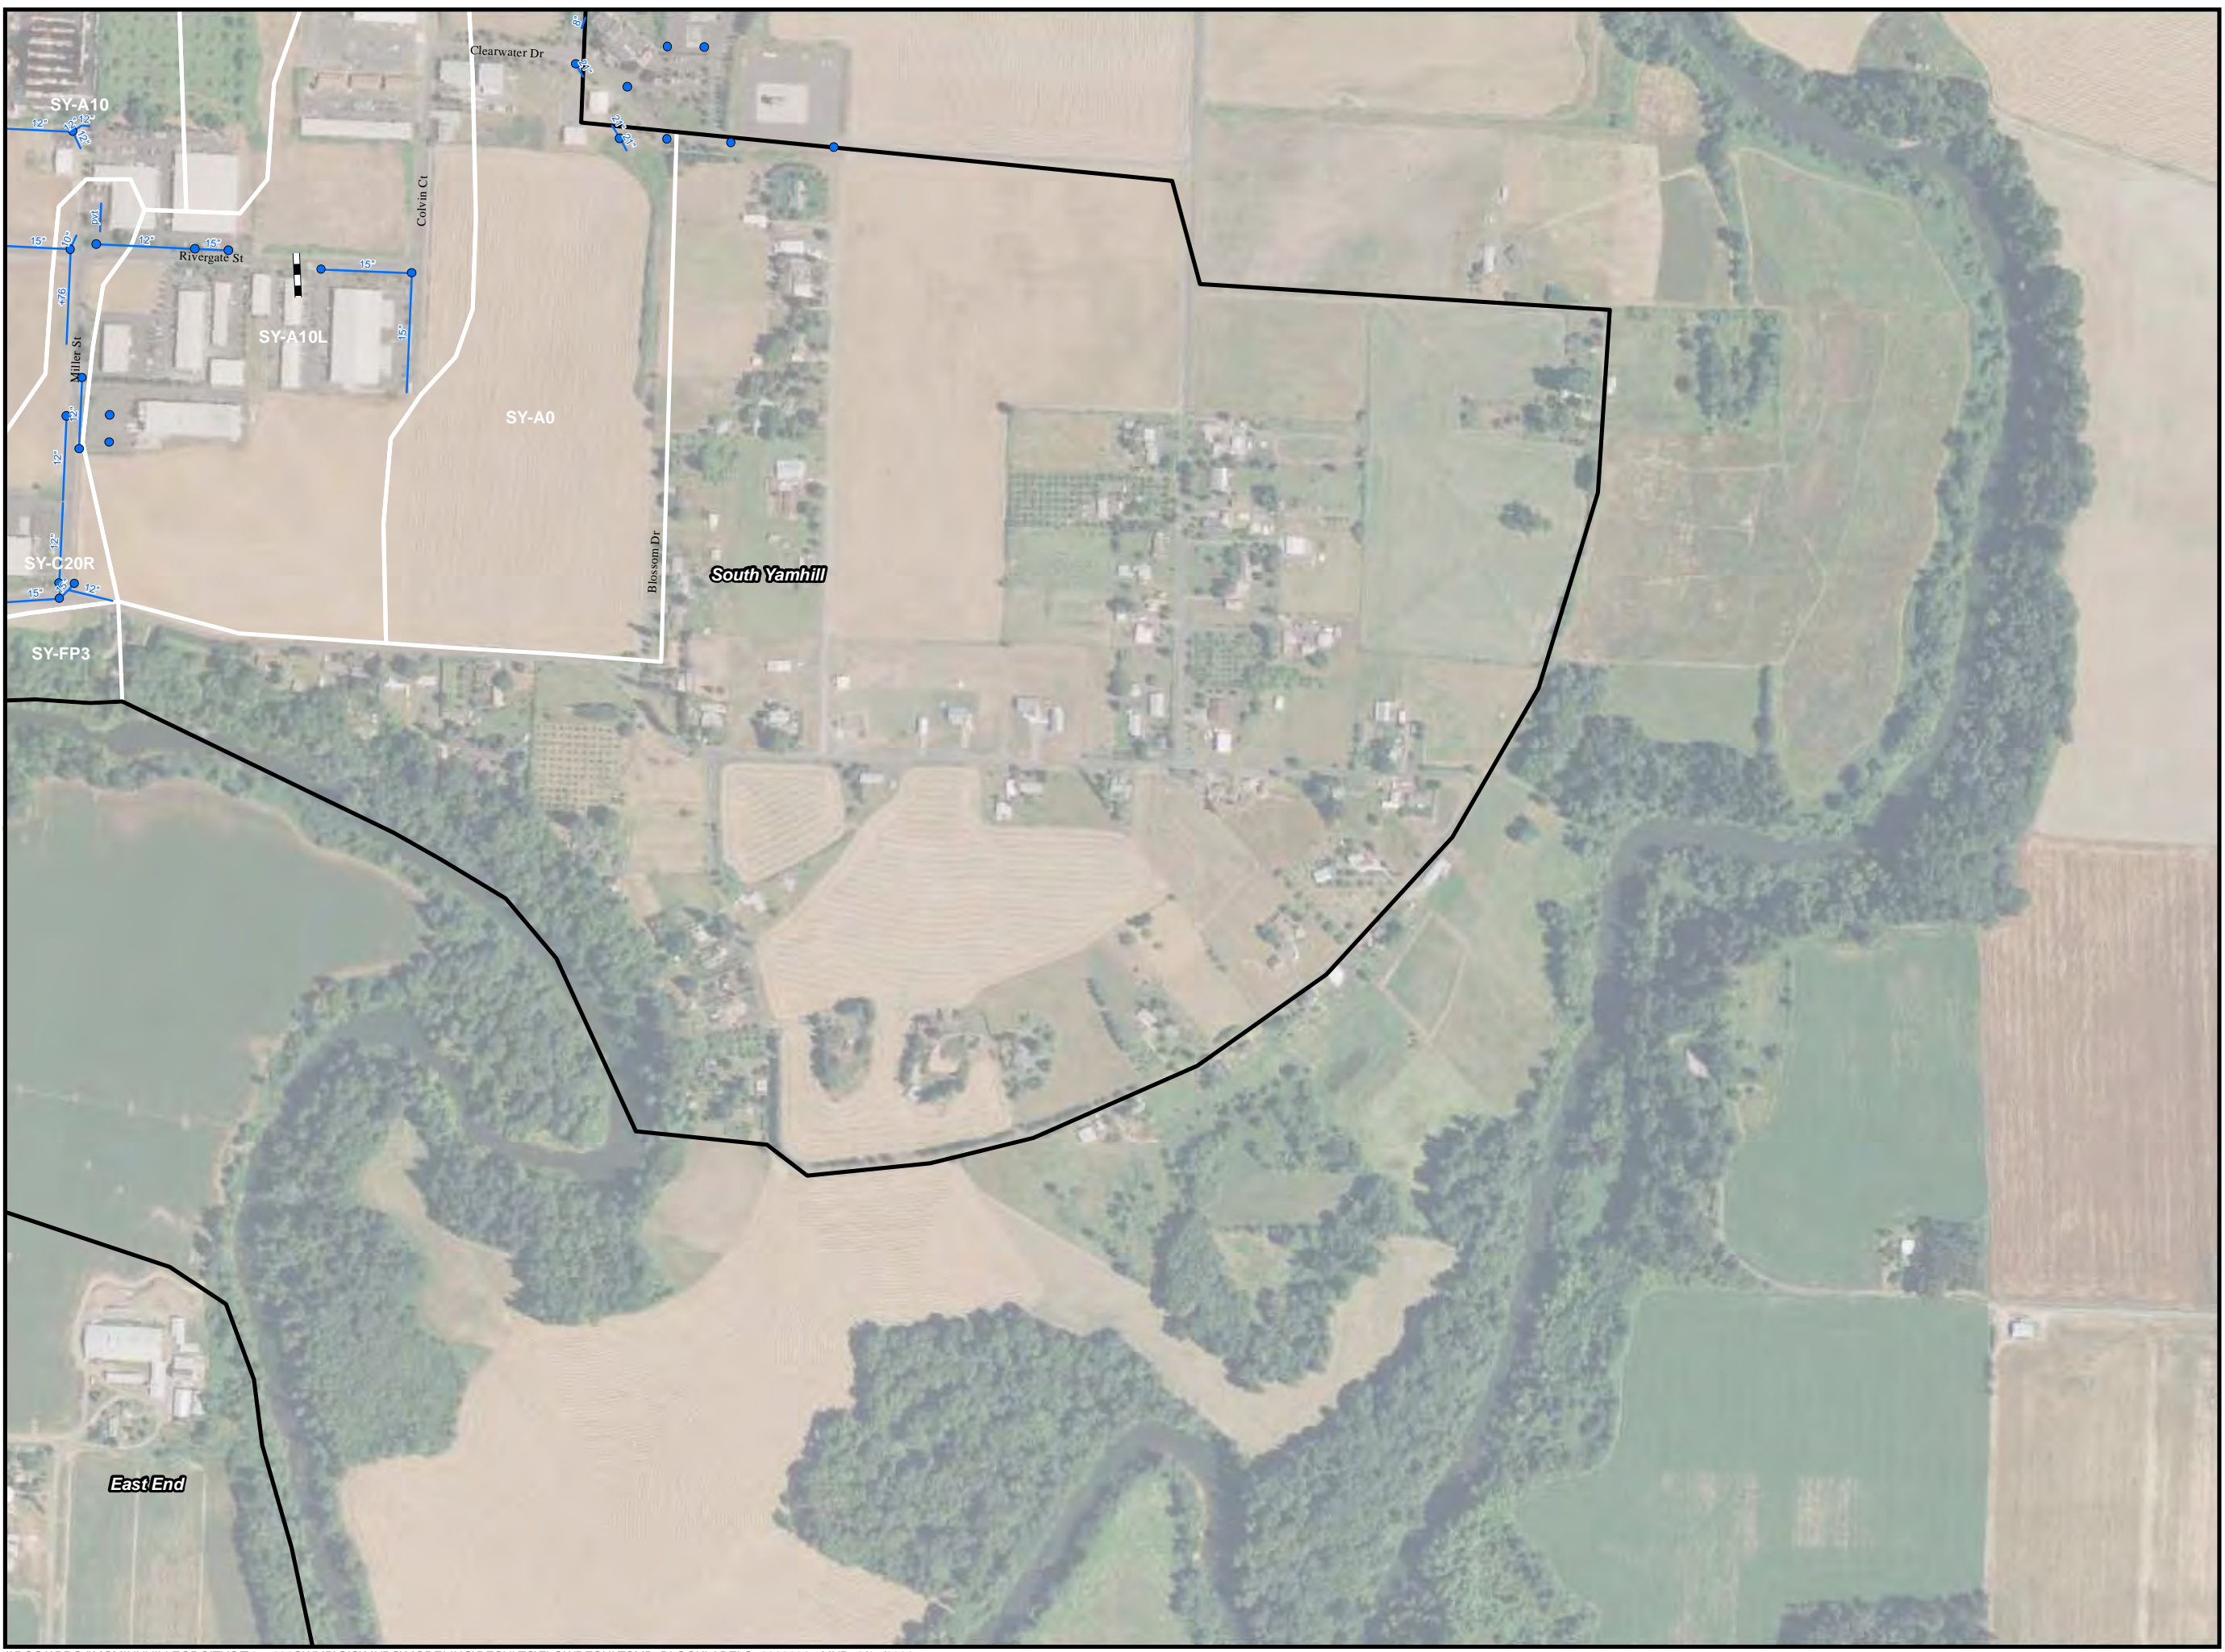
FIGURE 7-C4

HYDRAULIC RESULTS & RECOMMENDED IMPROVEMENTS

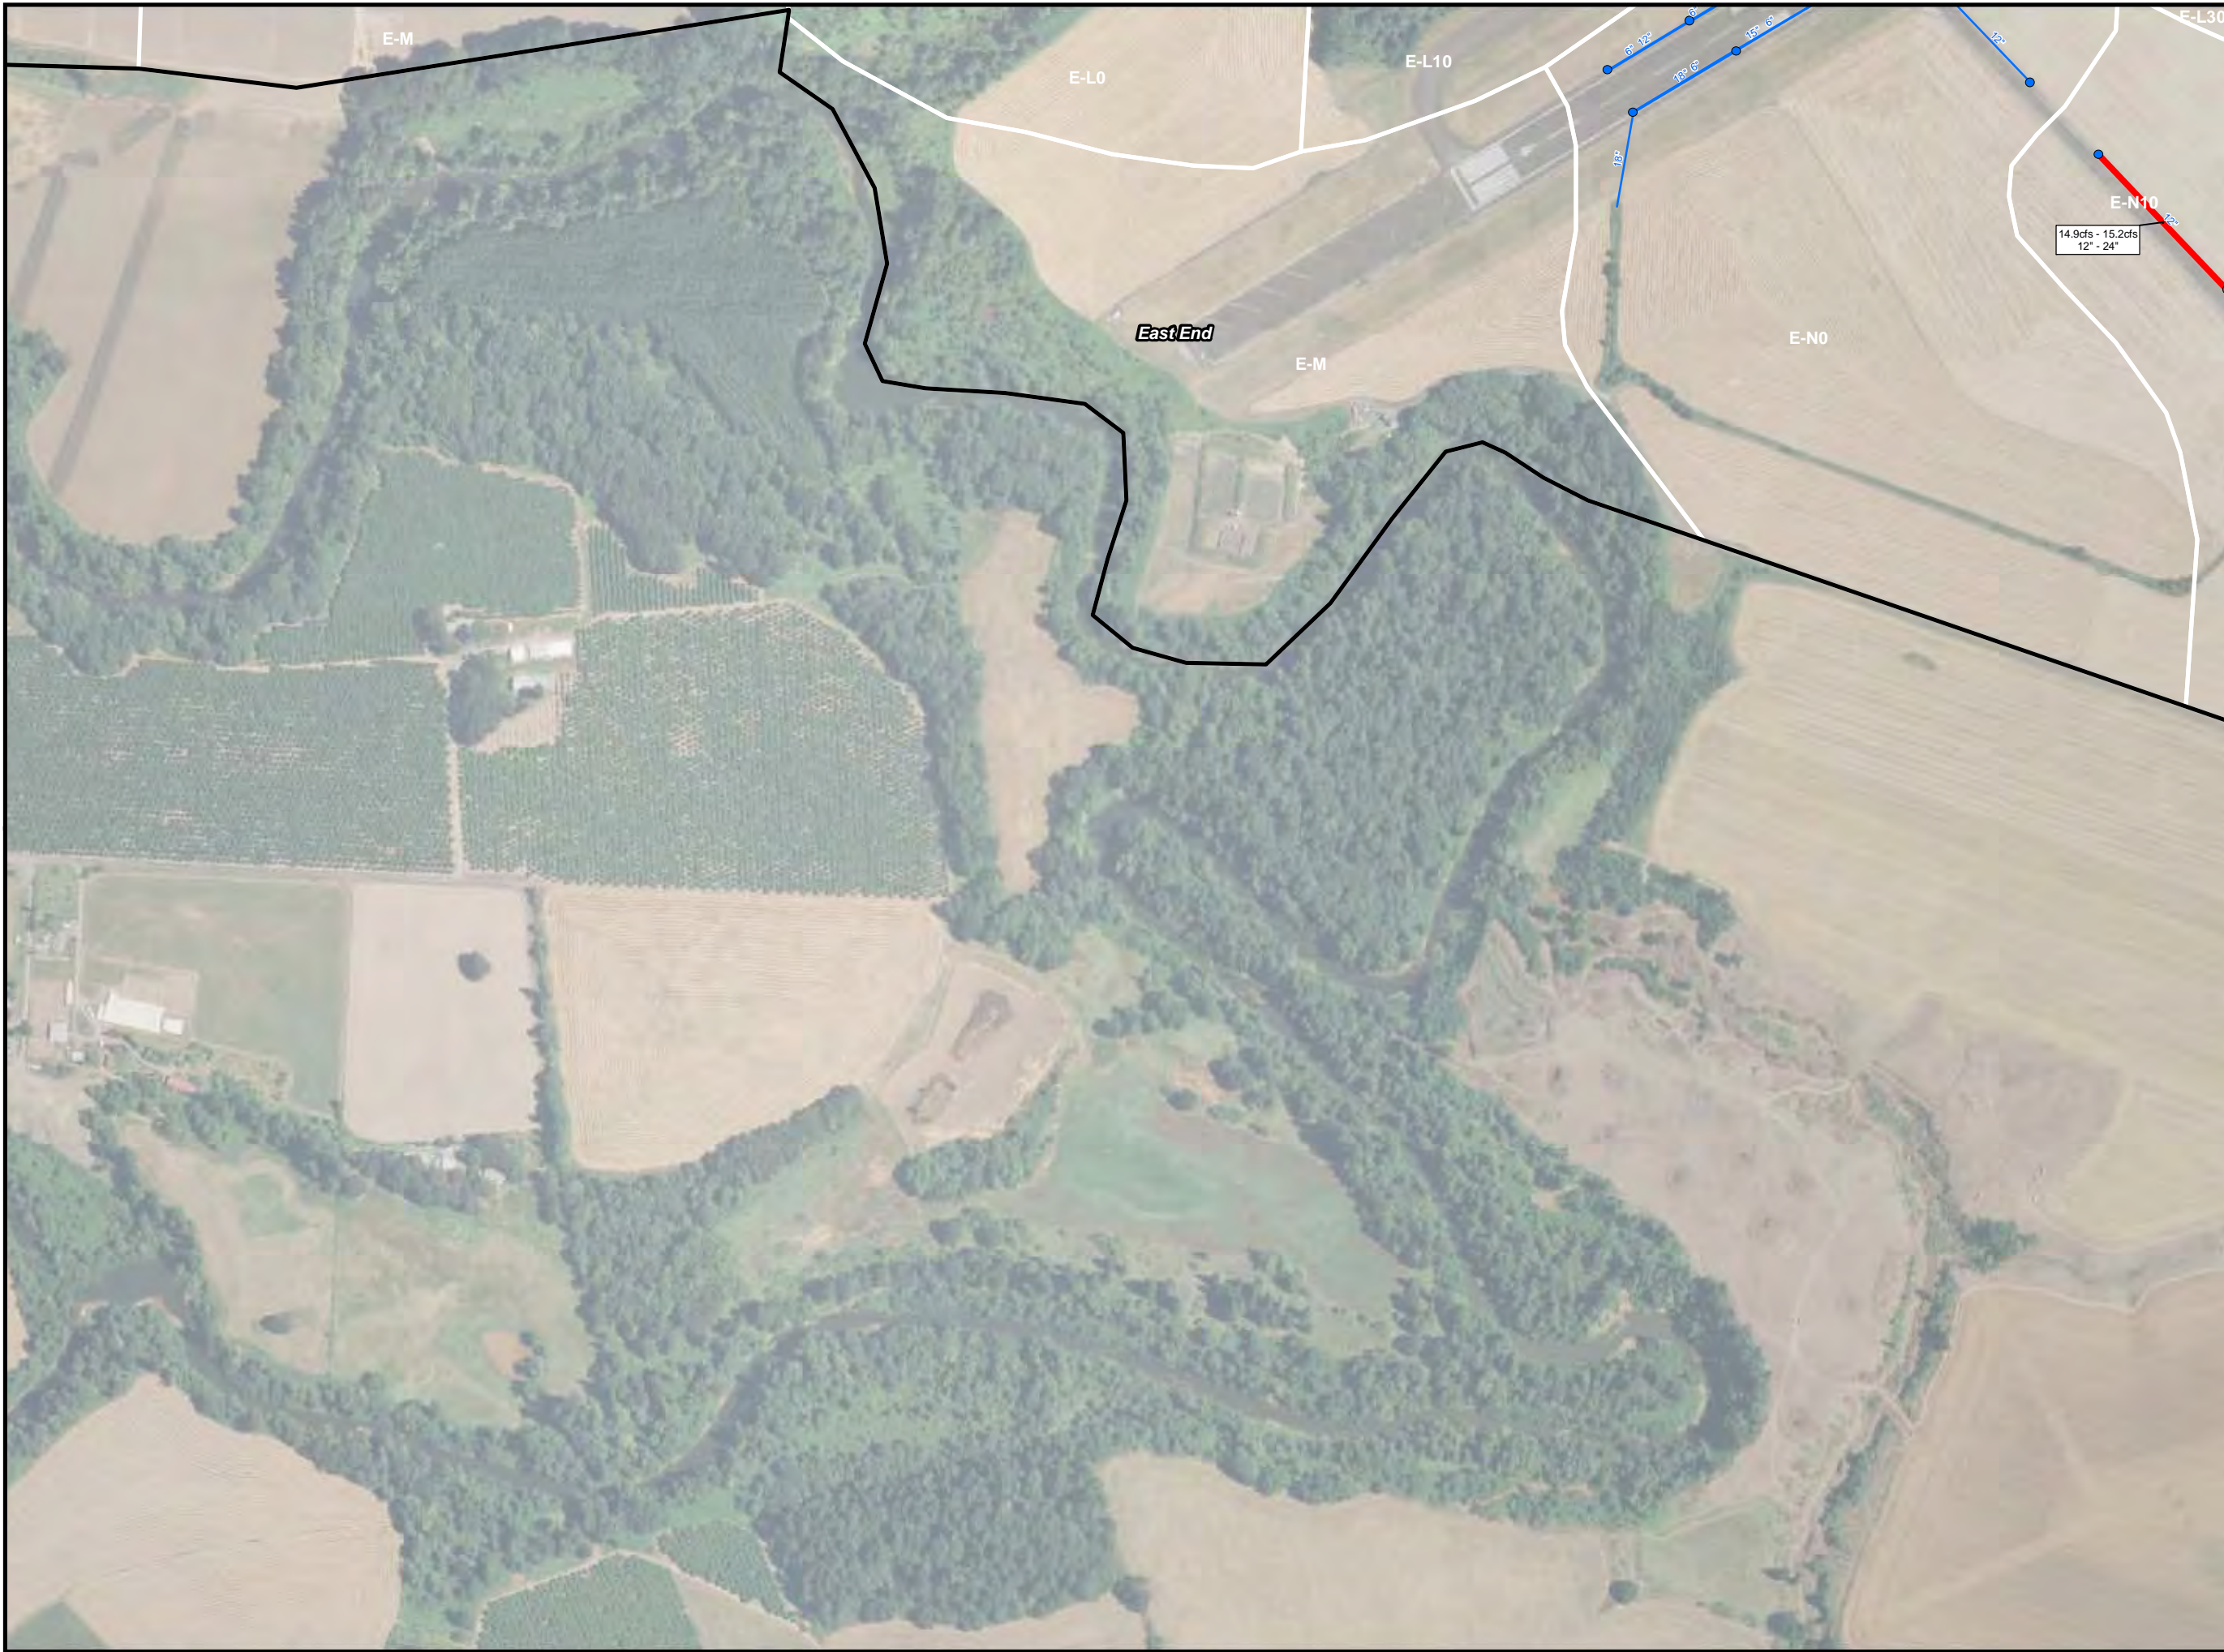
FIGURE 7-E4

HYDRAULIC RESULTS & RECOMMENDED IMPROVEMENTS

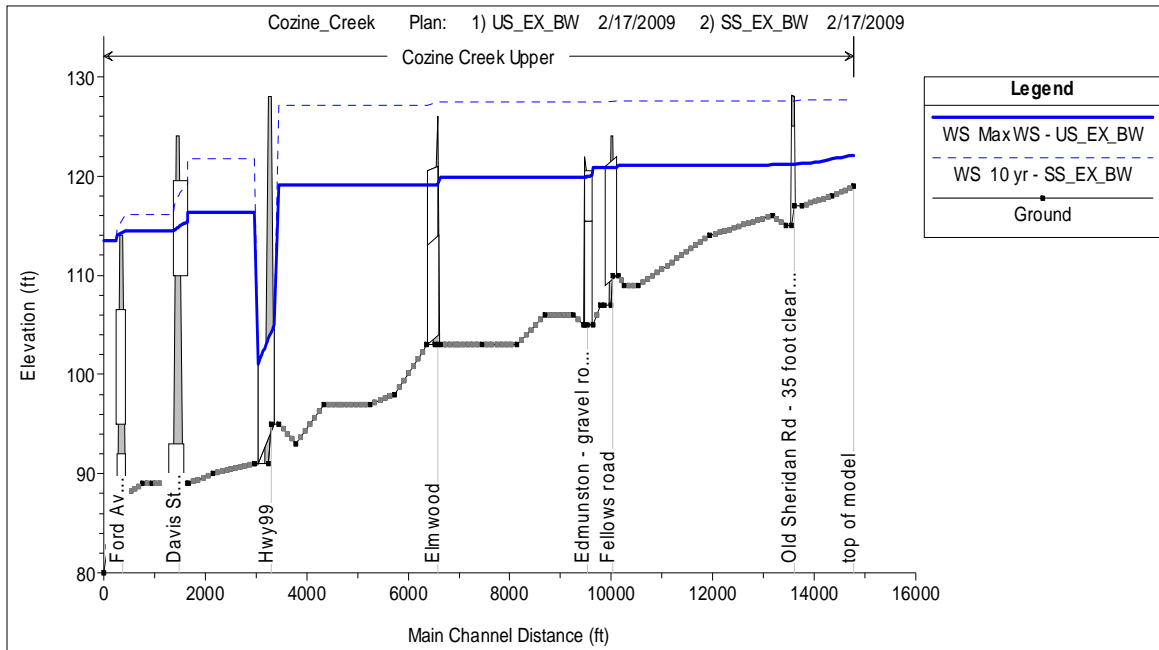
FIGURE 7-2

Comparison of 10-Year Maximum Water Surface Elevation Profiles Between Steady-State and Dynamic
The blue dashed line represents the steady-state 10-year water surface profile and the solid blue line represents the 10-year maximum water surface profile from the dynamic (unsteady) model.

Results from dynamic (unsteady) modeling indicate that the effects of storage and timing are critical factors that must be considered when evaluating hydraulic capacity of infrastructure in lower Cozine Creek. The resulting water surface profiles are considerably lower than the profiles computed using steady-state assumptions. The profile plots in Figures 7-2 and 7-3 illustrate the difference between the dynamic and steady-state model results for the 10-year event.

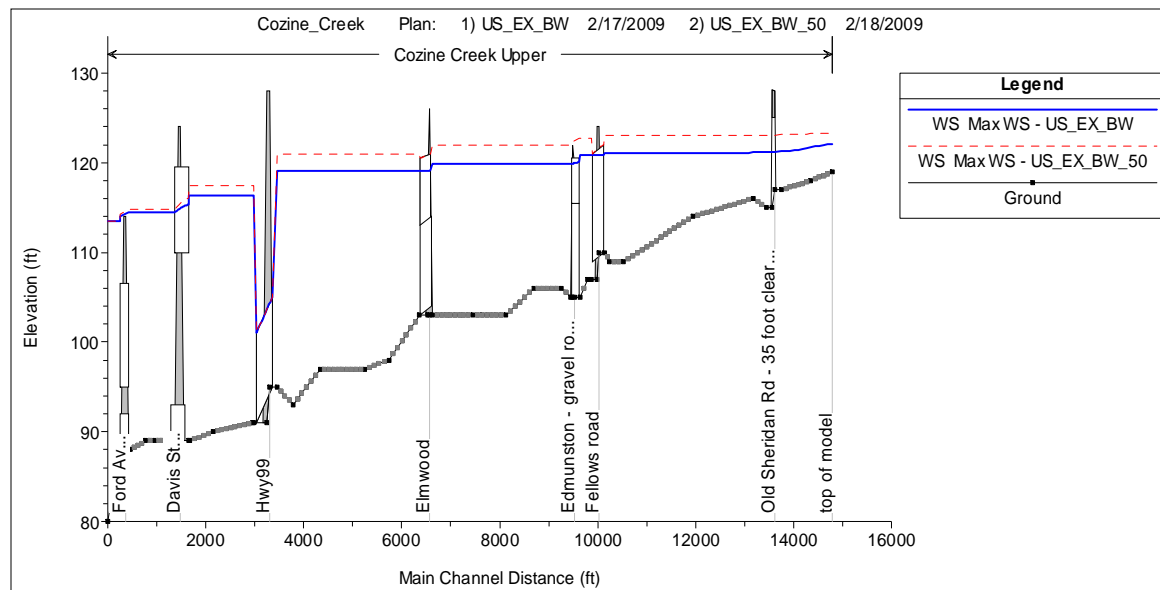
FIGURE 7-3

Comparison Between 10-Year and 50-Year Maximum Water Surface Profiles

Results from the 50-year event show that Cozine Creek overtops the road at Edmunston (private road) and Ford Avenue; all other roads remain dry. These results indicate that all culverts in the Cozine Creek system have adequate capacity. Therefore, no improvements are required beyond standard maintenance.

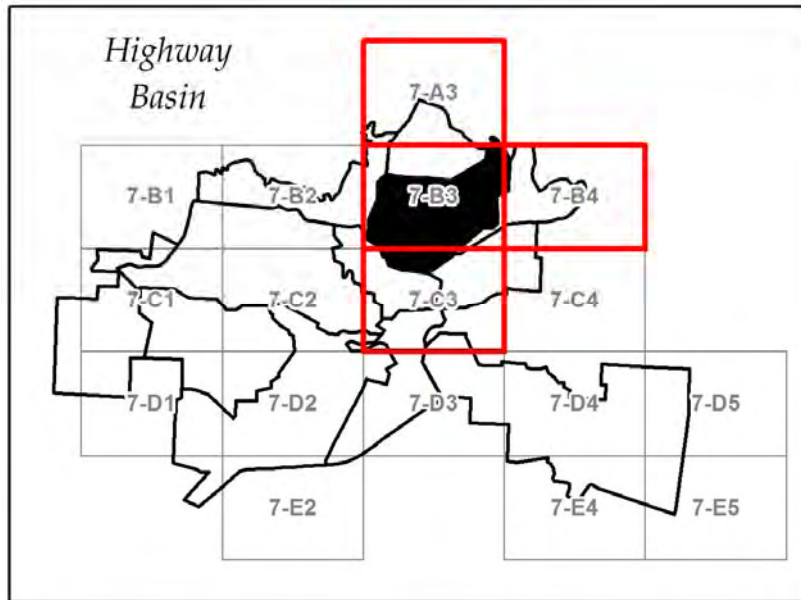
FIGURE 7-8
Highway Basin

Figure 7-8 provides an outline of the Highway Basin.

The hydraulic analysis shows the storm drain in McDaniel Street between 19th Street and its outfall into Wortman Park to be deficient, although, City staff reported that a diversion was constructed at 18th Street in 1999, which has likely relieved the flooding problem at this location.

- The existing pipes in McDonald Street between 17th and 18th Streets and between 21st Street and the “tee” manhole south of Highway 99W would be replaced.

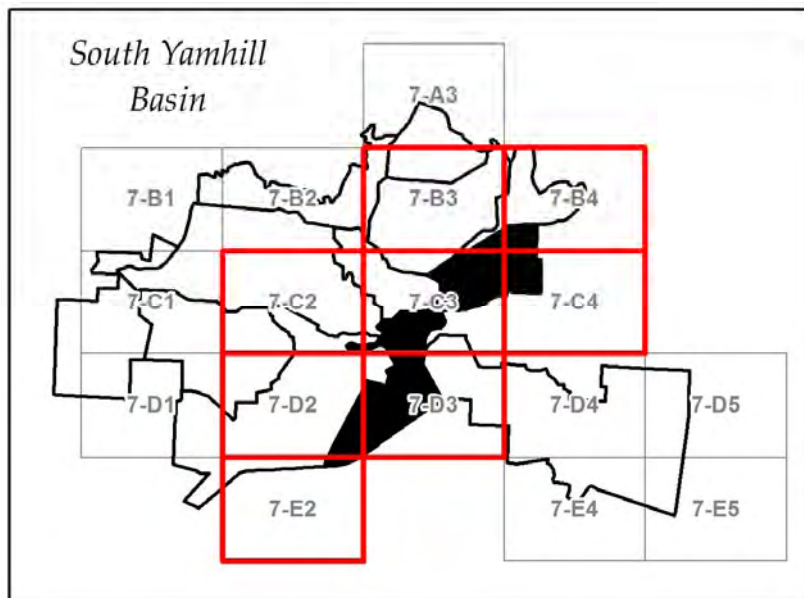
FIGURE 7-9
South Yamhill Basin

Figure 7-9 provides an outline of the South Yamhill Basin.

The storm drain in the easterly end of Riverside Drive has moderate deficiencies during the 10-year event and could benefit from a diversion into the South Yamhill River.

The sewer in Washington Street is adequate for stormwater flows. The sewer in Irvine Street is inadequate for 2-year existing flows, and the sewer in Macy Street is inadequate for 5-year events.

The Naomi Street area experiences regular ponding on Villard Street just south of Naomi Street. This is caused by insufficient capacity in the pipe, particularly east of Villard Street. This undersized segment runs through heavily landscaped private property and is considered inaccessible. The pipe segment in Rummel Street is undersized for the 5-year event.

- Replace Naomi Street Bypass and Storm Drain. This storm drain would relieve the flows between Rummel Street and Villard Street and would drain the low area on Villard Street just south of Naomi Street. A pipe would be constructed along Naomi Street between Rummel Street and the outfall at the east end on Naomi Street. The existing alignment through the private development at the east end of Naomi Street is suitable for construction. A bypass pipe from the low spot where the existing storm drain crosses Villard Street would connect this spot to the proposed storm drain in Naomi Street. Grades should be reviewed to ensure this is a feasible project.

- One option that would help relieve the flooding in Cleveland St. would be to replace the Morgan Lane storm drain. This storm drain would be constructed along Morgan Lane between Davis and Villard Streets to accommodate flows generated along Morgan Lane and to relieve future flows in Cleveland Street. There is potential for a bypass in Morgan Lane, which would relieve the storm drain in Cleveland Street.

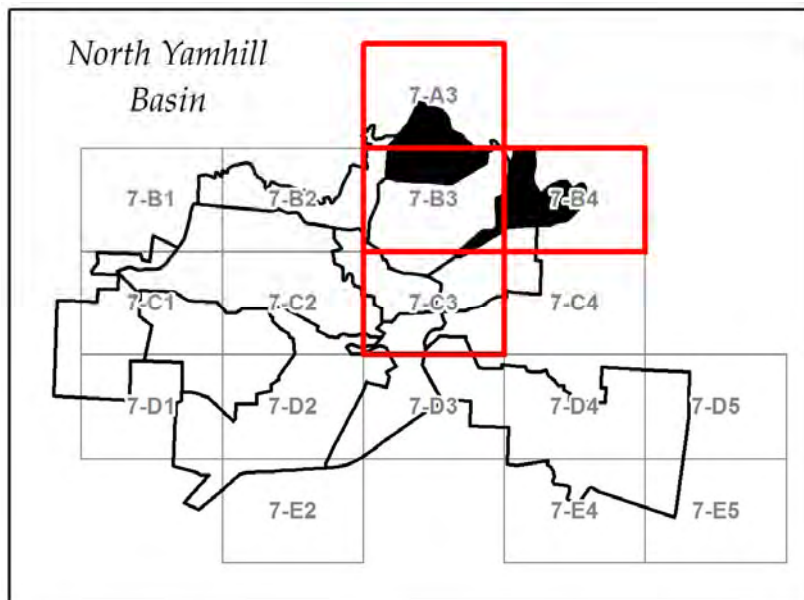
FIGURE 7-10
North Yamhill Basin

This is a relatively small basin with very little public infrastructure. The basin drains the northeast corner of the City split by Highway 99. The area south of Highway 99 is developed industrial land, which is assumed to have a private stormwater system that is not shown on the current mapping. The land to the north of Highway 99 is currently undeveloped farm land.

Figure 7-10 provides an outline of the North Yamhill Basin.
