RE: Applicant's Response - The Gwendolyn Hotel (DR 2-22); 611 NE 3rd Street (HL-6-23) & 619 NE 3rd Street (HL 6-24)

This office represents HD McMinnville LLC, applicant in the above-referenced land use applications. McMinnville City Planning Staff has requested that Applicant provide additional information and proposed findings to the Historic Landmarks Committee ("HLC") regarding certain approval criteria expressed below, concerning applications to demolish three buildings within the McMinnville Downtown Historic District (the "Historic District") and construct the proposed Gwendolyn Hotel in their place. The Applicant addresses each of those criteria in this letter. This letter should be considered an addendum to the above-referenced applications and the Approvability Memoranda provided by Otak, dated Nov. 4, 2022, which address each building separately.

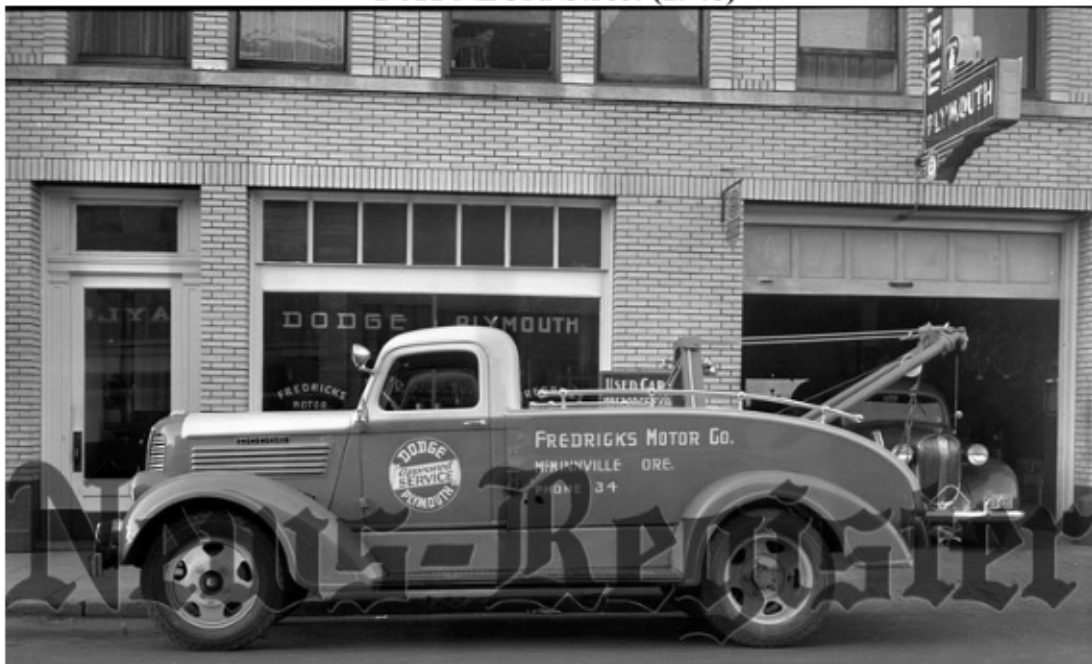
1 611 NE 3rd Street (1948)

The statement of significance explains the original physical characteristics of the buildings, but notes that the first floor façade was “extensively altered” with stucco cladding and has been “cutaway to expose two pillars.” The photos below illustrate the scope of how the building’s façade was altered after its period of significance:

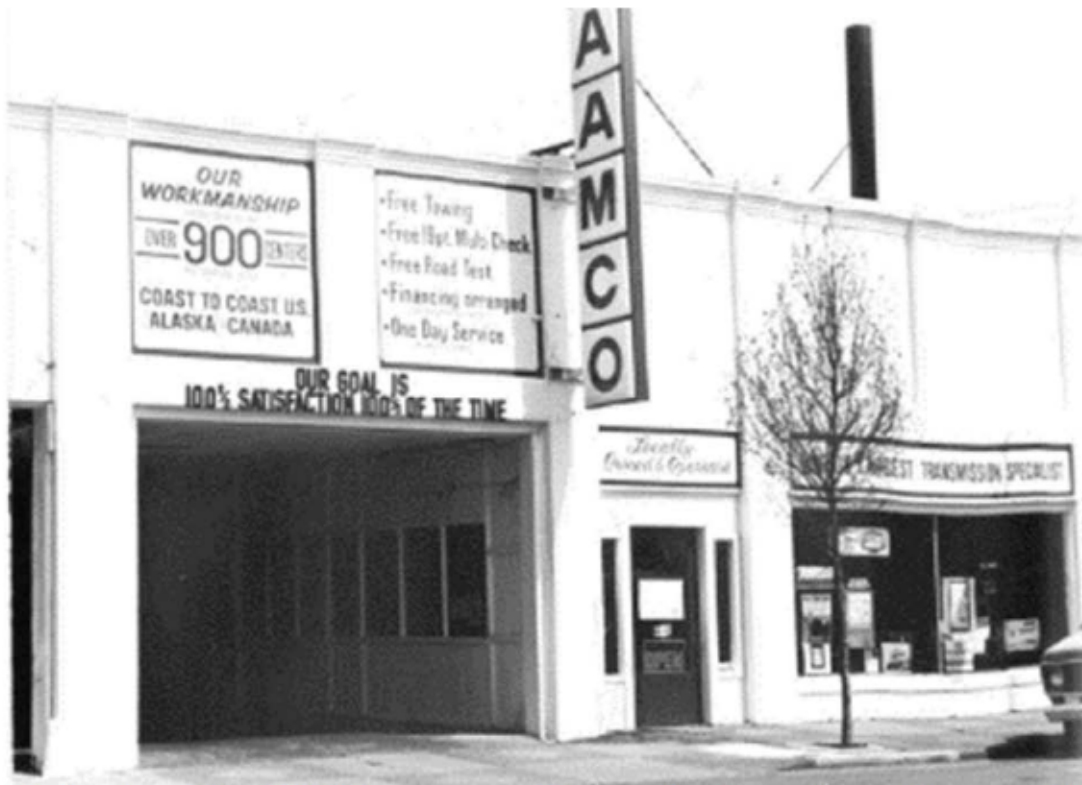
The photo and caption from the HRA is illustrative of the magnitude of the alterations of the building from its characteristics during the period of significance:

By the time of this 1983 historic survey photograph, the window to the east of the double-wide opening had been converted to an entry and the windows in the two easternmost bays had been replaced with a storefront window spanning both bays (Historic Resources Survey, City of McMinnville, Yamhill County, Oregon).

- Insertion of paired doors with wood trim elements in westernmost bay.
- Removal of all five windows and window openings that were originally east of the westernmost bay (four have been replaced with two double-wide storefront windows and one has been replaced with a door with sidelights and awning).
- White brick has been painted.
