608 NE 3RD ST. EXTERIOR ALTERATION

## Certificate of Approval (Alteration)

Property Address 608 NE Third Street, McMinnville, OR 97128

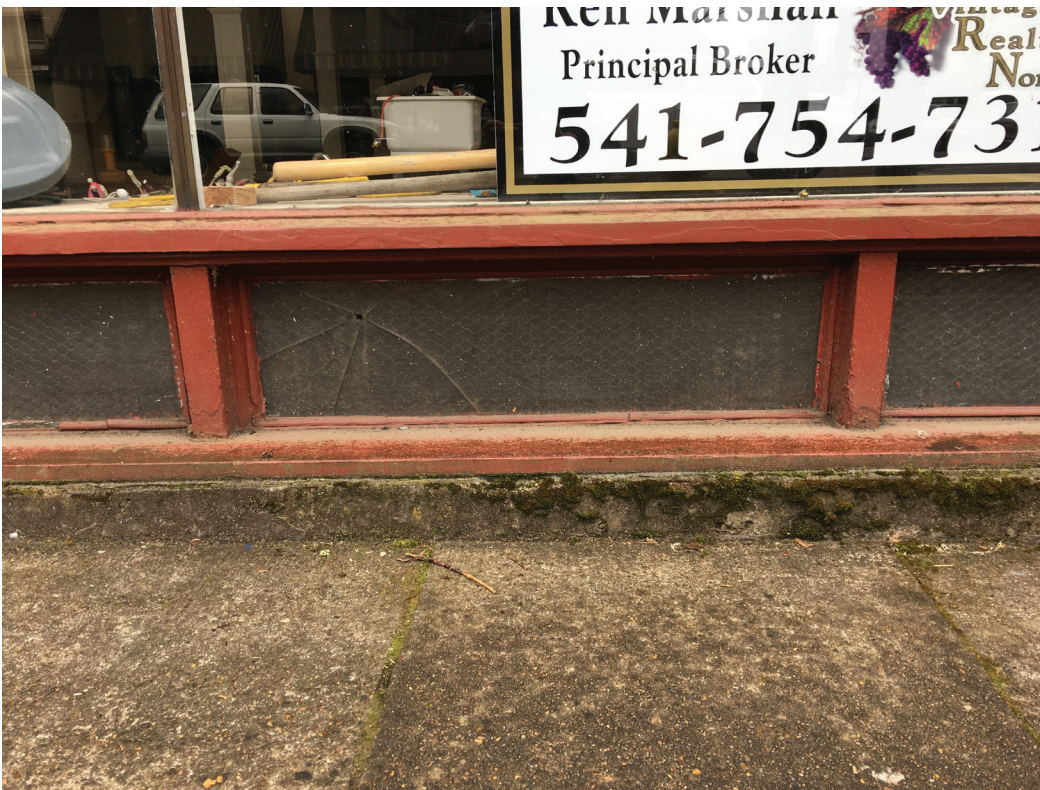
EXAMPLE OF WIRE GLASS SPANDREL PANEL AT STOREFRONT

1. If matching wire glass can be found, it will be used to replace the broken panes in the bulkhead below the storefront.
2. Second floor windows in the north and west facades cannot be repaired. They will be replaced in kind with replicas of the existing windows using the same material. The glazing will be tempered and insulated. Because of the insulated glass, the use of glazing compound will be replaced with wood stops. For reasons of child safety, and building envelope integrity, new sashes will be held closed except for one lower sash per sleeping area, which will satisfy current egress code. These 6 lower sashes will be heavier than the original. In lieu of added window weights, vintage Pullman Balance system may be used. This change will not be visible from the exterior. The replacement windows and doors will be crafted in Monitor, Oregon, with machinery which is contemporaneous with the building.

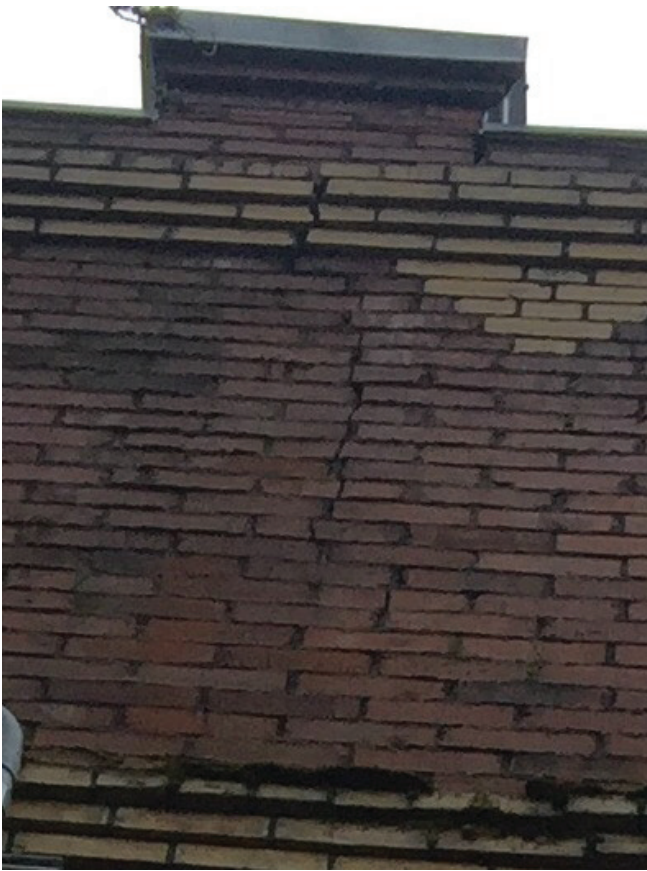
SPALLING RED BRICK AND CRACKING AT NORTH FACADE

The exterior masonry will be cleaned with a mild cleanser and low pressure wash, then repaired and repointed. While most of the north and west facing portions of the building are in good condition, the upper 8-9 feet of those facades are in need of a deep repointing. Fifteen to twenty red bricks, mostly in the area above the second floor windows, have spalled and must be replaced with matching brick, reclaimed from the building. Mortar used in the repointing will be custom mixed to be visually and physically compatible with the existing brick and mortar when cleaned.

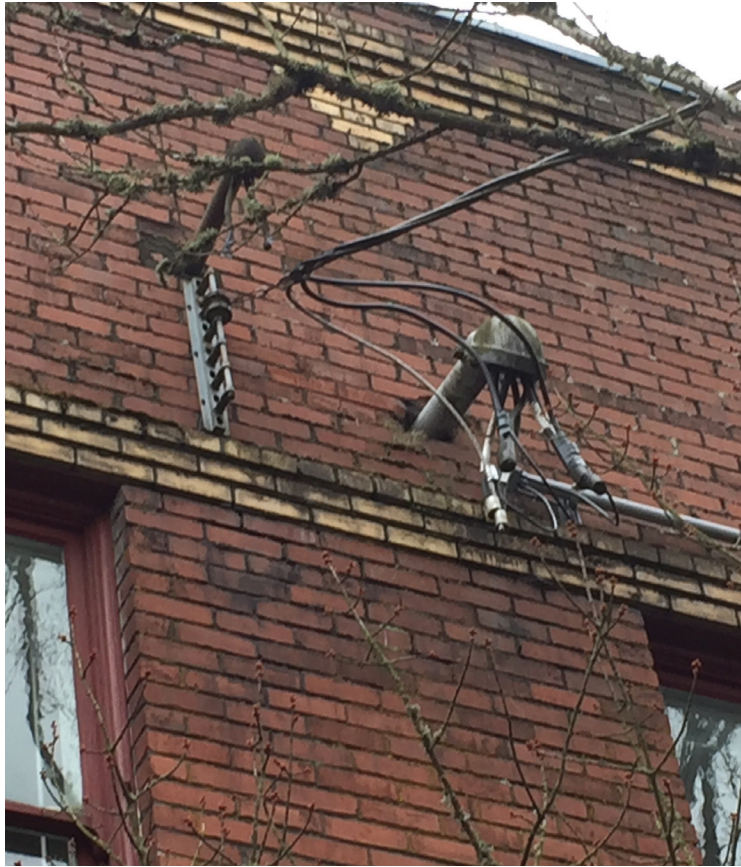
ELECTRICAL SERVICE PENETRATING BRICK

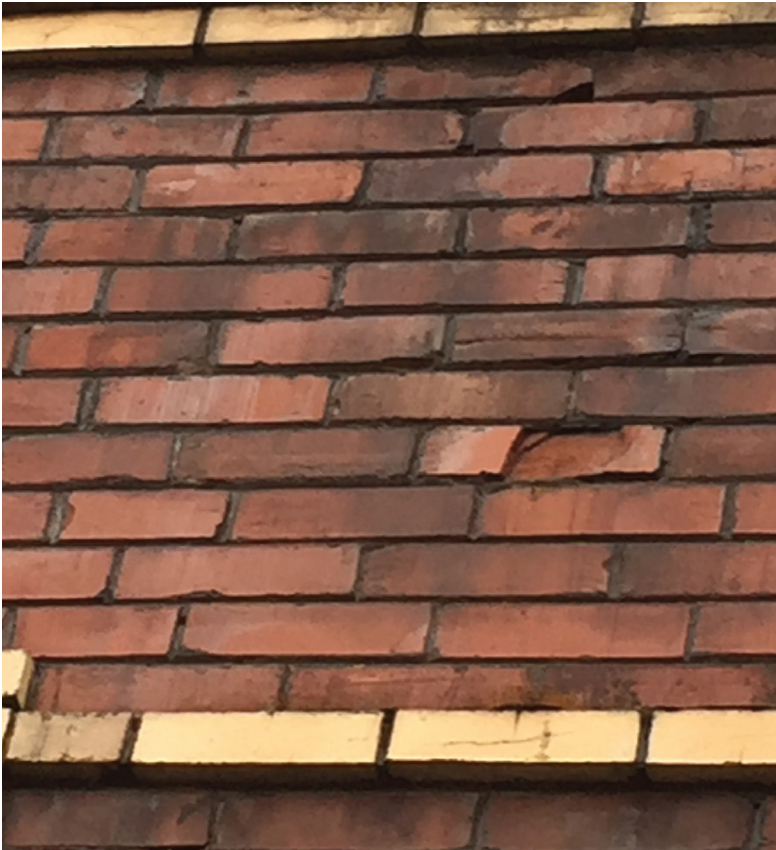
SPALLING RED BRICK AT NORTH FACADE

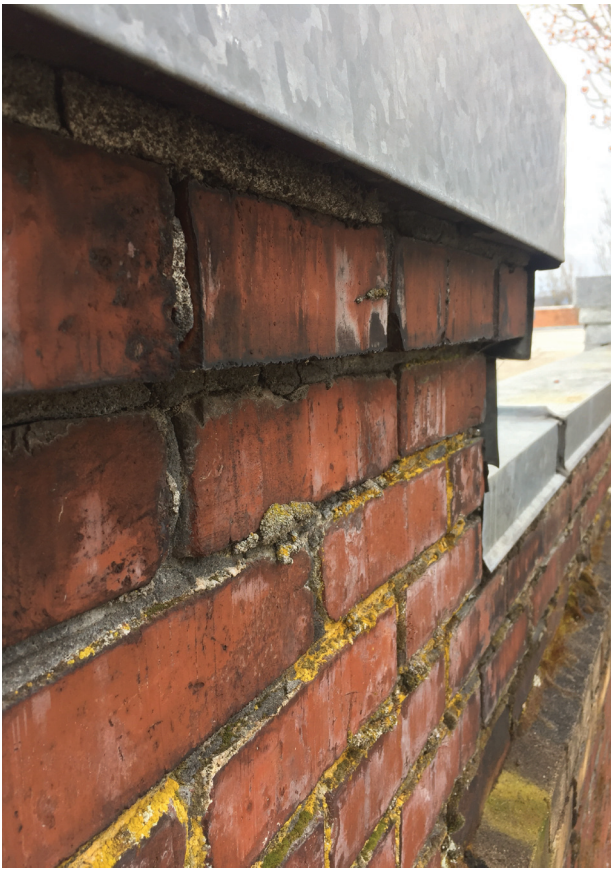
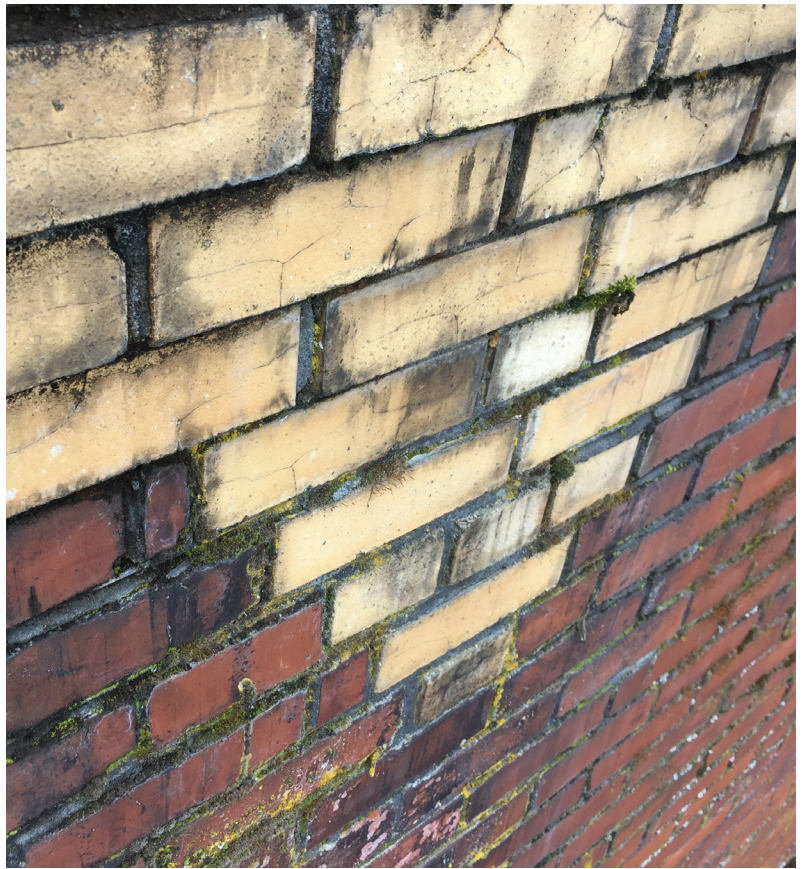
DETERIORATED MORTAR JOINTS AND ORGANIC GROWTH

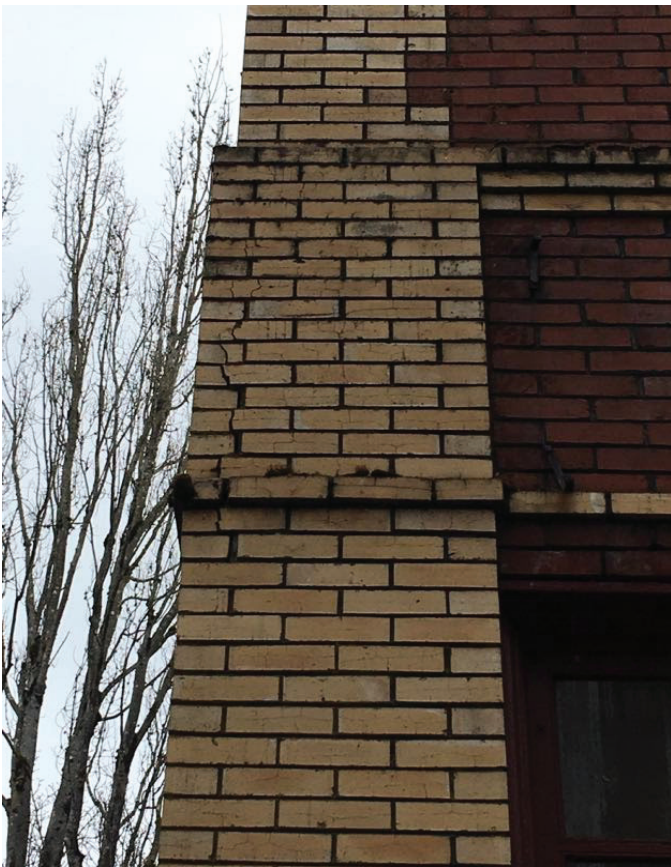
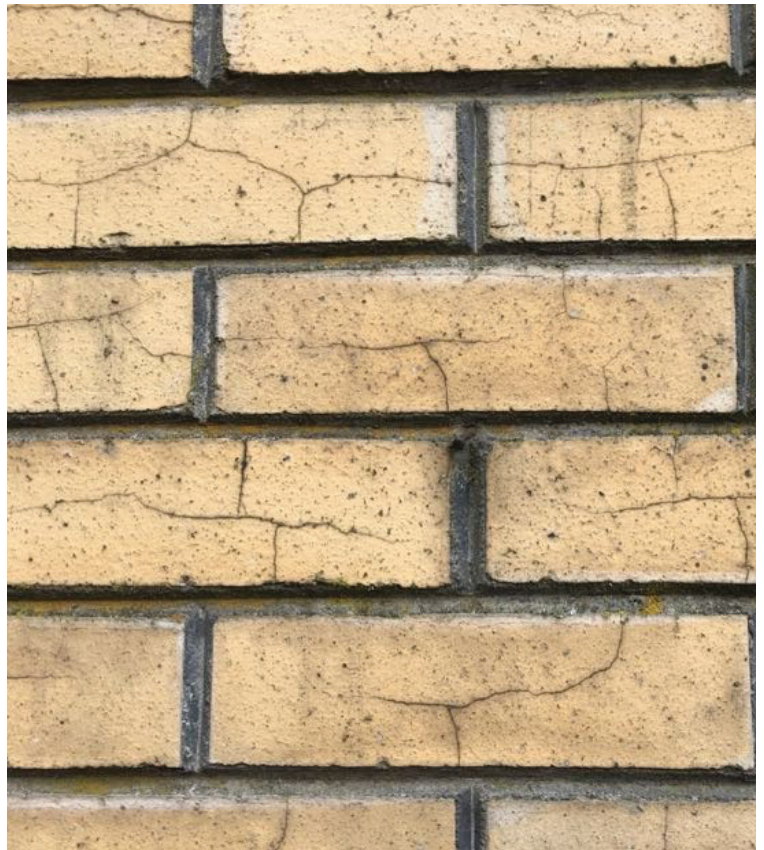
CRACKING AT BUFF-COLORED BRICK

There are two to three areas, on the north façade, where the buff colored brick has cracked, perhaps from rusting steel headers above the storefronts. This

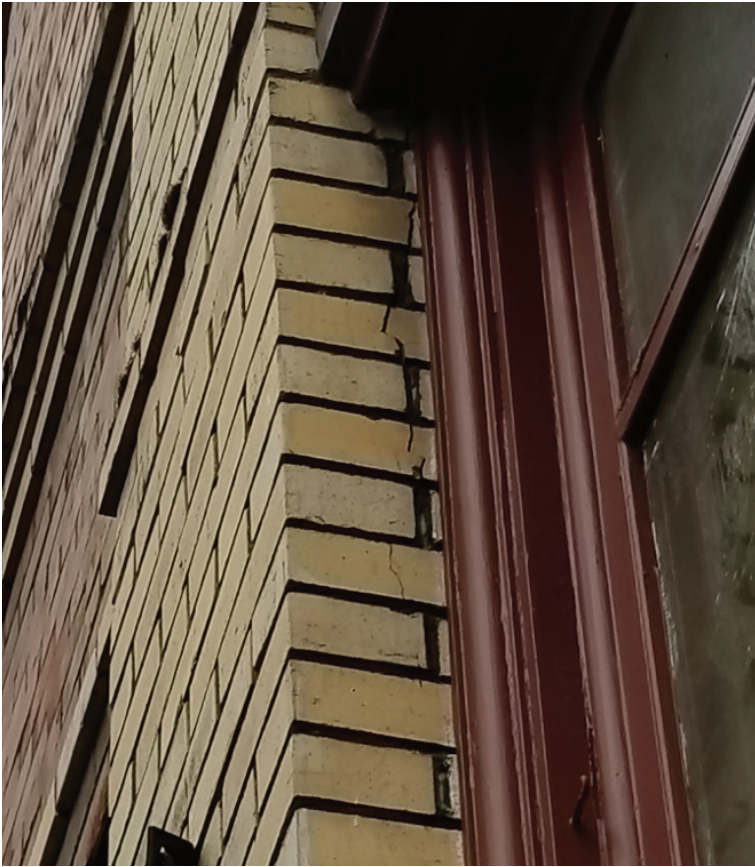
CRACKING IN BUFF-COLORED BRICK AT COLUMNS AND RUSTING OF STEEL LINTELS AT NORTH AND WEST FACADES

brick will be removed and salvaged. The steel headers will be cleaned and galvanized and the cracked bricks will be replaced. If additional buff colored bricks are needed for this and other repairs, they will be salvaged from the second story entrance area, (as discussed in a separate application).

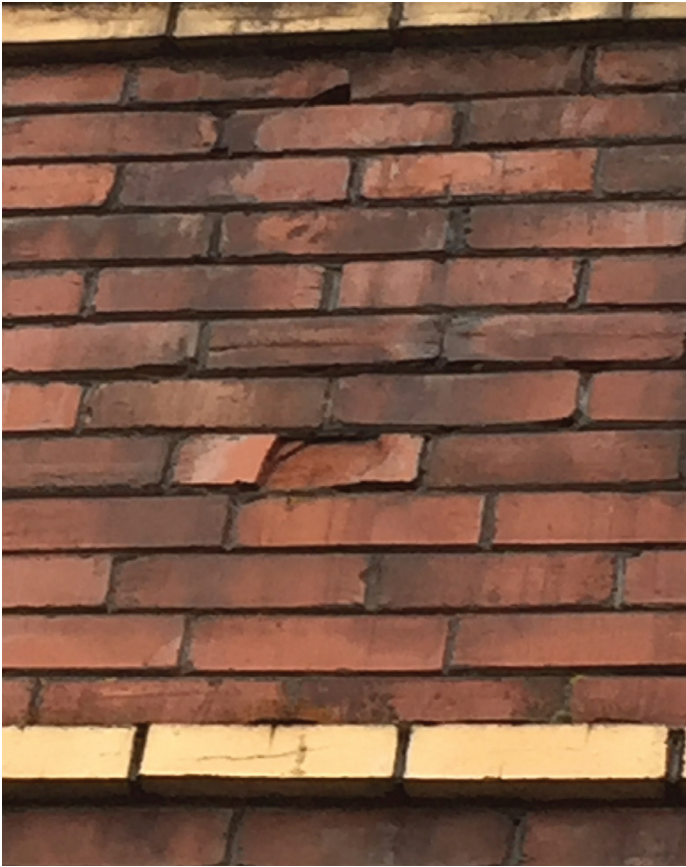
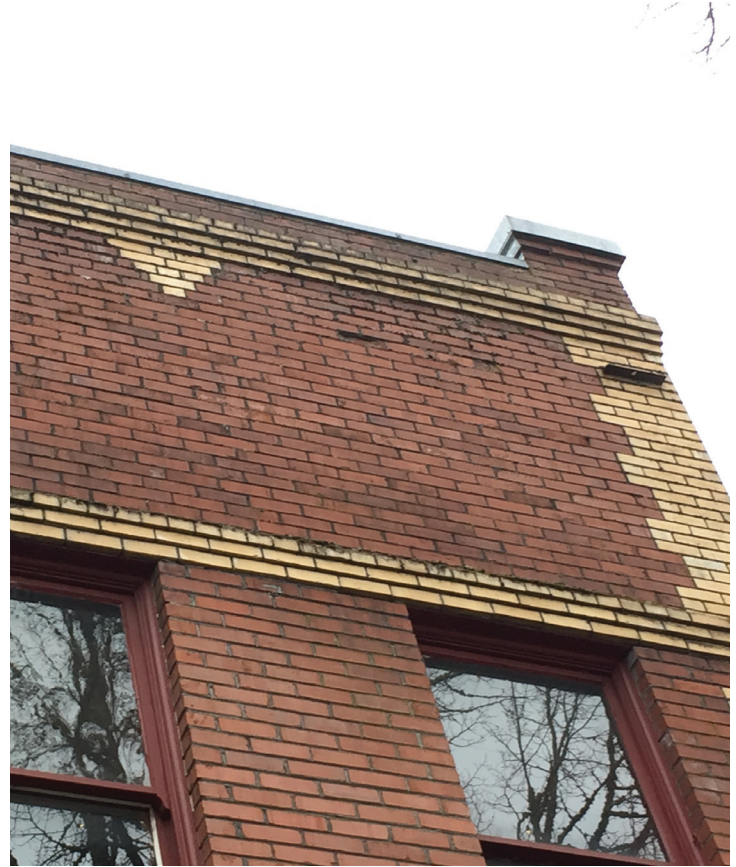
SPALLING BRICK AT WEST FACADE

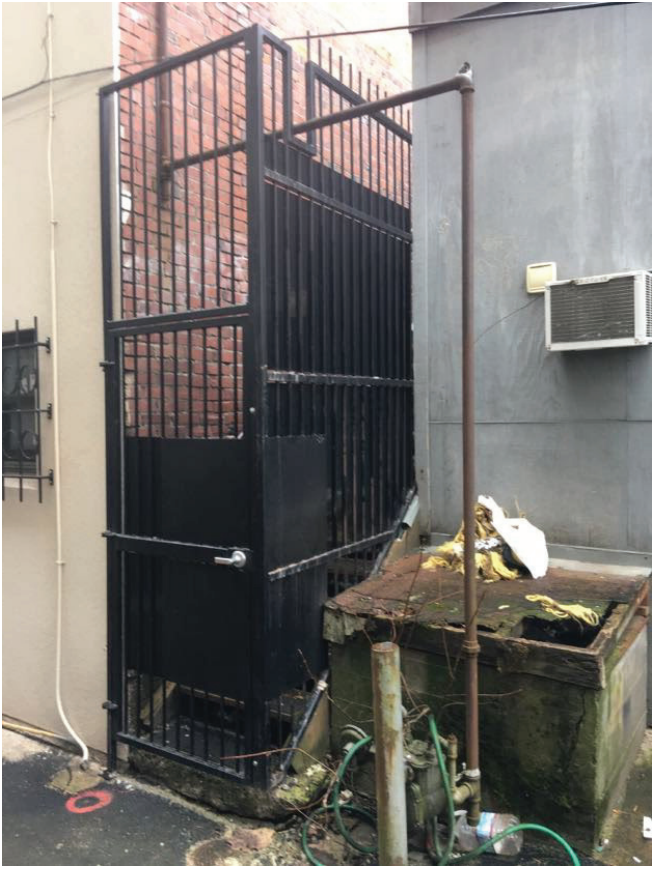
EXISTING EGRESS STAIR AND GATE AT ALLEY

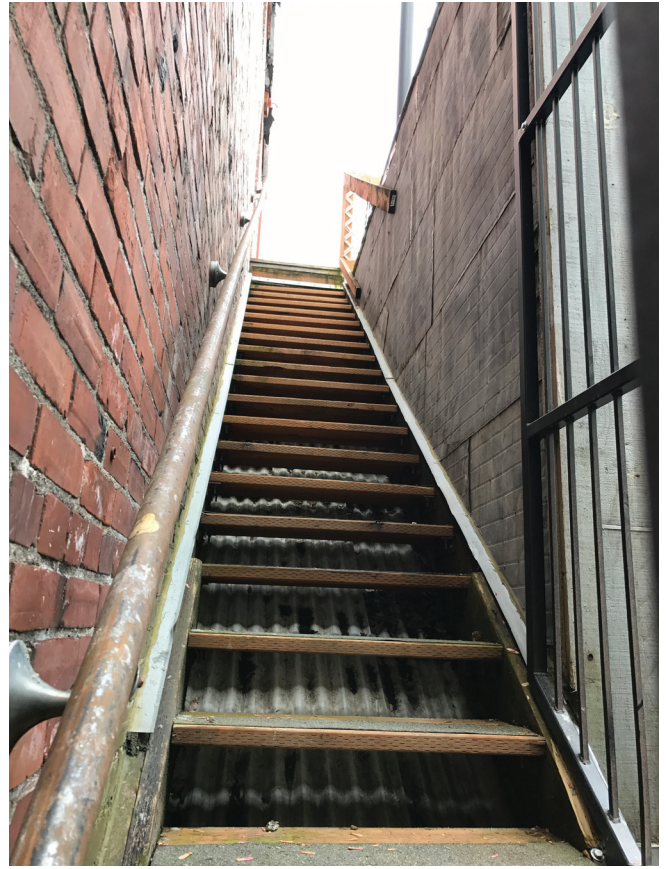
EXISTING EGRESS STAIR

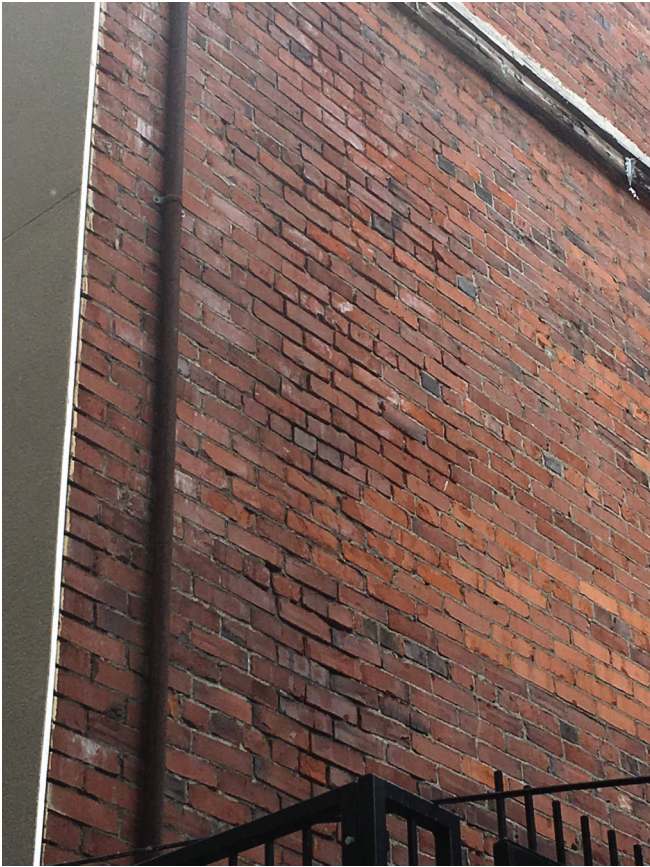
DETERIORATED RED BRICK AT EAST FACADE

The eastern face of the building, although partially obscured by the building at 618 NE 3rd Street is in need of extensive repair. The top three feet of the wall has deteriorated almost to the point where the brick will need to be removed and re-laid. The area may be saved by a deep cleaning and repointing of the mortar joints. Remnants of a deck and its cover need to be removed from the east wall. About 70 bricks have spalled or are missing and will need to be replaced. The plan is to salvage brick from the opening of the new egress door on that same, east façade. (This is discussed further in another Historic Review application.) To the extent possible through the restoration of the brick, the faded remains of the sign, "Jamison Hardware Sporting Goods", will be preserved.

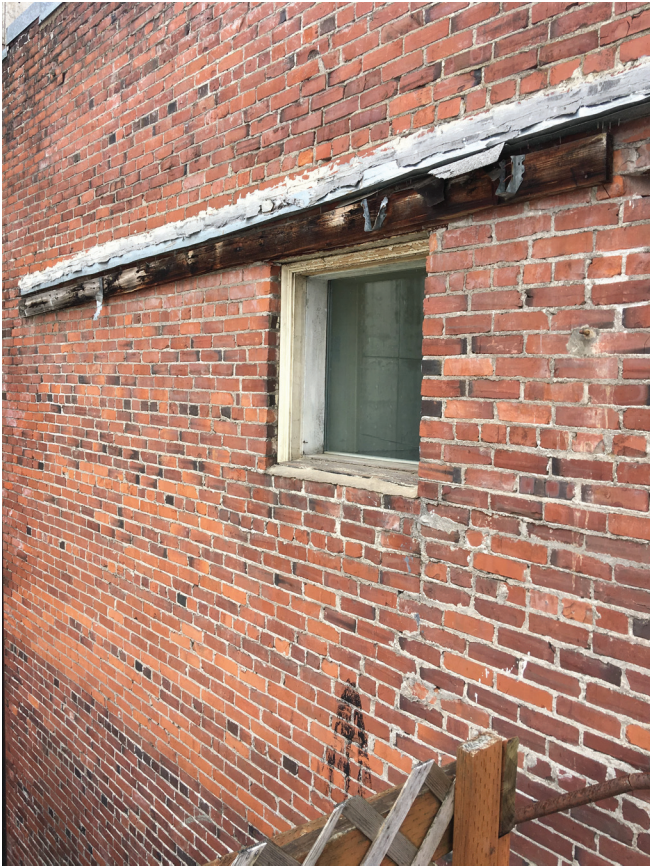
ROOF DECK LEDGER AT EAST FACADE

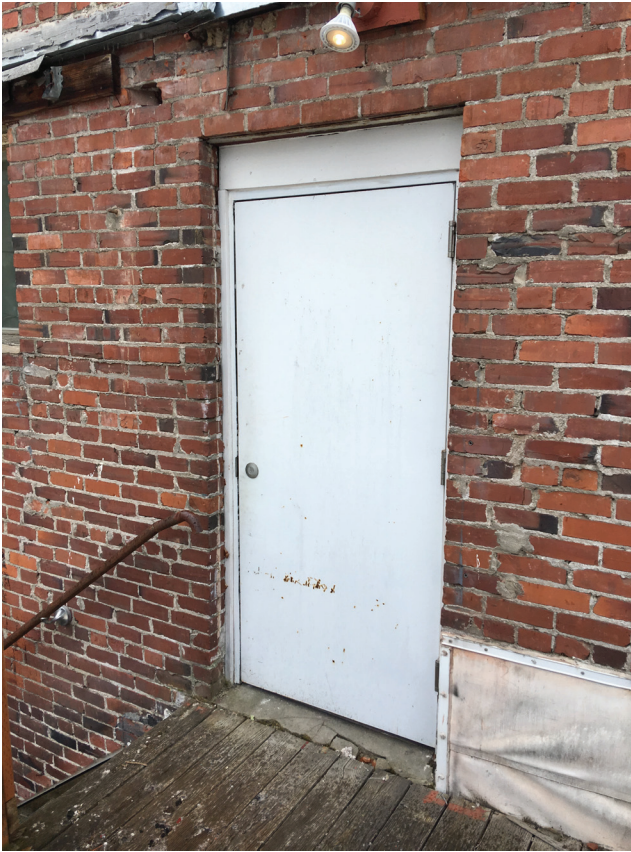
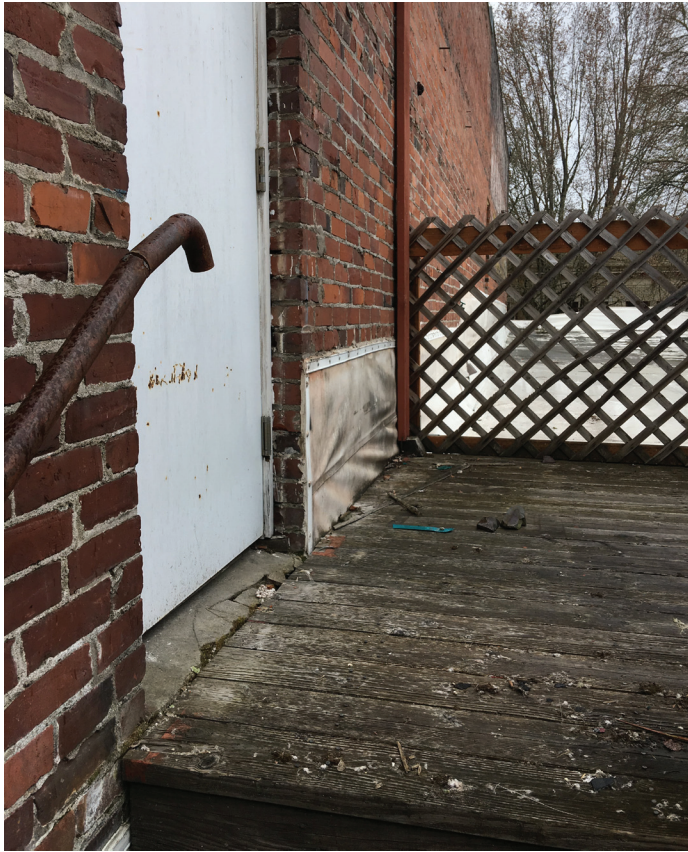
SECOND FLOOR EGRESS DOOR AND ROOF DECK AT EAST FACADE

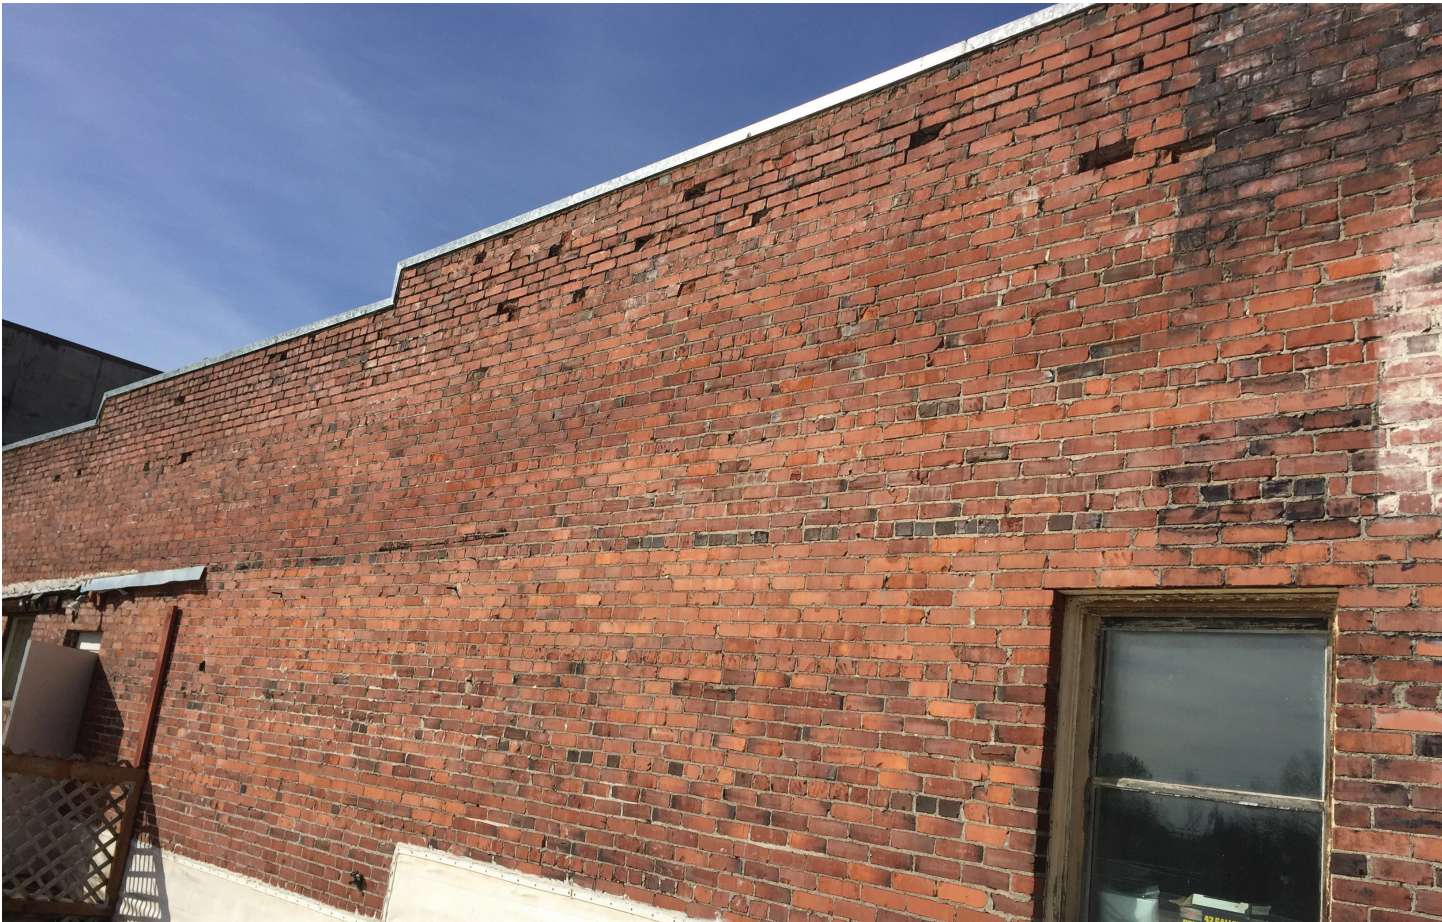
EAST FACADE, SHOWING MISSING AND DAMAGED BRICK

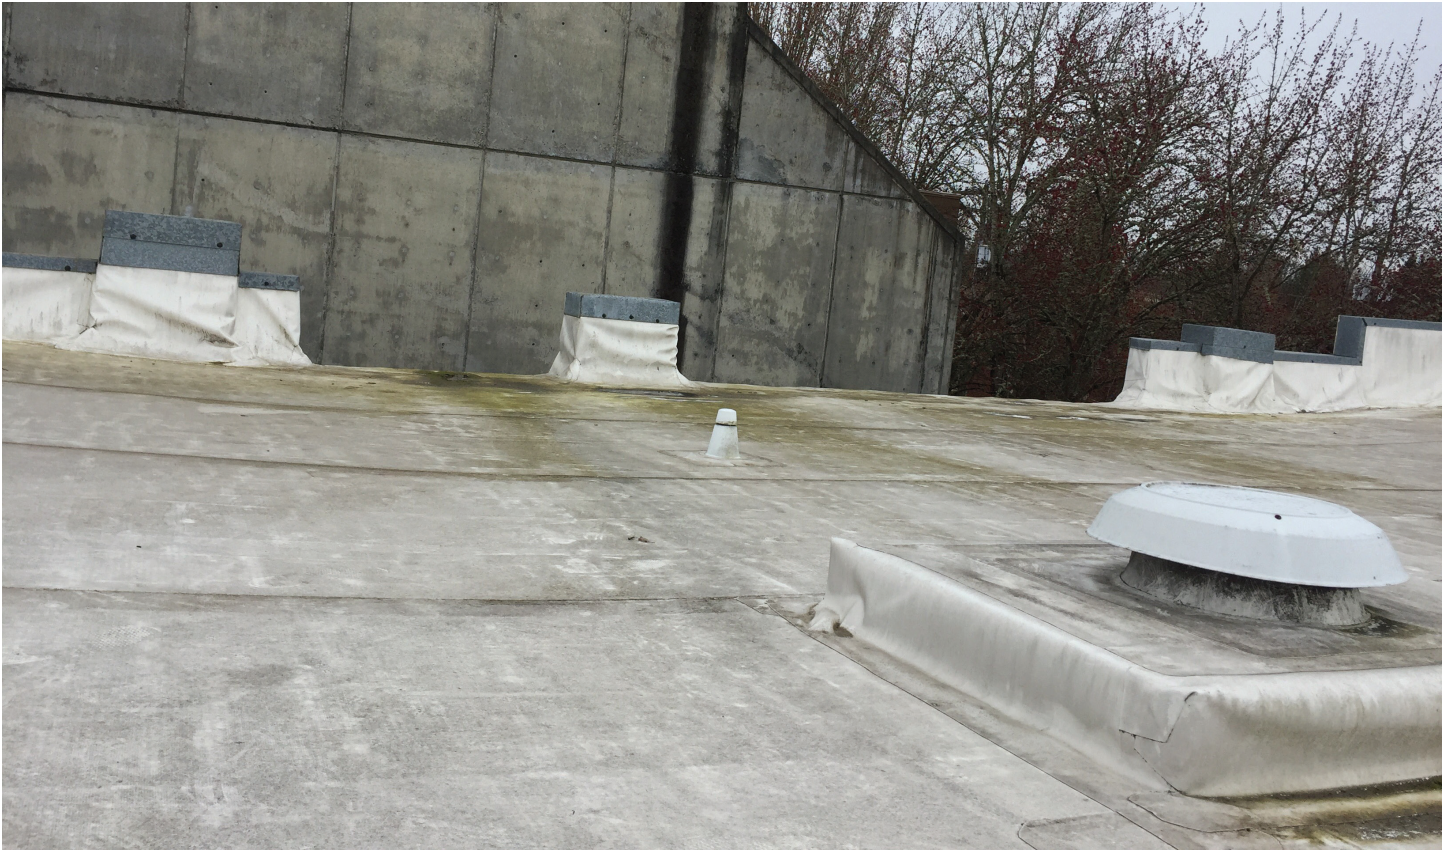
ROOF, LOOKING SOUTH TOWARD CHIMNEYS AT ALLEY

One chimney on the west façade has been shortened and will be rebuilt to its original height using red bricks salvaged from the tops of other chimneys that are now, and will be, hidden by cap flashings. There is also a large crack in the upper southwest corner of the west façade. It will be investigated, repaired and perhaps structurally reinforced using brick salvaged from other parts of the building.

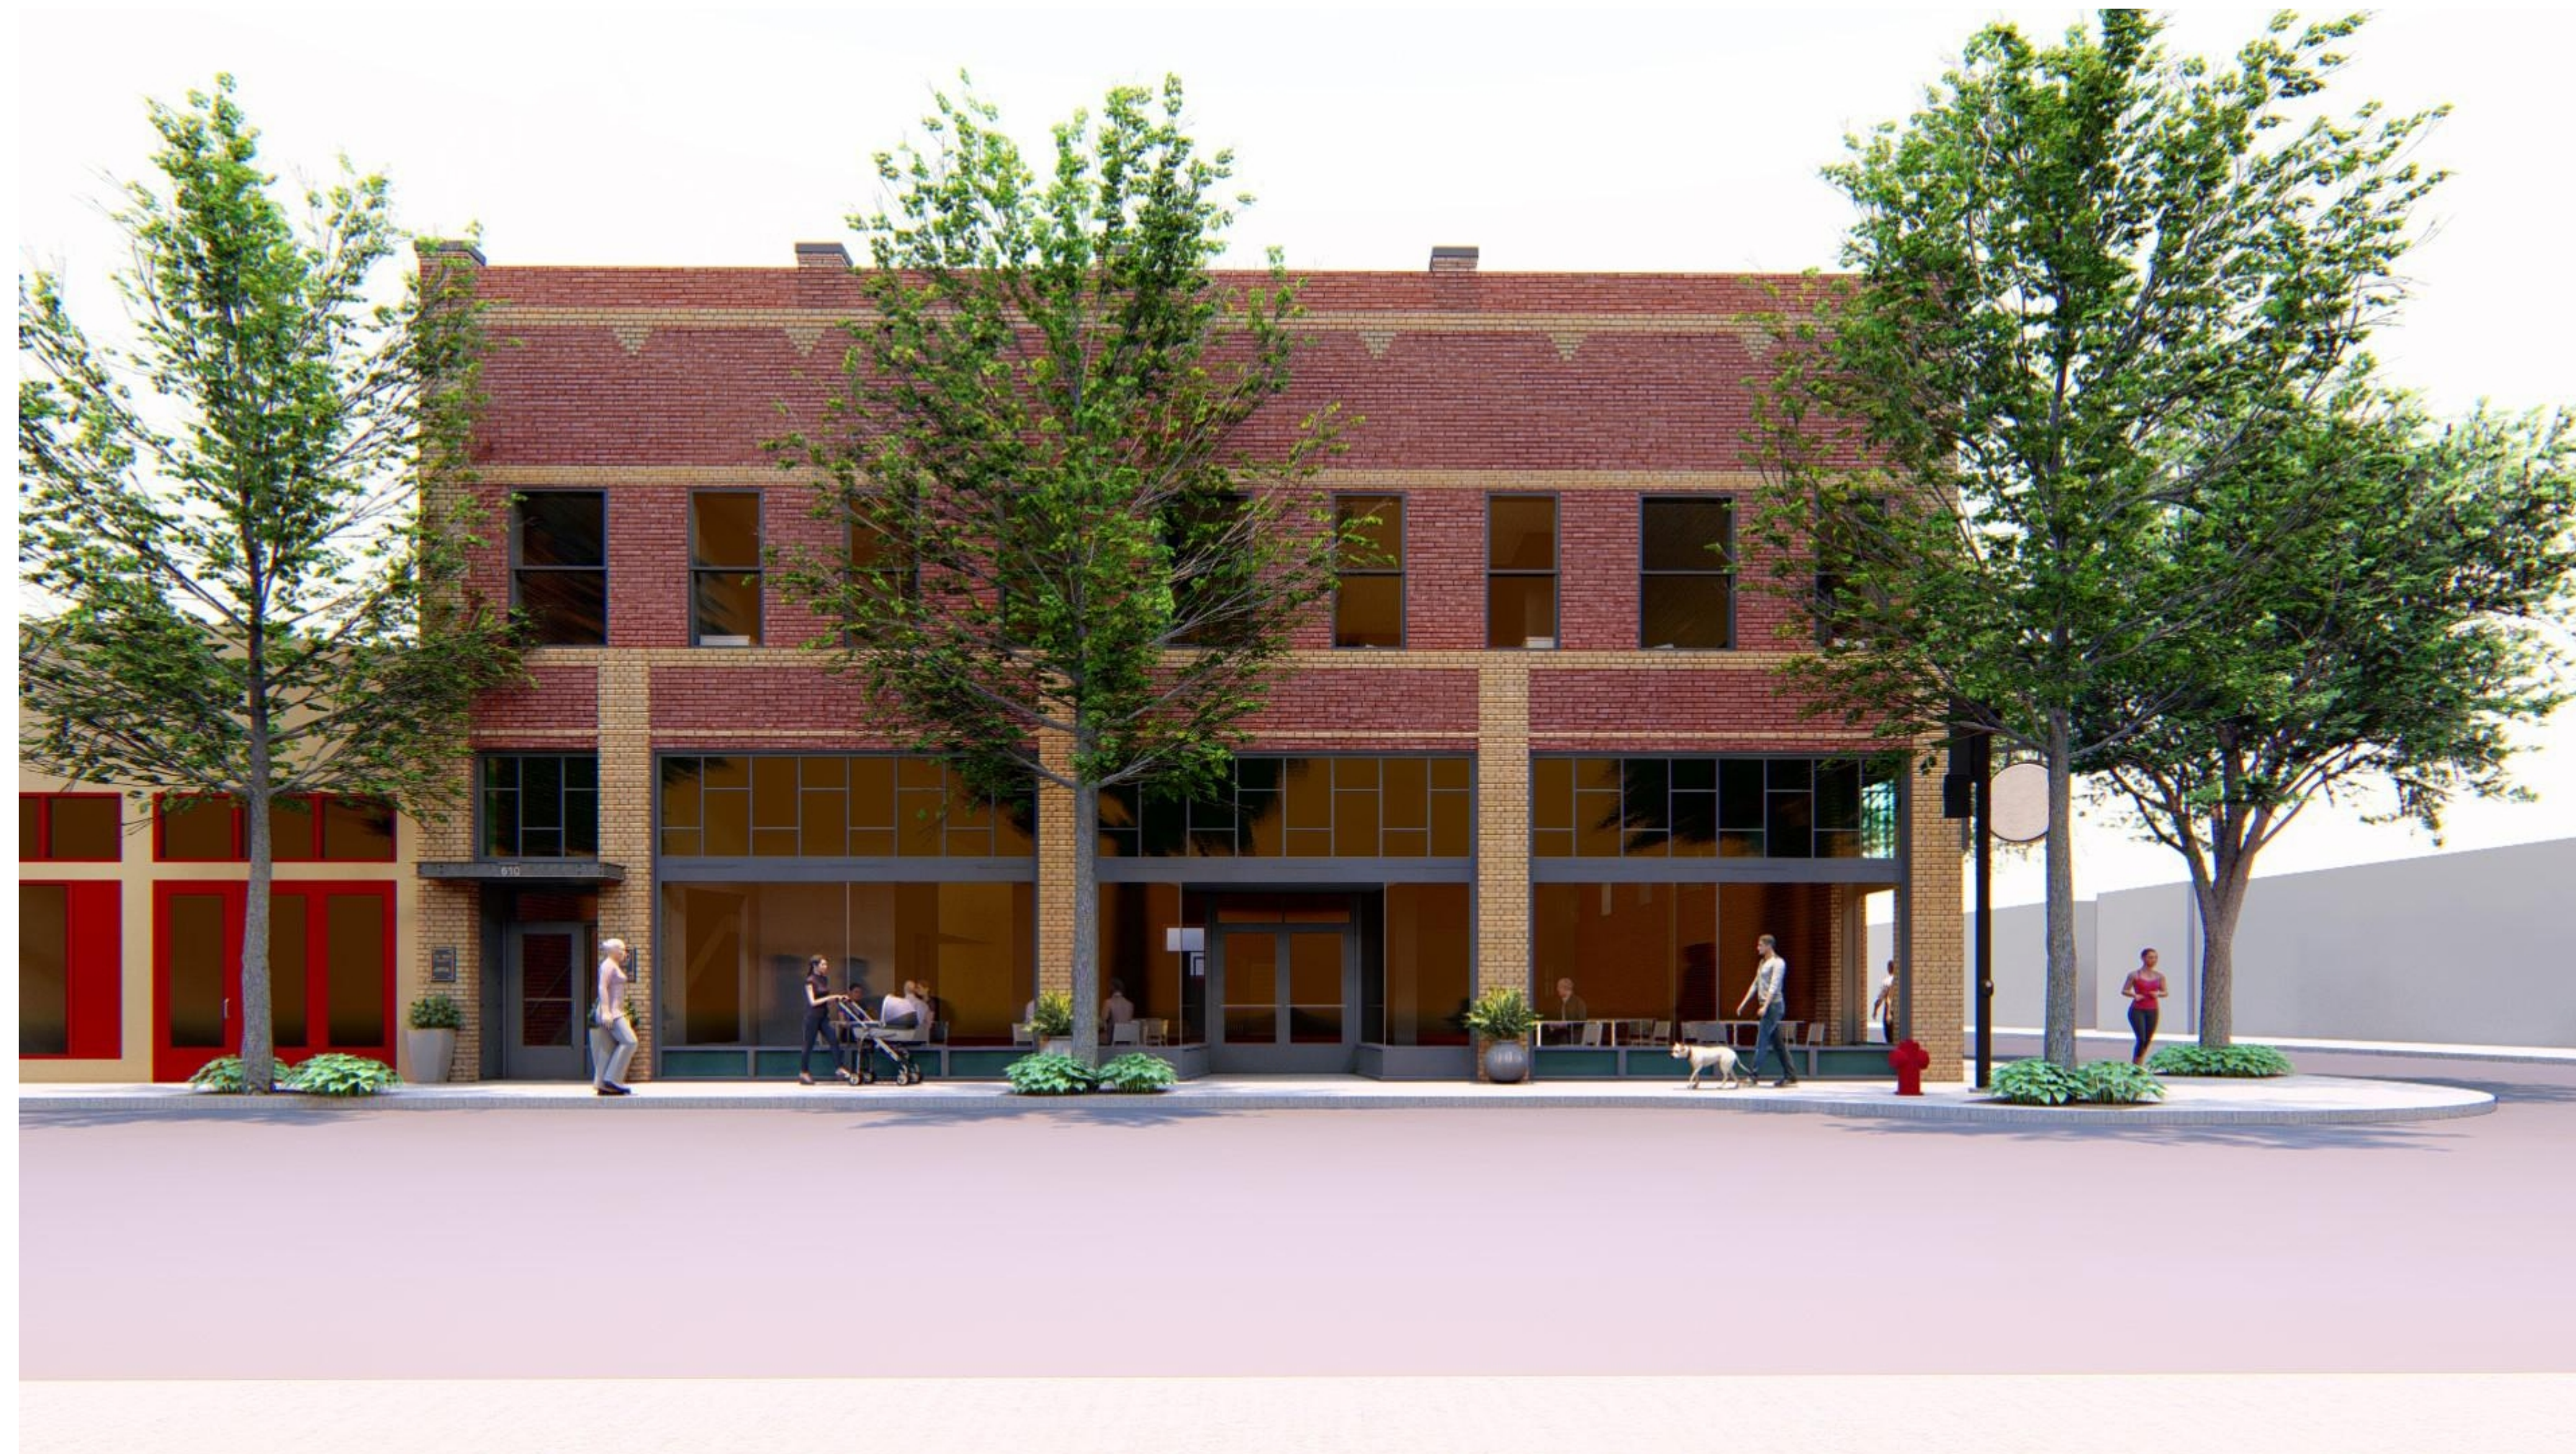
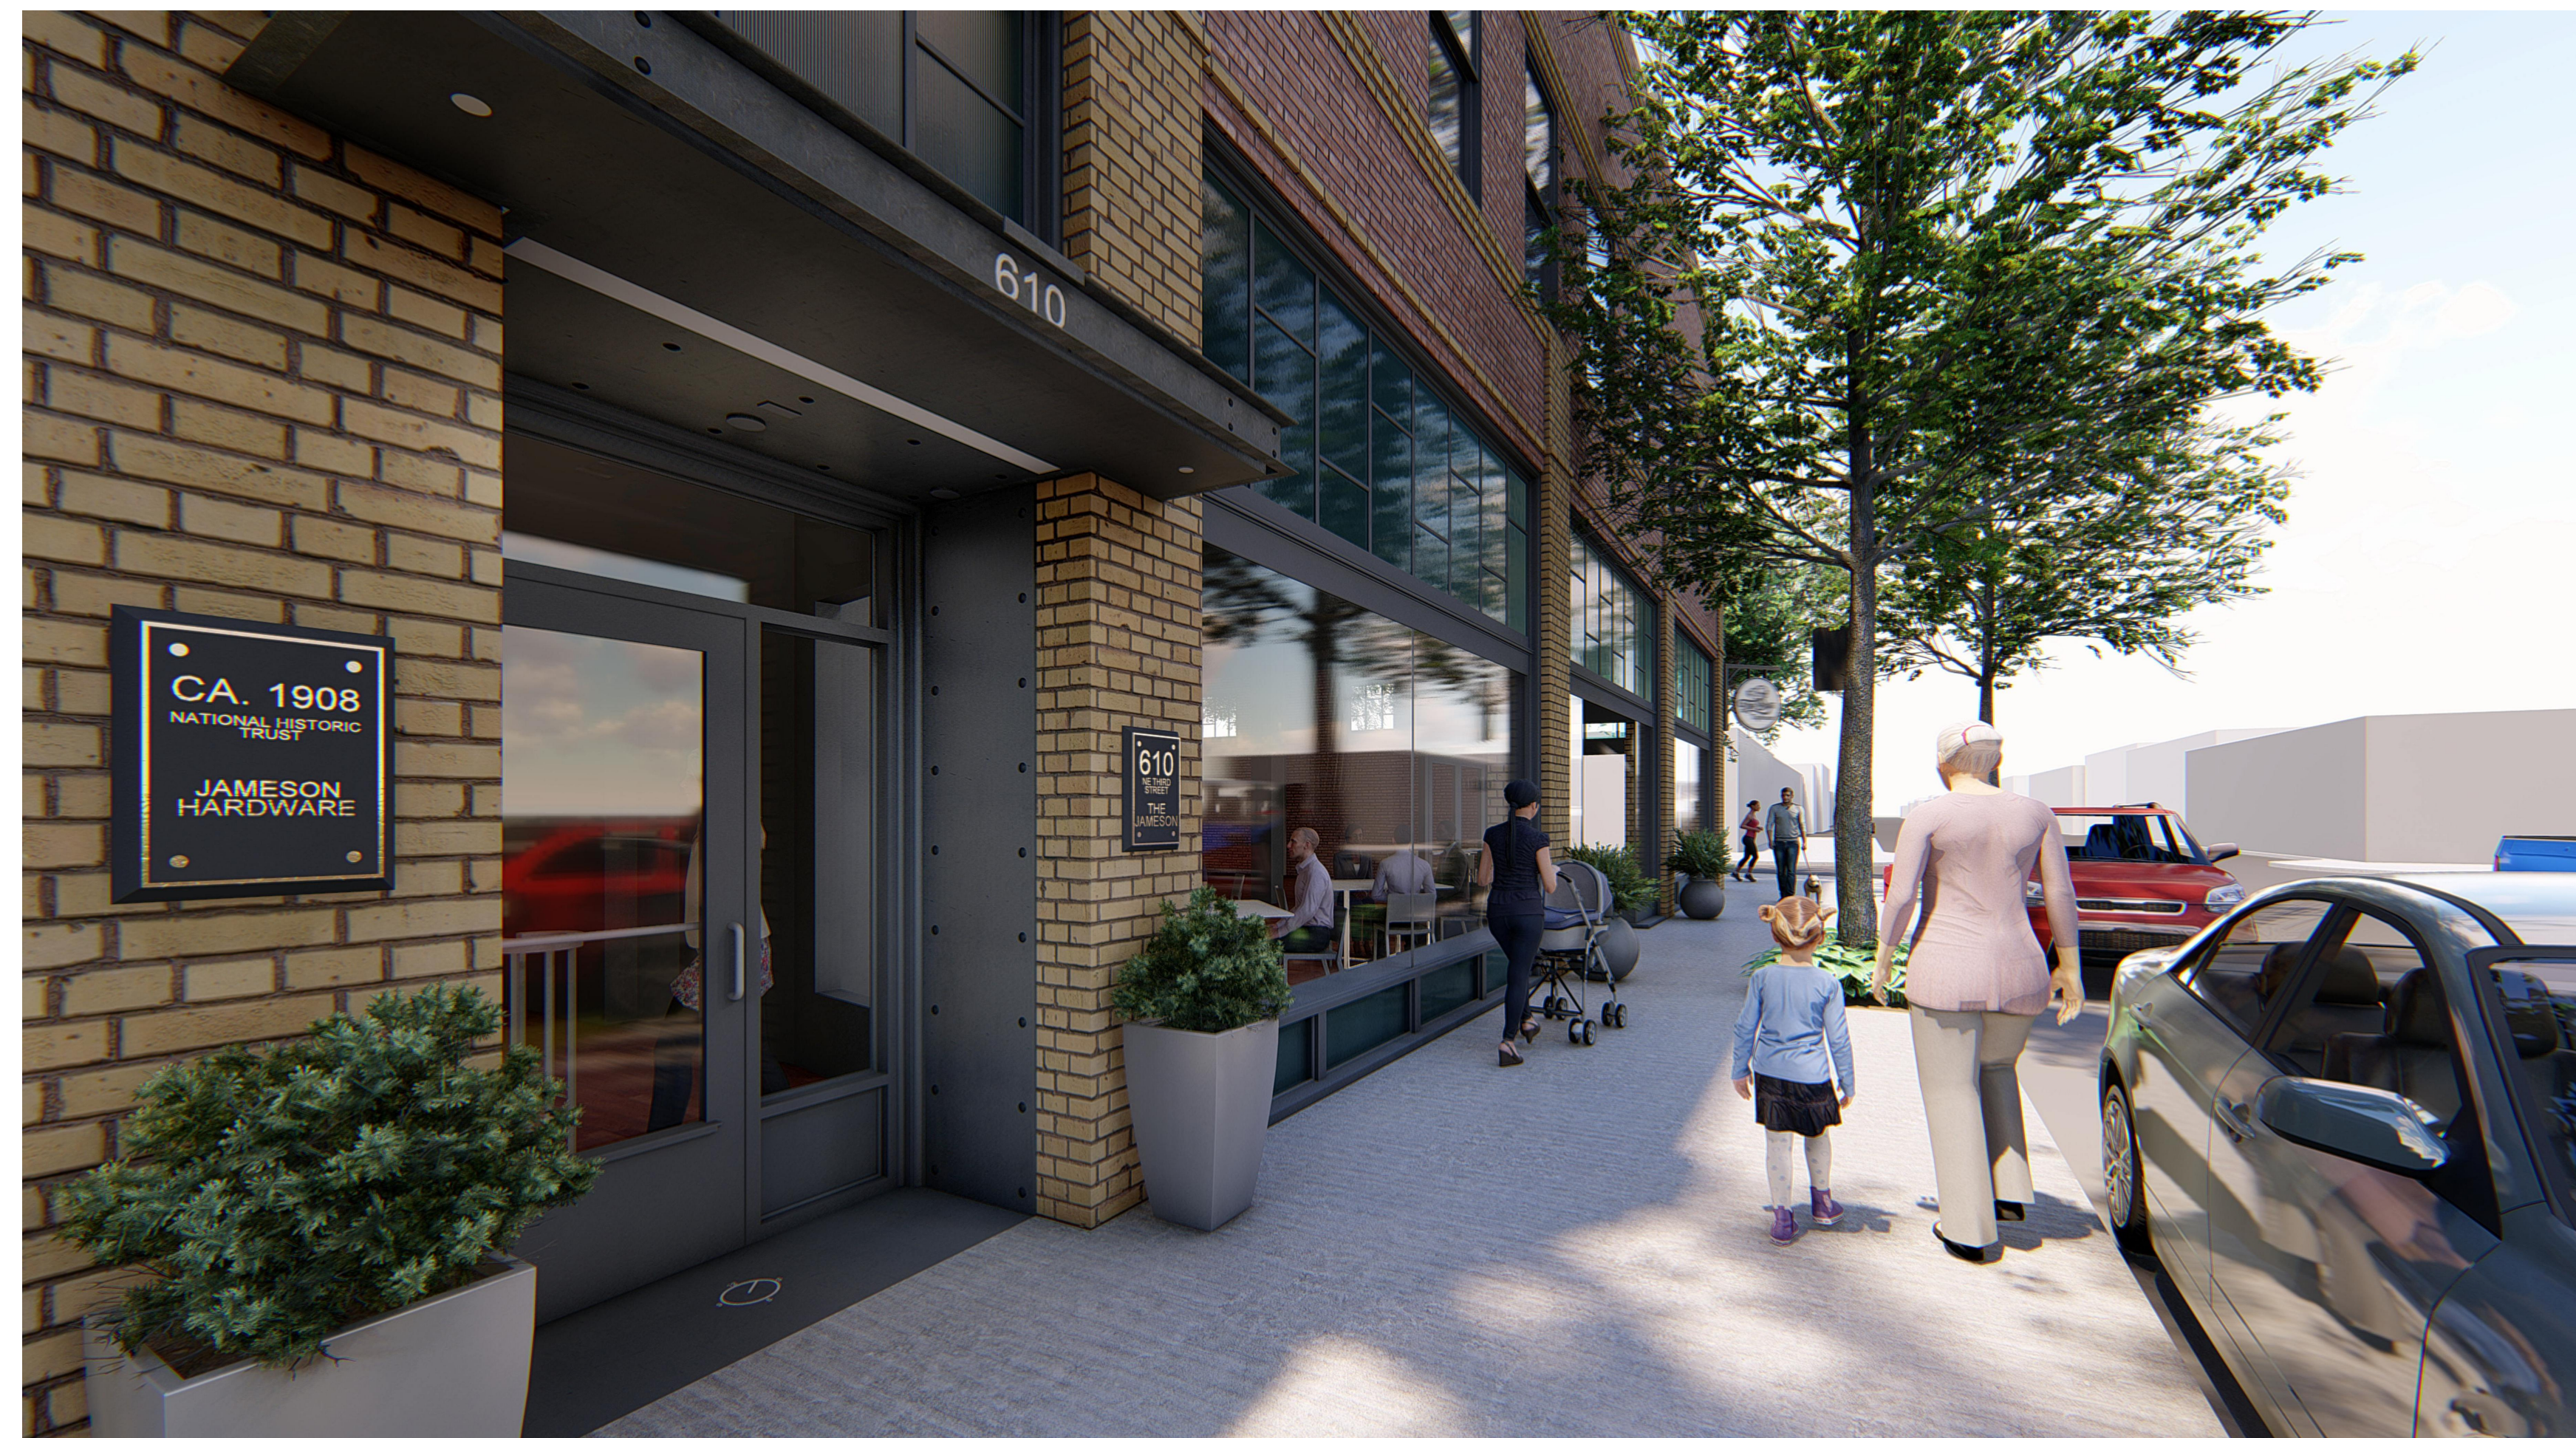
UPPER IMAGE: NORTH ELEVATION ACROSS NE 3RD STREET  
 BOTTOM IMAGE: PROPOSED ENTRANCE TO SECOND LEVEL
