608 NE 3RD ST. EXTERIOR ALTERATION

## Certificate of Approval (Alteration)

Property Address 608 NE Third Street, McMinnville, OR 97128

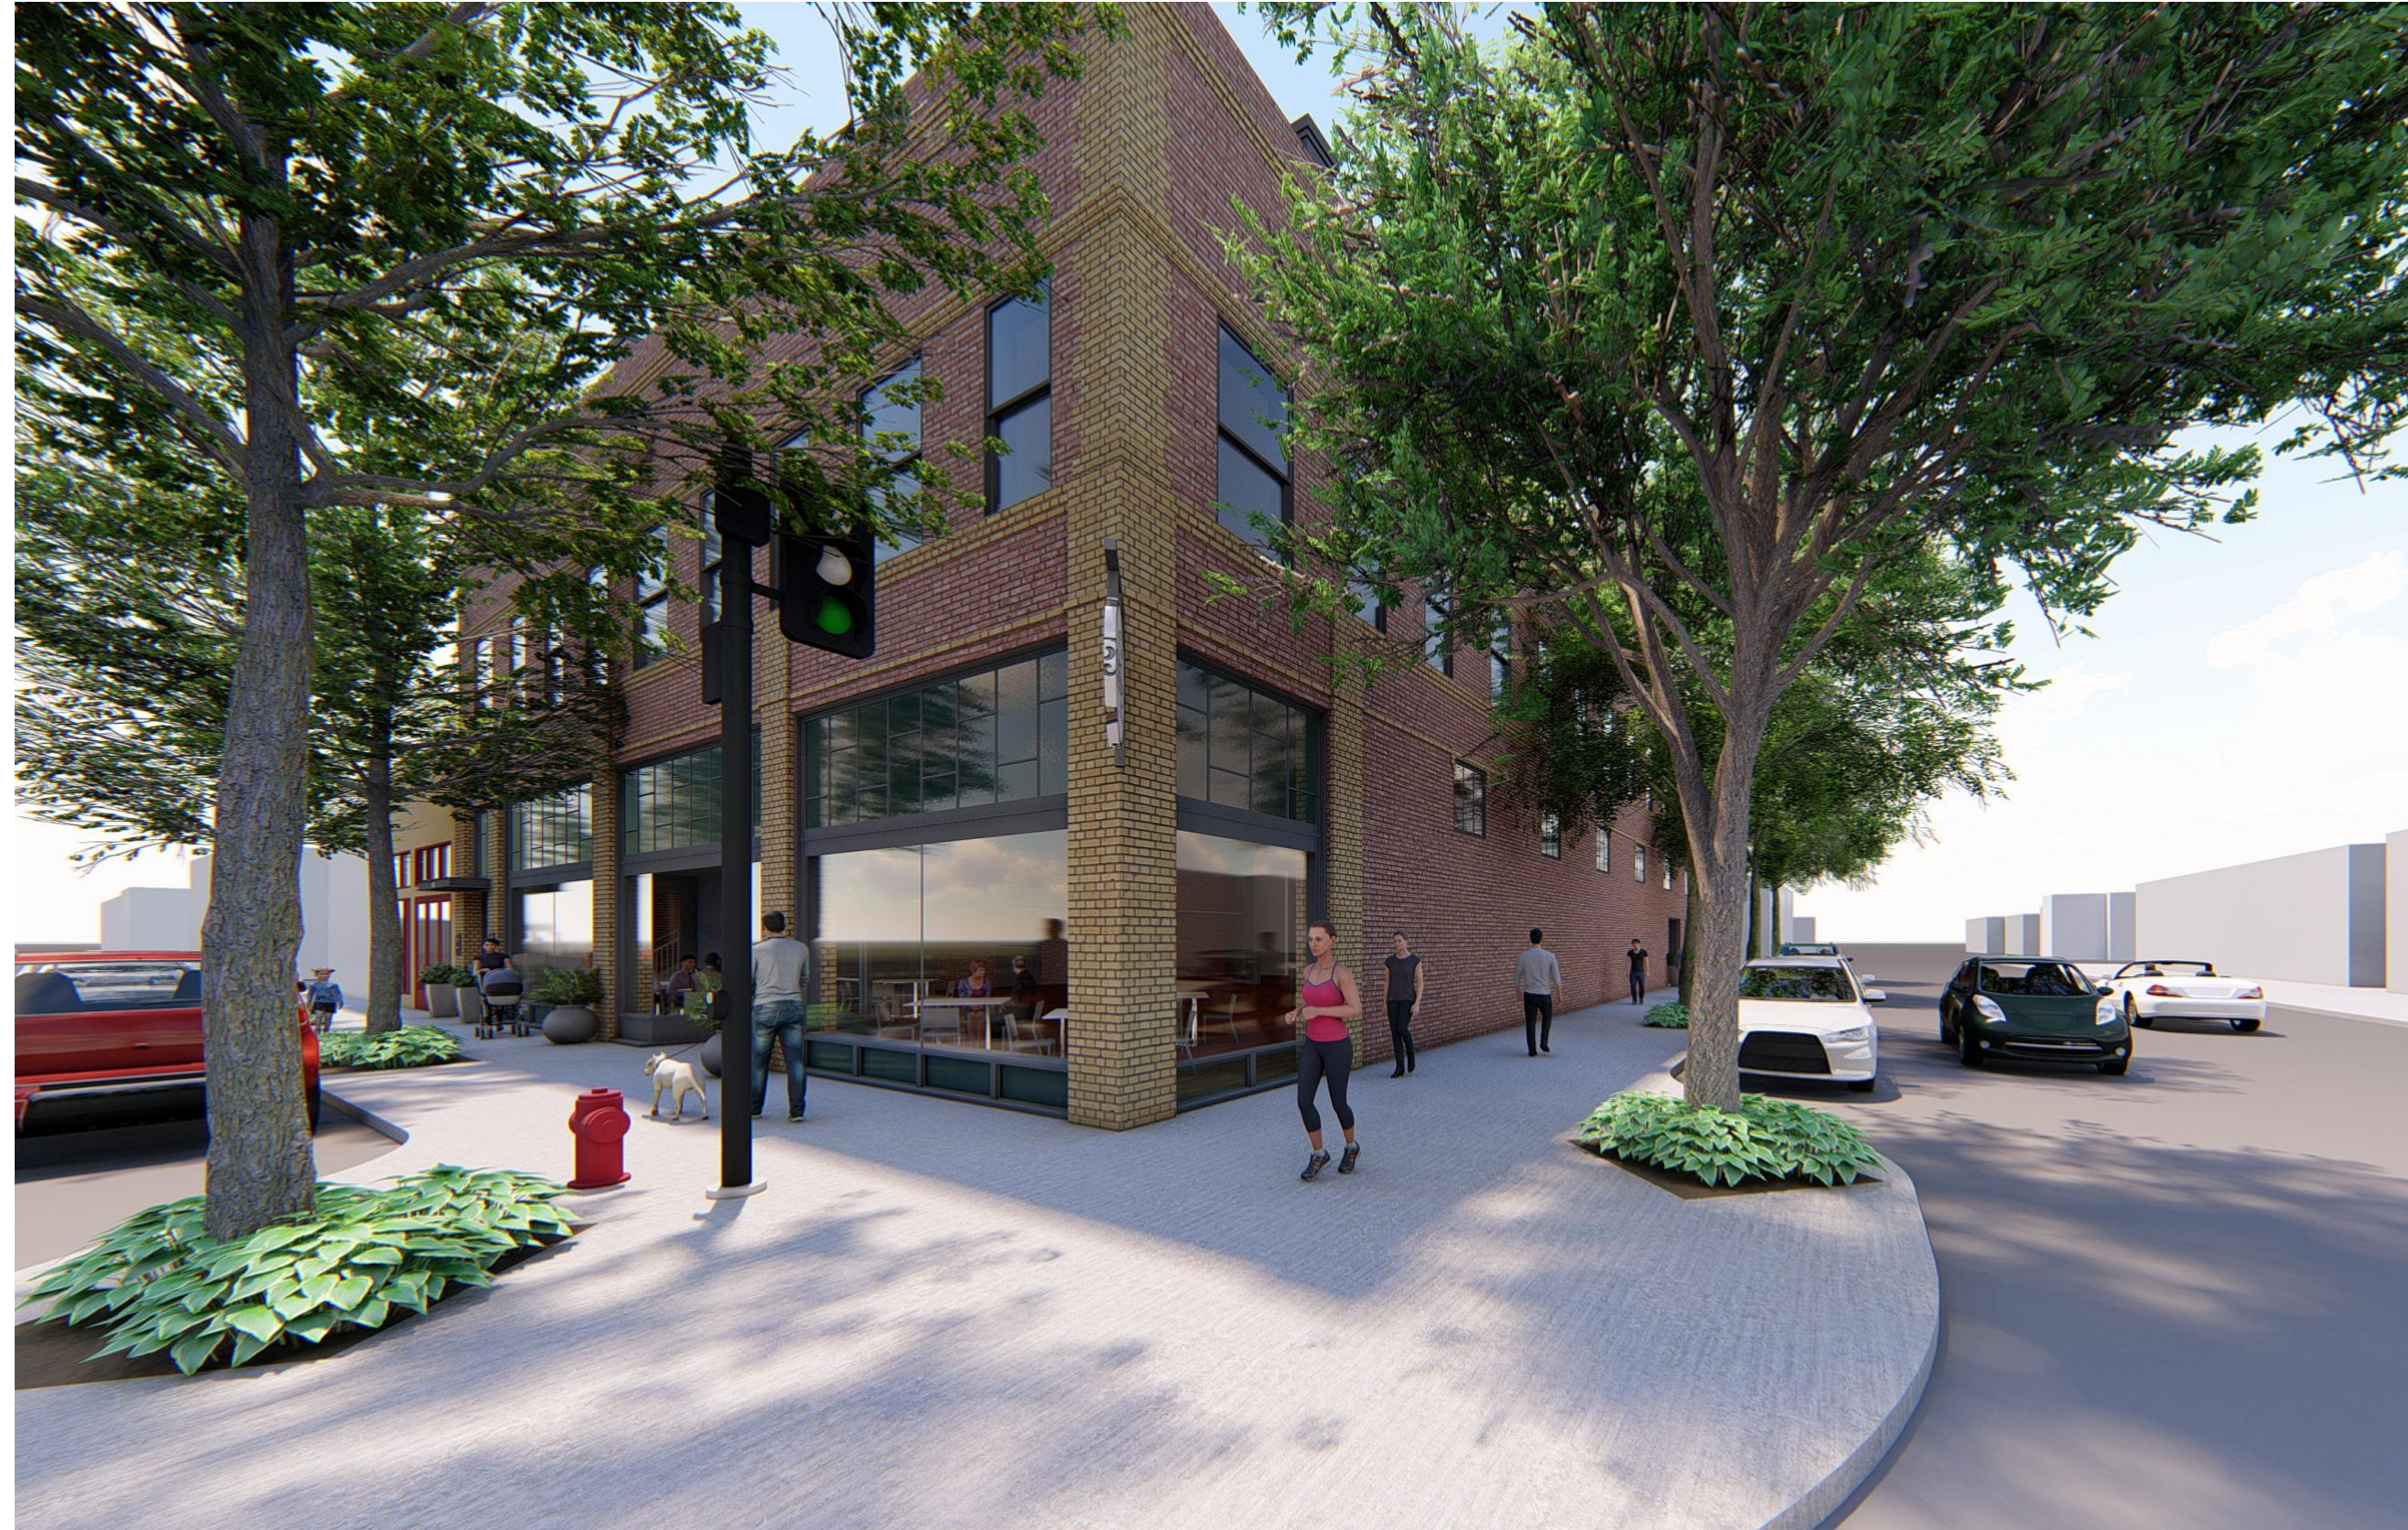
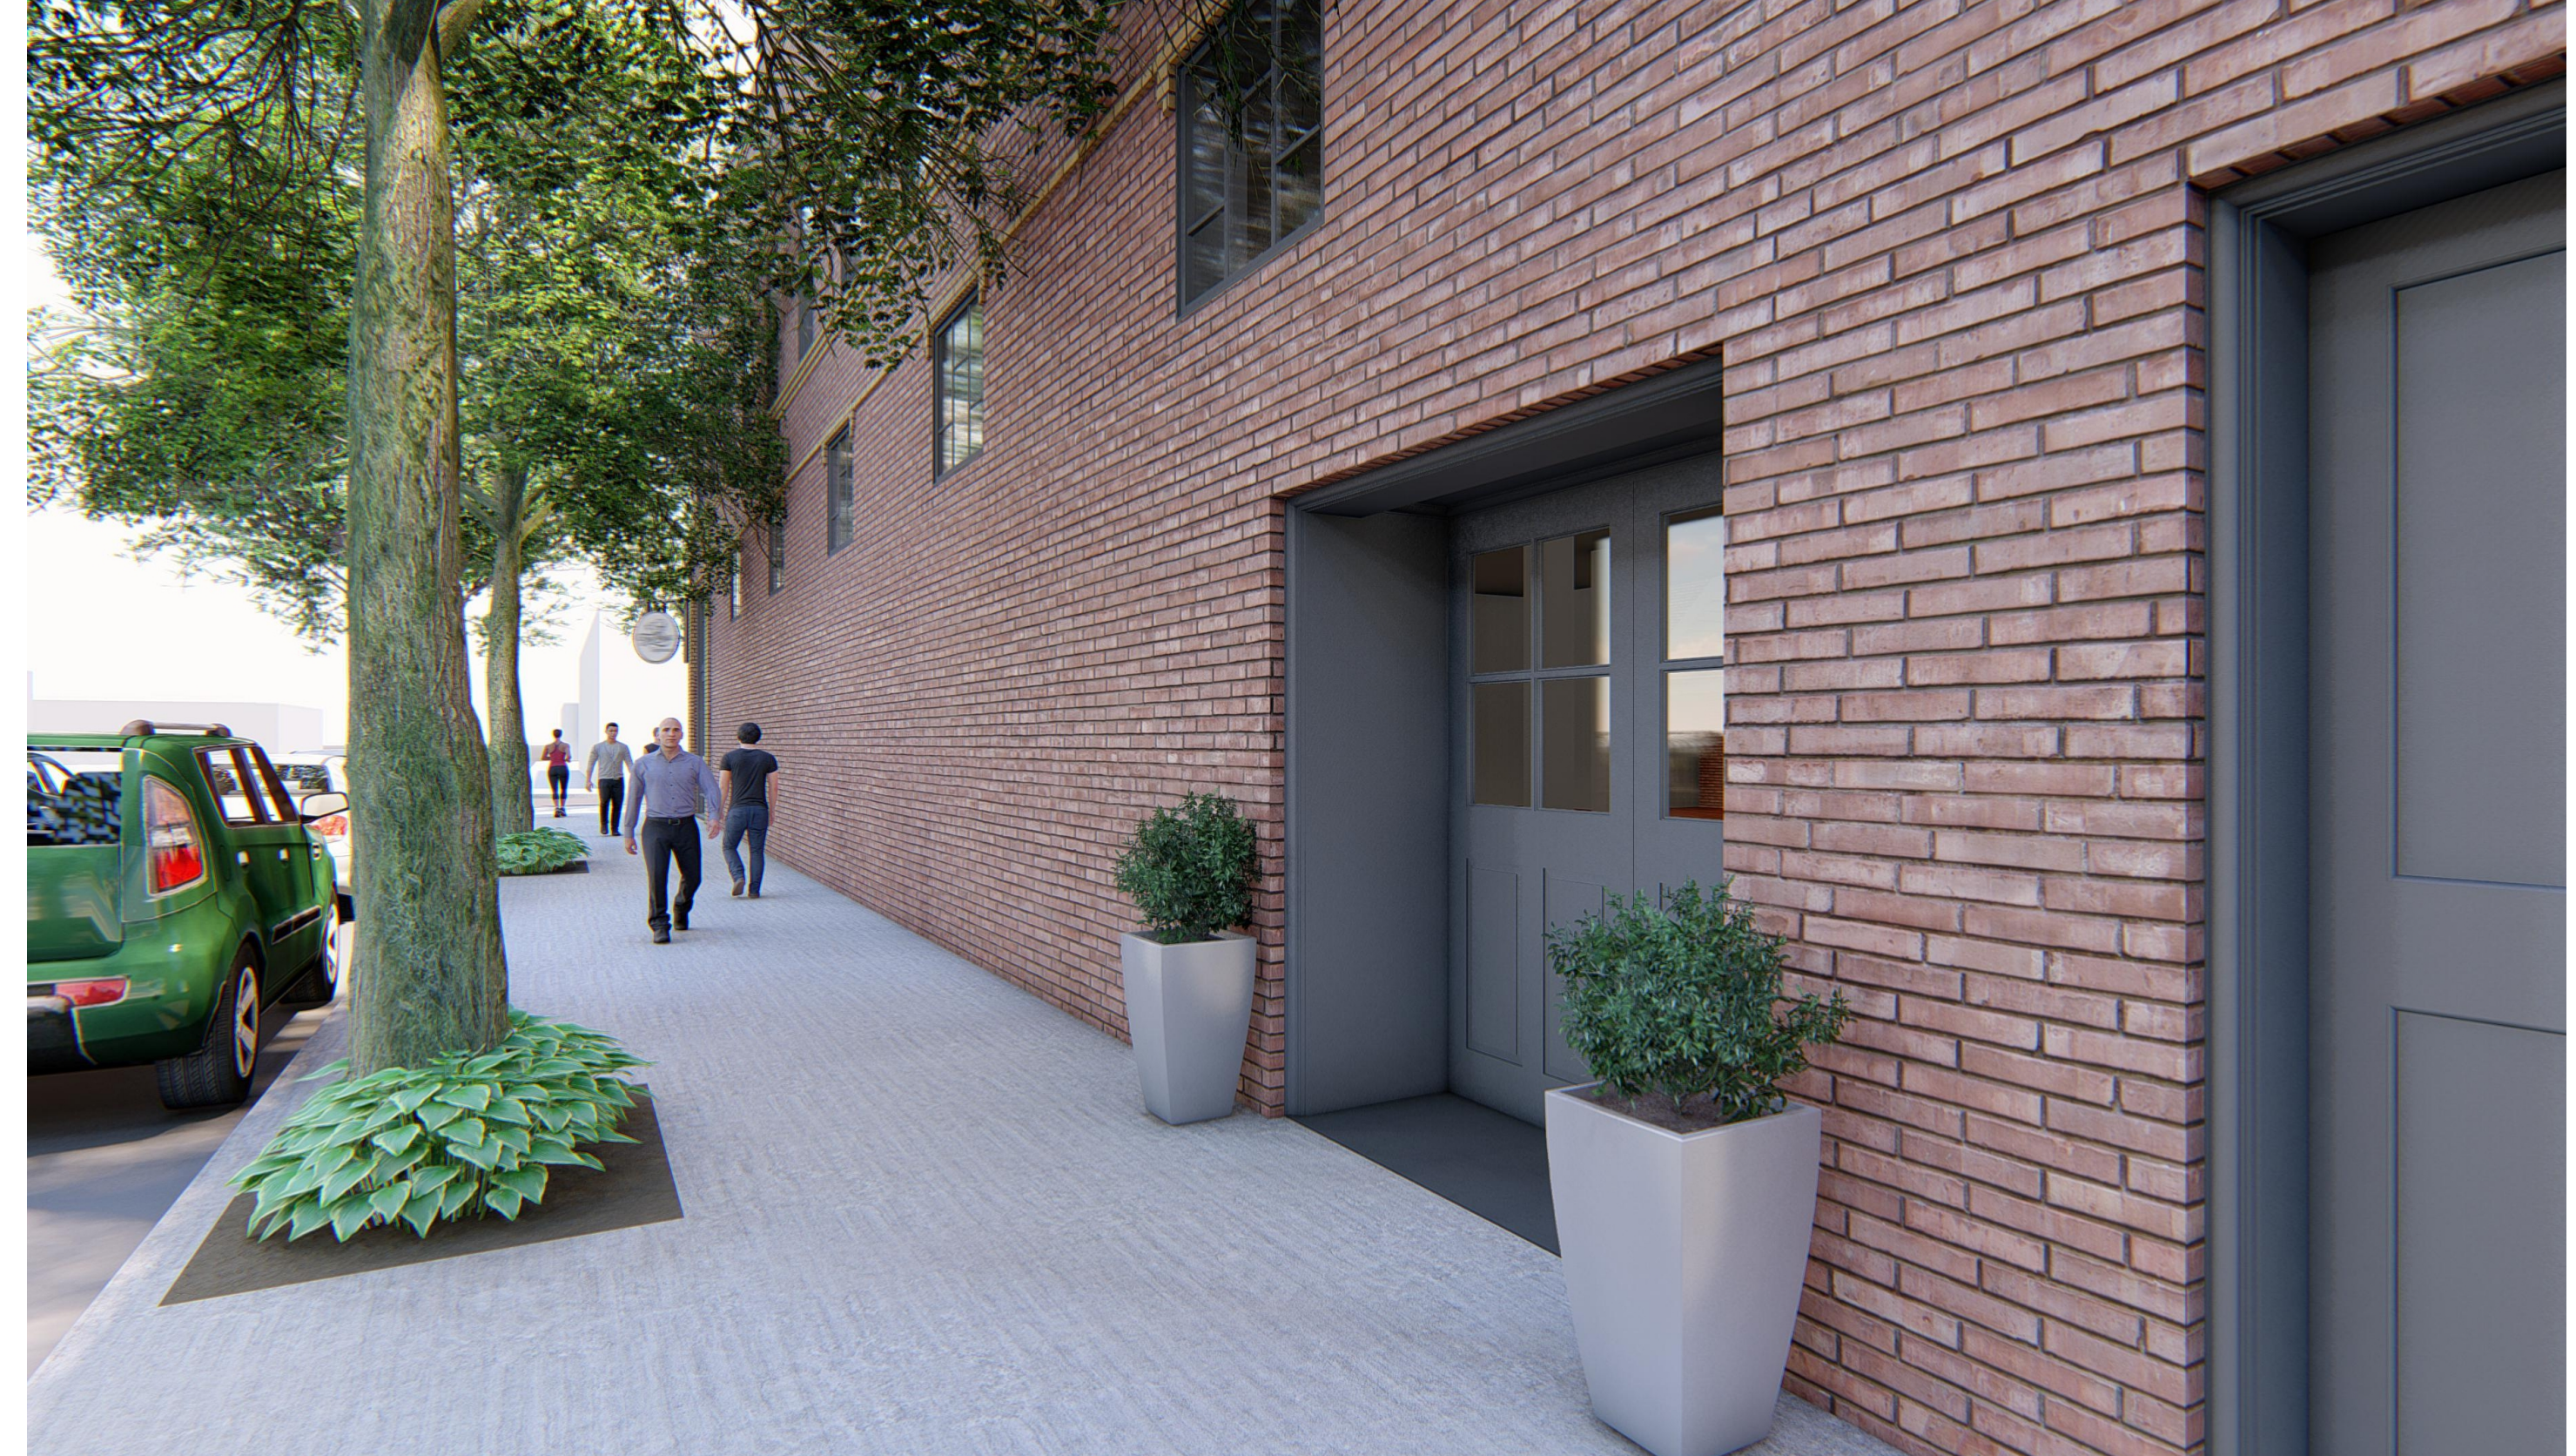
UPPER LEFT IMAGE: PERSPECTIVE OF NORTH WEST CORNER

UPPER RIGHT IMAGE: PROPOSED RECESSED ENTRANCE

The north and west storefronts will be restored in their original configuration. The large, 8' x 7', panes of plate glass will be replaced with tempered glass. Broken panes in the clerestory and bulkhead will be replaced if matching glass can be found. The original metal and wooden sashes will be cleaned, repaired and repainted.
