**Historic Resources Survey
City of McMinnville
Yamhill County, Oregon**

1005 NE Lafayette Avenue

Historic Resource No. B830

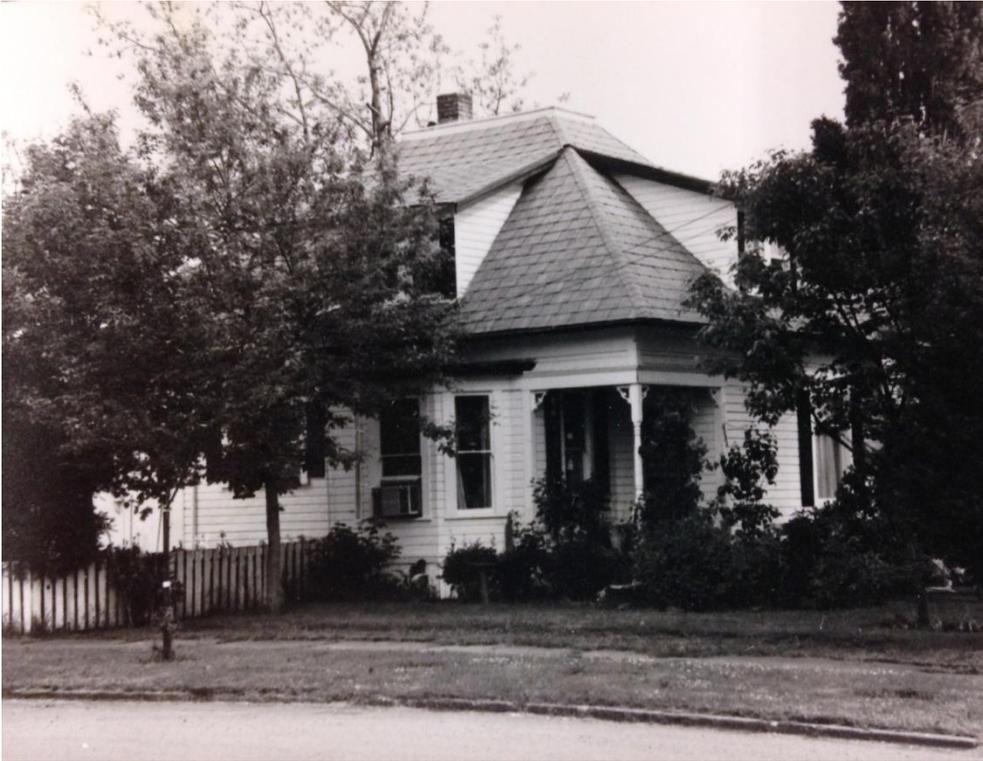
Small cracks in walls, chimney; Broken gutters or downspouts.

This is a fairly small one and one-half story wood frame dwelling of an unusual and attractive vernacular design. The basic floor plan is a perfect square. The roof is a high hip with a small flat top. On the northeast, southeast, and southwest sides are located large, shed-roofed dormers in perfect symmetry; their roofs intersection just below the flattened roofline, lending the main roof the air of a series of large corner hoods. The main entrance is located in the southern corner, in a small, square inset porch, decorated with a broad upper verge board, a lathed corner post and lathed brackets. Windows are double hung, with one light beneath a transom and are quite tall. Their upper mouldings are broad, extending to the eaves and are continuous with the verge board and moulding above the corner porch and with the cornice of a hipped-roof hexagon bay in the southwestern wall, giving an attractive continuity. The original tongue-in-groove siding and corner boards are preserved. This is a well preserved structure of interesting architectural design, altered only by the recent addition of a shed-roofed enclosed porch in the rear.

Original 1983 Survey Photo
